**The Influence of Sulphidizing Attack on the
Mechanism of Failure of Coated Superalloy Under
Cyclic Loading Conditions**

**Submitted in fulfilment of the academic requirements for the degree of
PHD in Mechanical Engineering in the Department of Mechanical
Engineering, University of Natal, Durban.**

January 1998

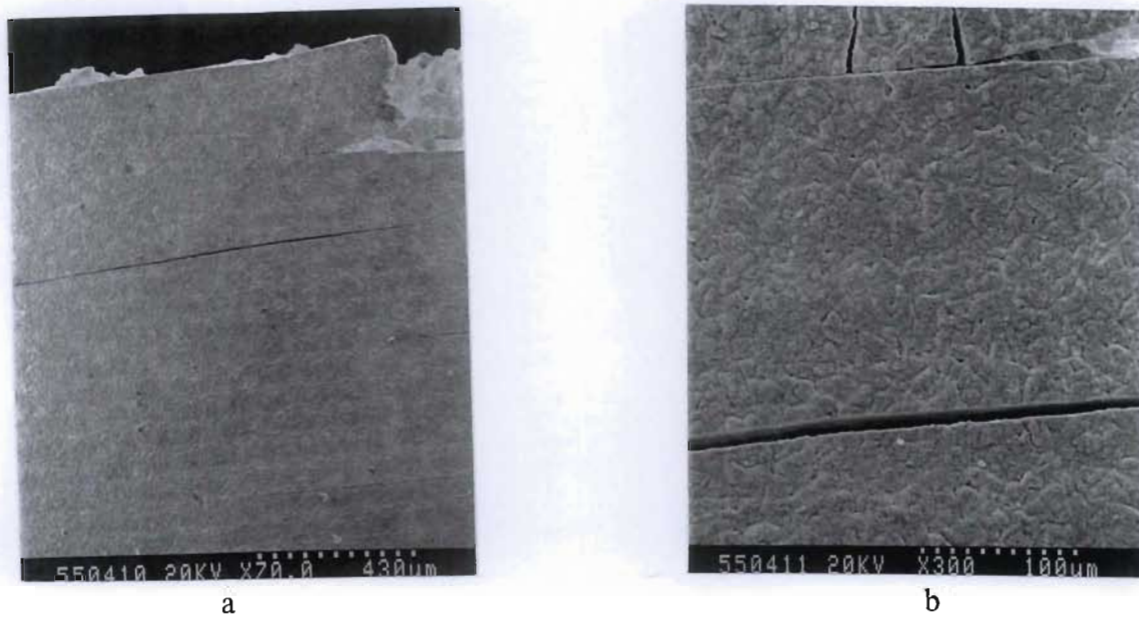
Figure 3.17 : Cracking of the coating near the fracture surface after HTLCF in argon atmosphere

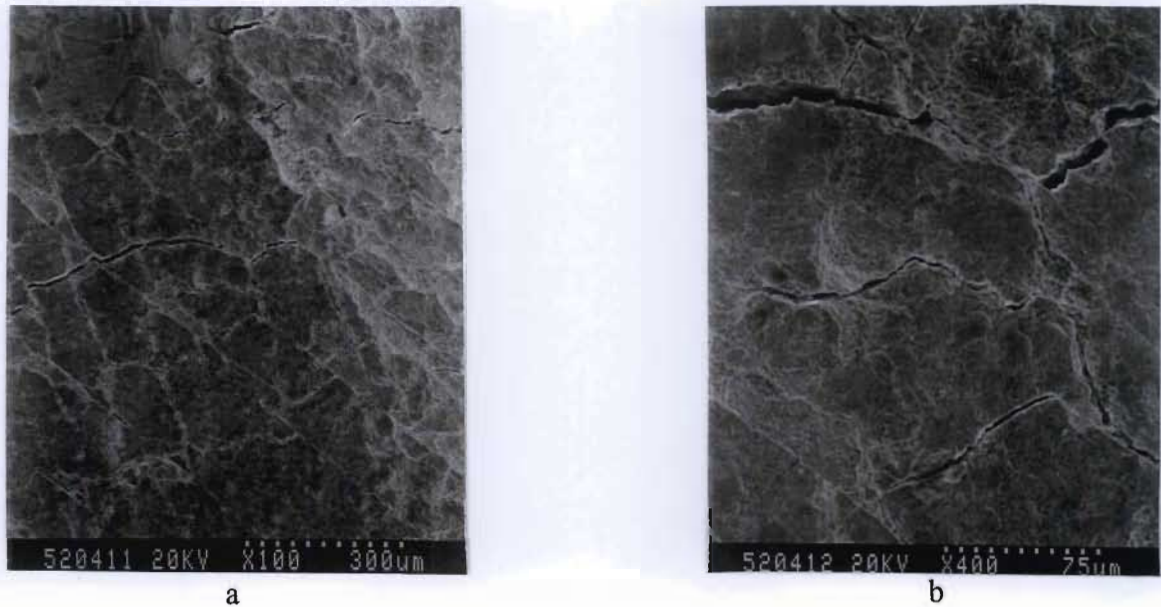
Figure 3.24 : Cracking of TYPE II platinum aluminide coating near the fracture surface after HTLCF in argon atmosphere

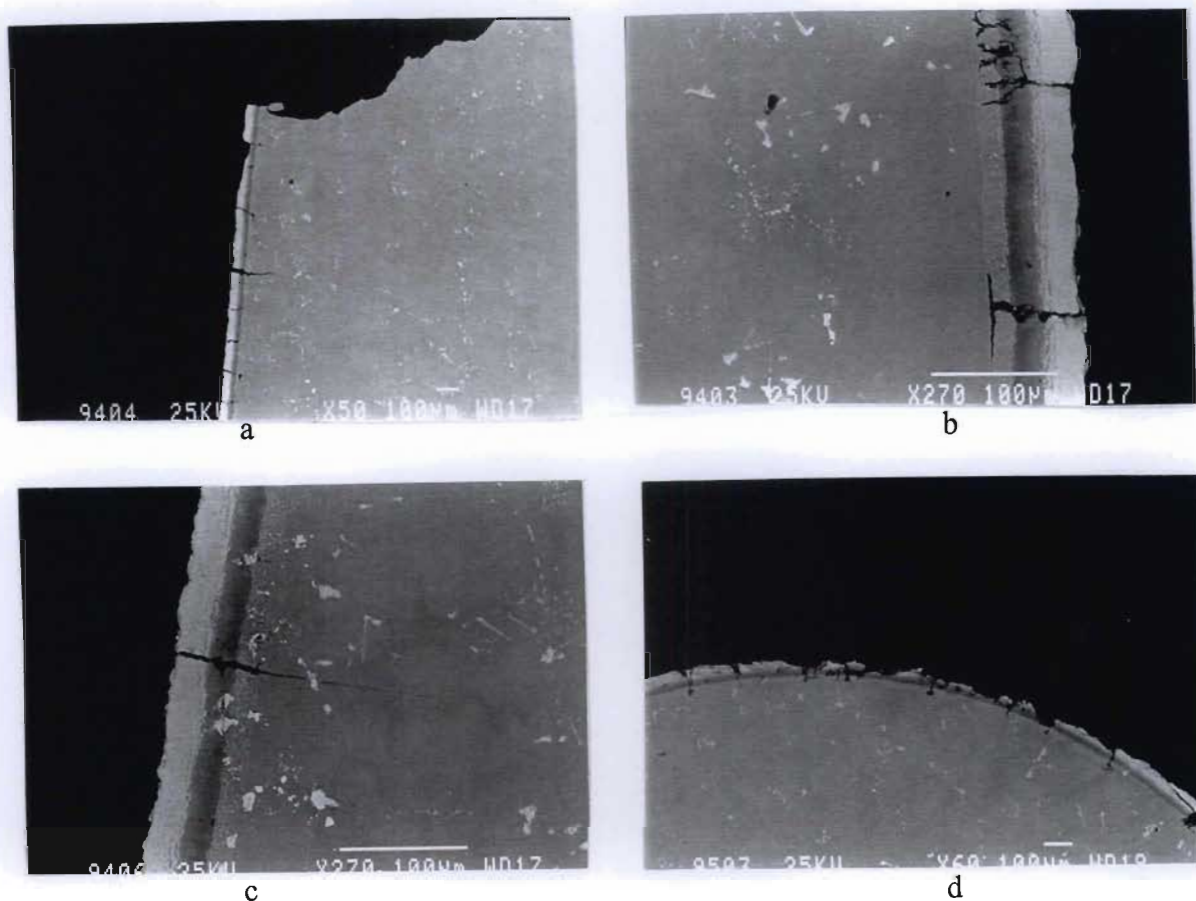
Figure 3.25 : Cross-sectional analysis of TYPE II platinum aluminide coated MAR-M002 after HTLCF in argon atmosphere showing a very coating

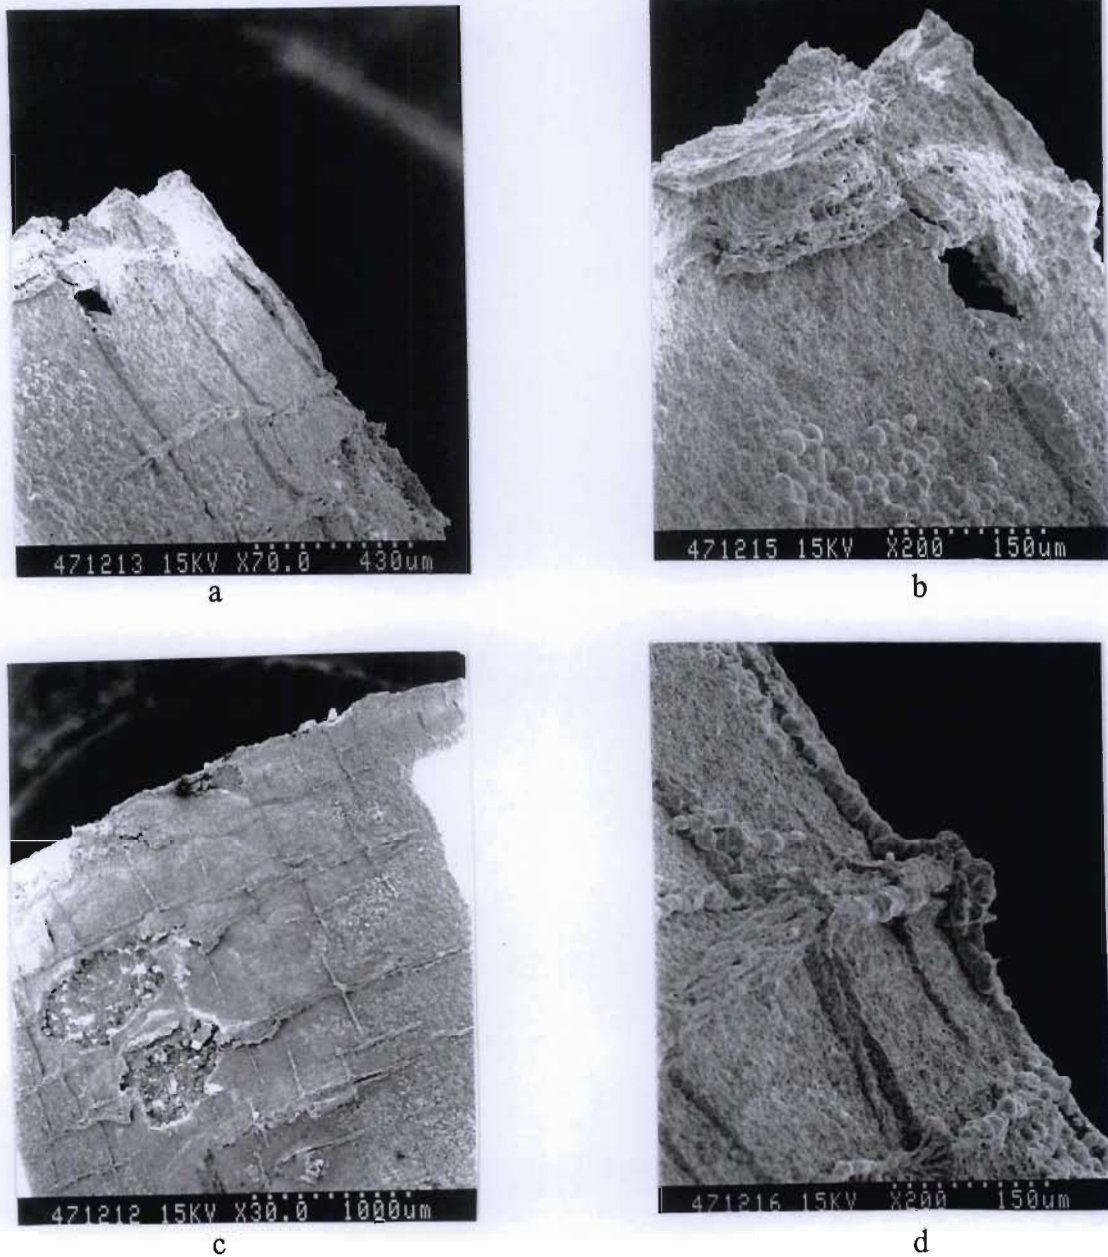
Figure 3.48 : Fractography of uncoated MAR-M002 after HTLCF in SO_2 bearing atmosphere.

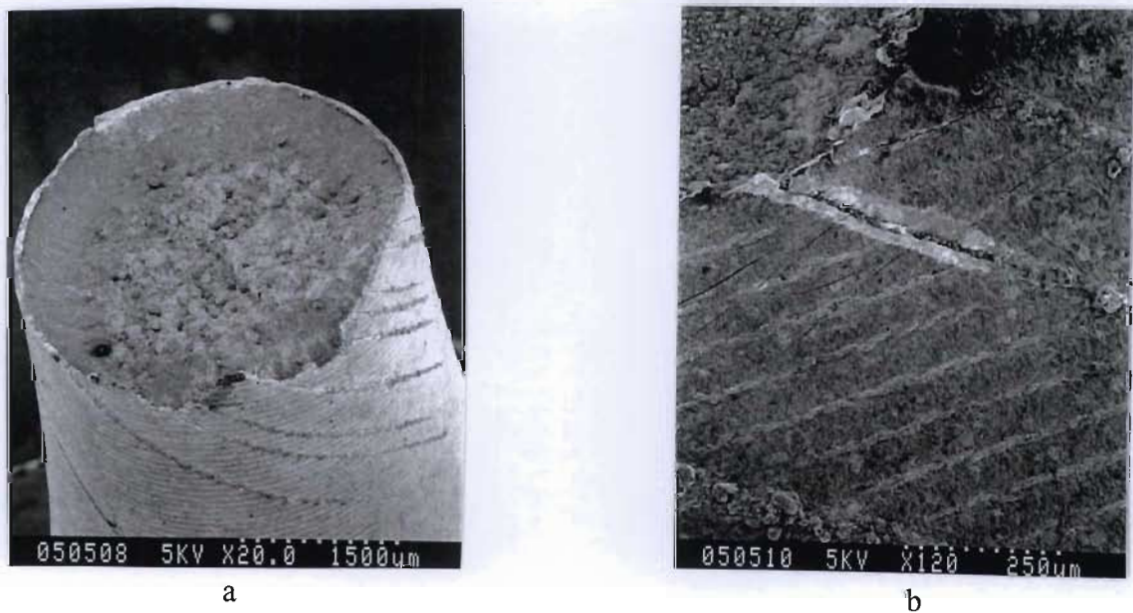
Figure 3.54 : Cracking of the coating close to the fracture surface due to HTLCF IN Ar + 5%SO₂ (S.R. 0.66%)

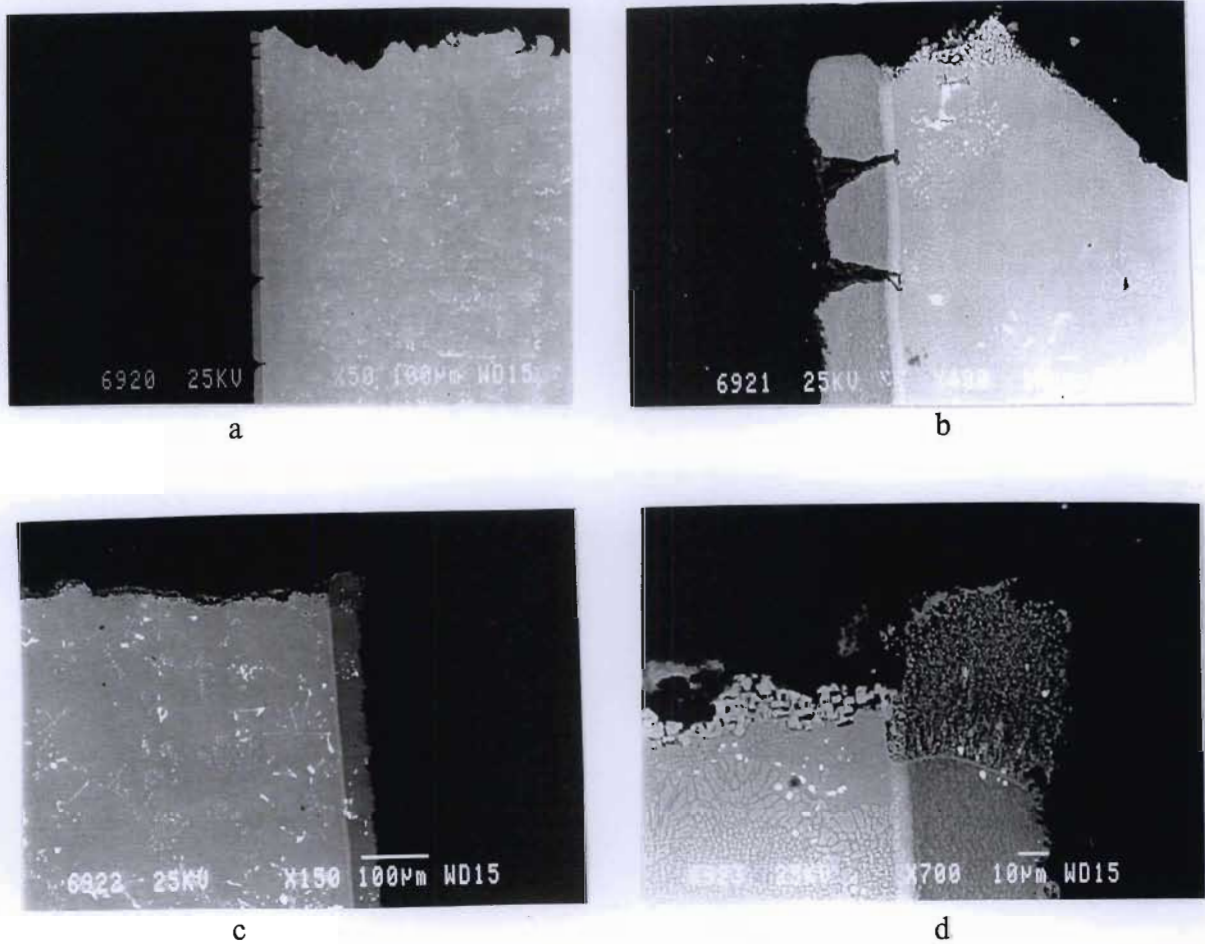
Figure 3.55 : Cross-sectional analysis of aluminide coated MAR-M002 after HTLCF in Ar + 5%SO₂

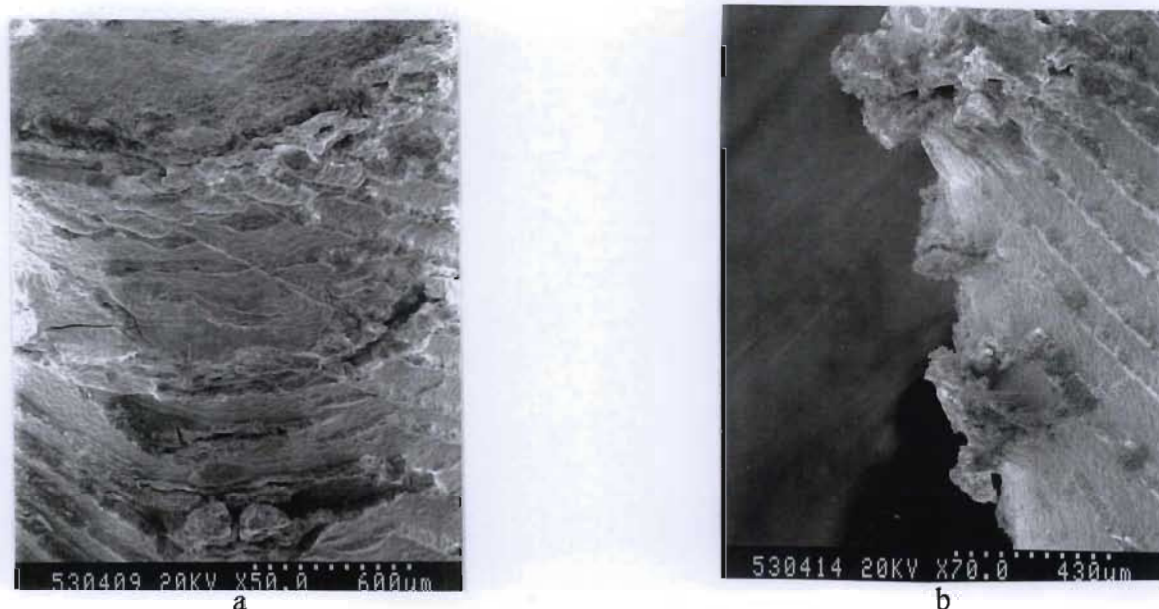
Figure 3.64 : Cracking of TYPE II platinum aluminide coating close to the fracture surface due to HTLCF IN Ar + 5%SO₂ (S.R. 0.66%)

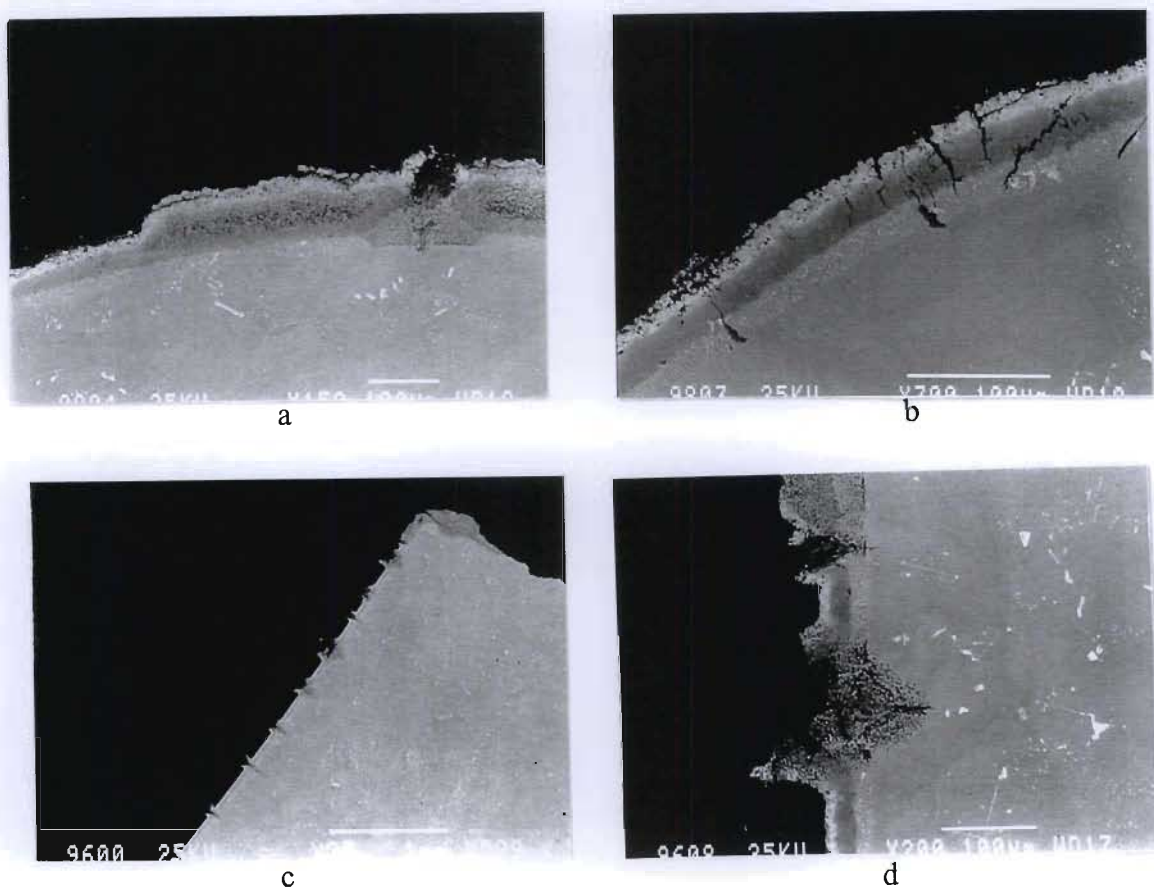
Figure 3.70 : Cross-sectional analysis of 2µm platinum aluminide coated MAR-M002 after HTLCF in SO₂ Containing environment (S.R. 0.66%)

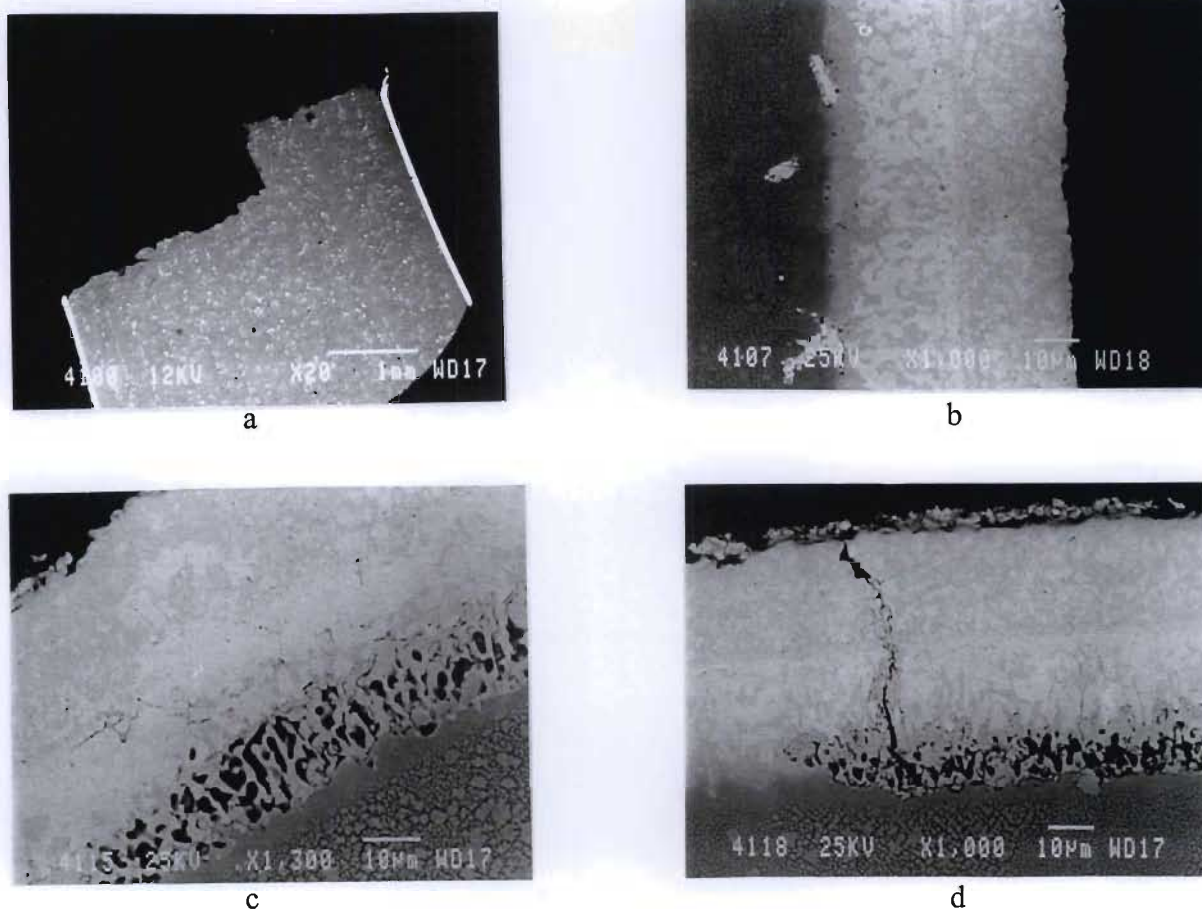
Figure 3.76 : Cross-sectional analysis of platinum coated MAR-M002 after HTLCF in SO_2 Containing environment (S.R. 0.66%)

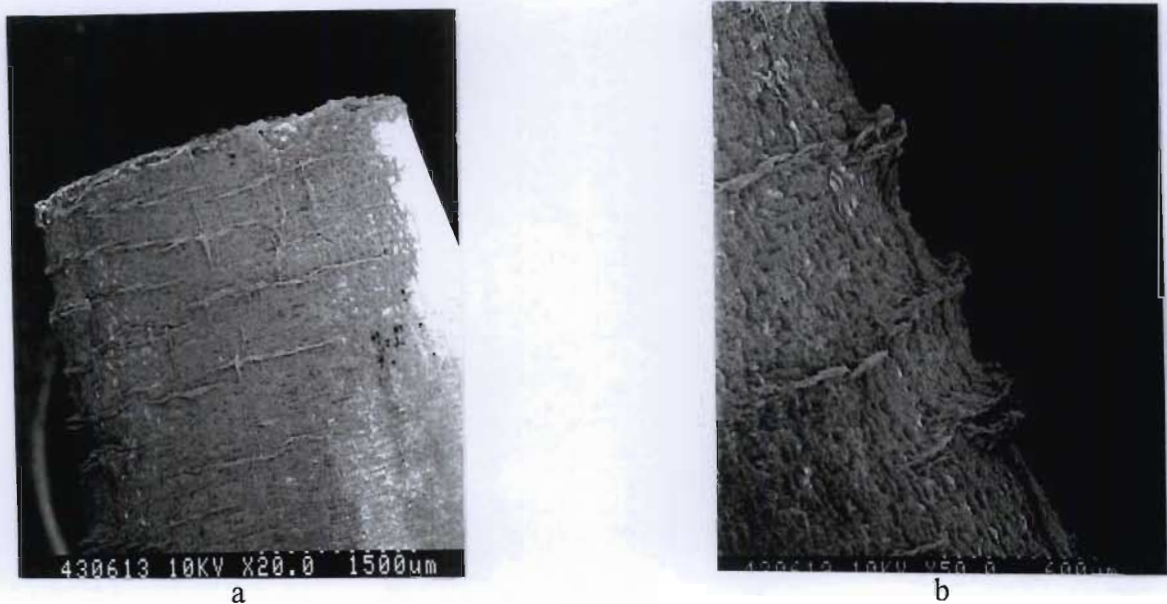
Figure 3.81 : Fractography of uncoated MAR-M002 after HTLCF in SO_2 containing environment showing corrosion on the external surface close to the fracture surface (S.R. 0.38%)

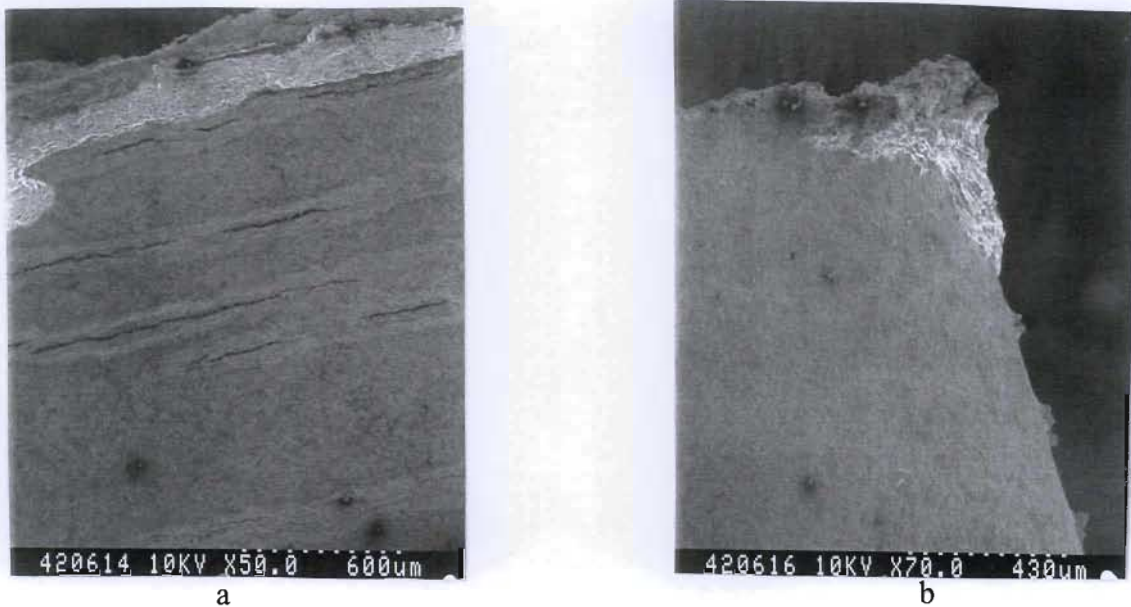
Figure 3.93 : Fractography showing cracking and localized sulphidation of the TYPE I platinum aluminide coating after HTLCF in Ar + 5% SO₂ (S.R. 0.38%)

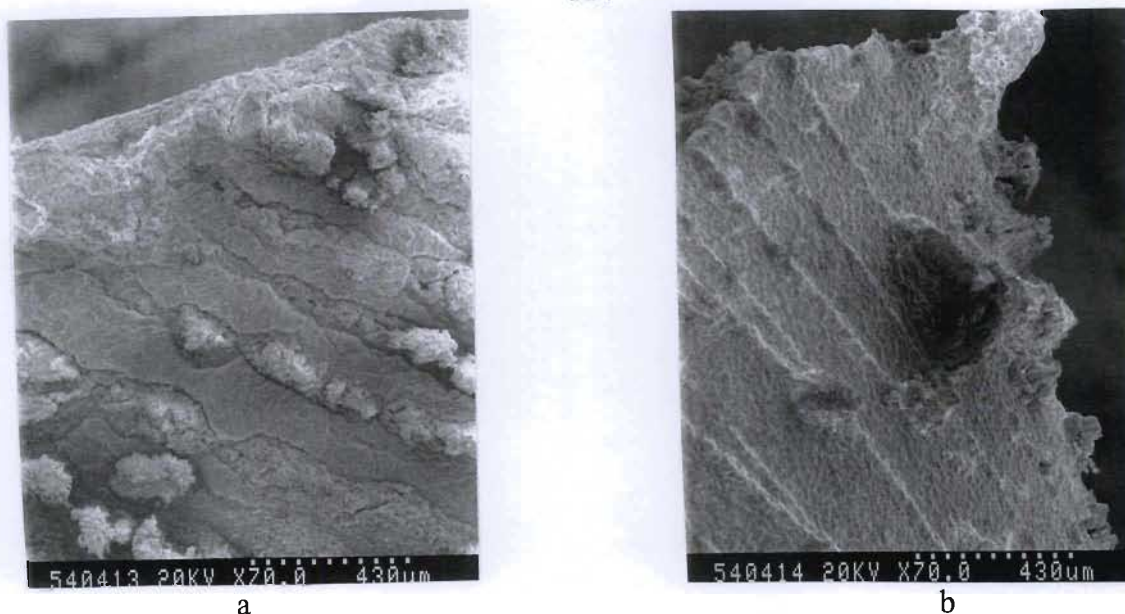
Figure 3.98: Fractography showing severe cracking of the coating close to the fracture surface in TYPE II platinum aluminide coating after HTLCF in Ar + 5% SO₂ (S.R. 0.38%)

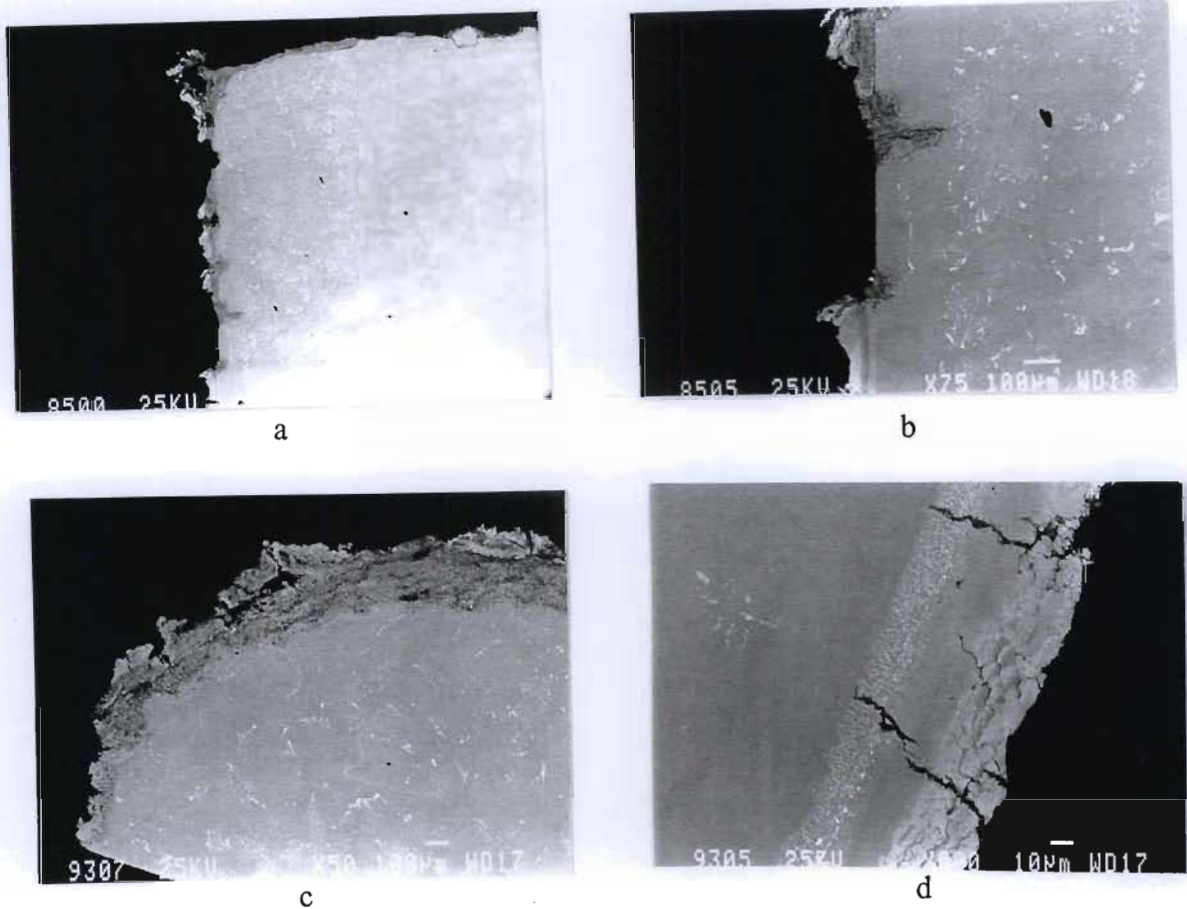
Figure 3.99: Longitudinal cross-section showing the morphology of cracks and corrosion-fatigue damage of the TYPE II platinum aluminide coating after HTLCF in Ar + 5% SO₂ (S.R. 0.38%)
 a&b) Longitudinal cross-section
 c&d) Transverse cross-section

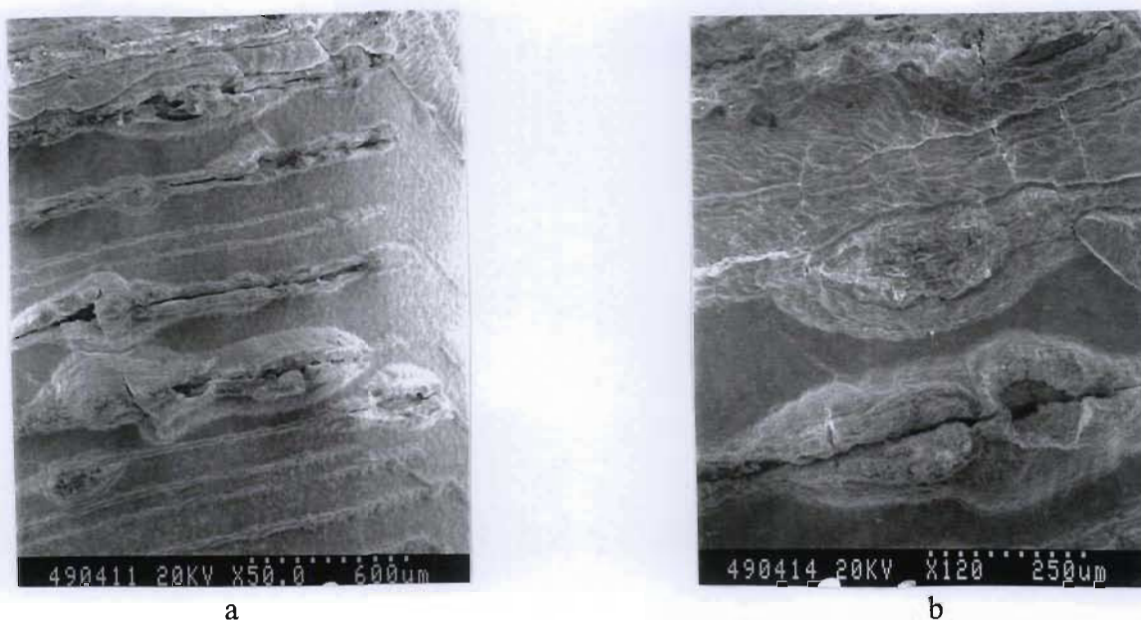
Figure 3.103 : Fractography showing cracking of the coating close to the fracture surface in the 2µm platinum aluminide coating after HTLCF in Ar + 5% SO₂ (S.R. 0.38%)

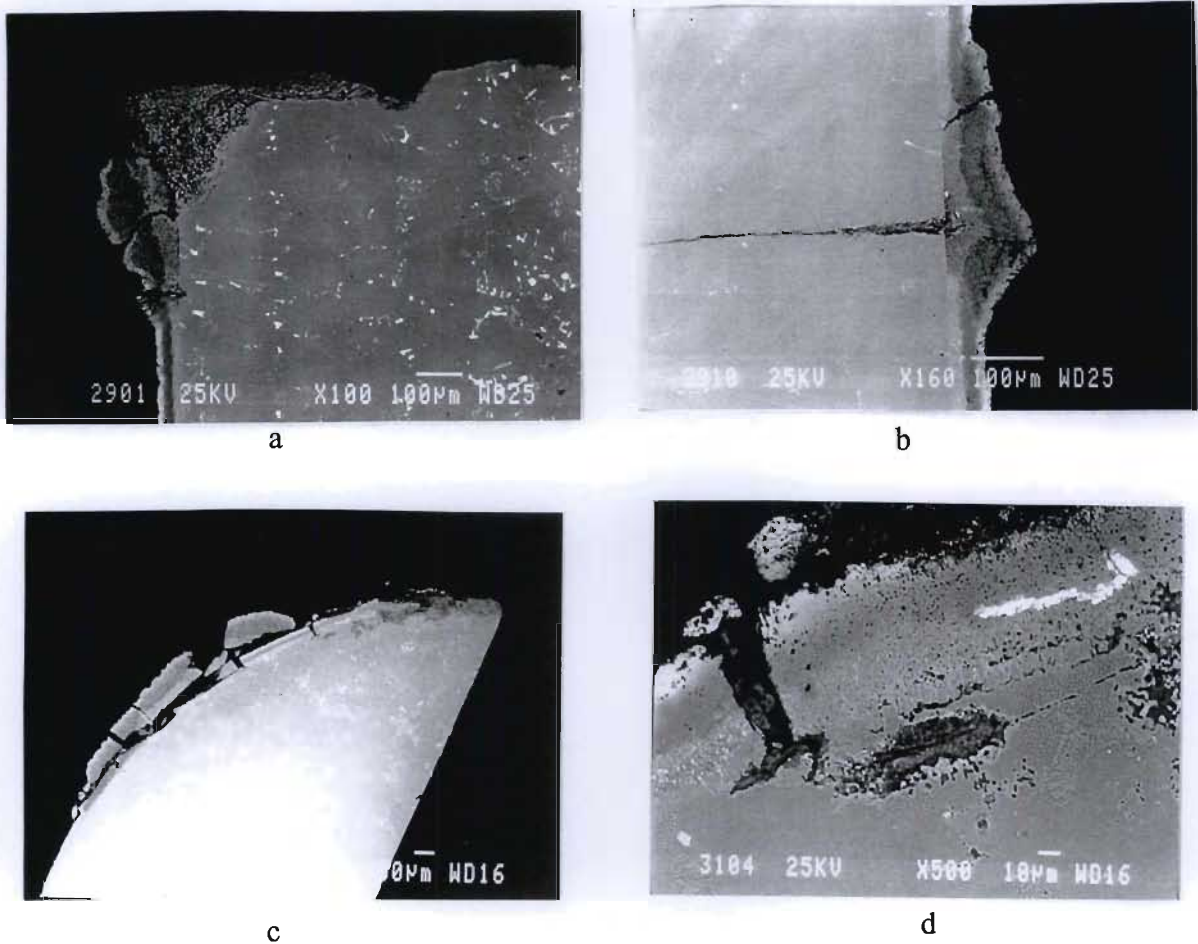
Figure 3.104 : Metallography of 2µm platinum aluminide coated MAR-M002 after HTLCF in Ar + 5% SO₂ (S.R. 0.38%)

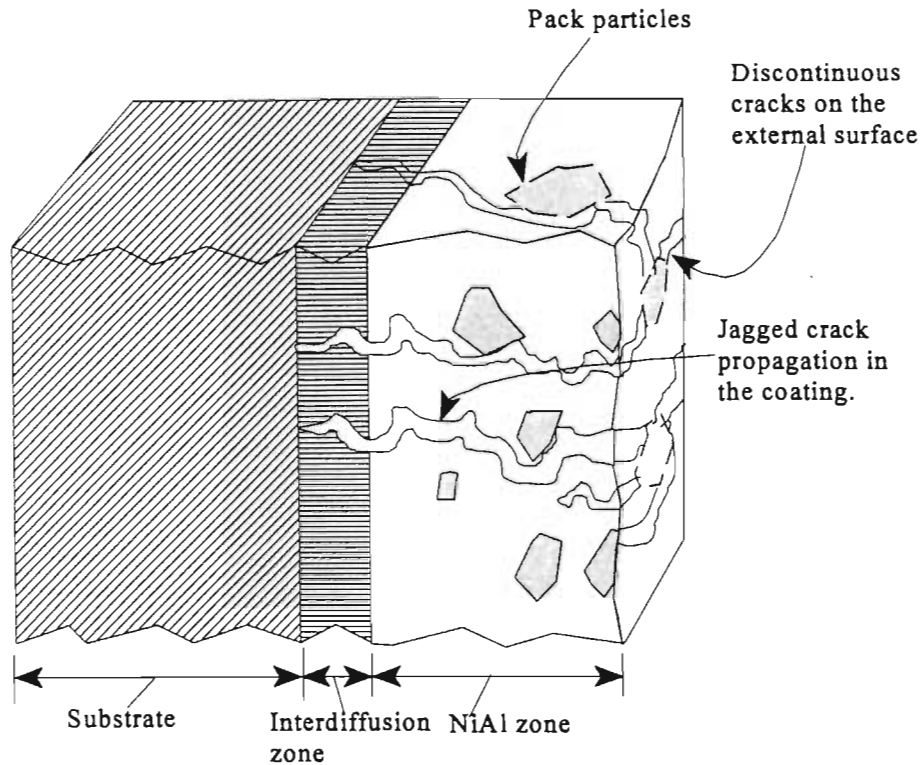
Figure 4.3 : Cracking of TYPE I platinum aluminide coated samples after HTLCF in argon

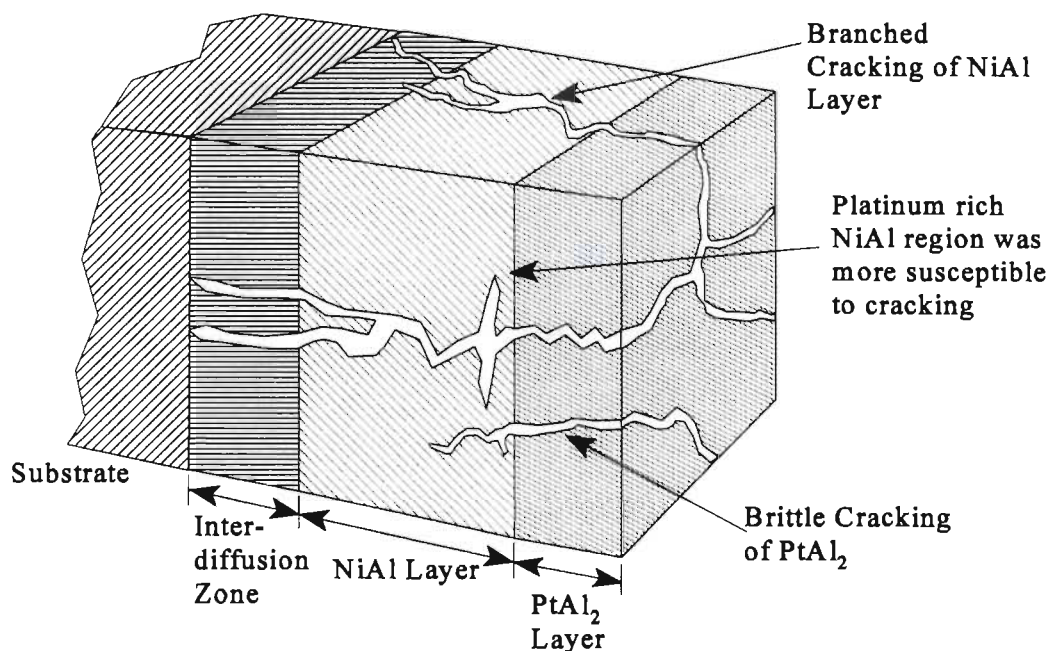
Figure 4.4 : Cracking of the TYPE II platinum aluminide coating after HTLCF in argon
