**AN IN-DEPTH STUDY INTO THE
VARIOUS FACTORS CONTRIBUTING
TO THE UNEXPLAINED LINE FAULTS
ON A LARGE
HIGH VOLTAGE NETWORK**

**This Thesis was submitted to the University of Natal in fulfilment of the
requirements for a Master's degree in Electrical Engineering**

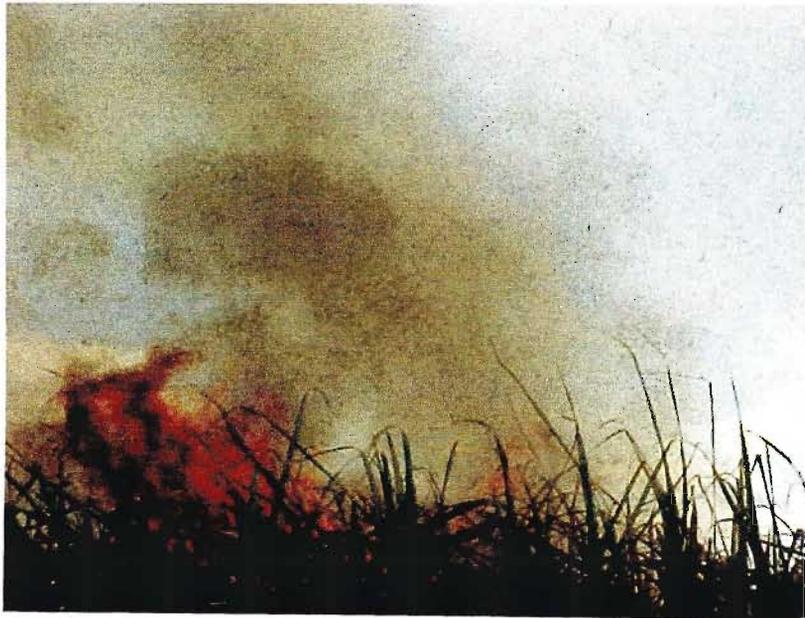
Figure 12. Photograph taken by the author of a sugar cane fire underneath Arnot – Maputo 400 kV line

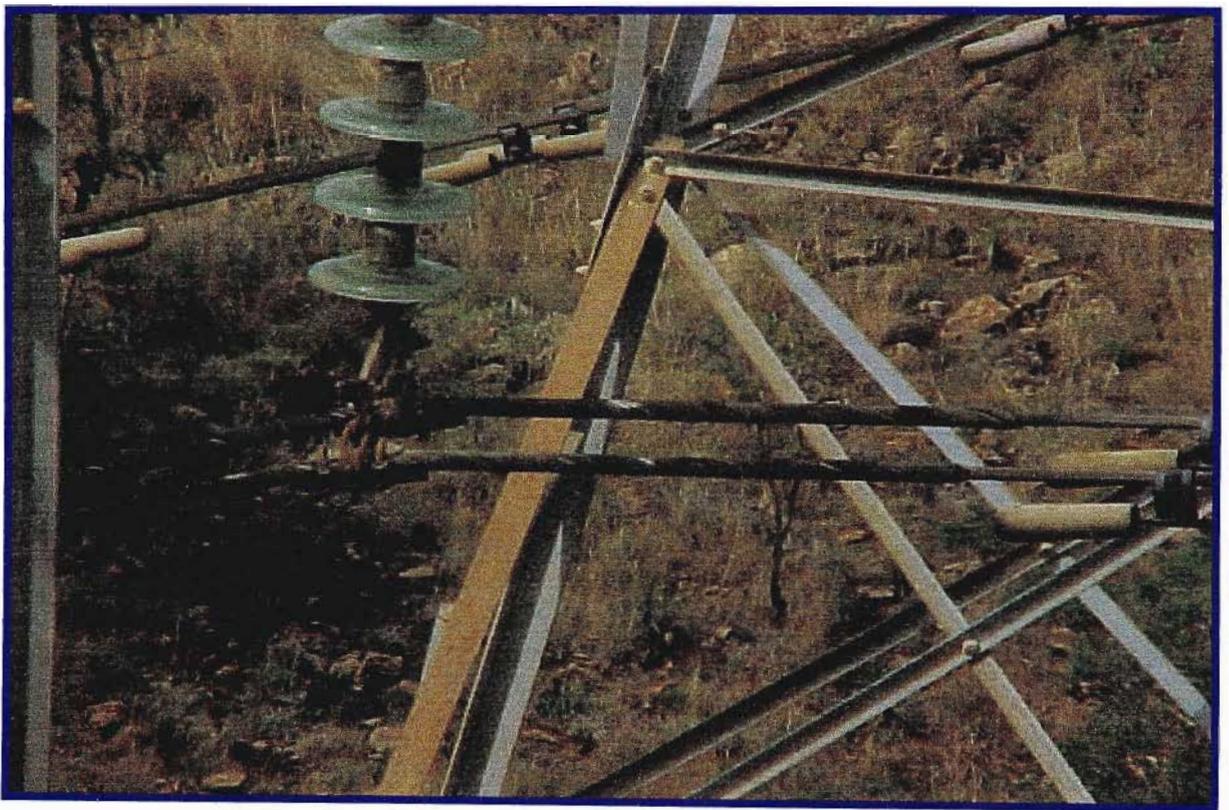
Figure 14. Photograph taken by the author of burn marks on the conductor caused by a lightning strike on the tower. Cause of fault identified by examination of LPATS data.

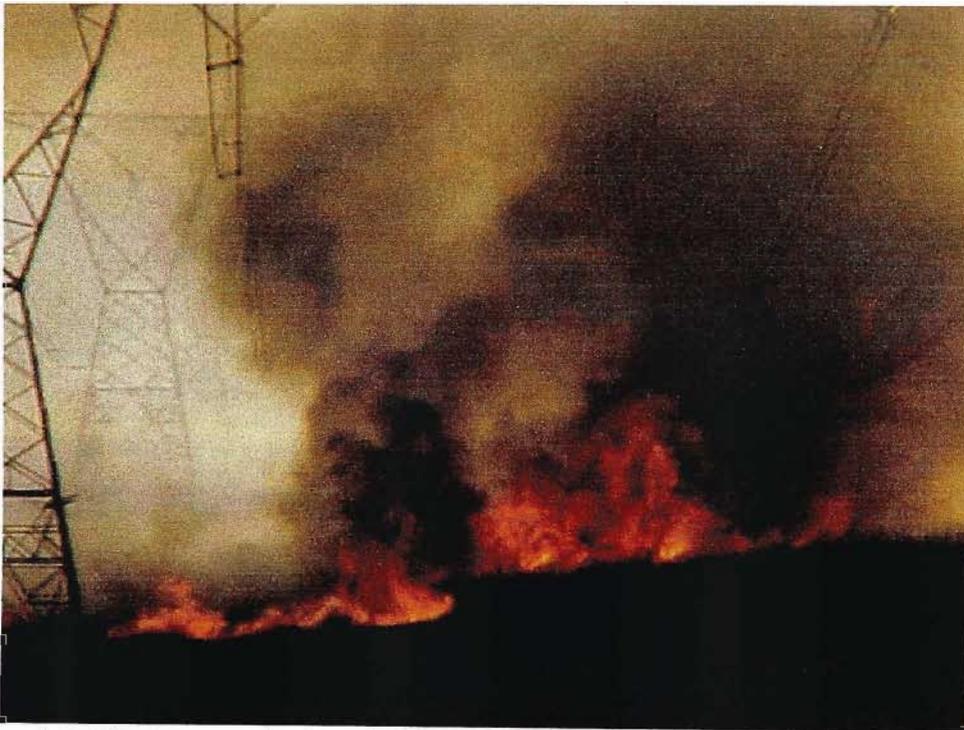
Veld or Sugar cane fires can normally be identified by visually inspecting the servitude underneath the line. Figure 15 shows the typical burning of veld grass underneath a power line.

**Figure 15. Photograph of veld fire the Apollo – Duvha 400 kV line
(Photograph taken by V Viljoen, Eskom Transmission)**

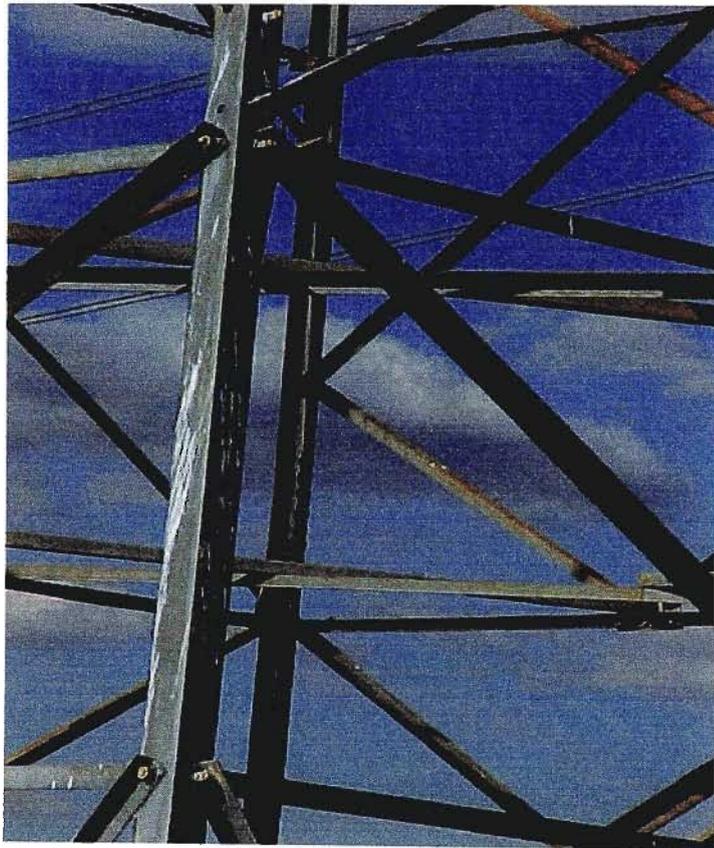
Residual bird streamer pollution may sometimes also be found on the tower via visual inspection. Photograph 17 gives an indication of evidence of the presence of bird streamers. Such evidence is sought by line patrolman who carry the post fault investigations.

**Figure 17. Photograph taken by the author of Bird Pollution
On a tower of the Arnot-Simplon 275 kV line**

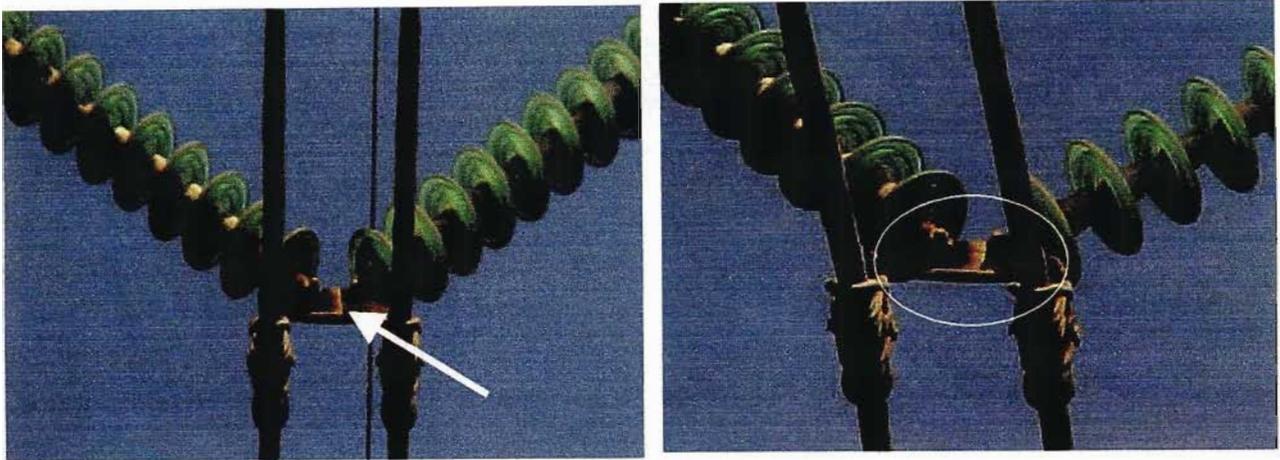
The photographs below show evidence of burn marks on the yoke plate.

Figure 18. Photograph indicating the burn marks on a yoke plate caused by a flashover (Photograph taken by M Sibanyoni, Eskom Transmission)

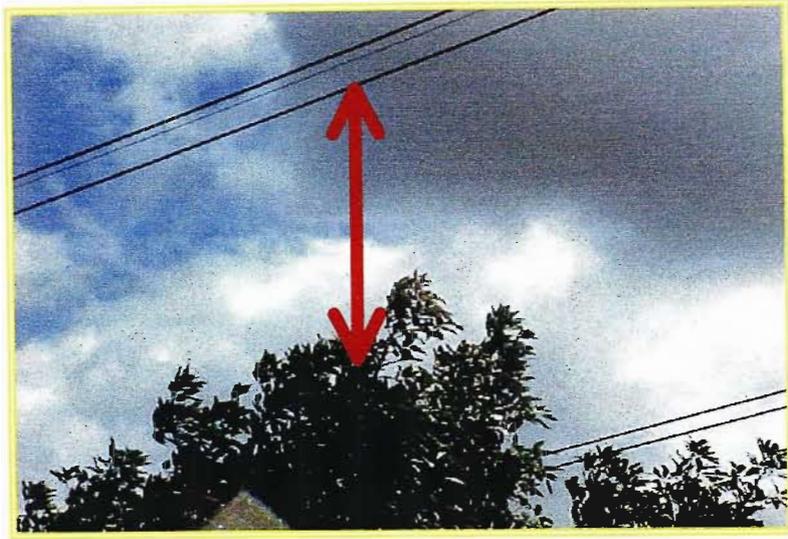
In most cases line faults caused by trees occur during mid day (results of an investigation (Eskom Transmission Investigation, 2000)). The reason is that Transmission lines may sag considerably during hot periods of the day and causing the line to flash over from the conductor to the tree. These types of line faults are normally easily identified by a burned tree.

Figure 19. Photograph taken of the encroachment of trees under an overhead Transmission line (Photograph taken by C Chiloane, Eskom Transmission)
