CONTINUOUS ON LINE RELATIVE TAN DELTA MONITORING OF HIGH VOLTAGE INSULATION

**In fulfillment of the requirement for a research Masters of Science in
Engineering degree for candidate Roger Cormack, University of
Kwazulu-Natal Student Number 991263768**

September 2004

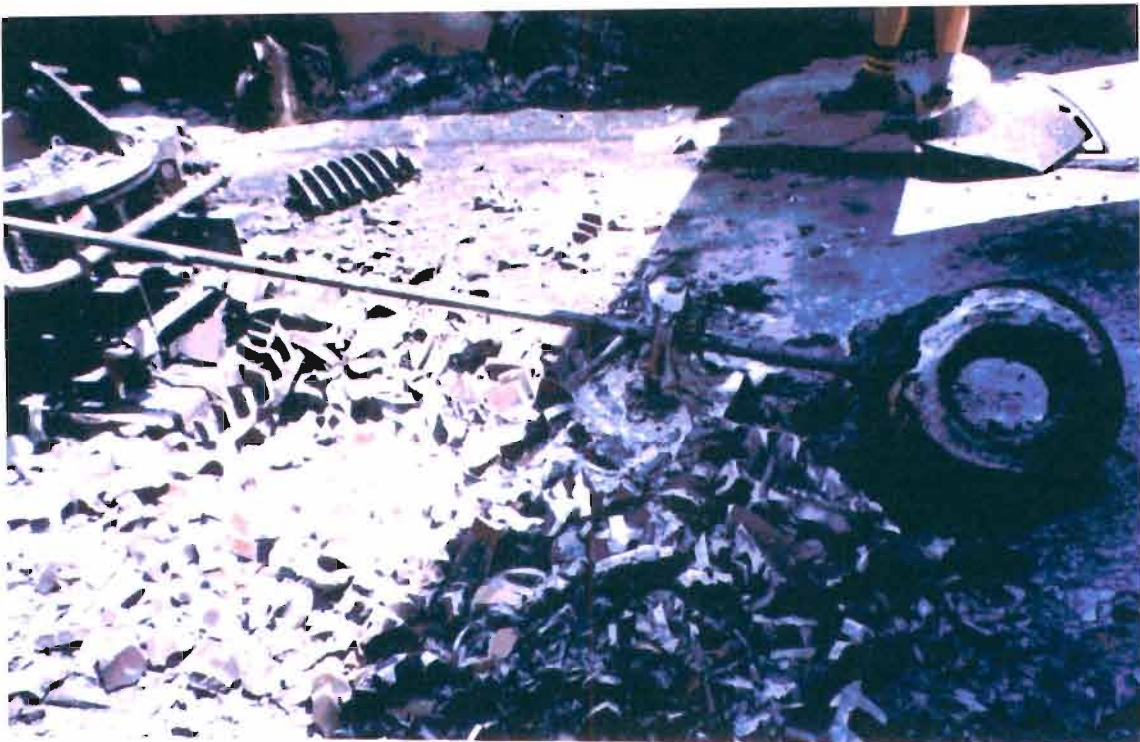
The protection operated correctly isolating the Tugela Bloukrans 1 feeder. The local control centre operators who were new to the test bay operations assumed that there was a line fault and re-energised the line, once from each end of the line, resulting in an additional two voltage dips. Although alarms had been received at the local control centre the change from the normal operating procedure had caused confusion with the operators.

Figure 6.2: The remains of the failed CT in test bay 5 (26 November 1999 at 13h35).

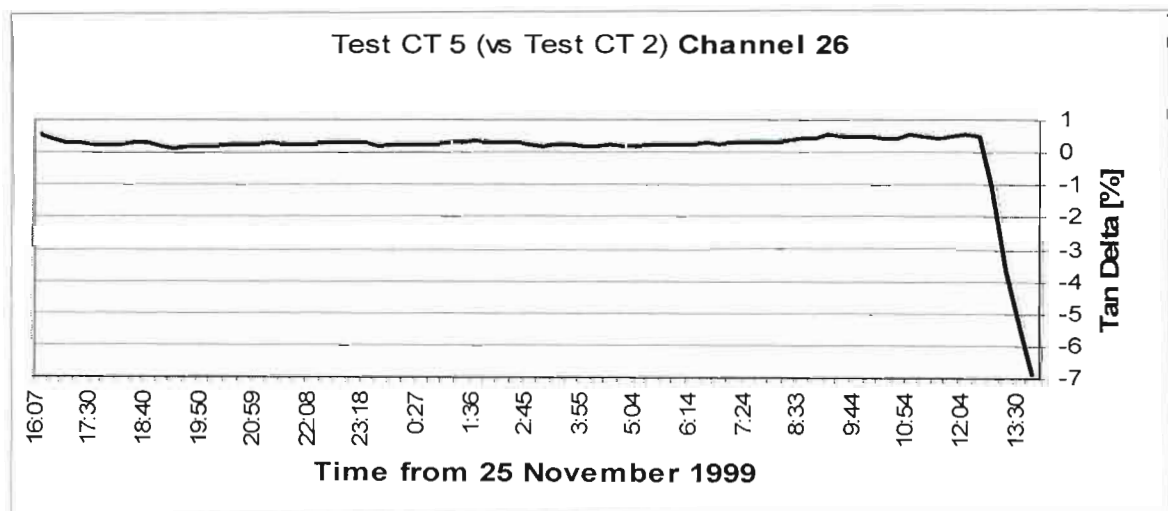
The above failure on the 26th of November 1999 had occurred too soon after energising, for the HVIEWWS system to produce a fingerprint. In the event that this failure simulated real apparatus insulation failure, the system did not detect the failure. On further analysis of the captured HVIEWWS data, the calculated relative dissipation factor reflected a change associated with the failing CT. The HVIEWWS recorded a rapid change in relative dissipation factor over a period of only 1 hour and 24 minutes prior to the final catastrophic stage of deterioration. The relative tan delta changed from 0.5 to – 6.85, a change of 7.35 over the last hour and 24 minutes prior to failure.

Figure 6.3: HVIEWWS relative tan delta of the CT in test bay 5 relative to the CT in test bay 2.

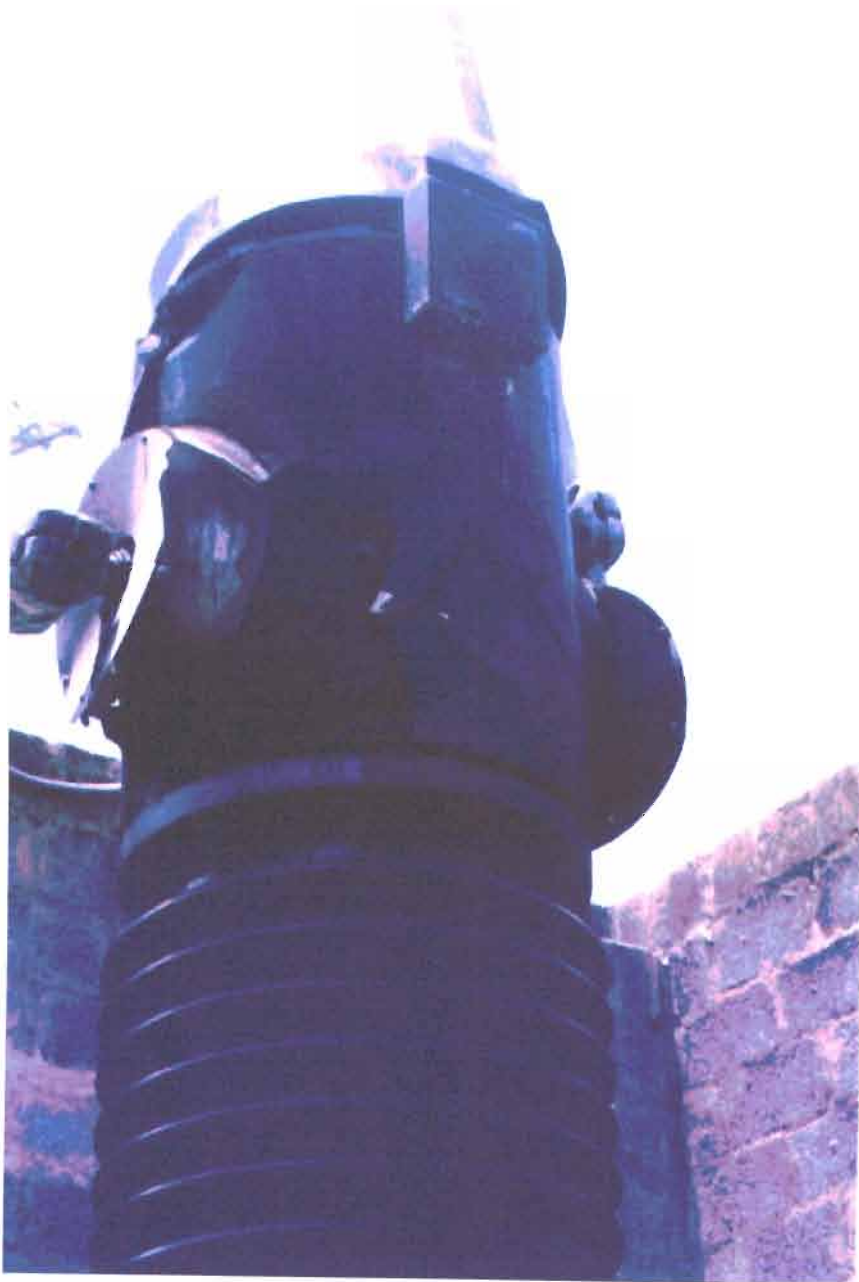
the porcelain remaining intact. The cause of the failure was initially assessed as moisture collecting in the head of the CT and forming a conductive path between the earth shield around the secondary cores and the line potential conductive tape in the epoxy head. Heating due to the high levels of dissipated power within the secondary cores was not discounted as the primary cause of failure.

Figure 6.4: Second CT failure in test bay 5 (14 December 1999 at 15h21) minor cracks in the epoxy head are visible.

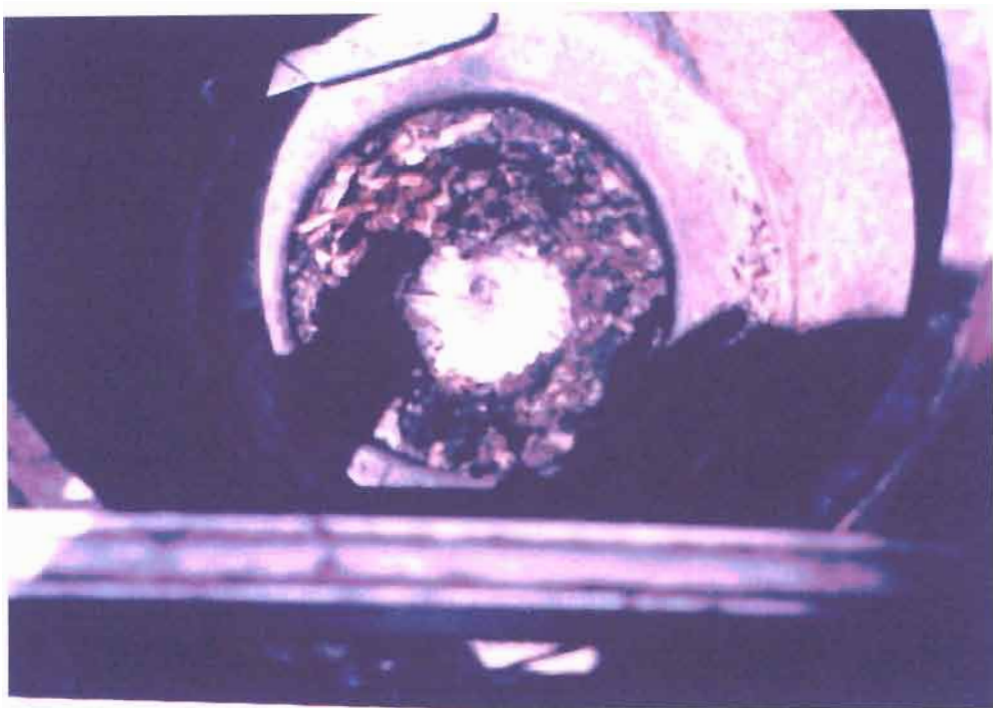
Figure 6.5: Top view - Paper insulation cut back to expose the arc point.

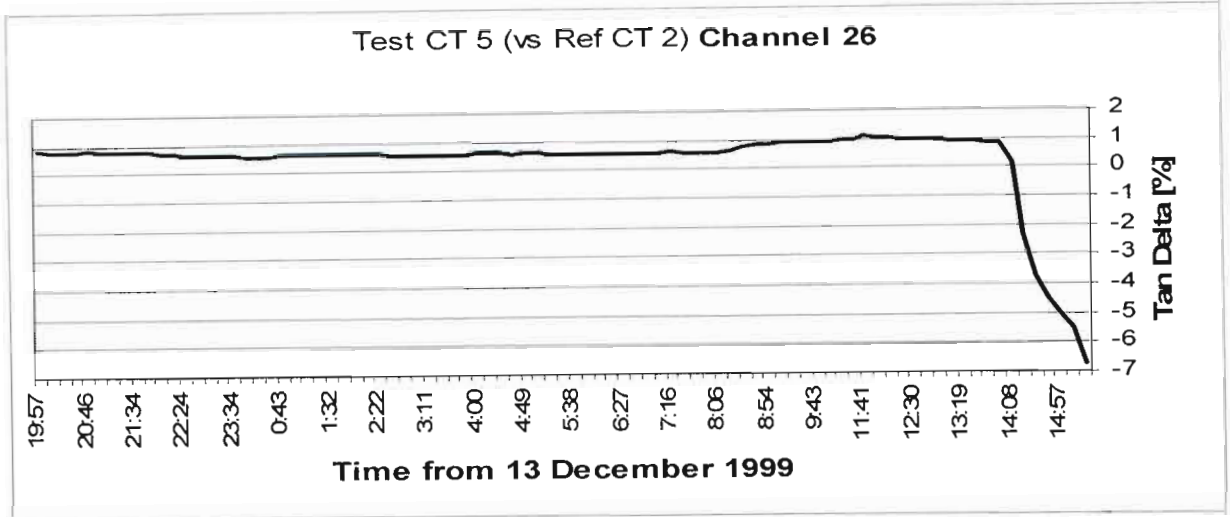
During the second failure on 14 December 1999, the test station had once again been energised for too short a period to develop fingerprints of the relative dissipation factor ($\tan \delta$). Therefore the established algorithms do not identify the failures being simulated in this fashion. Further analysis of the recorded data again indicated a rapid change in leakage current prior to the final catastrophic failure.

Figure 6.6: HVIEWWS relative tan delta of the CT in test bay 5 relative to the CT in test bay 2.

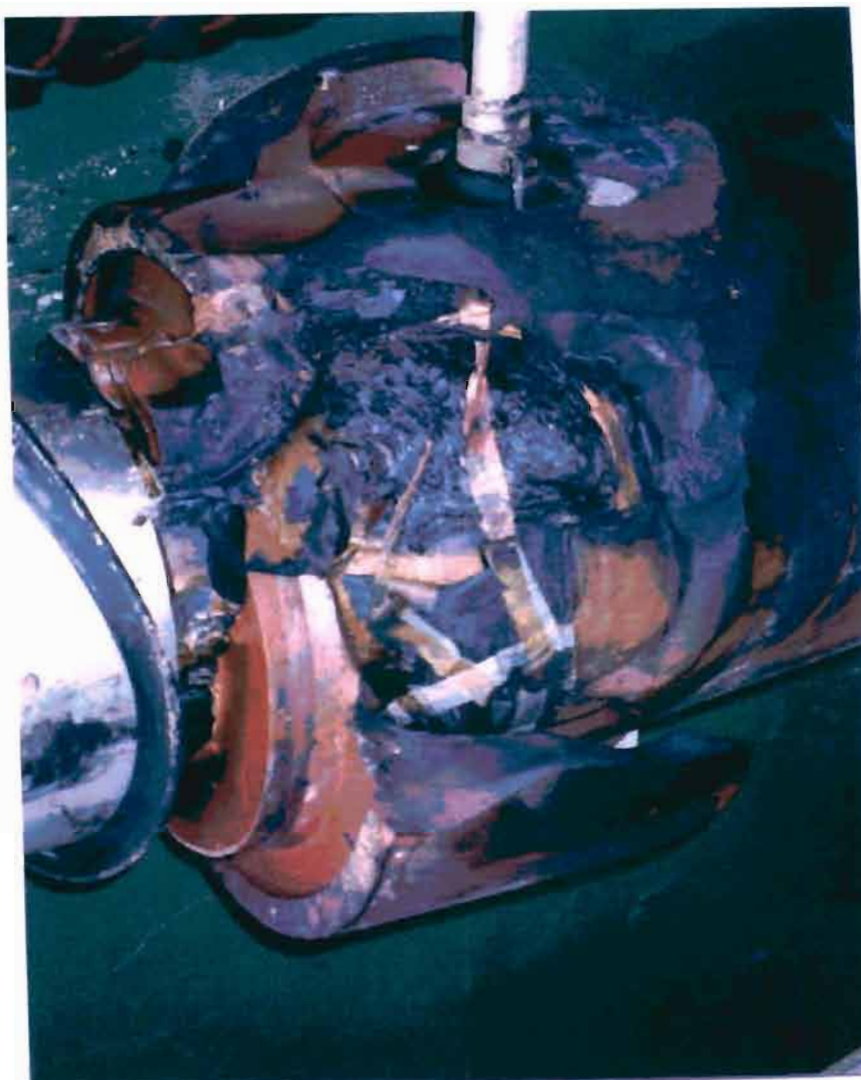
The tear down confirmed the hypotheses of overheating of the CT secondary windings resulting in large amounts of pd and hence tracking as the primary cause of failure.

Figure 6.7: The damaged CT with epoxy stripped back, exposing damage to HV screen which flashed over to earthed shell around secondary cores.

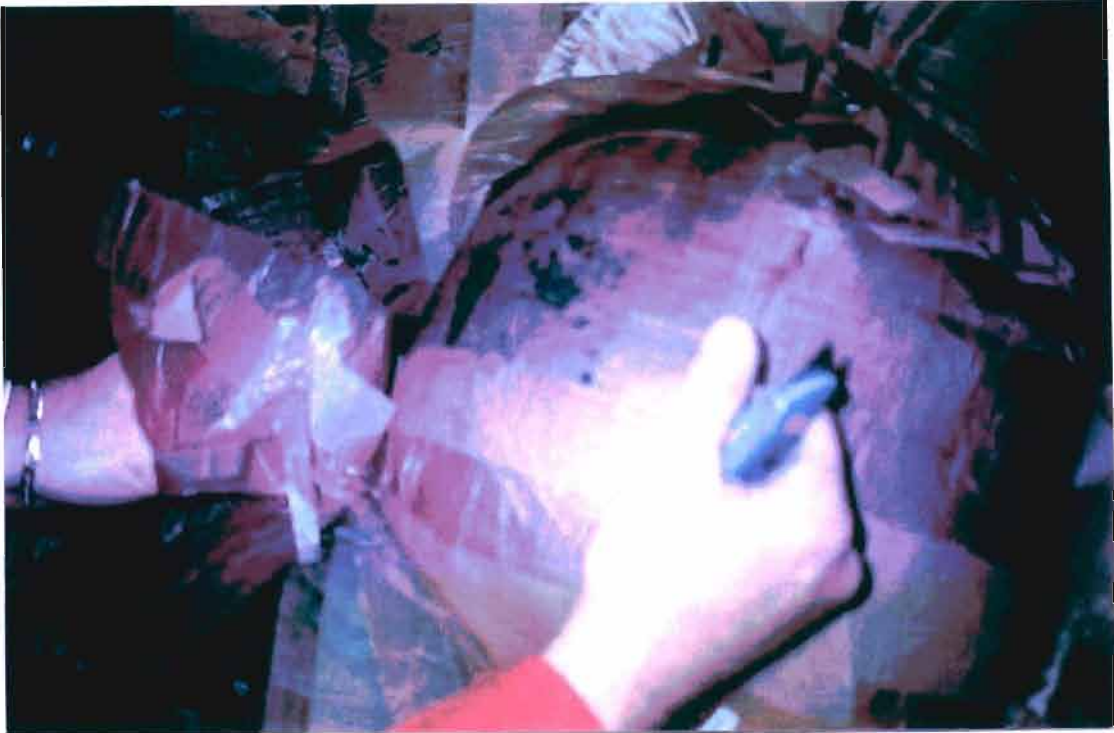
Figure 6.8: Stripped back insulating paper showing signs of partial discharge and treeing between paper layers.

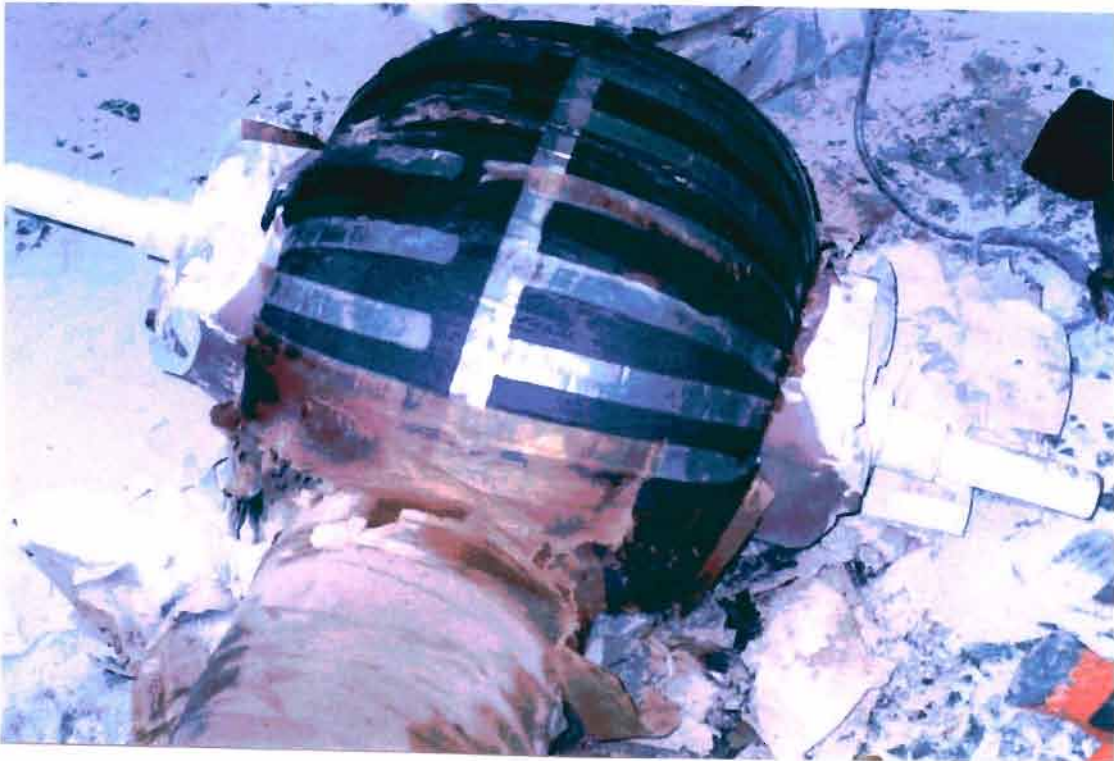
Figure 6.9: The dissected CT showing the HV stress screen attached to the bar primary conductor and in service at HV potential.

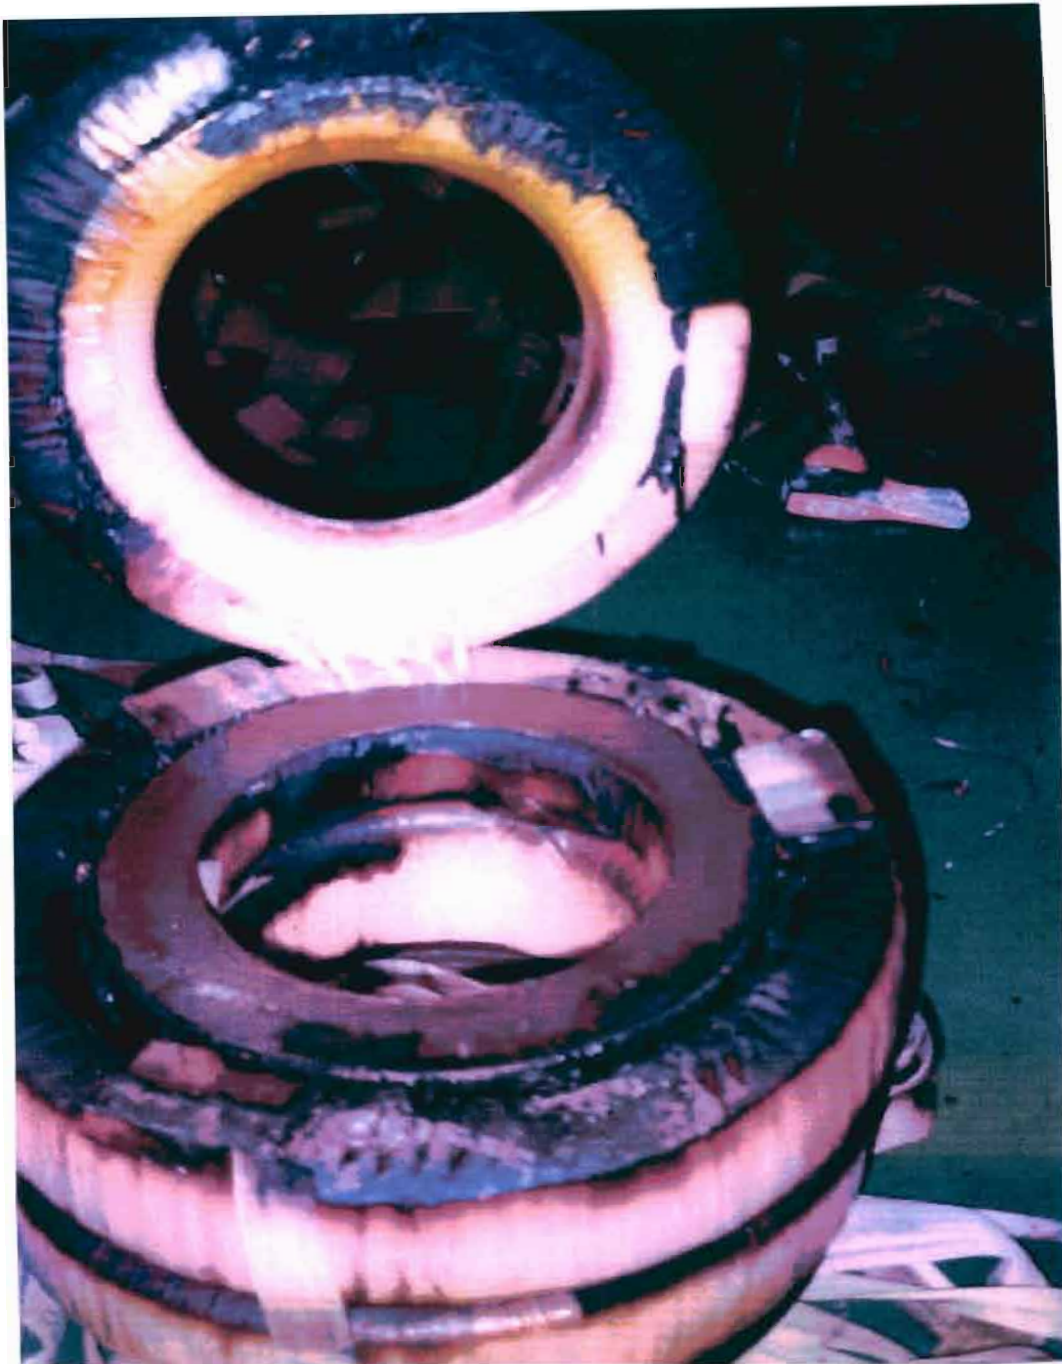
Figure 6.10: The stripped secondary cores of the damaged CT showing the burning marks caused by the overheating from the back energisation.

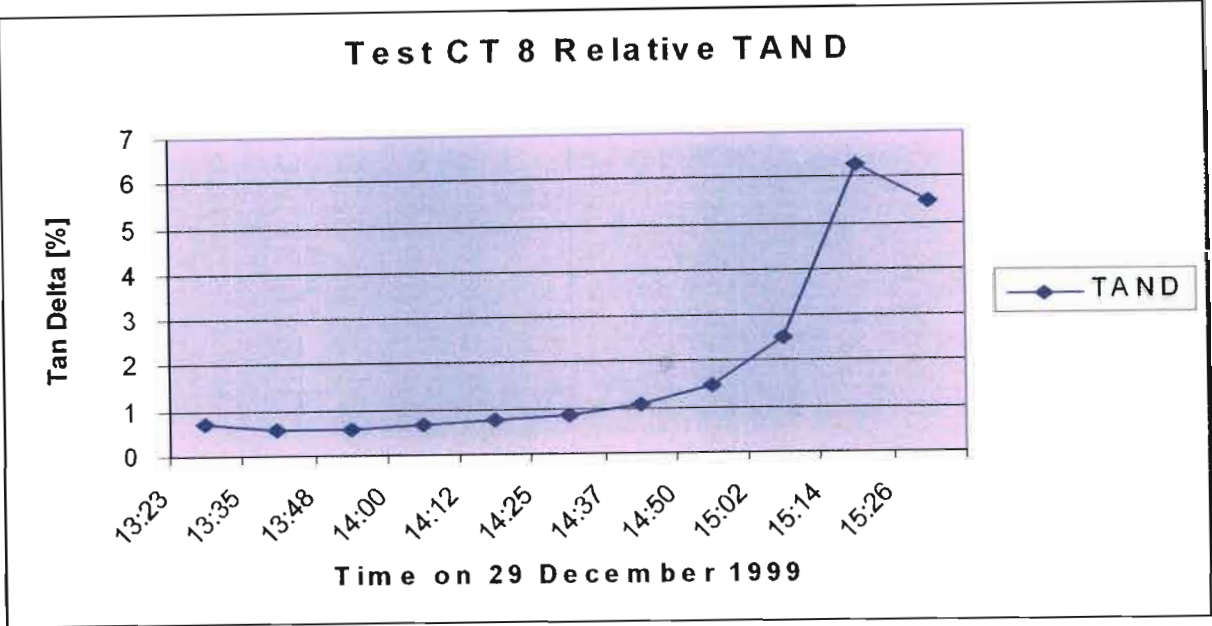
Figure 6.12 below shows that the rapid alarm is initiated on a minimum 1% step change in relative tan delta that occurred at 15h02, 24 minutes prior to the failure. The tan delta variable started increasing from 14h37 and at 15h28 the unit failed, the rapid changes took 51 minutes and the relative tan delta changed by 4.6%.

Figure 6.12: HVIEW “% relative tan delta” of CT in test bay 8.

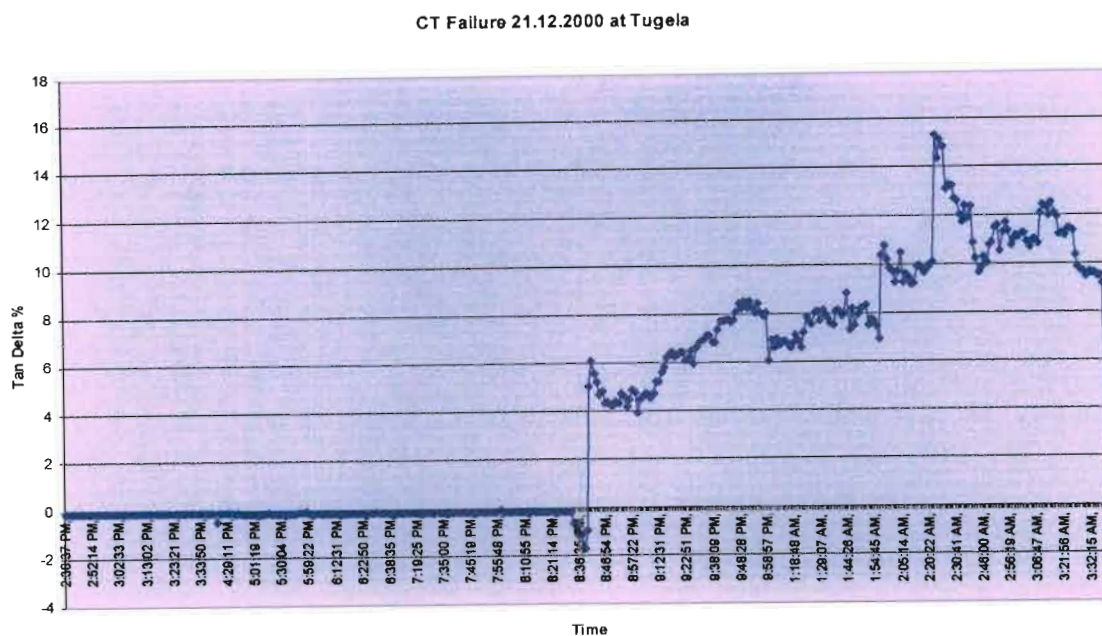
Figure 6.17: CT Failure in the Tugela test station on 21 December 2000.

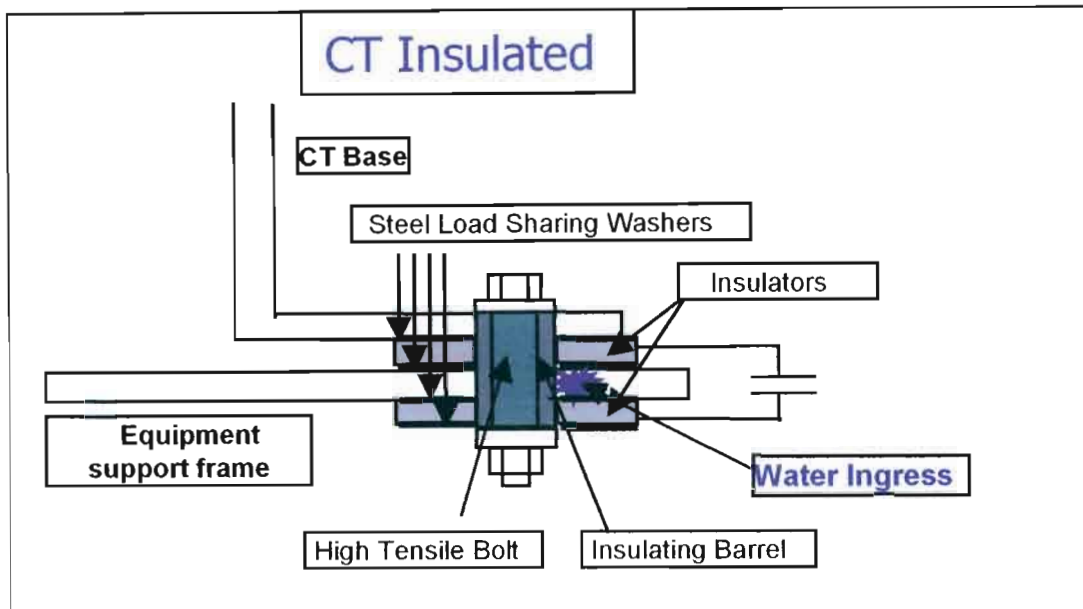
Figure 7.1: The insulator on the base of the CT being bridged out by rainwater ingress effecting the tan delta measurements [33].

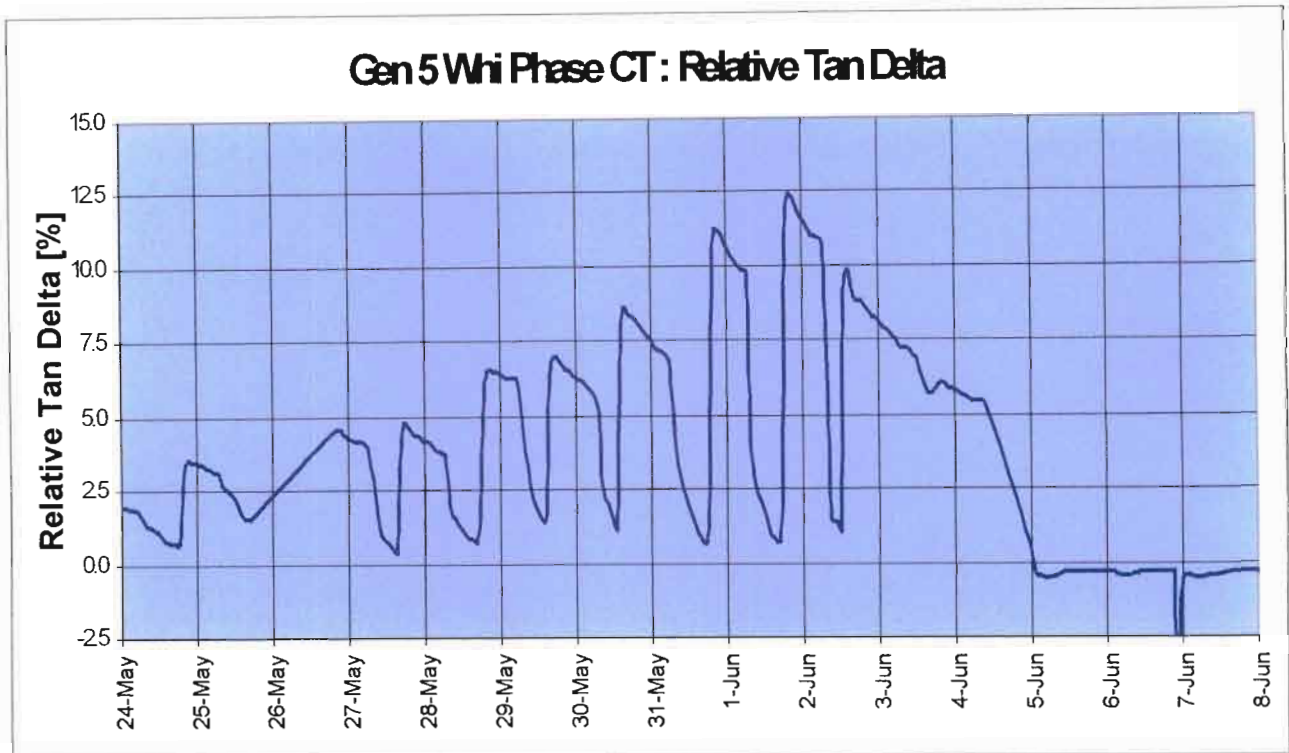
Figure 7.3: HVIEWWS relative tan delta trend for Duvha CT, caused by poor insulation quality, negatively effecting trending.
