**CASE STUDY OF BIRD STREAMER CAUSED**  
**TRANSIENT EARTH FAULTSONA 275 KV**  
**TRANSMISSION GRID**

This thesis was submitted to the University of Natal in fulfilment of the requirements for a Master's degree in Electrical Engineering.

This thesis discusses the results of an investigation that was initiated in January 1996 to determine the root cause of the increasing fault trend in respect of transient earth faults on the 275 kV transmission grid in KwaZulu-Natal, South Africa. Historically it was thought that the persistently poor performance of this network was caused by pollution faults. This network was reinsulated with silicone composite insulators, and cane fire as well as veld fire management programmes were introduced. These projects did not result in a consistently decreasing fault trend on this 275 kV transmission grid.

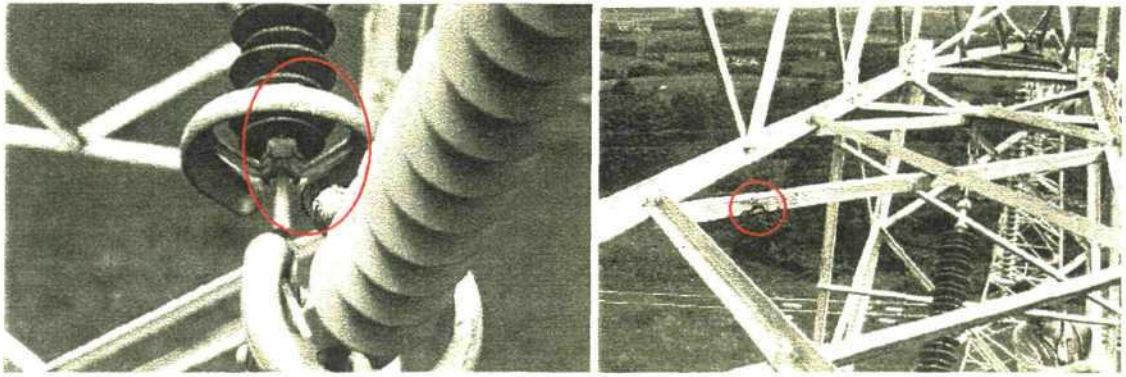
The burn marks caused by the power arcs, which were identified in this study, appeared to indicate that air gap breakdown was occurring. Birds were also observed in close proximity to the faulted towers. Consequently it was thought that bird streamers caused the transmission line faults. Welded rod bird guards designed to prevent bird streamer faults were installed on eighteen 275 kV transmission lines. The accumulative length of these transmission lines is 932 km. The implementation of this initiative coincided with a 73% reduction in the total number of transient earth faults. This improvement in performance indicates a strong statistical correlation showing that a large number of the transient earth faults on the transmission grid are related to bird streamers.

**Figure 9. Left: Burn marks on live corona ring**

**Right: Burn marks on centre of tower steelwork**

This case study determined that in order to prevent bird streamer faults the bird streamer must be moved away from the live tower hardware. The distance it must be moved is at least 900 mm for 275 kV power lines and 1 100 mm for 400 kV lines.

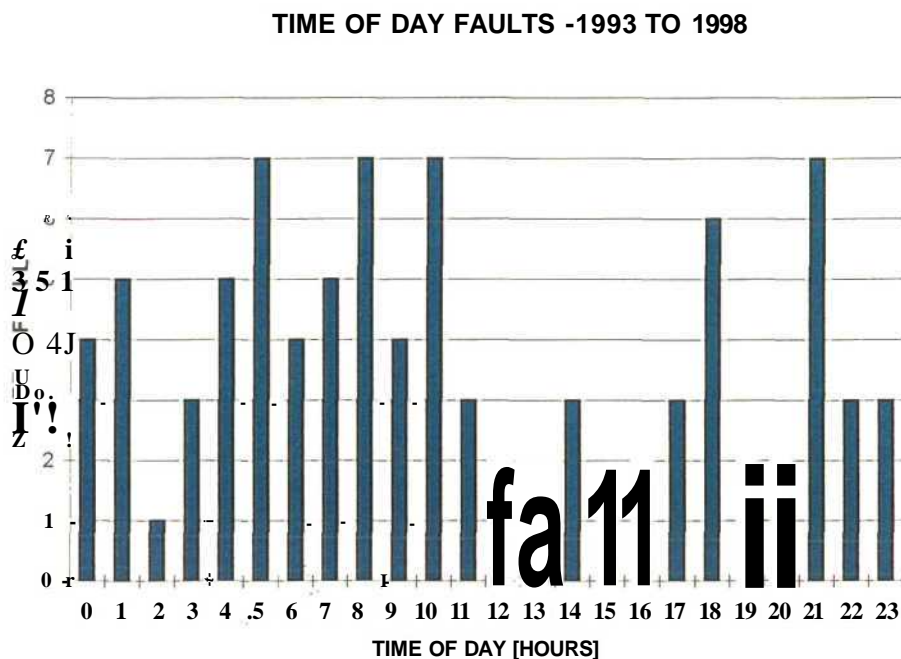
**Figure 12. Bird streamer faults versus time of day for a sample size of 90 faults**

It is noticeable that the faults occur over the entire 24-hour period. The distribution is summarised in Table 7.

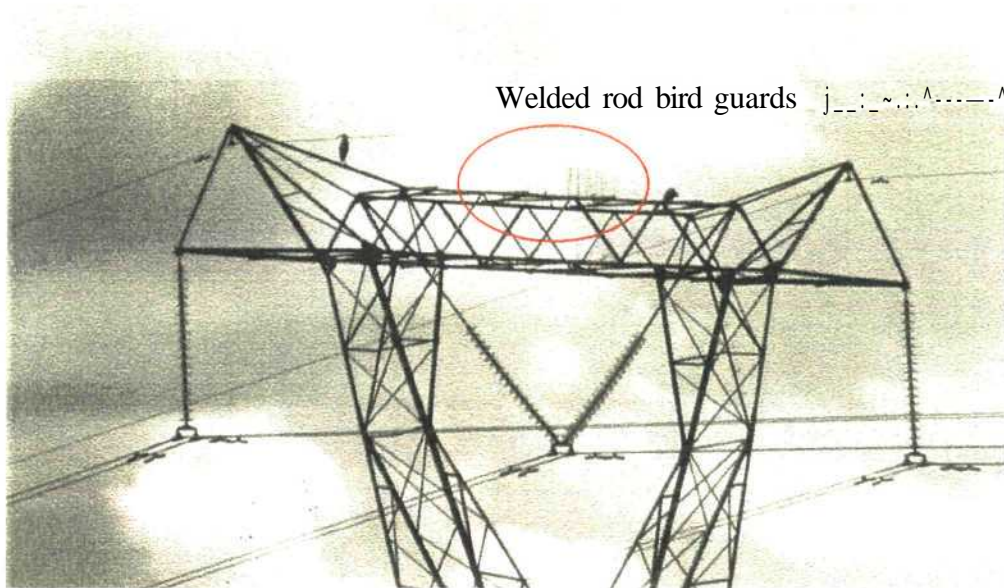
**Figure 38. Application of welded rod bird guard**

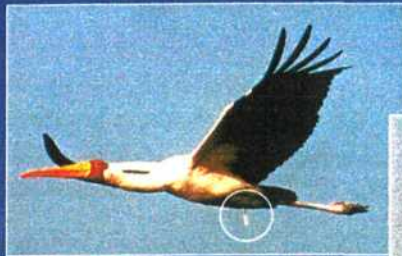
Bird streamers is a continuous conductive excrement.
