# **INVESTIGATION INTO CURRENT TRANSFORMER FAILURES WITHIN ESKOM DISTRIBUTION**

In partial fulfilment of the requirements for the degree  
Master of Science in Power and Energy Systems,  
Faculty of Engineering,  
University of KwaZulu-Natal

December 2010

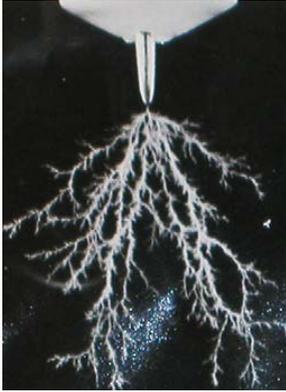
Figure 5-5A and figure 5-5B below, indicate a photographic image of the inception of internal partial discharges be it in the liquid or solid dielectric.

*Figure 5-5A: Partial Discharge in Oil*

*Figure 5-5B: Partial Discharge in a Solid Dielectric*

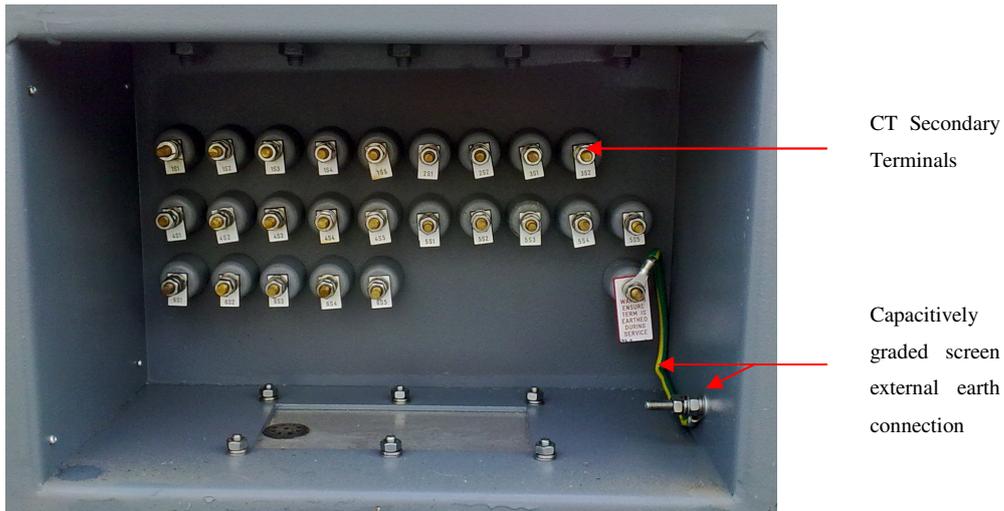
*Figure 6-1: CT Secondary Terminal Housing*

The substantially high risk factor of the third distinct technical impact is due to the mal-operation and possible damage to the secondary plant equipment. This arises when the earth connection from the capacitively graded screen to the earth point, between the housing for the secondary wiring and earth, on the CT burns off. This is depicted in figure 6-1 below.

The HV fault current now finds a path to earth in the protection and metering panels through the secondary wiring. The possibility of damage to relays and meters is imminent, as this high fault current on the secondary of the CT can flow directly into the protection relays and energy meters. With the loss of this earth connection on the CT, the potential difference between the earthed screen in the CT and earth creates an arc leading to pressure build-up. With the pressure build-up exceeding the withstand capabilities of the post insulator, a violent explosion then erupts enabling shrapnel and debris to be strewn across the substation yard.

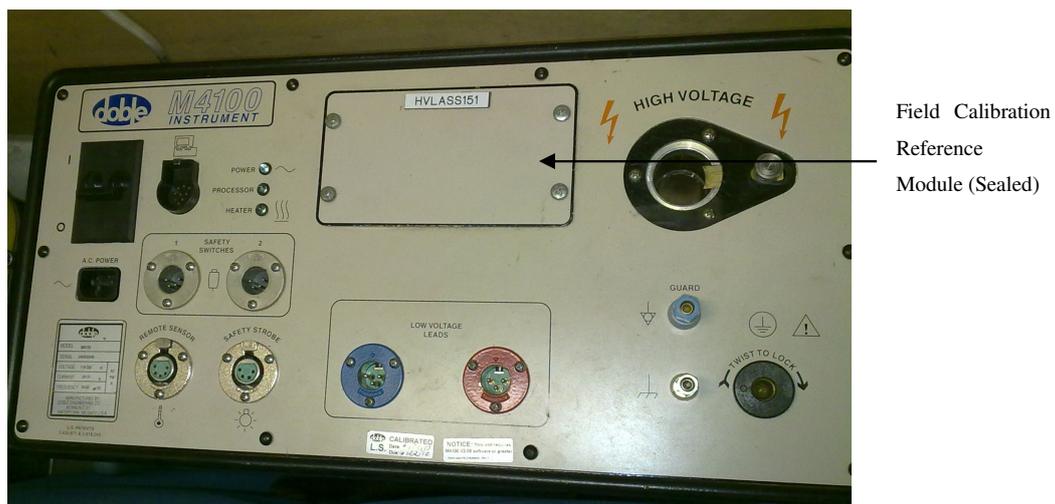
Figure 8-1: Doble M4100 Test System used in Eskom Distribution

The M4100 test system used to perform the tests was within its calibration certification requirements and ISO 9001:2000 certified, thereby ensuring that the test results obtained are referenced as true and correct. The test instrument used is depicted in figure 8-1 below.

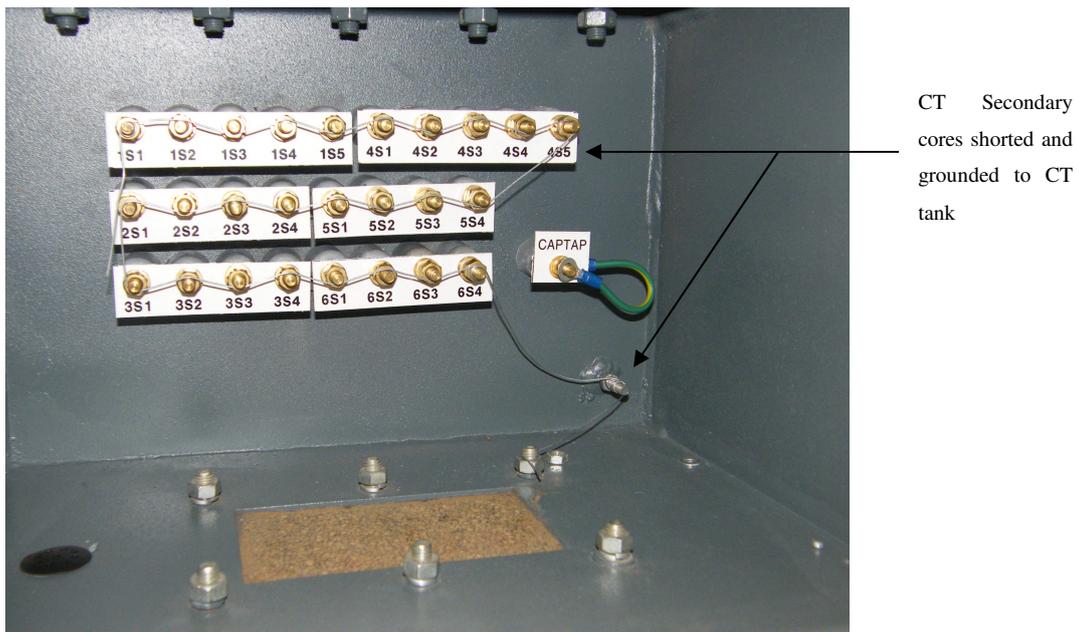
*Figure 8-3: Doble test connection in the CT secondary terminal box*

- Ensure that all the surfaces are clean, neat and clearly visible for termination and testing.
- In the CT secondary terminal box, short-circuit all the secondary cores and terminate to ground on the CT tank as depicted in figure 8-3.
- Disconnect the earth connection between the second last capacitive grading screen (CAPTAP) of the primary insulation and the CT tank.

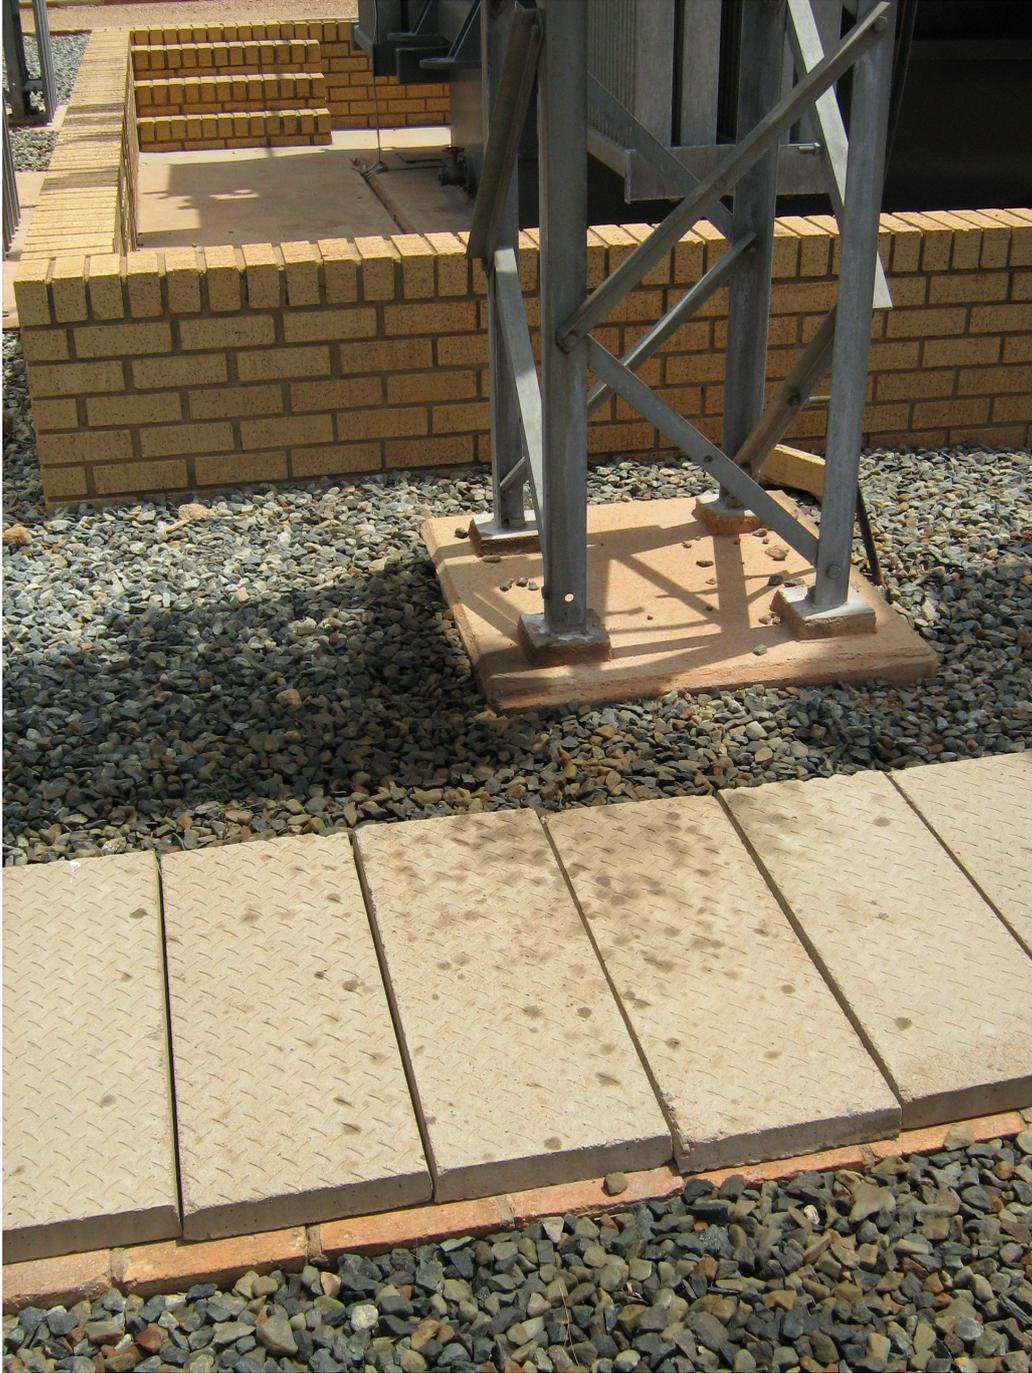
*Figure A1-1: Installed 132kV CT showing oil spillage on trench covers*

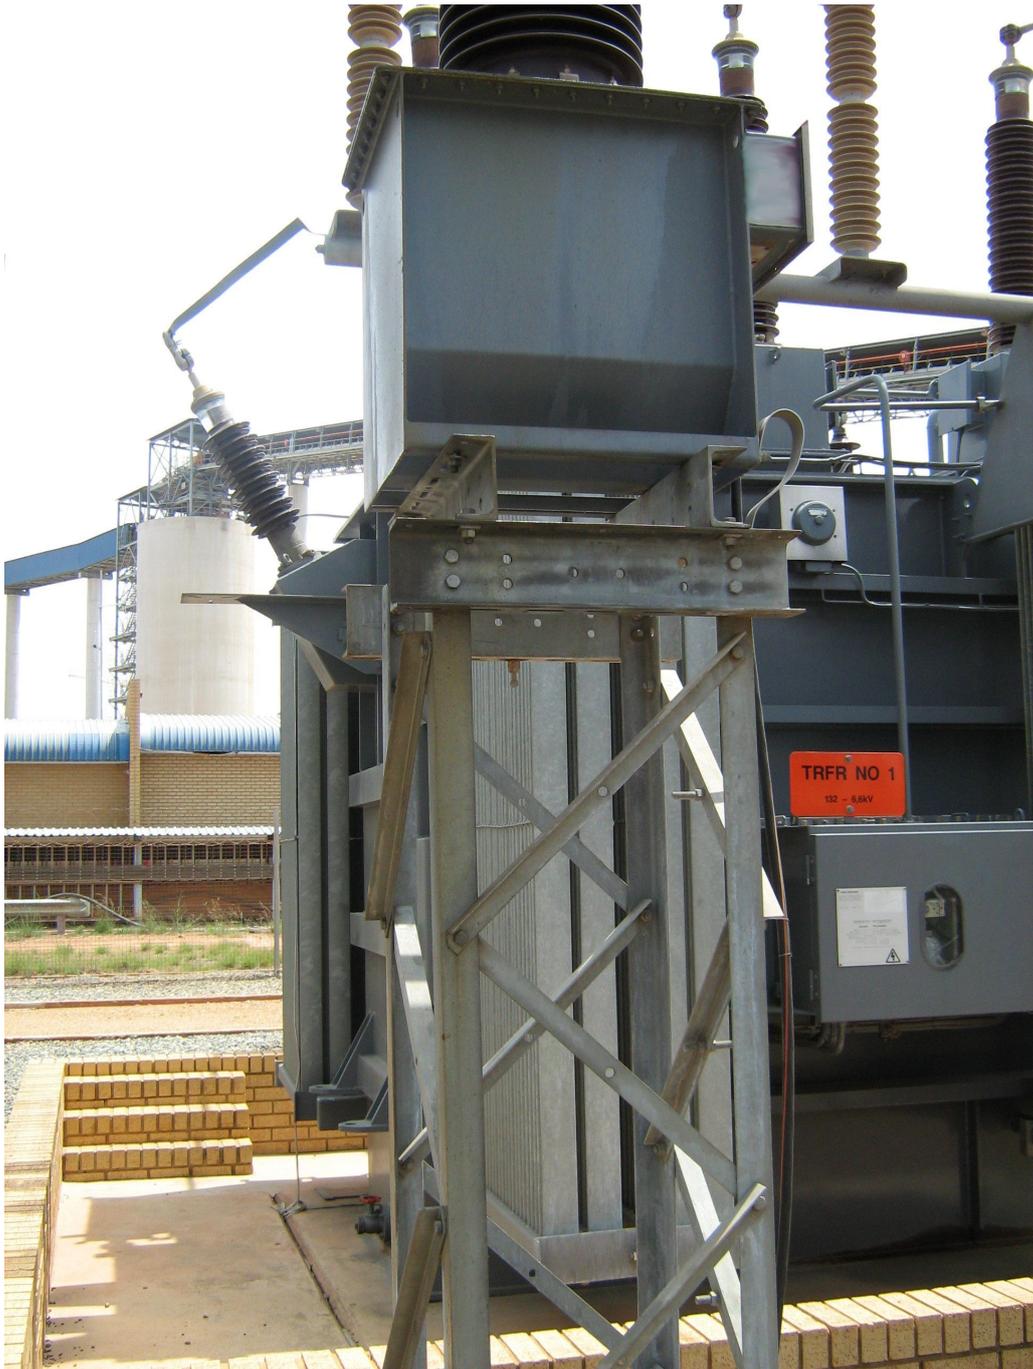
*Figure A1-2: Installed 132kV CT with oil leaks on base tank*
