ROCK MASS RATING AND SLOPE STABILITY ANALYSIS OF QUARRY  
FACES WITHIN THE DYWKA TILLITE OF KWAZULU-NATAL.

FEBRUARY 2002

SUBMITTED IN PARTIAL FULFILMENT OF THE REQUIREMENTS FOR  
A MASTERS DEGREE IN ENGINEERING GEOLOGY IN THE SCHOOL  
OF GEOLOGICAL AND COMPUTER SCIENCES, UNIVERSITY OF  
NATAL, DURBAN.

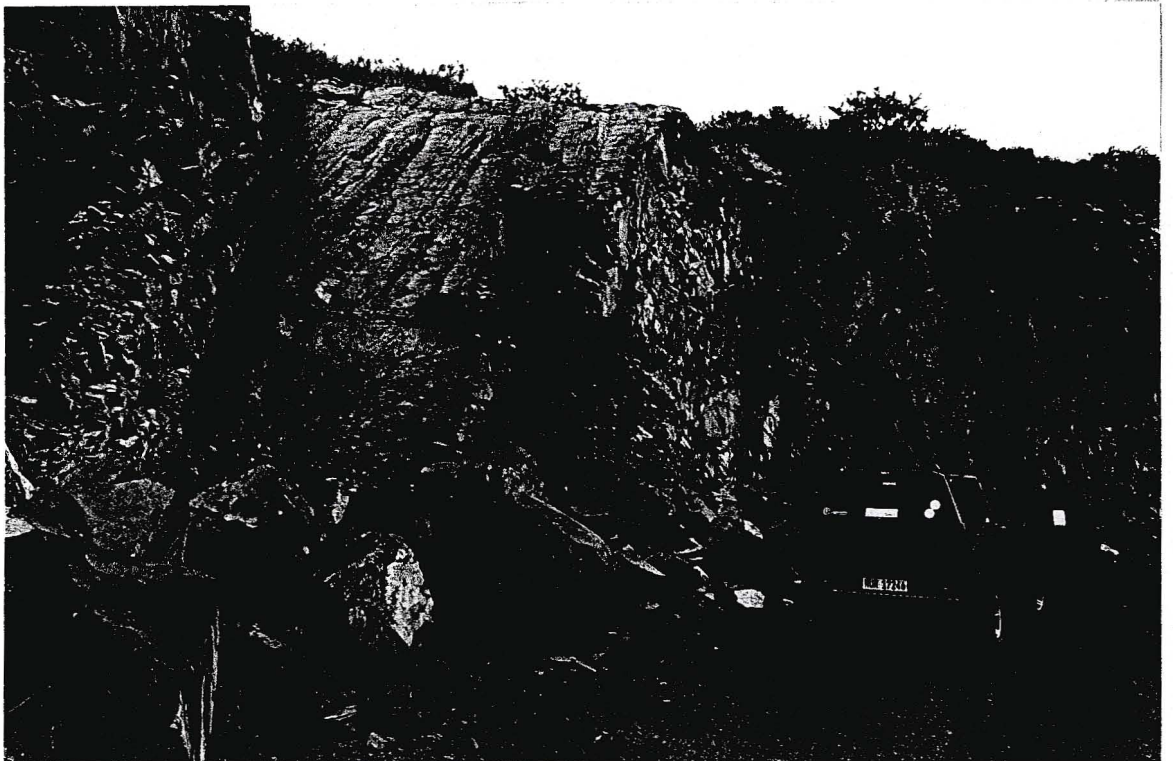
Plate 3.5: Fault 1 – Zululand Quarry. Note slickensided stepped fault plane.

No other structural features, such as faults and shear zones, were observed in the rock faces covered by the discontinuity survey lines. Three major faults were however observed in the north-western part of the Zululand Quarry (see Photographic Summary in Appendix G as well as Plate 3.5 and Plate 3.6). Two dolerite dykes, up to 3 m wide and

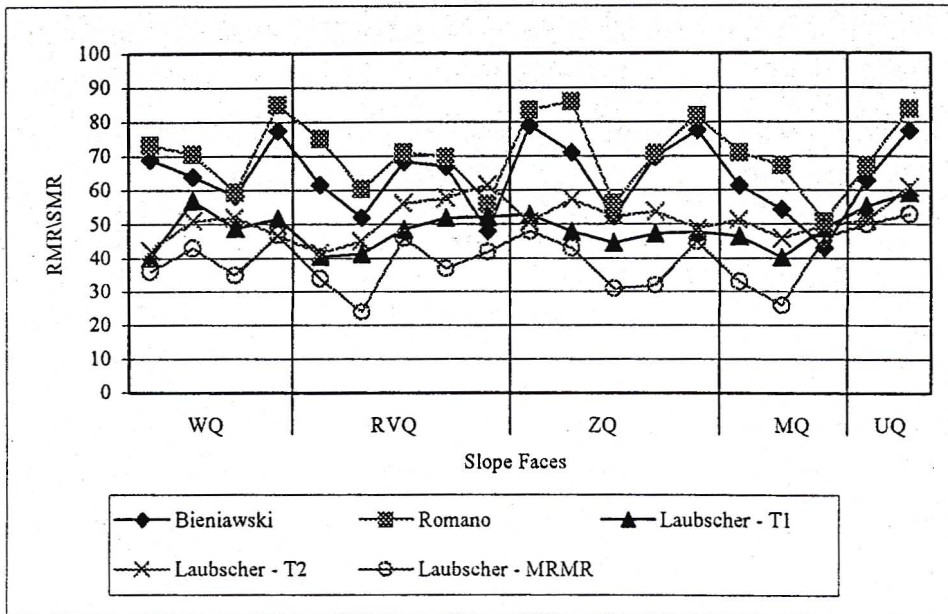
Figure 6.1: Line graphs comparing the Rock Mass Rating of Bieniawski, Romano and Laubscher.

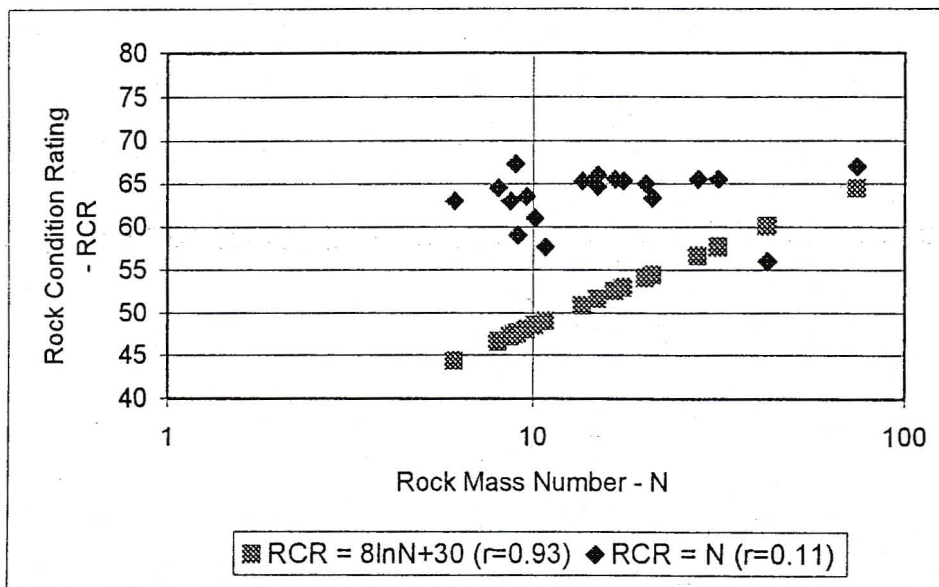
Figure 6.3: Relationship between N and RCR.
