Spatial and Temporal Aspects of Soil Erosion in Mt Ayliff and Mt
Frere, Eastern Cape Province, South Africa.

Submitted in partial fulfilment of the requirements for the degree of
Master of Science in the Discipline of Geography, School of
Applied Environmental Sciences, University of Natal,
Pietermaritzburg.

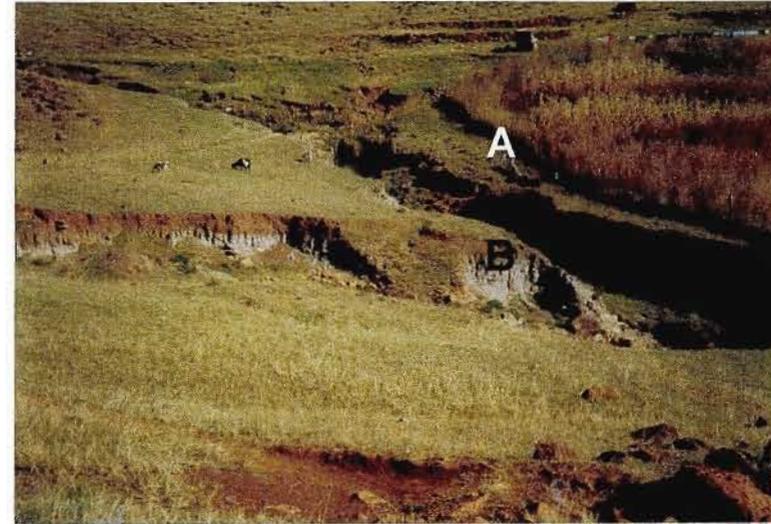
Fig. 5.2.3. A = overgrazed and fenced off grass species
 B = whitish grey soil at the two stream junction

We turn now to the confluence with the other tributary, which drains the opposite section of Brooks Nek [northeast facing grey slopes]. Stones and resistant grass species cover the rest of the valley sides. This section is covered up to 90% by short grazed grass. The exception is part of fenced off arable land (Fig. 5.2.3.A).

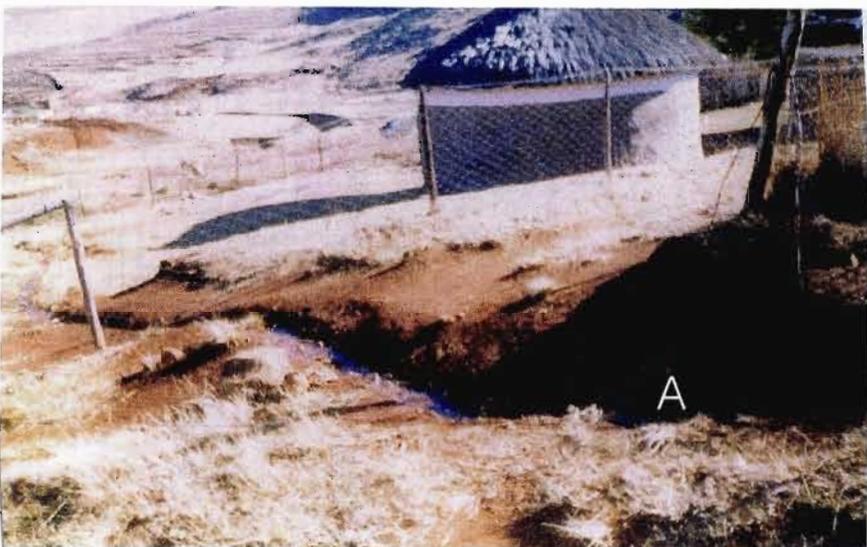
Fig. 5.4.2. A = heavily eroding furrow

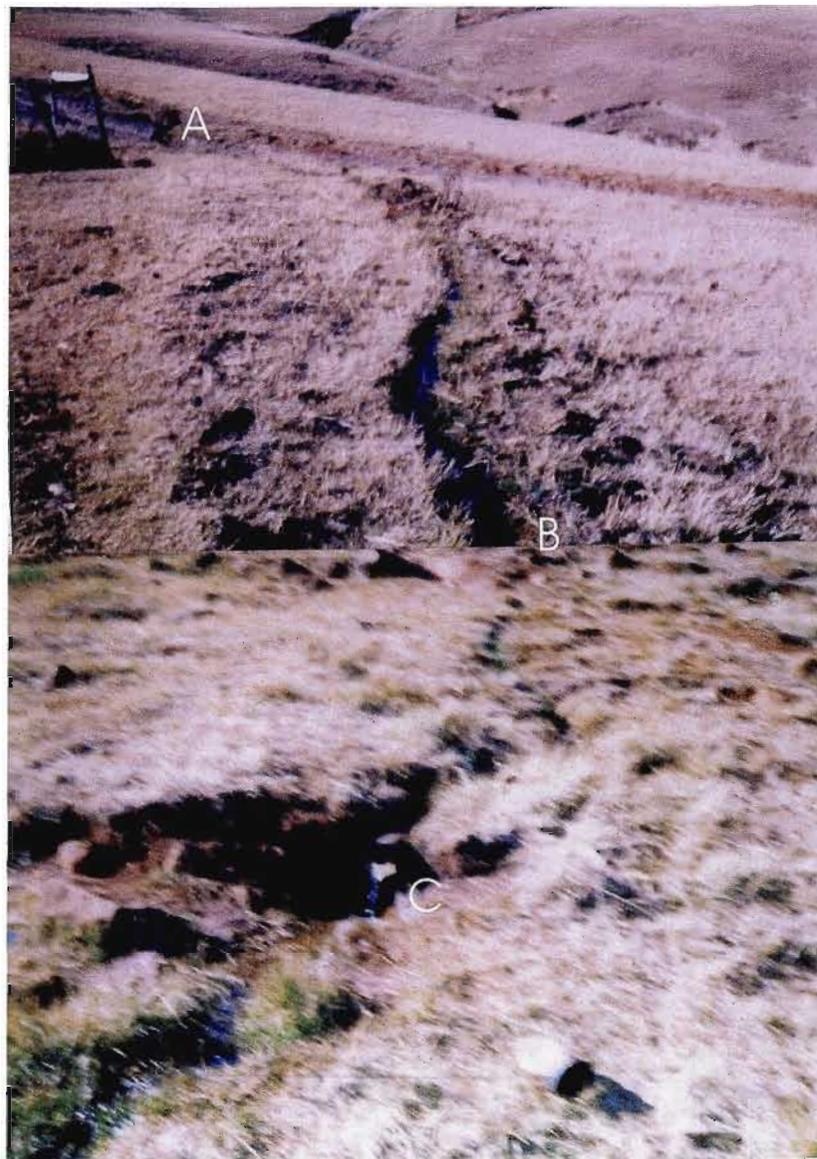
Fig. 5.4.3. A = footpath eroding to rills
B = furrow leading to the point where water is fetched
C = water pipe (collection point)

At label C, a small pipe is inserted to the minor degraded part - where a footpath cut across - and this facilitates water collection.
