**THE IMPACTS OF
WOODY INVASIVE ALIEN PLANTS ON
STREAM HYDROGEOMORPHOLOGY IN SMALL
HEADWATER STREAMS OF KWAZULU-NATAL**

Submitted in fulfilment of the academic requirements for the degree of
Master of Science in Hydrology

School of Bioresources Engineering and Environmental Hydrology
University of KwaZulu-Natal
Pietermaritzburg
March 2010

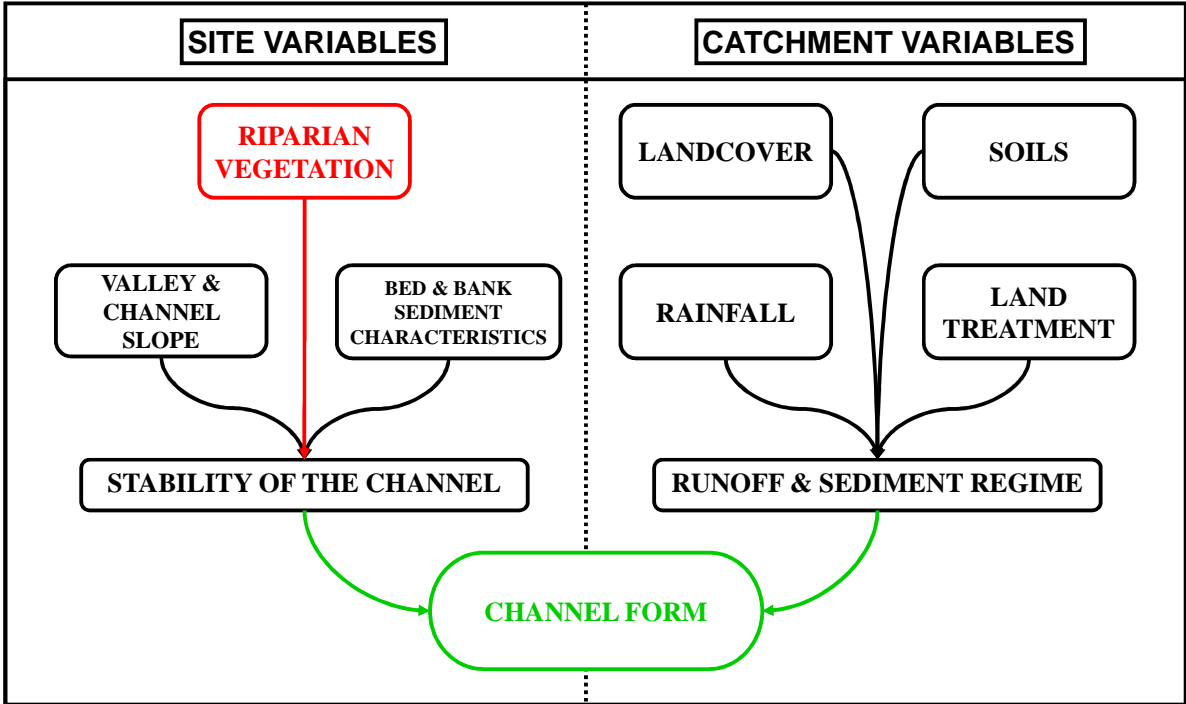
Riparian vegetation is seen as a key site variable controlling channel stability and channel form (Rowntree, 1991). This relationship is explored in Figure 3.3, showing that riparian vegetation transformation as a result of IAP invasion has the potential to influence channel form. Rowntree (1991, pp28) stated that “wherever alien vegetation invades the riparian zone it can be expected that there will be some sort of impact on the physical structure of the riparian habitat.” Transformer invasive species result in the transformation of a mixed indigenous community into a woody monoculture. Woody IAPs in particular, have a strong potential to cause channel modification. Their removal can induce significant soil erosion problems and cause streambank instability (Rowntree, 1991). In addition, the burning of dense stands of woody IAPs can lead to a significant increase in sediment yield from the catchment following rainfall events (Holmes *et. al.*, 2005).

Figure 3.3 Relationship of key variables important to controlling channel form (for illustrative purposes - list of variables not all inclusive)

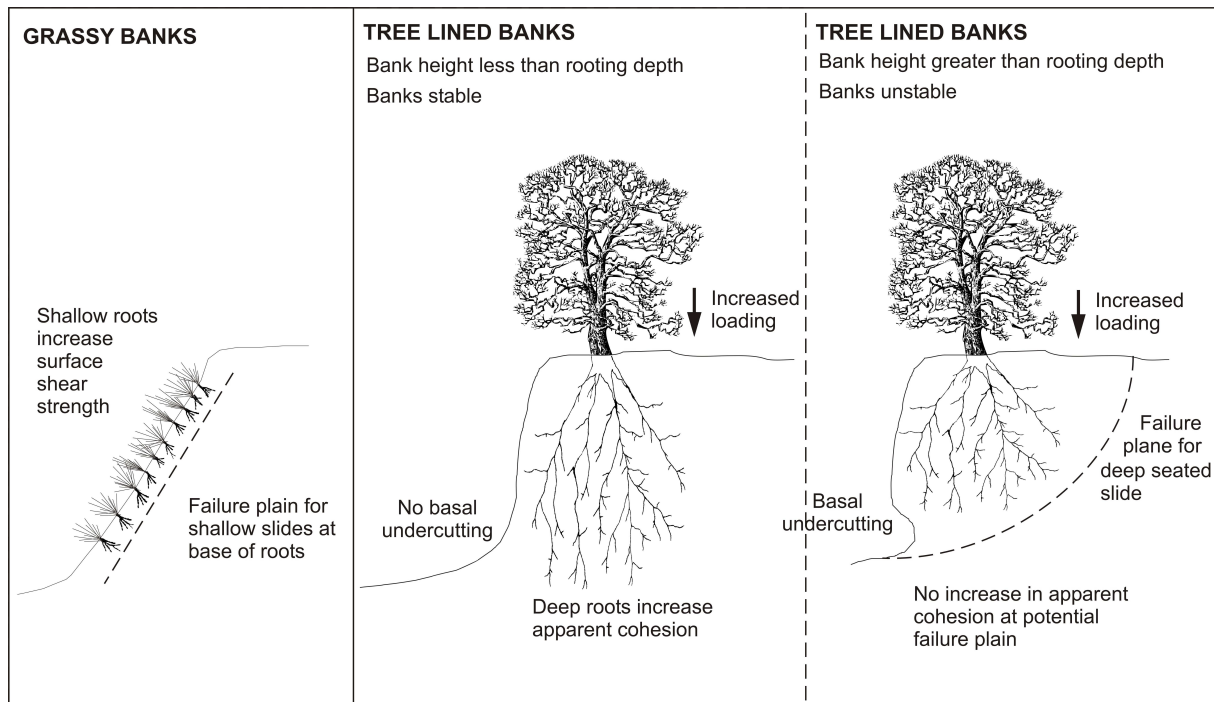
In a review of available literature at the time, Rowntree (1991) found important distinctions made between grassy and woody vegetation growing on streambanks and their effect on bank stability. These concepts are illustrated in Figure 4.1, where grass with its dense root mass is effective against surface scour of the banks as well as preventing shallow bank slips. In contrast woody vegetation, such as trees, lack this protective groundcover and so do not prevent scour of the bank. In addition the weight of the trees increases the bank mass and may increase chances of failure if bank undercutting is present and the tree roots do not extend deeper than the bank height. Under these circumstances a failure plane may develop resulting in a deep seated slide (Figure 4.1). However if the rooting depth extends deeper than the

height of the bank then the trees have the potential to reduce the chances of mass failure (Rowntree, 1991).

Figure 4.1 The effect of vegetation on bank stability (after Rowntree 1991)

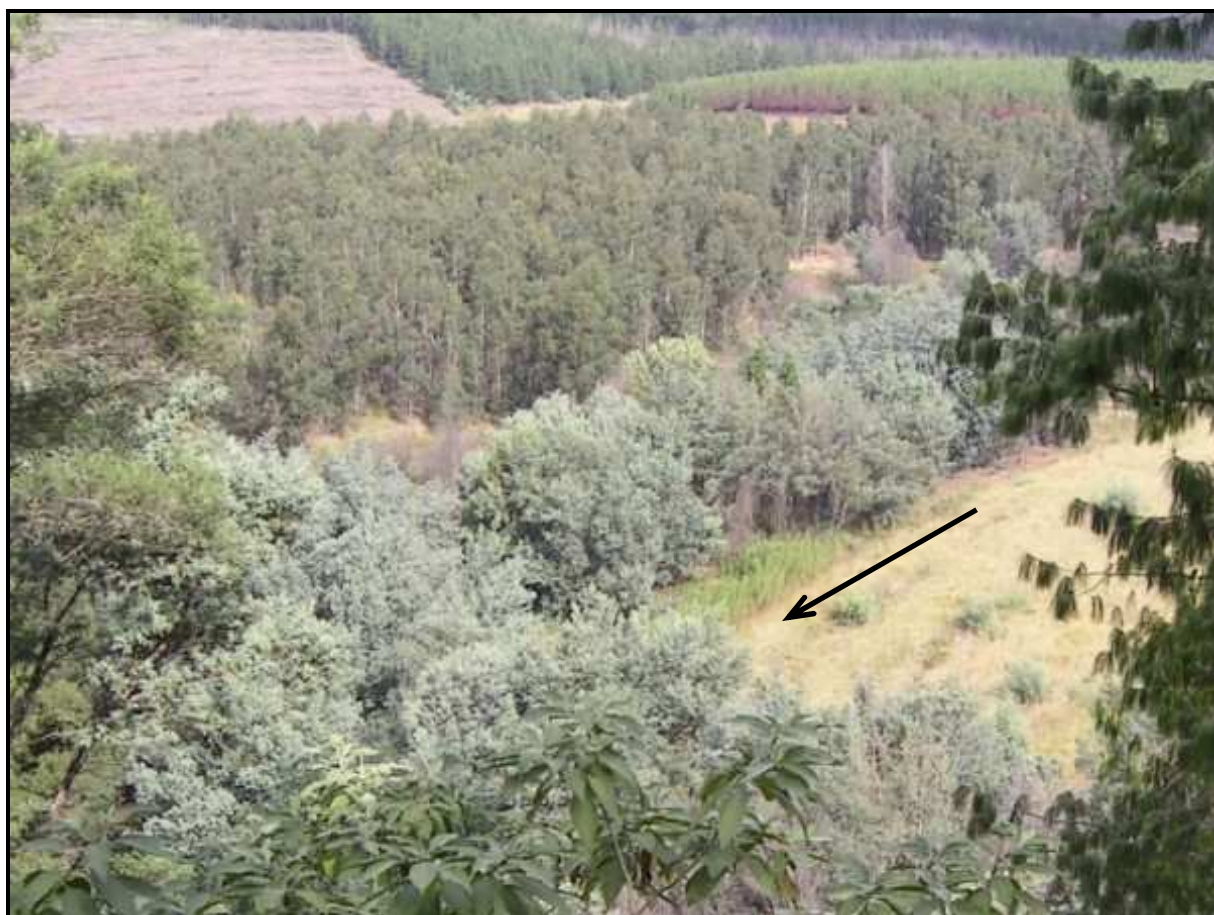
Figure 6.4 Umvoti IAP infested Site U1 showing IAP infested riparian zone and streamflow direction

The channel bed of Site U1 was comprised of largely unconsolidated material, but with boulders and cobble present. At the time of survey the riparian zone was densely infested with invasive wattle to the exclusion of groundcover in many sections. The valley form was asymmetrical, with a steep valley side shown in the foreground of Figure 6.4 and a flat valley

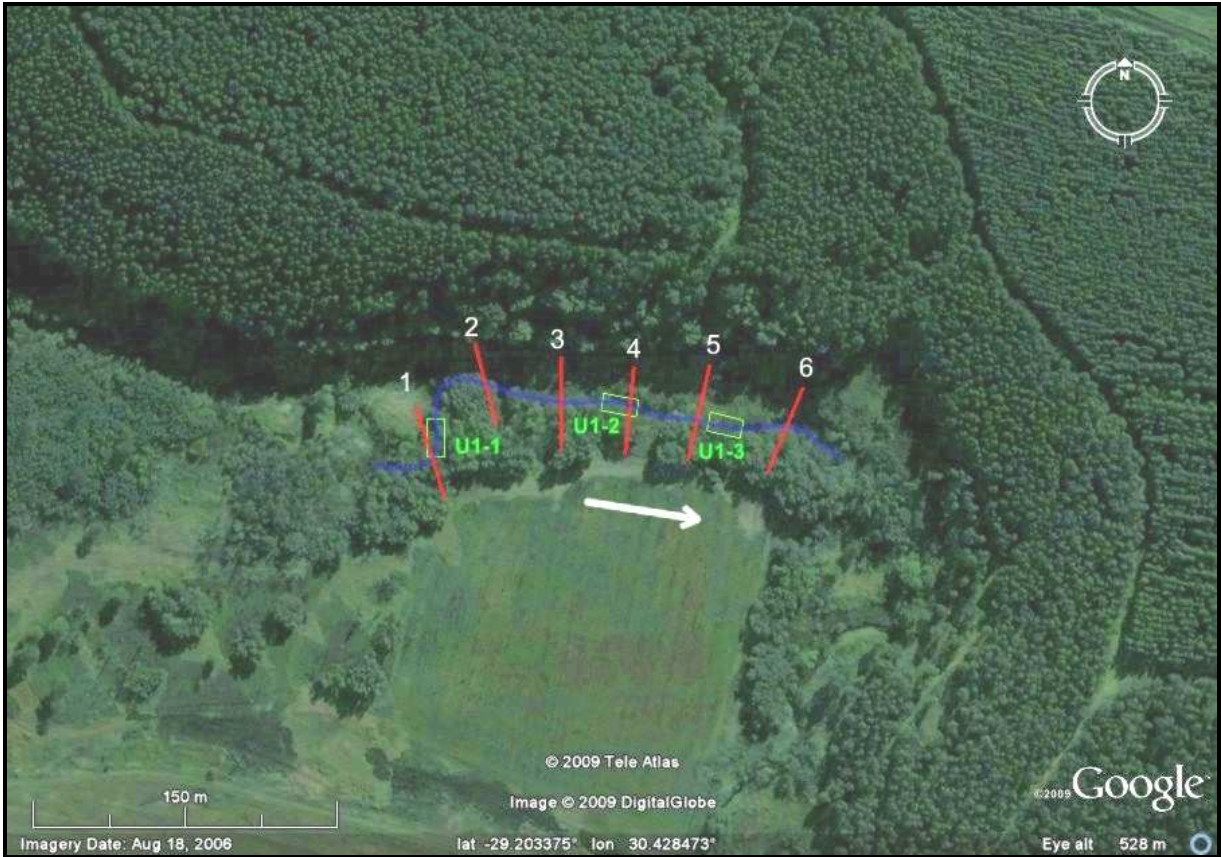
Figure 6.5 Aerial view of Site U1 study reach, MRHS/cross-profile transects 1-6 and morphological map sites U2-1 to U2-3

At each river surveyed a 500m study reach comprising 10 transects at 55m intervals was established (Figures 6.5, 6.7 and 6.9). The MRHS was performed along the 500m study reach, with certain features being noted at each transect intersection point. At each transect a cross profile was taken utilising a mapping grade Trimble Pro-XRS GPS receiver and TSC1 data collector. Following differential correction, this setup provides sub metre accuracy of less than 500mm in the horizontal (x and y) plane and less than 1000mm in the vertical (z) plane. The differential GPS was also used to capture the stream form and the boundaries of the channel for the entire length of the 500m study reach at each site. Finally, detailed mapping of the morphological units or hydraulic biotopes, as well as bank features was undertaken along three short study reaches at each of the Umvoti sites U1 to U3.

At Sites U1, U2 and U3 accurate maps of stream, bank and vegetative features were produced at three representative reaches of 20m length, within each 500m study reach (Figures 6.5, 6.7 and 6.9). The final methodology utilised combined methods extracted from King and Schael (2001) and Rowntree and Wadson (1999).

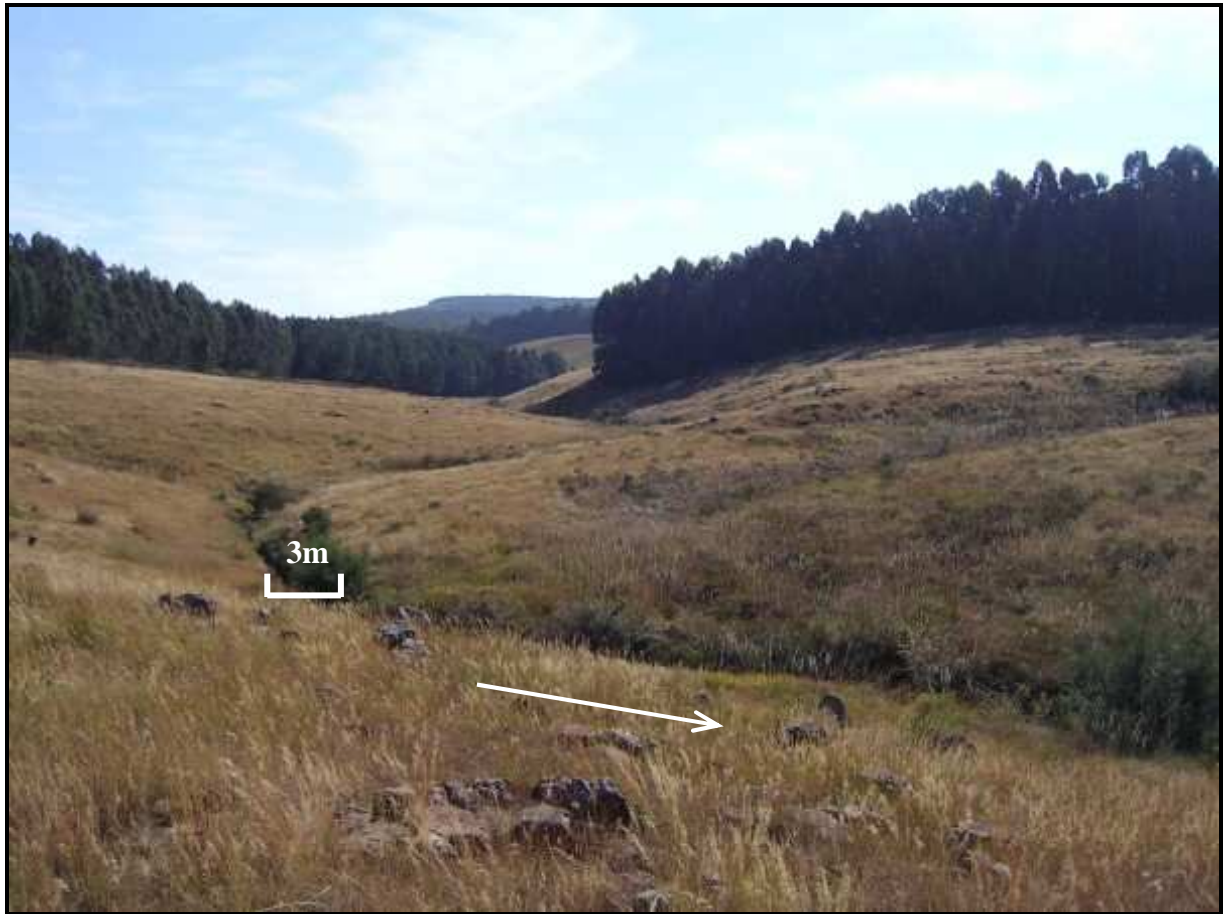
Figure 6.6 Umvoti natural Site U2 showing absence of IAPs

The Umvoti natural Site U2, was the most undisturbed section of river which could be found in the region, with only a few scattered individuals of invasive *Acacia* species found within the riparian zone at the time of survey. The riparian zone and surrounding slopes were dominated by grassland. The river is a bedrock dominated system, with the river bed comprising of bedrock for a large portion of the 500m study reach. At the foot and the head of the 500m reach (Figure 6.7) the valley form is asymmetrical, with the left bank (looking downstream) being significantly steeper in both cases. The central portion of the 500m reach, shown in the foreground of Figure 6.6, has a more symmetrical valley form. The dolerite intrusions associated with the bedrock culminate in a waterfall of greater than 5m height approximately 650m downstream of the site. The width of water within the channel at the MRHS transects of the 500m reach ranged from 1m to 3m, with the maximum water depth ranging from 0.15m to 1.1m at the time of survey.

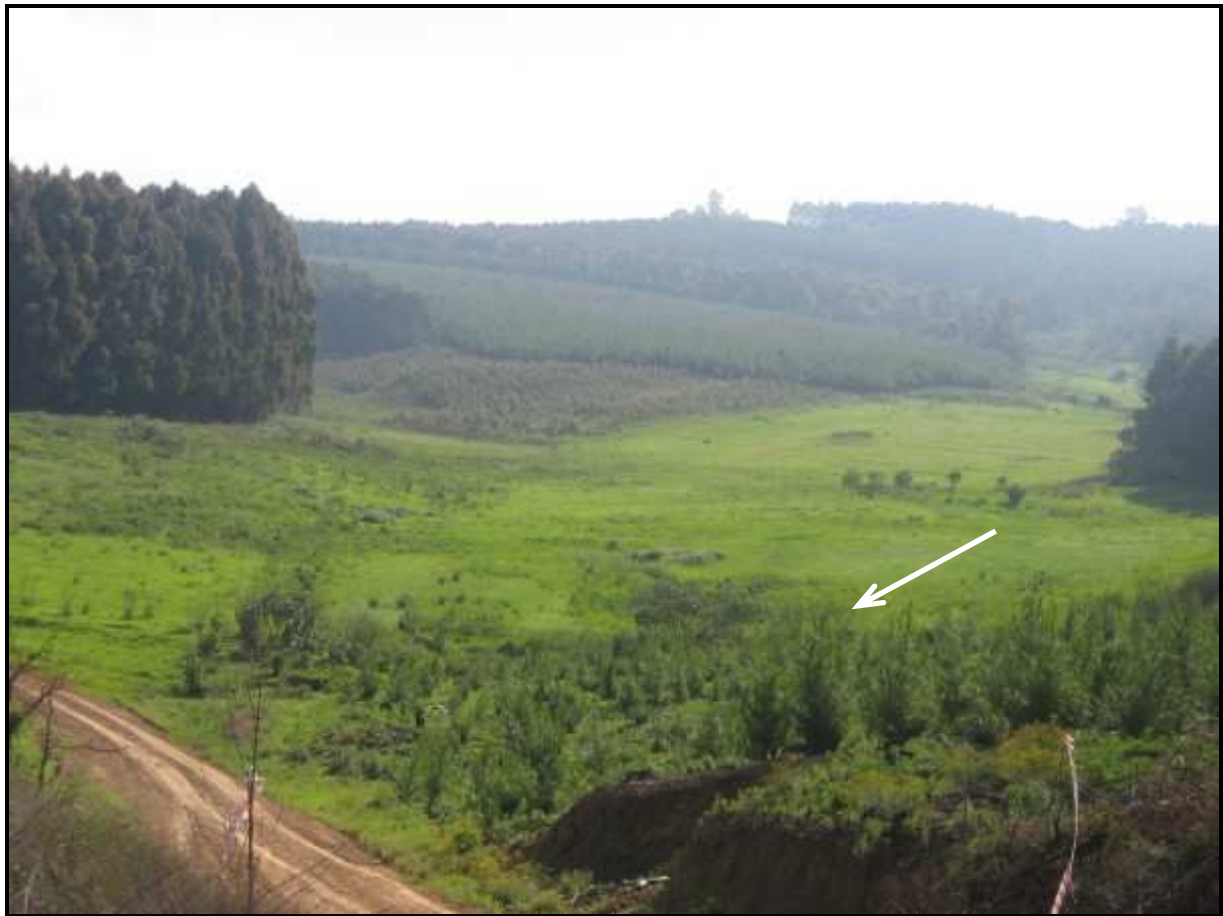
Figure 6.8 Umvoti IAP cleared Site U3 showing absence of woody IAPs

Site U3 shows evidence of the past presence of woody IAPs in the form of stumps scattered sparsely at various points along the channel banktop. The channel form is strongly meandering, as can be seen in Figure 6.9, with an average channel depth and width of 1.2m and 3.5m respectively at the time of survey. During the winter site visit, open water was not present along the entire 500m study reach, but scattered pools were present, as were signs of water seepage from the channel sides. The meandering reflects the flat relief of the site, which formed an open valley (Figure 6.8), and was classified as a 'shallow vee' in the MRHS form. Due to the relief of the site and the absence of macro-channel banks, it is suspected that the site formerly contained a significant area of wetland habitat. This was confirmed through a soils analysis utilising an auger to extract subsurface soil samples. Greyed soils with signs of mottling were found within 500 mm of the surface, which according to the DWAF (2005) guidelines, *A Practical Field Procedure for Identification and Delineation of Wetland and Riparian areas*, indicates the presence of wetland soils displaying signs of temporary wetness.

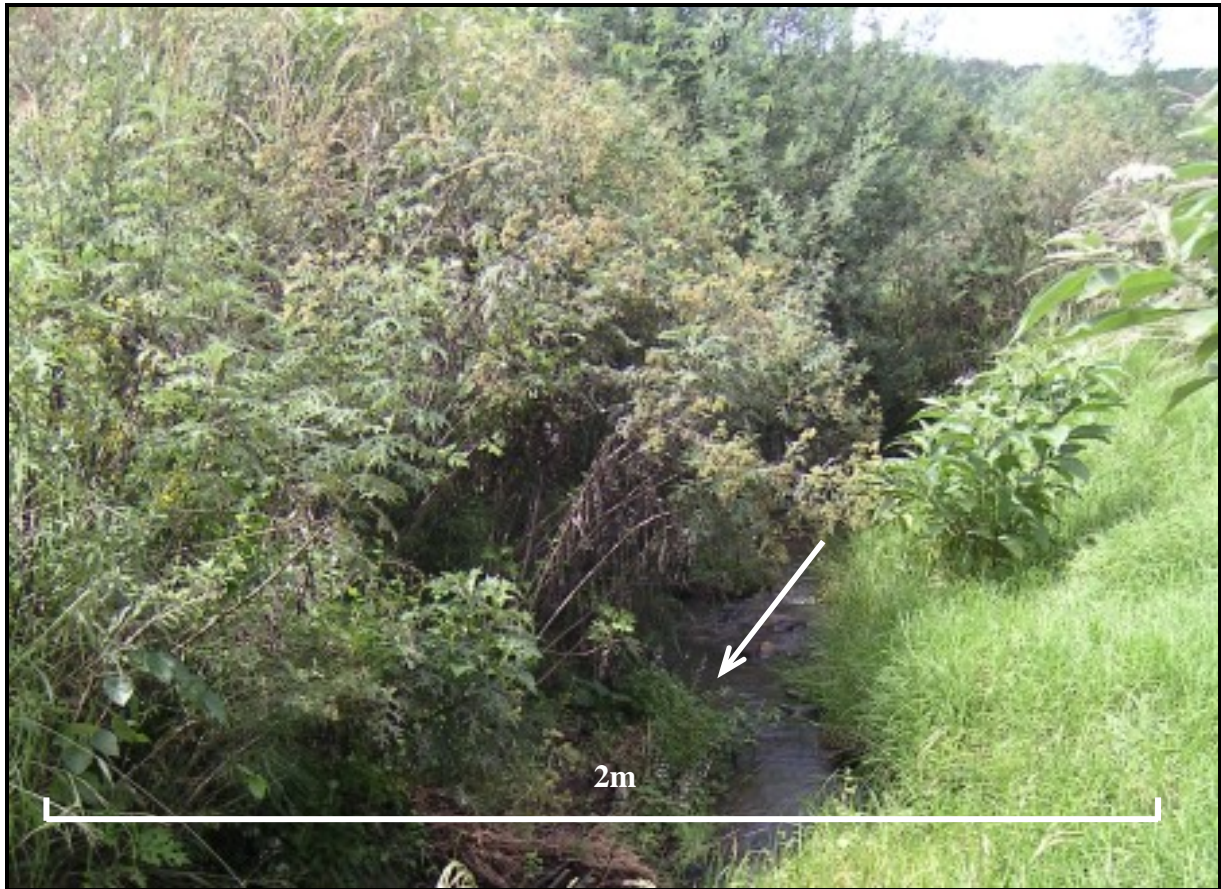
Figure 6.10 Umvoti IAP cleared Site U4 showing presence of some woody IAPs

Site U4 was classified as an IAP cleared site as the study focussed on the impact of large woody IAPs, which appeared to have been present in the near past due to the presence of invasive *Acacia* stumps. Since clearing of the large woody IAPs the site was colonised by *S. mauritianum* which had formed a closed canopy over portions of the site at the time of the fieldwork (Figure 6.10 and 6.11), but which would likely be cleared by the commercial foresters in due course through their IAP clearing follow-up schedule. Scattered individuals of invasive *Acacia* were present within the riparian zone. The stream bed consists of unconsolidated material, with the average channel depth of the study reach being 2.2m and the average width 4.6m at the time of survey. Site 4 was characterised by a concave, bowl shaped valley with a flat valley bottom.

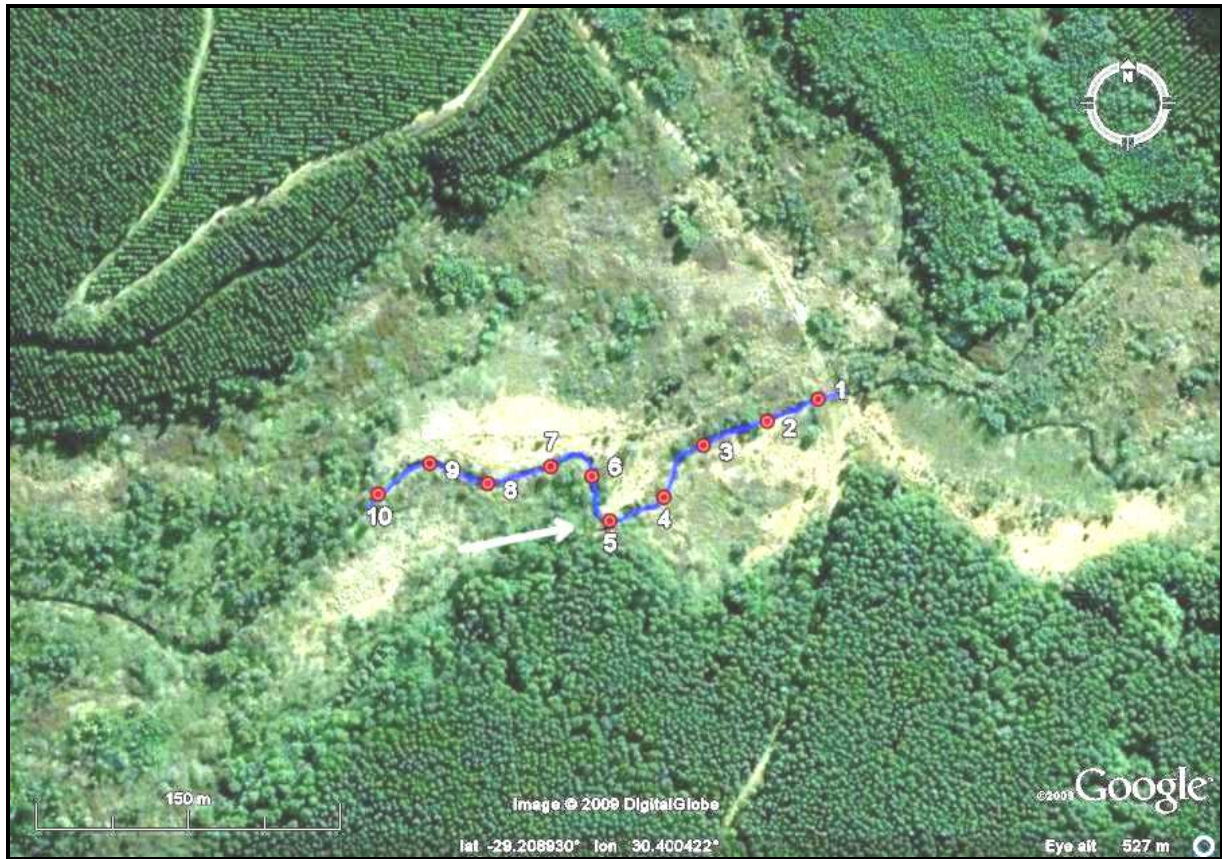
Figure 6.11 Aerial view of Site U4 study reach and MRHS transect points

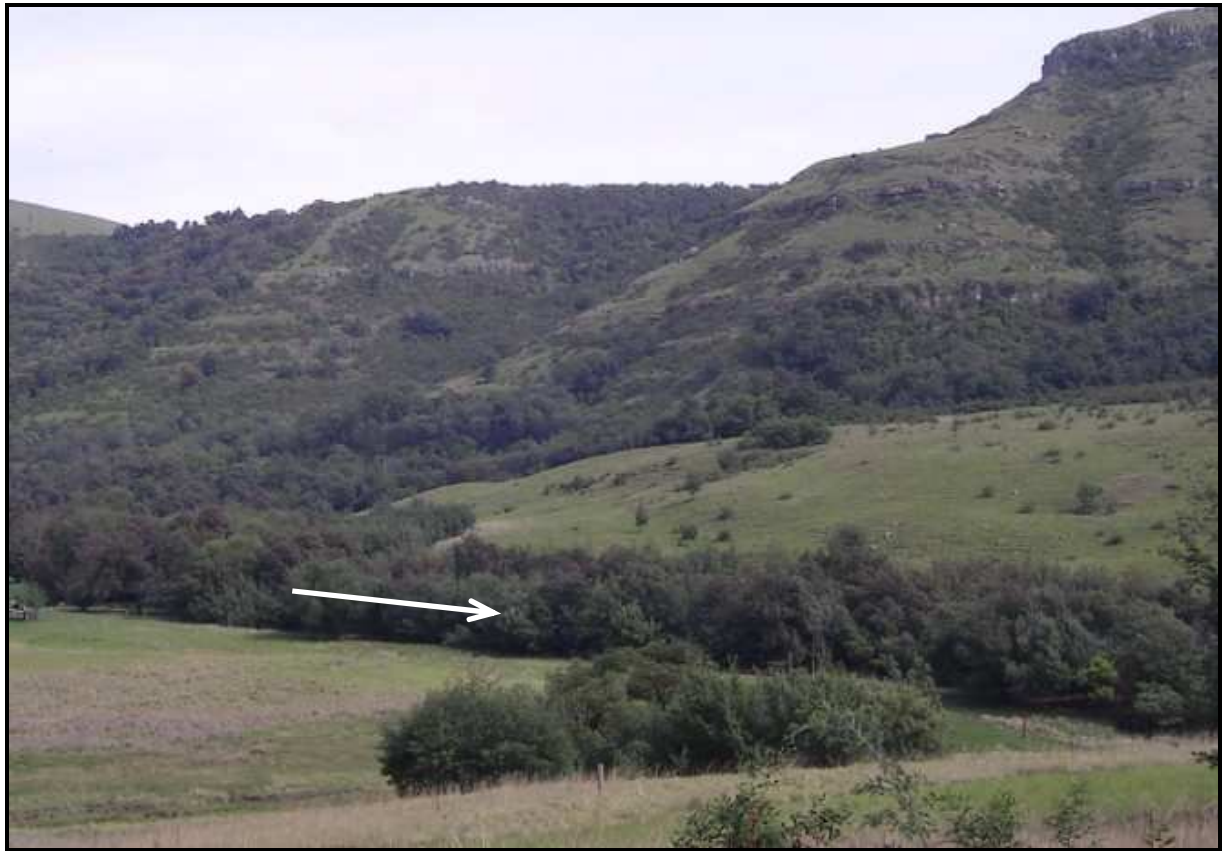
Figure 6.12 Cedarville IAP infested Site C1 showing density of alien invasive wattle

IAP infested Site C1 comprises of a riparian zone which was heavily infested with invasive *Acacia* species of varying age (Figure 6.12 and 6.13). The invasion by the woody IAPs extends from just below the source of the Mvenyane River a few kilometres to the west of the site, and continues for many kilometres downstream to the confluence with the Mzimvubu River. The study reach is a bedrock dominated site, with the stream bed crossing bedrock at numerous sections. At the time of survey the average channel depth of the study reach was 2.4m, with the average width being 8m. The width of water within the channel ranged from 2.1m to 6.2 across the ten transects, with maximum water depths from 0.02m to 0.35m at the time of survey.

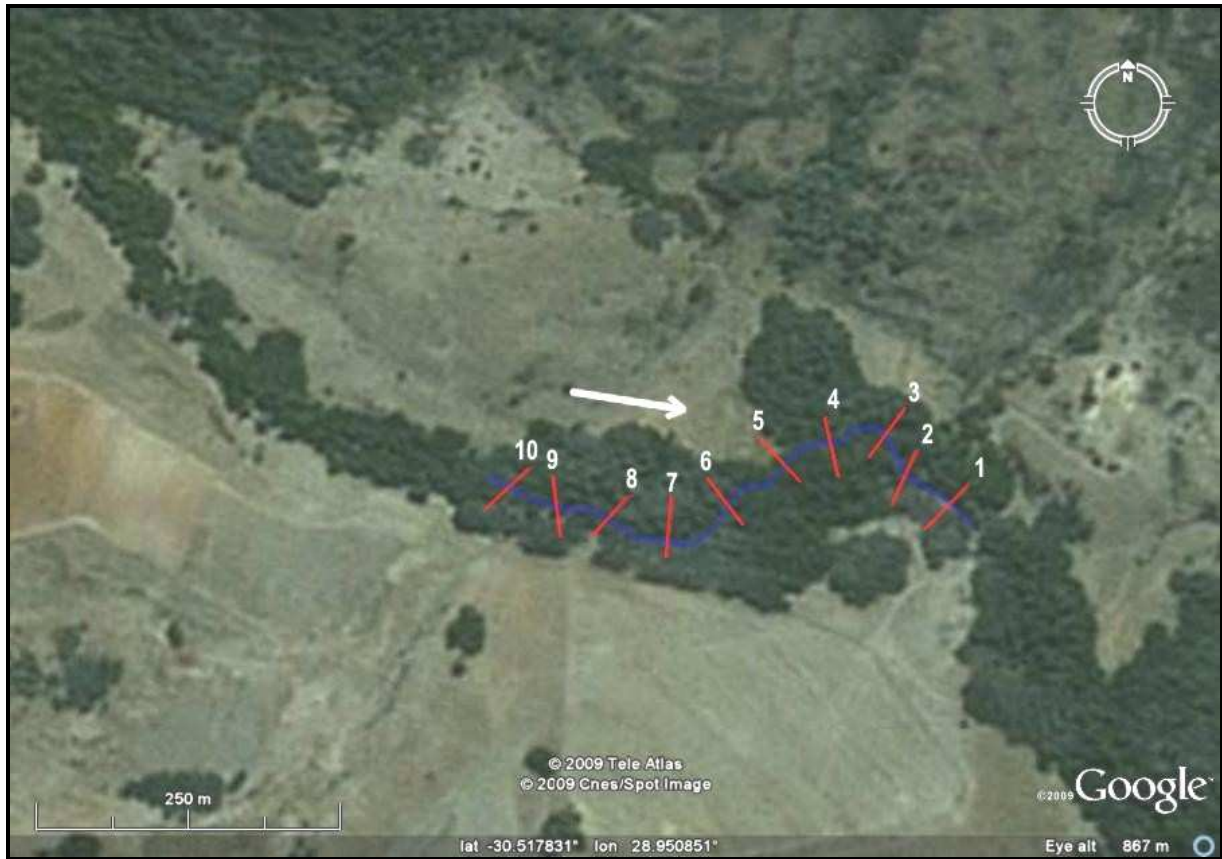
Figure 6.13 Aerial view of Site C1 study reach and MRHS/cross-profile transects 1-10

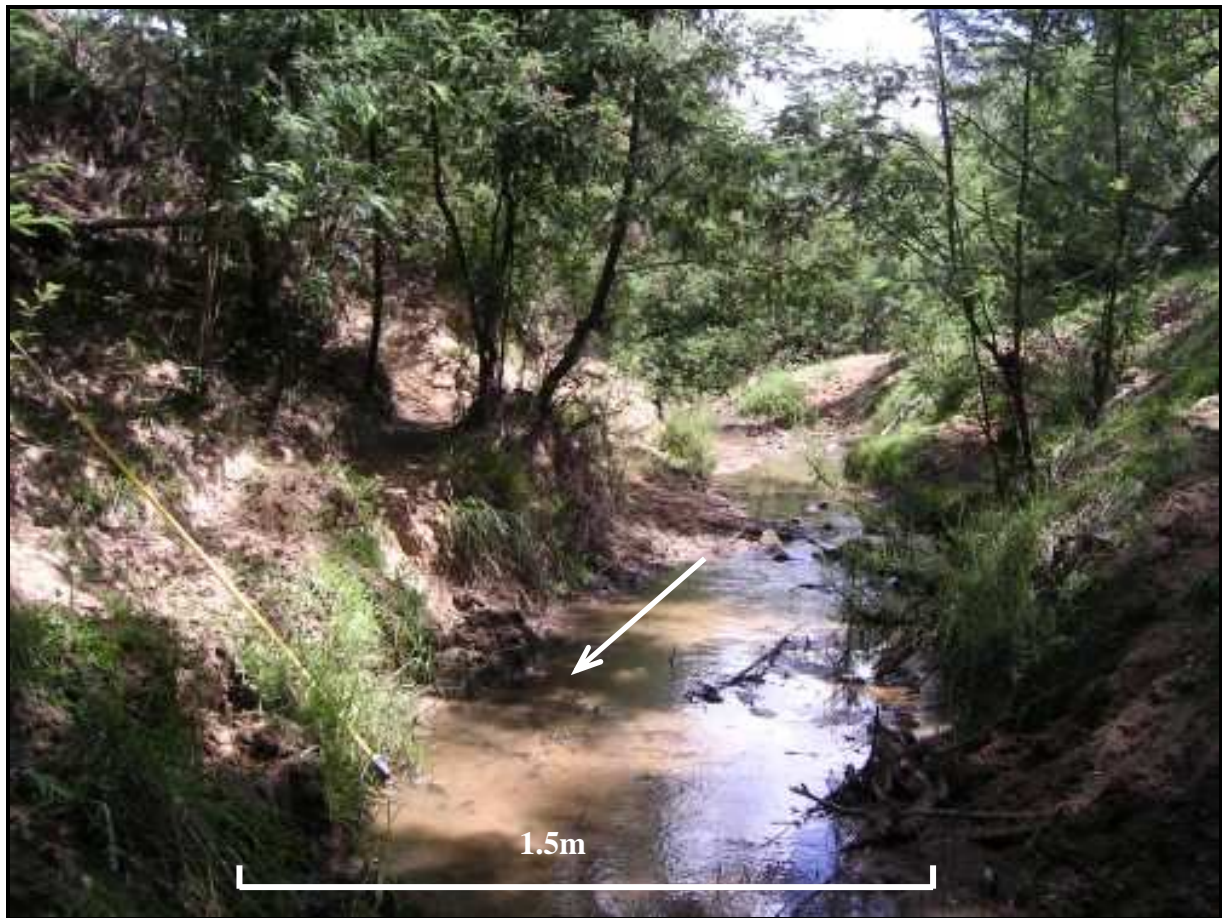
Figure 6.16 Cedarville IAP infested Site C3 showing density of wattle invasion

IAP infested Site C3 falls 1.4km upstream from Site C2, with Site C3 being situated above the confluence of another tributary (Figure 6.3). The banks and channel bed of Site C3 are comprised of the same soils of high sand content as Site C2. Large boulders were present, individually scattered along certain sections of the river reach. Consolidation of the sandy banks was very poor under the canopy of invasive wattle due to the lack of binding groundcover (Figure 6.16). The invasive wattle was only present on the banks of the riparian zone, and within the channel. Beyond the stream banktops the vegetation reverted to grassland (Figure 6.17). At the time of survey the average channel depth of the study reach was 4.1m, with the average width being 9.9m. The width of water within the channel ranged from 0.9m to 2.6m across the ten transects, with maximum water depths from 0.05m to 0.35m at the time of survey.

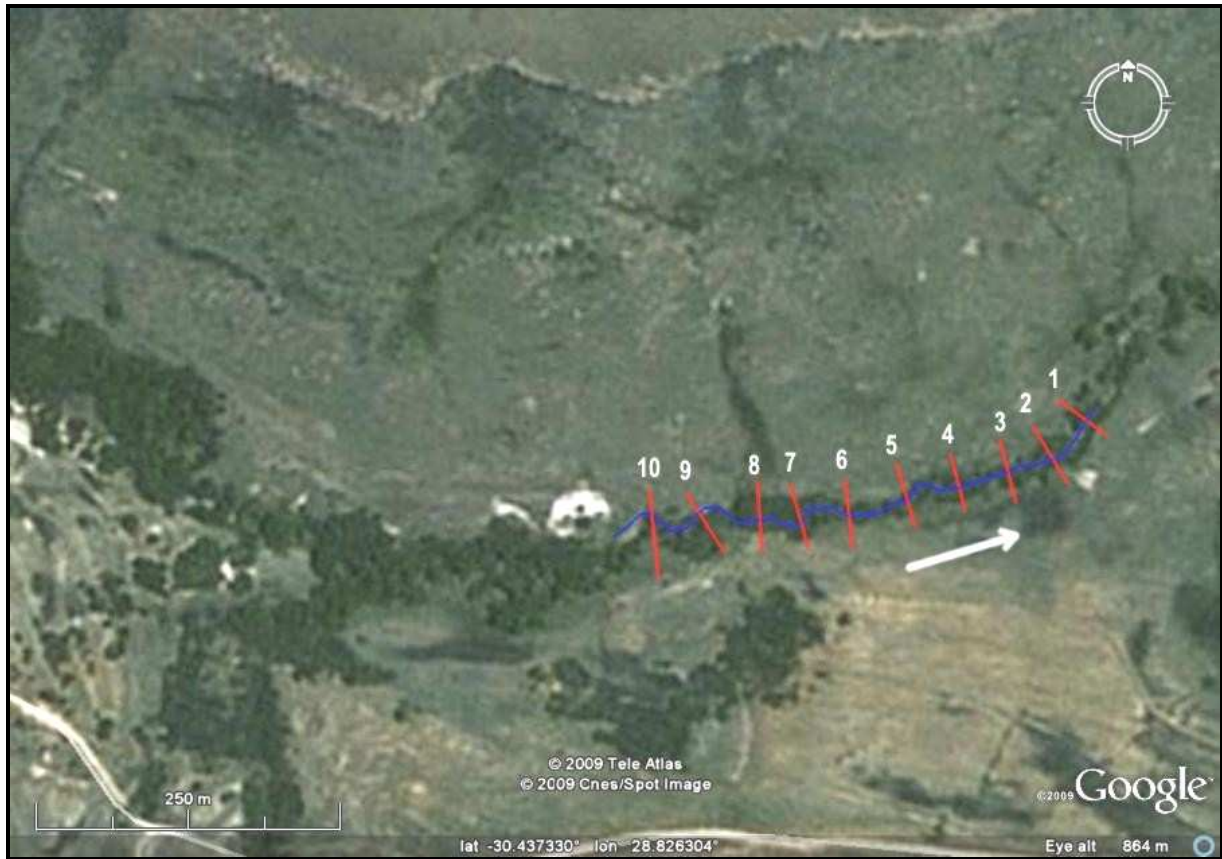
Figure 6.17 Aerial view of Site C3 study reach and MRHS/cross-profile transects 1-10

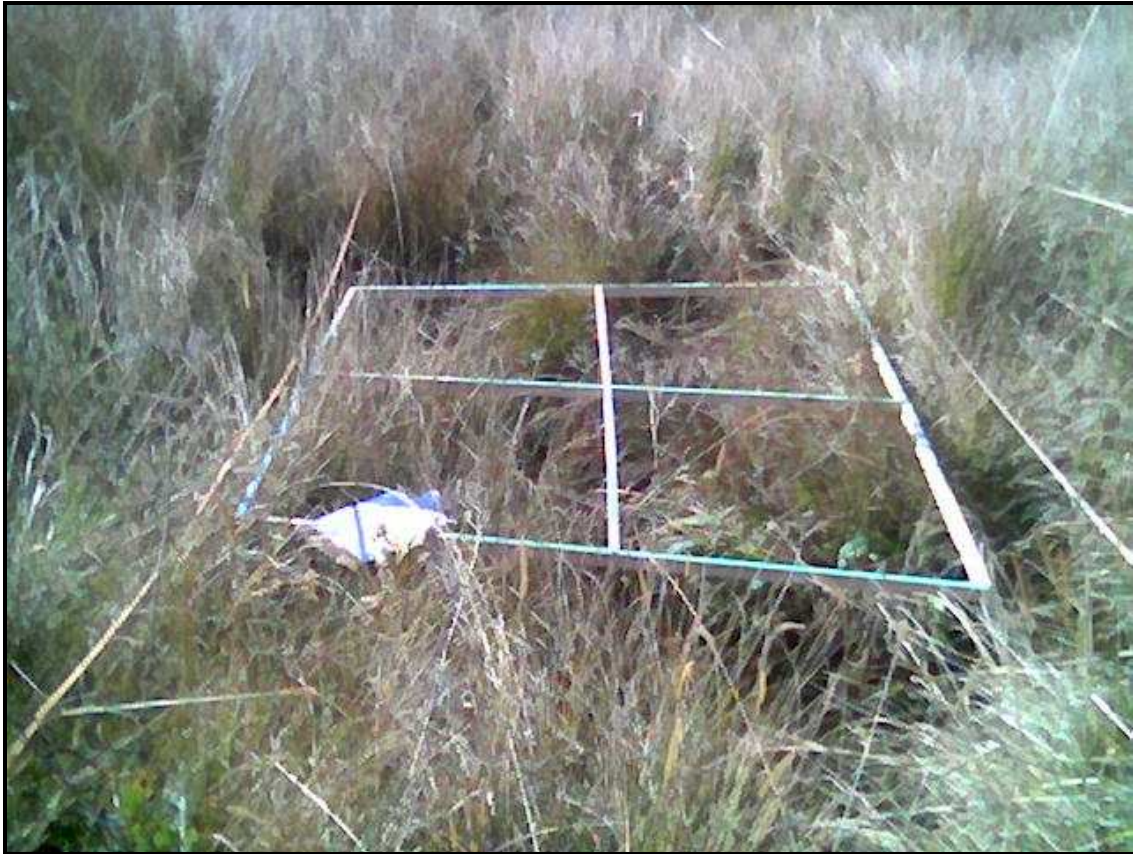
In the absence of useable GPS data for the infested sites, a manual methodology was developed for mapping the morphological units. Utilising a quadrat, features would be mapped manually on graph paper, and then digitised and geo-referenced using a digitising tablet and GIS. A 2m x 2m quadrat (Figure 6.18) was constructed of wood, producing four squares of 1m² each. Tape measures were attached to all ribs of the quadrat for quick and accurate measuring. Utilising multiple 20m tape measures, a grid was set up along the 20m reach to be mapped. The quadrat then had reference lines along which it could be moved to cover the entire 20m reach in a consistent grid pattern.

Figure 6.18 Wooden quadrat being utilised to map morphological features

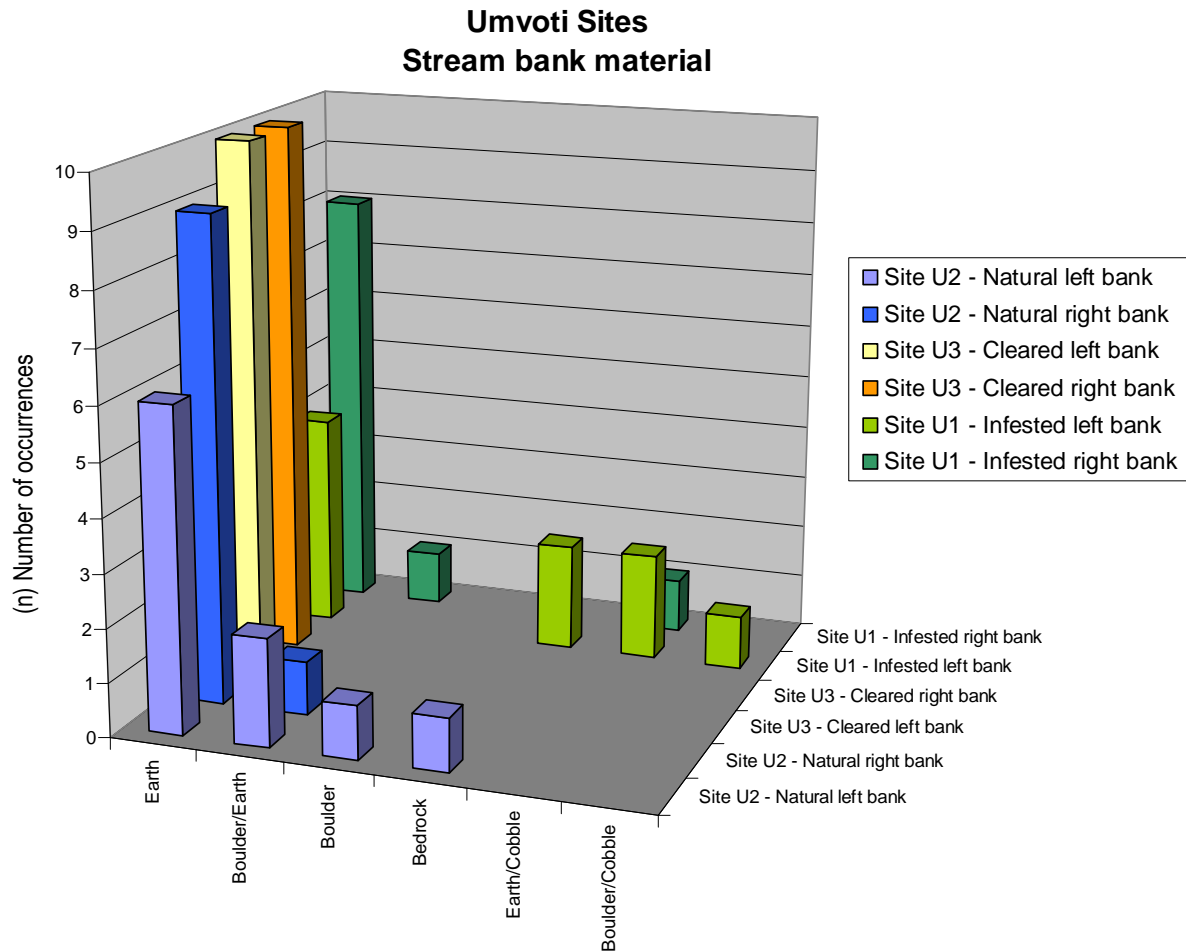
Figure 7.2 Comparison of streambank material across the Umvoti sites

From Figure 7.2 it can be seen that at the Umvoti sites the predominant bank material is earth. IAP cleared Site U3, the wetland site, shows no presence of cobble, boulder or bedrock, while the IAP infested Site U1 showed a presence of bedrock at two transects, with cobble and boulders being present within the earth banks at others. The natural Site U2 reflected the presence of bedrock at a single transect, with other transect points containing boulders but no cobble. This analysis illustrates that at site U3 the channel is cut through finer alluvium, which allows the channel greater flexibility in developing natural meanders and base level change. Stream form processes at Sites U1 and U2 will, to some degree, be influenced by the presence of boulders and cobbles of parent rock within the banks and bed material, as well as the temporary base levels of bedrock.

Figures 7.2 and 7.3 graph data from Section F. of the MRHS form which covers the physical attributes of the sites at each of the ten transects. The graphs show the distribution of streambank material types across all sites, with the Cedarville region sites being compared with the Umvoti region sites across the two graphs. This format is followed throughout Section 7.1. The purpose of the streambank material analysis is to establish possible influences on stream form by the different bank materials across the sites. The streambank material class ‘Earth’ (Table 6.3) refers to banks comprised predominantly of soil, in contrast to the “Earth/Cobble” or “Boulder/Earth” classes where boulder or cobble are omnipresent.

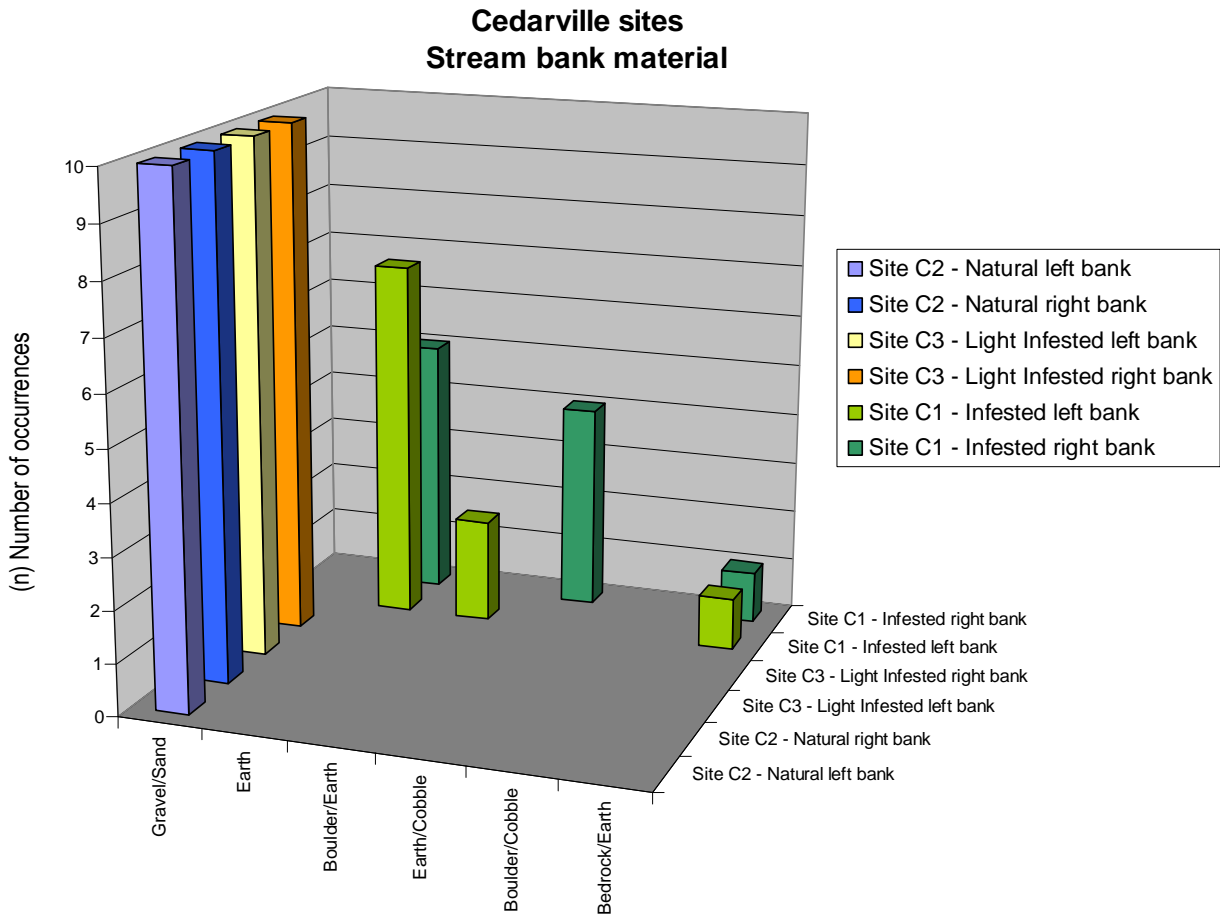
Figure 7.3 Comparison of streambank material across the Cedarville sites

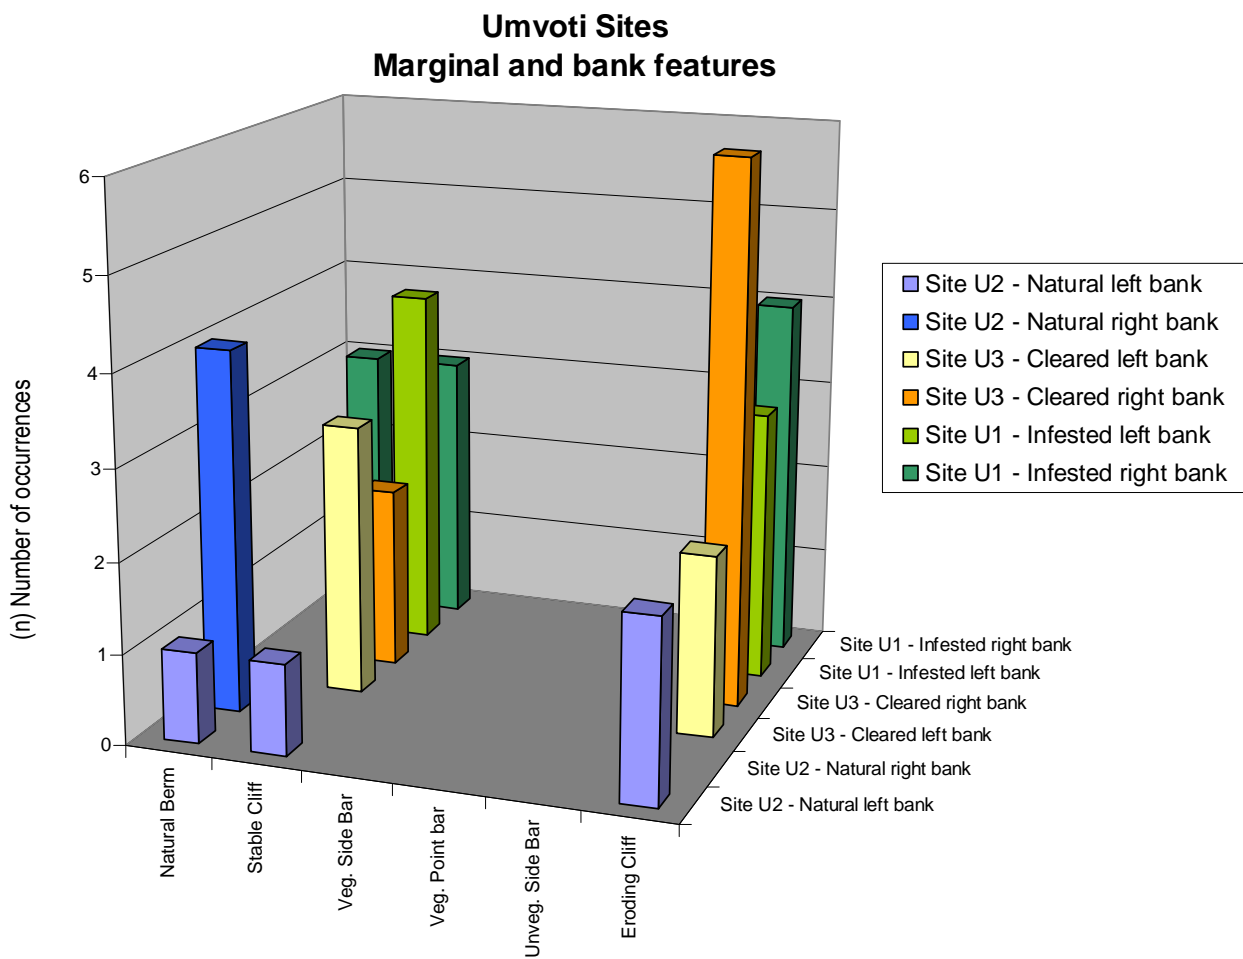
the natural Site U2 has a lower total number of stable and eroding cliff banks than the IAP infested and IAP cleared sites.

Figure 7.4 Comparison of stream marginal and bank features across the Umvoti sites

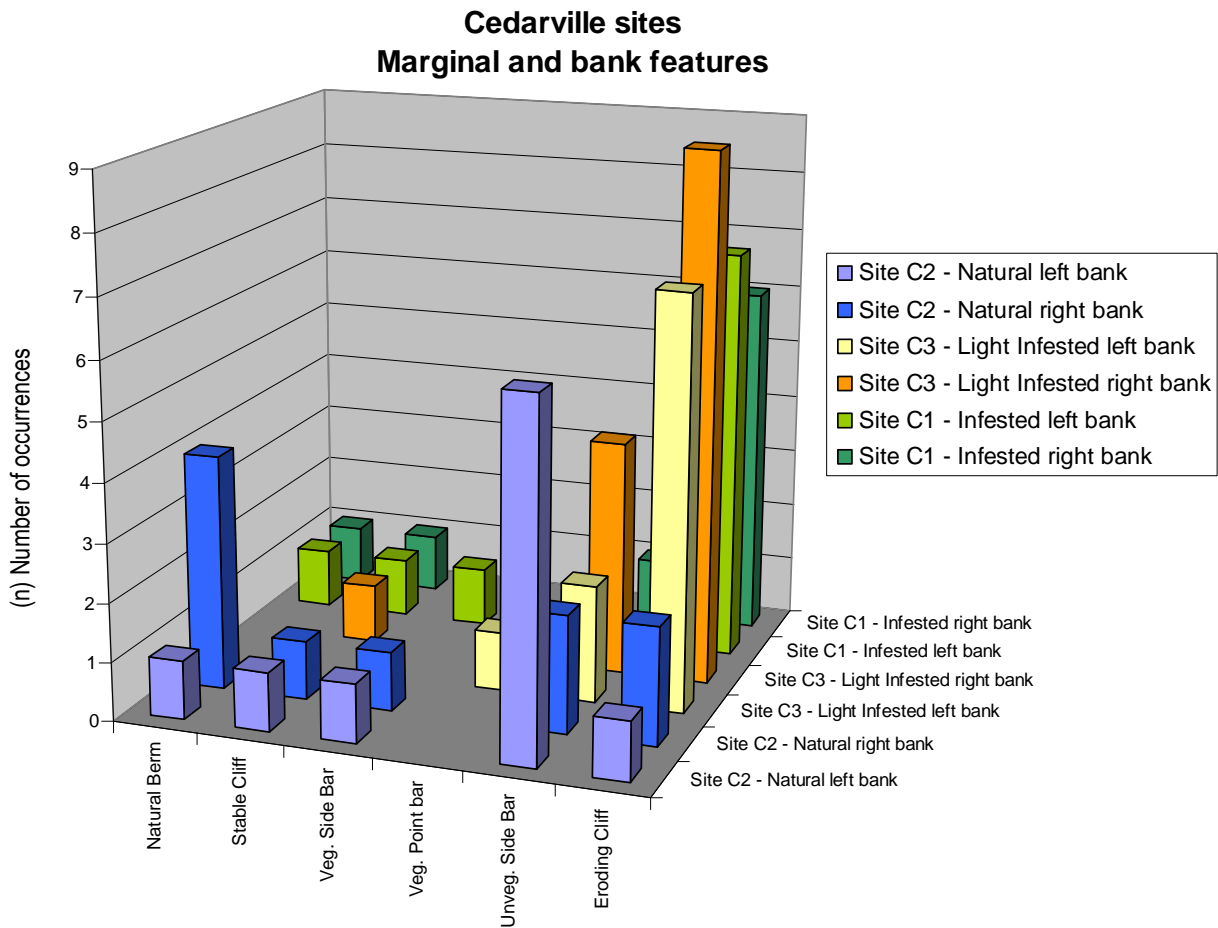
At the Cedarville sites shown in Figure 7.5, it can be seen that a similarly low distribution of stable cliff banks are present across the sites, but that there is a much higher prevalence of eroding cliff banks at the IAP infested sites than the natural site.

Figure 7.5 Comparison of stream marginal and bank features across the Cedarville sites

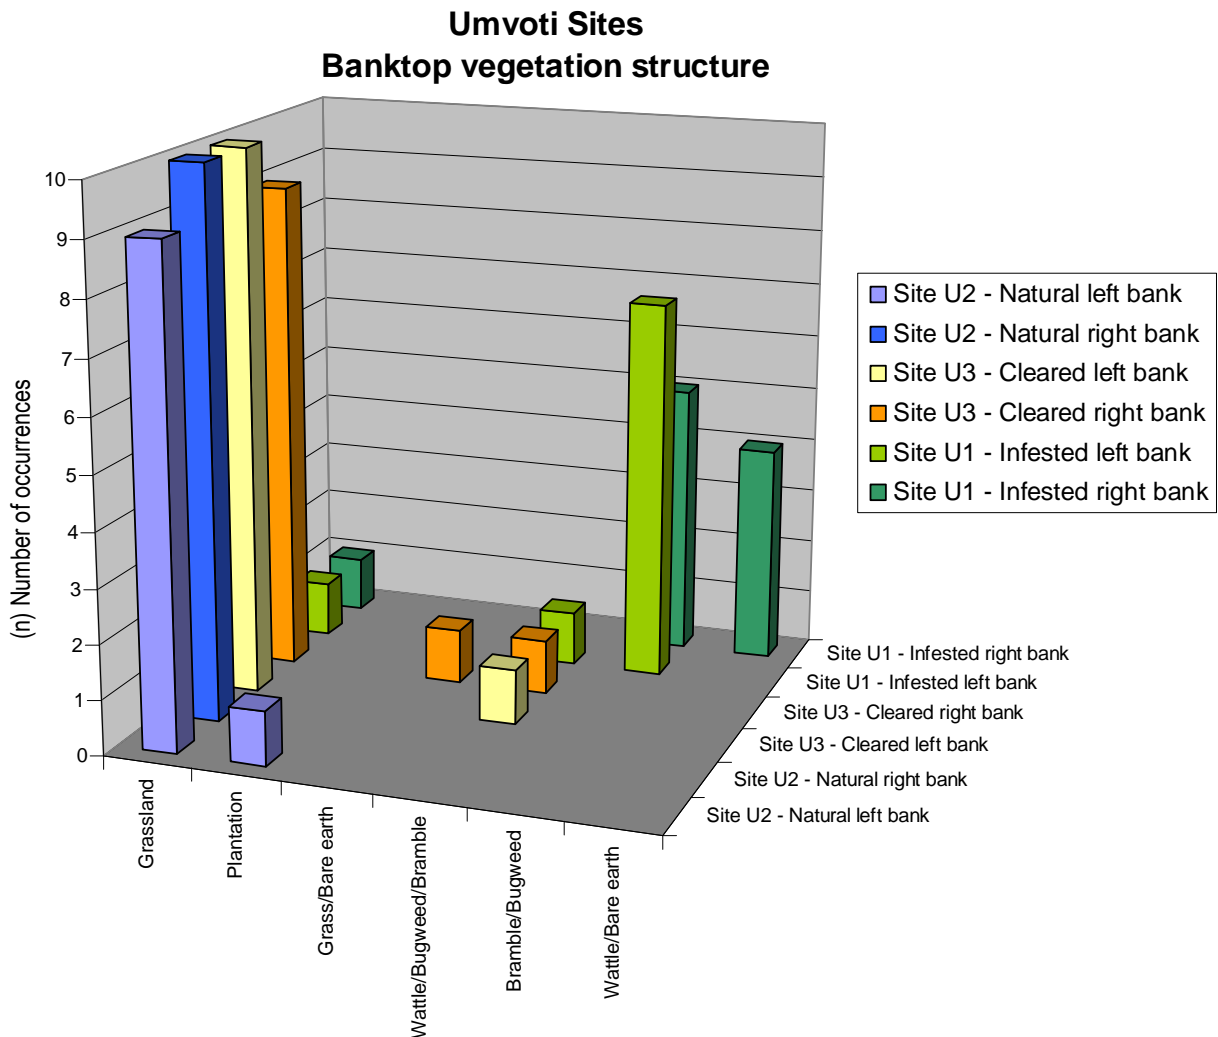
Figure 7.6 Comparison of banktop vegetation structures across the Umvoti sites
