**THE IMPACTS OF
WOODY INVASIVE ALIEN PLANTS ON
STREAM HYDROGEOMORPHOLOGY IN SMALL
HEADWATER STREAMS OF KWAZULU-NATAL**

Submitted in fulfilment of the academic requirements for the degree of
Master of Science in Hydrology

School of Bioresources Engineering and Environmental Hydrology
University of KwaZulu-Natal
Pietermaritzburg
March 2010

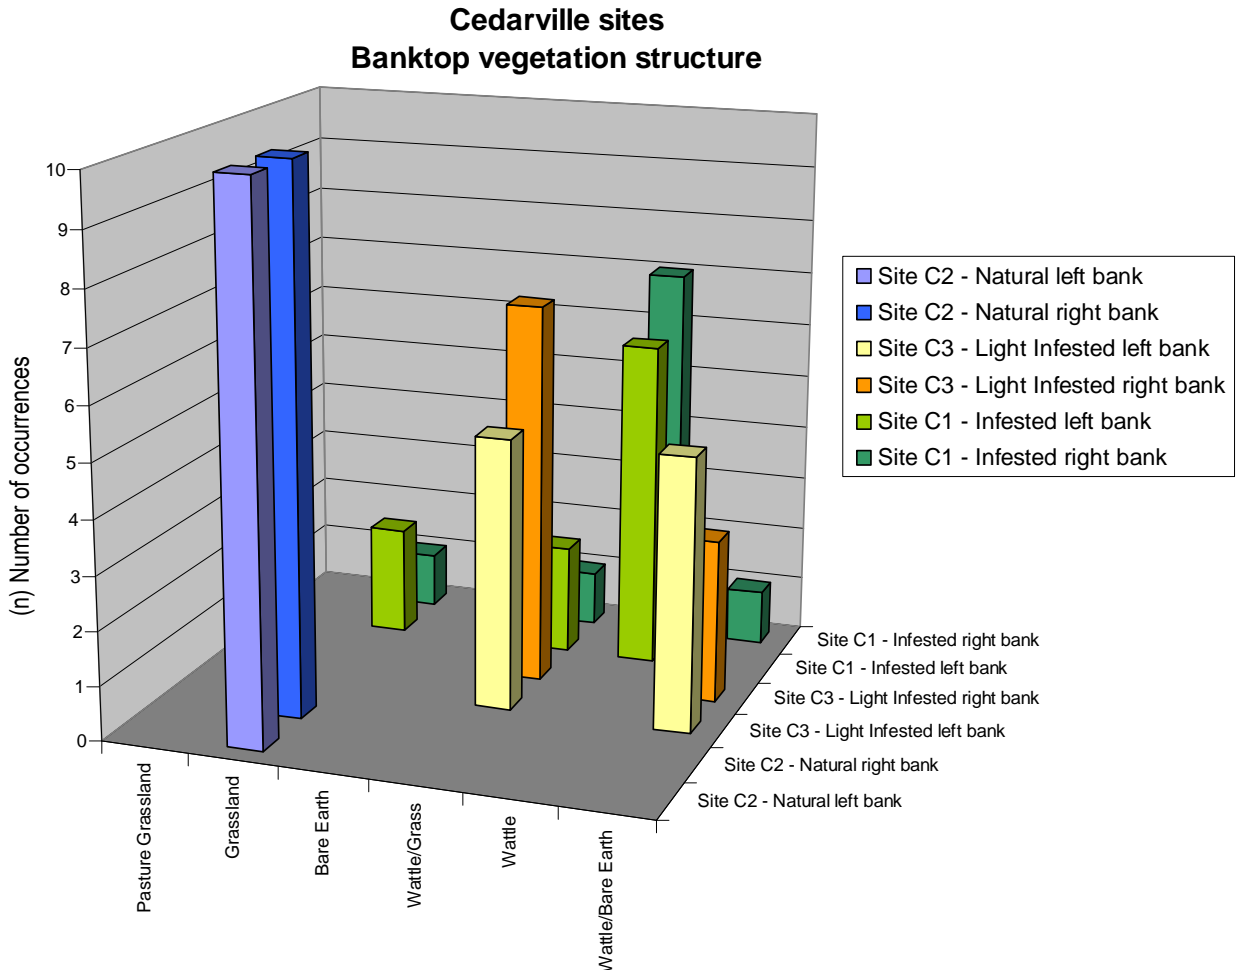
Figure 7.7 Comparison of banktop vegetation structures across the Cedarville sites

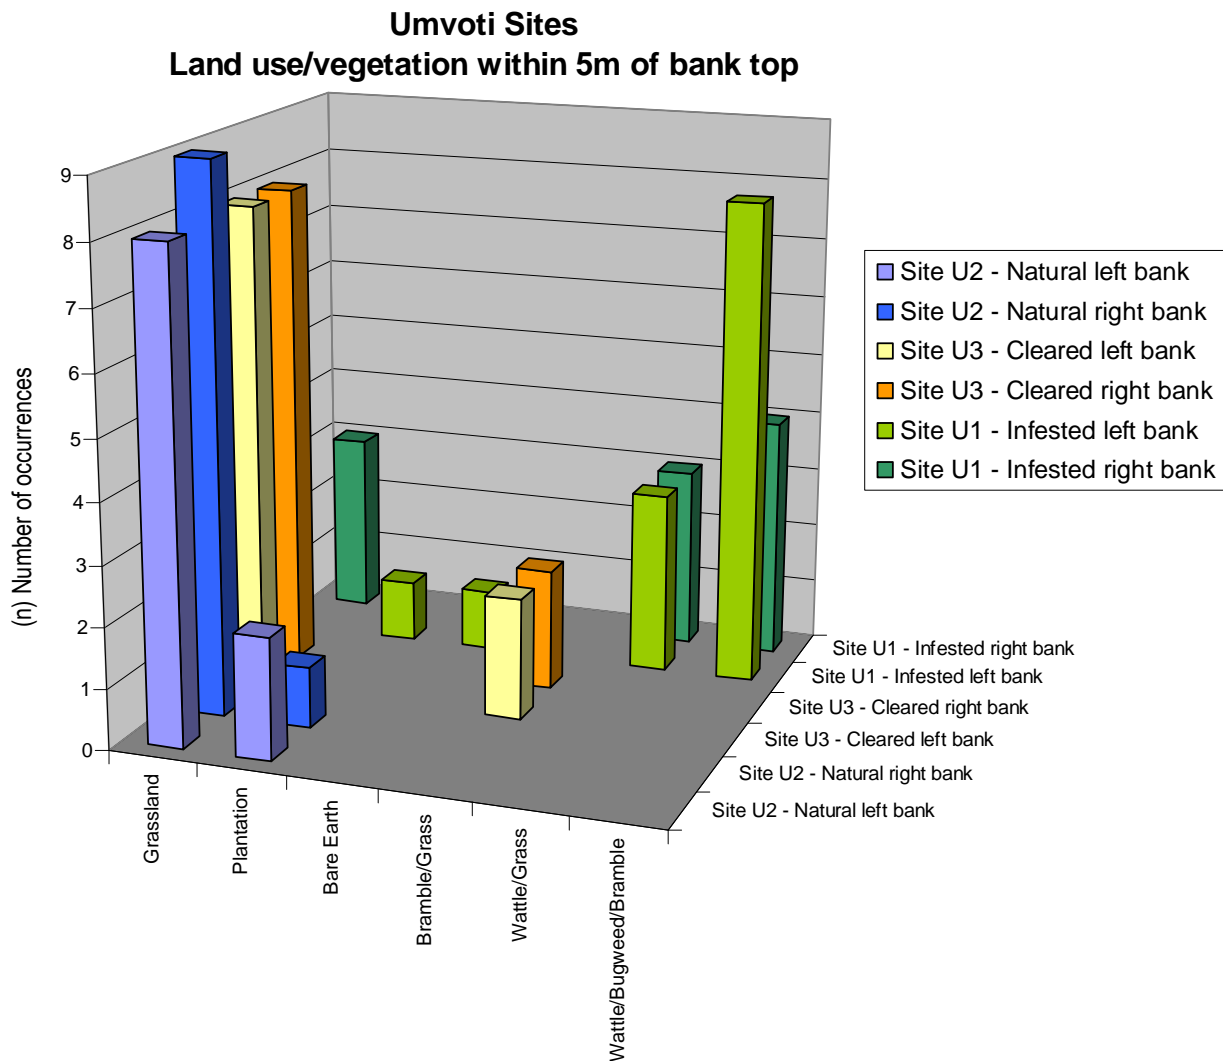
Figure 7.8 shows that at IAP infested Site U1 beyond the banktop wattle, Bugweed and Bramble continued to dominate the vegetation composition within 5m of the banktop, with grass cover present at only three of the transects 5m from the banktop. Moving away from the channel, the IAP cleared site and the natural site showed similar vegetation compositions to the banktop vegetation graph in Figure 7.6.

Figure 7.8 Comparison of land use/vegetation within 5m of banktop across the Umvoti sites

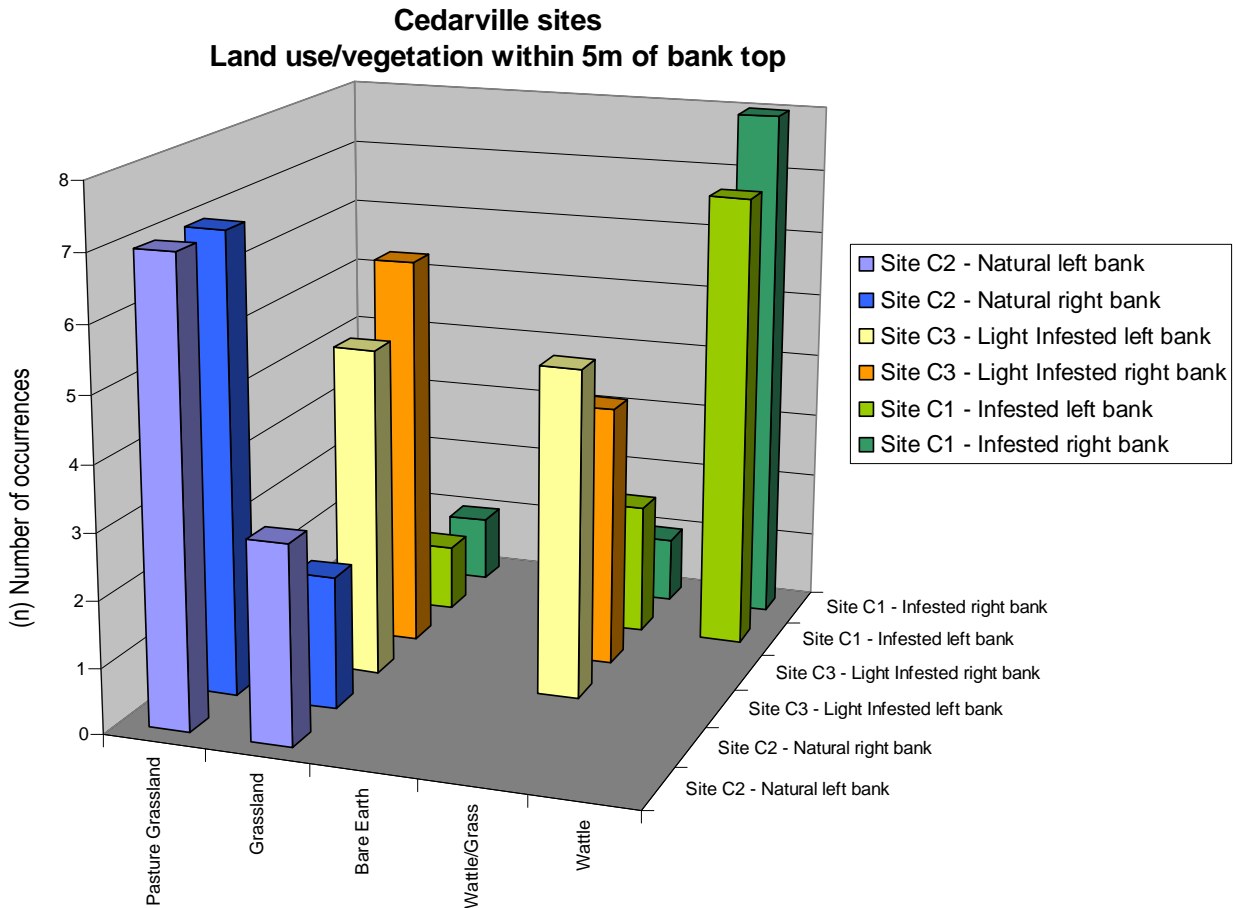
For the Cedarville sites grassland utilised for pasture was present within 5m of the banktop at the natural Site C2. This ‘pasture grassland’ differed from the predominantly natural grassland of the ‘grassland’ sites in that it was grassland where grazing selection and/or management has altered the grass species composition to more pastoral grasses. At the lightly infested Site C3, grassland is equally as abundant as wattle across the ten transects within 5m from the banktop (Figure 7.9). This shows that the invasive wattle infestation at C3 was in the form of a narrow band, almost confined by the banktops, which is in contrast to sites C1 and U1 where the extended area of the riparian zone was heavily infested, as shown in Figures 6.17, 6.13 and 6.5 respectively. Figure 7.9 shows that at IAP infested Site C1, grassland was present within 5m of the banktop at only one transect, at each left and right bank.

Figure 7.9 Comparison of land use/vegetation within 5m of banktop across the Cedarville sites

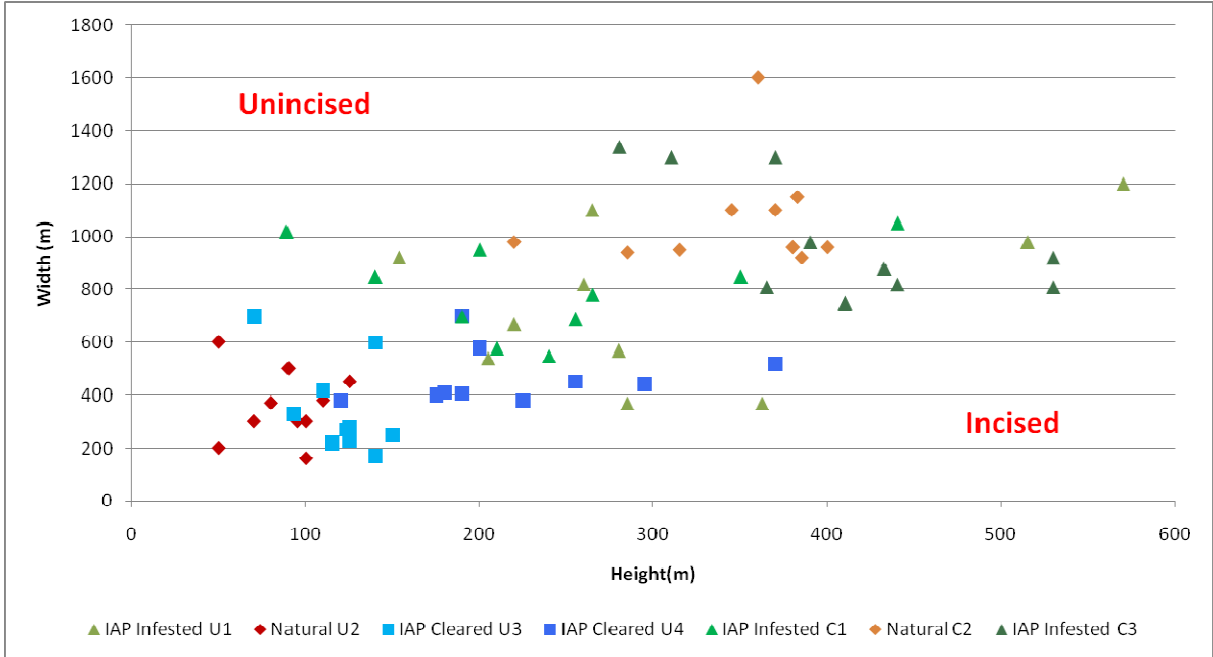
The two most densely IAP infested sites U1 and C1 show the weakest clustering between all the transects of each site, with points spread across the graph. This may indicate that IAP infested reaches cause instability and erosion of the channel banks at certain sections, resulting in non-uniformity in channel dimensions across the site. In contrast the tight clustering of the transects of natural Site U2 shows that the channel dimensions at all ten transects were similar, showing uniformity, possibly explained by bank stability and good bank vegetative cover limiting erosion.

Figure 7.11 Scatter plot of bank height-width relationships at all transects across all sites categorised by degree of infestation

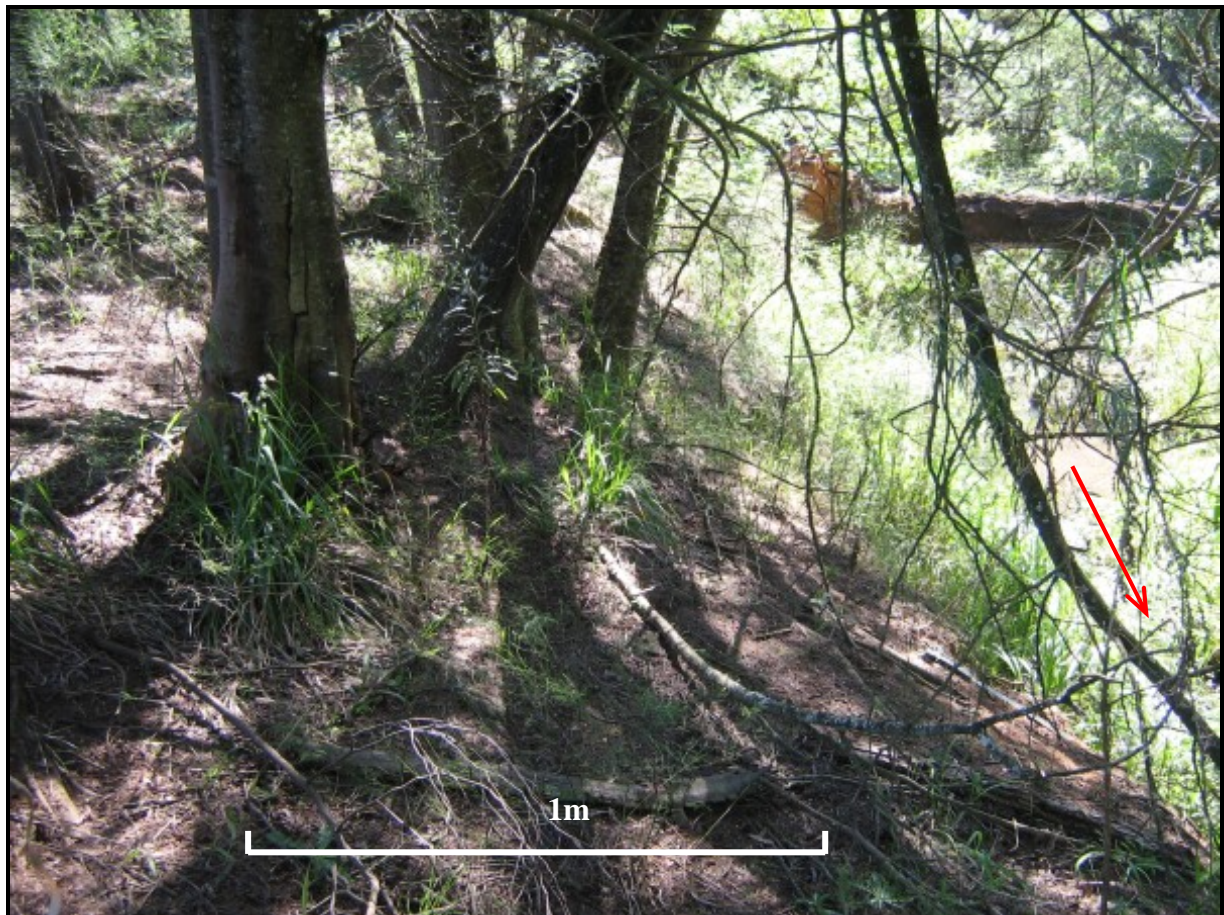
Figure 7.14, the right bank of U1 transect 4, is sited within Morphological Map U1-2 (Section 7.2.1 and Figure 7.29). The photograph shows the lack of vegetative groundcover growing on the riparian banks beneath the canopy of wattle. This is in strong contrast to the dense cover of vegetation growing on the banks of the natural Site U2 (Figure 7.16).

Figure 7.14 Lack of bank vegetative groundcover beneath wattle at transect 4 of IAP infested Site U1

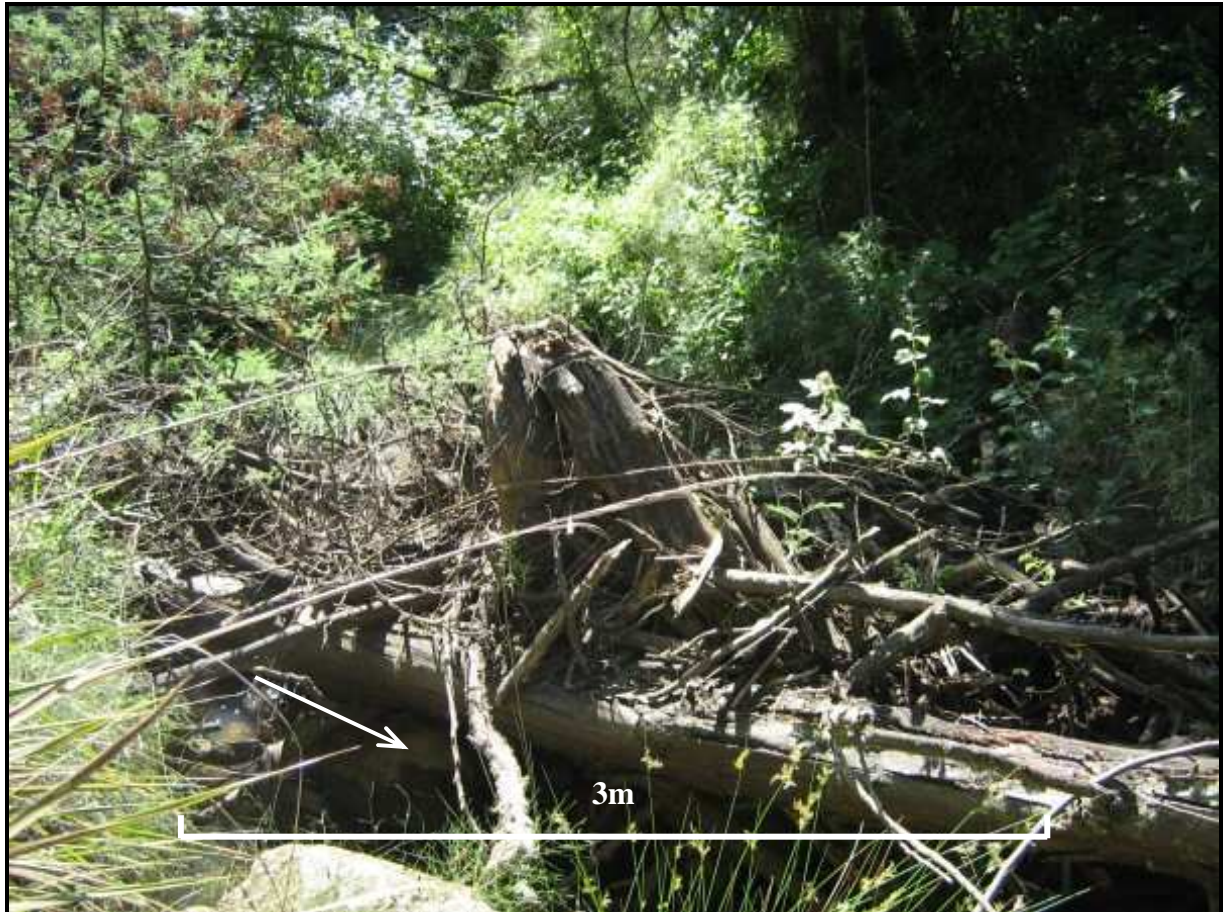
the channel frequently result in the accumulation of woody debris, as illustrated in Figure 7.15. The woody debris accumulation at the site shown in Figure 7.15 fills the channel from bank to bank and was observed on site in 2005 and 2009, showing that such blockages are long term features. The stream passing through infested Site U1 did not contain the large volumes of sediment that were present within the stream at infested Site C1, which resulted in damming and a raised bed level upstream of woody debris blockages (Figure 7.20).

Figure 7.15 Woody debris blockage at IAP infested Site U1 downstream of transect 5

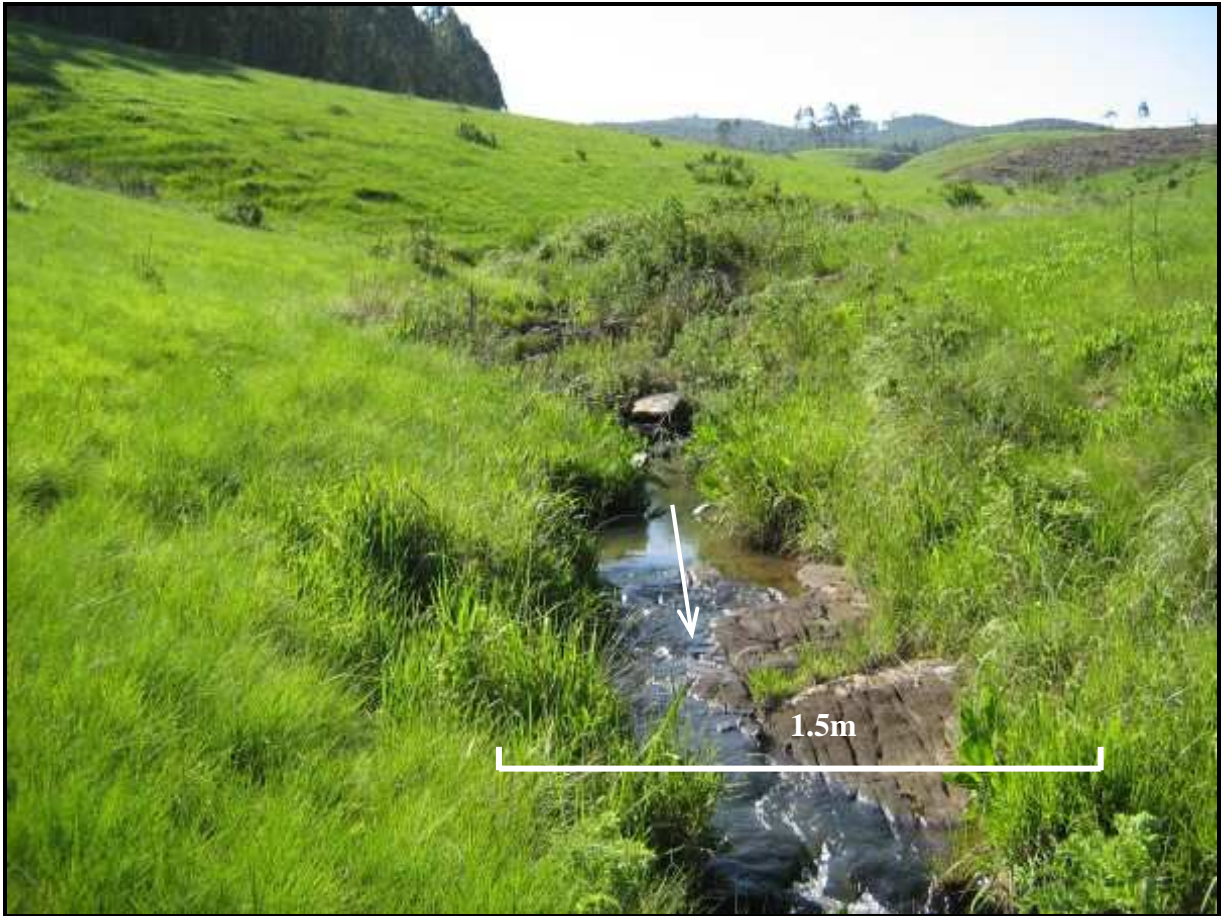
As shown by Figure 7.16, natural Site U2 shows a strong contrast in condition to the IAP infested Site U1. The riparian banks are densely vegetated, no woody debris is present and undercut, crumbling banks are absent. The bedrock dominated nature of the site can be seen, in addition to the riparian zone and buffer comprised predominantly of grassland. Figures 7.33, 7.35 and 7.37 in Section 7.2.2, which analyses the Morphological Maps produced for natural Site U2, show additional photographs of the stream within the 500m study reach. While the streambanks at U2 transect 5 shown in Figure 7.16 are dominated by grasses with

Figure 7.16 Upstream view of transect 5 at natural Site U2

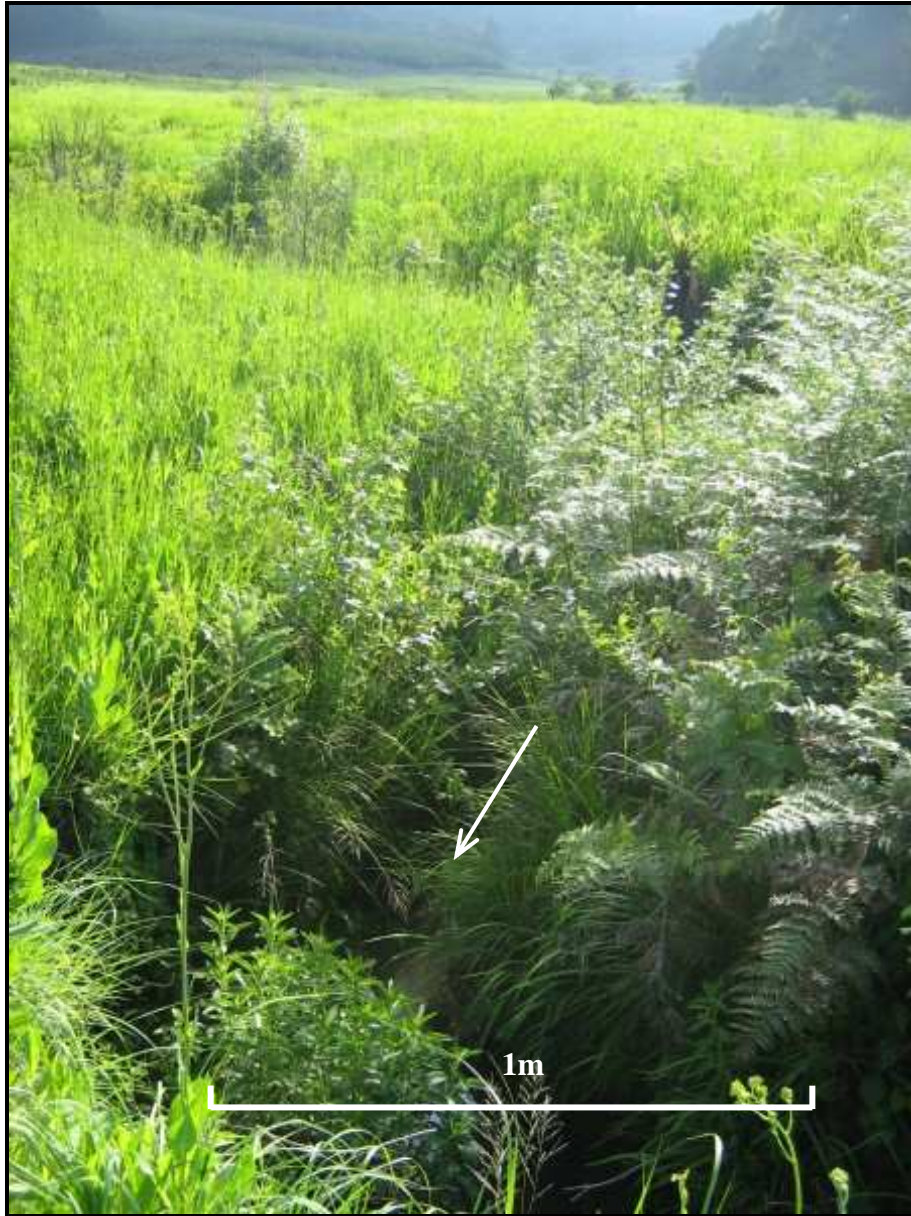
Figure 7.17 illustrates the channel at transect 4 of the Umvoti IAP cleared site U3. The flat topography of the site and absence of macro channel banks is shown by the photograph, which further points toward the site being a channelled wetland (presence of wetland soils – Section 6.2.3).

Figure 7.17 Upstream view of transect 4 at IAP cleared Site U3

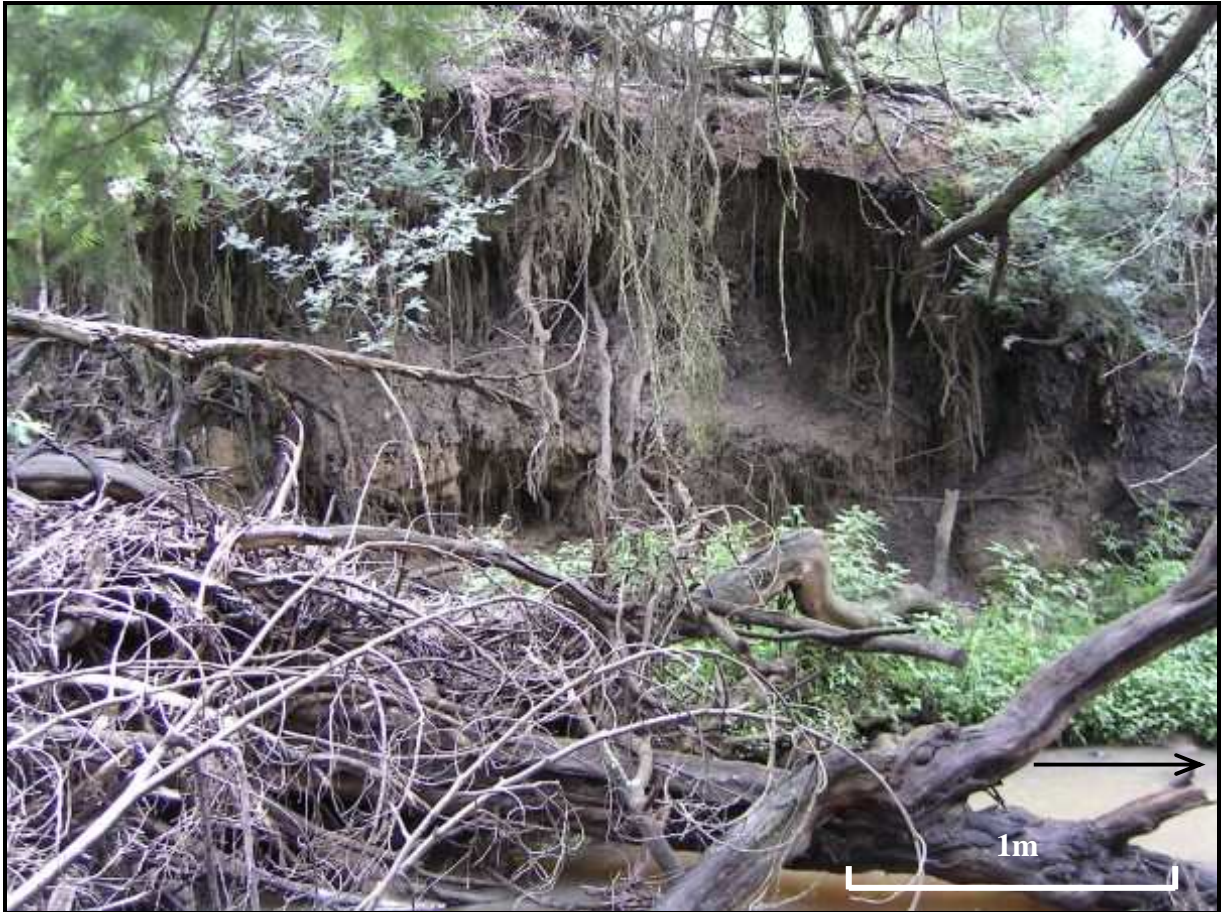
Figure 7.18 shows the left bank at transect 3 of the IAP infested Site C1 near Cedarville. Alien invasive wattle is present at the top of both banks, with the left bank being undercut resulting in scouring of bank material, exposure of tree roots and the progressive collapse of the banktop. The woody debris blockage in the foreground is formed by the collapse of the banktop woody IAPs into the channel, with further woody debris transported from upstream accumulating against the collapsed trees.

Figure 7.18 Left bank of transect 3 at IAP infested Site C1

At some sites (Figure 7.20) the woody debris is sufficiently dense that sediment has accumulated within the debris, creating a dam and upstream pool which soon backfills with sediment, raising the bed of the river and resulting in more regular overtopping of the channel banks. The level of sediment entrained by the stream is illustrated by the brown colour of the stream in Figure 7.18.

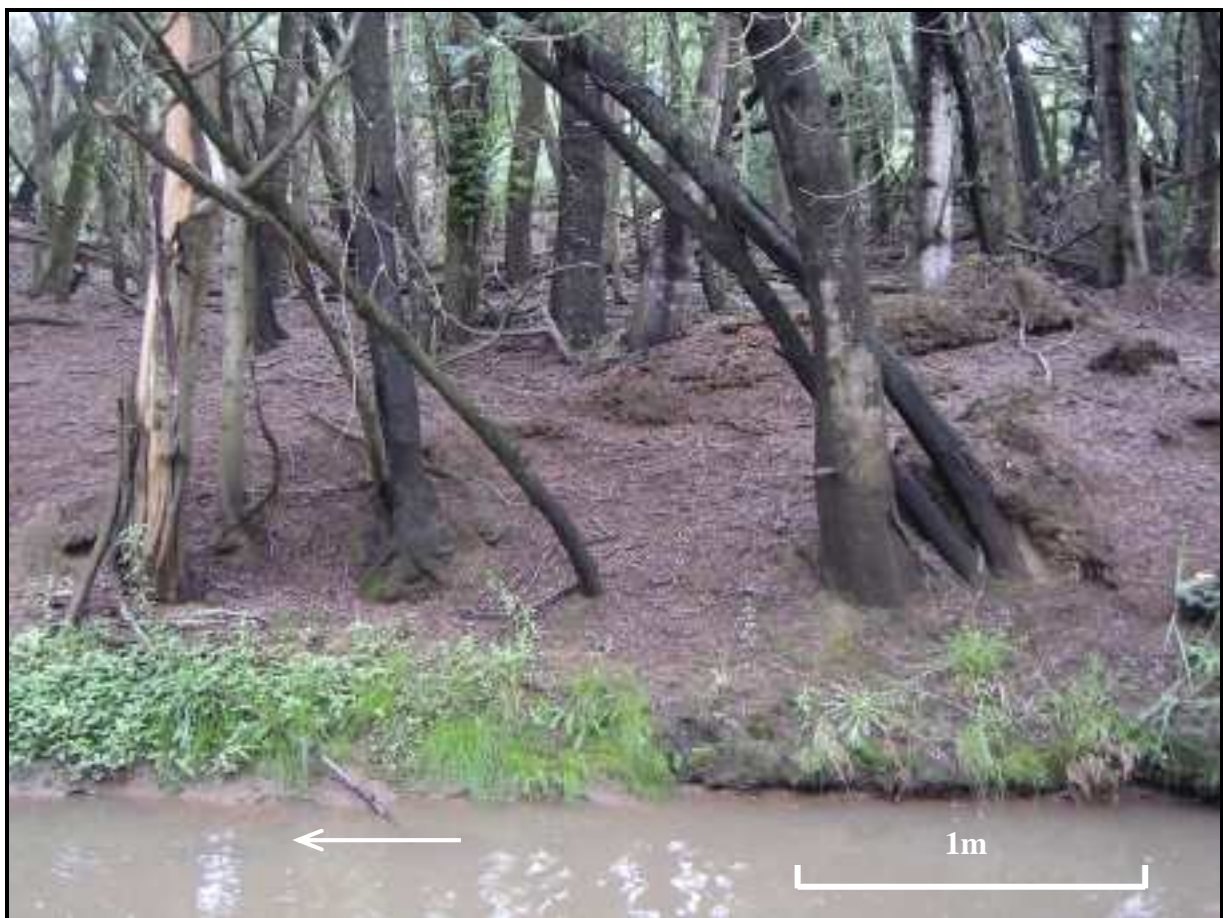
Figure 7.19 shows the right bank at transect 5 of the IAP infested site, upstream of transect 3 shown above. The photograph illustrates the impact of dense wattle infestations on the indigenous riparian vegetation. Riparian vegetation has been excluded from the marginal zone and the riparian bank face, with almost no vegetative groundcover present. Beyond the riparian banktop the grassland area has been completely out-competed by the wattle, with the soil being covered only by a mat of wattle seeds and fine leaves. The interface between wattle and grassland at the furthest extent of the invasion appears similar to that shown in Figure 7.21. The channel bank in Figure 7.19 below shows a similar lack of vegetation cover and coverage of wattle leaves and seeds as Figure 7.14 at Umvoti IAP infested Site U1.

Figure 7.19 Right bank at transect 5 of IAP infested Site C1 showing loss of groundcover

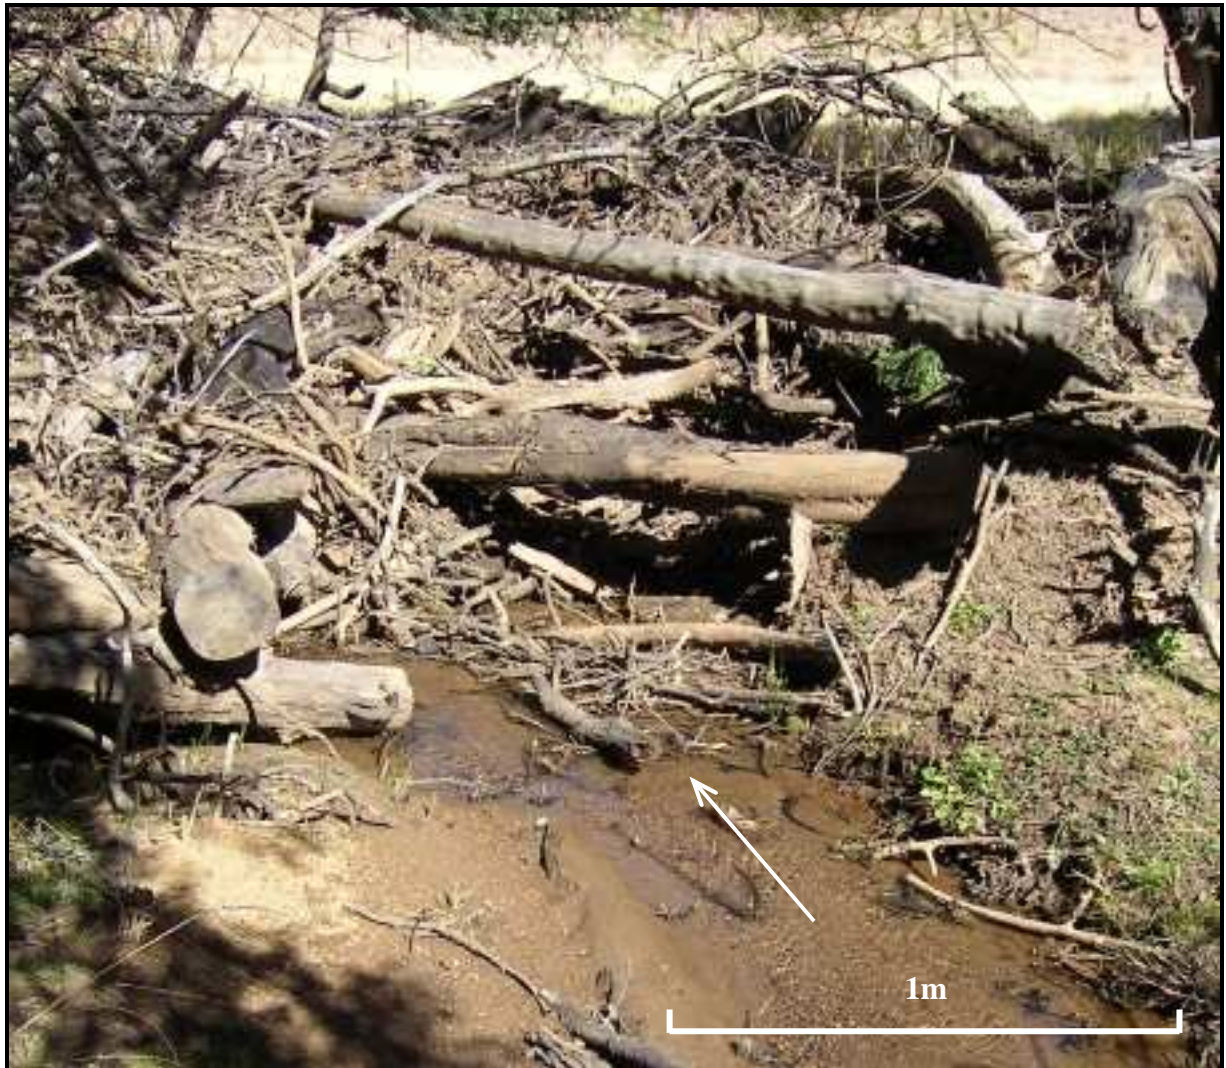
photograph in Figure 7.20 below was taken during winter, with the stream low flows containing a low level of entrained and dissolved sediments. In contrast photographs taken in summer (Figures 7.18 and 7.19) show a high bed load of suspended sediments. The channel in the foreground is almost completely filled with sediment deposited upstream of the debris dam, in contrast to below the debris dam where a deep channel is present.

Figure 7.20 Woody debris blockage at IAP infested Site C1

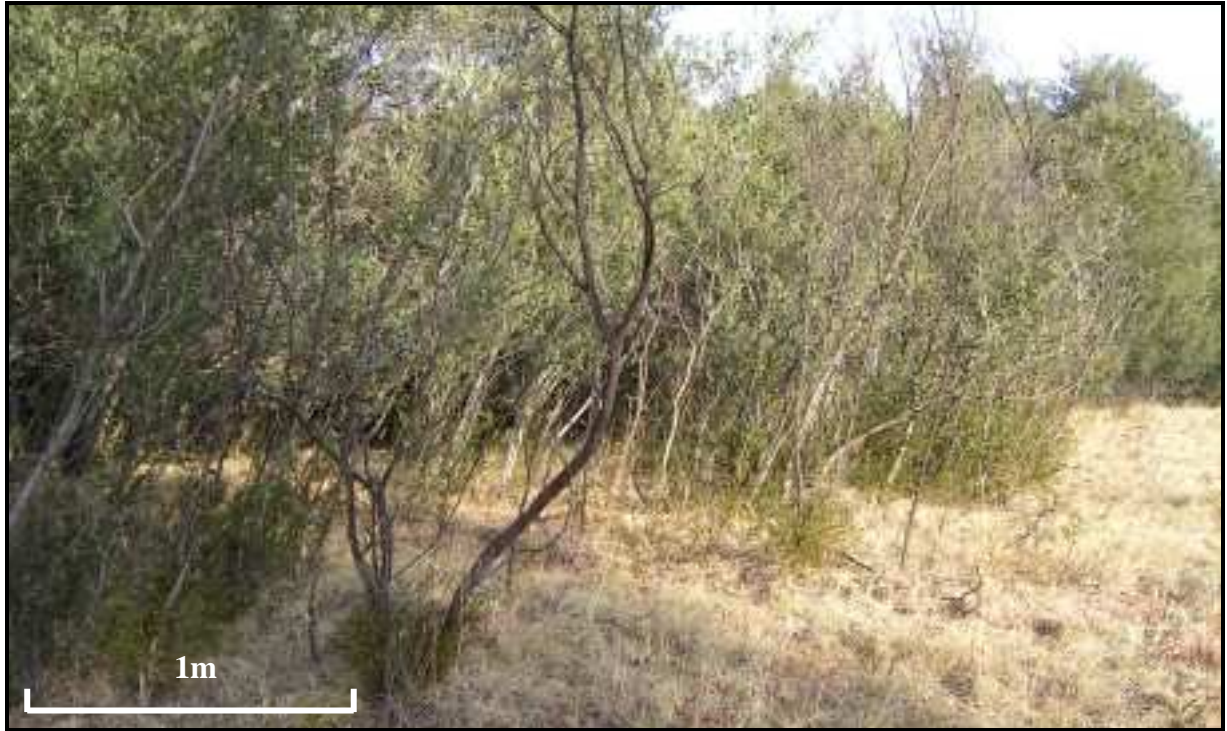
Figure 7.21 shows the rapid expansion of invasive wattle extending from the riparian zone and advancing further into the surrounding grasslands. This is confirmed in the literature (Richardson and Kluge, 2008), where it has been noted by researchers that *A. mearnsii* species commonly advance into a virgin area along riparian zones, from where the species then expands into the remaining terrestrial areas of the catchment over time (Section 3.3).

Figure 7.21 Advance of invasive *Acacia* out of the riparian zone and into grassland at Site C1

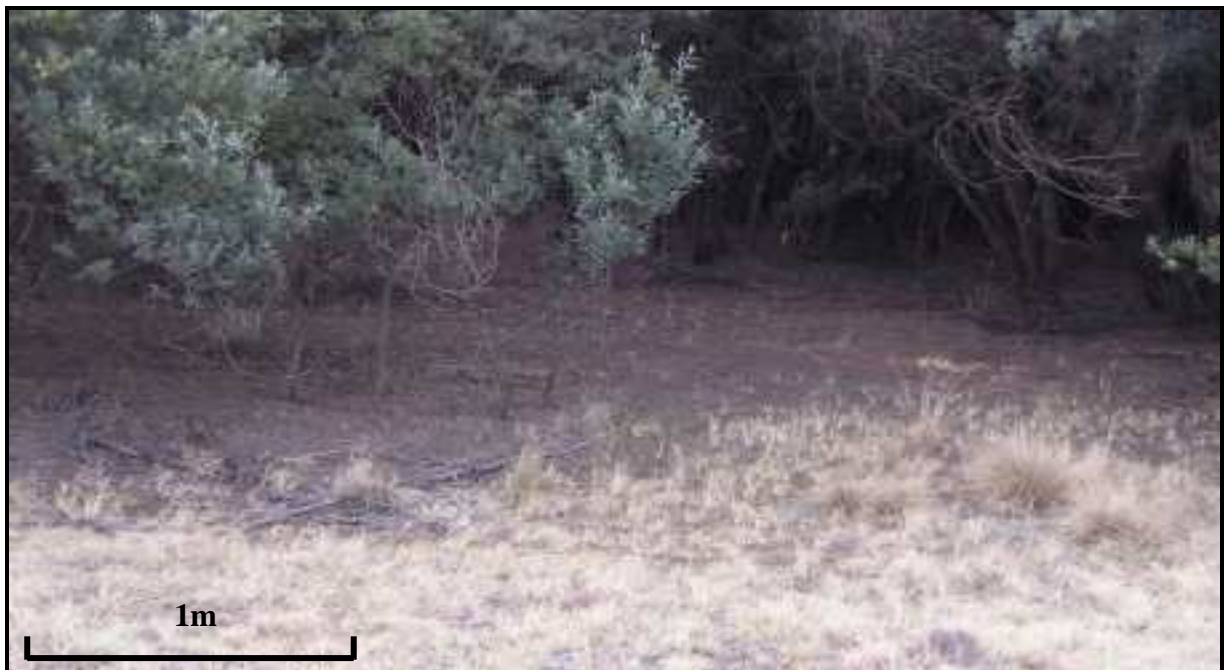
At most long established wattle-grassland interfaces the exclusion of grassland by shading from the dense tree canopy, and hydrophobic soils as a result of the infusion of wattle hydrophobic organic substances, result in a stark contrast in the presence of groundcover as shown in Figure 7.22.

Figure 7.22 The exclusion of grassland growth beneath the invasive wattle canopy at Site C1

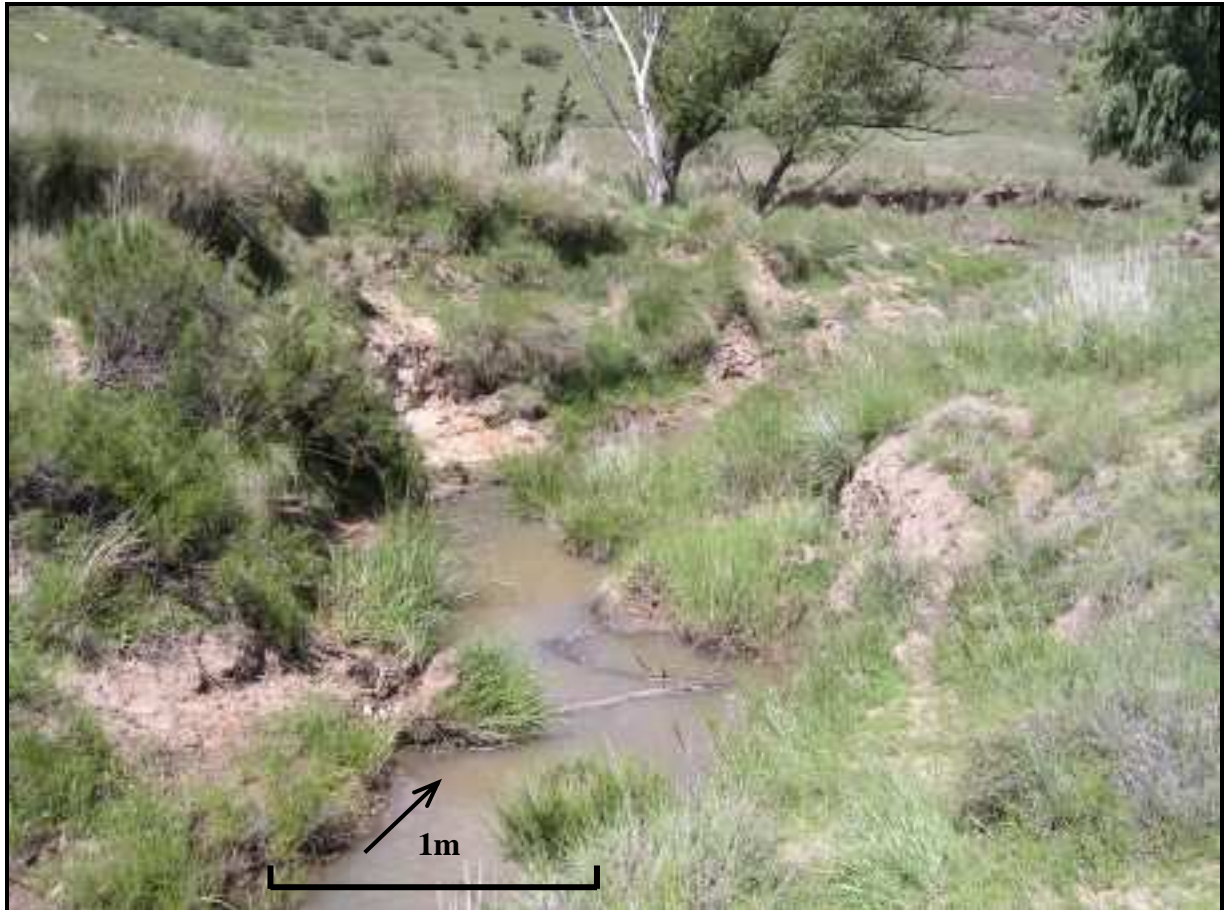
Site C2, the Cedarville natural site, shows through Figure 7.23 the increased vegetative cover present at a site which receives little impact from IAPs. A strong increase in the extent of bank vegetative cover can be seen at natural Site C2 when contrasted with a photograph of the Cedarville infested sites shown in Figure 7.19. The sandy nature of the soils at Sites C2 and C3 can be seen in the following three photographs. These soils are particularly sensitive to disturbance of the riparian bank vegetation through trampling by livestock.

Figure 7.23 Transect 3 of natural Site C2 showing typical vegetation structure

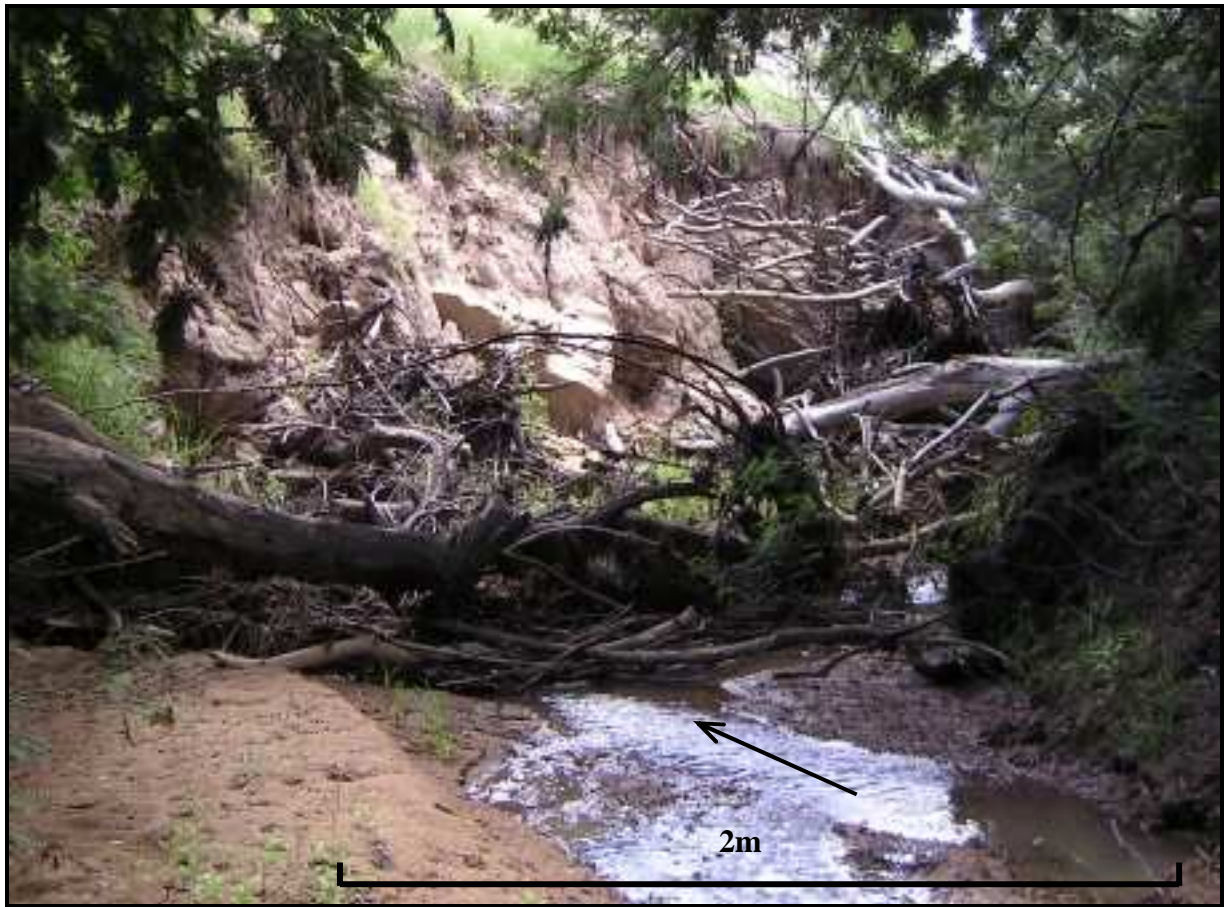
Figure 7.24 is a photograph taken facing downstream from transect 9 at IAP infested Site C3. The photograph shows the build up of woody debris which was distributed along sections of the 500m long study reach, which had a lighter IAP infestation than Site C1. Also shown in the photograph is the presence of steep, unvegetated bank faces, which at many transects were being undercut, with chunks of banktop vegetation collapsing into the channel. This is in contrast to the natural Site C2 downstream, shown above, which has a far lower prevalence of steep eroding banks. The lower density of woody invasive plants at Site C3, when compared to infested Site C1 is illustrated by the grassland banktop vegetation structure shown in Figure

7.24. This observation confirms the MRHS, which reflected dominance of grassland within 5m of the banktop at Site C3.

Figure 7.24 Downstream view at transect 9 of IAP infested Site C3

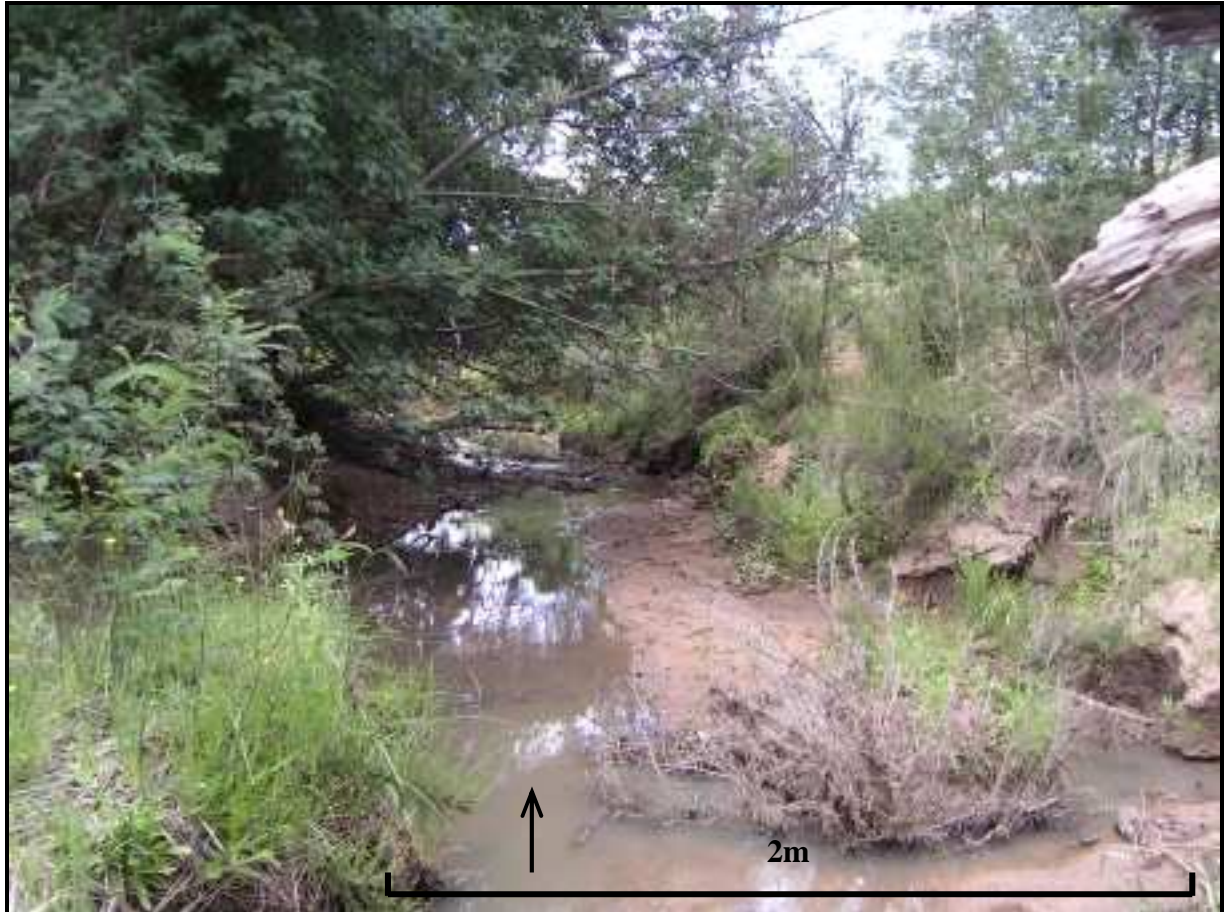
The downstream view of transect 6 shown in Figure 7.25 illustrates the lower density of invasive wattle at Site C3 in comparison to Site C1 (Figures 7.19 and 7.21). The lower density of invasion has allowed grass and other groundcover to grow beneath and between the wattle in many sections. This was highlighted by the MRHS results in Section 7.1.3, which indicated a higher grass cover on the riparian banks at infested Site C3 than infested Site C1. Another observation which distinguishes Site C3 as a more lightly infested site with a shorter infestation history, is the general age of the alien invasive trees which were observed to be older at Site C1 (Figure 7.19).

Figure 7.25 Downstream view at transect 6 of IAP infested Site C3

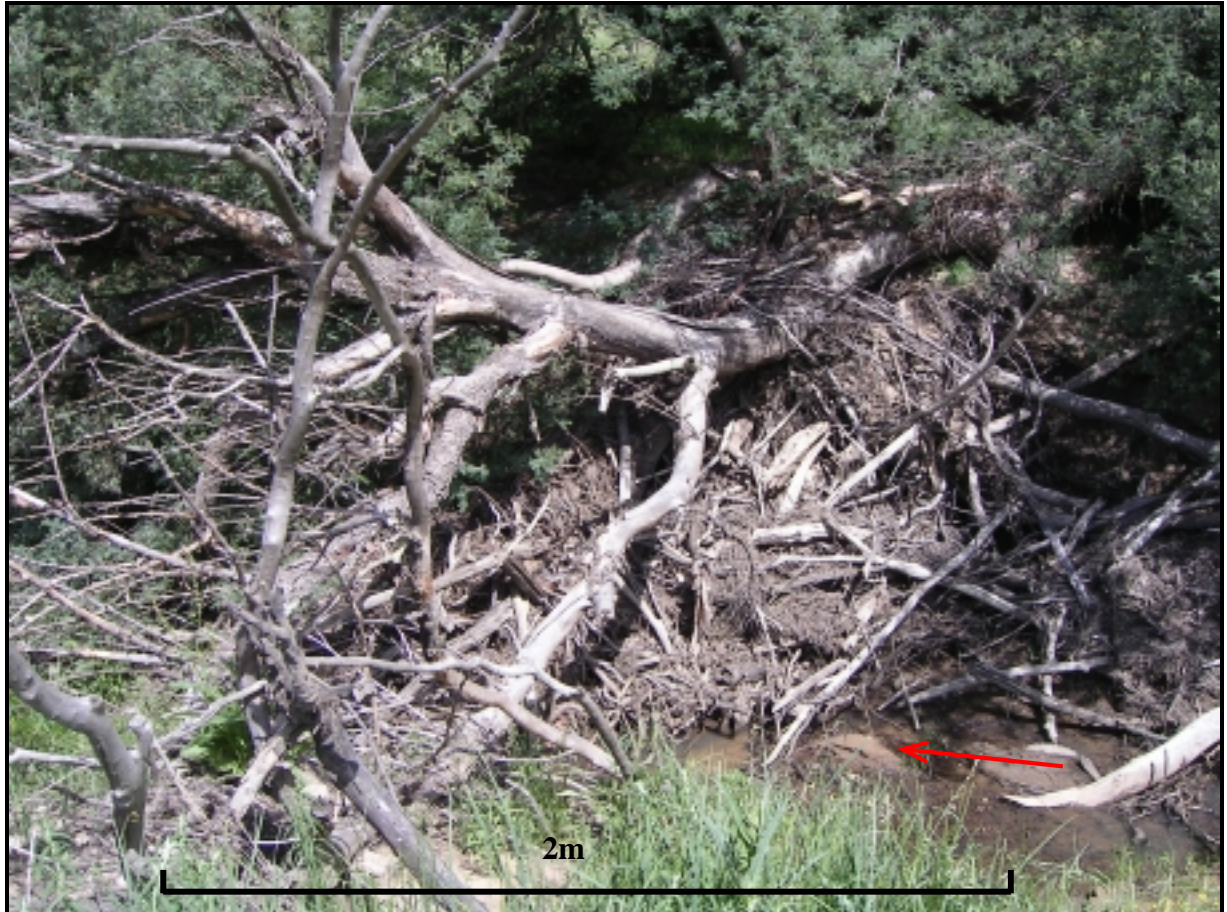
Figure 7.26 shows one of the more severe woody debris blockages at infested Site C3. The debris dams present at Site C3 were not as large or dense as the debris dams at Site C1 (Figures 7.18 and 7.20), most likely as a result of the lower density of woody infestation within the Site C3 riparian zone (illustrated by aerial photograph Figures 6.13 vs. 6.17 and 7.19 vs. 7.25), contributing less woody debris to the channel. The severe damming and raising of the bed level associated with the severe debris dams at Site C1 were not present at Site C3. This may be explained by the lower density of woody debris, but also the sandy nature of the soils and stream alluvium. The finer silts present at Site C1 are more easily entrained by the majority of flows, where the sandy sediments at Site C1 would only be transported during storm events and high flows. The fine silts regularly transported at Site C1 would partly be deposited during the slowing of the flows as the stream flow enters the pools created by the debris dams. The finer sediments would more readily seal the debris dams to the passage of water, creating a further build up of sediment and rise in the stream bed level.

Figure 7.26 Woody debris blockage within the 500m study reach at IAP infested Site C3
