**THE IMPACTS OF
WOODY INVASIVE ALIEN PLANTS ON
STREAM HYDROGEOMORPHOLOGY IN SMALL
HEADWATER STREAMS OF KWAZULU-NATAL**

Submitted in fulfilment of the academic requirements for the degree of
Master of Science in Hydrology

School of Bioresources Engineering and Environmental Hydrology
University of KwaZulu-Natal
Pietermaritzburg
March 2010

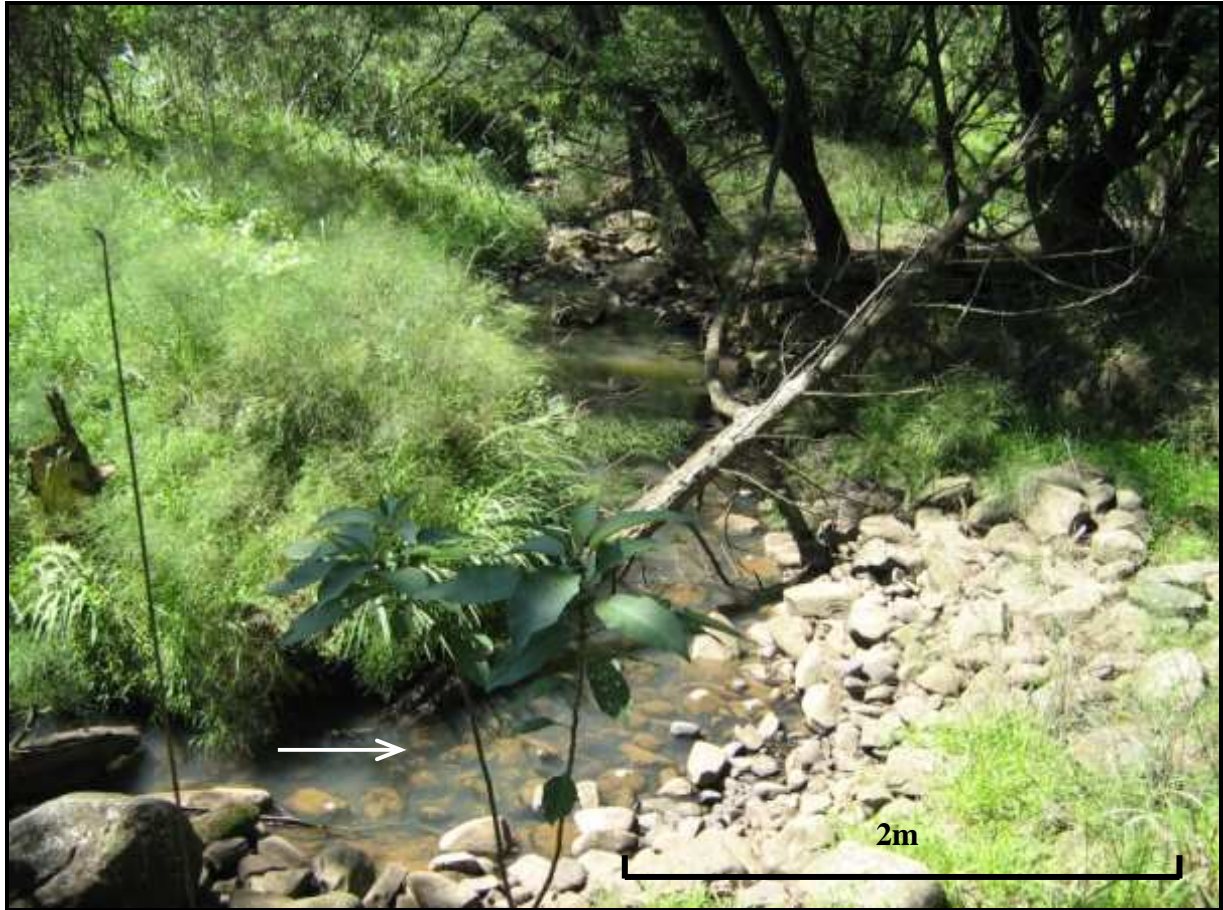
Figure 7.27 Downstream view at site of Morphological Map U1-1

Morphological Map U1-1 (Figure 7.28) shows no strong signs of impact as a result of IAP invasion. The left bank shows good grass cover, with the right bank containing a grass, broadleaf and woody alien invasive mix with limited groundcover beneath the larger woody IAPs. The limited groundcover directly beneath the woody IAPs can be seen in Figure 7.29. The left bank formed a low but vertical 'cliff bank' for approximately 10m of the mapped length as shown by the dashed line in Morphological Map U1-1. This feature is hidden by long grass in Figure 7.27.

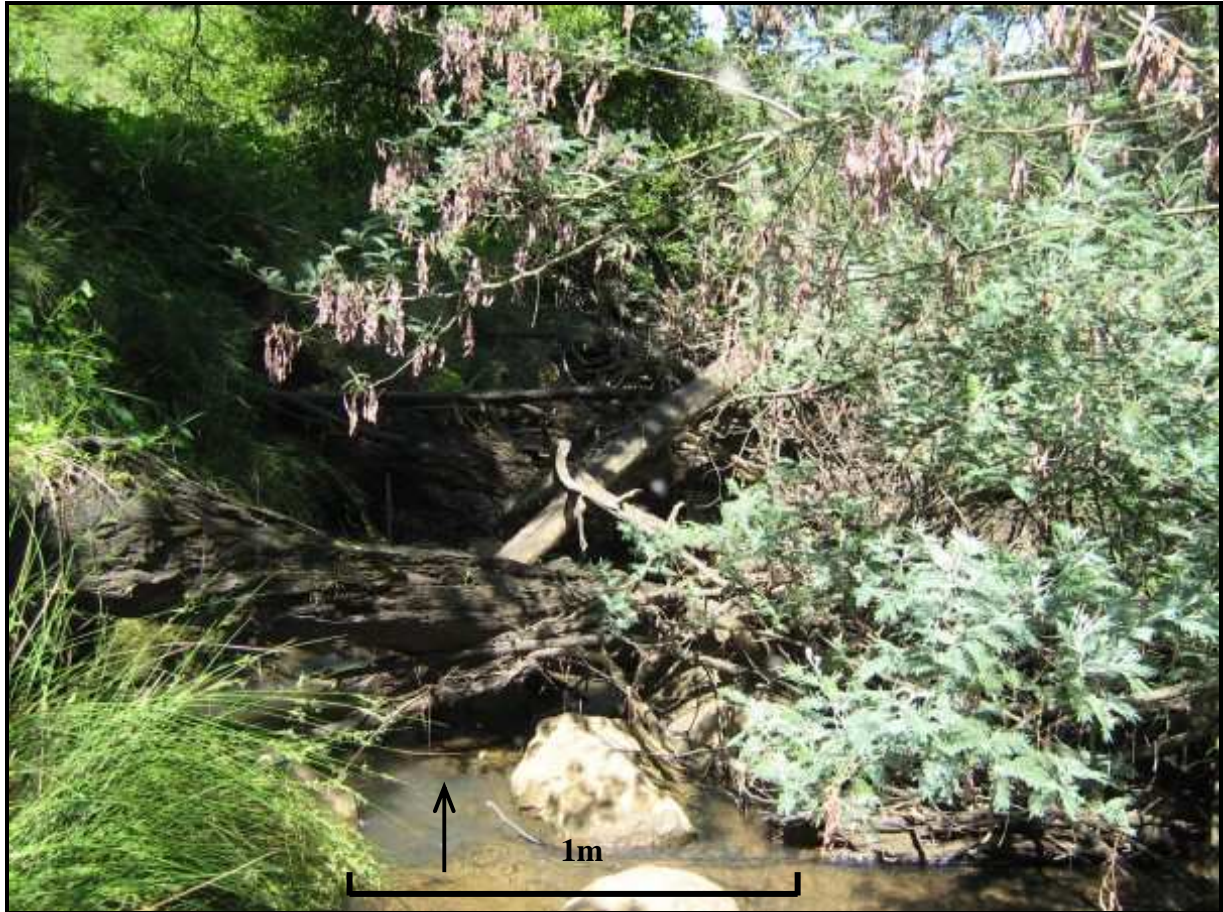
The presence of these faster flowing flow types shows that along this section finer debris and sediment has not accumulated within the debris to a sufficient density to slow flows significantly. However on the left of the channel sections of backwater are present indicating no flow through the debris.

Figure 7.31 Downstream view at site of Morphological Map U1-3

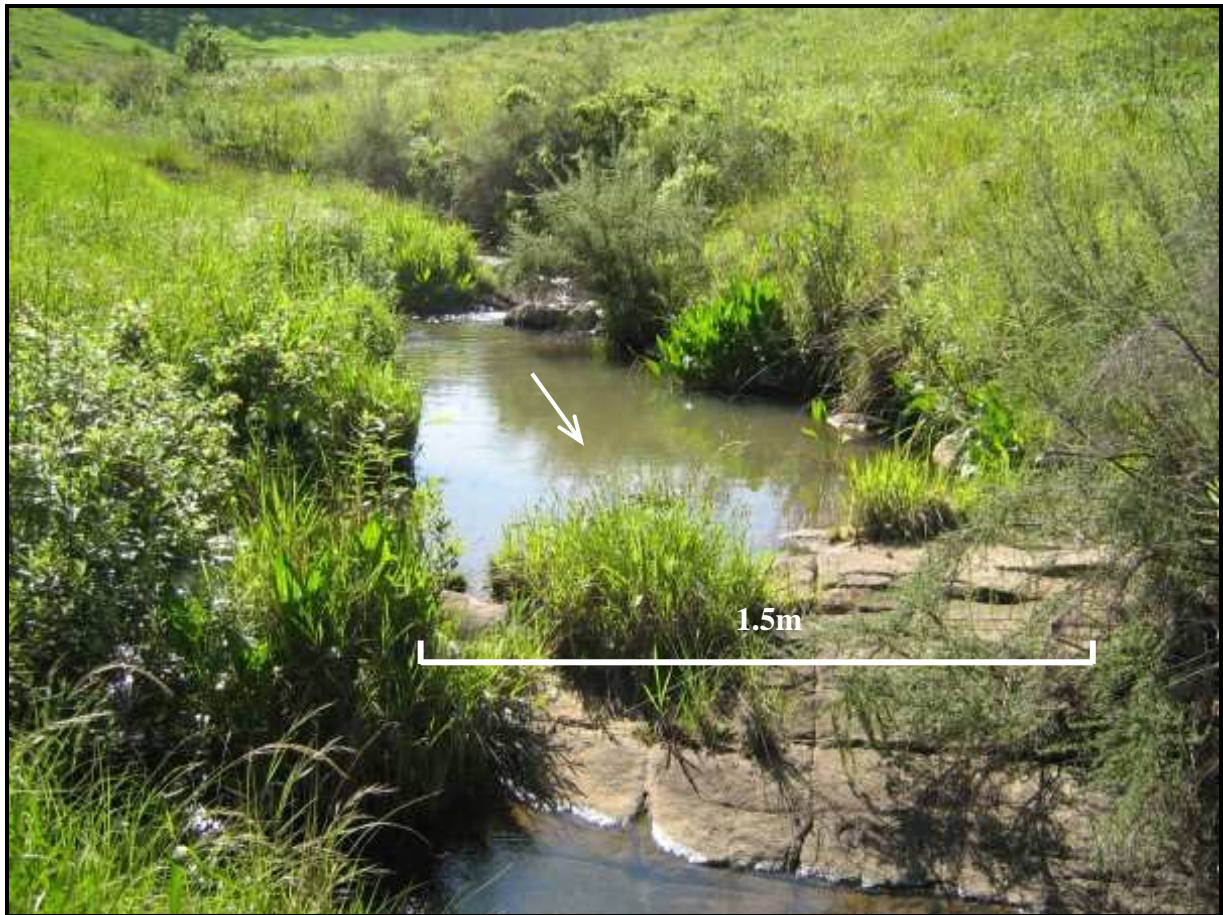
At the Umvoti natural Site C2 the Morphological Map U2-1 (Figure 7.34) shows good grass cover within the riparian zone, and an absence of bare earth and cliff banks. This is confirmed by Figure 7.33, which shows an upstream view along the 20m reach. The presence of large bedrock outcrops shows the stream bed to be dominated by bedrock and boulders. In terms of flow types the glide at the head of the 20m reach illustrates shallow, unconfined and smooth flow over bedrock. The remainder of the flow types take the form of natural pool and run sequences with a chute present where boulder and bedrock outcrops have constricted flow and produced a drop in the base level of the stream bed downstream.

Figure 7.33 Upstream view at the site of Morphological Map U2-1

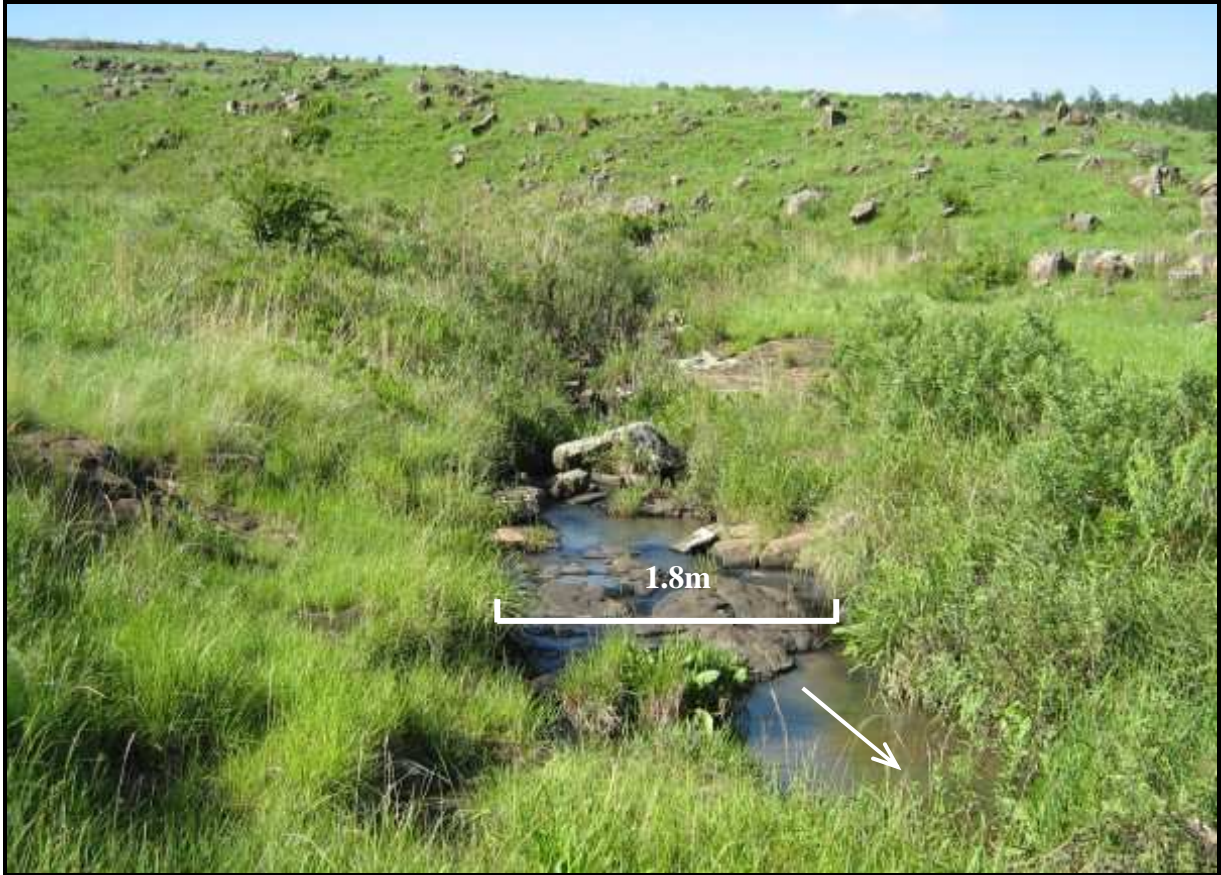
Morphological Map U2-2 in Figure 7.36, shows similar features to map U2-1, with the only major difference being the presence of a small vegetated bar and a cascade sequence. The cascade is produced in response to a drop in stream bed level and flow constriction associated with a large bedrock outcrop, which can be seen at the upstream end of the Morphological Map. This feature can be seen in the background of the site photograph in Figure 7.35 below.

Figure 7.35 Upstream view at the site of Morphological Map U2-2

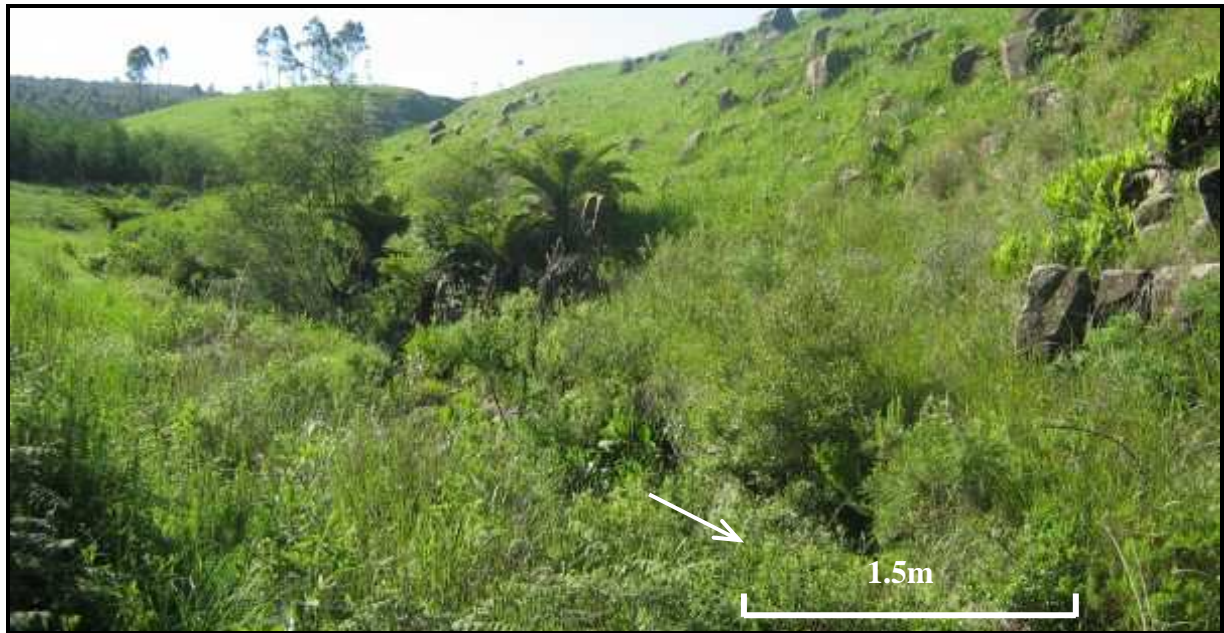
Figures 7.37 and 7.38 at Morphological Map U2-3 again show well vegetated banks, with the presence of bedrock outcrops. Only one channel bar was present within this 20m reach, and was vegetated.

Figure 7.37 Upstream view at the site of Morphological Map U2-3

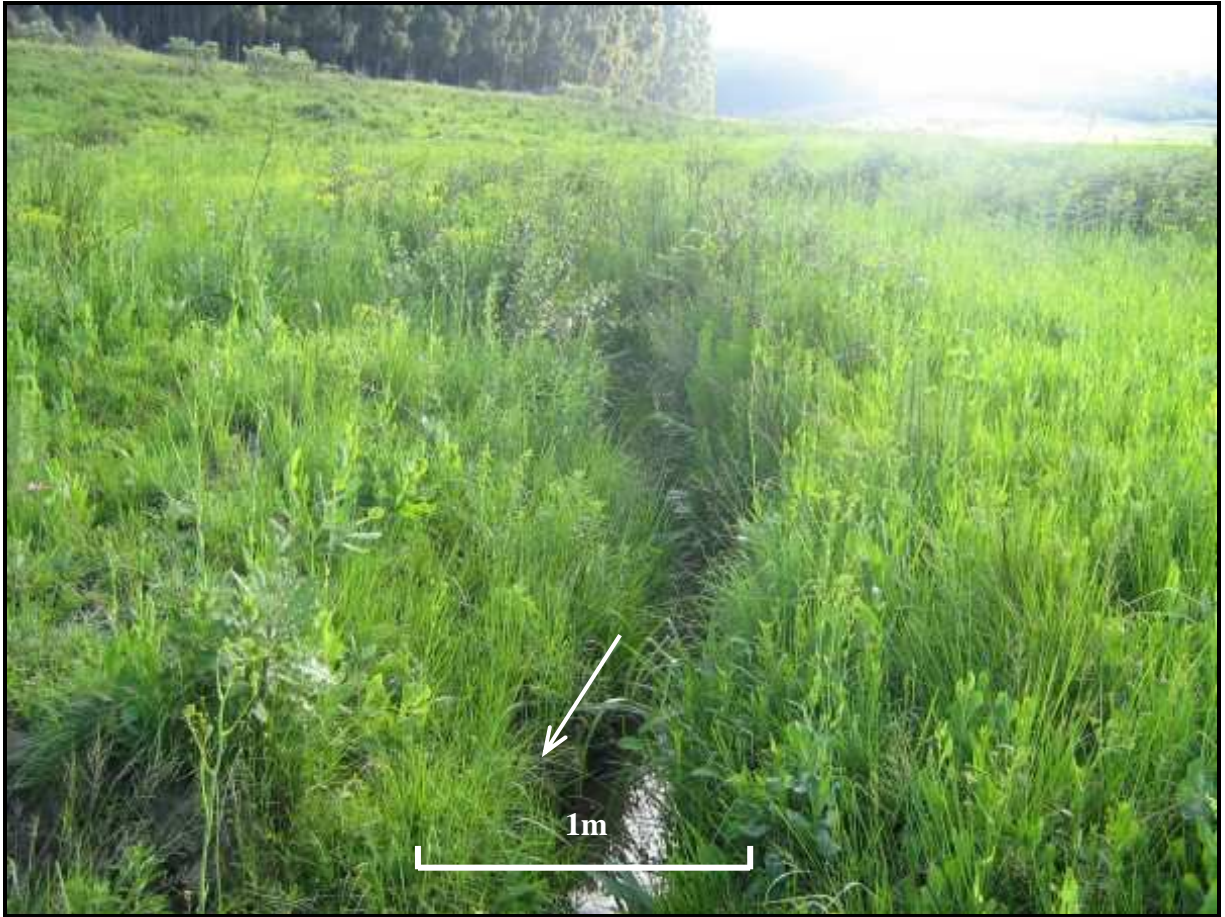
The morphological Maps U3-1 to U3-3 appear to show no major impact as a result of previous infestation by invasive alien plants. Riparian and streambank vegetation grows dense with no bare earth present within any of the Morphological Maps of the site (Figures 7.40, 7.42 and 7.44). The presence of strong meandering in the channel form (particularly Morphological Map in U3-1 in Figure 7.40) is an indication of the flat relief of the site, with the riparian plain adjacent to the channel indicating the presence of wetland soils during field sampling (Section 6.2.3). Figure 7.39 shows an upstream view of Morphological Map U3-1, visually illustrating the narrow channel which meanders through the site.

Figure 7.39 Upstream view at the site of Morphological Map U3-1

In contrast to the site photographs of the natural site U2 (Figures 7.33, 7.35 and 7.37), the photographs of IAP cleared Site U3 (Figures 7.39, 7.41 and 7.43) show a dominance of grassland within the riparian zone with very low presence of reeds, herbaceous vegetation and woody shrubs. This could be as a result of the site not being a typical riparian channel with associated features, such as riparian banks and a channel shelf (Figure 2.1), but rather that the site was formerly an un-channelled wetland which developed an incised channel through man-made activity or erosion.

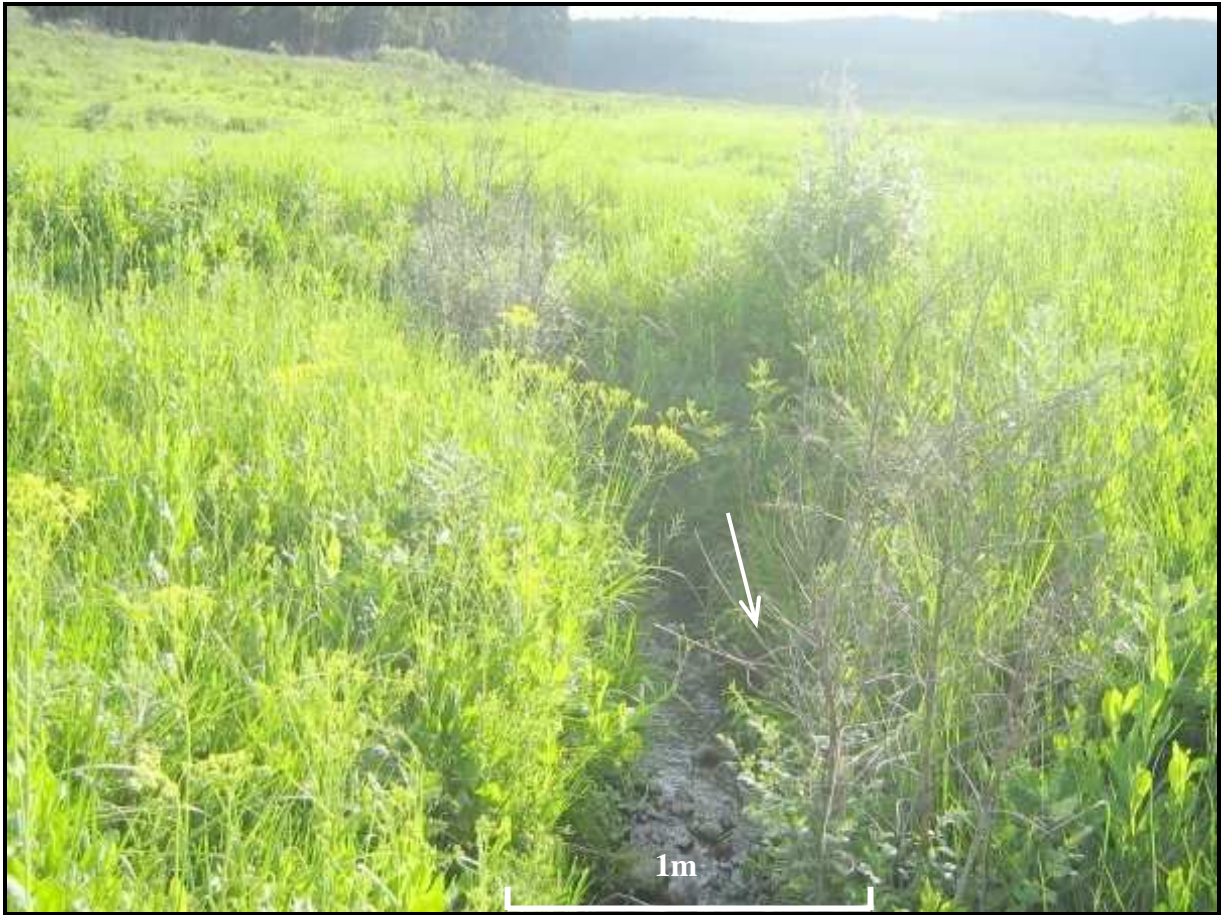
Figure 7.41 Upstream view at the site of Morphological Map U3-2

No Bedrock outcrops are present at Site U3, however boulders and pebble beds are present at selected sections of the site. Figure 7.41 includes a view of a pebble bed which is mapped and grouped under boulders within Morphological Map U3-2 (Figure 7.42). The pebble bed is associated with a riffle sequence as illustrated in Morphological Map U3-2 (Figure 7.42).

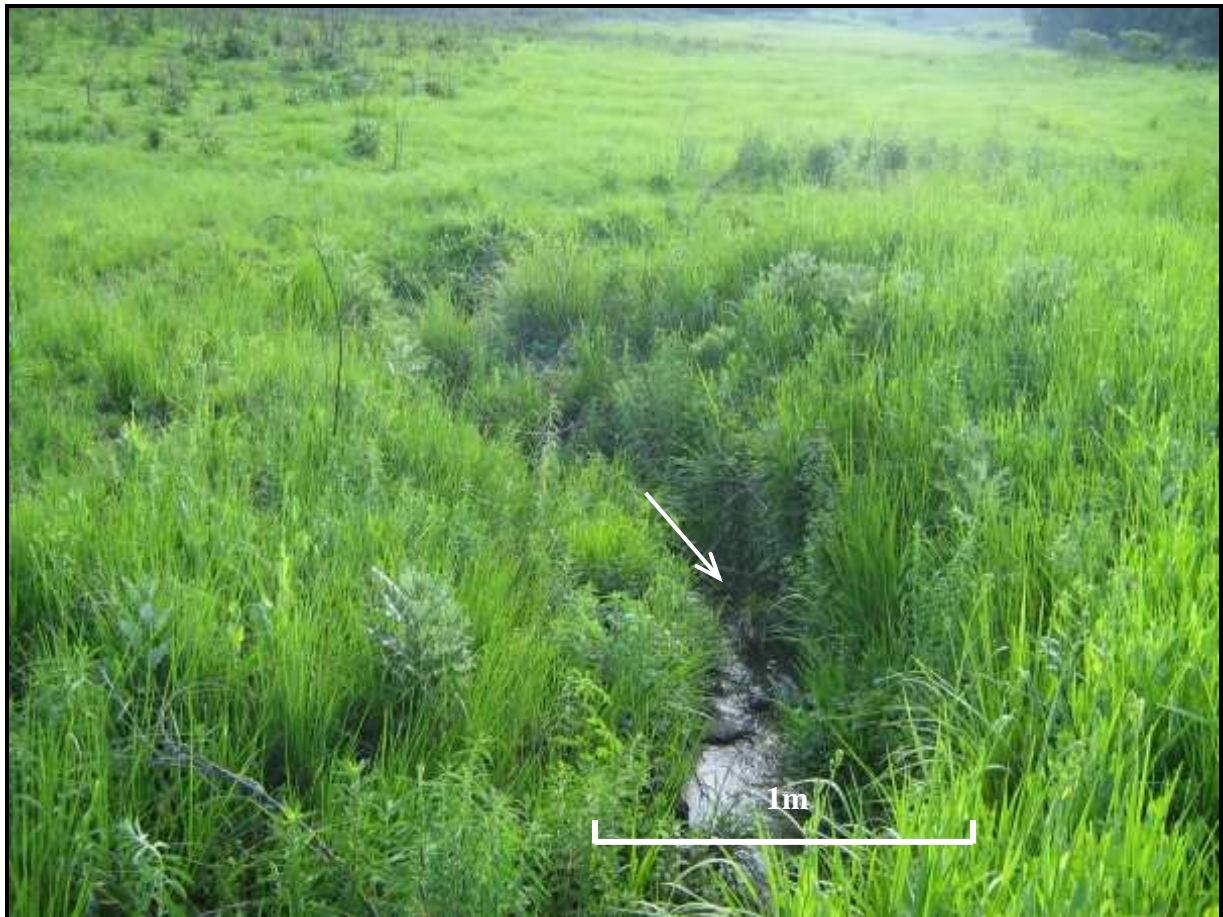
Figure 7.43 Upstream view at the site of Morphological Map U3-3

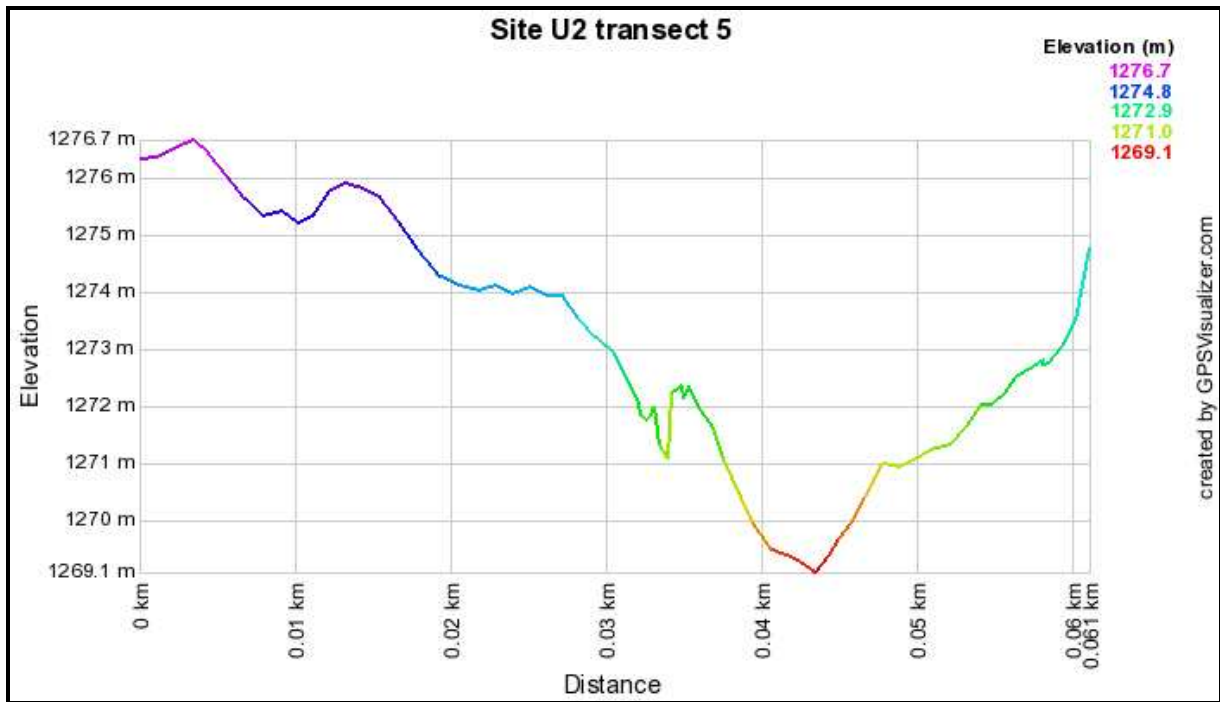
Figure 7.53 Site U2 - Cross profile for natural site at transect 5

No strong relationships can be seen across the profiles at the Umvoti sites and between the Umvoti sites and the Cedarville sites. Part of the reason for this could be that the channels were not as incised and sharply defined within the valley form as was the case at the Cedarville sites. The overall valley form of the Umvoti sites dominates the cross profile, with the channel form lost in the scale. This can be seen in Figure 7.30 where the photograph of natural Site U2 transect 5 shows a poorly defined channel in comparison to natural Site C2 transect 3 in Figure 7.37.

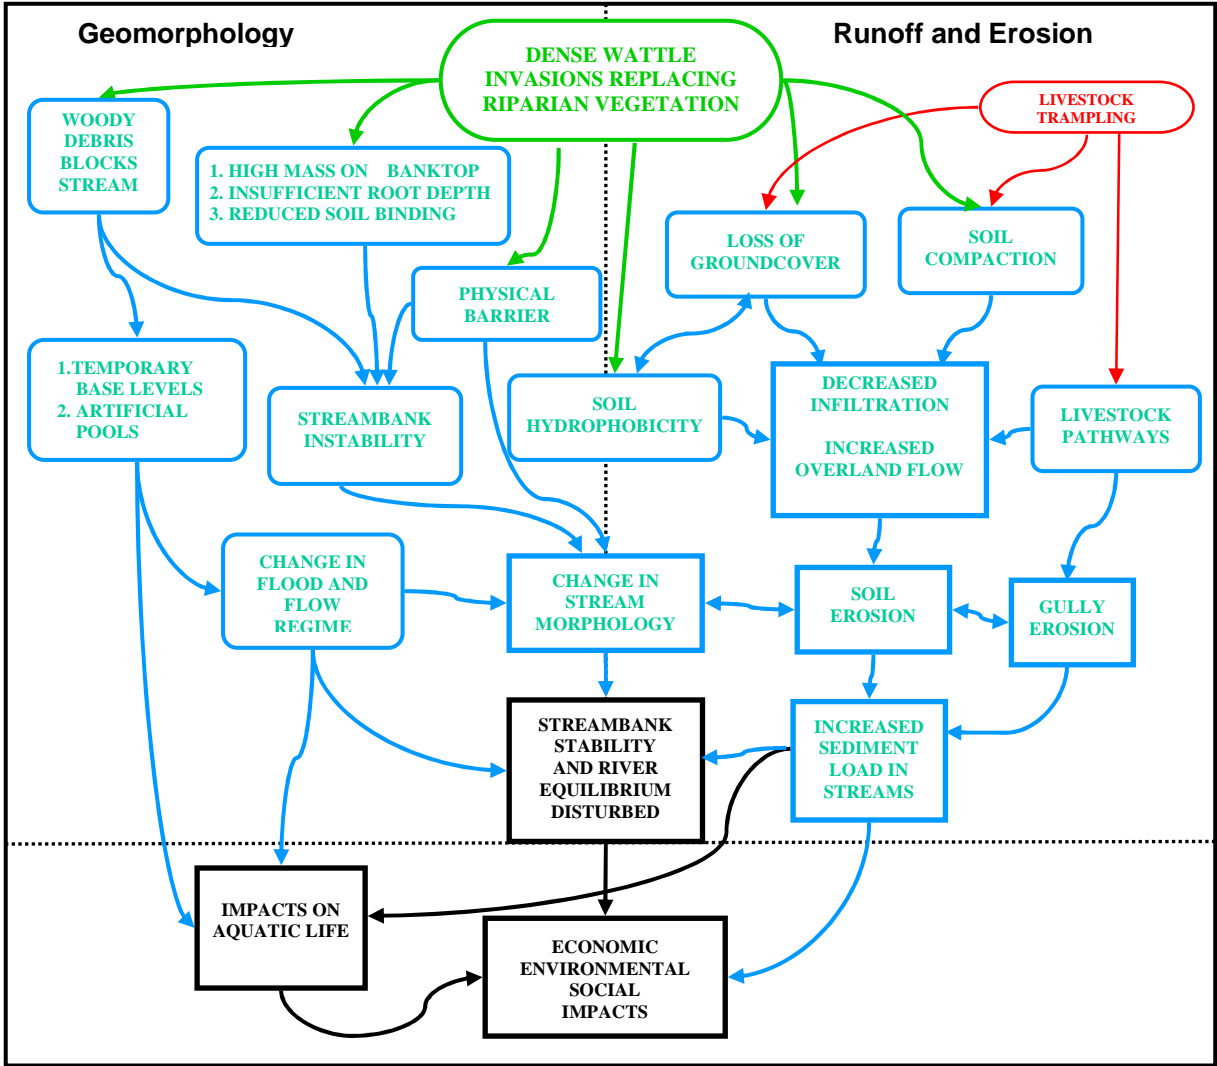
Through review of literature and observations during field visits the following flowchart has been compiled to illustrate the authors’ understanding of the processes and impacts of the dense invasion of riparian zones by alien invasive wattle. The flowchart integrates findings discussed in Chapters 2 to 4, and field observations made during the fieldwork component of this study. The following paragraph links the diagram to the literary and field evidence presented earlier in the document.

Figure 8.1 Potential impacts of invasive alien wattle on stream hydrogeomorphology and erosion within the riparian zone
