INVESTIGATION INTO THE
PERFORMANCE OF OUTDOOR
INSULATORS UNDER HIGH HUMIDITY
CONDITIONS

In fulfillment of Masters in Electrical Engineering, School of
Electrical, Electronic and Computer Engineering at the University
of Kwa-Zulu Natal

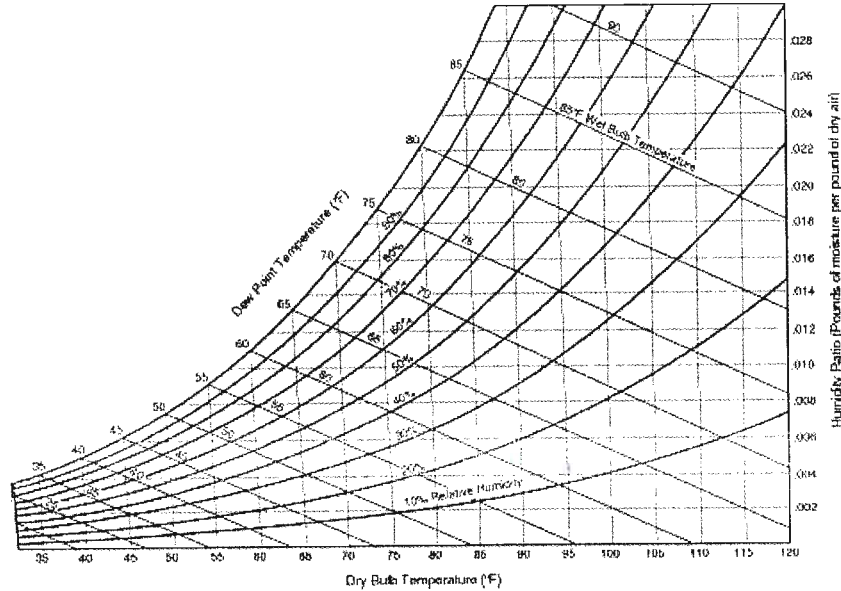
environmental temperature on the horizontal axis, moving up to the required humidity curve. Once here, move horizontally towards the 100% humidity curve. When one reaches this point, drop down to the temperature axis again and read off the temperature, this is dew point temperature for the given weather conditions. Condensation will occur if the surface temperature of the insulator is below dew point temperature.

Figure 5.1: Psychrometric Chart, taken from [9]

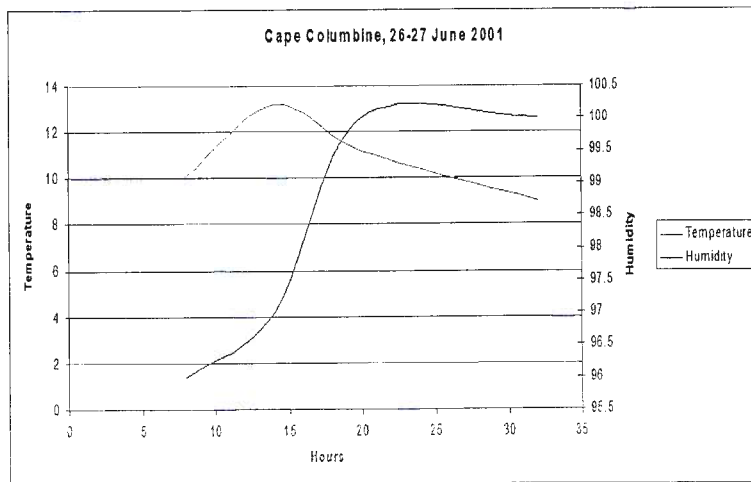
years, they were 2001, 2002 and 2003. From the data analyzed the following graphs show situations where water droplets are likely to form on the surface of the insulator due to normal condensation i.e. dew formation. On the 26th and the 27th of June 2001 it can be seen that the humidity reached 100% at 8 o'clock on the evening of the 26th and remains at 100% until 8 o'clock the next morning, with a corresponding temperature drop from 11.2 °C to 9 °C, thus resulting in dew formation. This can be seen in *Figure 5.5*.

Figure 5.5: Graph of Temperature and Humidity levels at Cape Columbine

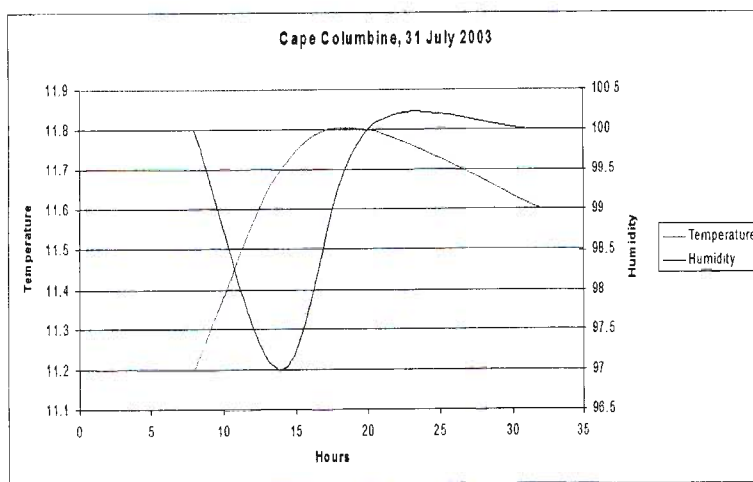
Figure 5.6 is another example of when condensation would occur on the insulator surface due to the temperature reaching dew point. The graph shows the temperature and humidity levels on the 31st of July and the next morning, the 1st of August 2003.

Figure 5.6: Graph of Temperature and Humidity levels at Cape Columbine

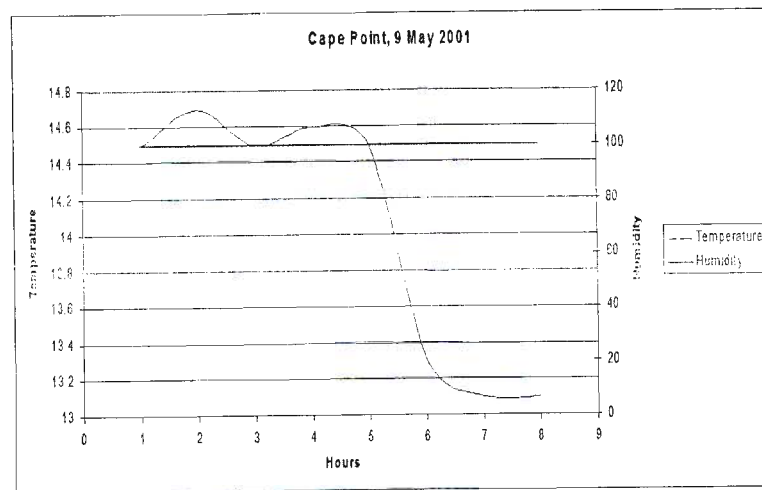
The weather data obtained for Cape point was in the form of hourly readings every day for the years 2002, 2003 and 2005. Both *figures 5.7* and *5.8* show occasions where the humidity has been at 100% and the temperature decreases. This would lead to condensation on the surface of the insulator due to the temperature dropping below dew point. The figures show the temperature and the humidity levels on the 9th May 2001 and the 13th May 2002.

Figure 5.7: Graph of Temperature and Humidity levels for Cape Point

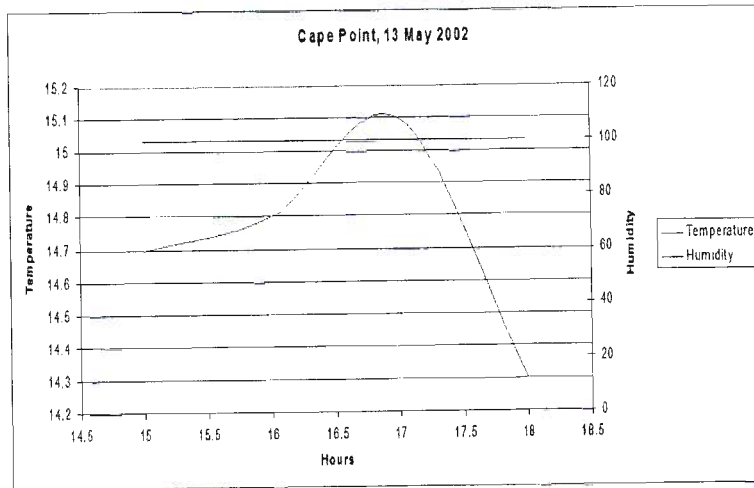
Figure 5.8: Graph of Temperature and Humidity levels for Cape Point

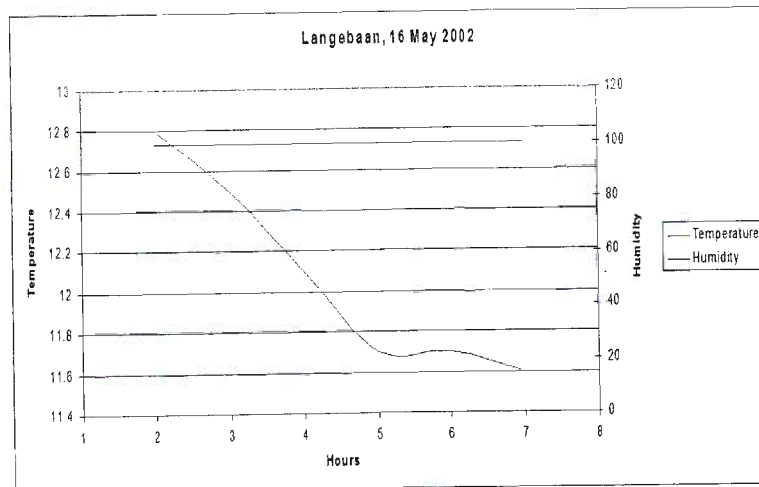
Langebaan's data was extensive. Hourly humidity and temperature readings were received for 2001 through to 2005. *Figures 5.11* and *5.12* show occasions where the temperature and humidity levels would lead to condensation on the surface of the insulator. On the 16th of May 2002 and the 13th of May 2004 the temperature decreased accompanied by a humidity level of 100%.

Figure 5.11: Graph of Temperature and Humidity levels for Langebaan

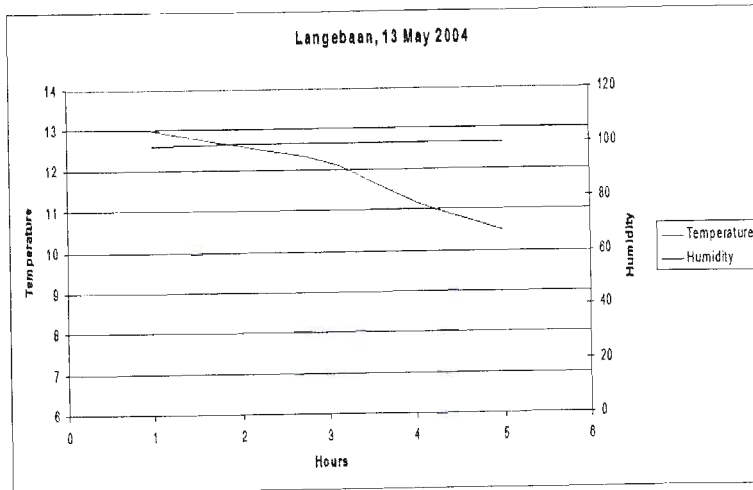
Figure 5.12: Graph of Temperature and Humidity levels for Langebaan

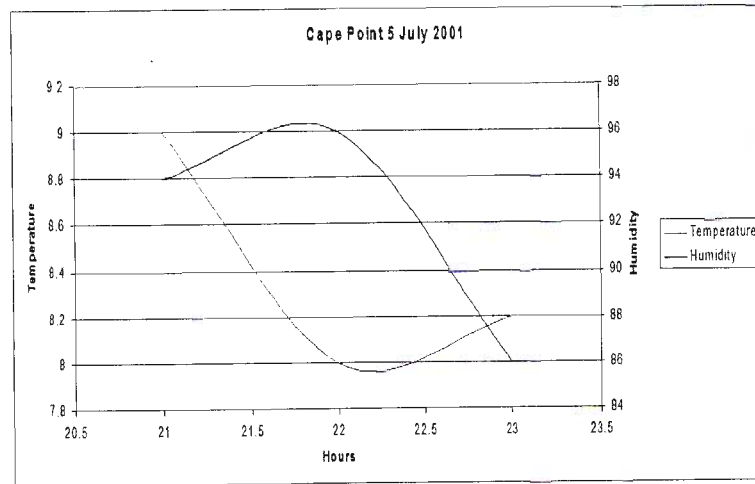
In *Figure 5.23* above the temperature at ten o'clock, the twenty second hour of the day, is 8°C and the humidity is at 96%. From equation (1) it was found that the corresponding insulator surface temperature at this time was 6.4°C. Using the psychrometric chart it was found that under these conditions surface

Figure 5.23: Surface Condensation at Cape Point

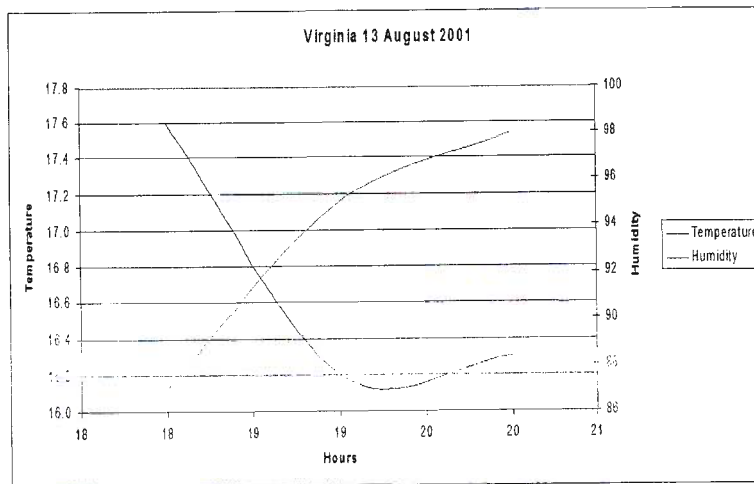
The data was analyzed to determine whether surface condensation would take place given the temperature and humidity levels given in the data. *Figure 5.27* shows the weather conditions on the 13th of August 2001 which would have lead to surface condensation on the insulator.

Figure 5.27: Surface Condensation at Virginia

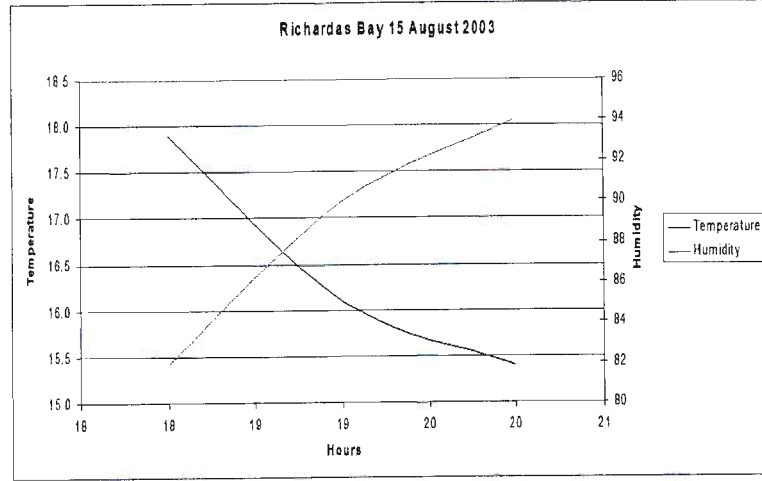
The environmental temperature at seven o'clock was 16.2 °C while the insulator temperature was calculated to be 14 °C and the humidity was 95%. It was estimated using the psychrometric chart that the insulator surface would have to cool to below 15.2 °C in order for surface condensation to take place. The insulator surface temperature did so and it can therefore be concluded that surface condensation did take place. Again surface condensation occurred mainly in the winter months and temperatures ranged between 11.7 °C and 22.9 °C, with the lowest humidity leading to surface condensation being 88%.

Figure 5.28: Surface Condensation at Richards Bay

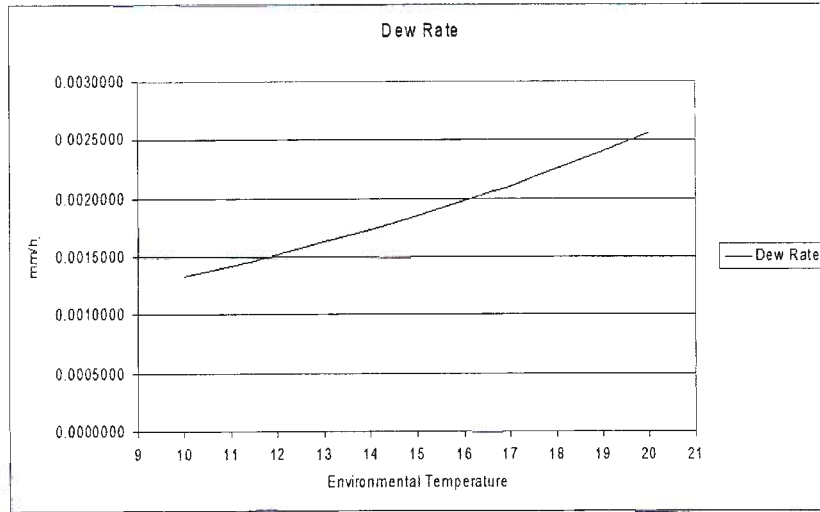
The condensation rates which result from surface condensation were also tabulated and graphed. *Table 5.10* shows the surface condensation rates resulting at different humidity levels and different temperatures. The difference in the environmental temperature and the insulator surface temperatures was taken to be 3 °C. The temperature indicated in the table represents the environmental surface temperature. The resulting condensation rates (CR) are then shown for four different humidity values. The same was done for a difference

Figure 5.29: Graph of Dew Rate

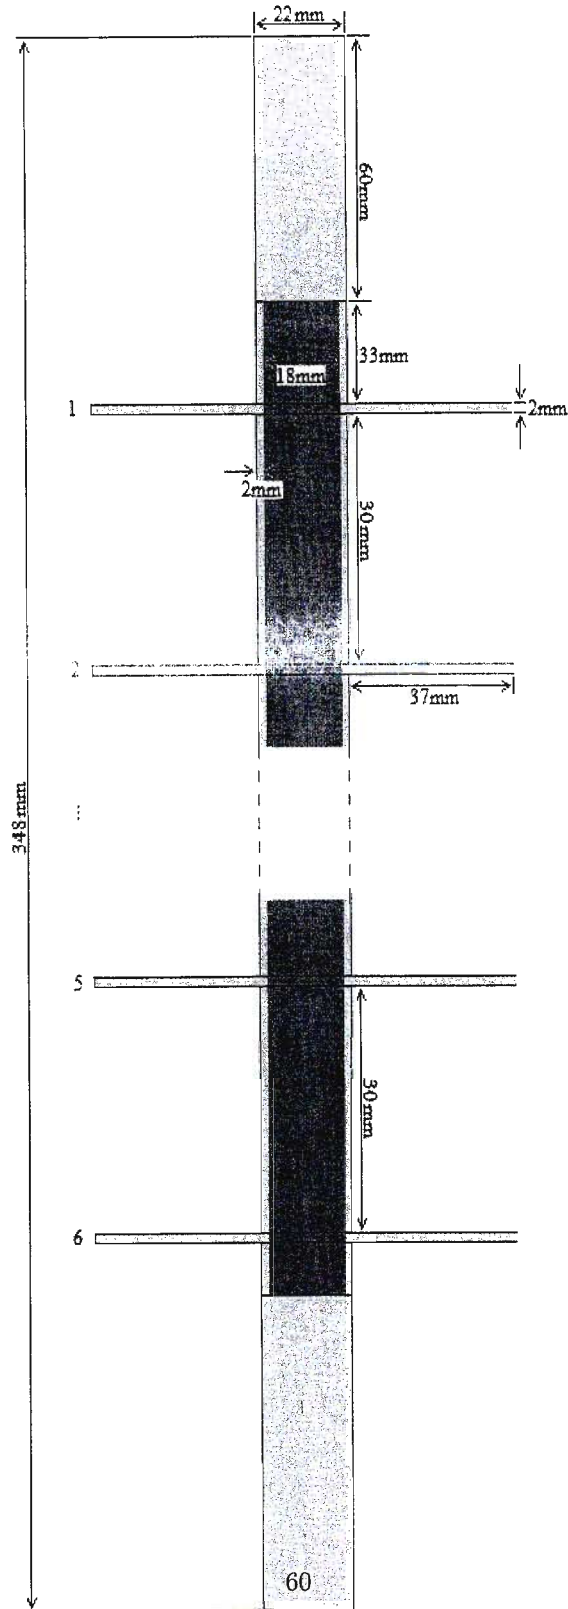
Figure 6.2: EPDM1 Insulator Profile

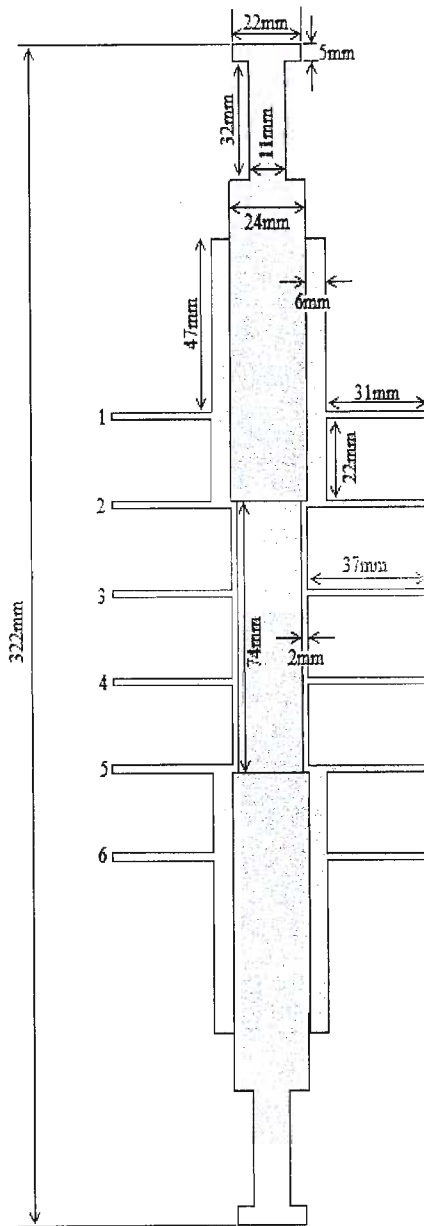
Figure 6.1: SiR1 Profile

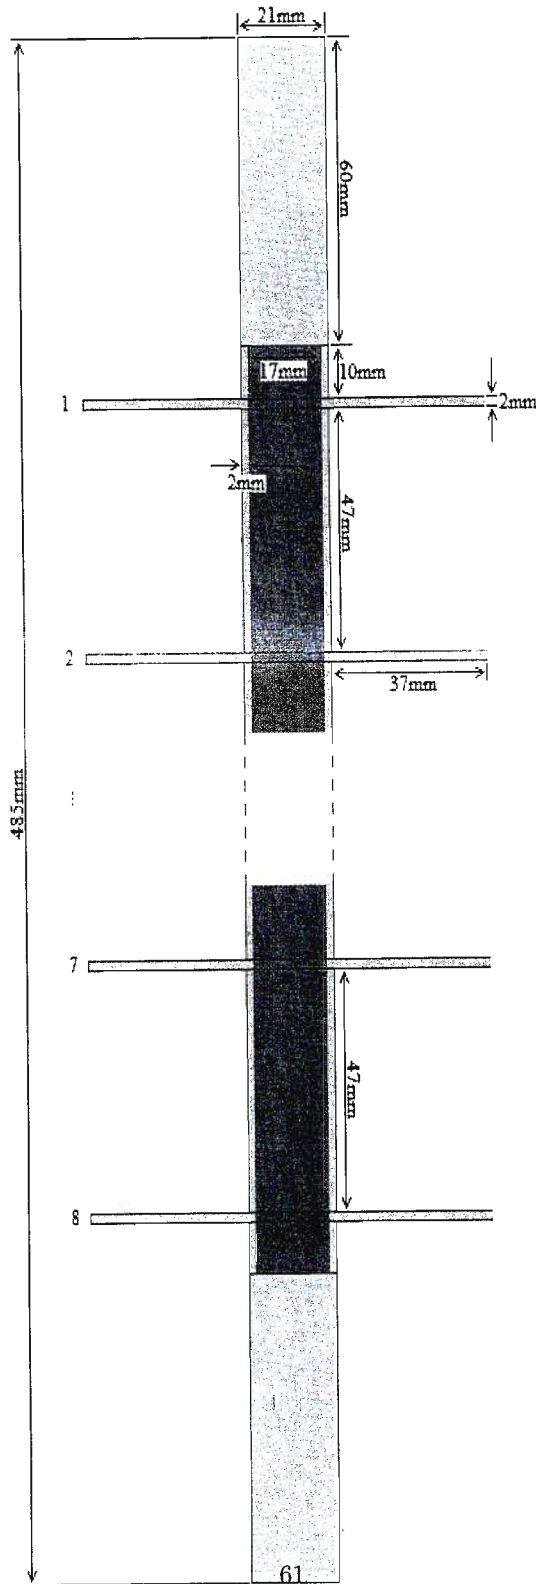
Figure 6.3: EPDM2 Insulator Profile

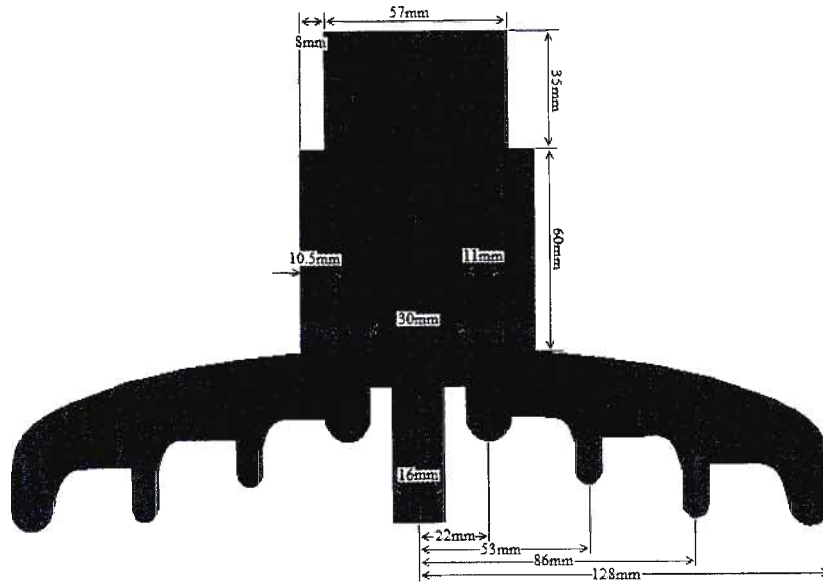
Figure 6.4: Glass1 Insulator Profile

The glass was set to be the standard glass in the *Maxwell* materials library. It had a permittivity of 1. The metal cap and pins were set to be steel. Again the pollution layer on the glass cap-and-pin insulator was set to have varying

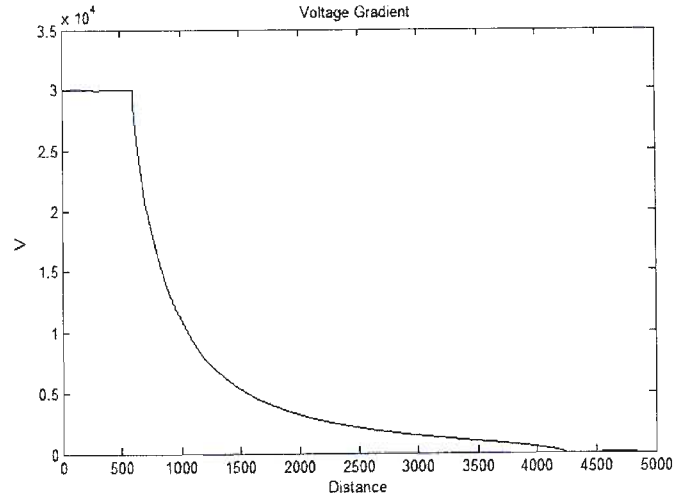
The Unpolluted insulators were simulated with a 30kV source applied to the high voltage terminal. The voltage and electric fields which resulted were then plotted. These values were plotted along the length of a polyline which ran along the length of the insulators. Two different EPDM insulators were simulated and one silicone rubber and one glass cap-and-pin insulator were simulated. The voltage gradient plotted for the polymer insulators were all similar and all showed a uniform exponential decay from the high voltage end as shown in *Figure 7.1*, which shows the voltage plot for the unpolluted EPDM2 insulator.

Figure 7.1: Voltage Gradient of EPDM2 Insulator

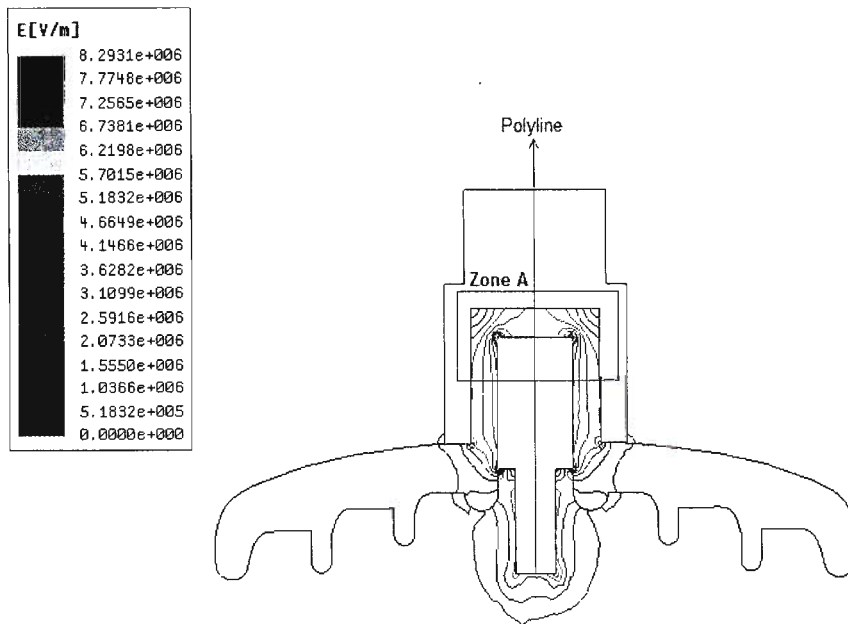
Figure 7.3: Glass1 Electric Field

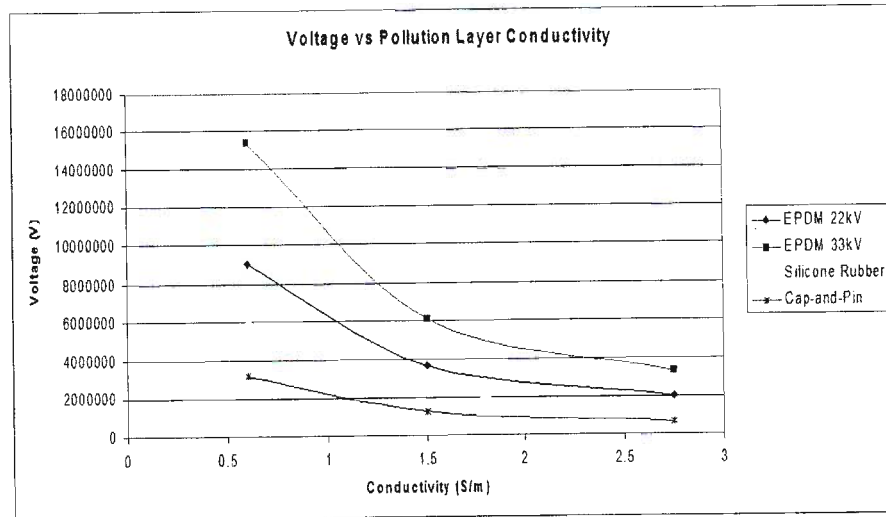
Figure 7.4: Voltage vs Conductivity

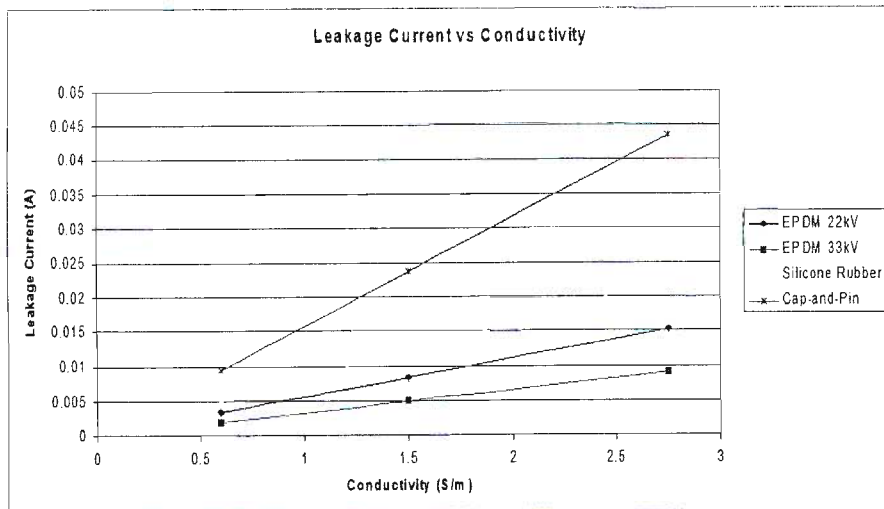
Figure 7.5: Leakage Current vs Conductivity

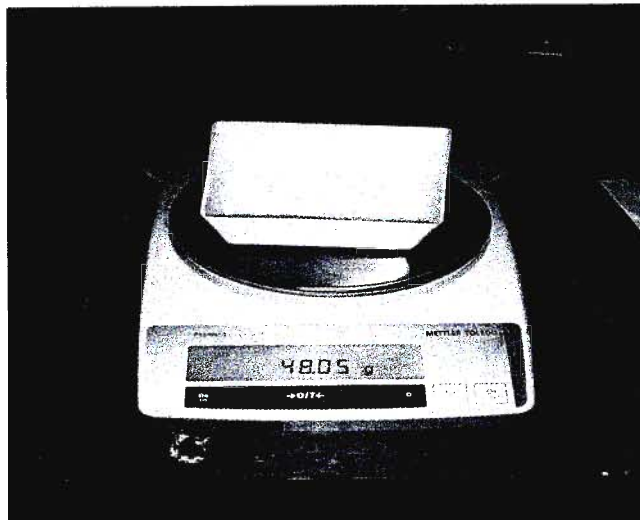
Figure 8.1: Electric Scale

The insulators were polluted by means of dipping into a wet slurry. The slurry was made up with tap water, kaolin and salt and was contained in the appropriate container for dipping. The amount of kaolin added to the slurry was 40g/liter of water as recommended in [2]. The amount of salt added depended on the required conductivity of the pollution layer, and is detailed in section 3.1. All amounts were weighed out on an electrical scale as shown in *Figure 8.1*.

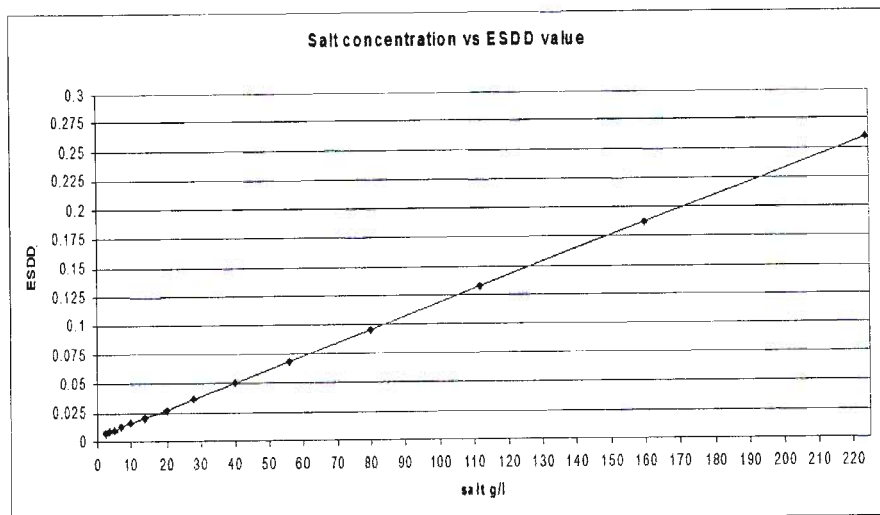
The insulators had to be polluted so as to achieve the ESDD levels as specified in IEC 60815 [6]. Very little data could be found which indicated the amount of salt which would have to be added to the slurry in order to achieve the required ESDD values. The process used was trial and error. First 5 grams of salt was added per liter of slurry. The ESDD value was then measured, then further salt was added to the slurry to make a salt concentration of 10 grams per liter, again the ESDD value was measured. The average ESDD value for each different salt concentration in the slurry was calculated and a graph was plotted from these values. *Figure 8.2* shows the plot of the graph which shows the amount of salt which would have to be added to the slurry to result in the desired ESDD value. The line of the graph was extrapolated so that higher salt concentrations and ESDD values could be viewed. *Table 8.2* shows the amount of salt which needed to be added, per liter of water, to get the predicted ESDD values, in mg/cm^2 , as indicated in the graph plotted in *Figure 8.2*.

Figure 8.2: Graph of Salt concentration verses ESDD values

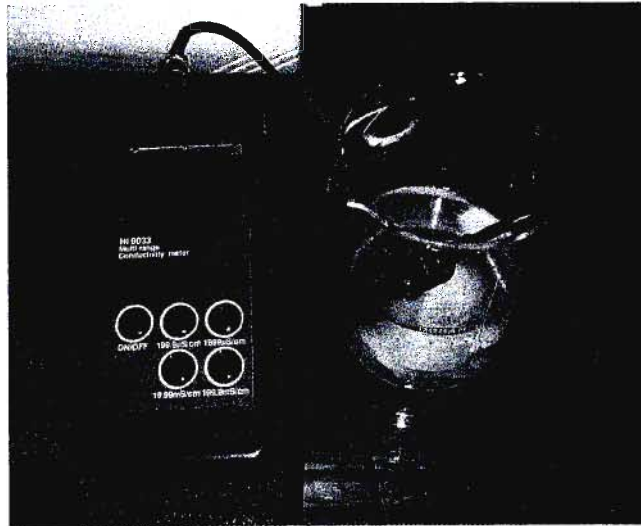
Figure 8.4: Measuring the Conductivity with the Conductivity Meter

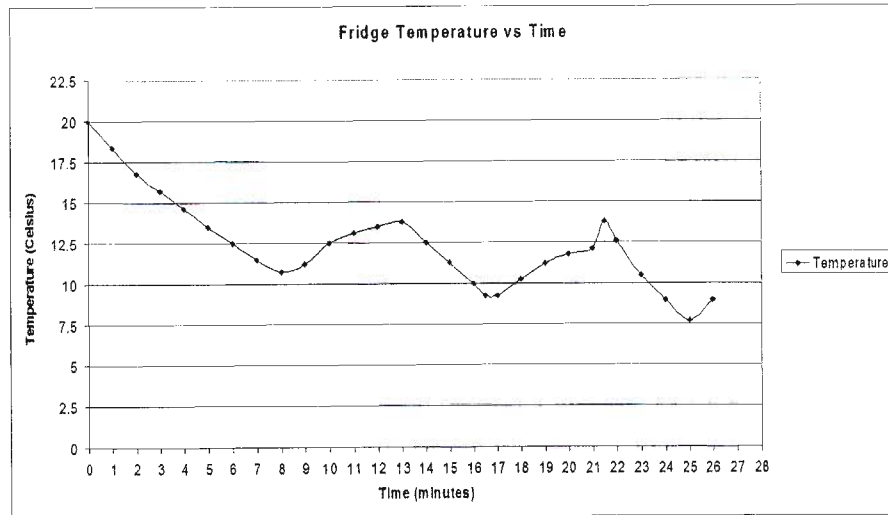
Figure 8.5: Temperature cycle of the fridge

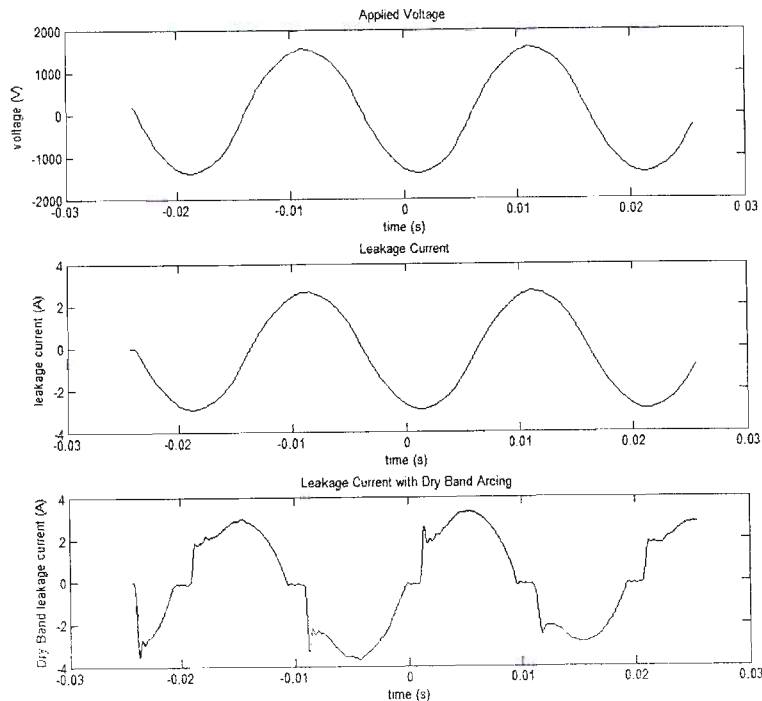
Figure 8.8: Example of measured voltage and leakage current signals

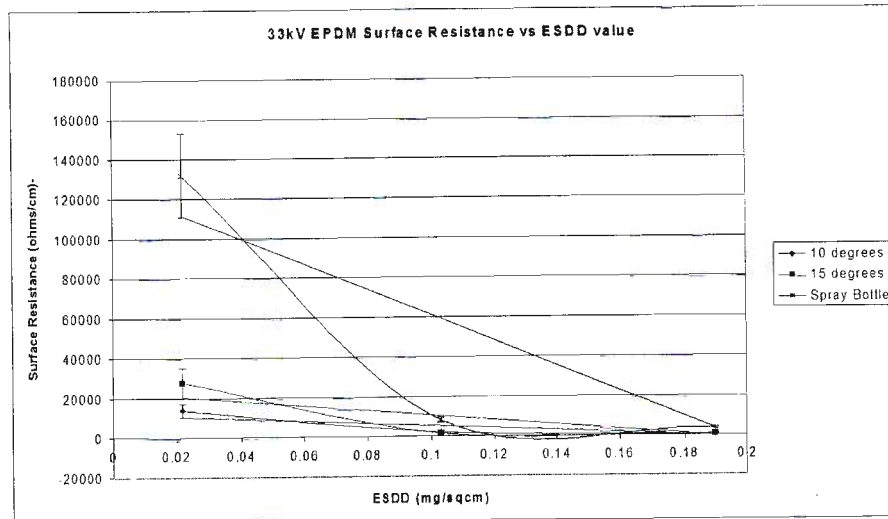
Figure 9.3 shows the plot of the surface resistances measured versus the

Figure 9.3: EPDM2: Per Unit surface resistance vs ESDD values

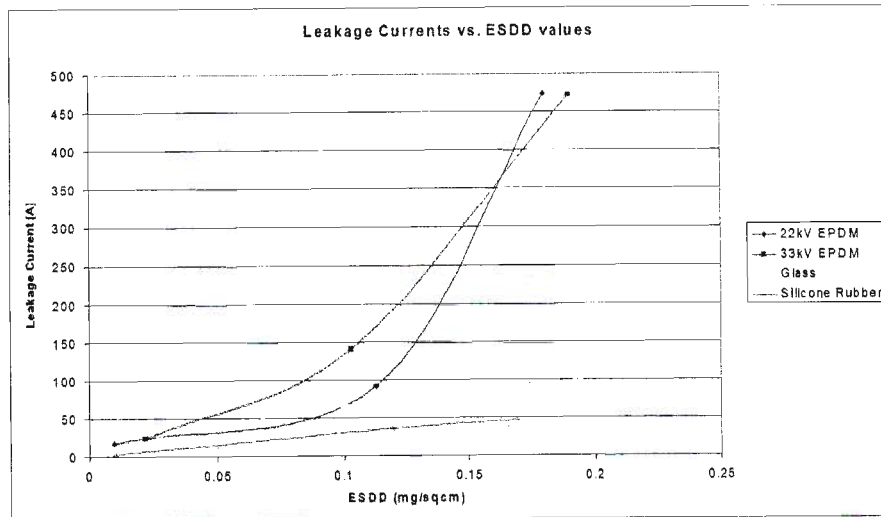
Figure 9.11: Weather chamber leakage current verses ESDD values
