**Geomorphic Considerations in the deterioration of Rural Roads: The Case of  
Inkandla, Indwedwe and Ga-Modjadji**

**Submitted in fulfilment of the academic requirements for the degree  
of  
Master of Science**

**University of Natal, Pietermaritzburg**

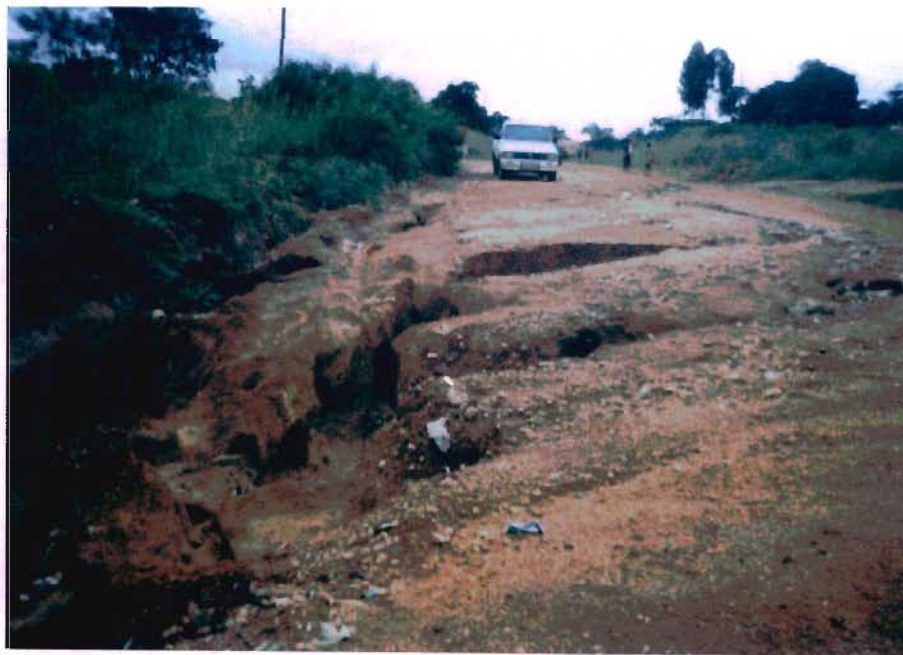
**Figure 2.1.** An example of commonly occurring erosion forms on rural roads, photograph taken after a severe downpour

In addition, roads are subject to unavoidable erosion. Hindson (1983) defines unavoidable erosion as the loss of soil from the road surface, either in the form of dust that has been pulverized by the passing traffic or as mud which is splashed out of tracks by passing vehicles during heavy rains. In the USA for example, Carrara and Carroll (1979) and Walter *et al.* (1983) found that exposed tree roots were the major cause of accelerated erosion on road cuts which is also unavoidable erosion. Erosion and landslide failure became widespread through root-derived cohesion on New Zealand North Island (Preston and Crozzier, 1999). Such losses are difficult to prevent but are nearly always insignificant compared with the loss by avoidable erosion. Simple maintenance procedures to combat or reduce unavoidable erosion on roads include widening of side drains and filling of potholes before and after rains. Common erosion processes that affect most rural roads in South Africa are gullying, rilling and sheet erosion ( see Figure 2.1).

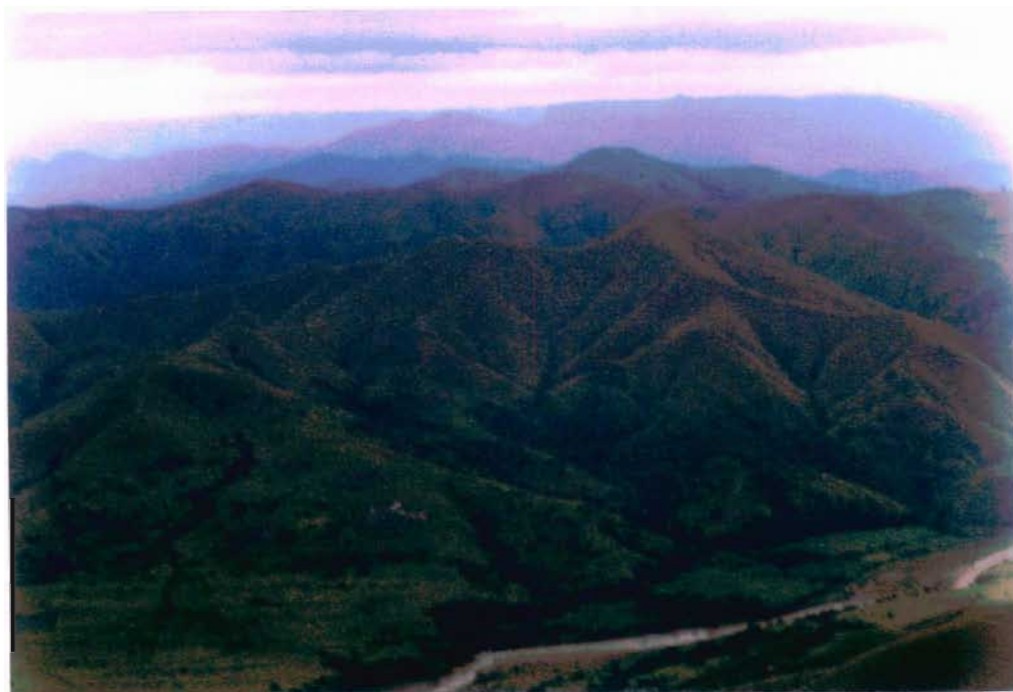
**Figure 3. 4** The ruggedness of Inkandla terrain impedes the construction of roads in the area

It has been observed that the streams rising in the forest have cut deep gorges leading into the Nsuze river, which runs along the base of the ridge. It has a broken terrain and very steep slopes which further limit the construction of roads.

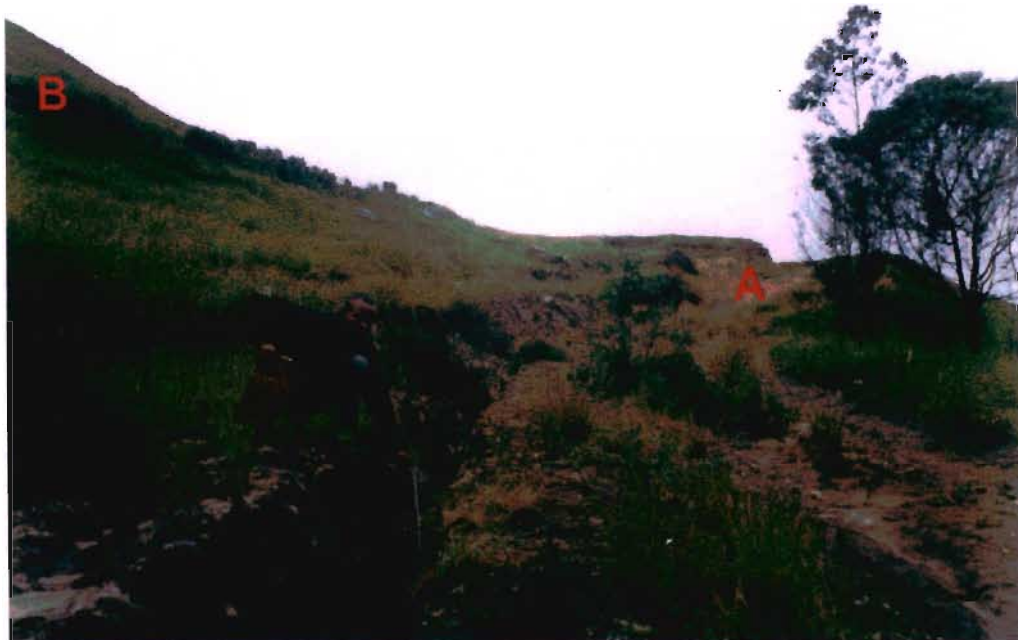
**Figure 5.2** An abandoned access road A constructed by the community with the newly constructed road marked B. Note the 1.8 metre deep gully being indicated by the field assistant

Soil erosion on both roads is severe, especially on the abandoned road (A). Rill erosion on Road B is observed to be the dominant process acting on this section of the road and has played a significant role in the deterioration of the road. Rills have developed into gullies extending 300 m in length and are up to 1.8 m in depth (see Figure 5.2 and Figure 5.3). The influence of slope angle on soil entrainment by sheetwash and rill erosion triggered by the lack of protective cover, have also had an effect on this road. Slope angles perpendicular to the road section were found to be in the range of  $17^{\circ}$ - $22^{\circ}$ , which is steep for road construction.

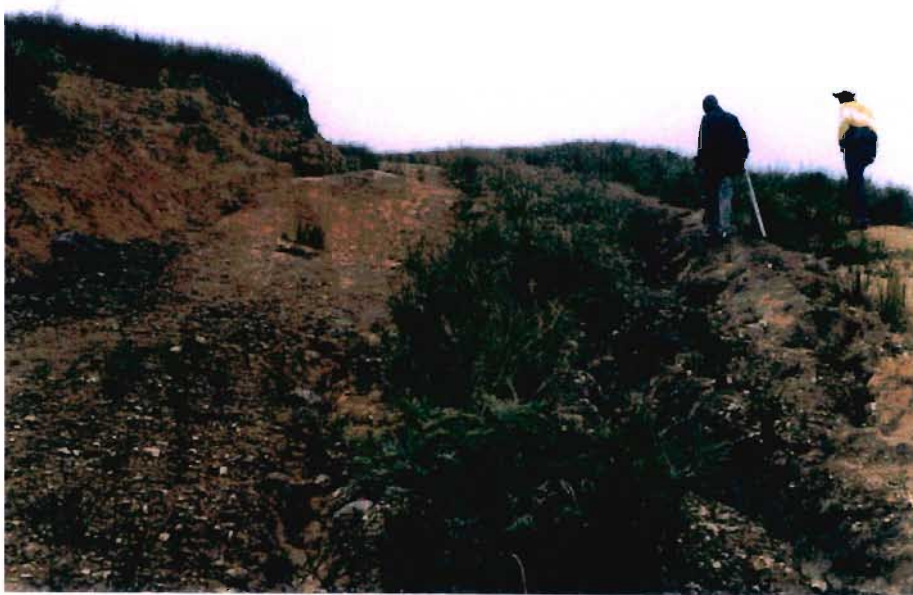
**Figure 5.4** An access road constructed by the community on a steep slope and later abandoned because of severe erosion (Upper Kwa-Dlabe, site 1, Fig 5.3).

The formation of rills in the Inkandla area can generally be attributed to an increase in hydraulic gradient as a result of slope gradient. Theoretically, erosion is expected to increase with an increase in slope steepness and length, both as a result of the increase of velocity and of volume of surface runoff (Hudson,1981; Morgan,1986). Morgan (1995) attests that rills are initiated at a critical distance downslope where overland flow becomes channeled and breaks into rills, as is the case at Inkandla. Figure 5.4 is an example of the extent to which such soil erosion can destroy a road to such a degree that it becomes unusable.

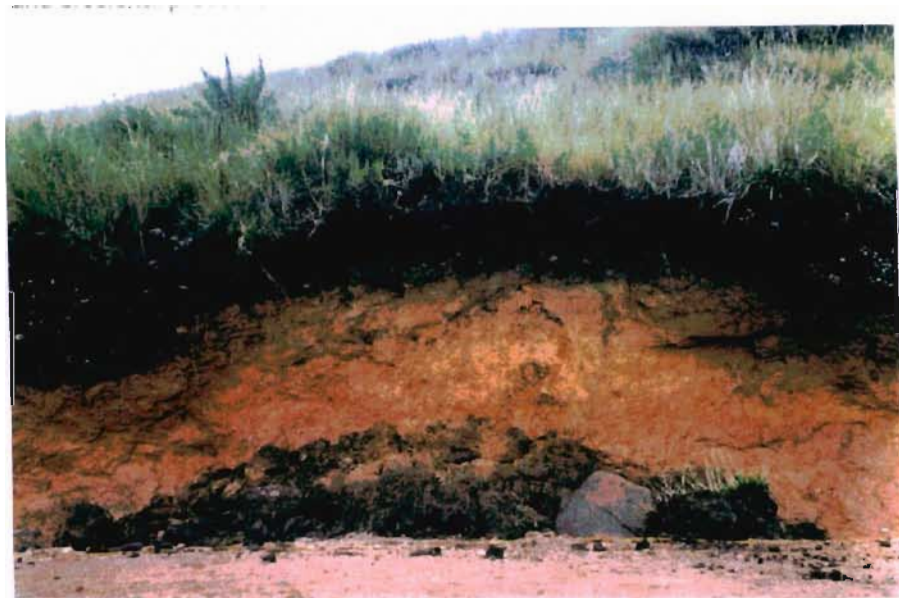
**Figure 5.5** Road degradation as a result of soil slumping at the main Kwa-Dlabe site, Inkandla

Extensive slumping was observed as an additional factor in road degradation. An embankment of 1.14 m exists on the main Kwa-Dlabe road section (see site 2, Fig 5.3), with slumping being the major erosional process degrading the embankment ( Figure 5.5). Representative soil samples were collected from the different soil horizons of the embankment itself and from the slumped material, for laboratory analysis. Although the texture will be discussed in greater detail later, the material collected from the slump material in this study site shows high sand values with a low clay fraction and thereby confirms the susceptible nature of the soil from this location. In terms of the recommendation by the TRH 4 (1985), a proper balance of stones, sand and fines must be maintained when constructing roads, in order to attain proper and long term stability. When any of these is missing or present in wrong proportions, stability problems will occur.

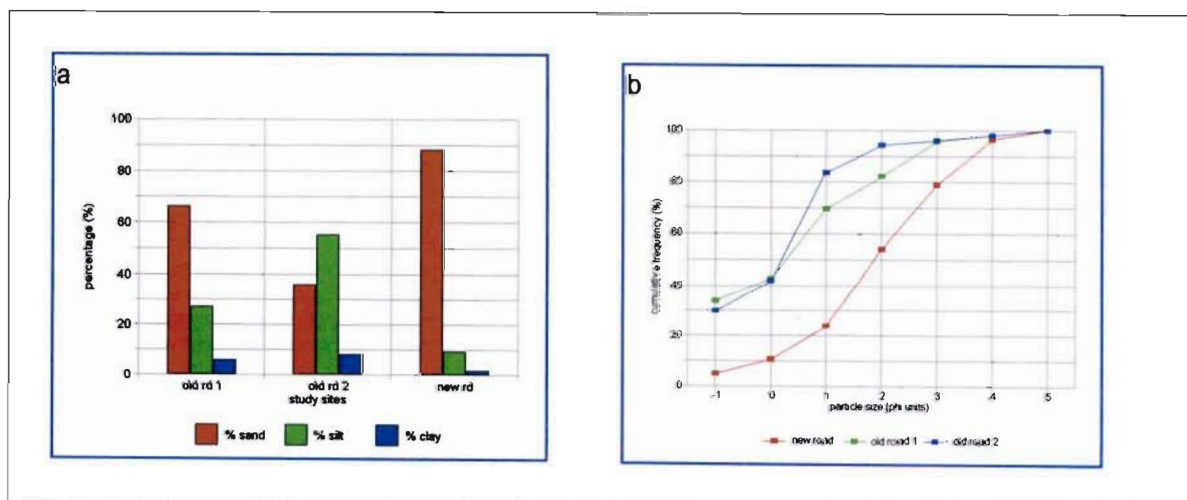
**Figure 5.6** Mean textural fractions(a) and cumulative frequency plots (b) of representative samples collected at Upper Kwa-Dlabe (site 1, Fig 5.3) rd on graph=road

Texture analysis for the new road shows a phi mean value (1.93) with a slight increase in finer particles as compared to the samples collected in the abandoned road. The old road 1 has shown a coarsening texture ( phi mean=2.90) with a more finer material observed in old road 2 (phi mean=3.00).

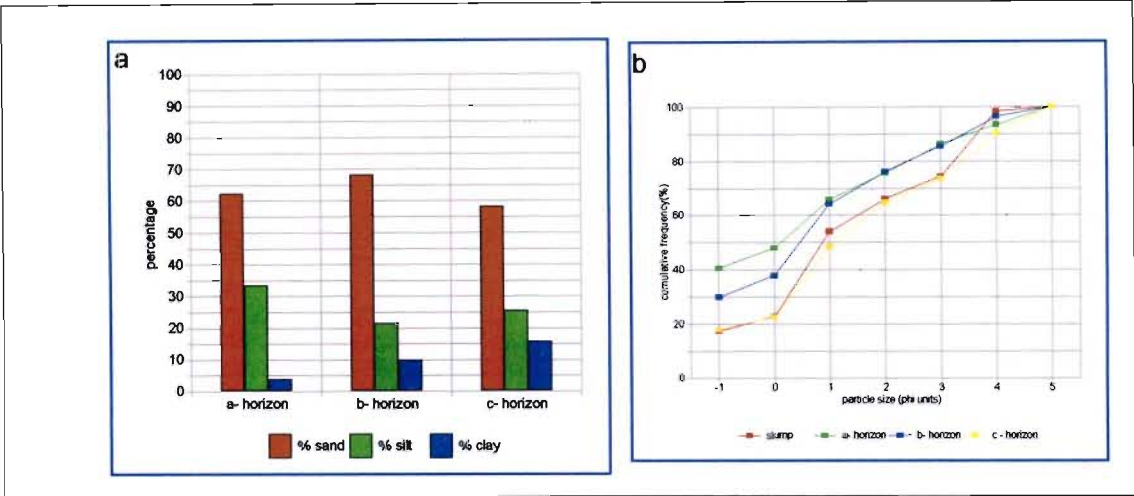
**Figure 5.8** Mean textural fractions (a)and cumulative frequency(b) of representative samples collected at the Main Kwa Dlabe site

The texture of the A and B horizons are not greatly different (A horizon=0.4 and B horizon=1.16), whereas the C-horizon is significantly finer with a mean phi value of 1.36.

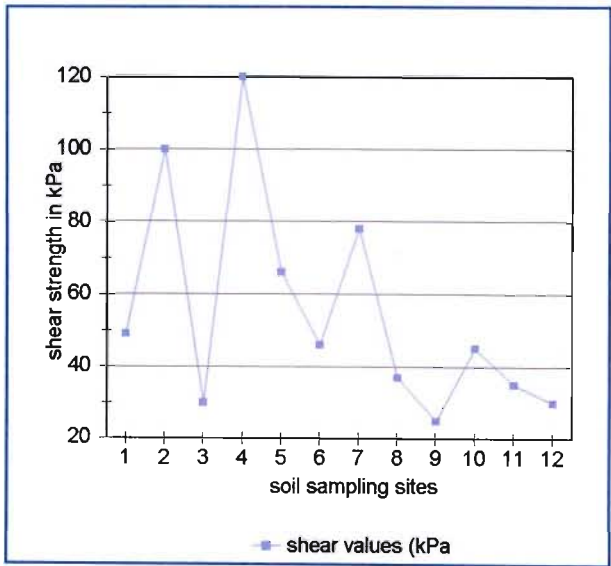
**Figure 5.10** Mean Soil Strength for Soils collected at different sites (Inkandla)

One of the physical characteristics that has been considered important in this study is the shear strength of the soil, which is an indicator of soil erodibility. Soil shear strength indicates the cohesiveness and the resistance to shearing forces exerted by external forces (Morgan,1986). These forces include factors such as raindrop impact, trampling animals and gravitational slumping. In this study, a Farnell-type hand shear vane was used to determine the resistance of soil to shear stress.

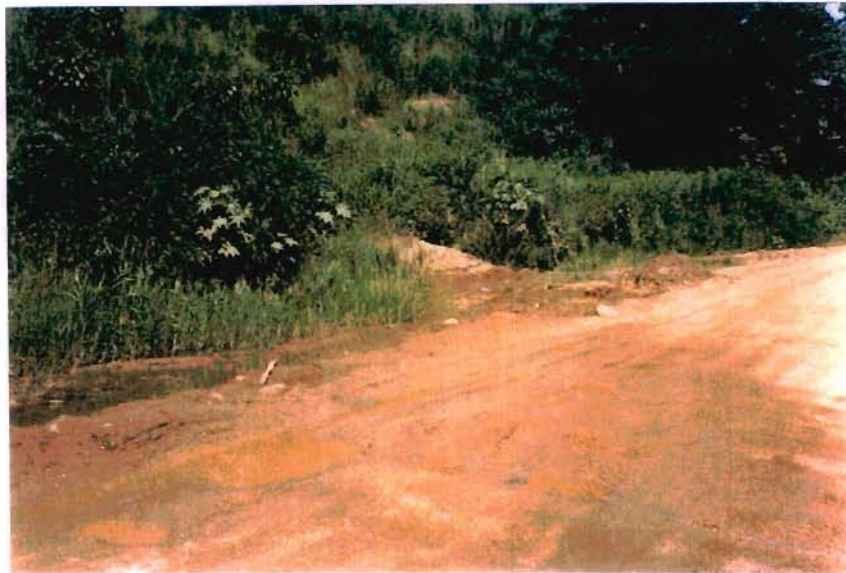
**Figure 5.14** A wetland on the roadside(upper Mzinyathi) makes vehicular access difficult in periods of prolonged rains.

This site is situated a few metres from the second bridge, some distance away from the Lower Mzinyathi study site, on the road to Indwedwe Mission (site 2, Figure 5.11 and Figure 5.12). A major constraint to effective vehicular access here is the location of a wetland adjacent to the roadside, as in Figure 5.14. The wetland has formed adjacent to the road and has resulted in pooling of water on the causeway due to poor drainage. It is this wetland that makes vehicular access in this section of the road a problem, especially after heavy rains, when the wetland experiences heavy flooding, partially submerging the road surface due to the high water table effects.

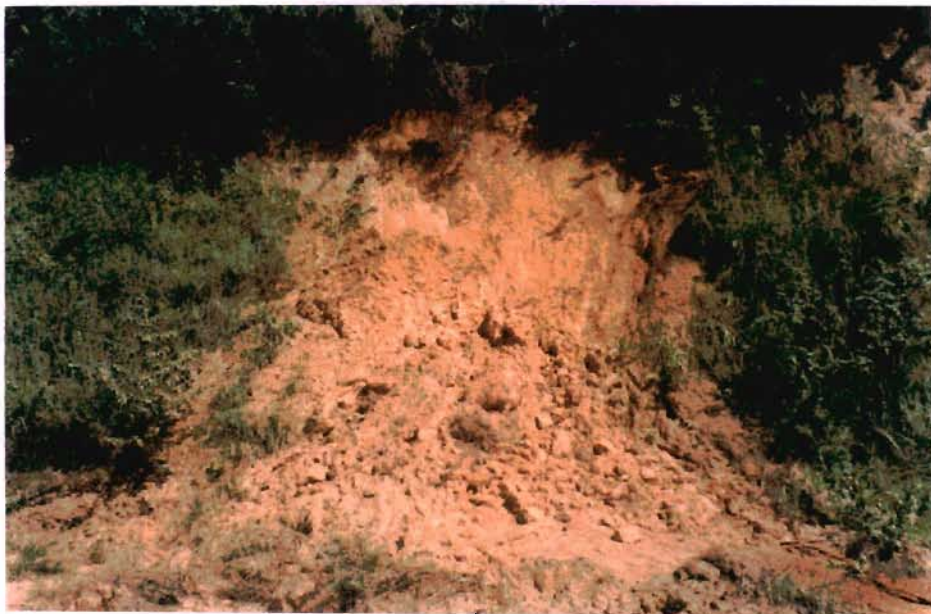
**Figure 5.15** Soil slumping at upper Mzinyathi commonly occurs on road cut slopes.

In a manner similar to that described for the Inkandla area, major slumping was observed mainly onto the roadside, as shown in the Figure 5.15 (site 2, Fig 5.12).

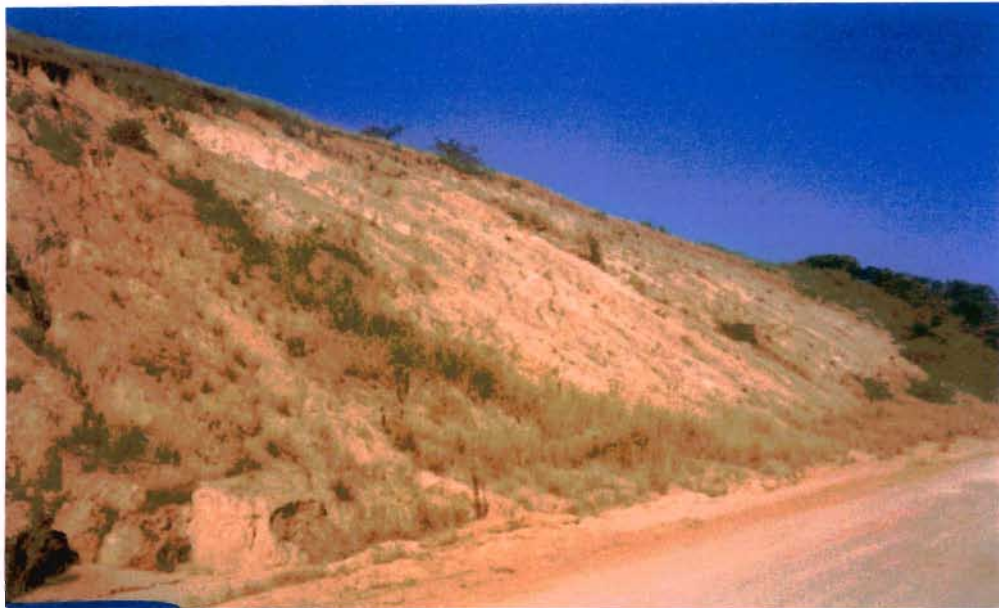
**Figure 5.16** Extensive erosion of an embankment in a road cutting at Engonweni, Indwedwe. Note the sparse vegetation cover.

This is a severely eroded road cut located at the village of Engonweni (site 4, Figure 5.11 and 5.12). This study site consists of an embankment approximately 500 m long, with heights ranging from 9 m to 13 m. Gullies on the roadside are approximately 400 m long, with a depth of two and half metres. The first part of the slope cut is sparsely vegetated, with large erosion scars which appear to have occurred through gully and pipe erosion, where vegetation is bare, as shown in Figure 5.16. The width of the road in this section has decreased from 7,5m to 4,5 m because of the erosion occurring on the side of the road.

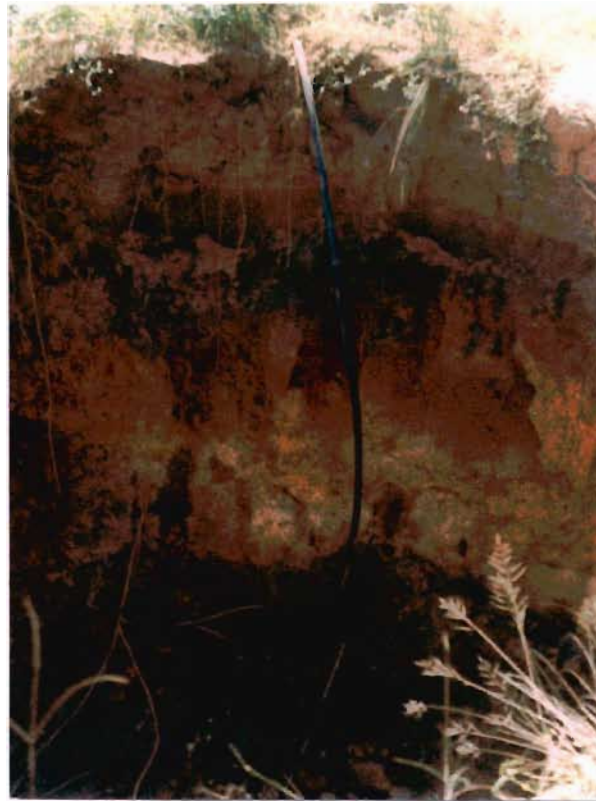
**Figure 5.17** Gully erosion below a road cutting at Egonweni in the Indwedwe area. Note the depth of the gully. The soil surface is approximately 2m above the irrigation pipe, which is 3m long.

Gullies are 'relentless destroyers of roads', particularly earth roads (Hindson, 1983). At the Engonweni site (see Fig 5.17, site 4), a deep extensive, active gully exists below the road cutting. The gully seems to have developed through slumping and acts as a means of transporting water from the road surface downslope. Water erosion thus plays a dominant role in this instance. Gully head retreat is actively occurring, contributing to the general increase of the gully and affecting the width of the carriageway.

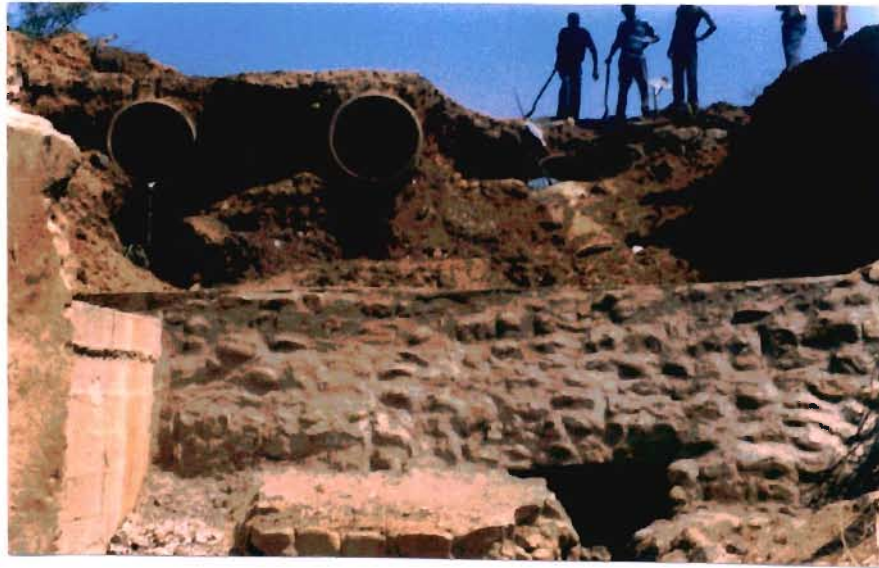
**Figure 5.18** A culvert that was destroyed by heavy rains at Mzunga Drift, Indwedwe

Study site 5 (Figure 5.11 and 5.12) is located in Mzunga village, next to a poorly constructed bridge with streams crossing to join the Mdloti river. However, with increased flow of the river during the December 1999 and January 2001 floods, the bridge was partially damaged by erosion, as is shown in Figure 5.18.

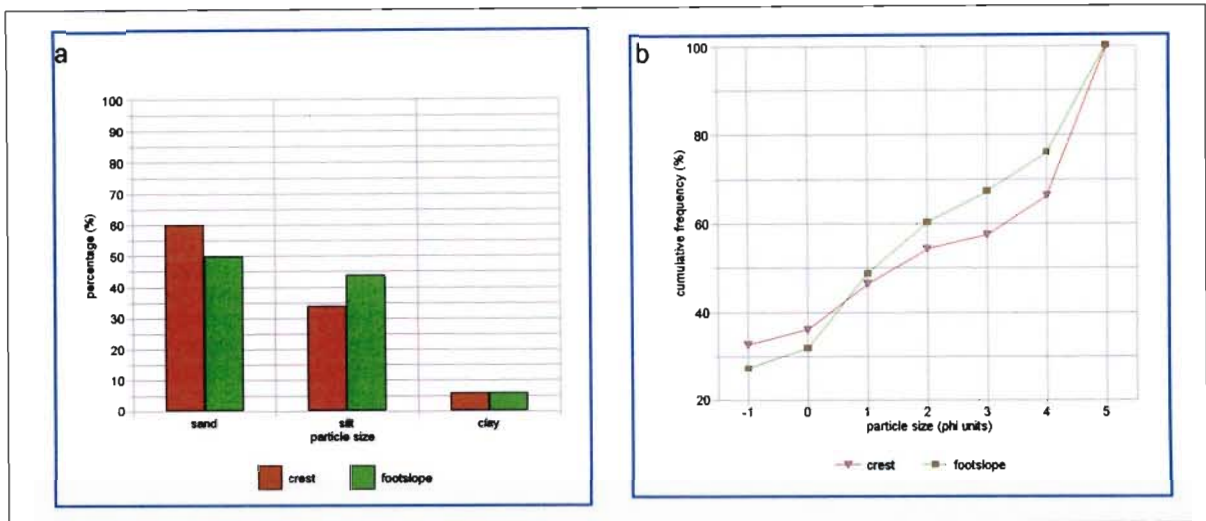
**Figure 5.21** Mean textural fractions (a) and cumulative frequency(b) of representative samples collected at Engonweni in the Indwedwe area

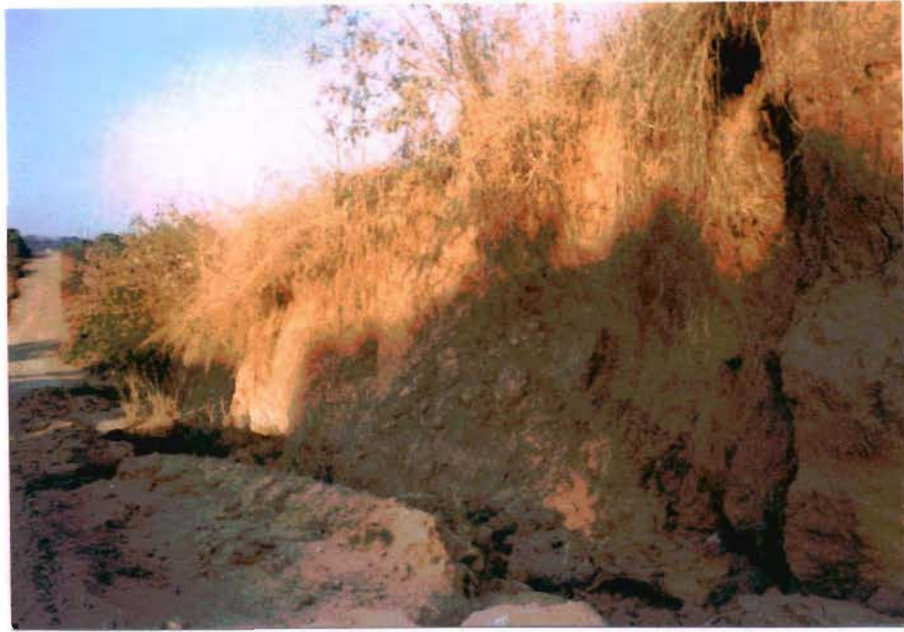
**Figure 5.26** Undercutting of the embankment at Lower-Moleketla by an incipient gully before the floods. Figure 5.27 was taken at the same location after further severe rainfall in February 2000.

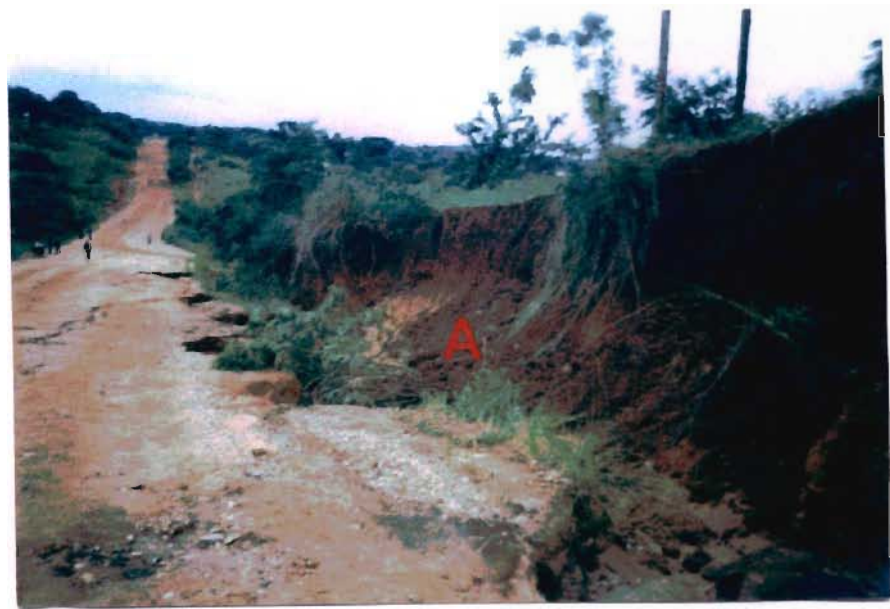
**Figure 5.27** Slumping of an undercut embankment (A) at Lower-Moleketla after the February 2000 rains, at the same location as Figure 5.26.

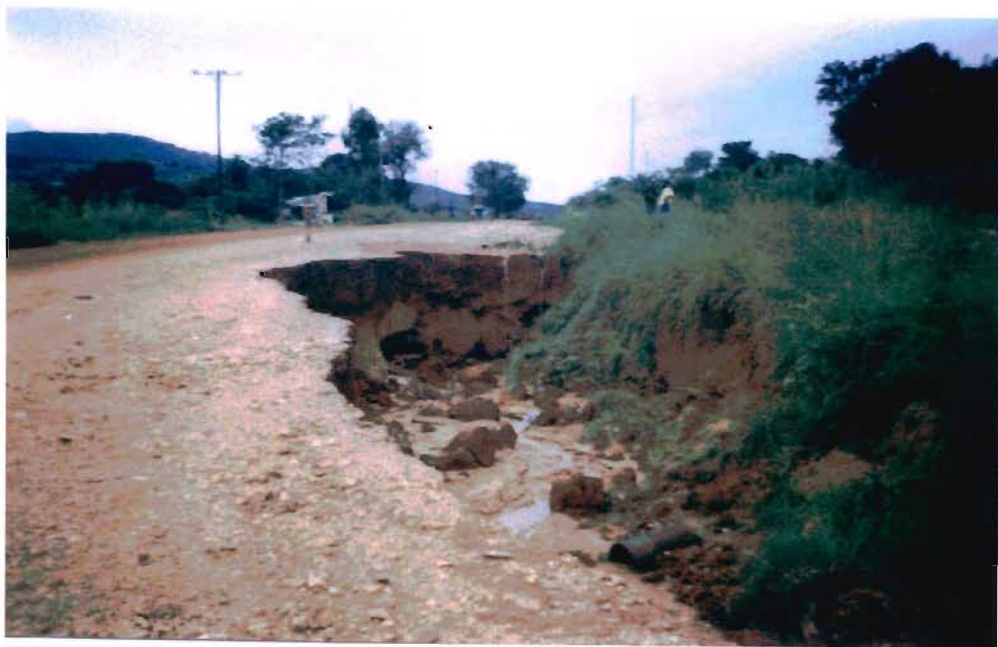
**Figure 5.28** A road section damaged by the February 2000 rains at study site one (Ga-Modupa) in the Ga-Modjadji area (Fig 5.25, site 1).

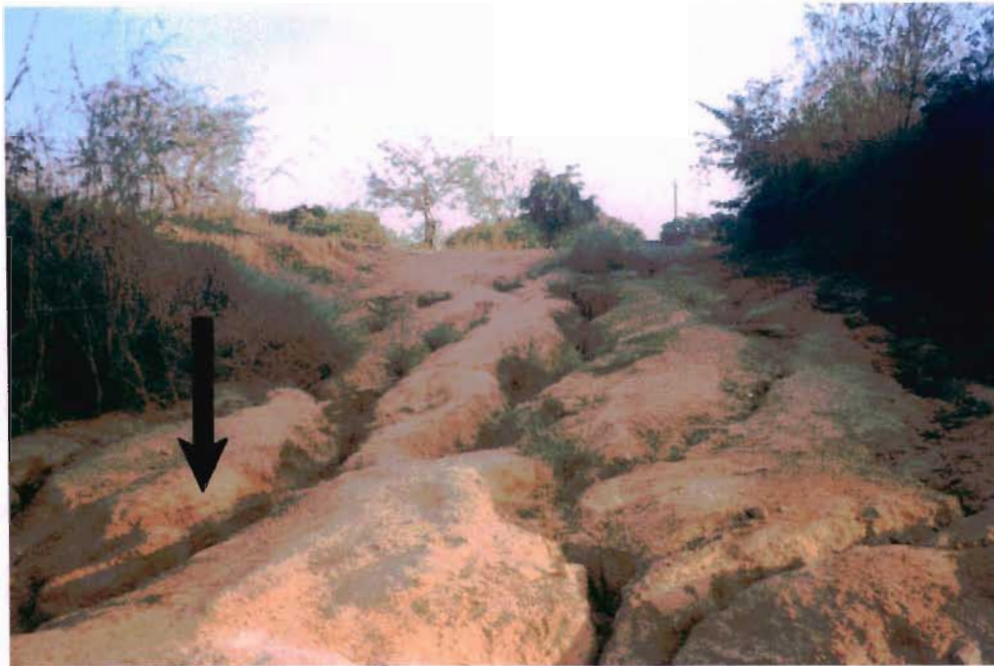
**Figure 5.29** Deep rills formed on unprotected soils of low permeability with moderate gradient at Ga-Modjadji before the heavy rainfalls of 2000.

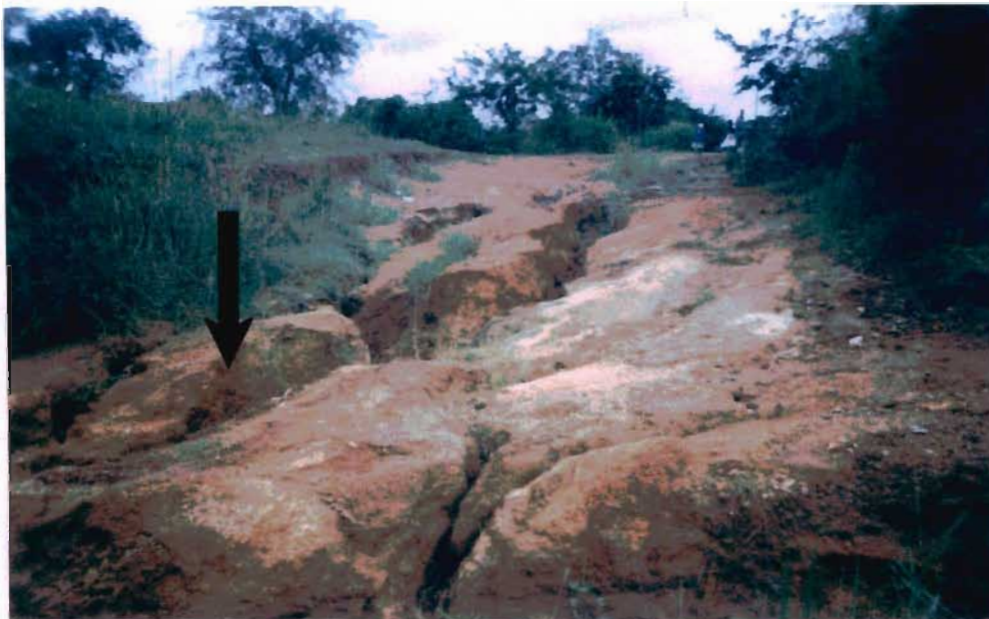
**Figure 5.30** Rill erosion, as in **Figure 5.29**, after floods and severe rainstorms of 2000 at Ga- Modjadji. Note the difference in rill width and depth after the runoff (designated by the arrows above).

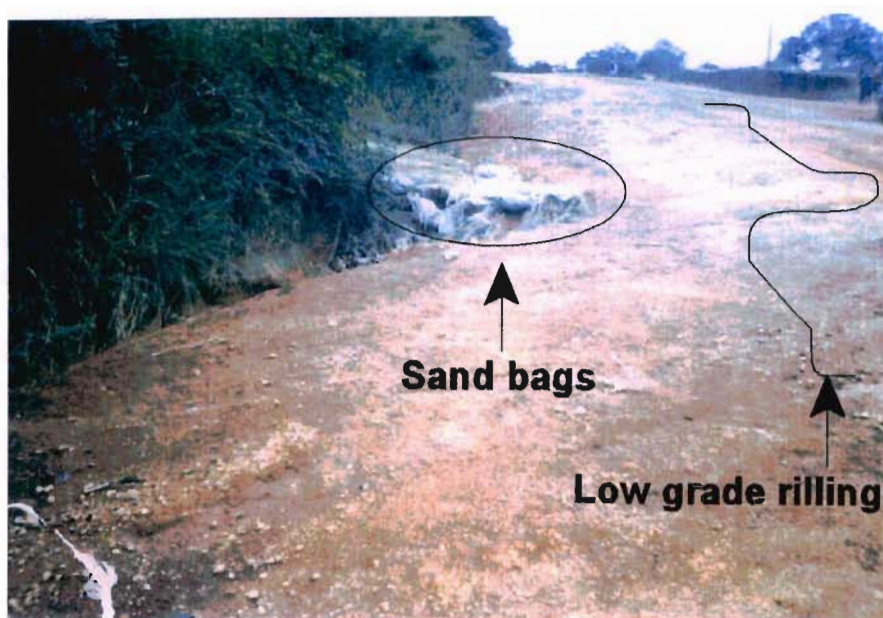
**Figure 5.31** Ga-Modjadji villagers employ low cost conservation techniques (the use of sand bags) in controlling road erosion in the Upper Maleketla. Note how sheetwash and low grade rilling have degraded the road.

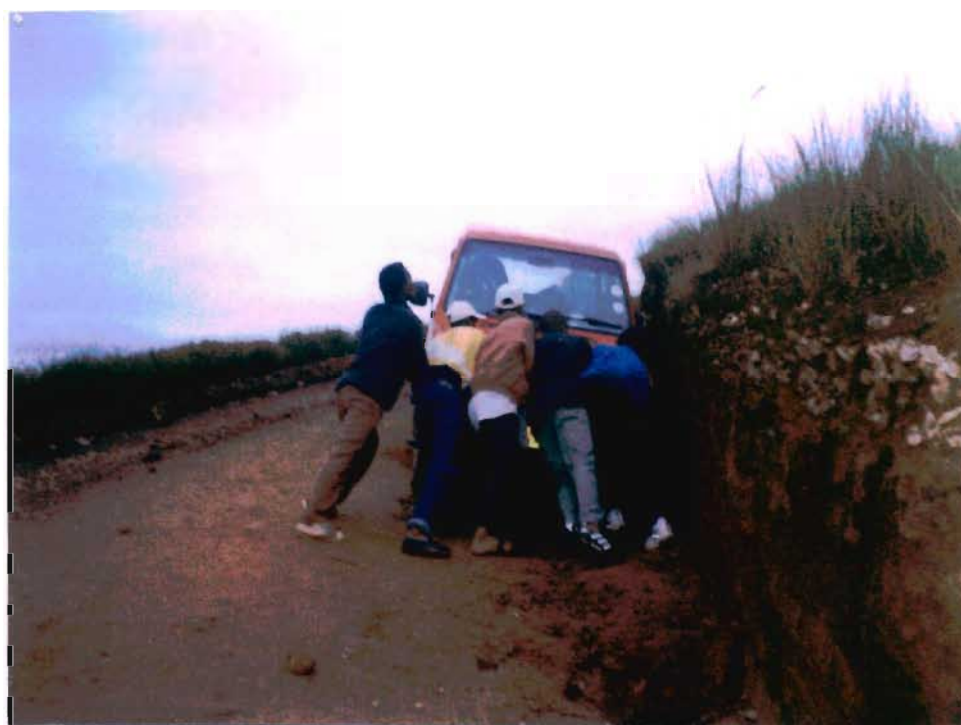
**Figure 6.1** Slippery roads after heavy rains were identified by respondents from Inkandla as one of the road access problems

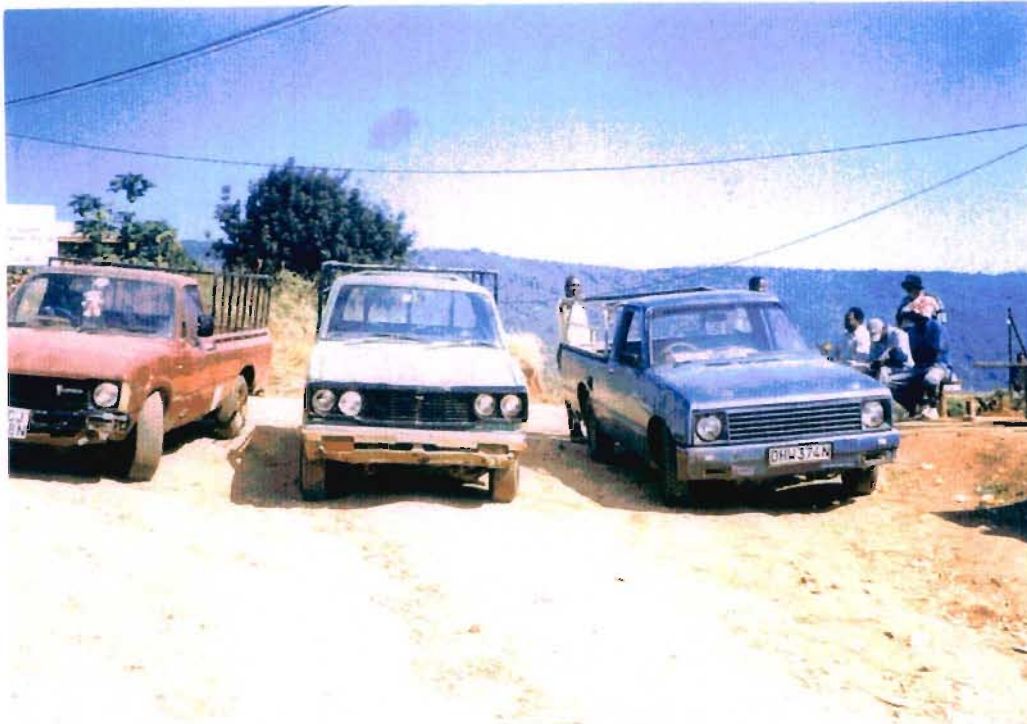
**Figure 7.1** Poorly maintained access roads at Ga-Modjadji reduces the lifespan of vehicles. These *bakkies* are used to transport local people to the nearby towns and villages.

Rural people require access to roads of an adequate standard (in terms of reliability and safety), for buses and minibuses to operate effectively and at an affordable cost. There is very little public transport in all the study areas and that which exists is very expensive due to the costs of maintenance of vehicles on such bad roads. In the Ga-Modjadji area, the majority of vehicles that are used as public transport are vans that are not road-worthy as shown in Figure 7.1. Vehicles are poorly maintained due to poverty, ignorance (overloading) and other factors which warrant investigation. All these factors are controllable by government policies. Governments in these study areas owe their inhabitants the duty to keep roads safe and ensure that only road-worthy vehicles ply the roads. There are many safety, environmental concerns attached to these used vehicles. The road worthiness of public transport is a primary concern because of the many accidents that have claimed the lives of the poor people working in farms. With it comes the safety of driver and passenger as well as of other road users.
