UNIVERSITY OF KWAZULU-NATAL

**BACK ANALYSIS OF AN ANCIENT ROCKSLIDE AT LAKE FUNDUDZI, LIMPOPO
PROVINCE, SOUTH AFRICA**

A dissertation submitted in fulfilment of the requirements for the degree of
Master of Science (MSc) in Environmental and Engineering Geology

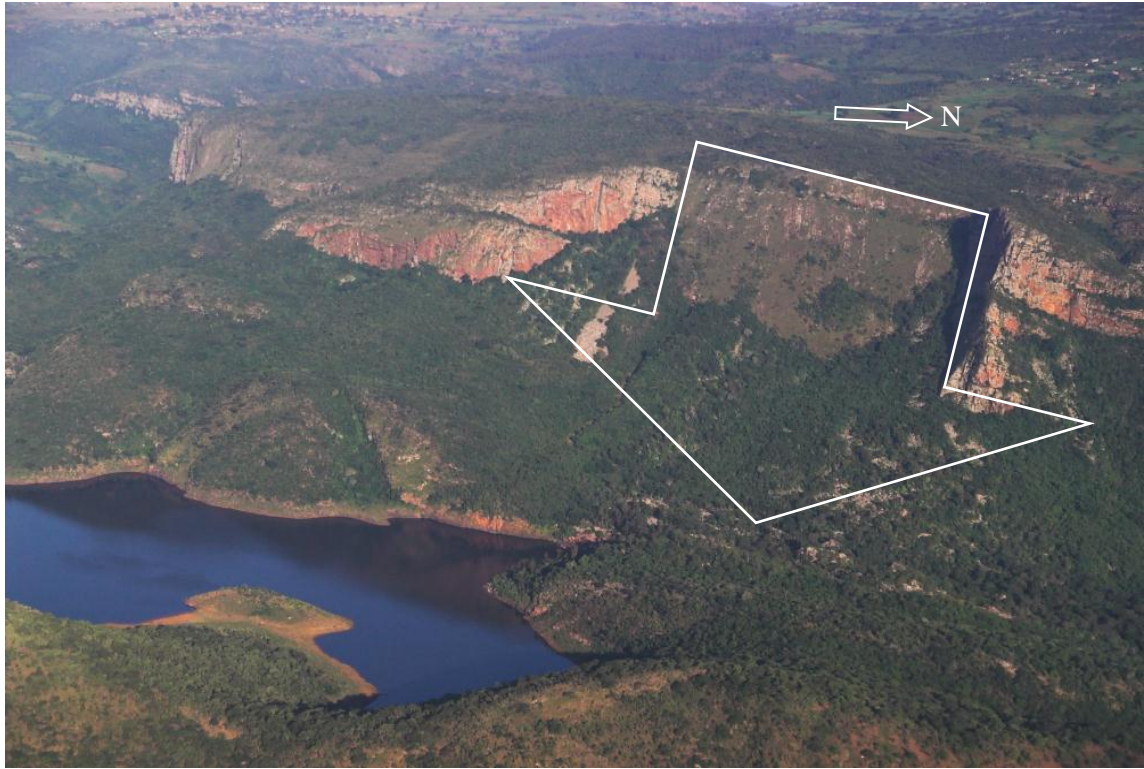
Figure 1.2: A diagonally aerial view of the Lake Fundudzi landslide situated in the Soutpansberg mountains.

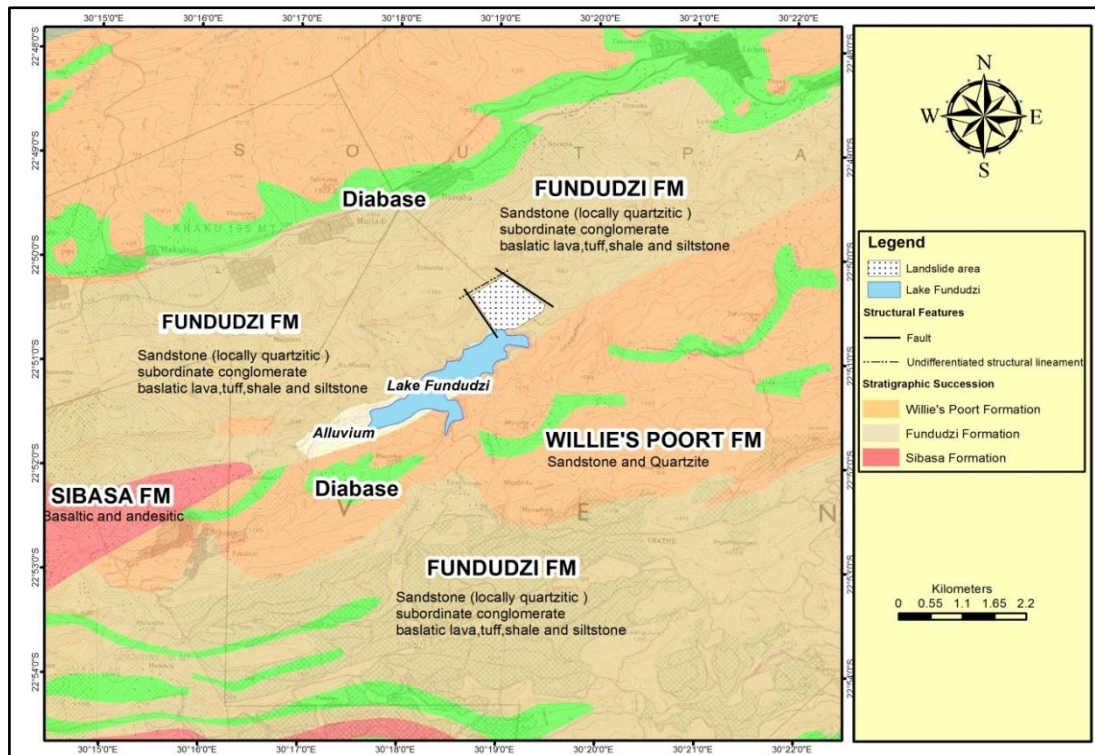
The geology in the vicinity of the site is characterised by sandstone which is quartzitic in places. The rock strata were named the Fundudzi Formation after the landslide lake. The 1:250 000 geological map describes the lithology of the Fundudzi Formation as sandstone and quartzitic in places, locally gritty or conglomerate with interbedded basaltic lava, tuff, shale, agglomerate and siltstone as shown in Figure 2.2 (Barker, 1976).

Figure 2.2: Local geological map of the Lake Fundudzi landslide area.

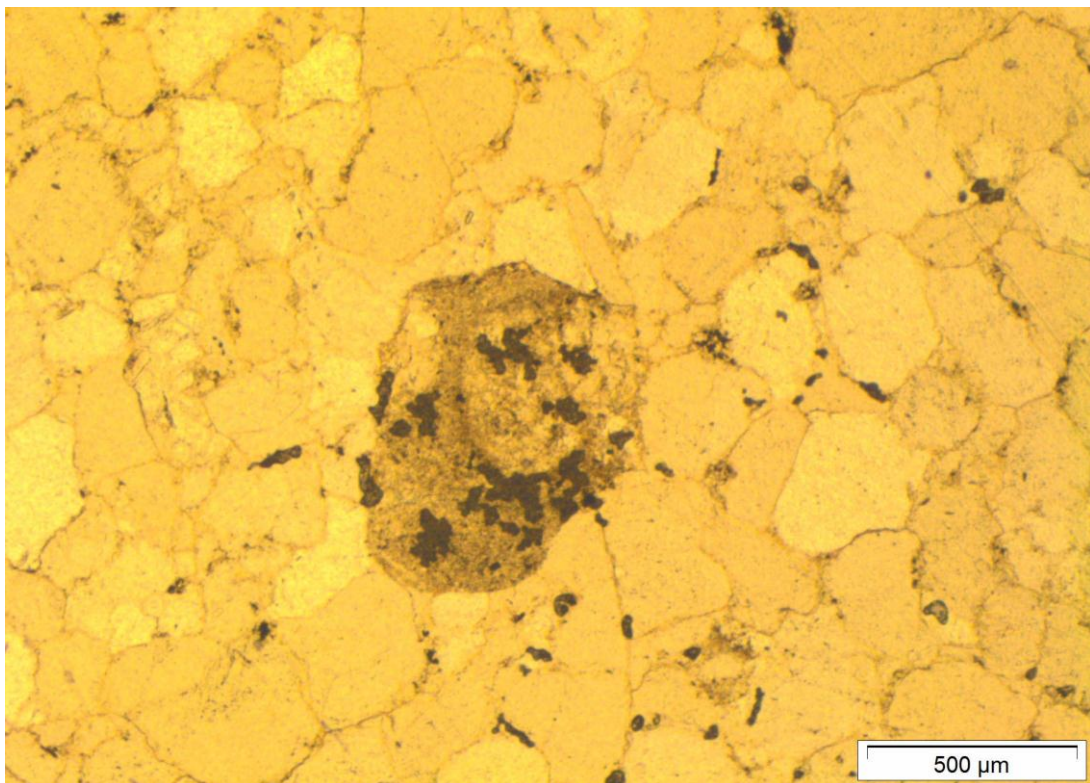
Evident from thin section (Figure 2.3) microscope analysis is that the sandstone is composed predominantly of quartz (+95%) and minor amounts of secondary carbonate minerals. Distinctly visibly also on stage rotation under crossed polarized light (Figure 2.4) is an undulatory extinction of quartz grains which indicates quartz minerals had undergone deformation. Grain to grain contact was evident and almost interlocking indicating recrystallization. The majority of these sediments also reflected in the increased sphericity (0.7 – 0.9) and roundness (0.5 – 0.9) of the mineral grain and in general the sorting is good. Quartz veins are also present. Silica cements around quartz grains forming very hard rock sandstone. The original shape of many of the quartz grains may have been reworked because they are well sorted and are basically of equal size.

Figure 2.3: Photomicrograph of sandstone under plane polarized light.

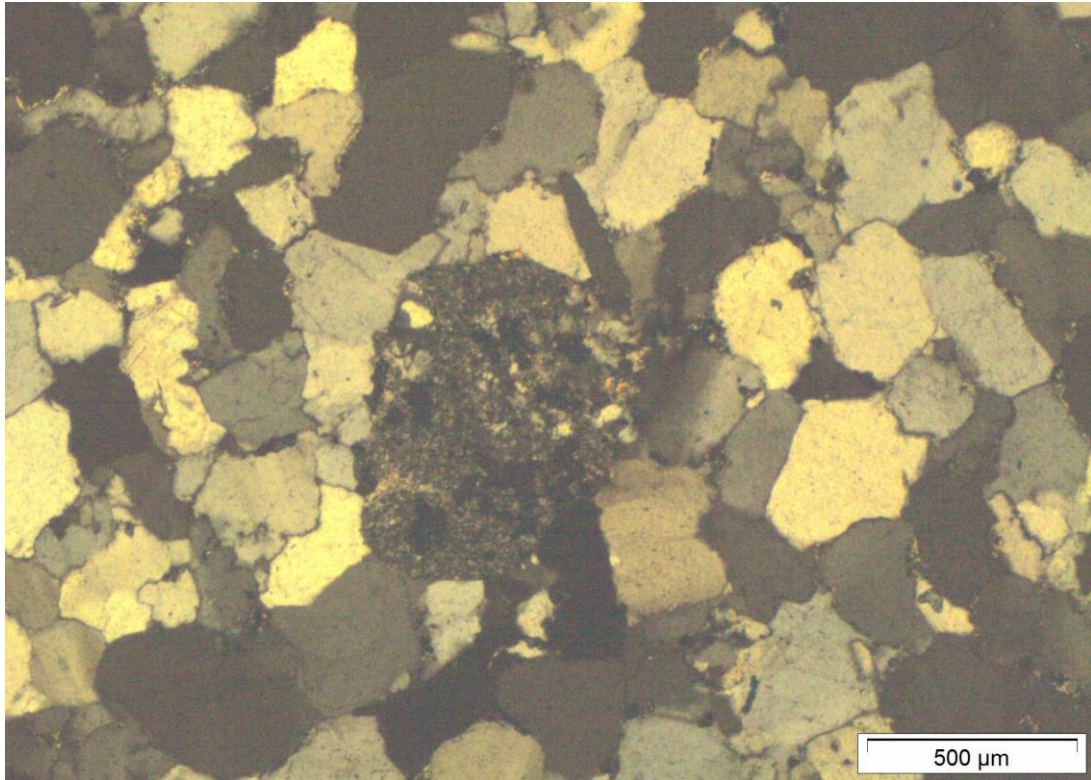
Figure 2.4: Photomicrograph of sandstone under crossed-polarized light.

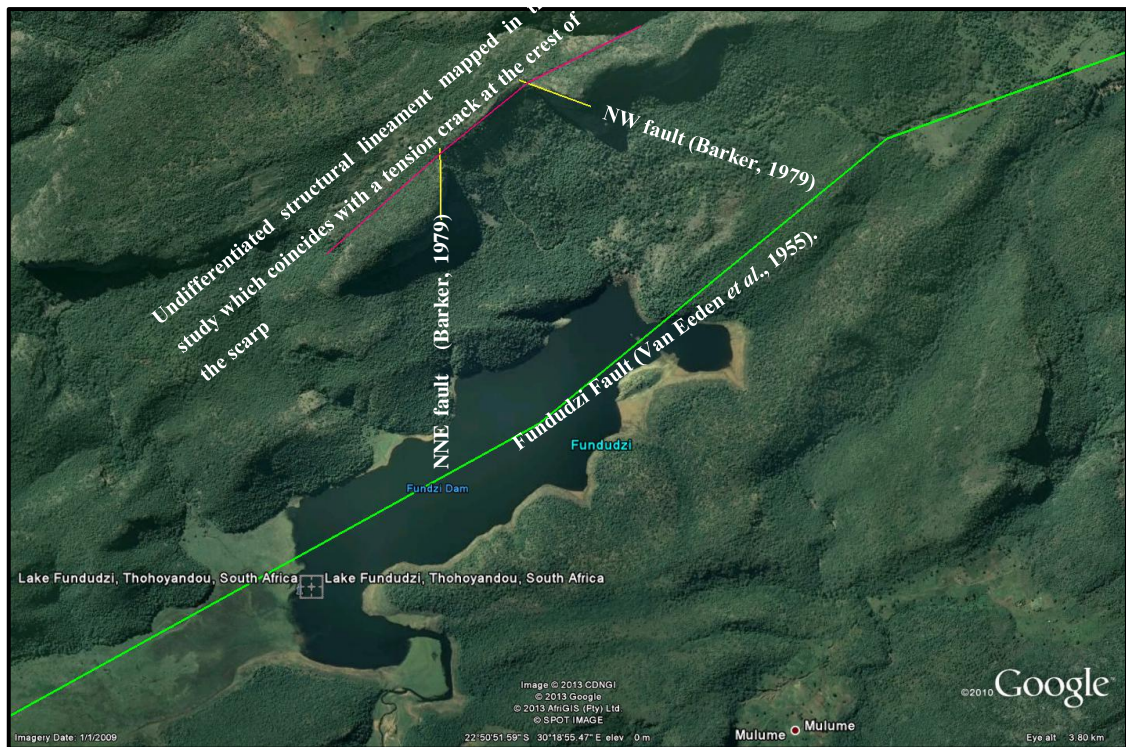
Barker (1979) mapped two NW-SE and SW-NE intersecting faults which form the failure release surfaces (or buttresses) also as shown in Figure 2.5. A lineament that was identified in this study from satellite imagery perusal is the one that coincides with the tension crack at the scarp of the landslide. This lineament extends far beyond either of the release surfaces for over 500 m from each release surface side. Several minor rock slides and falls are still active and noticeable on each of the release surfaces, and were also noted by Janisch (1931). A 23 m deep vertical tension crack was also observed at the crest of the failure plane.

Figure 2.5: A Google Earth® satellite imagery showing major structural features in the vicinity of the site.

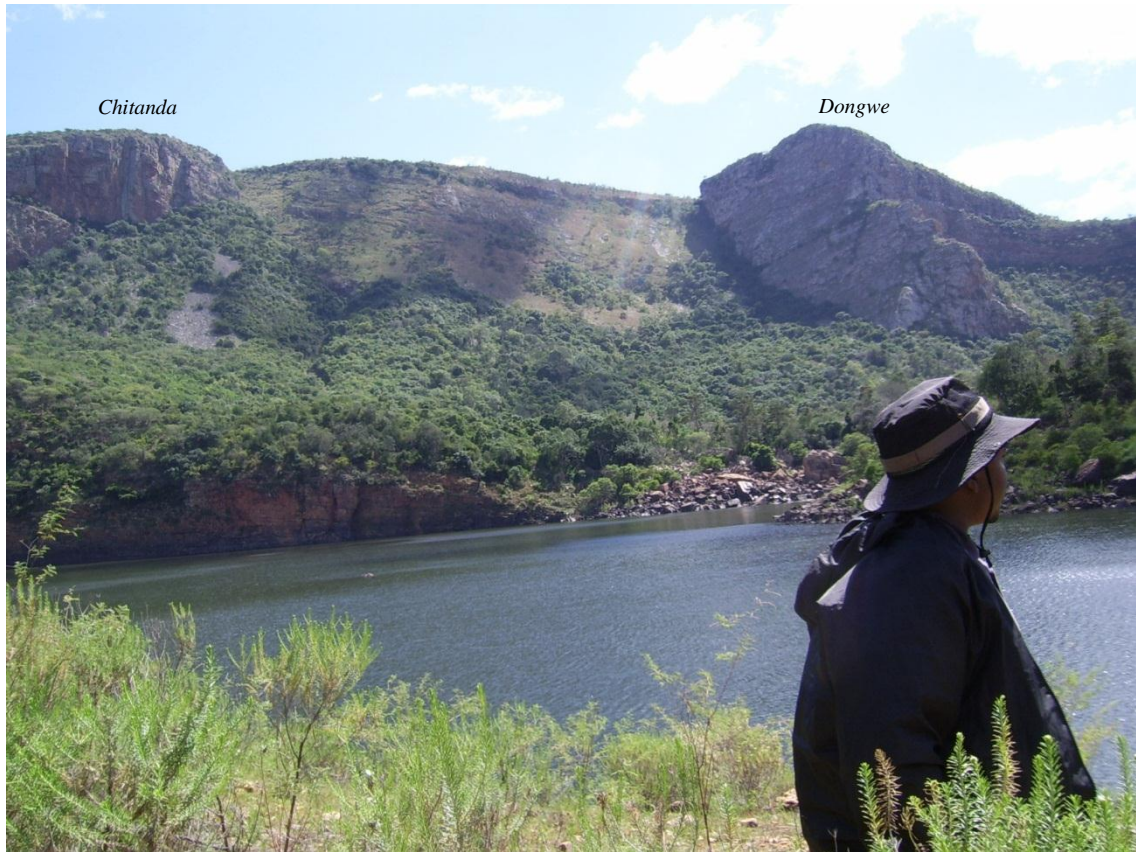
Figure 2.6: A view of the landslide failure surface from the southern shore of the lake showing northward dipping beds of the rock mass.

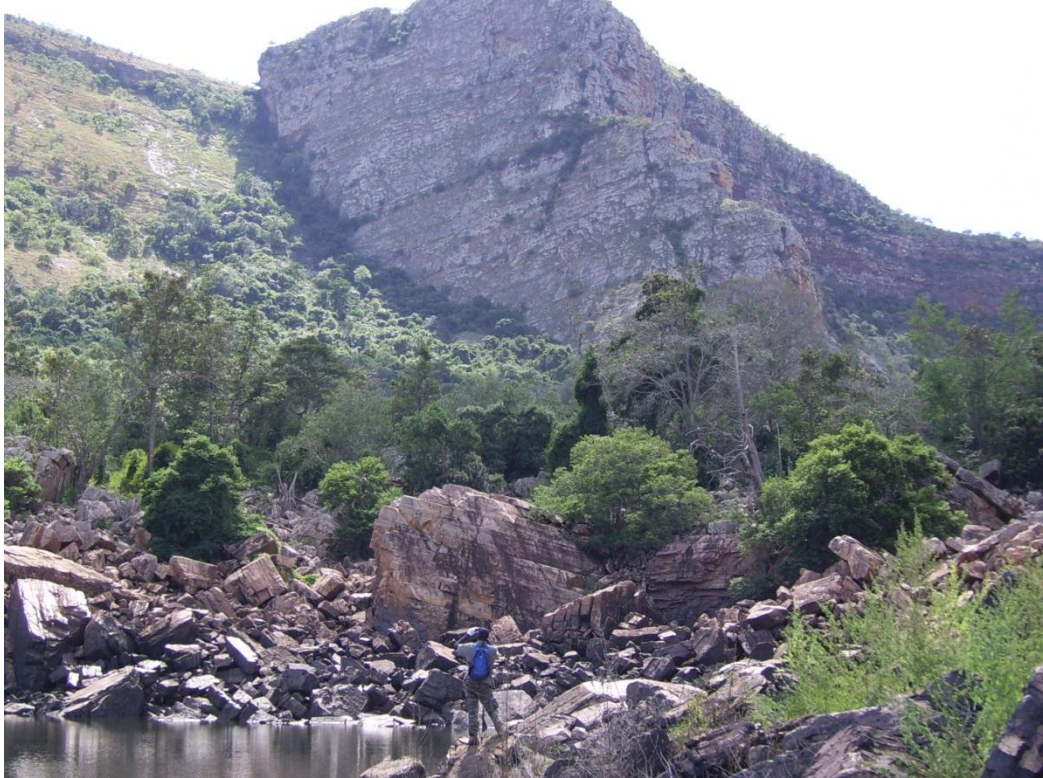
Figure 2.8: A view of a mass of rock debris blocking the Mutale River.

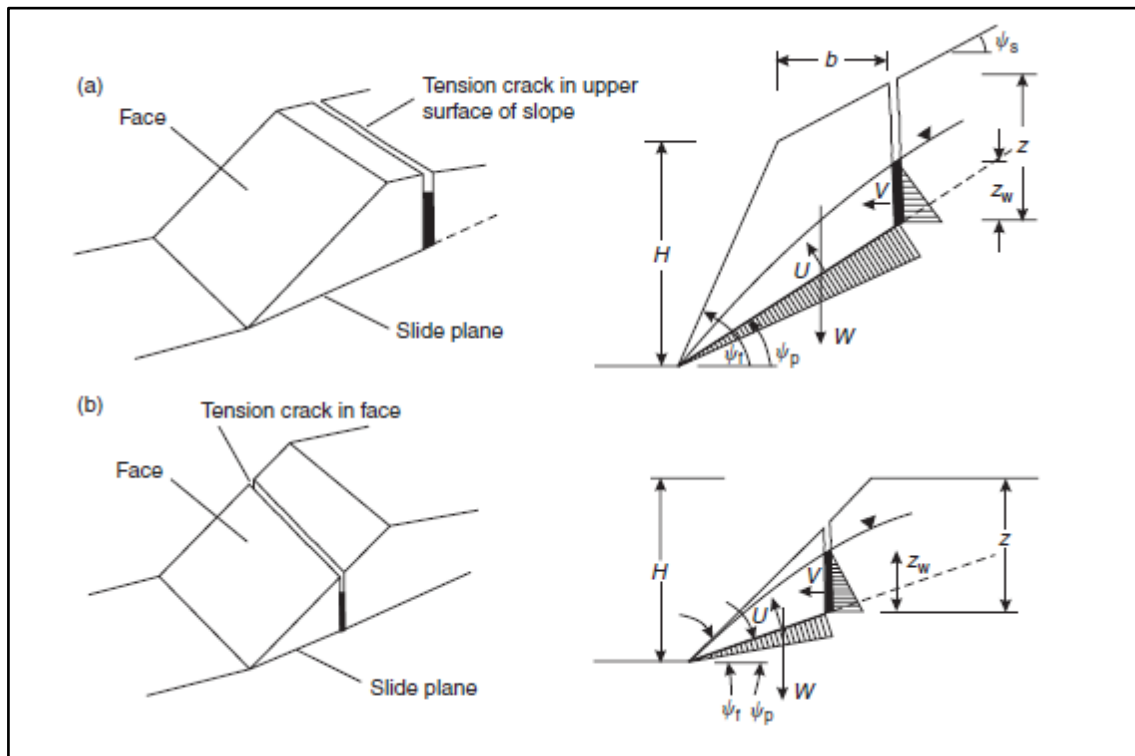
- a) a slope having a tension crack in its upper surface (Figure 3.3a), and
- b) a slope with a tension crack in its face (Figure 3.3b).

Figure 3.3: Geometries of plane slope failure: (a) tension crack in the upper slope; (b) tension crack in the face (after Willie and Mah, 2005).

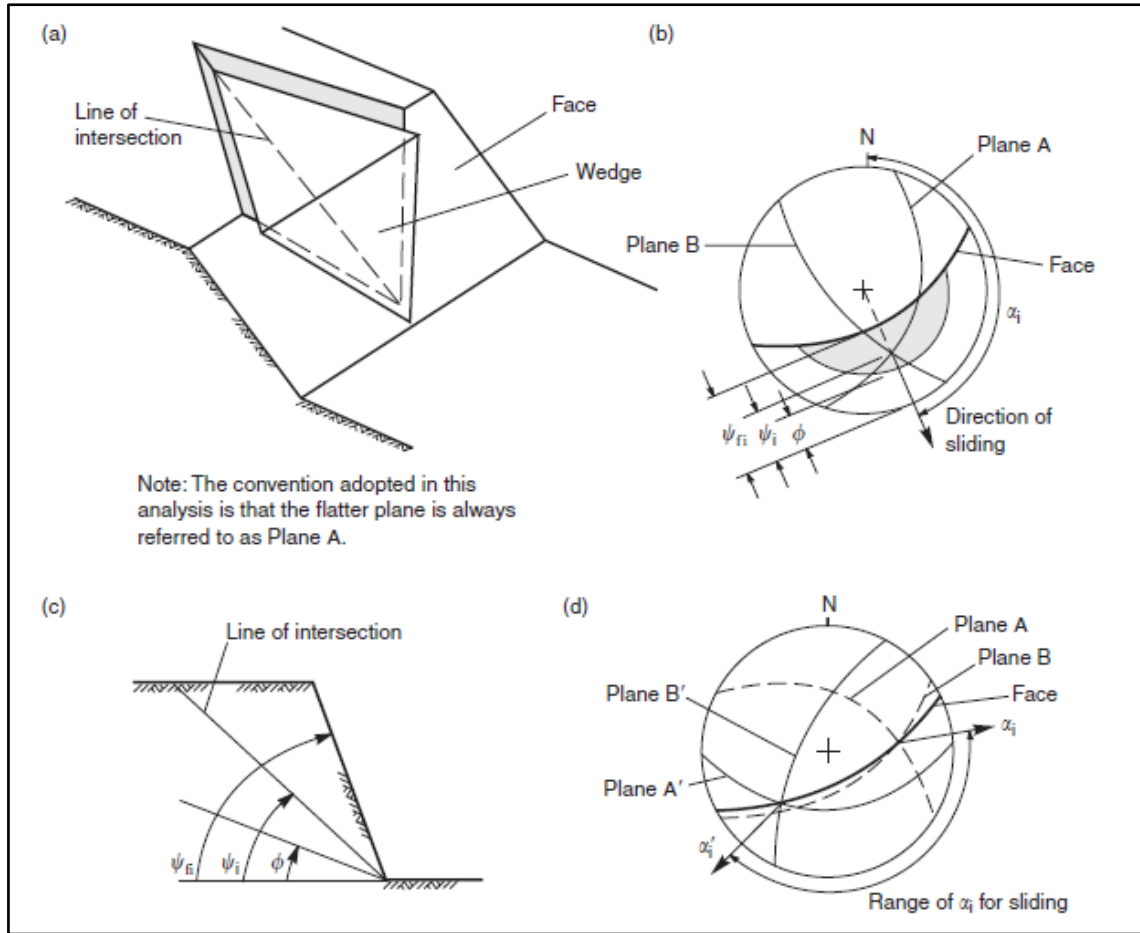
Figure 3.4 depicts wedge failure geometry and the basic mechanics of sliding. The flatter of the two planes is called Plane A while the steeper plane is called Plane B.

Figure 3.4: Wedge failure geometry (after Willie and Mah, 2005).

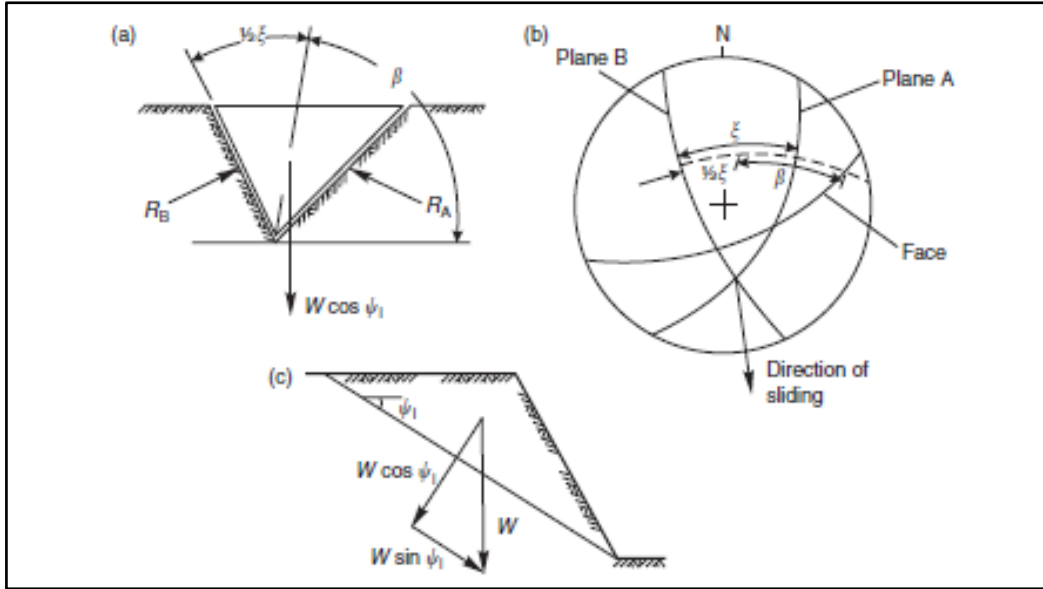
Figure 3.5: Resolution of forces to calculate factor of safety for wedge: (a) view of wedge looking at face showing definition of angles β and ξ , and reactions on sliding planes R_A and R_B ; (b) stereonet showing measurement of angles β and ξ ; (c) cross-section of wedge showing resolution of wedge weight W (after Willie and Mah, 2005).

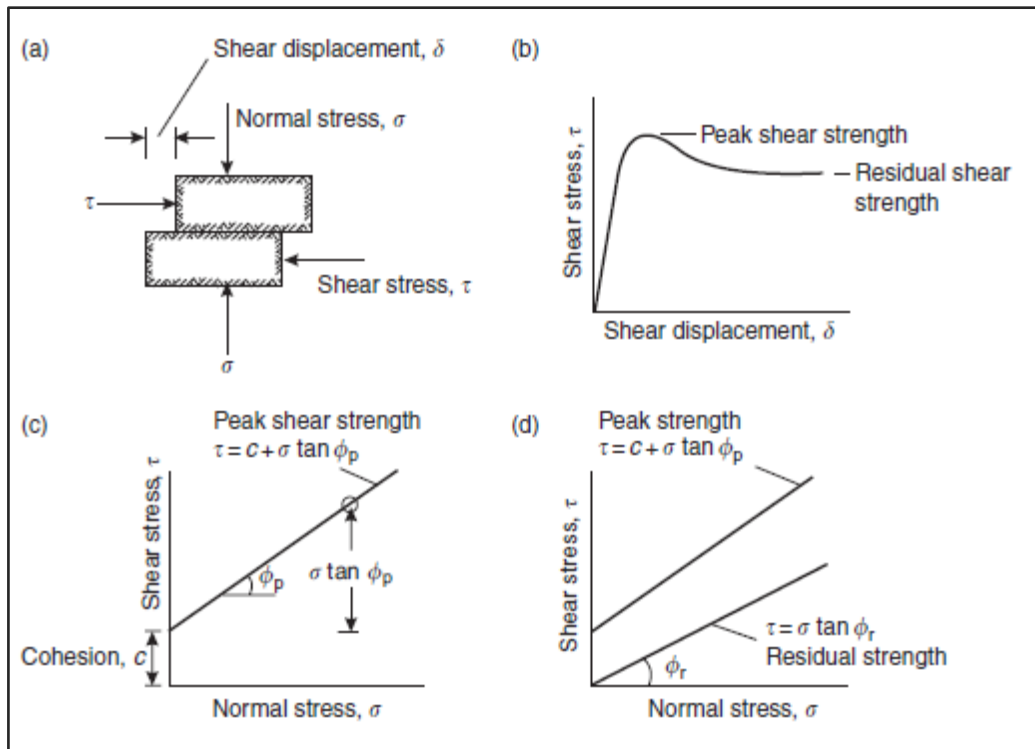
If the peak shear strength values from tests carried out at different normal stress levels are plotted, a relationship shown in Figure 3.6(c) is obtained; this is termed a Mohr diagram (Mohr, 1900). When the residual shear stress values at each applied normal stress are plotted on the Mohr diagram, the residual shear strength line is obtained as shown on Figure 3.6(d) (Willie and Mah, 2005)

Figure 3.6: Definition of shear strength of discontinuity surface; (a) shear test of discontinuity; (b) plot of shear displacement vs shear stress; (c) Mohr plot of peak strength; (d) Mohr plot of peak and residual strength (after Willie and Mah, 2005).

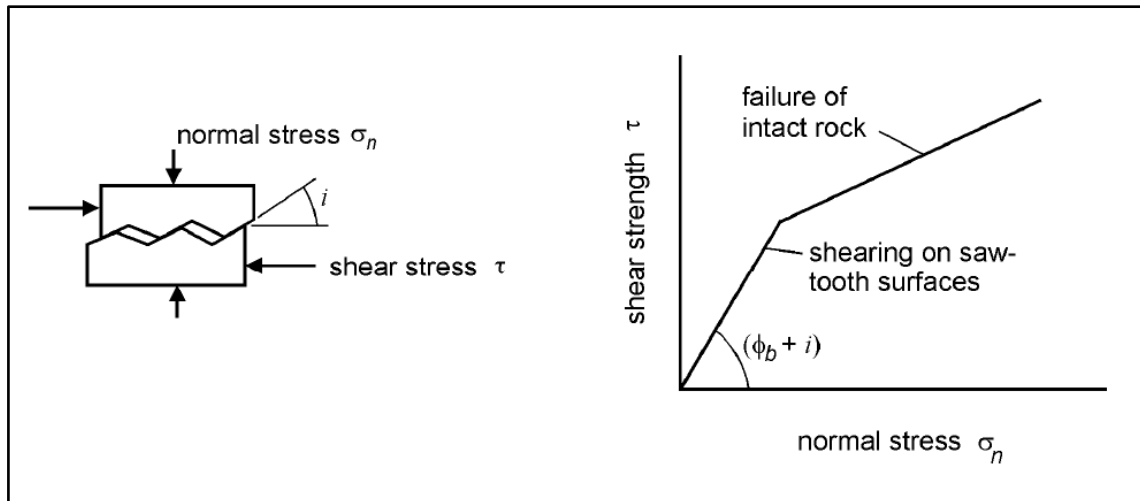
Figure 3.7: Patton's experiment on the shear strength of saw-tooth specimens (after Hoek, 2007).

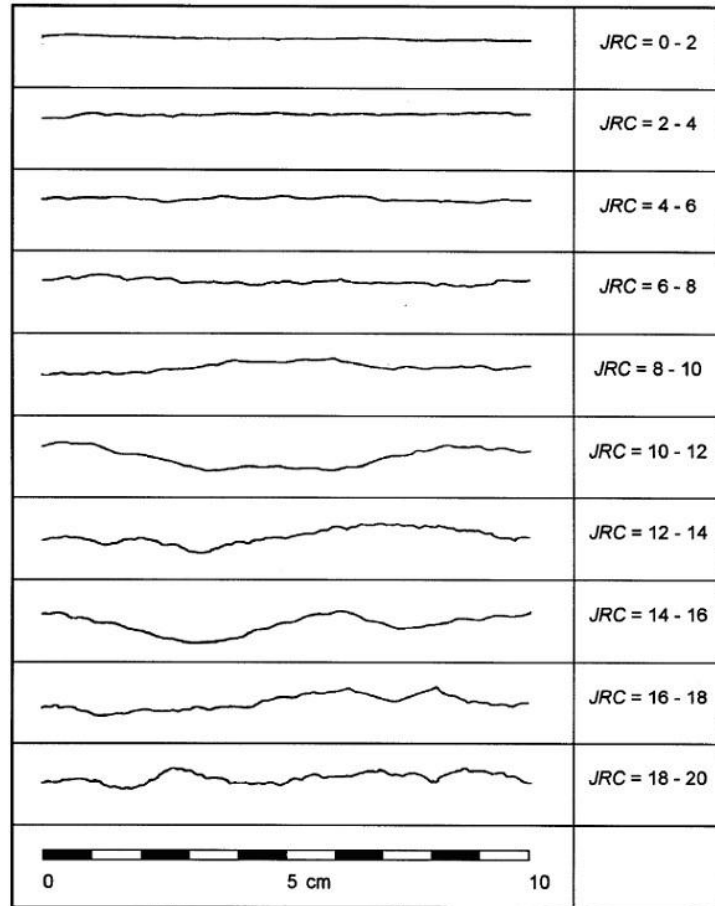
Figure 3.8: The ten joint roughness profiles showing the typical range of JRC (after Barton and Choubey, 1977).

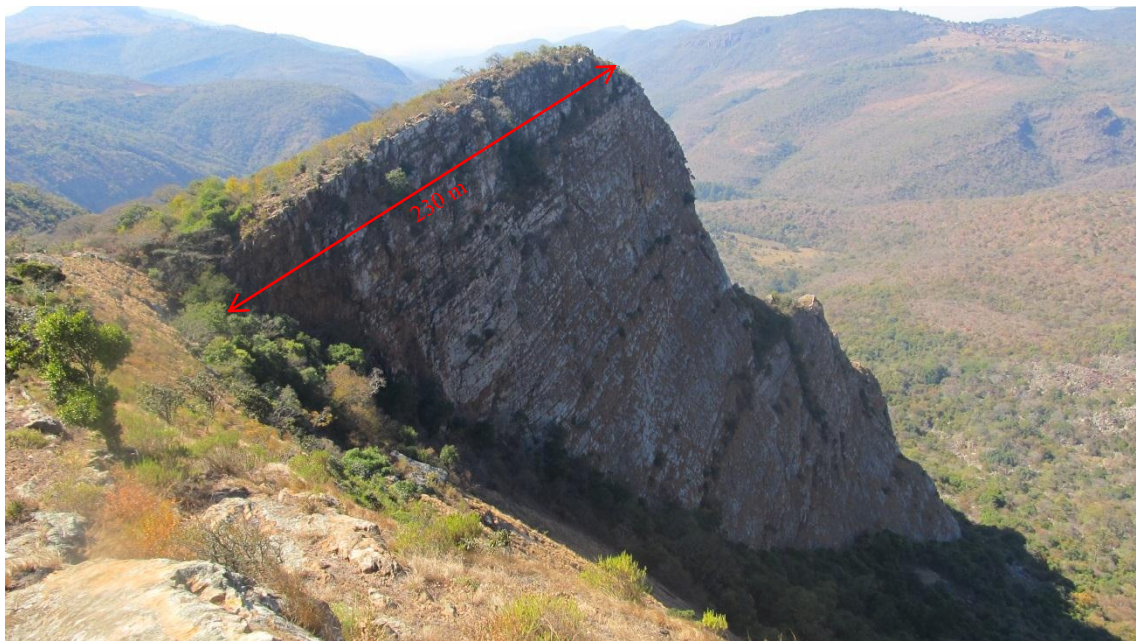
The landslide which piled up its largest blocks against the highest part of the spur consists of great angular blocks of sandstone, many of them exceeding 7 m in diameter, lying randomly and naturally with great spaces between them, so that climbing is extremely difficult. The landslide has obviously come from the northern mountain side where a great block of rock has slipped from between two high buttresses (release surfaces) which are about 500 m apart. The scar (failure surface) extends back for about 230 m from the faces of very steep buttresses, leaving a bare and steep rock slope above the accumulation of rock debris (Figure 3.9).

Figure 3.9: An illustration of a failure surface which extends back for about 230 m from the face of very steep eastern buttress or release surface (Dongwe). This photo was taken halfway between the shown buttress and the western buttress (Chitanda) not shown here which is at the back of the photographer.

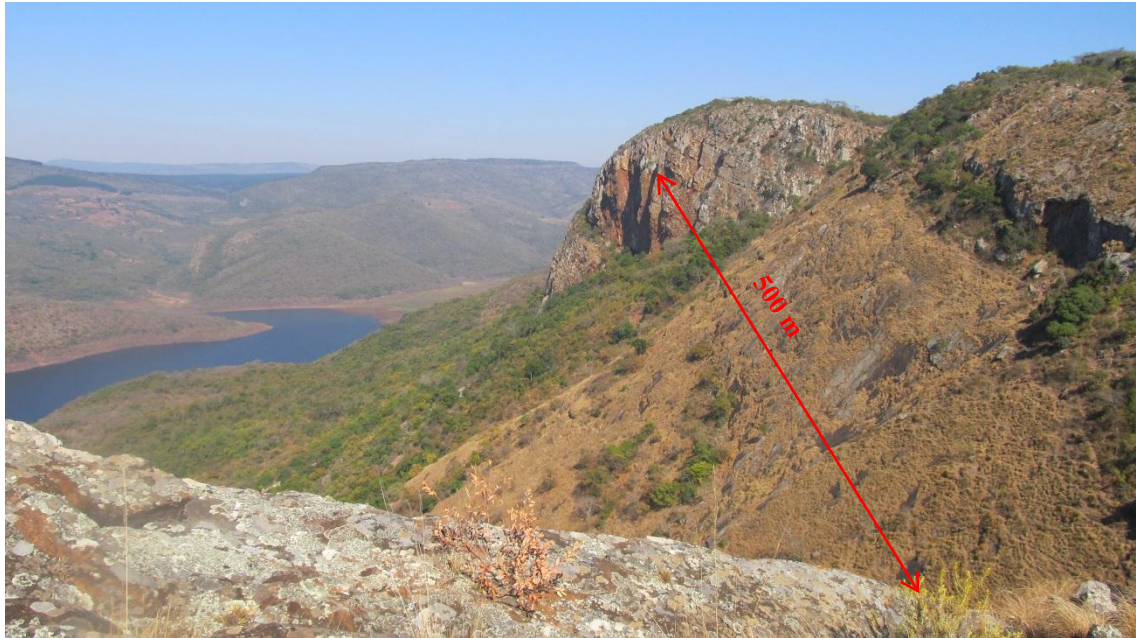
Figure 3.10: An illustration of a failure surface and the distance between the two buttresses. This photo was taken from Dongwe buttress facing in the direction of the western buttress (Chitanda).

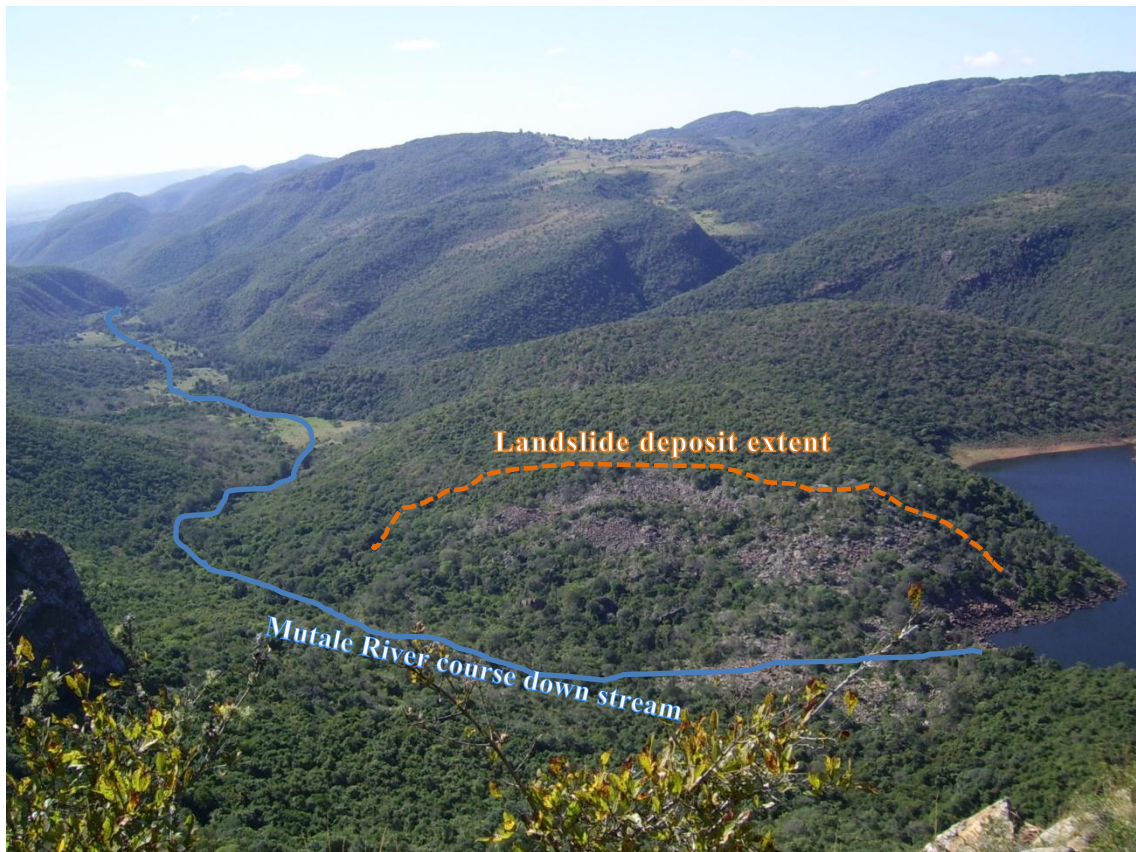
Figure 3.11: Extent of landslide deposit across the valley floor.

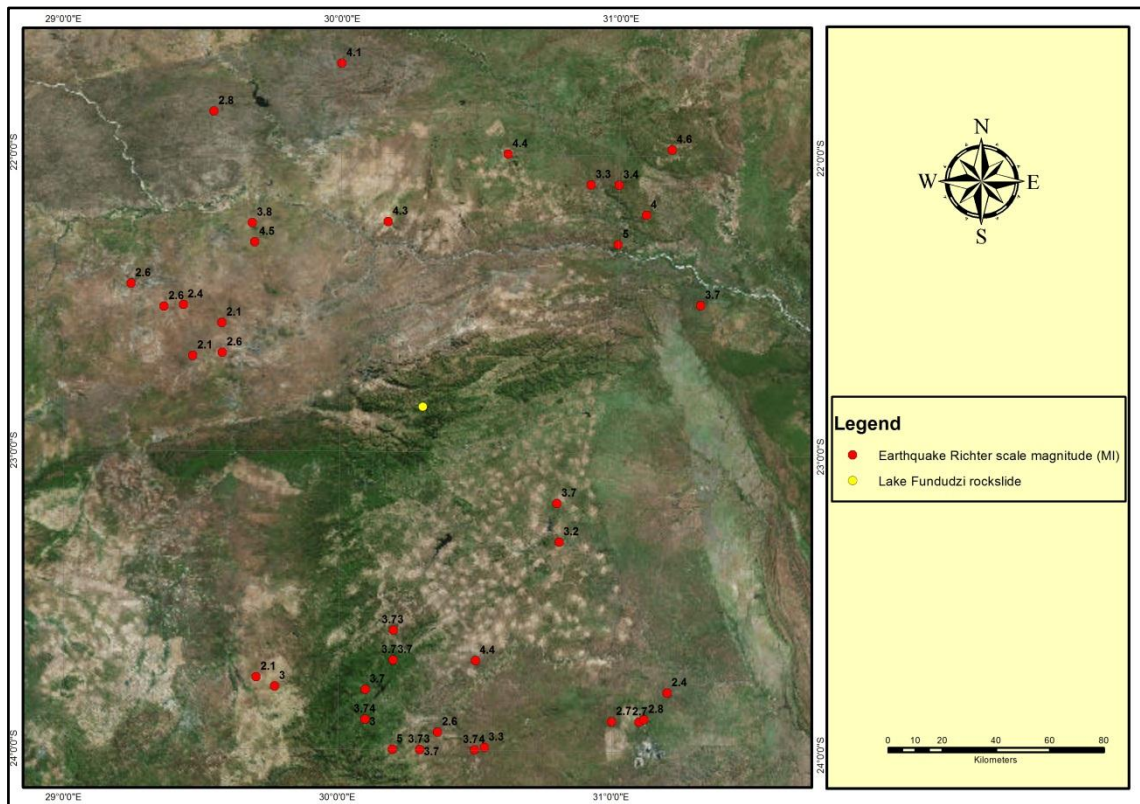
Figure 3.12a: Spatial distribution of historical earthquake magnitudes (MI) within 150 km of Lake Fundudzi rockslide.

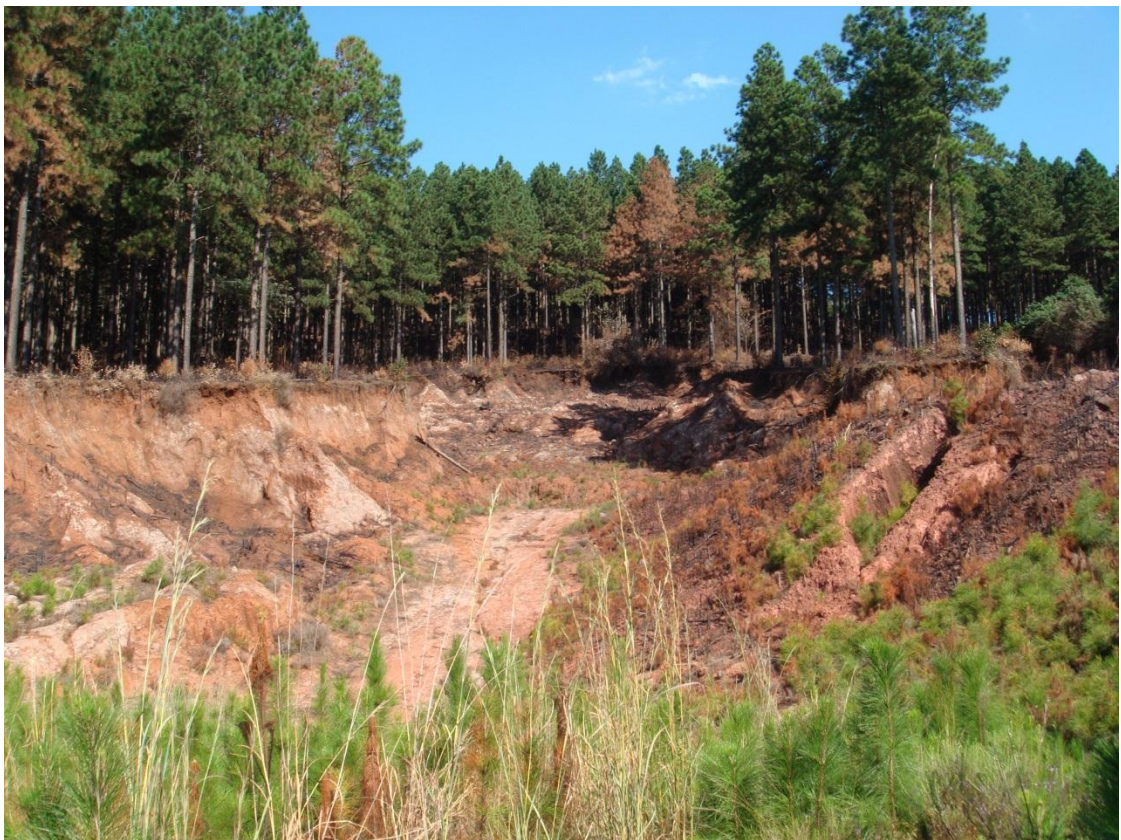
Figure 3.14: Forestry plantation land removed by an earth flow landslide triggered by the 2000 heavy rainfall in the region.

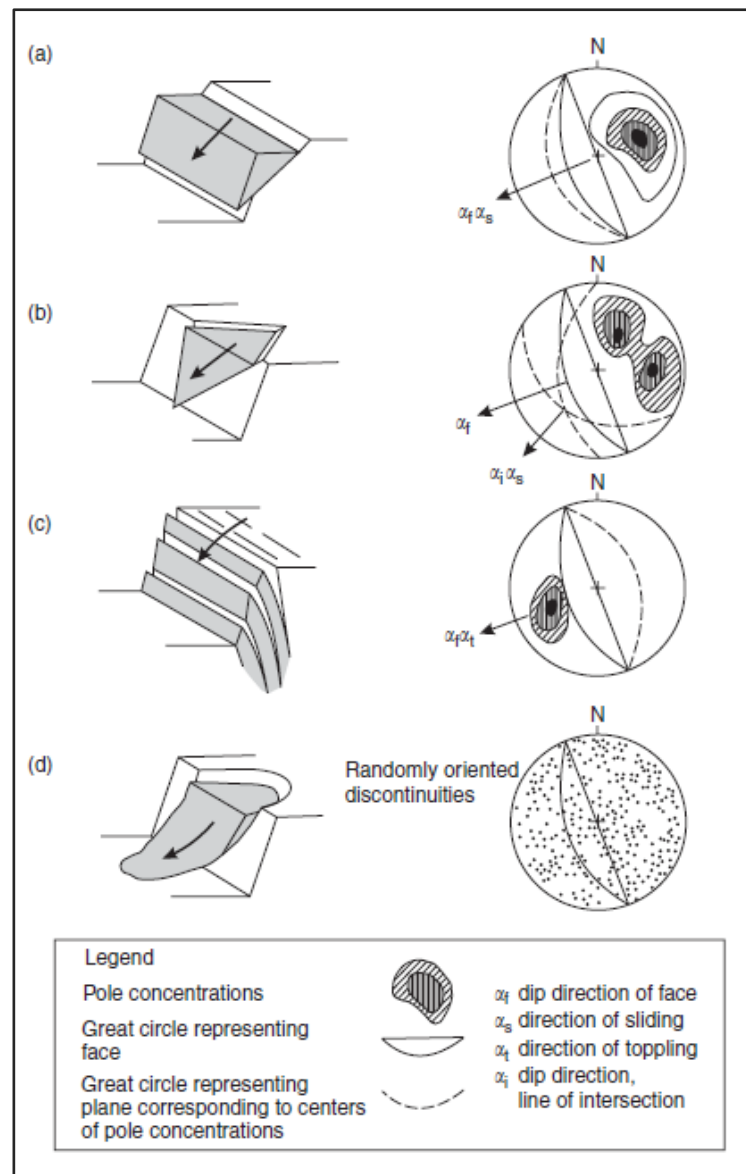
Kinematic analysis for the four modes of rock slope failures is based on Markland's test which is described in Hoek and Bray (1981). These are summarized in Figure 4.1.

Figure 4.1: Modes of rock slope failure and stereo plots of structural conditions (after Hoek and Bray, 1981).

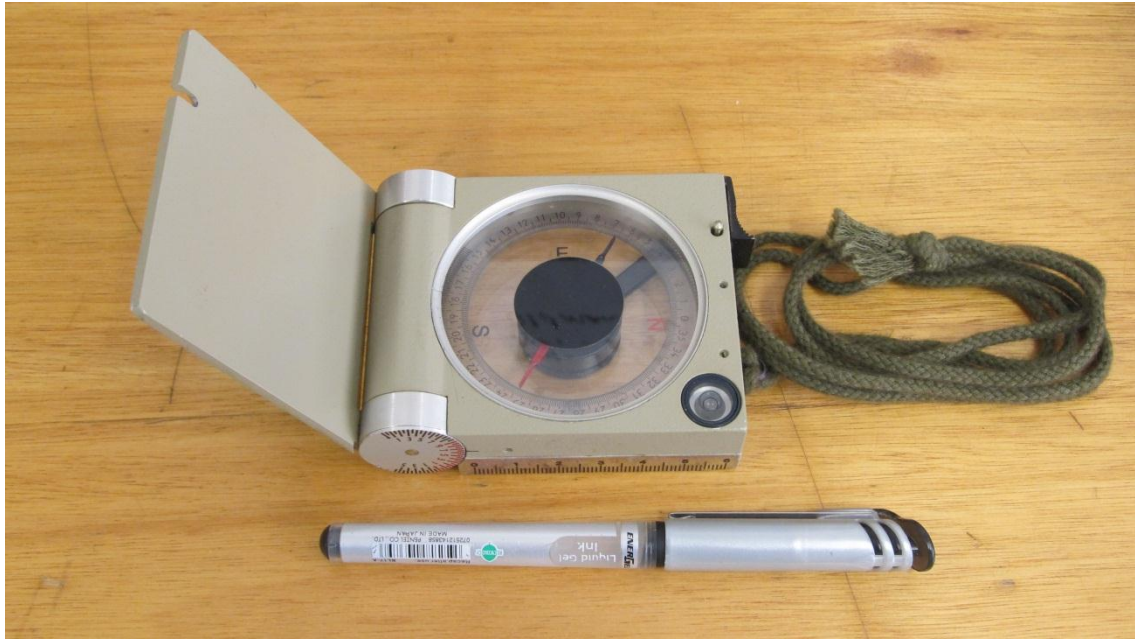
Figure 5.1: A Clar type geological compass used for the discontinuity survey conducted.

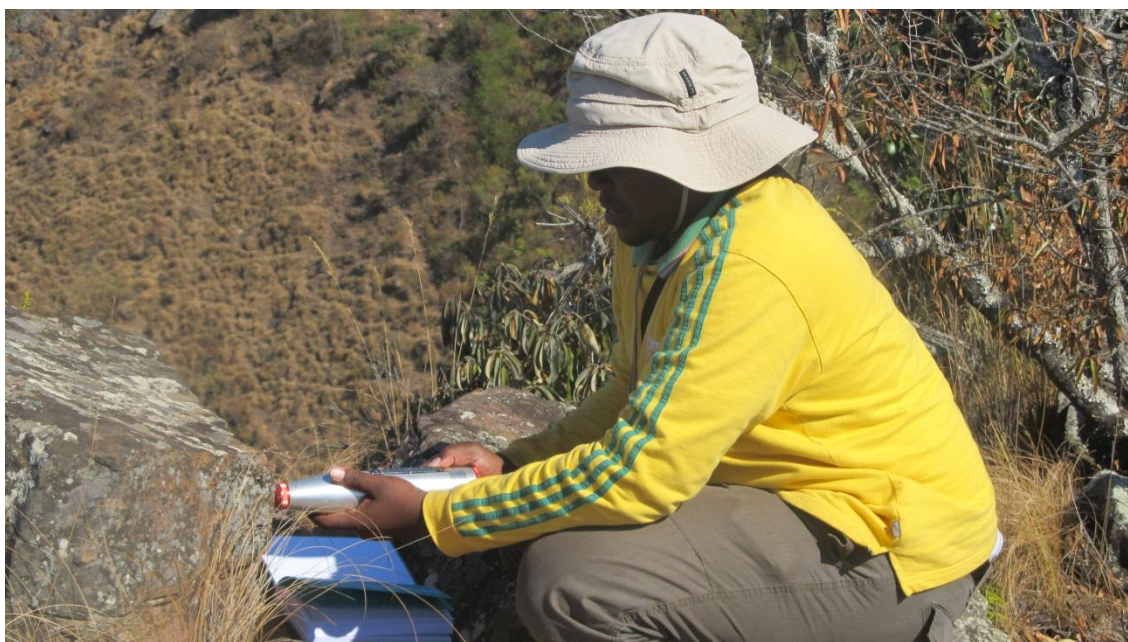
Figure 5.2: Schmidt Hammer Rebound tests as carried out on site.

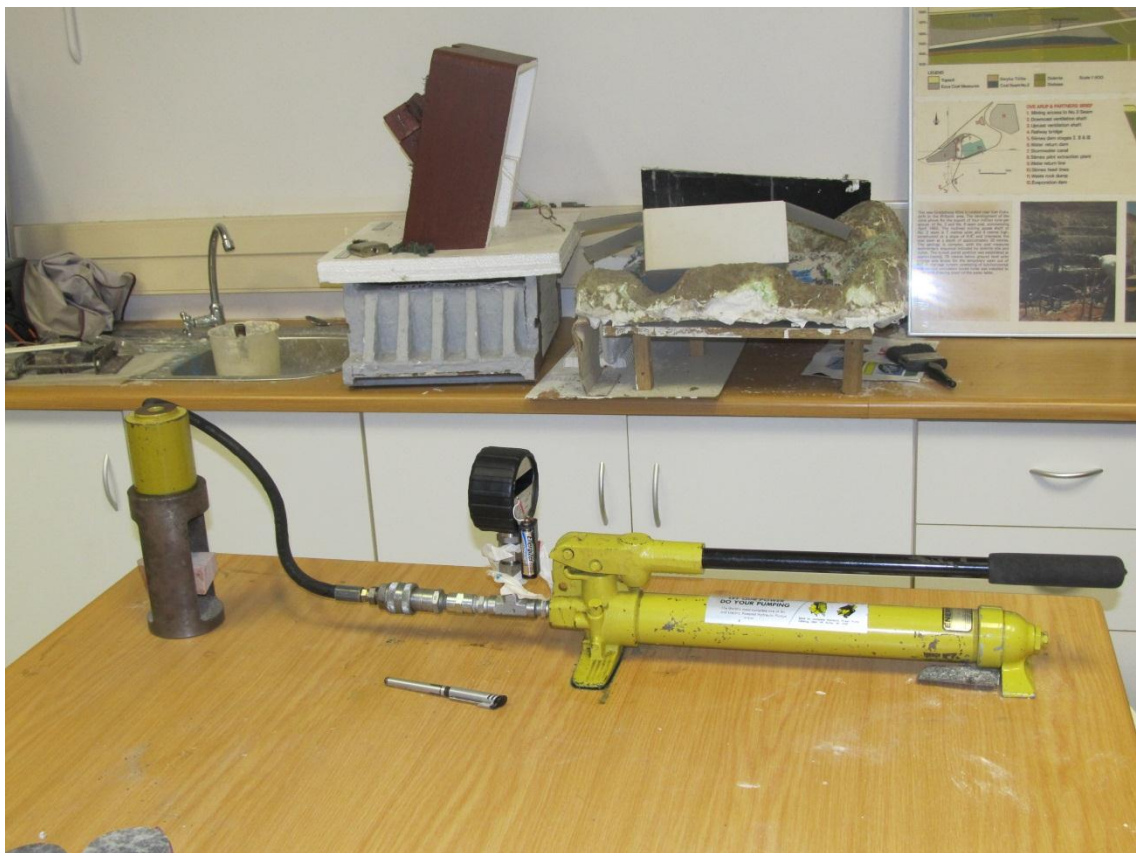
Figure 5.4: An illustration of the point load testing apparatus.

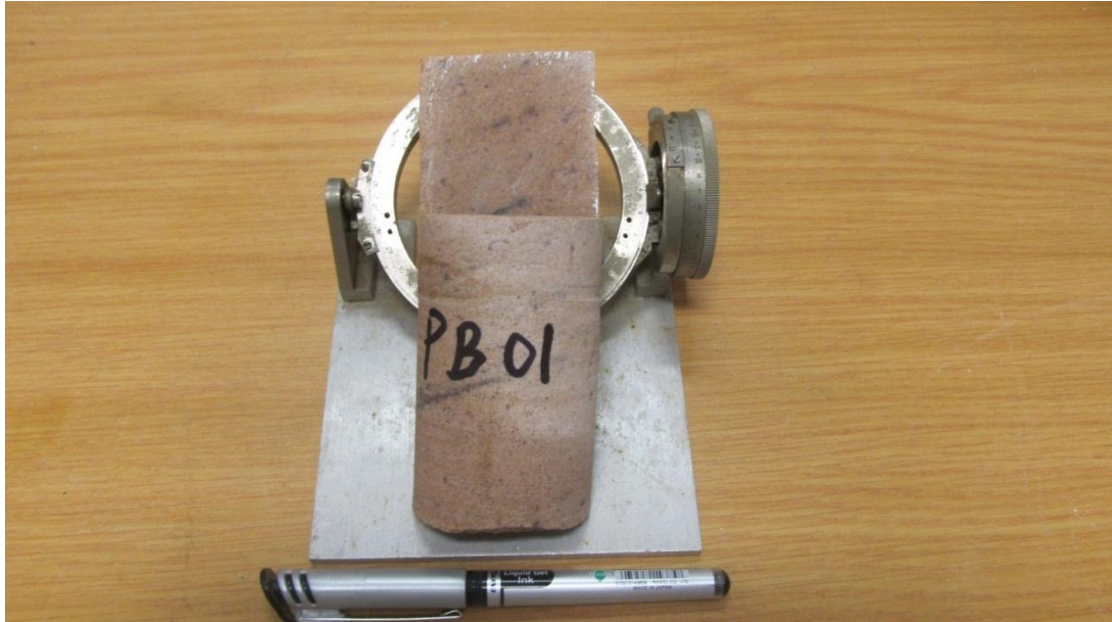
Figure 5.5: Tilting devise for the determination of ϕ_b .

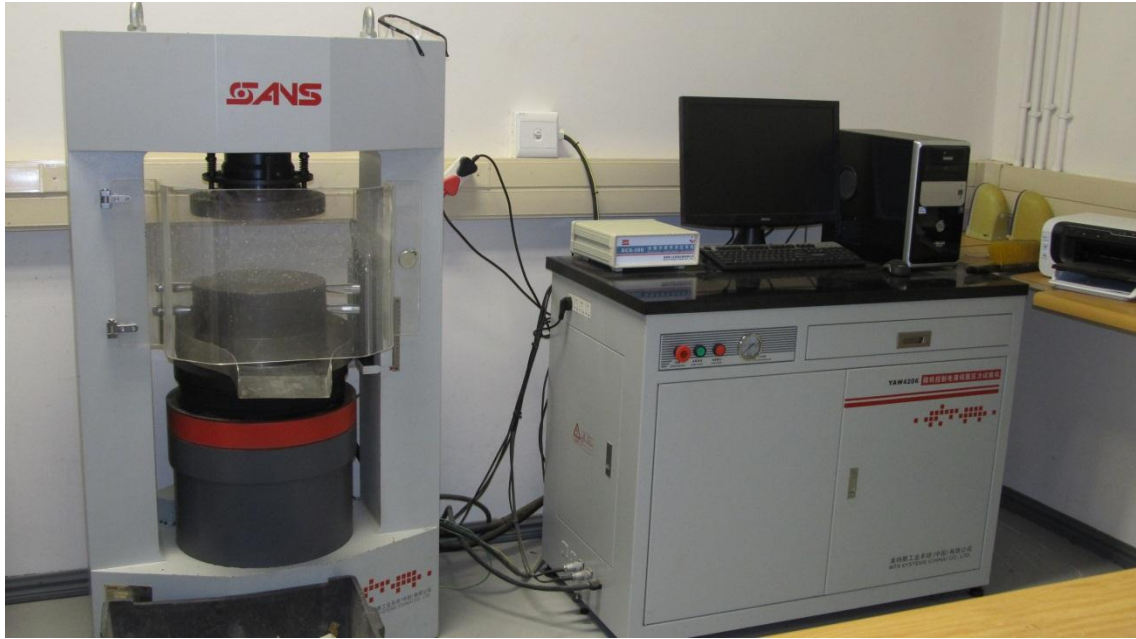
Figure 5.6: The UCS testing machine used at the University of KwaZulu-Natal.

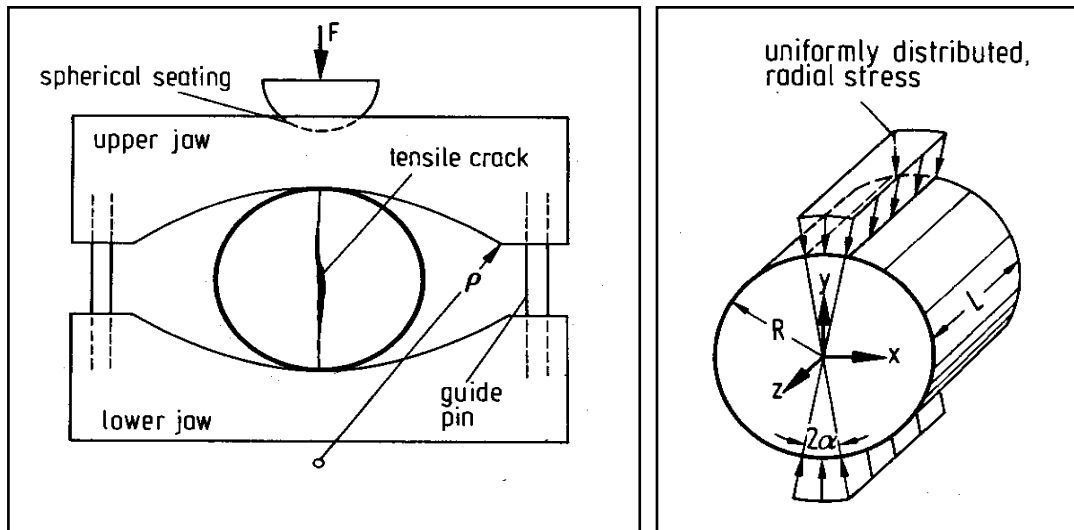
Figure 5.8: Principle of the Brazilian testing arrangement and apparatus and nature of failure (after Wittke, 1990).

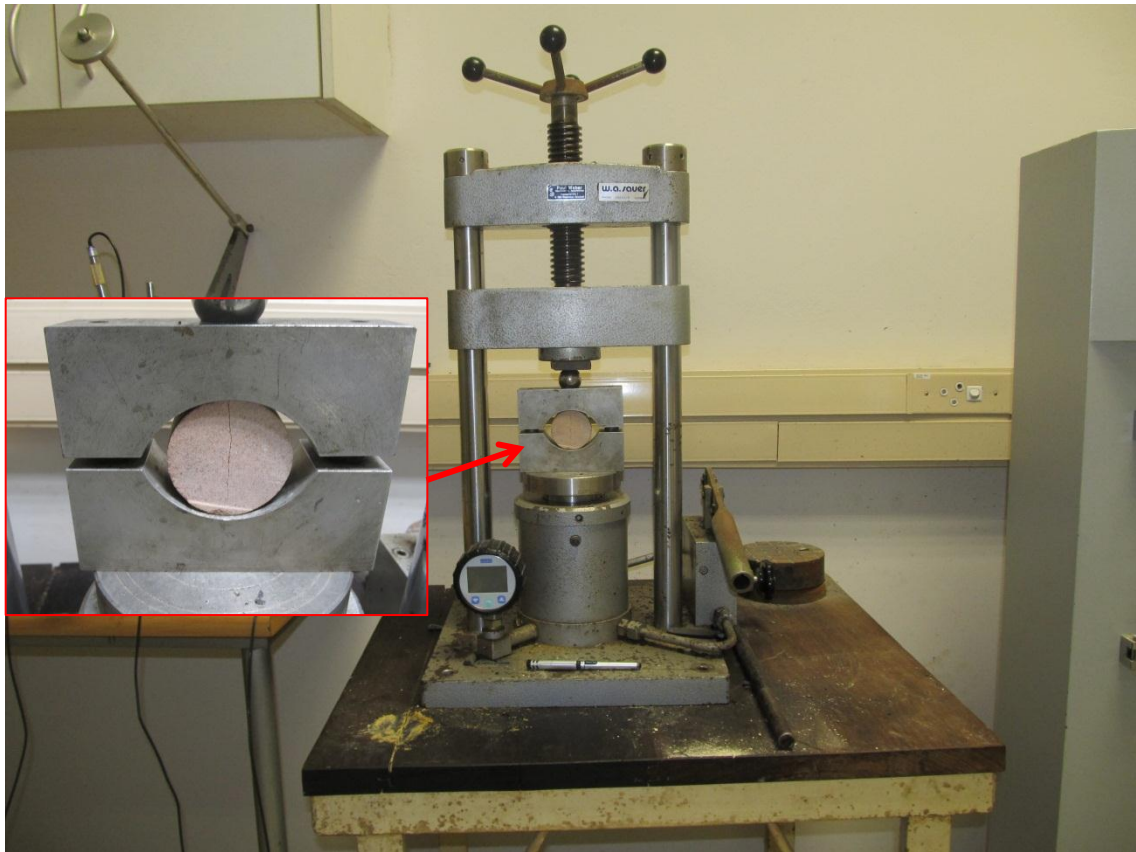
Figure 5.9: Laboratory set up for the Brazilian indirect tensile strength test.
