UNIVERSITY OF KWAZULU-NATAL

**BACK ANALYSIS OF AN ANCIENT ROCKSLIDE AT LAKE FUNDUDZI, LIMPOPO
PROVINCE, SOUTH AFRICA**

A dissertation submitted in fulfilment of the requirements for the degree of
Master of Science (MSc) in Environmental and Engineering Geology

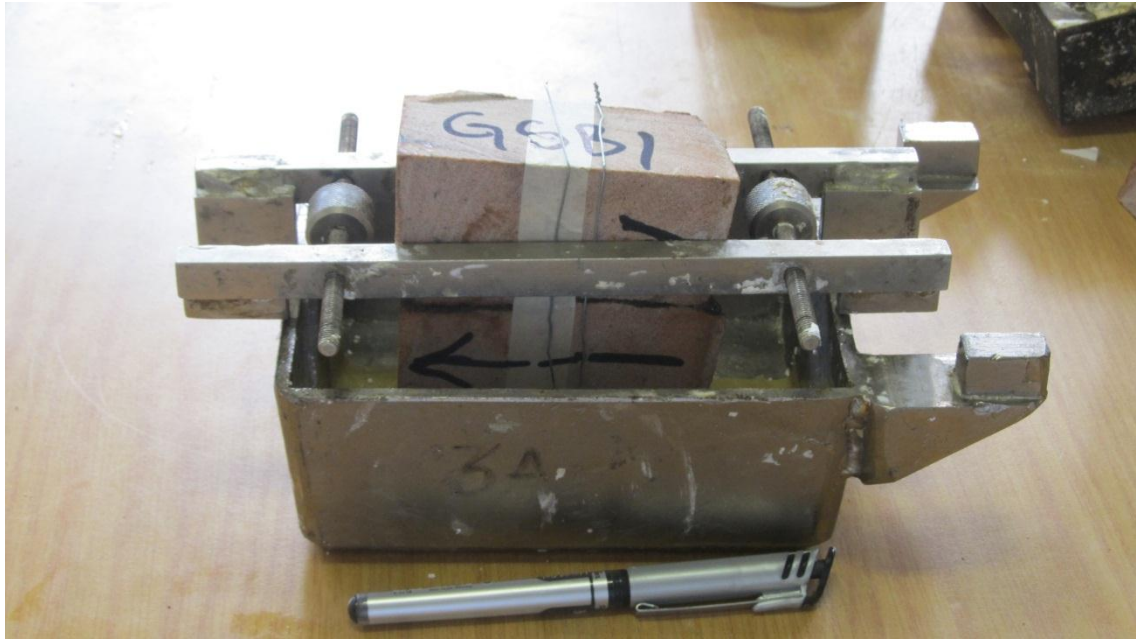
Figure 5.10: Casting position with clamp holding the joint sample.

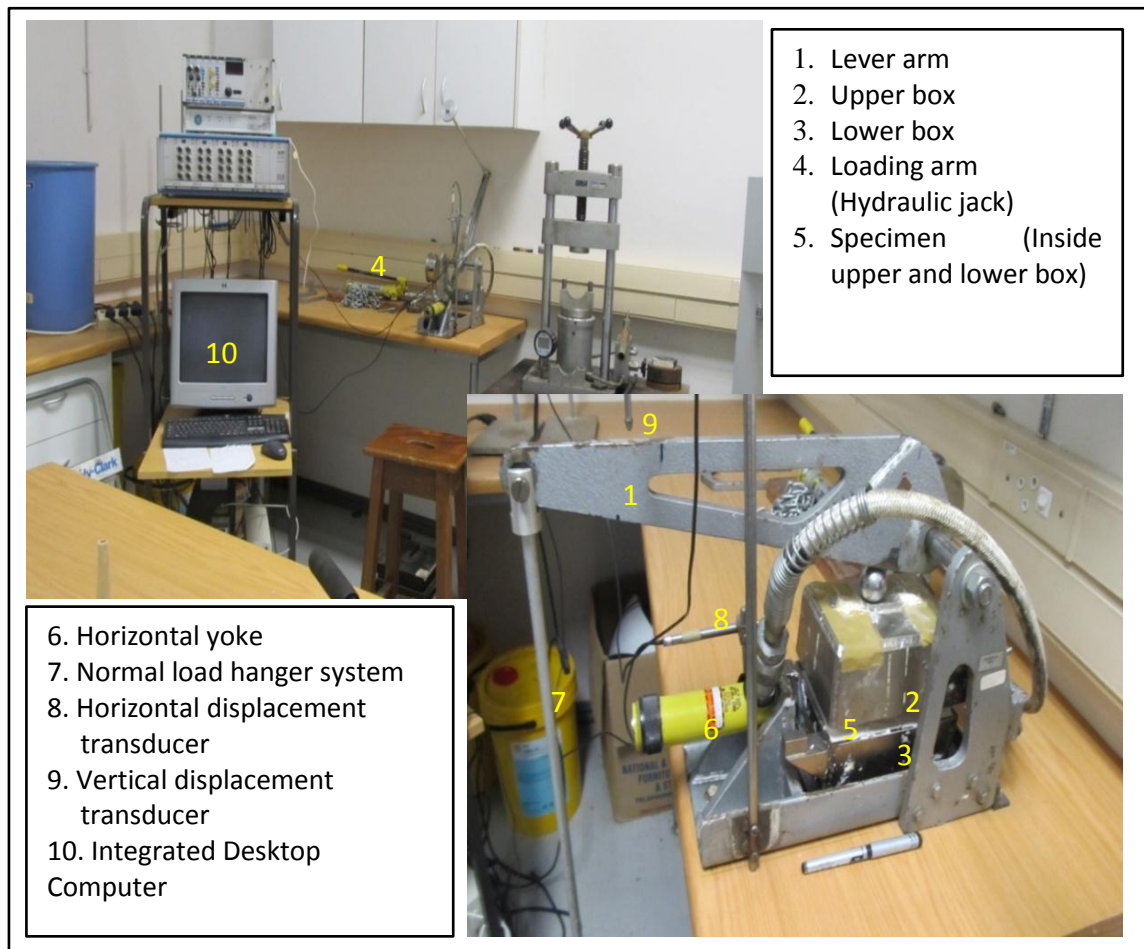
Figure 5.12: A Golder shear box machine set up.

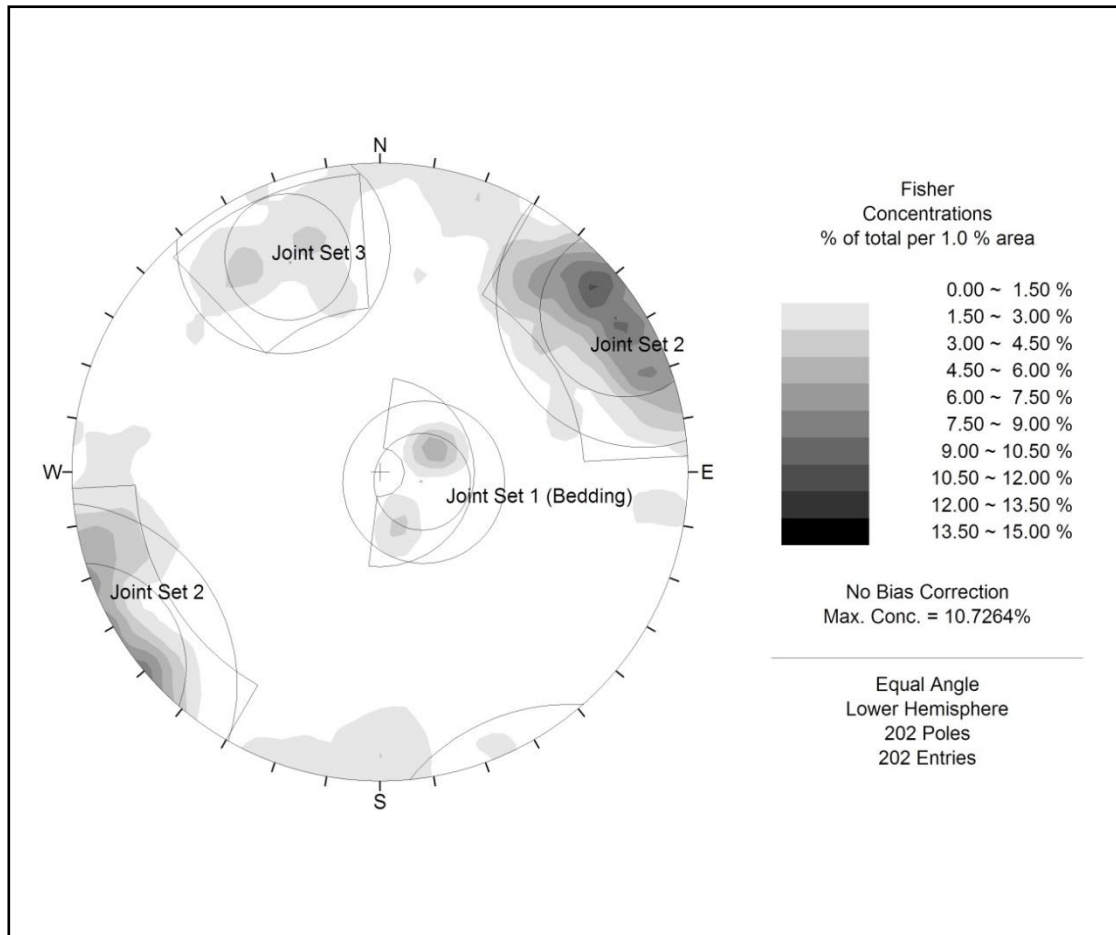
Figure 6.2: Stereoplot showing the contoured plot of the poles and the three joint sets.

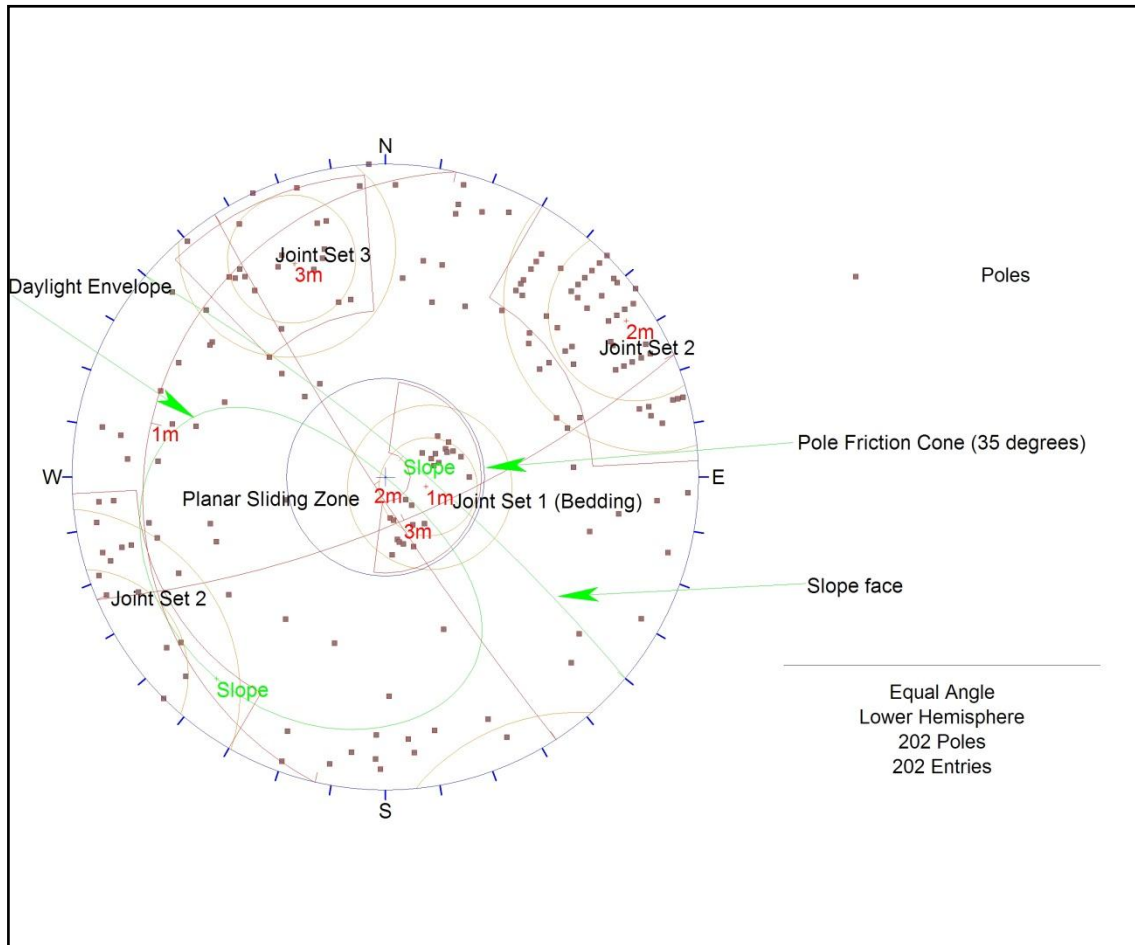
Figure 6.3: Stereonet plot showing analysis of plane failure using daylight envelope and friction cone.

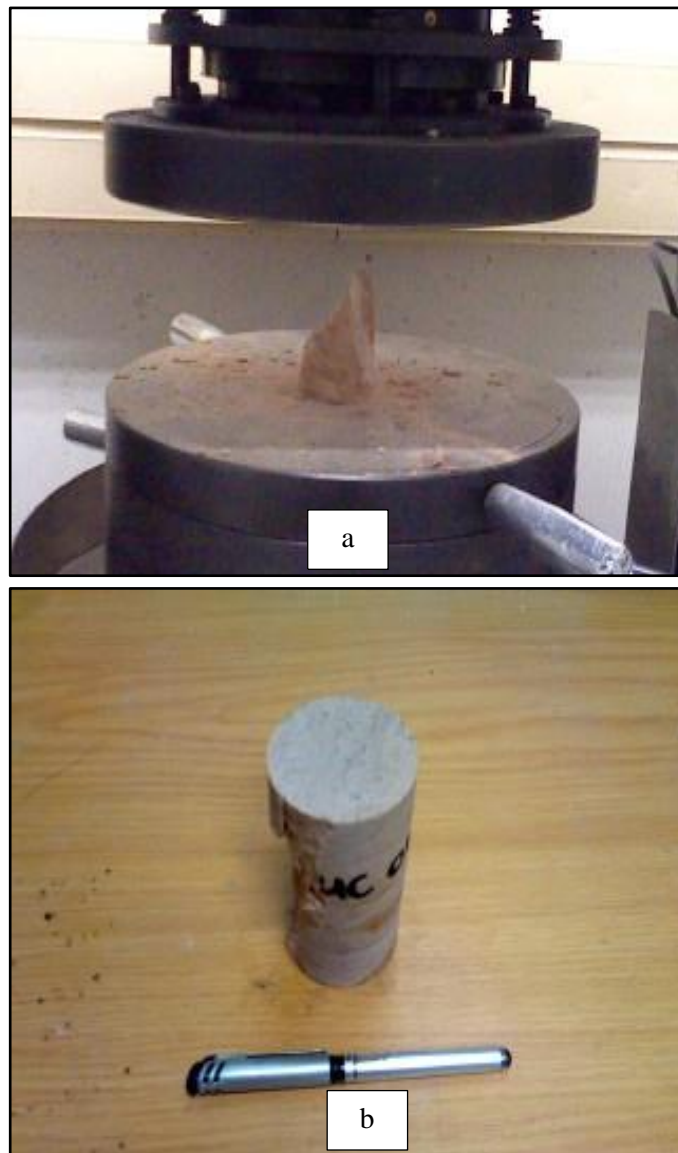
Figure 6.4: Conical and axial splitting failure patterns (a, and b respectively) from UCS testing.

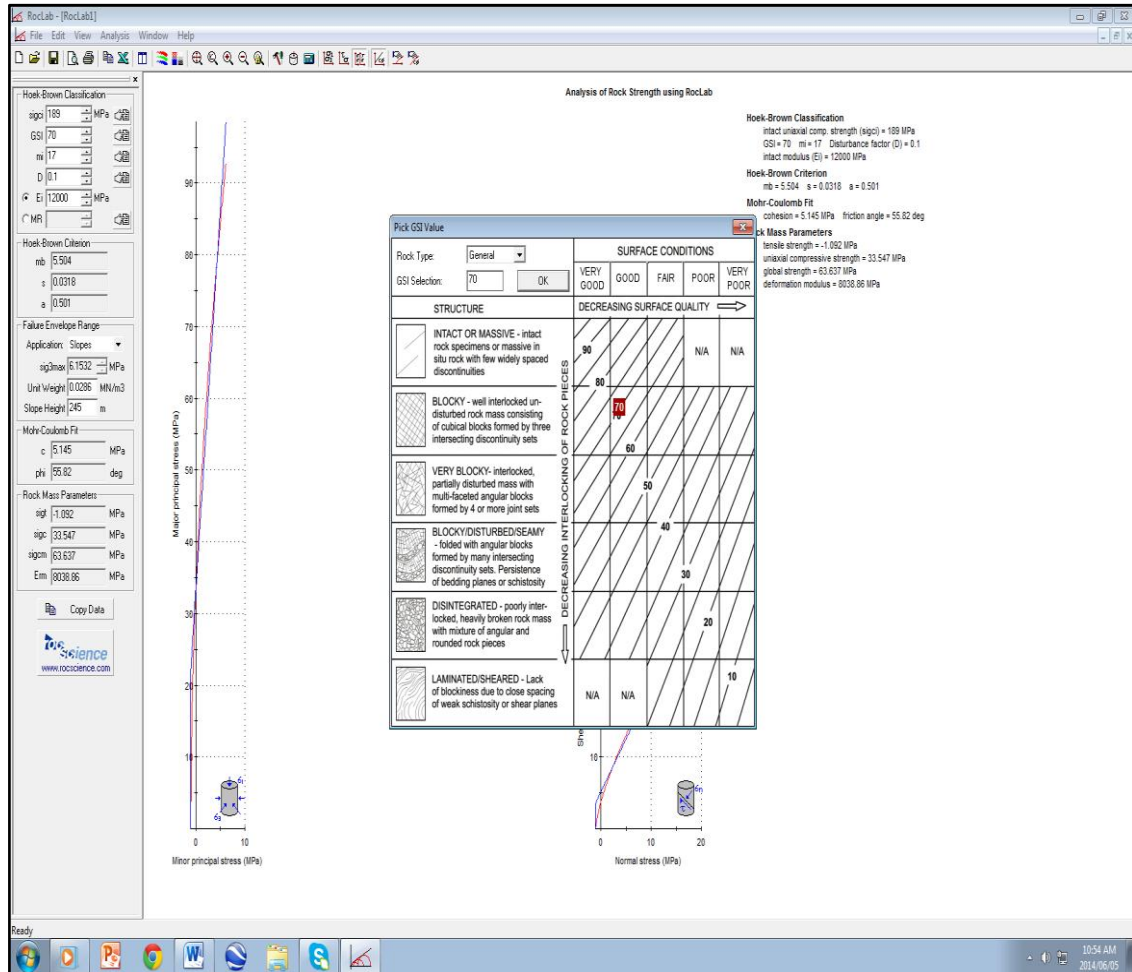
Figure 6.5: GSI values selection on *RocLab* program and resultant rock mass properties.

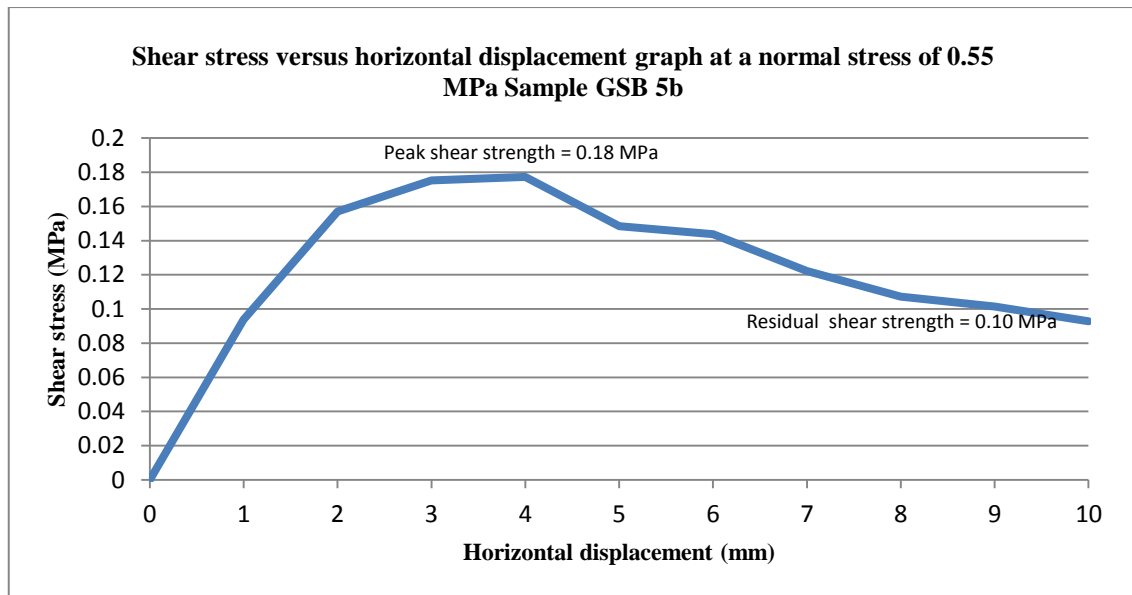
Figure 6.6: Shear displacement versus horizontal displacement graph for Golder shear box sample GSB-5b.

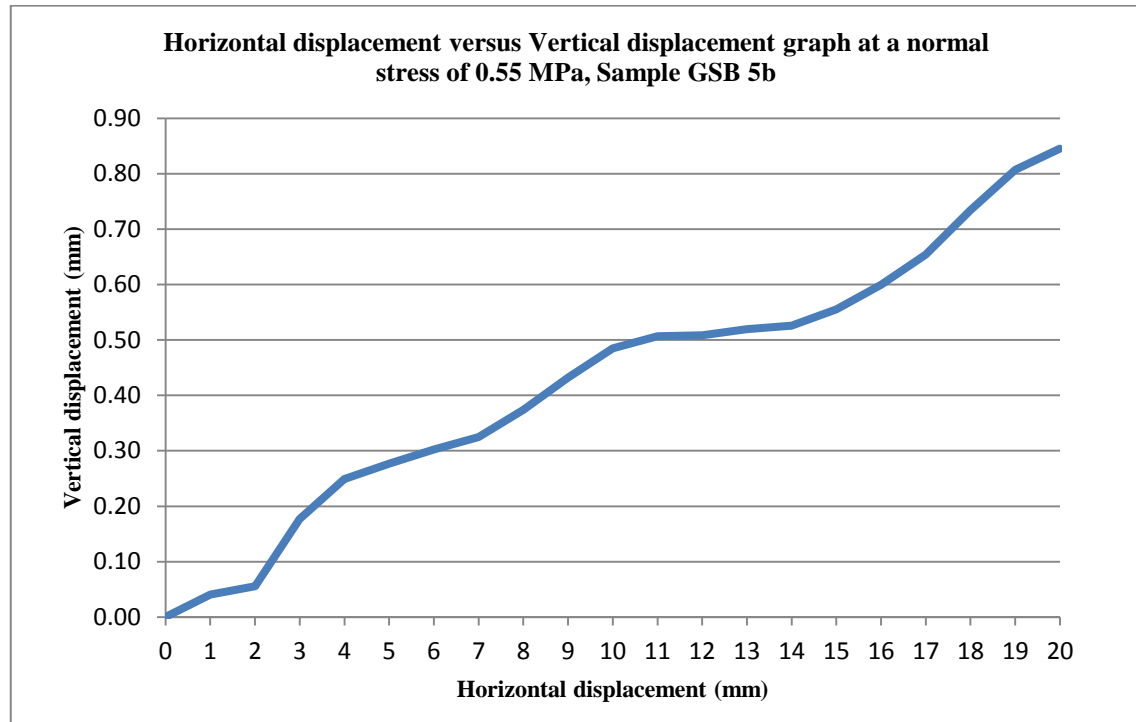
Figure 6.7: Shear displacement versus vertical displacement graph for Golder shear box sample GSB 5b.

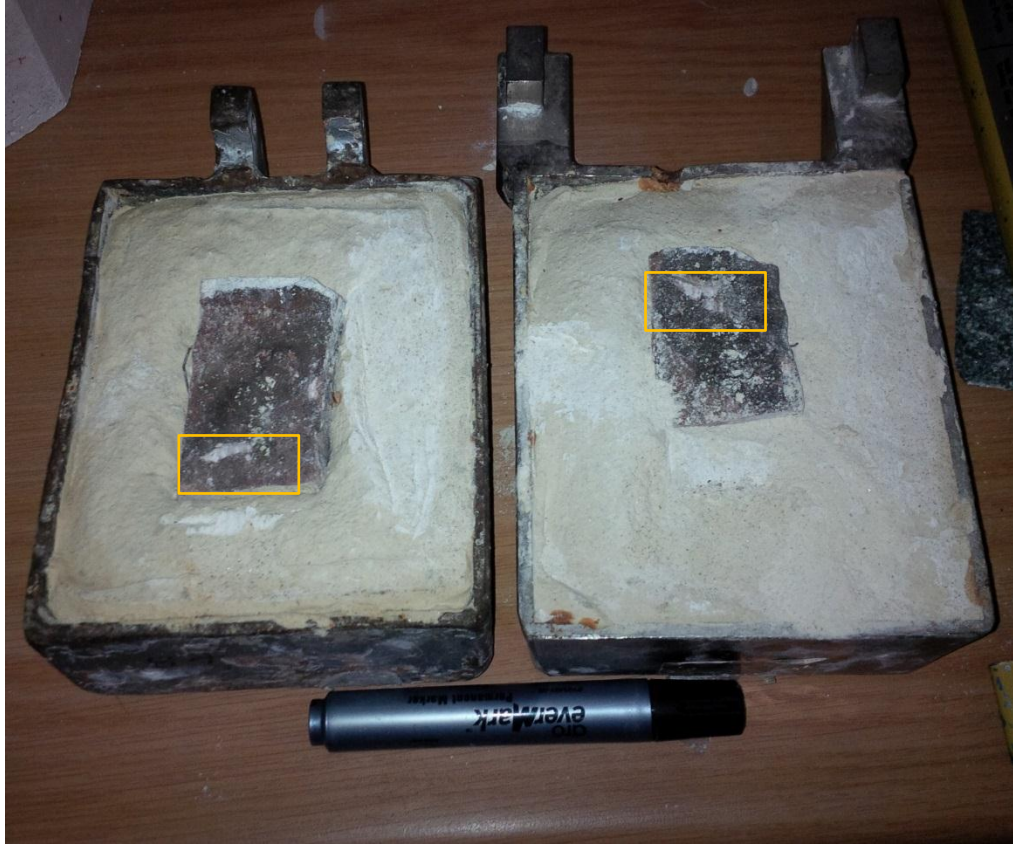
Figure 6.8: Shearing contact showing actual contact surface area for Sample GSB 4.

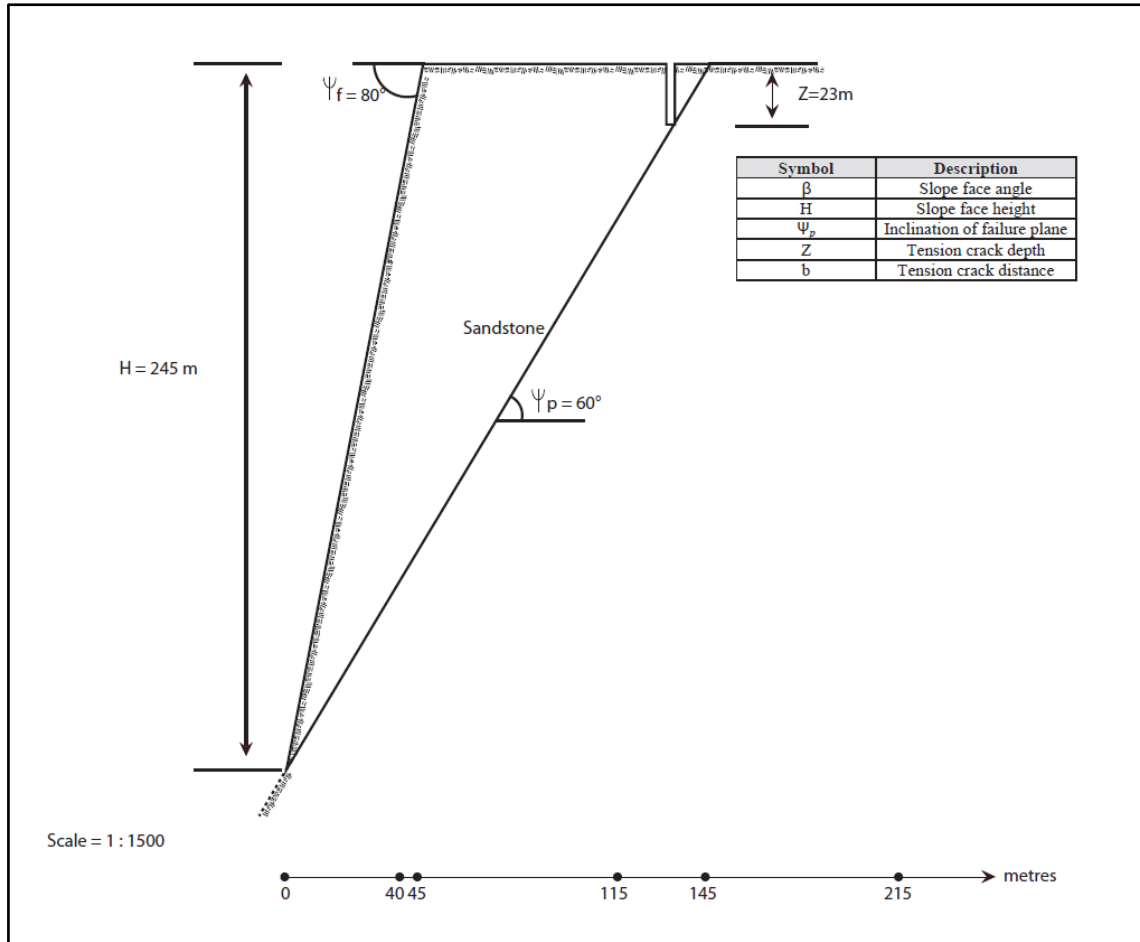
Figure 7.2: Re-constructed slope of the Lake Fundudzi rockslide cross section A-A' shown in Figure 7.1.

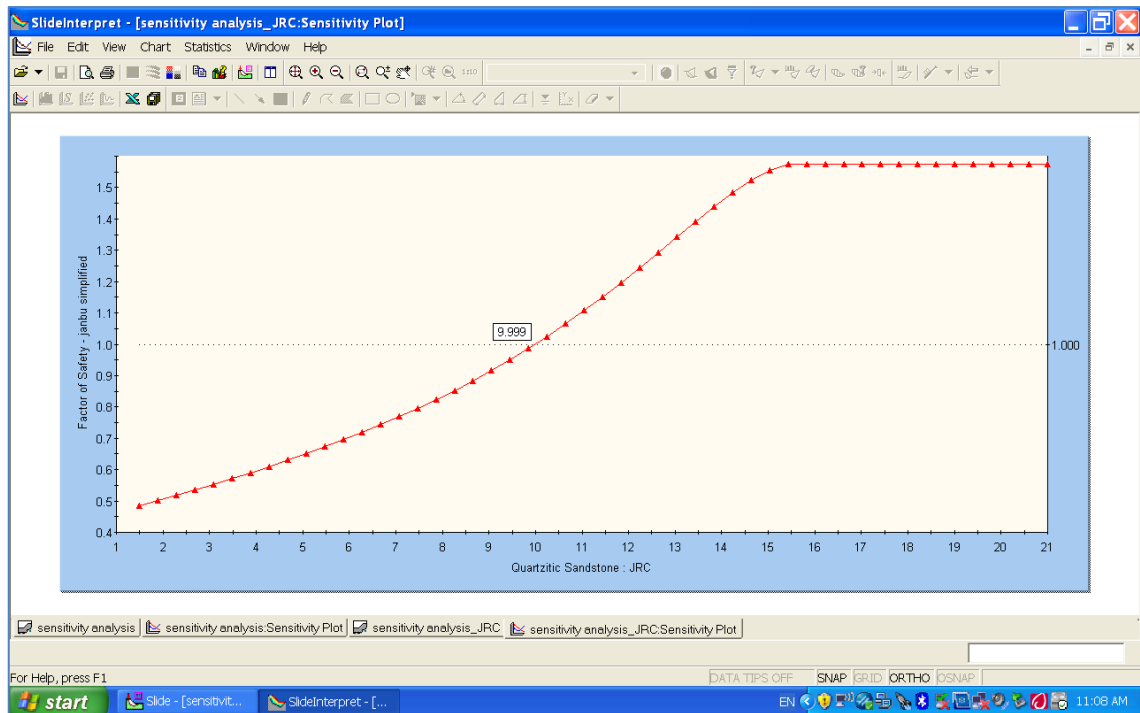
Figure 7.3: Sensitivity analysis plot for JRC (*Slide*).

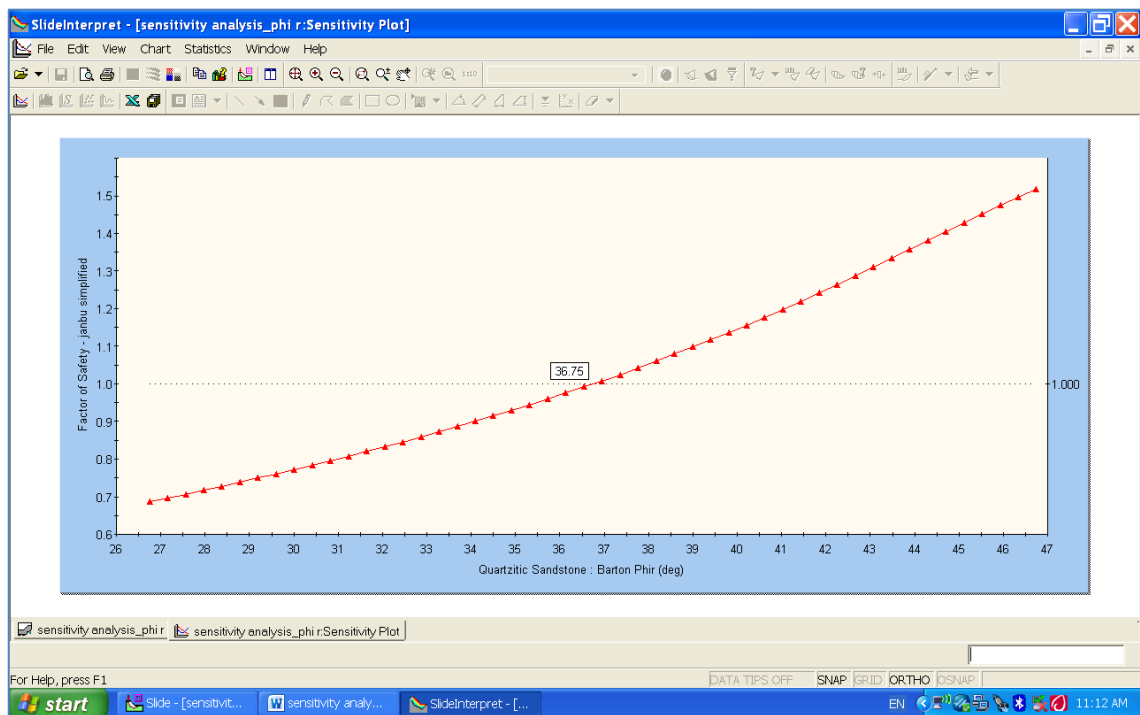
Figure 7.4: Sensitivity analysis plot for the residual friction angle (*Slide*).

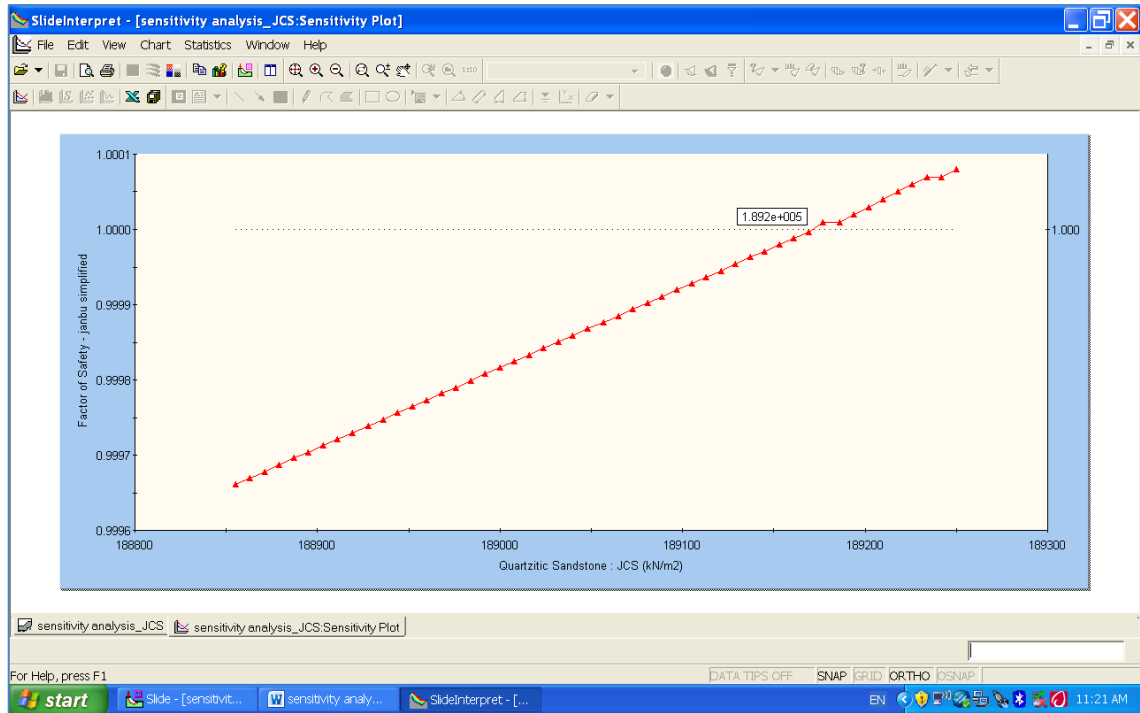
Figure 7.5: Sensitivity analysis plot for JCS (*Slide*).

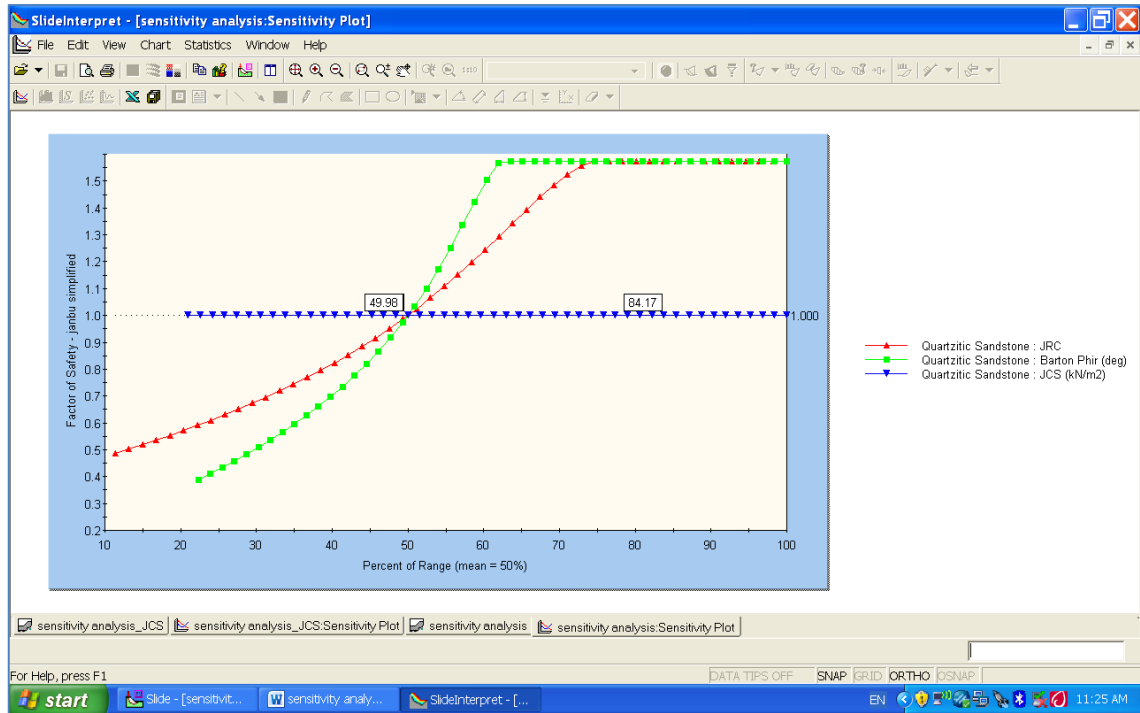
Figure 7.6: Sensitivity analysis of back calculated shear strength parameters (*Slide*).

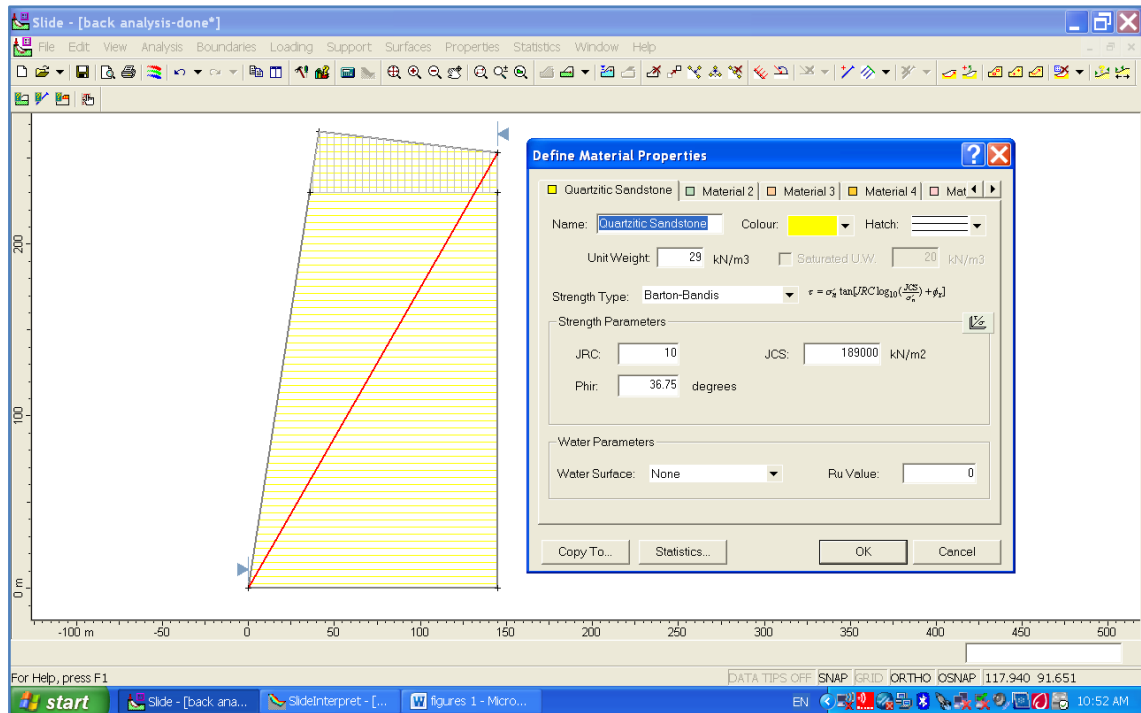
Figure 7.7: Input parameters for back analysis of residual friction angle along the failure surface.

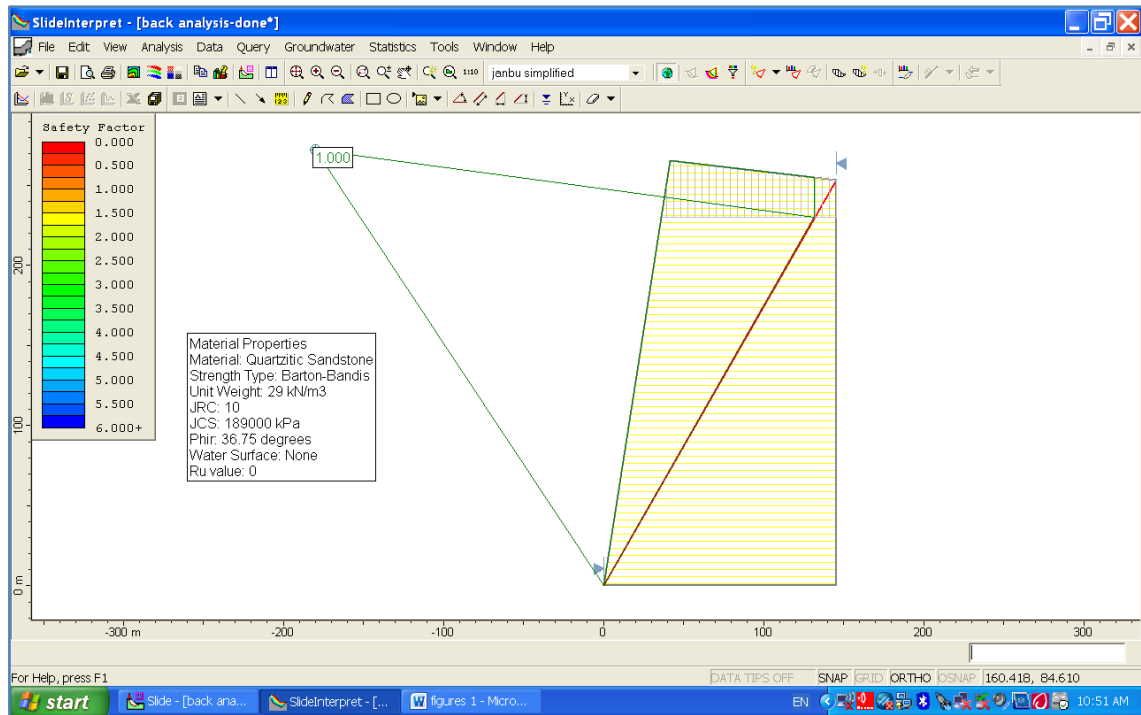
Figure 7.8: Back analysis of the shear strength parameters based on the Barton-Bandis shear strength criterion (*Slide*).

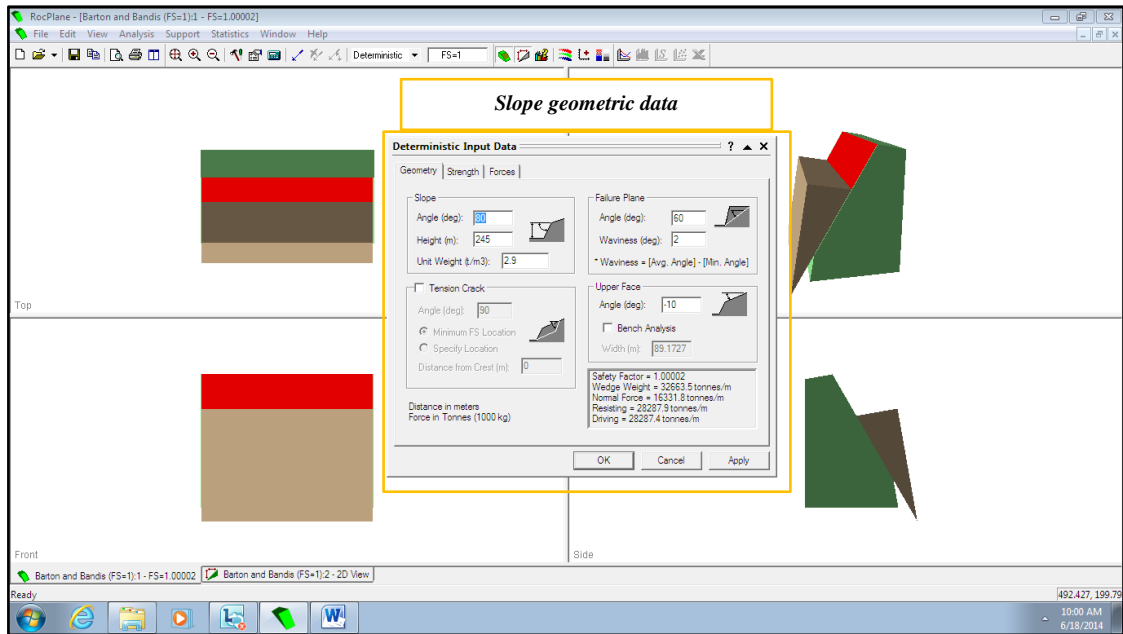
Figure 7.9: Geometric slope parameters captured on *RocPlane*.

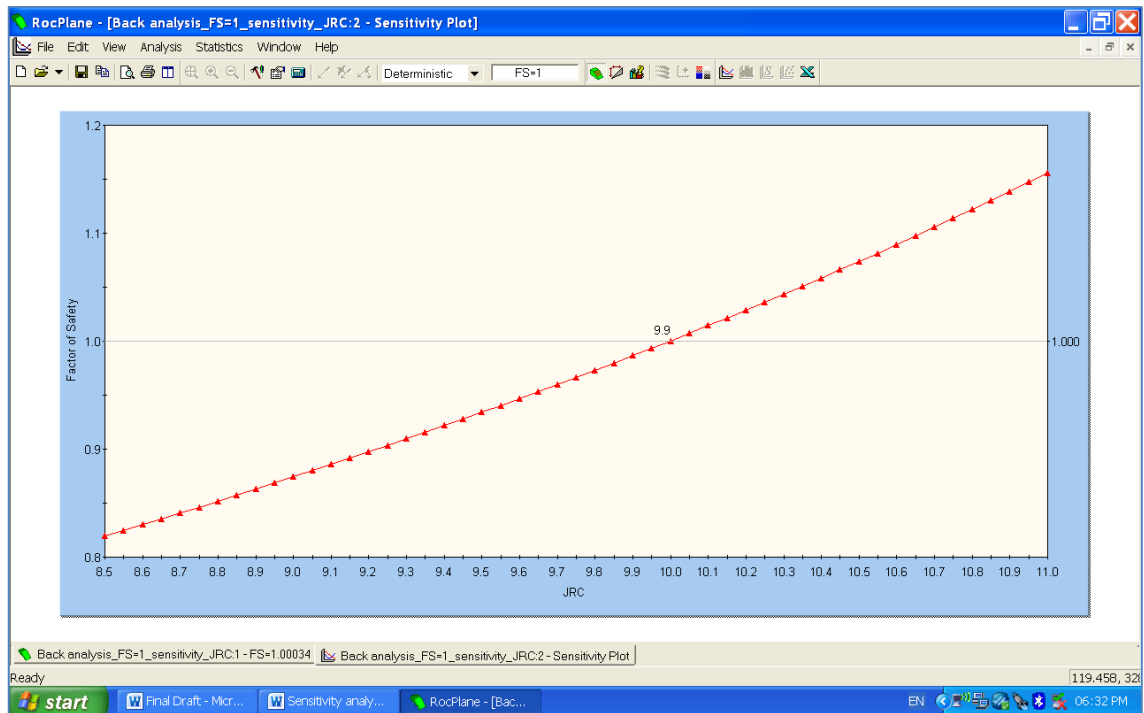
Figure 7.11: Sensitivity analysis plot for JRC (*RocPlane*).

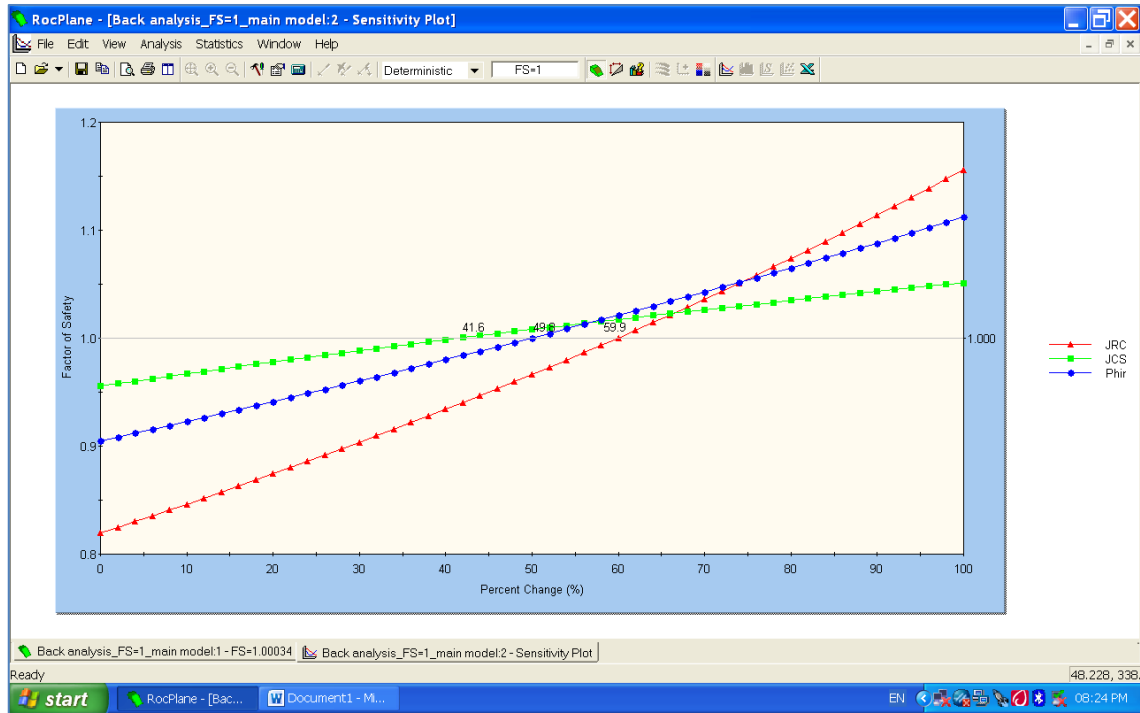
Figure 7.14: Sensitivity analysis of back calculated shear strength parameters (*RocPlane*).

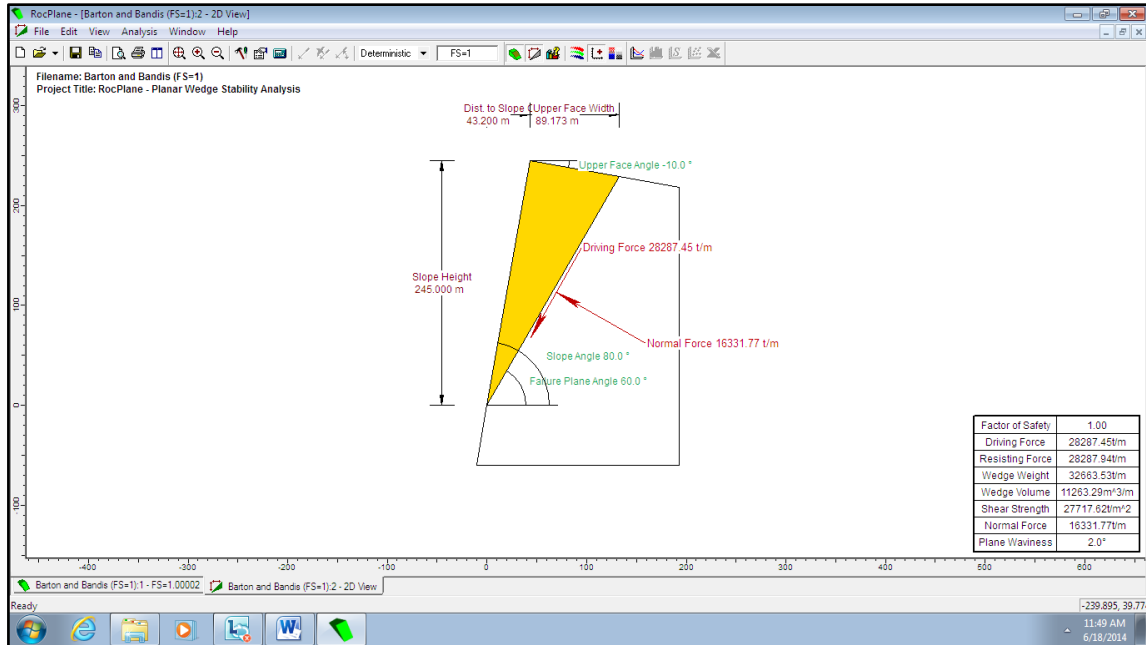
Figure 7.15: Planar failure stability back analysis using *RocPlane*.

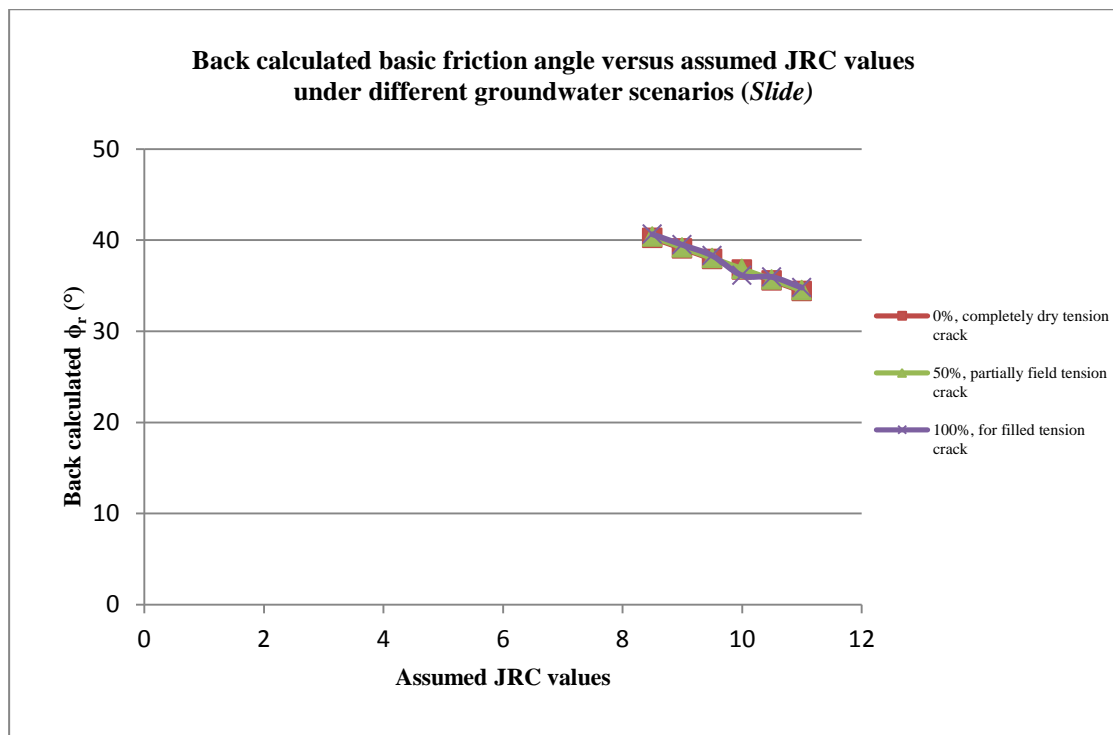
Figure 7.16: Graph of back calculated JRC values versus residual friction angle obtained from different groundwater conditions (Slide).

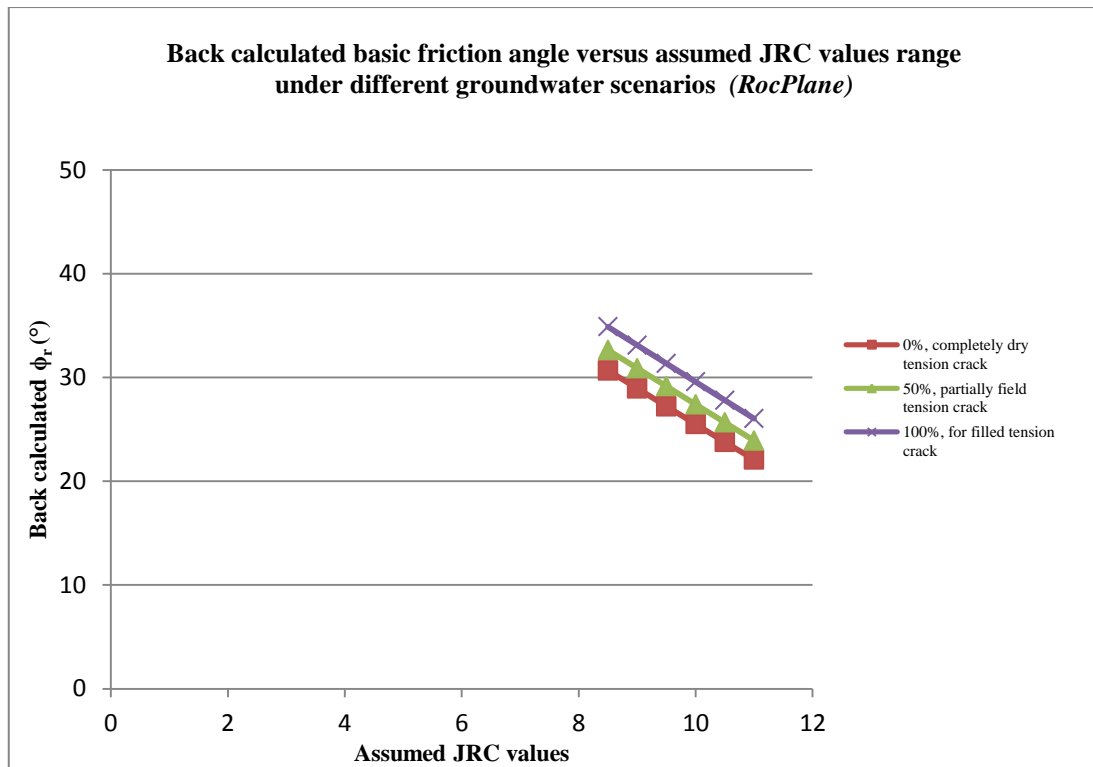
Figure 7.17: Graph of assumed JRC values versus residual friction angle obtained from different groundwater conditions (*RocPlane*).

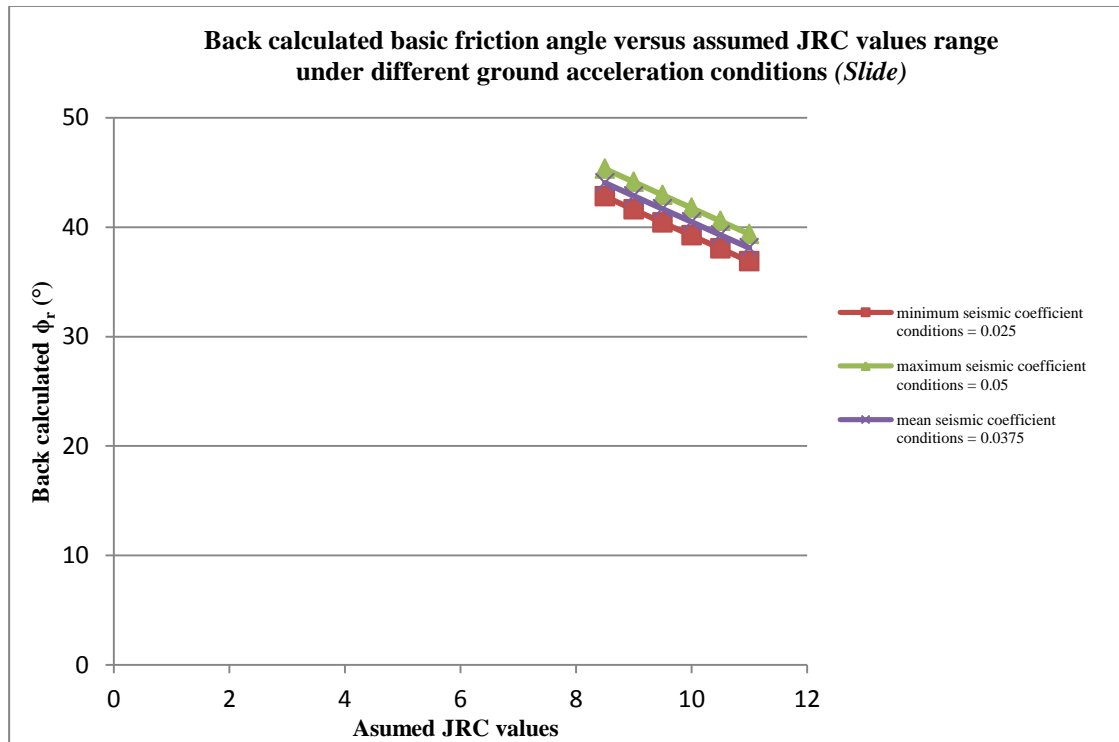
Figure 7.18: Graph of assumed JRC values versus residual friction angle obtained from different seismic ground acceleration scenarios (*Slide*).

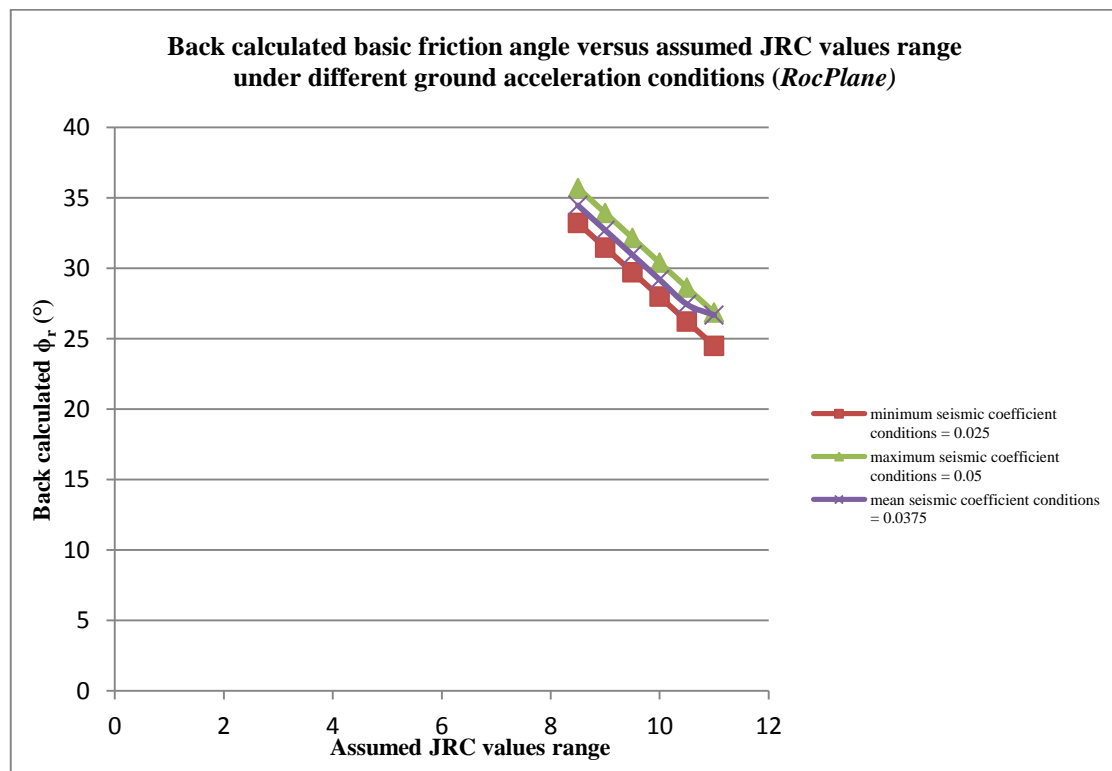
Figure 7.19: Graph of assumed JRC values versus residual friction angle obtained from different seismic ground acceleration scenarios (*RocPlane*).

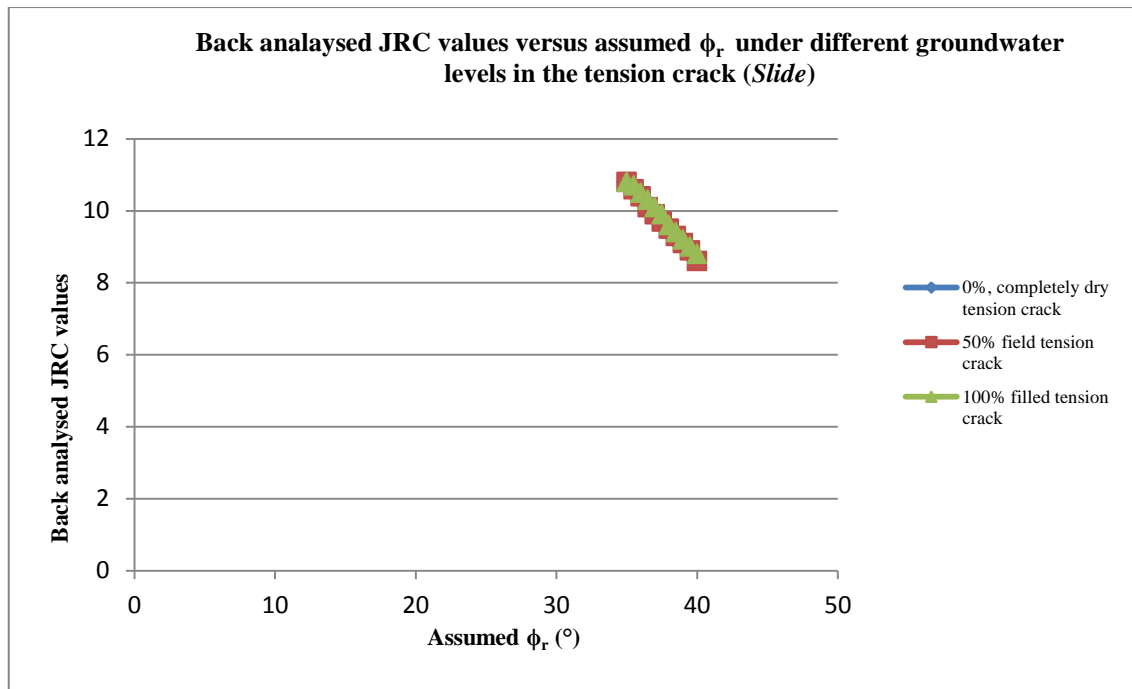
Figure 7.20: Back analysed JRC values for an assumed range of ϕ_r values angle under different groundwater levels in the tension crack (*Slide*).

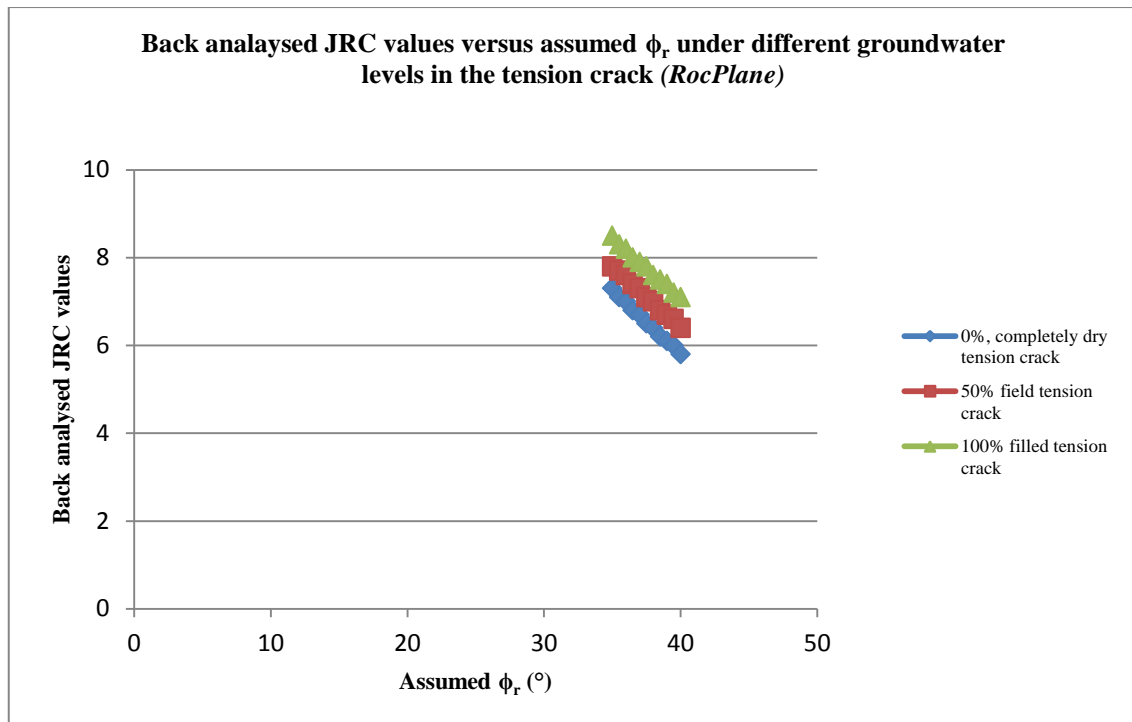
Figure 7.21: Back analysed JRC values for an assumed range of ϕ_r values under different groundwater levels in the tension crack (*RocPlane*).
