UNIVERSITY OF KWAZULU-NATAL

**BACK ANALYSIS OF AN ANCIENT ROCKSLIDE AT LAKE FUNDUDZI, LIMPOPO
PROVINCE, SOUTH AFRICA**

A dissertation submitted in fulfilment of the requirements for the degree of
Master of Science (MSc) in Environmental and Engineering Geology

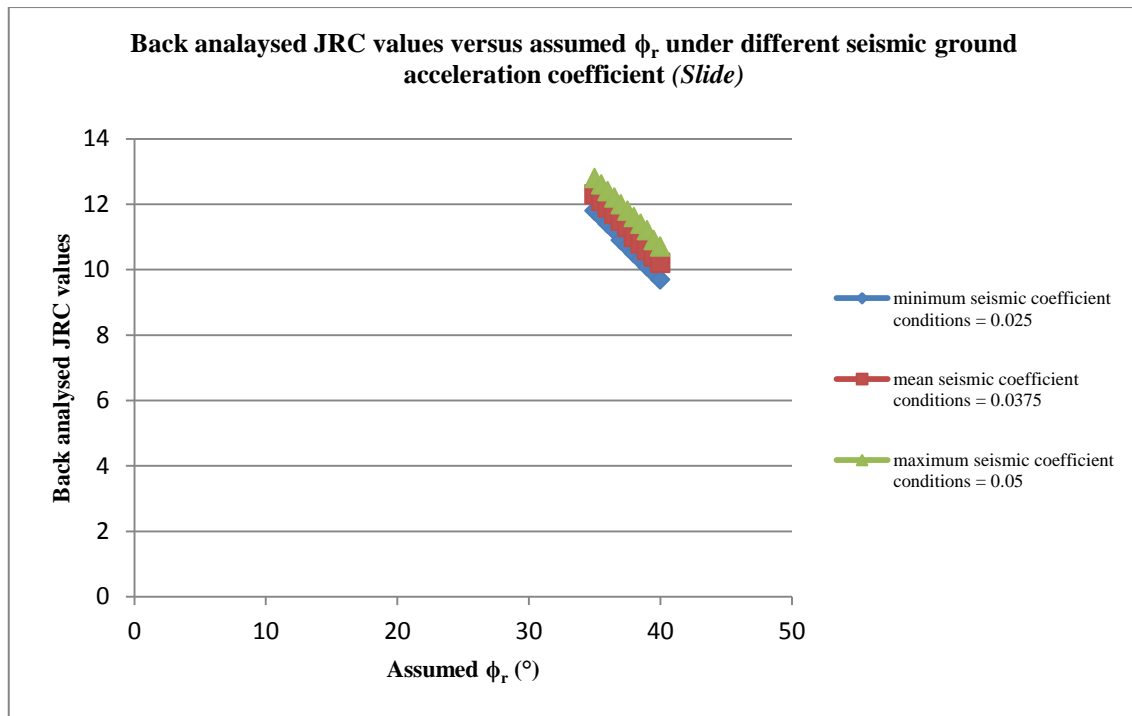
Figure 7.22: Back analysed JRC values versus assumed ϕ_r under different seismic ground acceleration coefficient (Slide).
