**GEOTECHNICAL CHARACTERIZATION
AND SLOPE STABILITY ANALYSES
OF THE TOWN BUSH VALLEY,
PIETERMARITZBURG
SOUTH AFRICA**

Keval Singh

2018

Submitted in fulfilment of the requirements for the degree of Master of Science

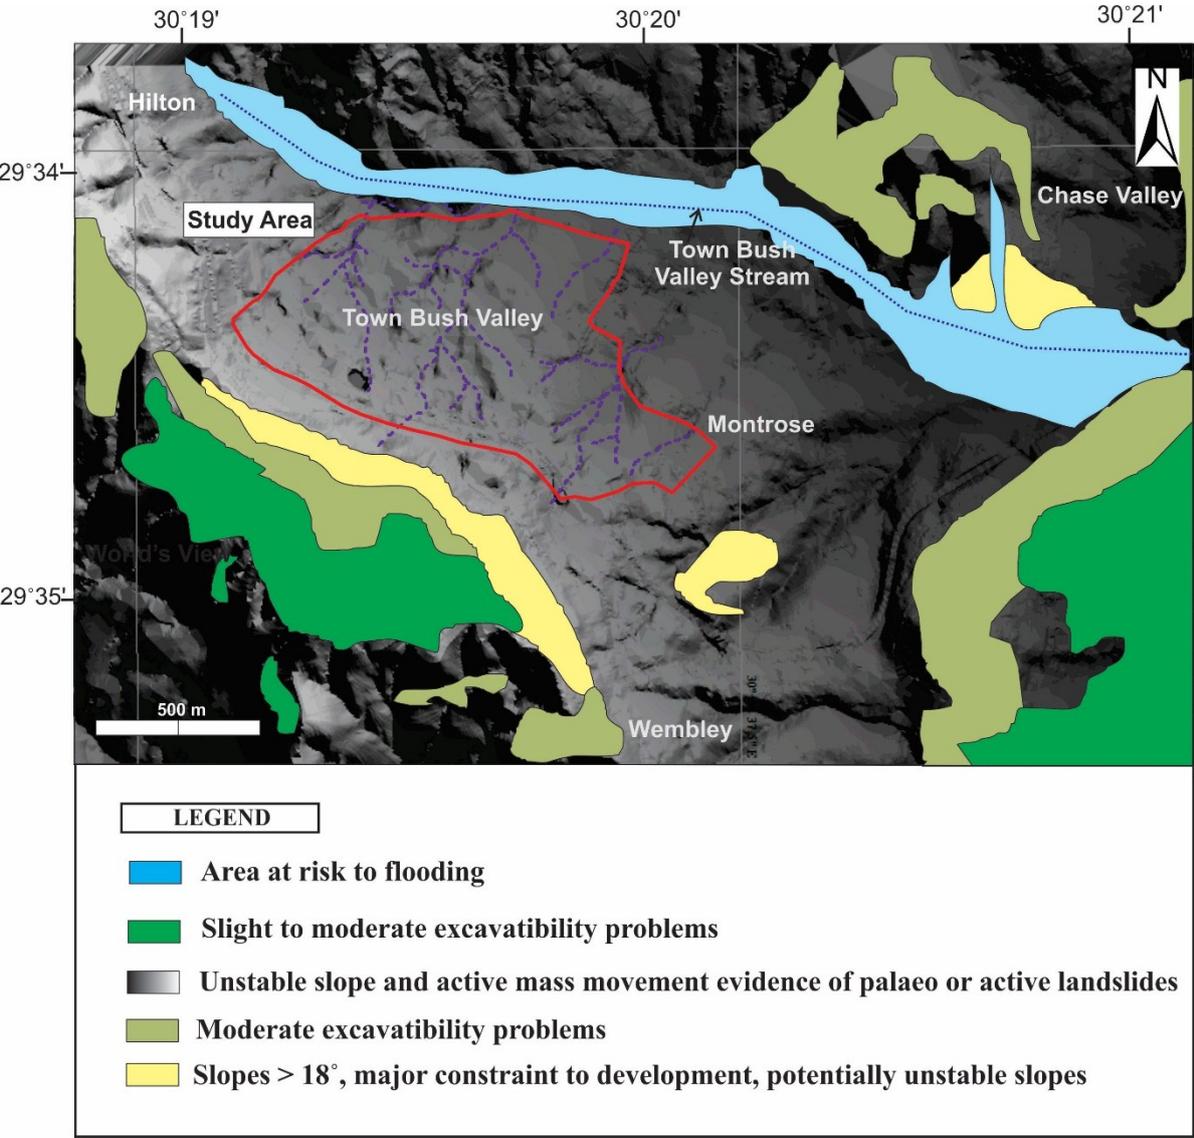
Figure 2.4: Geotechnical map of Pietermaritzburg highlighting areas of geotechnical limitations to development based on the 1: 50 000 Geotechnical Series 2930CB Pietermaritzburg.

The main geotechnical problem in the study area is slope instability as shown in Figure 2.4. The Council for Geoscience (2008) classified the study area as having active mass movement and unstable slopes. In areas where slope gradients exceed 18°, there are not only limitations to development but a likelihood of slope instability (Richards *et al.*, 2006). The geotechnical map also indicates areas of mass movement where the potential for slope instability exists as these slope gradients exceed 18°.

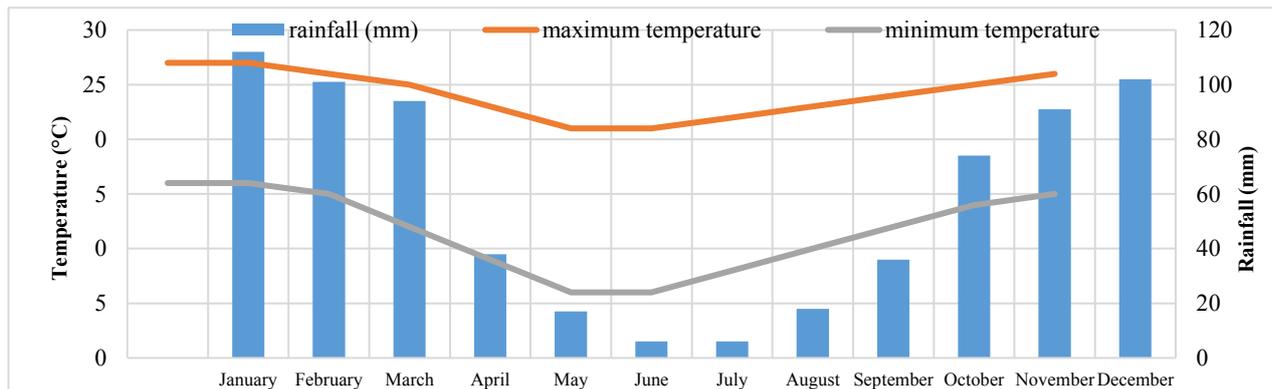
Figure 2.5: Mean monthly rainfall, maximum and minimum temperatures at Pietermaritzburg (source: SA explorer, 2015).

The region is characterized by a subtropical climate with warm summers and moderately dry winters. The area receives about 695 mm of rainfall annually, with most rainfall occurring mainly during mid-summer. The study area falls within the Quaternary Catchment U20J and is located in rainfall zone U2D and evaporation zone 30B (Department of Water and Sanitation, 2015). Pietermaritzburg receives the lowest rainfall in June (6 mm) and the highest in January (112 mm). The average midday temperature for Pietermaritzburg ranges from 20.5°C in June to 27°C in February. Figure 2.5 summarizes the climatic conditions of the city of Pietermaritzburg.

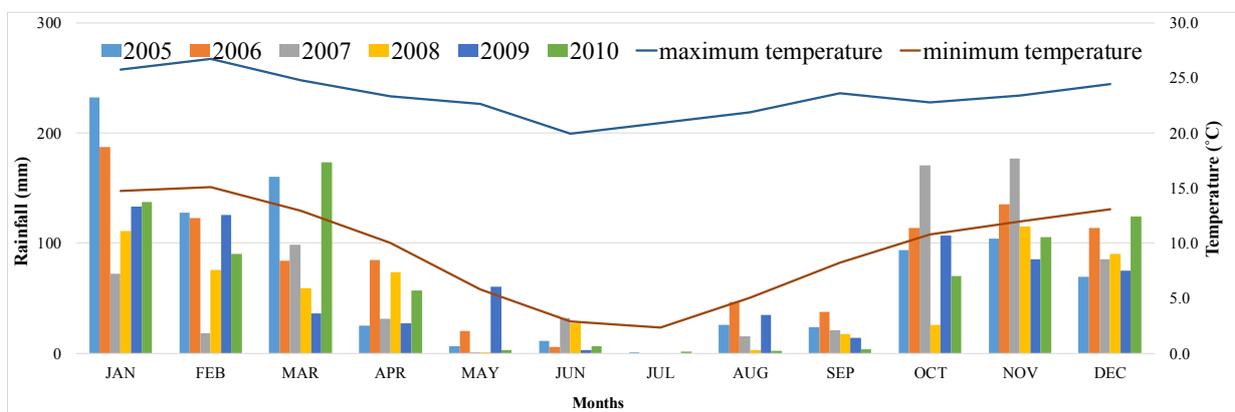
Figure 2.6: Average monthly rainfall, maximum and minimum temperature range from 2005 to 2010 (SAWS, 2015).

KwaZulu-Natal receives more rainfall than most parts of southern Africa, the majority of which falls in the summer months (Maurenbrecher & Booth, 1975). Figure 2.6 presents the average minimum and maximum temperatures over a ten-year period (2005-2010) recorded at the Cedara weather station (02394820) located in Cedara, Pietermaritzburg approximately 5 km from the study site. Figure 2.6 further presents a summary of the average rainfall conditions recorded at the Cedara weather station for the period of 2005 to 2010. Climatic data was acquired from the South African Weather Services (SAWS) the data spans from 2005 to 2010.

The rainfall data indicates that the Town Bush Valley receives its highest rainfall during the warm, summer months of November to February. Over the ten-year period, January 2005 recorded the highest rainfall of 232 mm. This is followed by March 2010, which recorded 174 mm of rainfall. The year of 2006 received on average the highest annual rainfall (79 mm) over the ten-year period. Although a mild annual decrease in the rainfall pattern was observed over the ten-year period, sporadic and heavy monthly rainfalls offset the recorded average values. These sudden heavy rainfall events are few and isolated but are prevalent during the present years of 2010 to 2016.

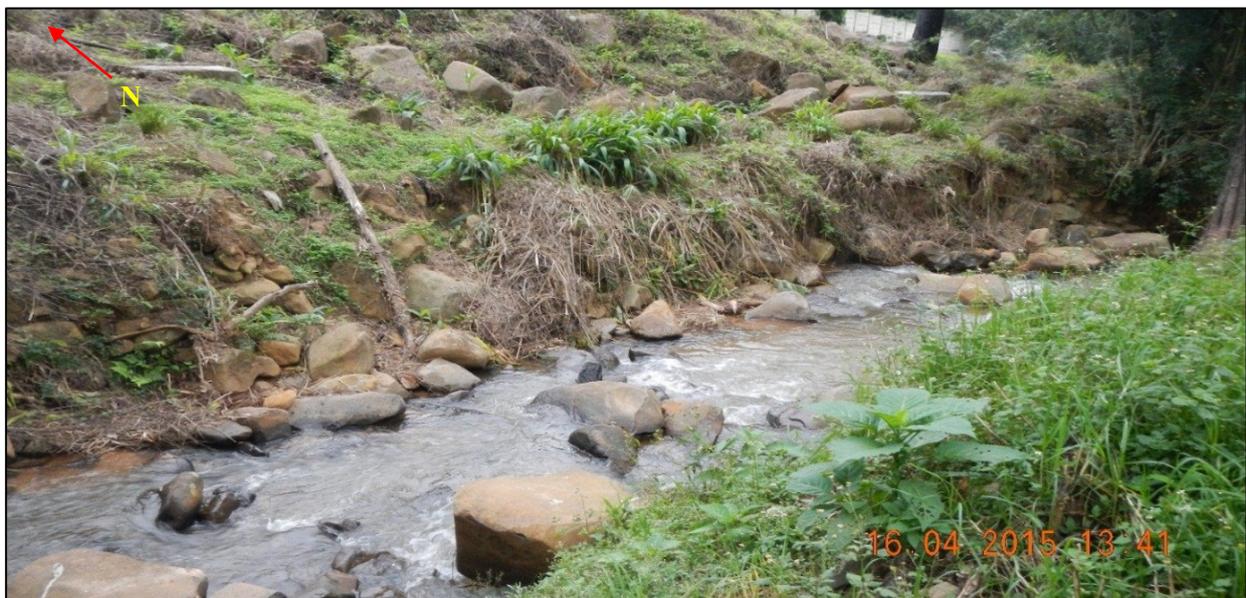
Figure 2.7: The Town Bush Stream with boulder dolerite in the alluvial channel derived from talus material.

The Town Bush Stream is aligned perpendicular to the Town Bush Valley and has been identified as the central drainage feature which flows in a north-easterly direction and is shown in Figure 2.7.

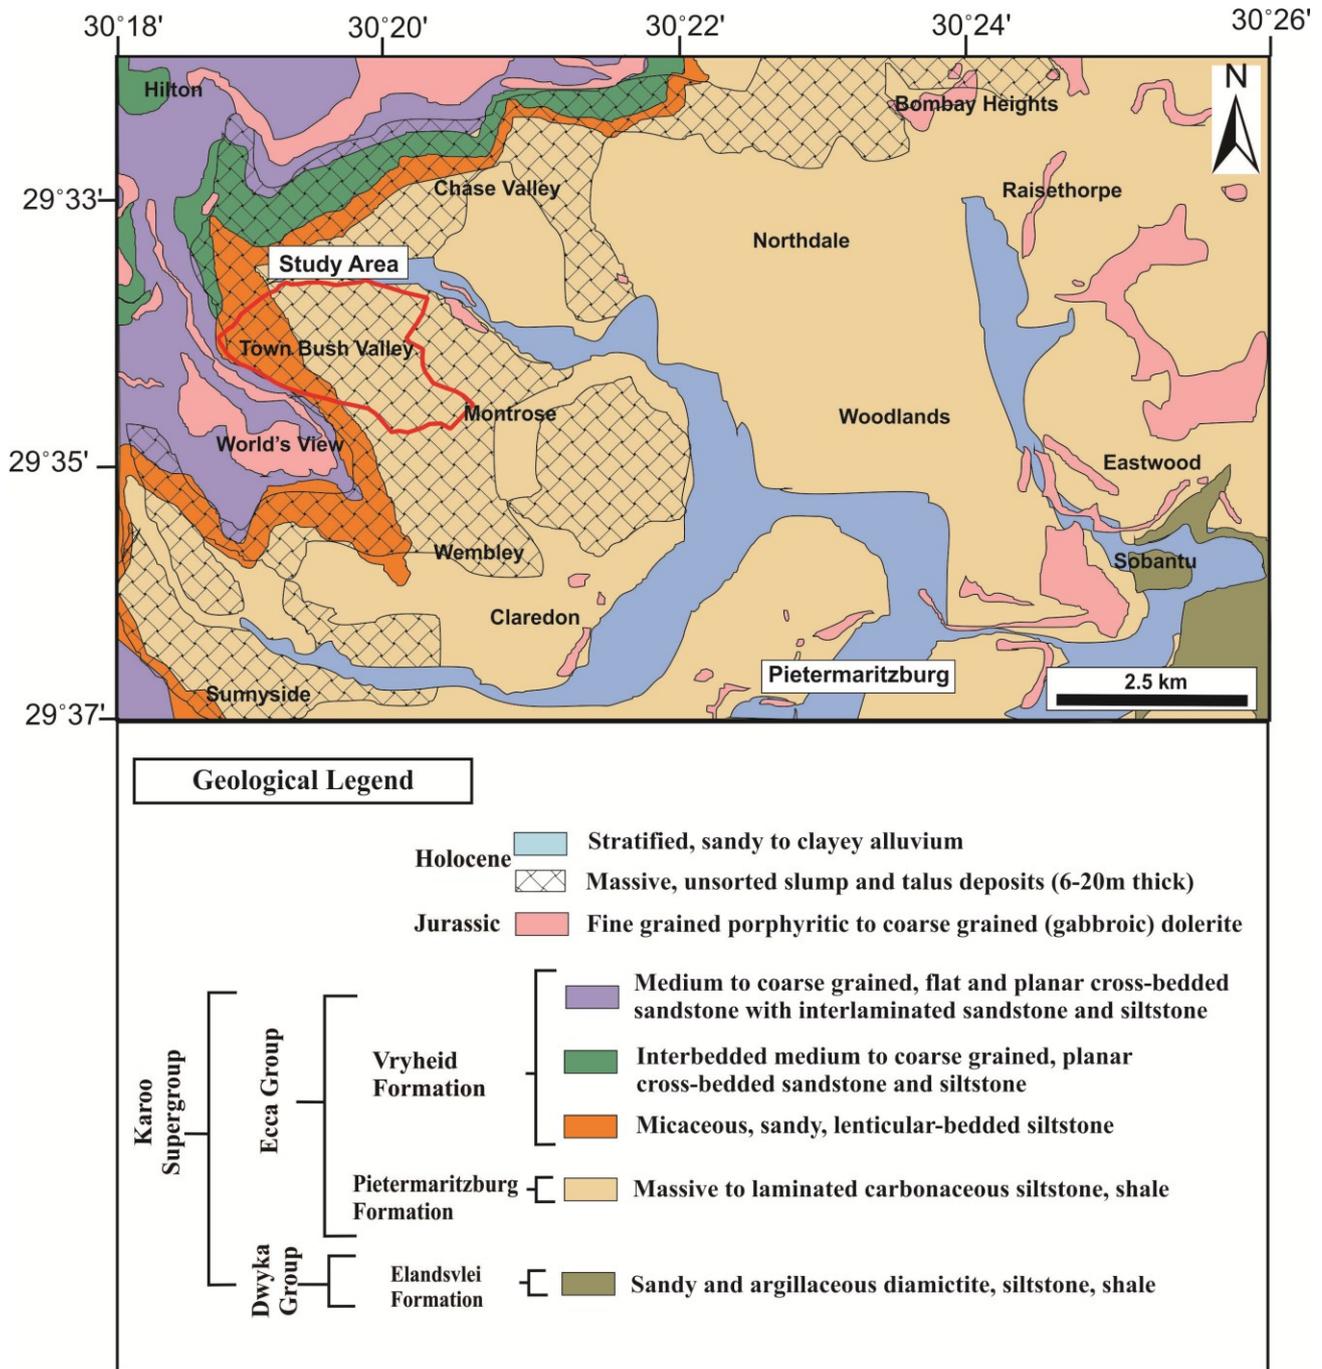
Figure 2.9: Generalized geological map of the Pietermaritzburg region based on the 1:50 000 Geological Series 2930CB Pietermaritzburg.

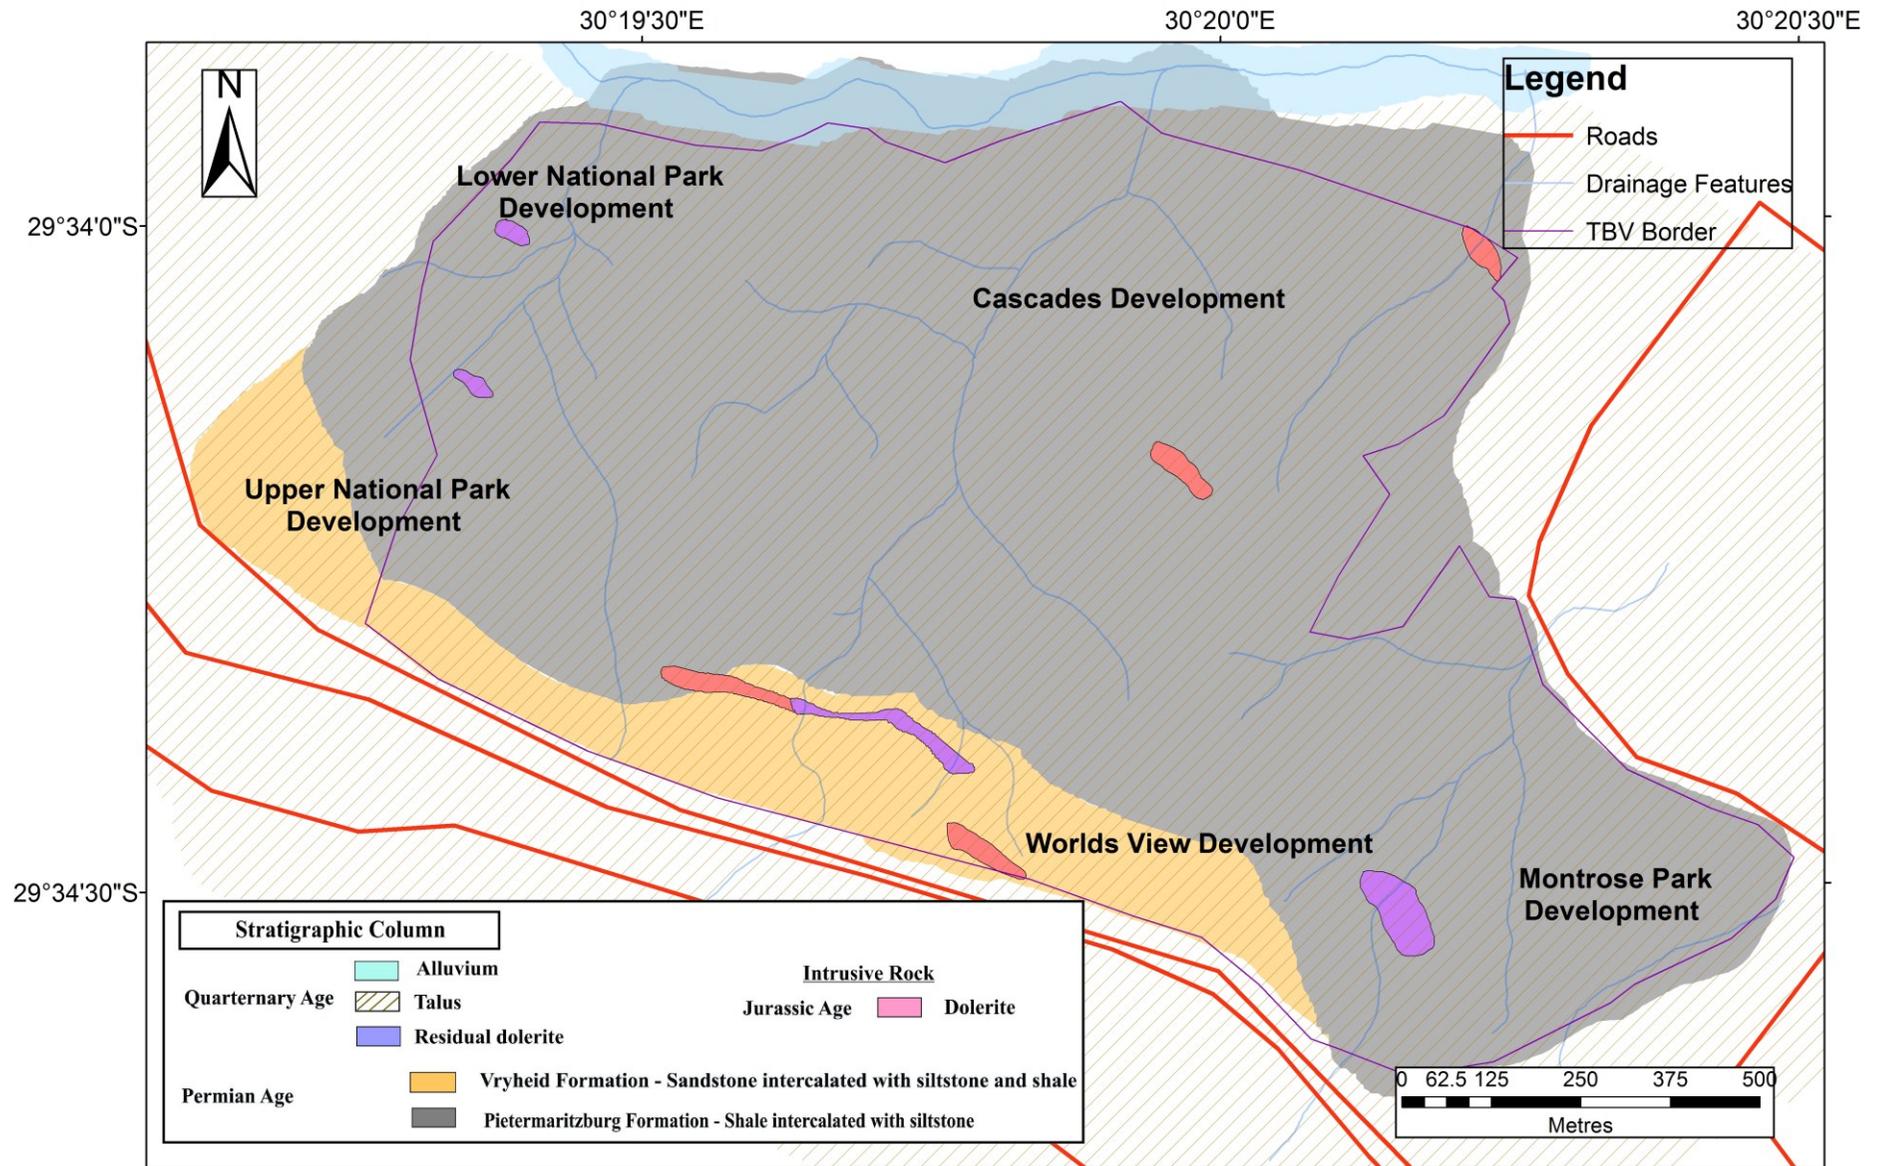
Figure 2.10: Local geological map of the study area.

A site geological map has been produced and is presented in Figure 2.10. The map has been compiled based on sub-surface investigation results (borehole drilling, augering & trial pitting) and geological field mapping. The primary geological units, namely the Pietermaritzburg Formation, Vryheid Formation, dolerite intrusives and talus material are discussed in the following subsections in context with Figure 2.10.

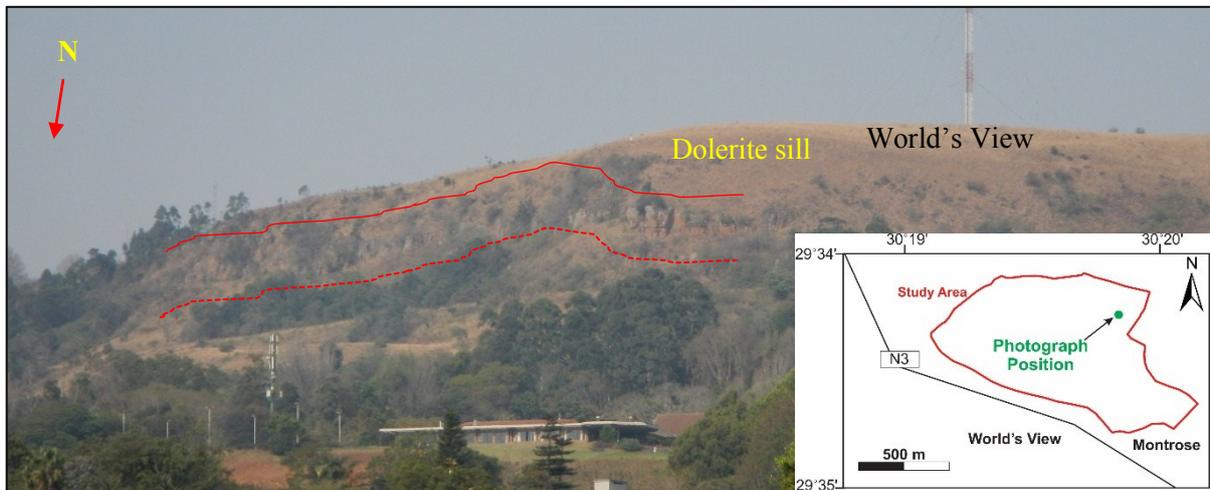
Figure 2.11: A dolerite sill observed from the Town Bush Valley looking towards World's View.

Some intrusions appear to be continuous and extend over large areas while others appear to be localised. Figure 2.11 illustrates a prominent dolerite sill located above the study area (1.7 km west), which characterises the typical elongated appearance of the dolerite sills in the Town Bush Valley.

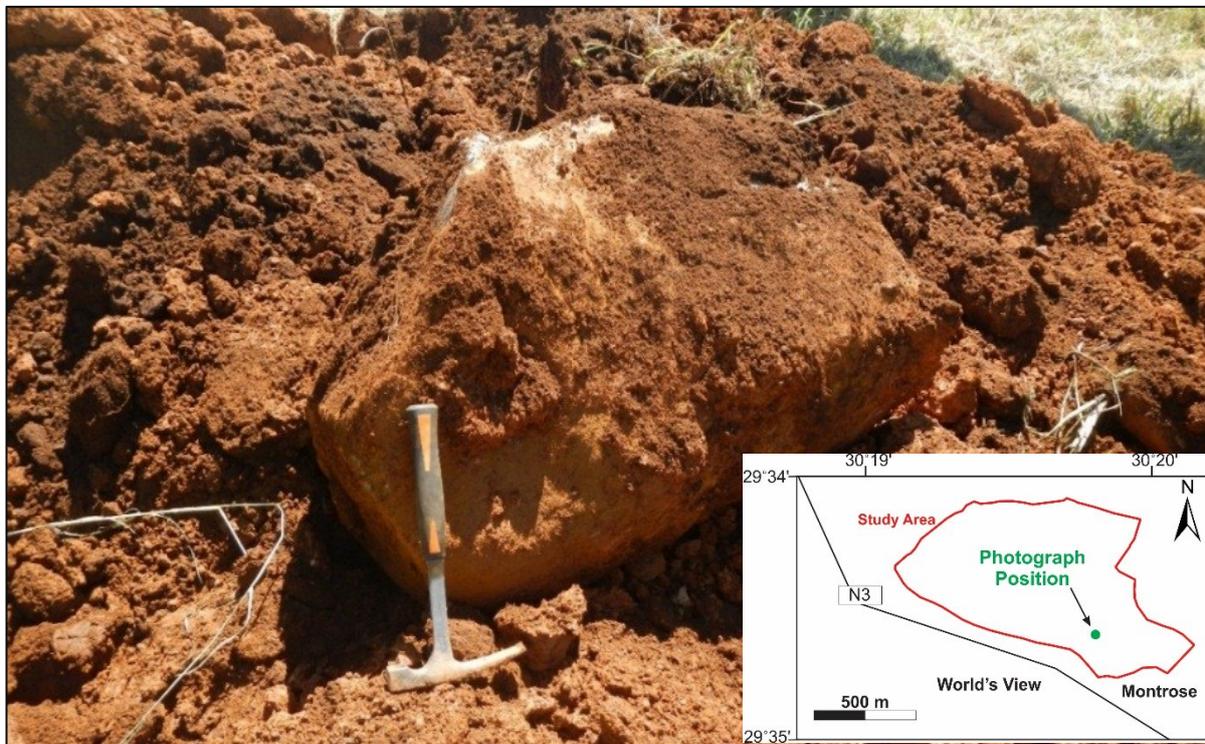
Figure 2.12: Boulders intersected in the talus horizon during trial pitting in the Montrose Park Development.

Soil profiling undertaken according to the South African Institute of Civil Engineering guidelines for soil logging (SAICE, 2002) indicates that the soil texture of the talus material is generally described as a silty sandy clay or silty clayey sand. Gravel to cobble sized shale and dolerite fragments form part of the soil matrix. More notable is the occurrence of boulder sized dolerite fragments in the soil texture which have been noted in various silt and clay matrixes, as illustrated in Figure 2.12.

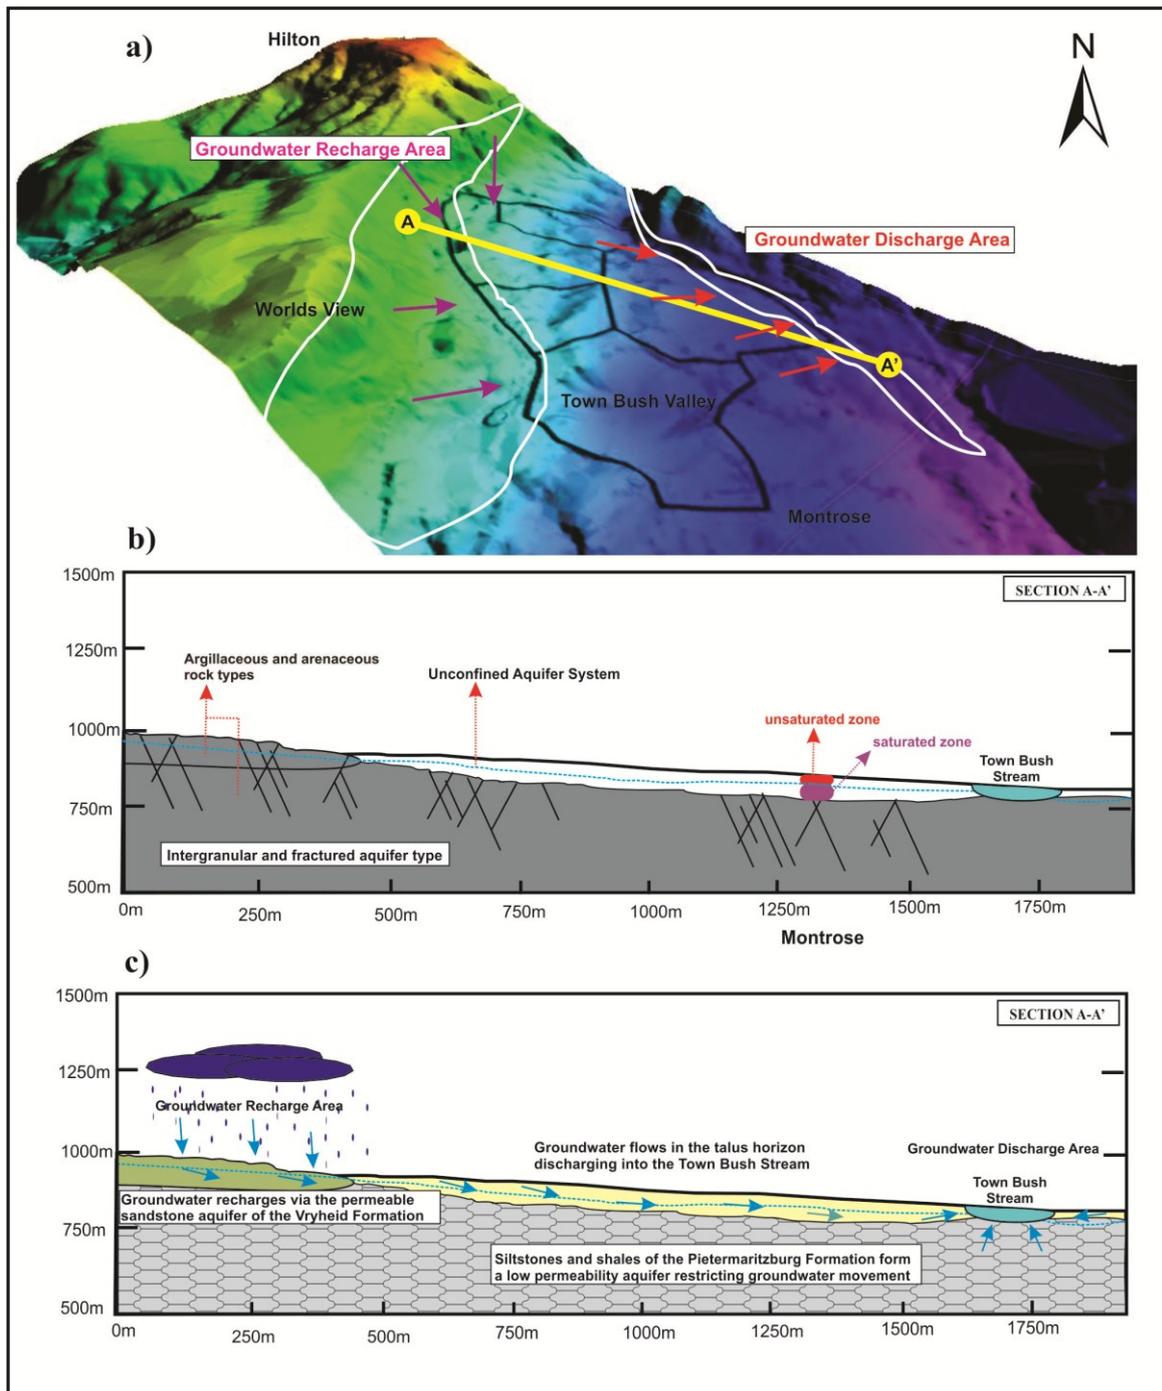
Figure 2.13: Town Bush Valley hillslope schematic presentation of groundwater flow.

& Cherry, 1979). Recharge and discharge areas in the study site is illustrated in Figure 2.13 (insets a, b, c). Groundwater flow is anticipated to flow through the unconsolidated talus material and along the talus and shale bedrock interface, representing an unconfined aquifer system.

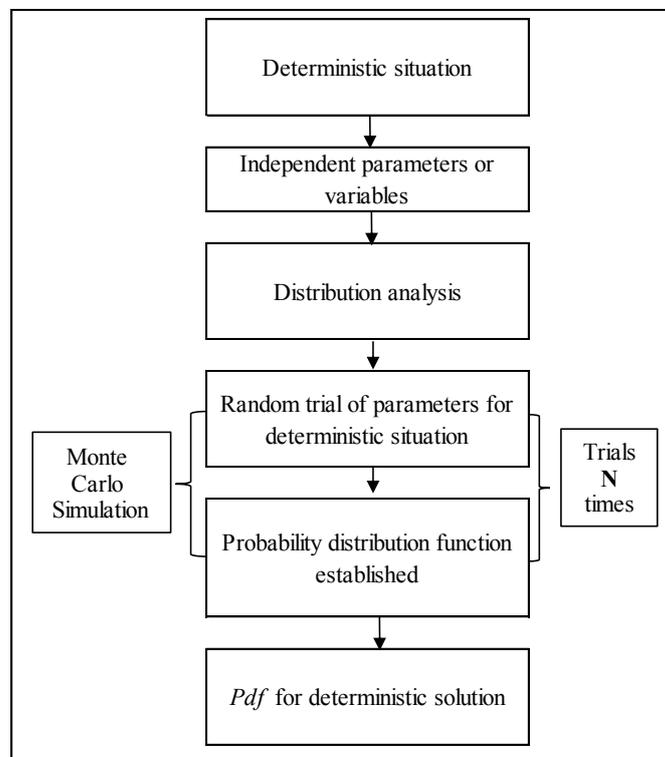
Figure 3.3: Steps involved in a Monte Carlo Simulation (Hutchinson & Bandalos, 1997).

The Monte Carlo method was developed in 1949 by John von Neumann and Stanislaw Ulam, wherein they designated the use of random sampling procedures for treating deterministic mathematical situations. The foundation of the Monte Carlo Simulation gained significance with the development of computers to automate the laborious calculation (Sharma, 2016). The Monte Carlo simulation involves the generation of random numbers and a FOS value associated with a set of random values of the basic stochastic variables (Chowdhury, 1984). After the generation of many FOS values, the *pdf* of the FOS is calculated. The *Pf* may be estimated from the generated distribution or directly from the relative frequencies with which the FOS was found to be $FOS \leq 1.00$ during the simulations (Sharma, 2016). During each pass, a random value from the distribution function for each parameter is selected and entered into the calculation, the concept is illustrated in Figure 3.3.

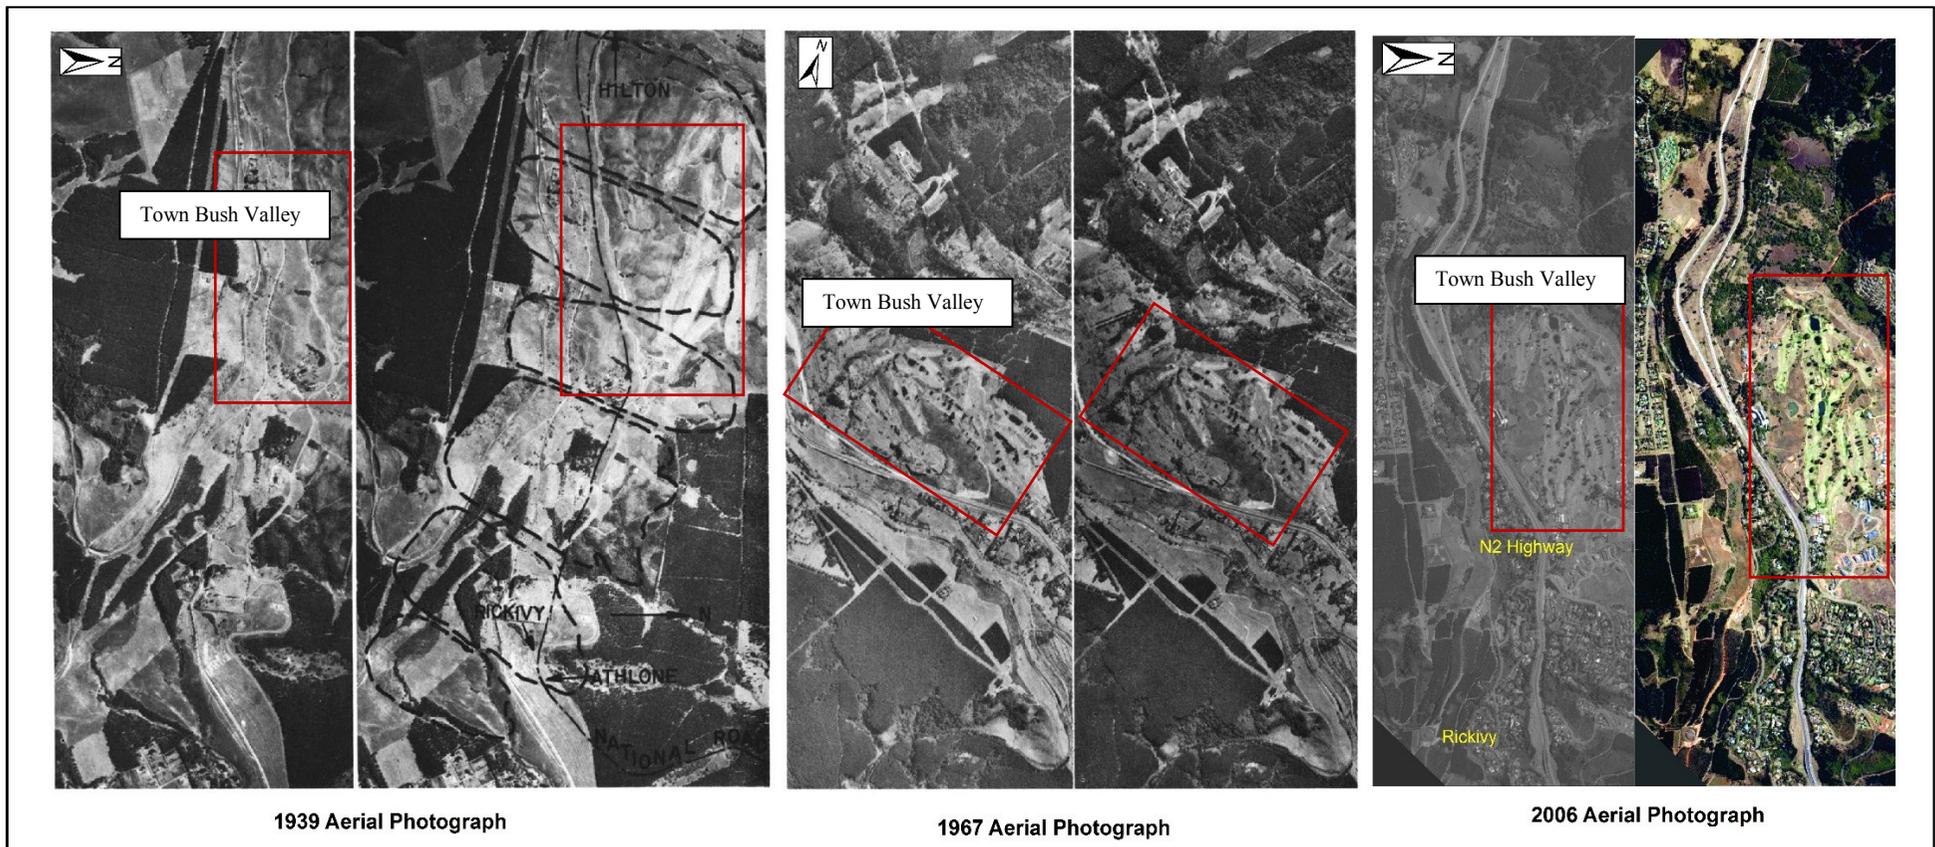
Figure 3.4: Comparative aerial photographs of the Town Bush Valley outlined in red spanning 67 years (adapted from Maurenbrecher and Booth, 1975).

The 1967 aerial photograph shows distinct changes in the slope geomorphology. It is evident from the aerial photographs that the valley is still actively undergoing colluvial processes. The distinct hummocky topography evident in the 1939 (outlined in the black dotted lines) and the 1967 aerial photographs are less prominent in the 2006 aerial photograph.

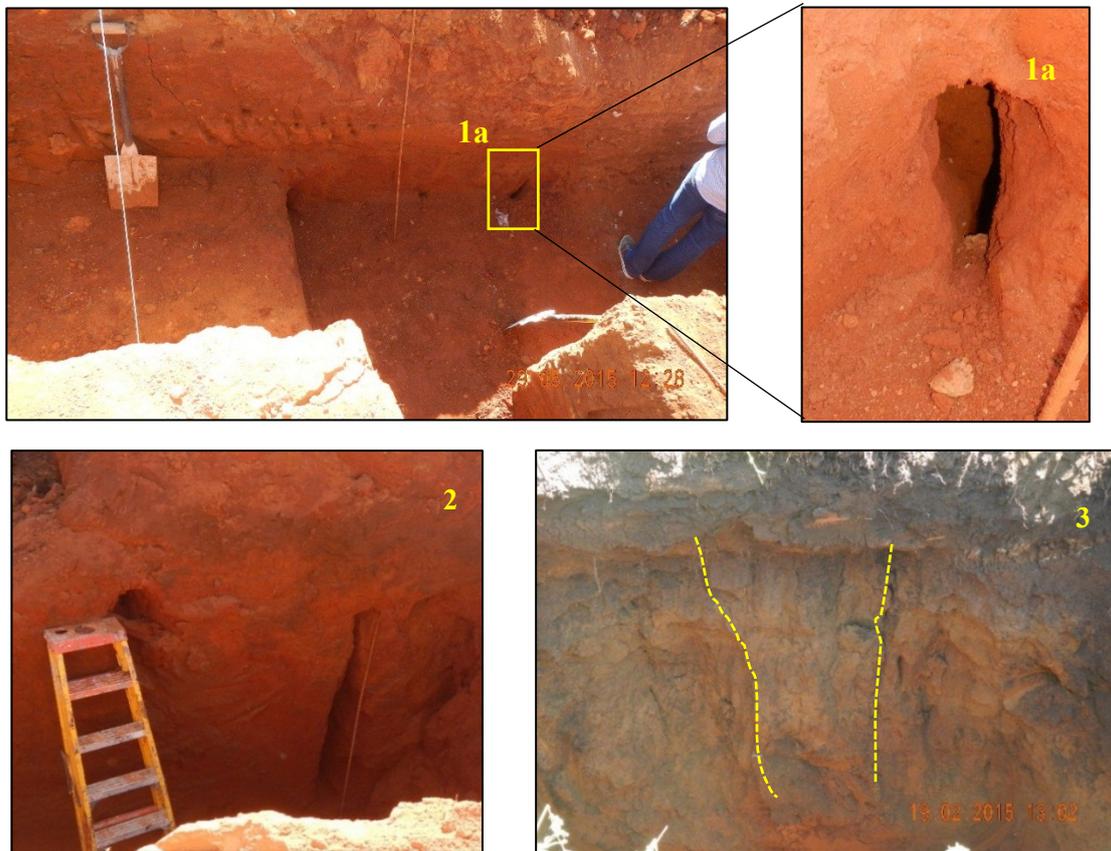
Figure 3.5: Fissures intersected in the Cascades Development (Photo 1a & 2) and MPD (Photo 3).

Large scale fissures in the talus horizon of the Town Bush Valley were initially recognized by Price (2006) during investigations undertaken in the Cascades Development. These fissures were later documented by investigations undertaken by Singh (2015a), during site investigations in the Cascades Development and Montrose Park Development. These natural discontinuities are illustrated in Figure 3.5.

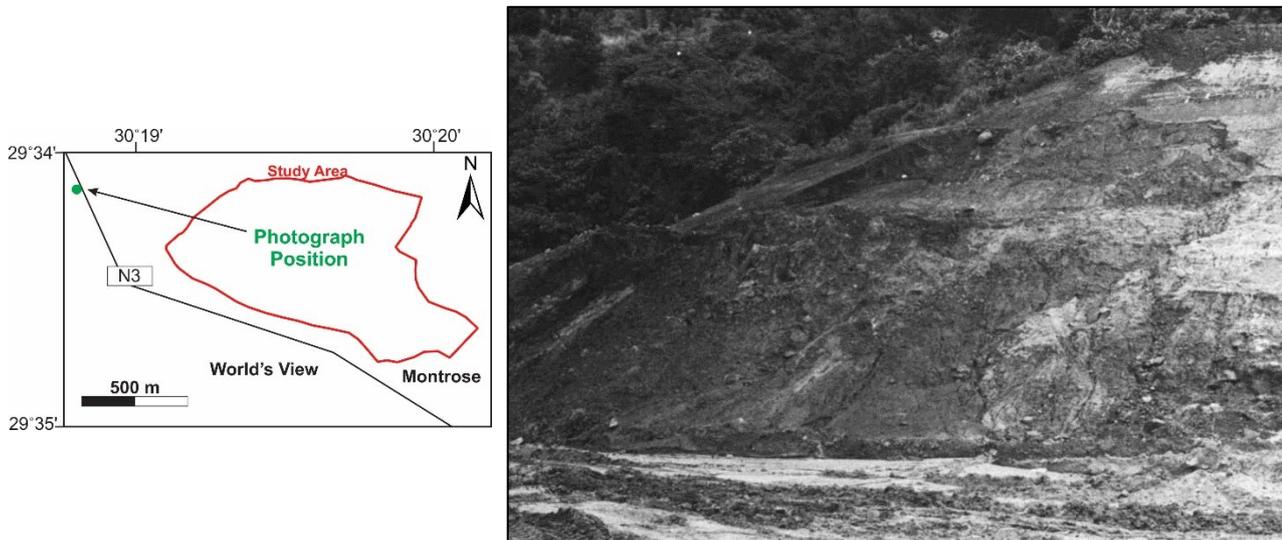
Figure 3.6: Cutting failure near Hilton in 1967 (adapted from Maurenbrecher and Booth, 1975).

main cause of failure was deemed to be inadequate drainage and the possible contribution from naturally unstable subsoil was not mentioned.

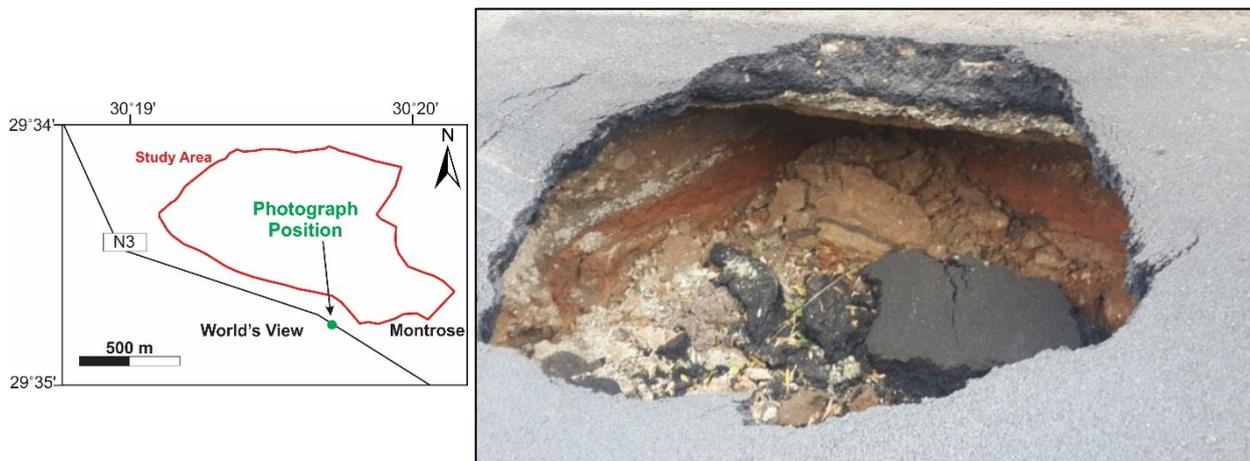
Figure 3.7: Sinkhole development in the N3 Highway in 2015.

In 2015, a large sinkhole developed in the southbound carriageway of the N3 Highway (Figure 3.7).

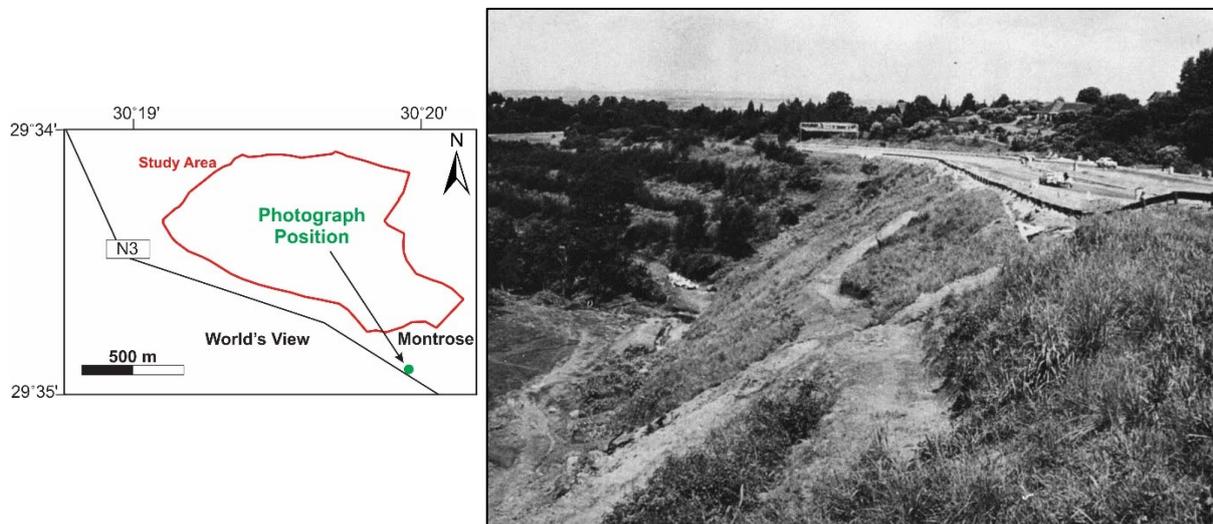
Figure 3.8: Rickivy embankment failure in 1970 (adapted from Maurenbrecher and Booth, 1975).

Arguable, the most documented historical geohazard problem in the Pietermaritzburg area is the zone of slope instability around Rickivy and Athlone below the World's View escarpment. Mass movement in the area started with failure of the Rickivy fill material during construction in 1957 (Maurenbrecher & Booth, 1975). In 1965, initial slumps resulted in minor damage which was rectified by resurfacing of the road. In 1969, cracking occurred and in early 1970, movement accelerated and continued until the end of the rainy season when movement ceased (Maurenbrecher & Booth, 1975). In 1971, the natural slope to the east of the fill failed resulting in a vertical displacement of about 2 m as shown in Figure 3.8.

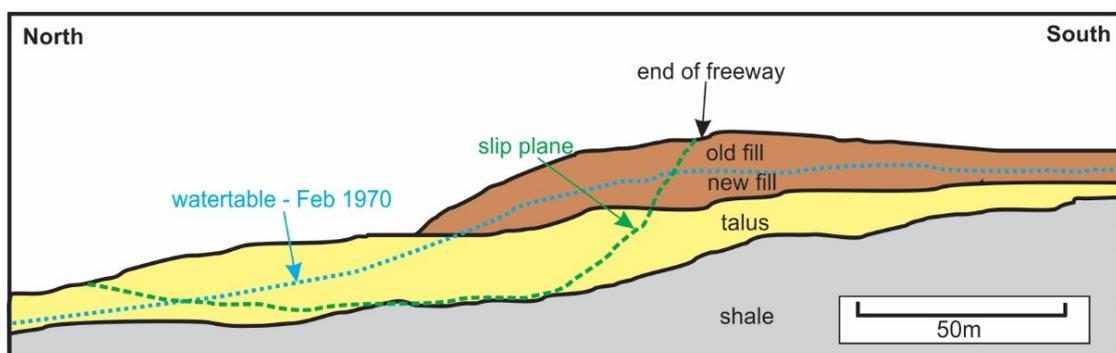
Figure 3.9: Cross-section of the Rickivy embankment (adapted from Maurenbrecher and Booth, 1975).

Geotechnical investigations undertaken on the Rickivy Embankment to establish the cause of failure concluded that the slip surface occurred in the *in-situ* talus below the fill material (borrowed talus material) as illustrated in Figure 3.9 (Maurenbrecher & Booth, 1975).

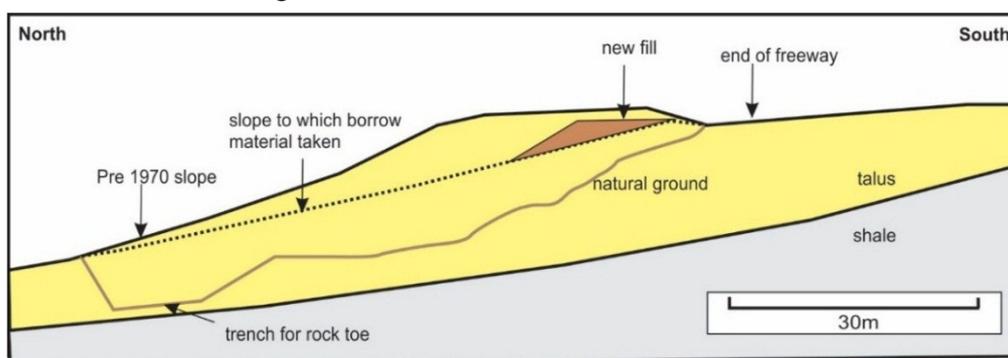
Figure 3.10: Cross-section of the Athlone slope failure (adapted from Maurenbrecher and Booth, 1975).

Following a heavy period of rainfall in 1971, vertical tension cracks marked the initiation of the Athlone slope failure as illustrated in Figure 3.10.

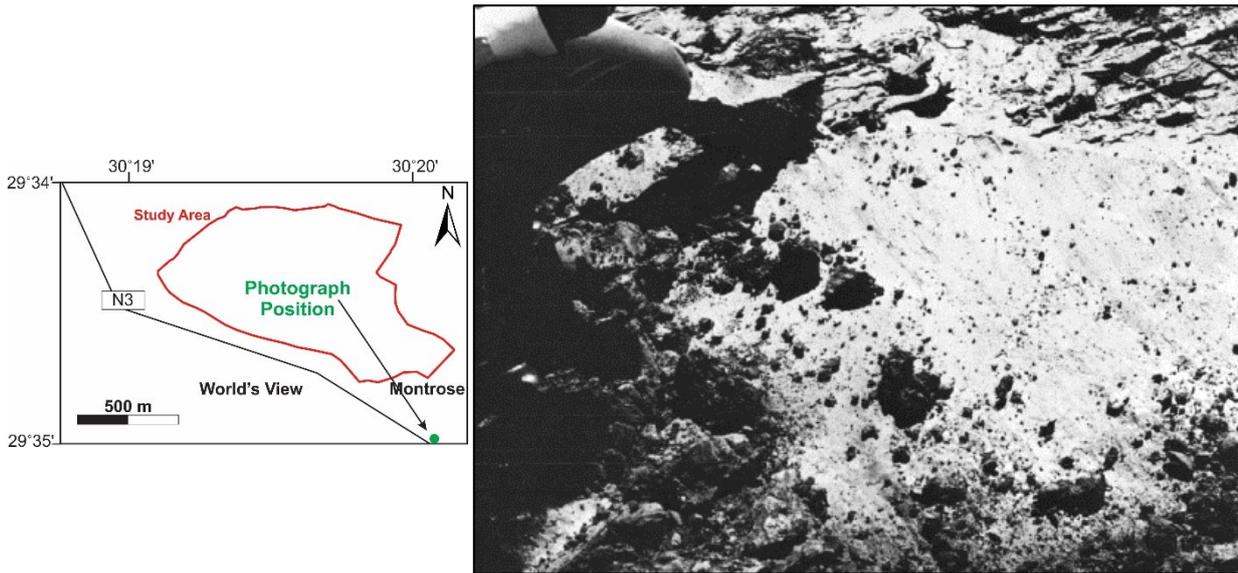
Figure 3.11: A shear plane on the Athlone Slope (adapted from Maurenbrecher & Booth, 1975).

During the reconstruction phase of the failed slope multiple shear planes were observed by contractors as illustrated in Figure 3.11.

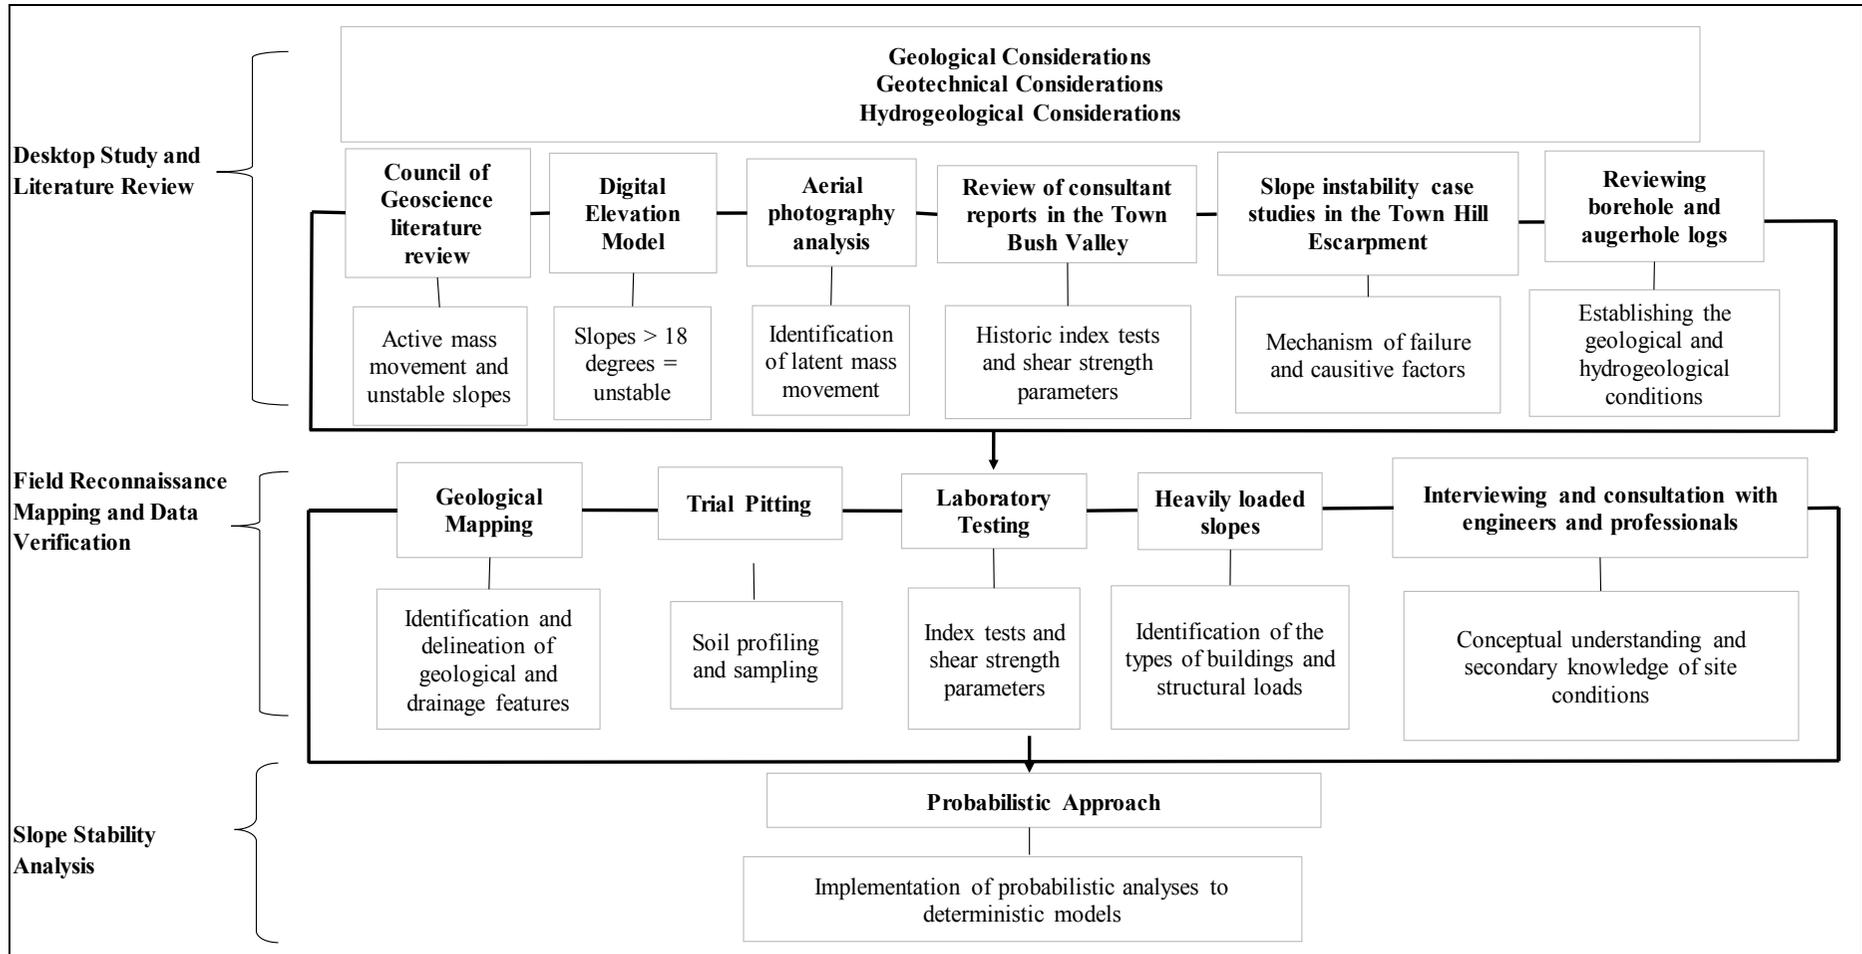
Figure 4.1: General flow chart indicating the scientific steps followed during the study.

The general scientific processes followed in this study is presented in Figure 4.1.

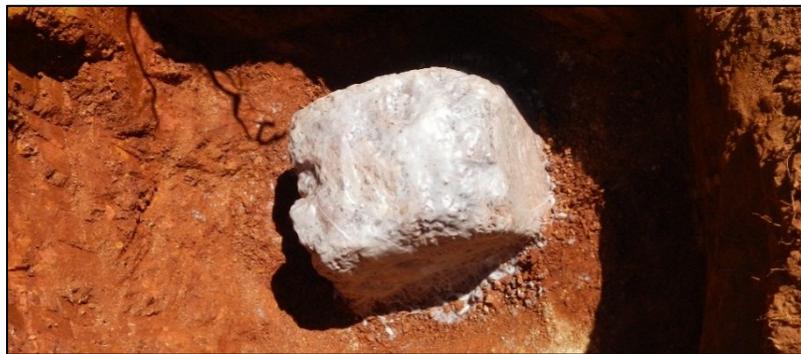
Figure 4.4: Waxed soil block at trial pit MPD3.

Undisturbed sampling involved the cutting of a block sample and the application of wax to the *in-situ* soil block in order to create a rigid mould and to preserve moisture at the *in-situ* condition as illustrated in Figure 4.4. The coated block was carefully extracted from the soil and transported to the laboratory for further testing.

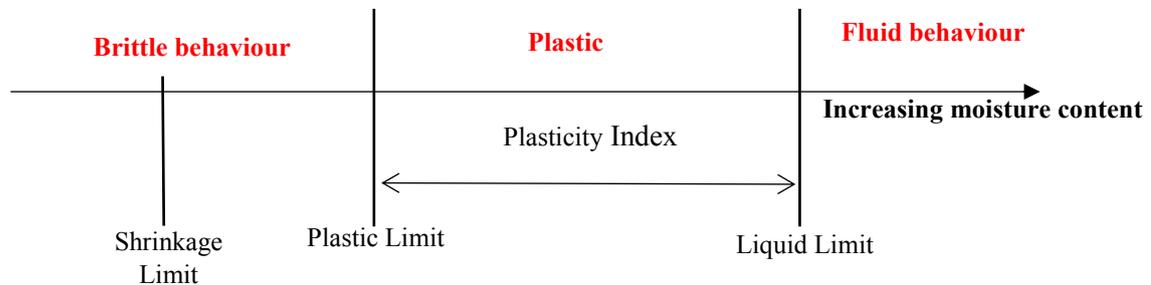
Figure 4.5: Changes in the soil state when water is added (adapted from Knappet & Craig, 2012).

The physical and mechanical behaviour of fine grained soils is linked to three states: brittle, plastic and fluid behaviour, the concept of which is shown in Figure 4.5 (Knappet & Craig, 2012).
