**GEOTECHNICAL CHARACTERIZATION
AND SLOPE STABILITY ANALYSES
OF THE TOWN BUSH VALLEY,
PIETERMARITZBURG
SOUTH AFRICA**

Keval Singh

2018

Submitted in fulfilment of the requirements for the degree of Master of Science

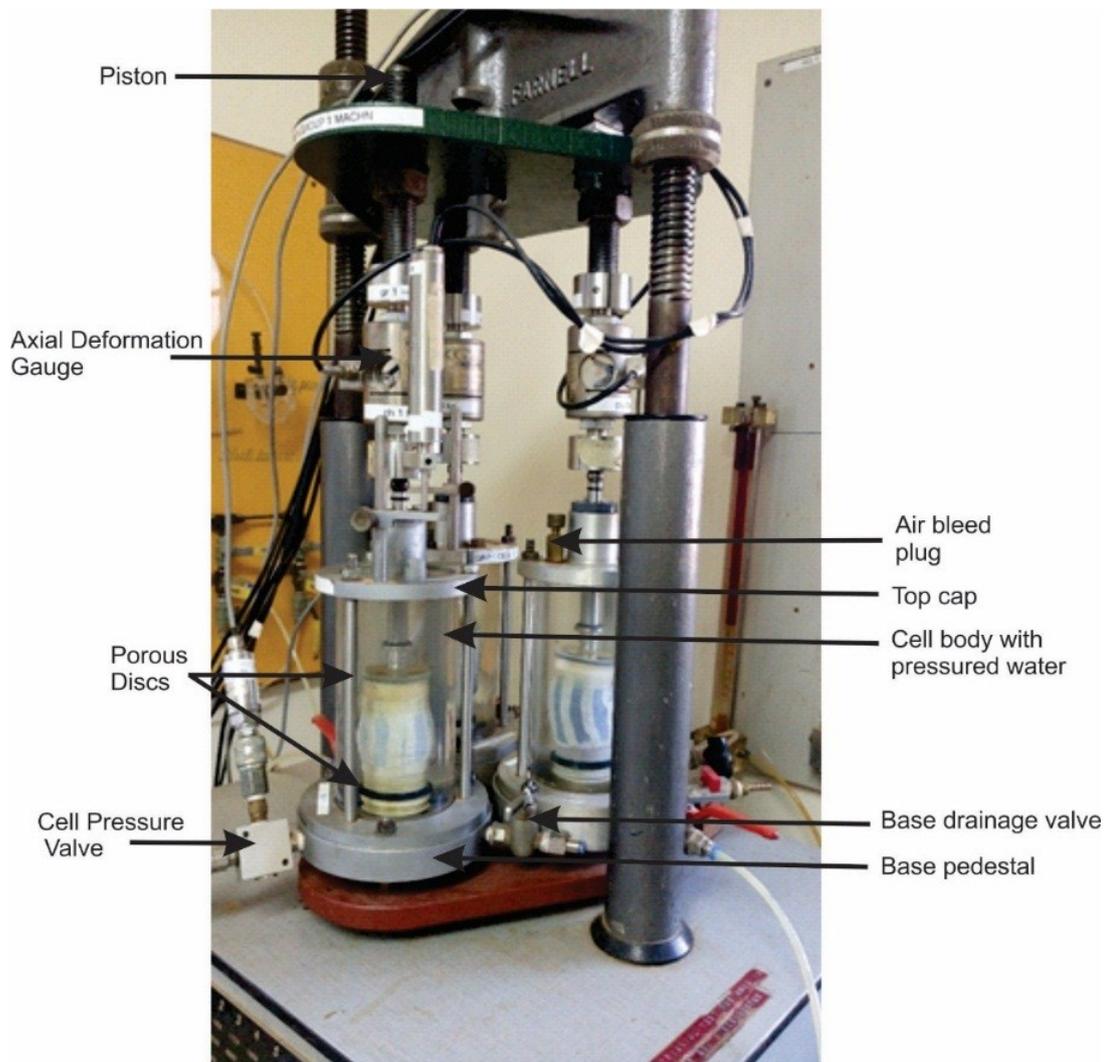
Figure 4.6: Typical triaxial system setup in a laboratory.

Consolidated-drained tests are carried out by consolidating the specimen under a confining pressure and allowing drainage during the compression stage (Head, 1998). The test has the advantage that drainage conditions can be controlled, enabling saturated soils of low permeability to be consolidated and pore water measurements to be made (Knappet & Craig, 2012). The rate of shearing must be slow enough to allow the complete dissipation of the resulting pore water pressure and to ensure that no excess pore water pressure develops (Head, 1998). A routine consolidated-drained triaxial test consists of three stages namely saturation, consolidation and compression. The typical layout of a triaxial pressure system with the ancillary apparatus is illustrated in Figure 4.6.

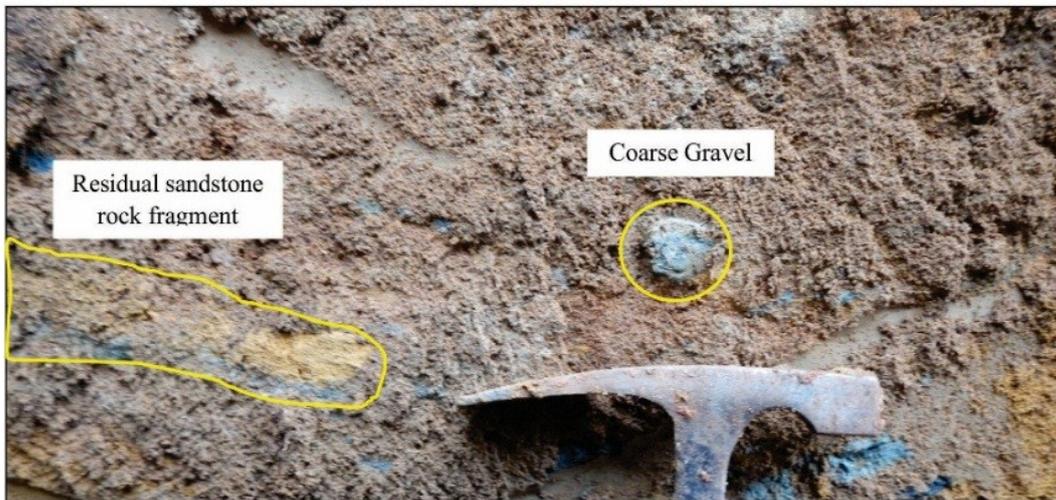
Figure 5.10: Matrix supported talus profile intersected in trial pit LNP1.

Trial pitting in the LNP generally intersected similar profiles to the borehole logs presented in digital Appendix B1.4. In trial pit LNP1, residual siltstone and sandstone rock fragments were observed to form part of the matrix composition as illustrated in Figure 5.10 and 5.11.

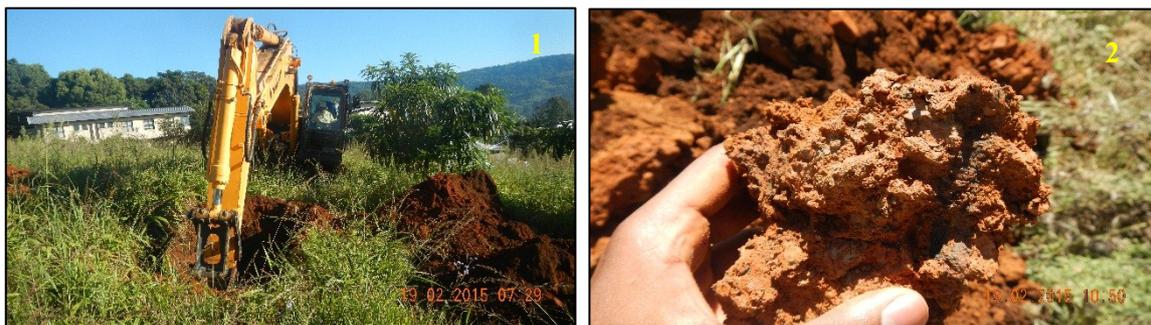
Figure 5.12: Excavator used during trial pitting (Photo 1), talus material intersected in trial pit MPD2 (Photo 2).

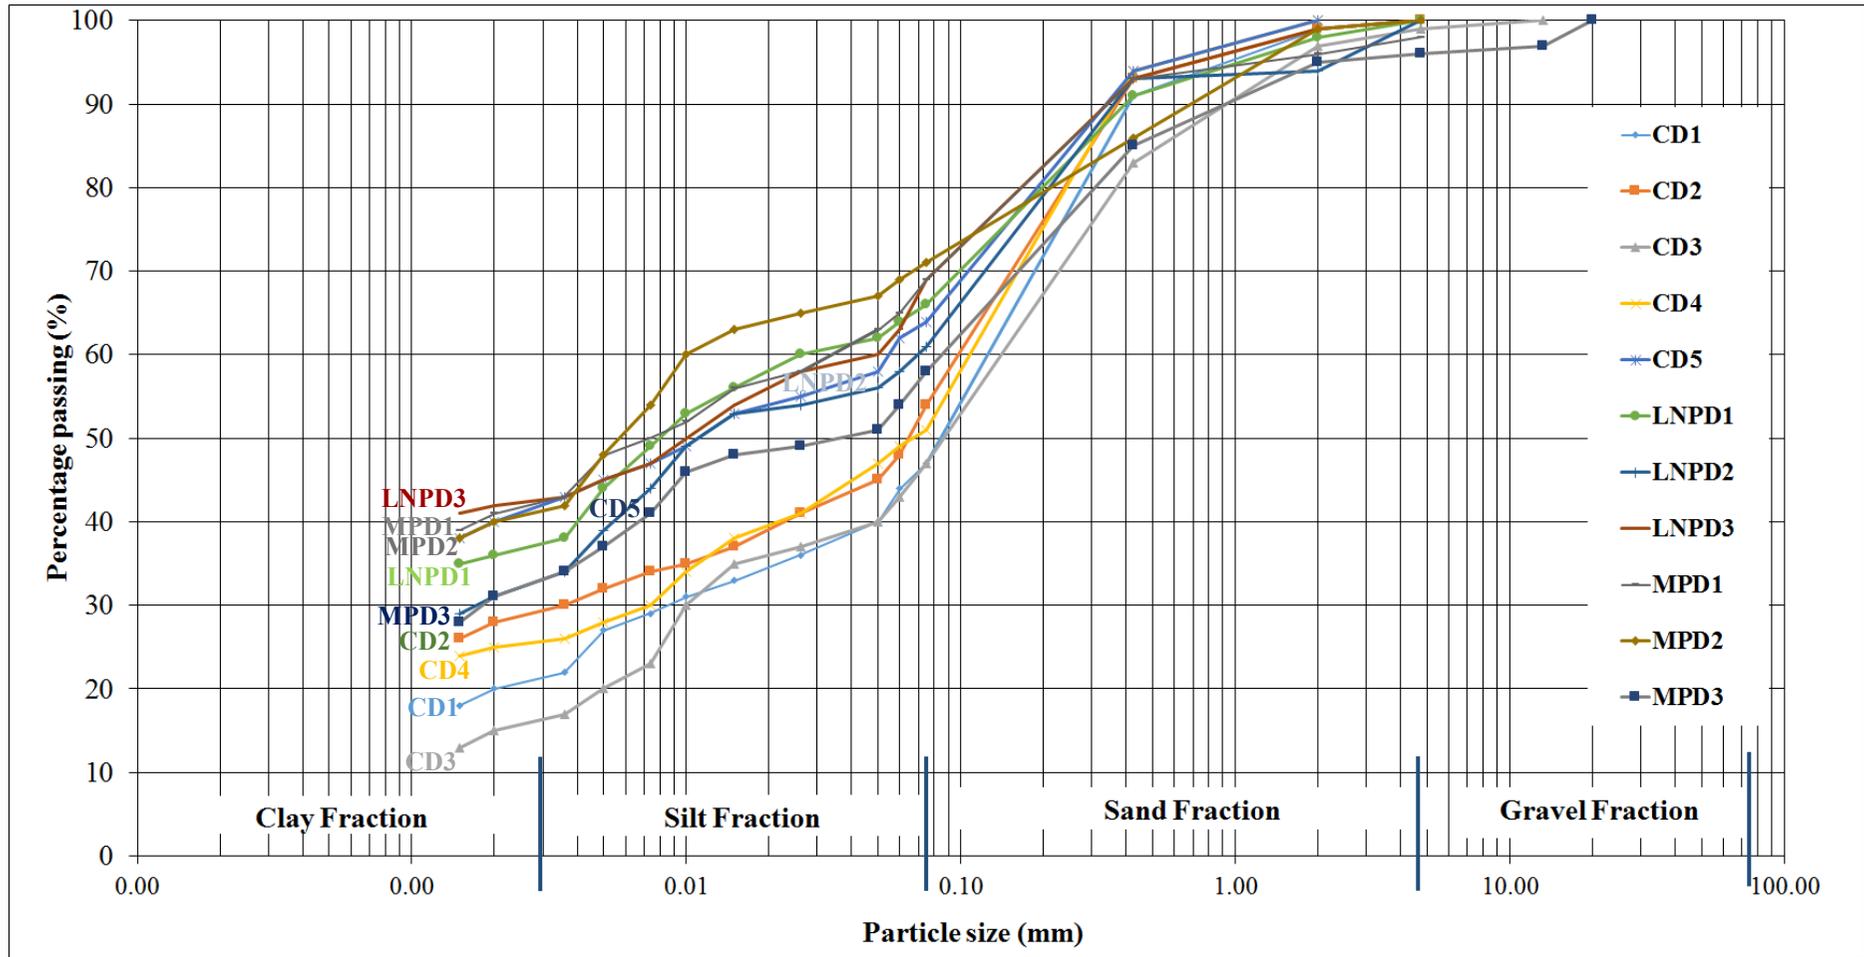
Figure 5.13: Particle size distribution curves for the talus material.

The particle size distribution (PSD) results are presented in Figure 5.13, with the full set of results presented in Appendix B2.

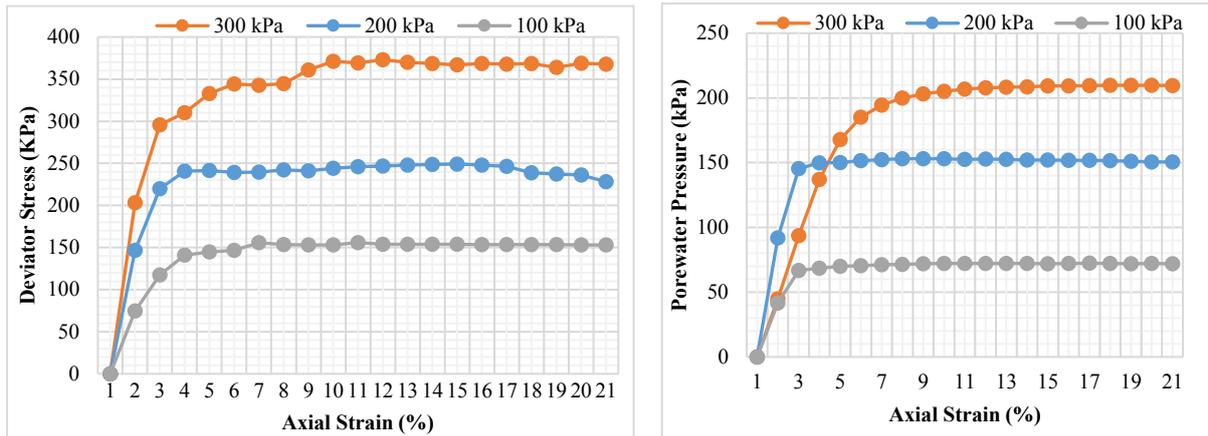
Figure 5.15: Sample MPD3 - Deviator stress (kPa) vs Axial strain (%) (left) and Pore water pressure (kPa) vs Axial strain (%) (right).

The deviator stress vs axial strain curves for the 100 kPa and 200 kPa cell pressures respectively show no pronounced peak even at high axial strain rates (17-20 %). Head (1998) reasoned that in soils in which the axial stress does not readily reach a maximum value, failure is deemed to have occurred when a 20 % axial strain has been reached. In the case of the talus test specimens, the maximum deviator stresses were taken at the maximum strains tested. Figure 5.16 illustrates barreling failure of the MPD and LNPD specimens. In a sample that fails completely by barreling failure there is no definite failure point as the deviator stress increases slightly with strain (Smith, 1990).

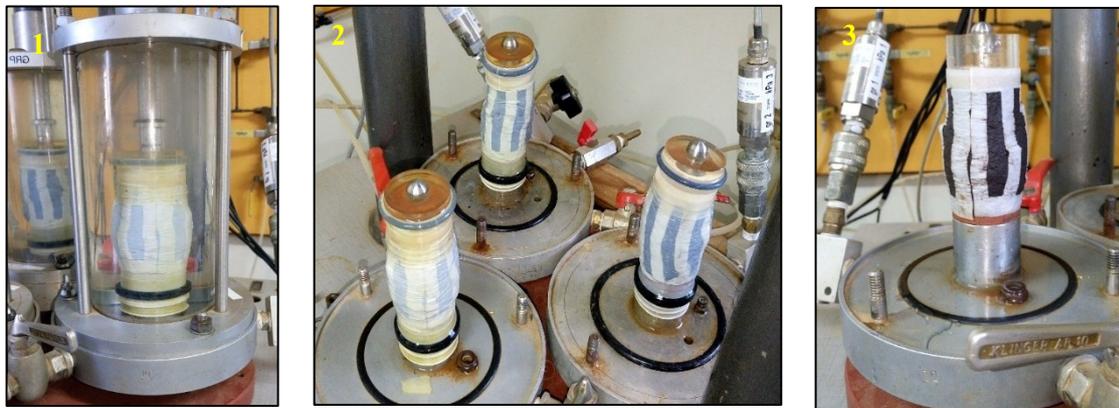
Figure 5.16: Barreling failure of specimens (Photo 1 - sample LNPD3; Photo 2 - LNPD specimen sets; Photo 3 - sample MPD3).

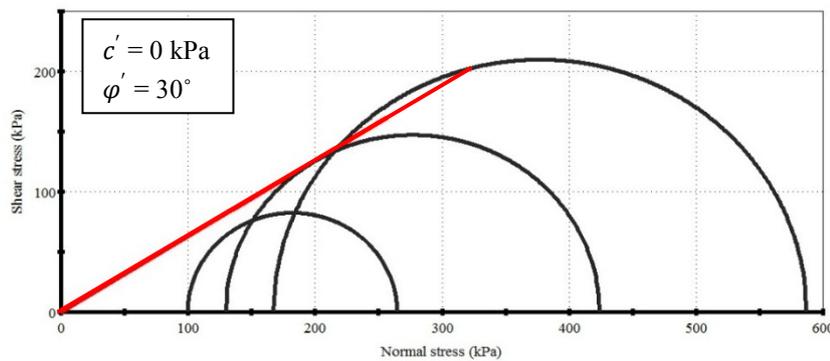
Figure 5.17: Mohr circles used to define the effective cohesion and effective angle of friction for sample LNPD3.

The effective stress parameters (σ_1' and σ_3') were used to construct Mohr-circle diagrams using the Rockscience Inc. software package RocData (version 3.0). Mohr-circles were constructed for the tested LNPD3 and MPD3 samples and tangents were drawn to the Mohr-circles from which the effective shear strength parameters, c' and ϕ' were obtained. The diagrams are illustrated in Figure 5.17 and 5.18 respectively. The tangent intersection with the Y-axis represents the effective cohesion value and the acute angle formed with the tangent and the effective cohesion value intercept, represents the effective angle of internal friction.

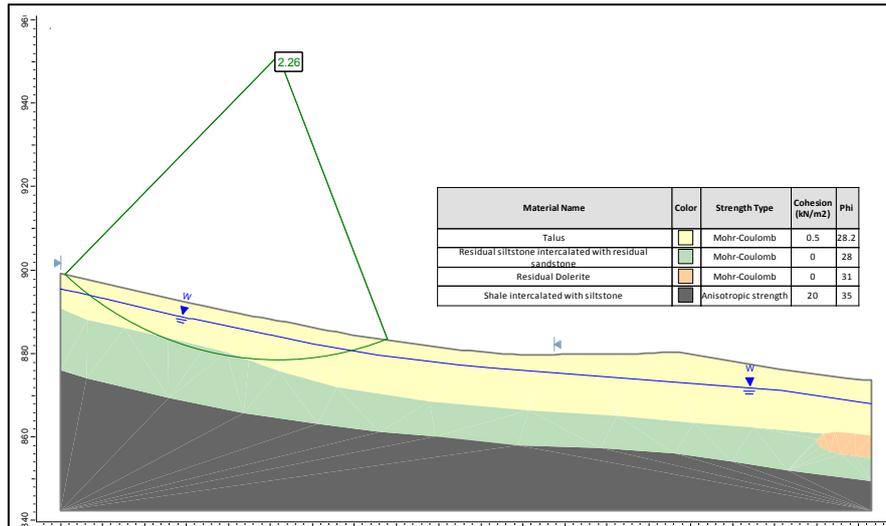
Figure 5.20: LNPd analysis 1 scenario 1, at the measured groundwater table.

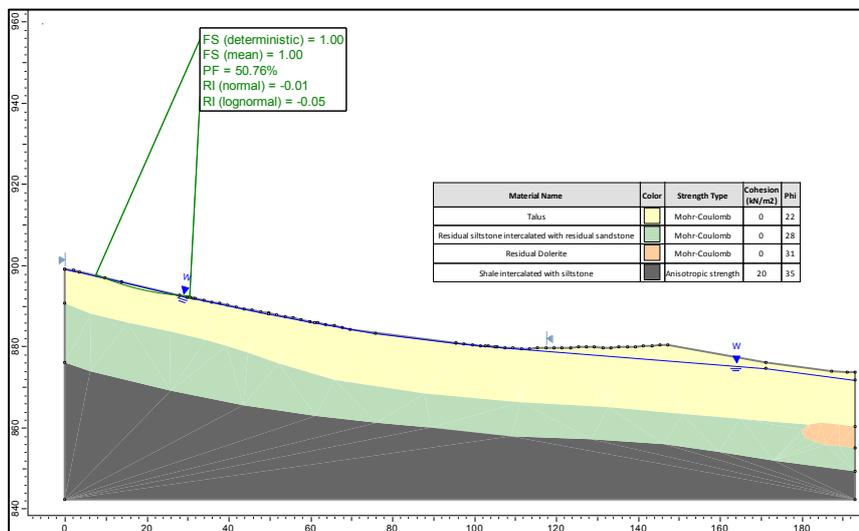
Figure 5.21: LNPd analysis 1 probabilistic analysis, at the maximum increase in the groundwater table using the minimum range of effective shear strength parameters.

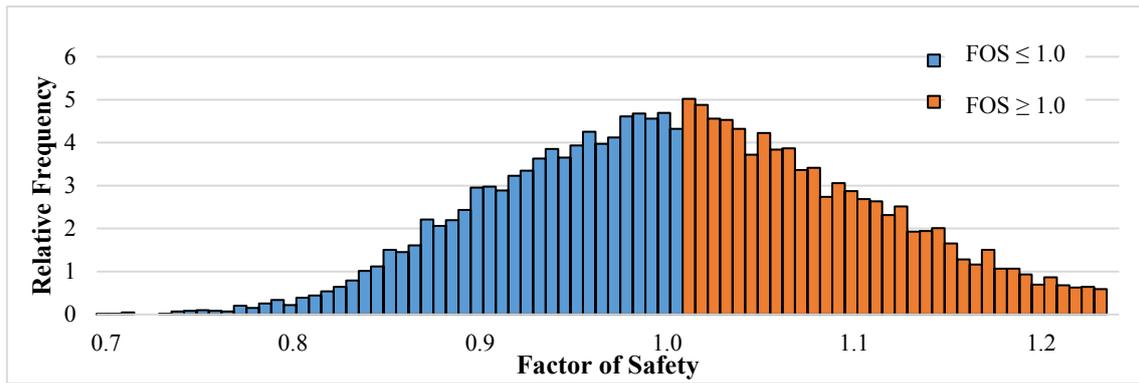
Figure 5.22: LNPD analysis 1 scenario 4, histogram of the relative frequencies for the FOS, at the maximum increase in the groundwater level.

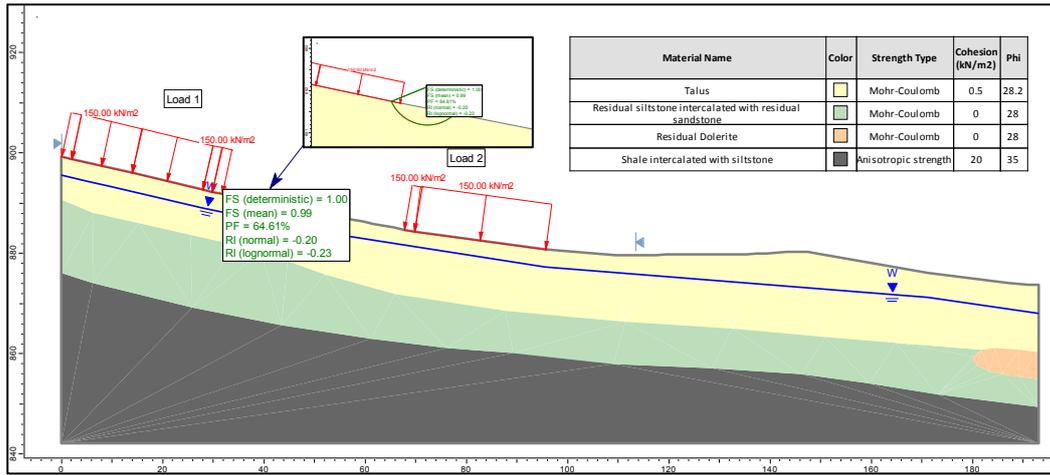
Figure 5.23: LNP analysis 2 probabilistic analysis, at the measured groundwater level using the mean effective shear strength parameters.

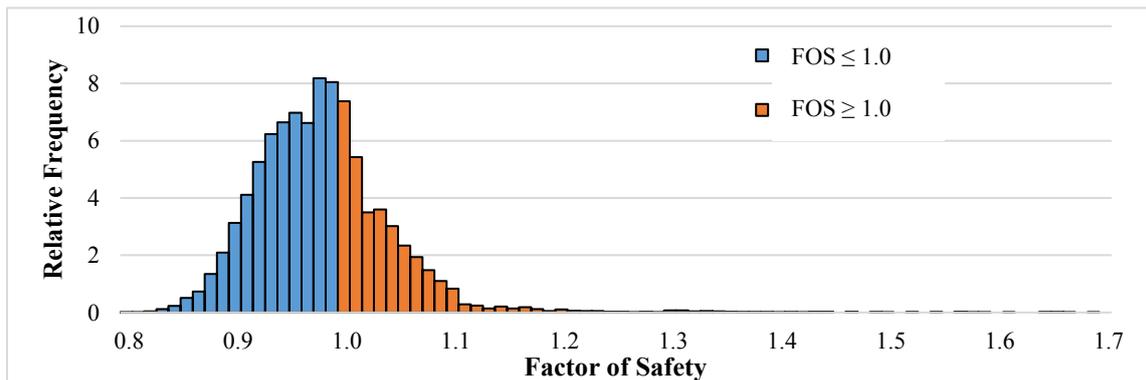
Figure 5.24: LNP analysis 2, histogram plot of the relative frequencies for the FOS, at the measured groundwater table.

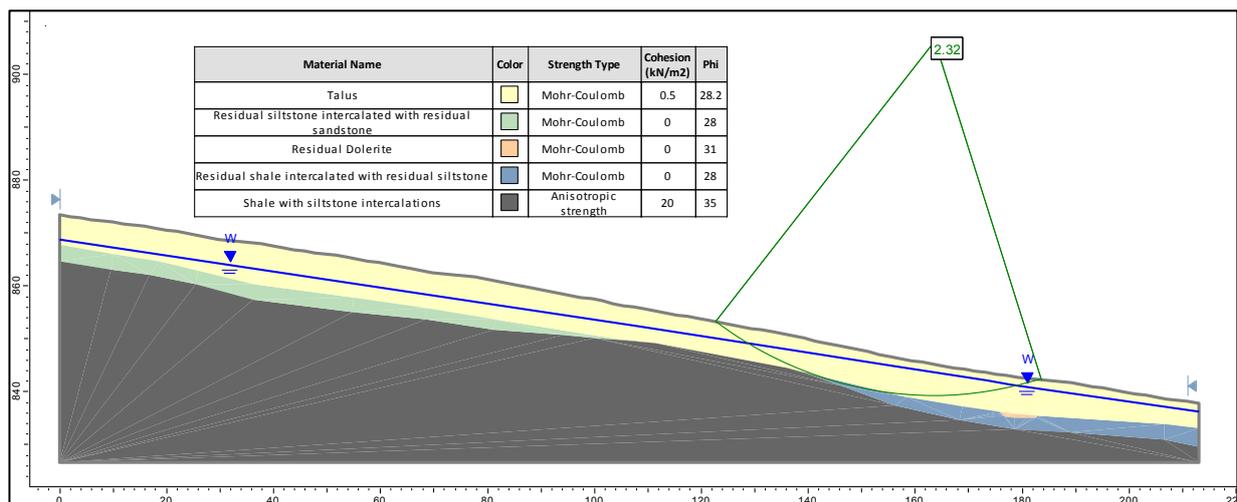
Figure 5.25: MPD scenario 1 analysis 1, at the measured groundwater table.

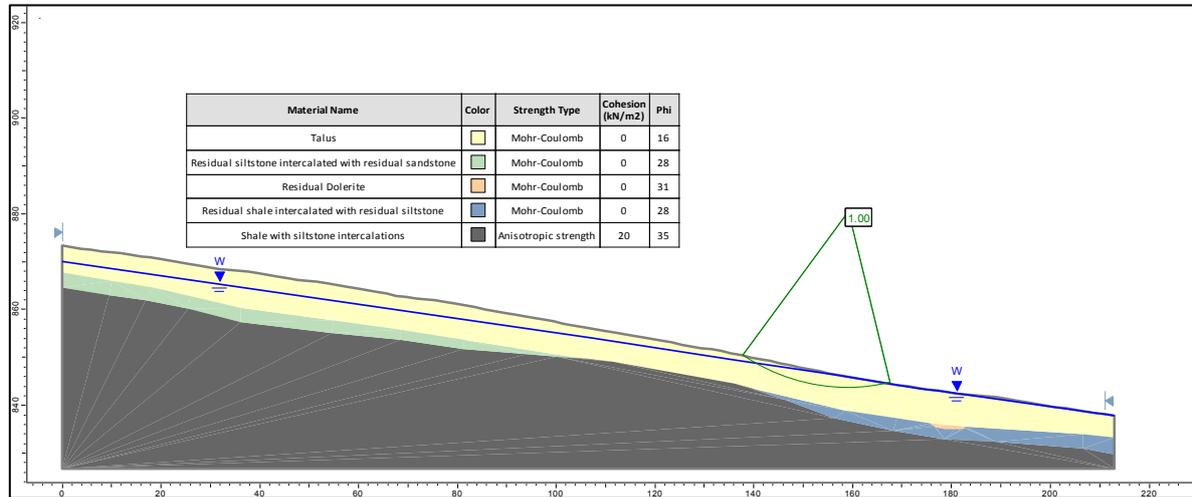
Figure 5.26: MPD analysis 1 scenario 5, at the maximum groundwater table.

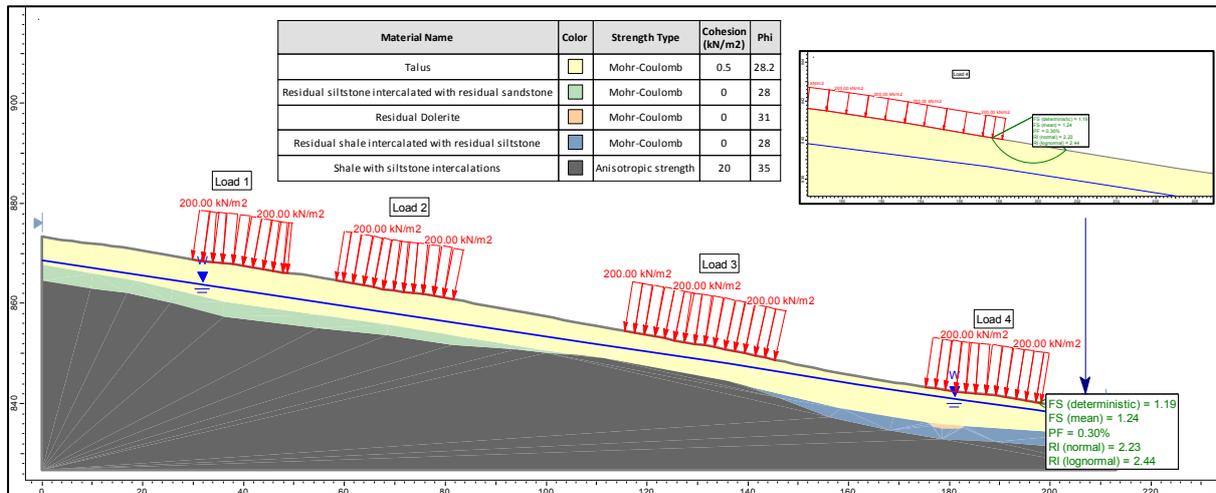
Figure 5.27: MPD analysis 2 probabilistic analysis, at the measured groundwater table using the mean effective shear strength parameters.

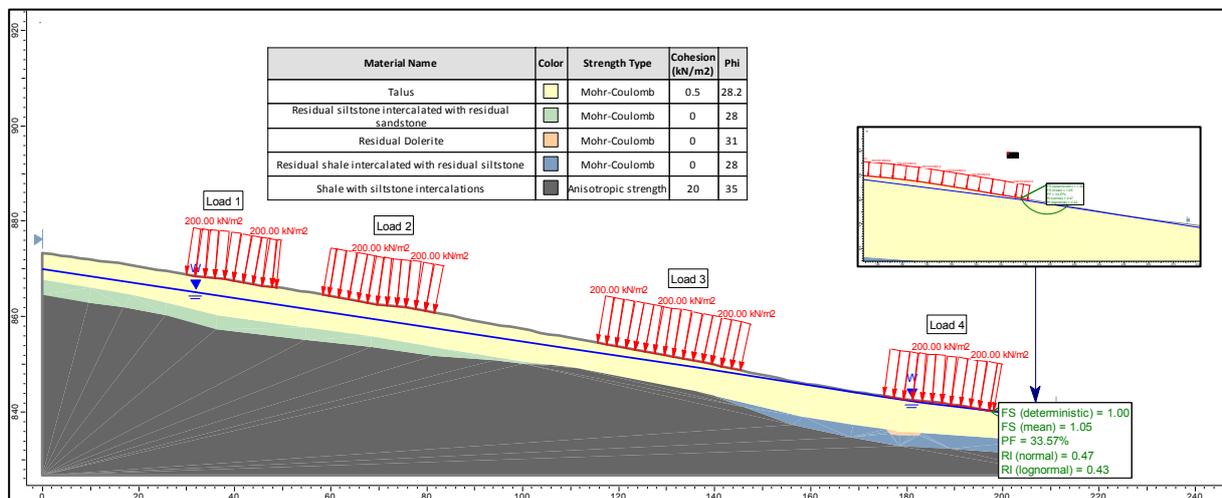
Figure 5.28: MPD analysis 2 probabilistic analysis, at the maximum increase in the groundwater table using the mean effective shear strength parameters.

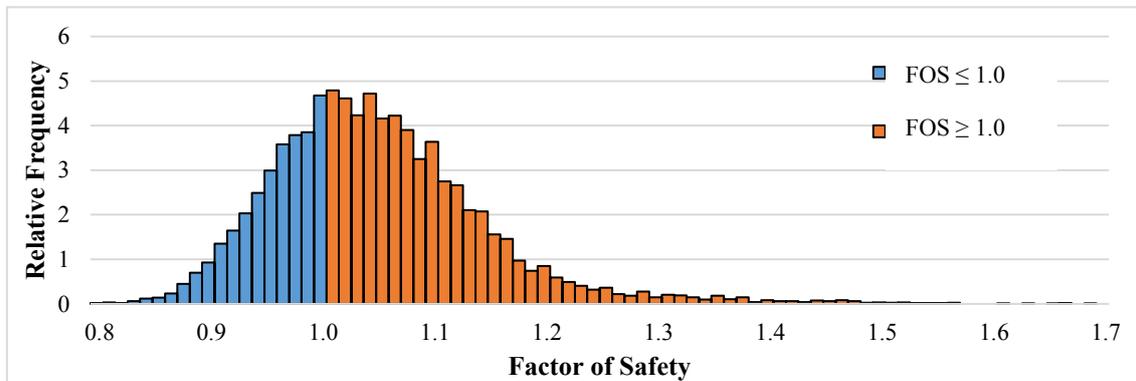
Figure 5.29: MPD analysis 2, histogram plot of the relative frequencies for the FOS, at the maximum increase in the groundwater table.
