**THE DESIGN AND DEVELOPMENT OF A MECHANISED  
SUPPORT SYSTEM FOR TABULAR STOPES**

**A dissertation submitted to the Faculty of Engineering, University of Kwa-Zulu Natal, in fulfilment  
of the requirements for the degree Master of Science in Engineering**

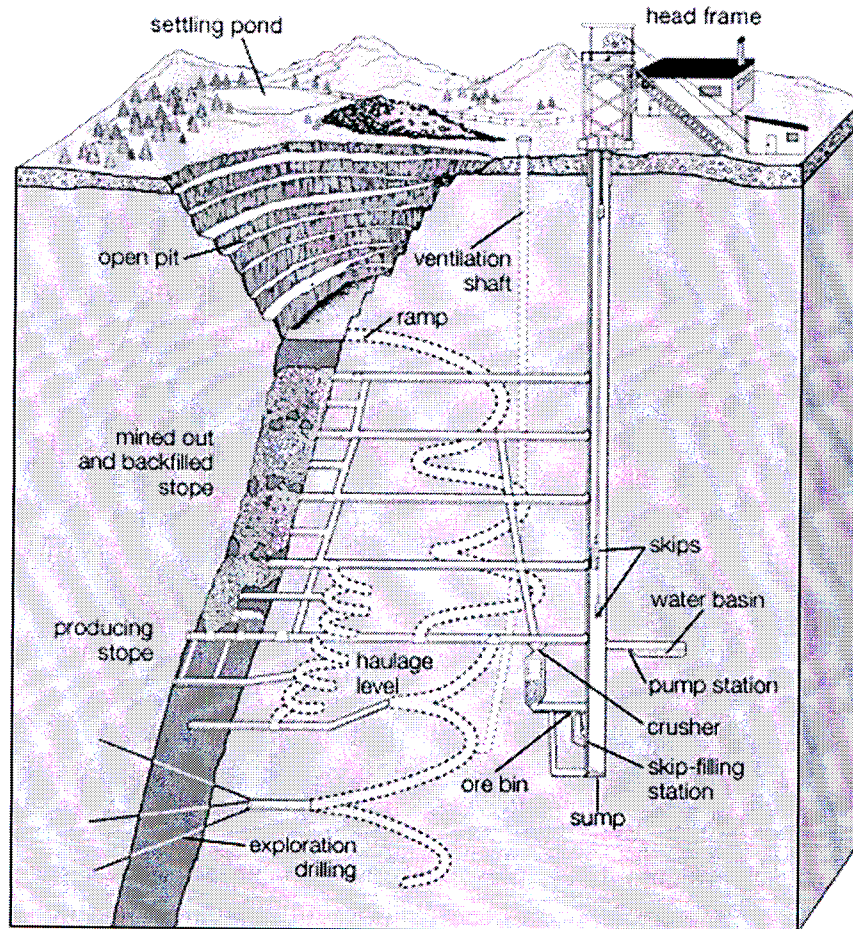
A typical mine layout (Figure 1-1) would entail a straight vertical shaft being drilled and blasted to a specified depth (A mine can have a depth as high as 3 km's in some cases). This would involve the use of shaft sinking technology that are generally pneumatic or hydraulic driven drilling rig systems. Blasting involves loading the drilled holes with a specific type of explosive and igniting the explosive with an initiating device.

*Figure 1-1 A typical mine layout (After Hamrin, 1997)*

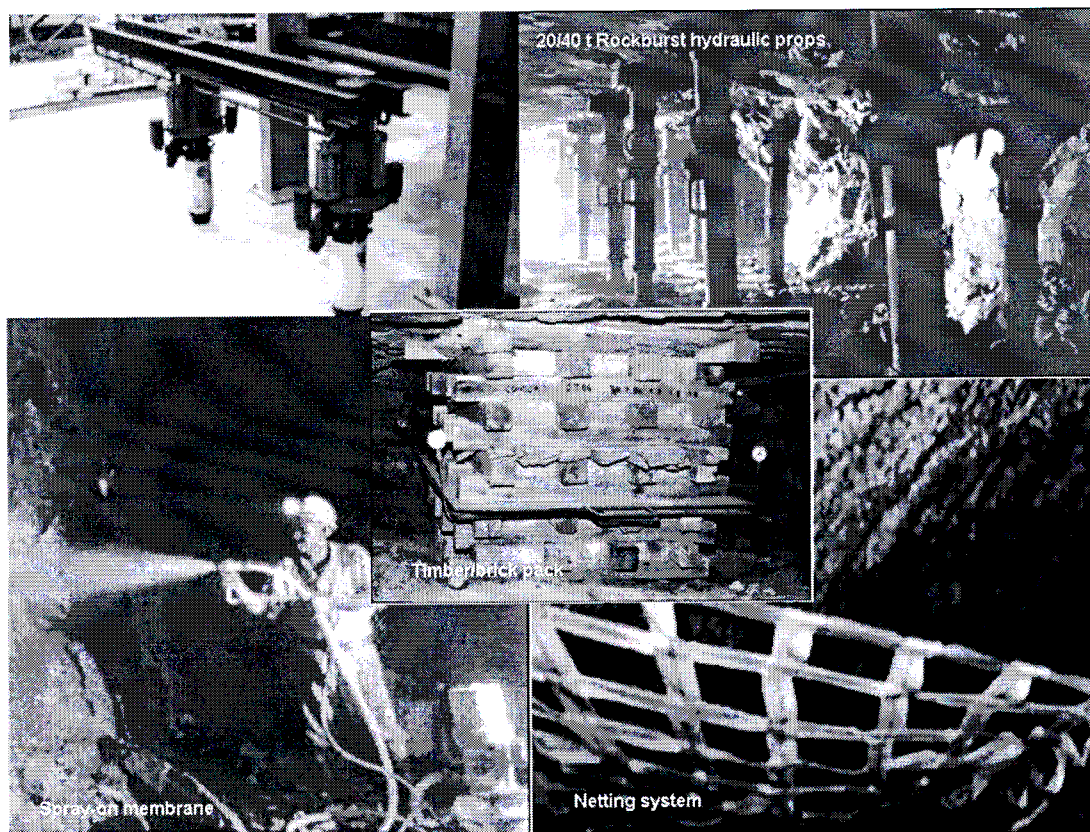
With regard to the issue of sufficient areal coverage, the CSIR: Division of Mining Technology was involved in the development of alternative support systems that offered extensive coverage. These included the twin beam support system, netting systems installed between prop units and spray-on membranes that provide 100% coverage in the applied area (Ryder et al., 2002). Figure 1-3 shows photos of these systems and additionally, a stope installed with rockburst props, and a timber/brick pack.

*Figure 1-3 Group of photos showing different support system types*

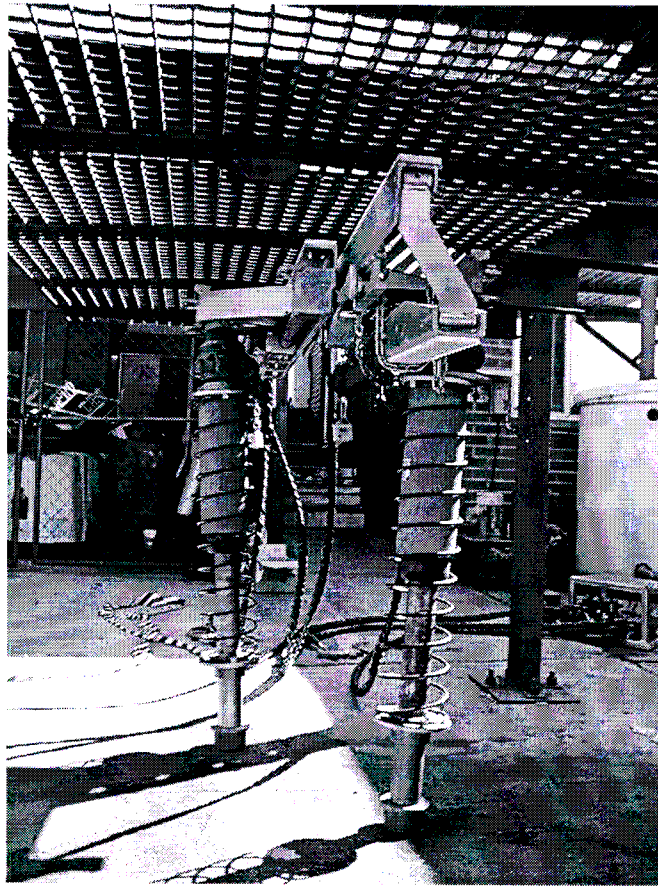
*Figure 1-4 The walking beam stope support system*

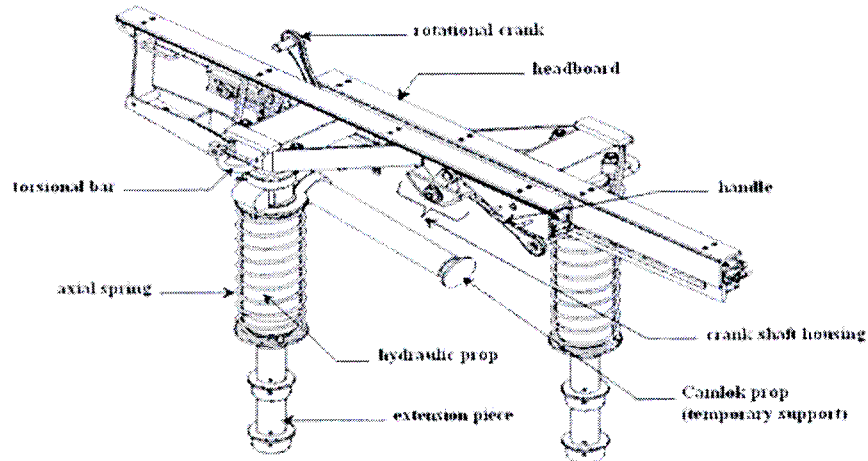
*Figure 2-1 Main components of the system*

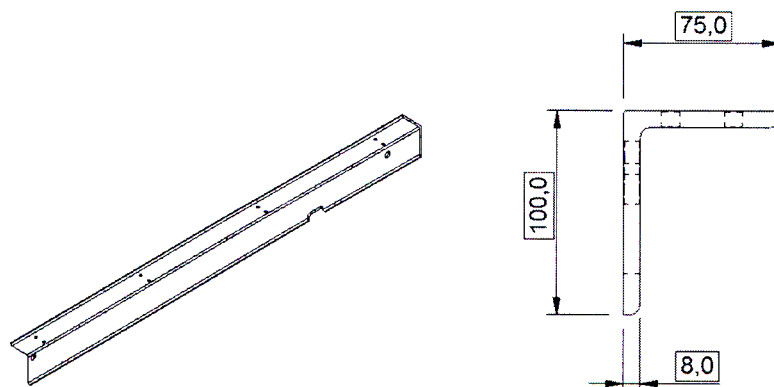
The headboards are 8 mm angle-iron sectioned mild steel beams that have nominal lengths of 1.4 m and 1.5 m respectively (Figure 2-2). The angle-iron beam cross-section was selected because it enables the hydraulic cylinders to be attached efficiently to the beams and thus provides greater dynamic flexibility. The main idea behind having long beams is to give greater areal coverage for the hangingwall and hence extra support. The long axis of the beam is oriented on strike (perpendicular to the face area) such that face-parallel fractures are covered (refer to Appendix B for more information on rock engineering issues).

Figure 2-2 Beam design showing angle-iron cross-section

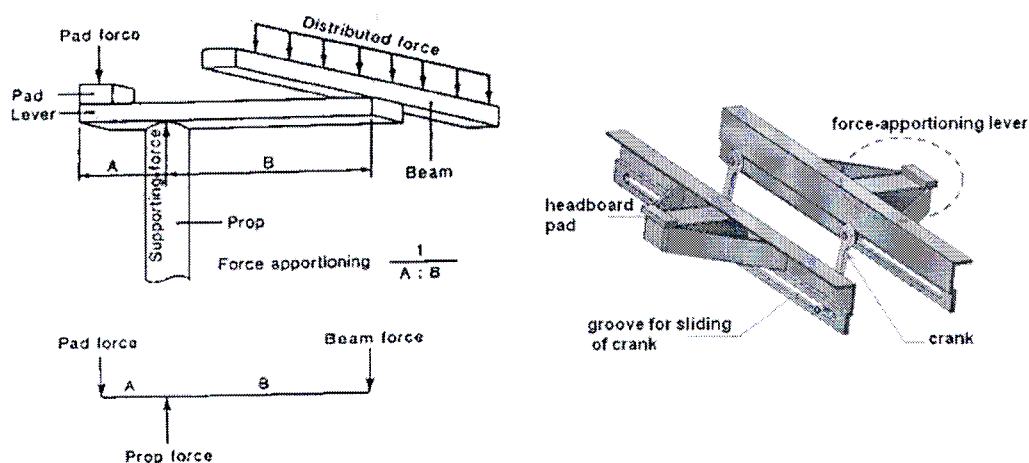
The headboard system is based on a headboard developed by the Chamber of Mines Research Organisation (COMRO) in the early 1990s. It makes use of a force-apportioning lever (Figure 2-3). The principle of force apportioning is to share the prop force between the beam and a metal pad so as to limit the force carried by the relatively weak beam. The relative lengths of the lever arms determine the proportion of force carried by the beam and the pad. The beams carry a sufficient load for providing rockfall protection only, while the aggregate beam and pad are sufficient for controlling rockburst energy (Taggart *et al.*, 1992).

Figure 2-3 Principle of force-apportioning (After Taggart *et al.*, 1992)

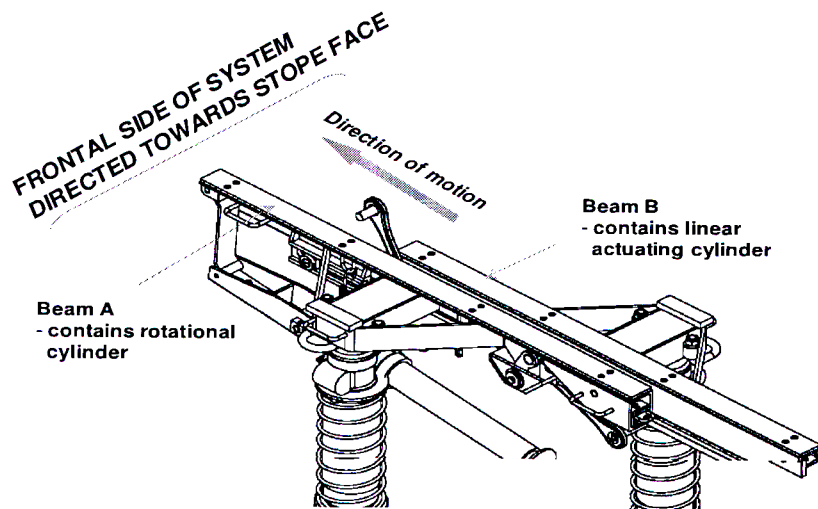
Figure 2-4 shows the beam configuration and its orientation relative to the stope face. Note that the beam on the left contains a rotational cylinder, while the beam on the right contains a linear actuating cylinder. The hydraulic cylinders are designed to provide two specific dynamic actuations of each beam, namely rotation and translation.

Figure 2-4 Headboard set-up

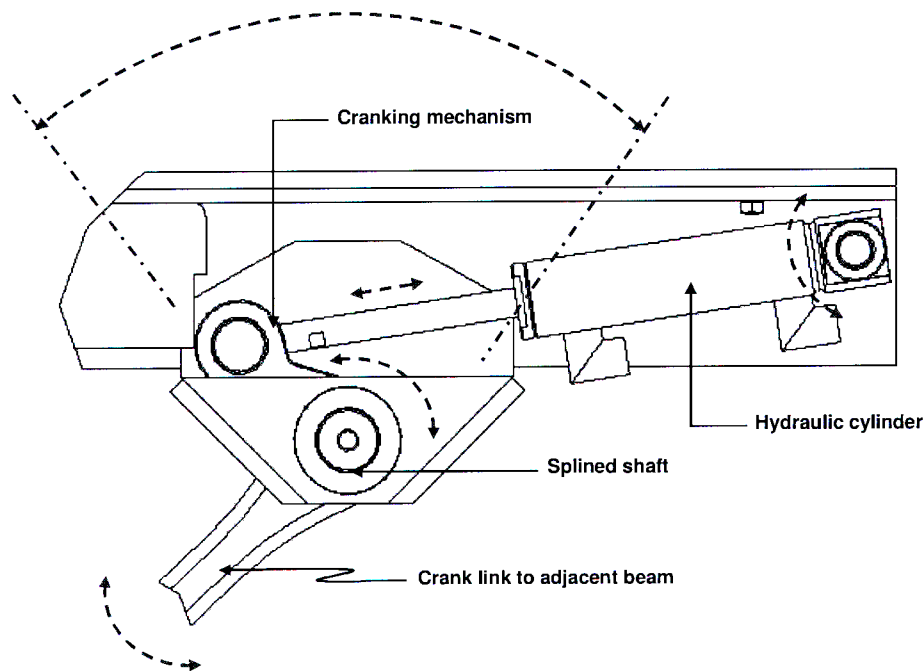
connection. A splined shaft interconnects with the cranking mechanism and the crank linkage is TIG (tungsten inert gas) welded to the opposite end of the splined shaft. All components of this assembly are dimensionally and dynamically constrained by the angle-iron beams and therefore adequate tolerances had to be incorporated into the design. The dynamic functioning of the rotational cylinder system can be visualised from Figure 2-5, from the arrows that indicate the respective directional dynamic motions.

*Figure 2-5 Rotational cylinder components and dynamics*

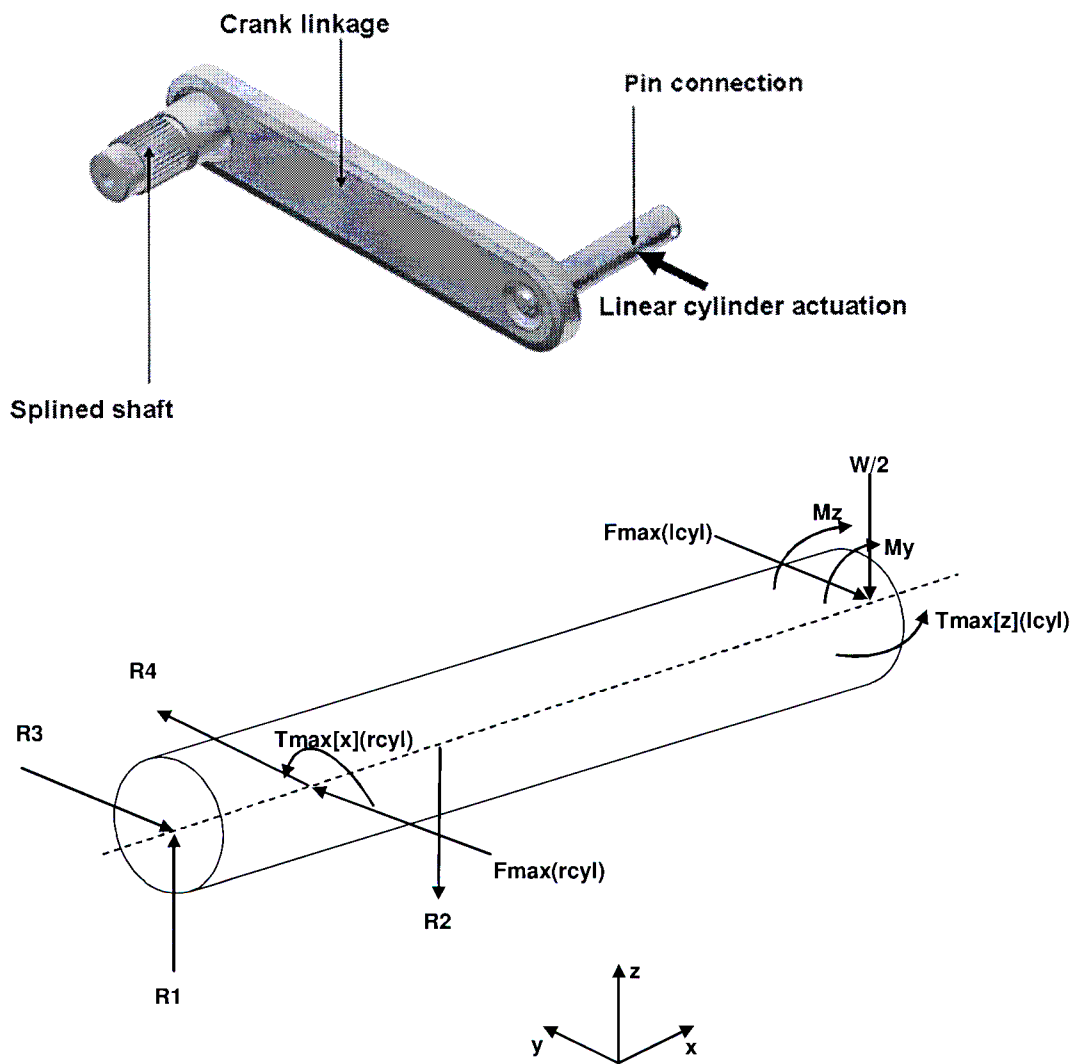
The first step in the design process for the splined shaft involved an analysis of the forces and moments that the system would be subjected to. This analysis was conducted primarily to establish the strength requirements of the splined shaft and ultimately to determine the optimal shaft diameter. The method that was used for the force analysis is presented below.

Figure 2-7 The derived force diagram for the splined shaft

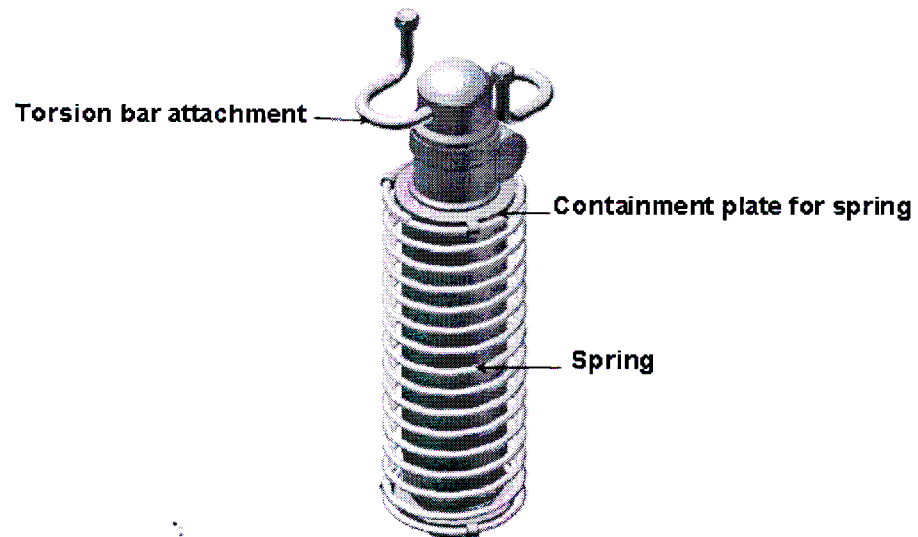
The hydraulic props used were single-acting props. A co-axial spring was designed to provide retractional dynamics to the props. The spring set-up was a temporary solution for the prototype as it was envisaged that double-acting hydraulic props could be developed at a later stage.

*Figure 2-8 Hydraulic prop assembly*

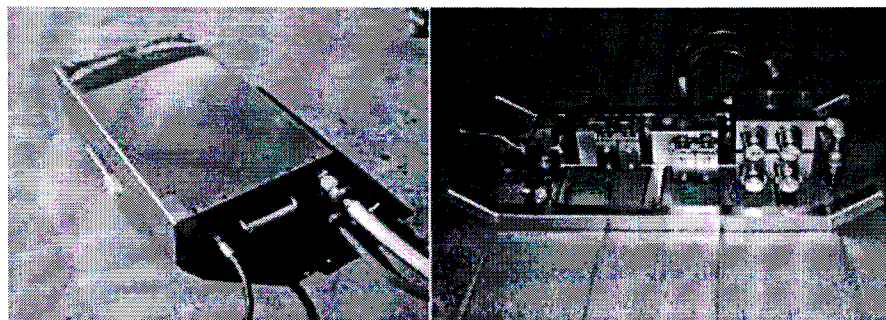
The control valves are mounted in a skid frame, which provides for ease of movement of the valves along the footwall and protection for the valve components. The pump unit (Figure 2-10) is a double-acting unit with an air inlet and a hydraulic output. It is encased in a stainless steel box (to protect the internal components against damage, contamination and corrosion, which are common problems underground) with angle-iron skids for movement along the footwall. The pump was custom designed at PF Hydraulics (Villani, 2003).

Figure 2-10 Pump and control system

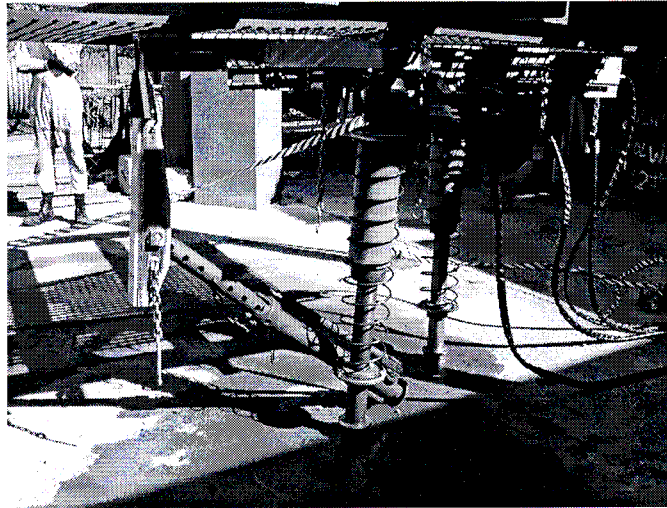
A special headboard has been designed for the Camlok to provide more areal coverage in the face area during drilling operations (Figure 2-11). The headboard is made of 8 mm U-section mild steel and is approximately 0.7 m in length.

*Figure 2-11 Camlok prop attached to front of headboard*

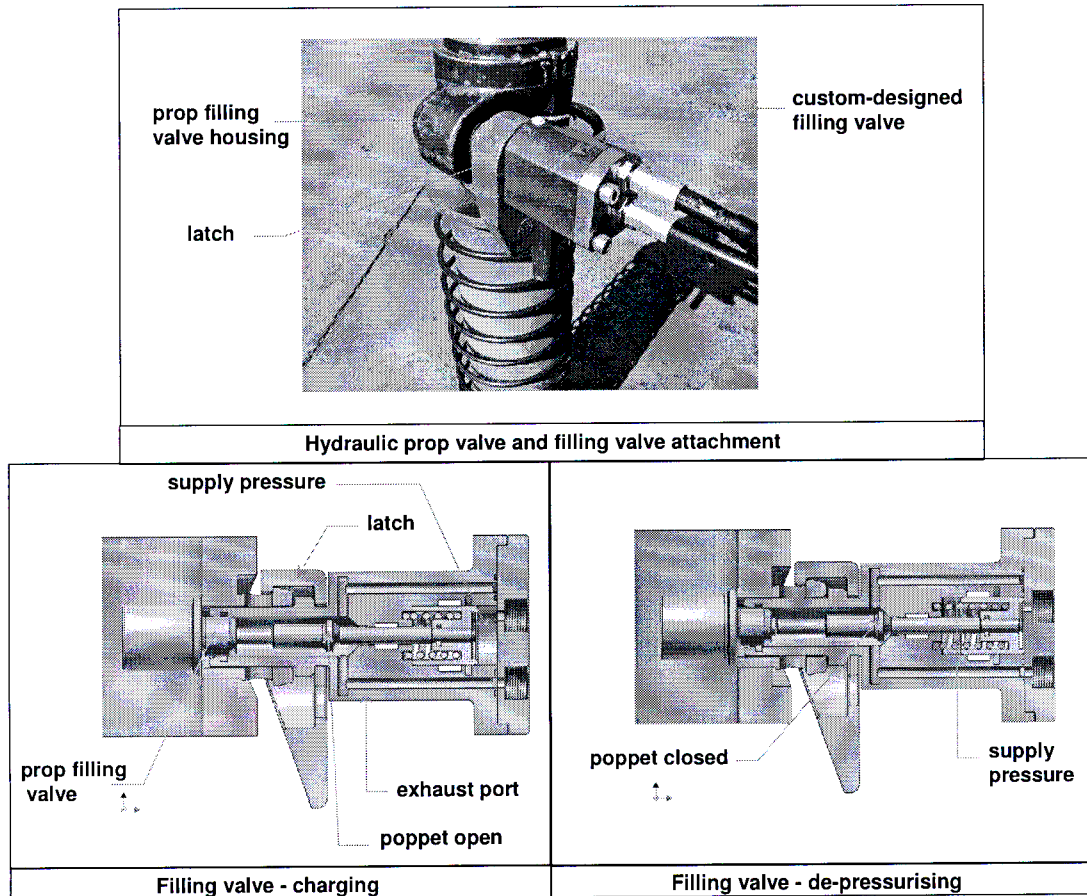
props and is kept in place with a latching device. The charging and discharge hydraulic lines of the filling valves are connected to the hydraulic control system.

*Figure 2-13 Hydraulic prop and filling valve interface*

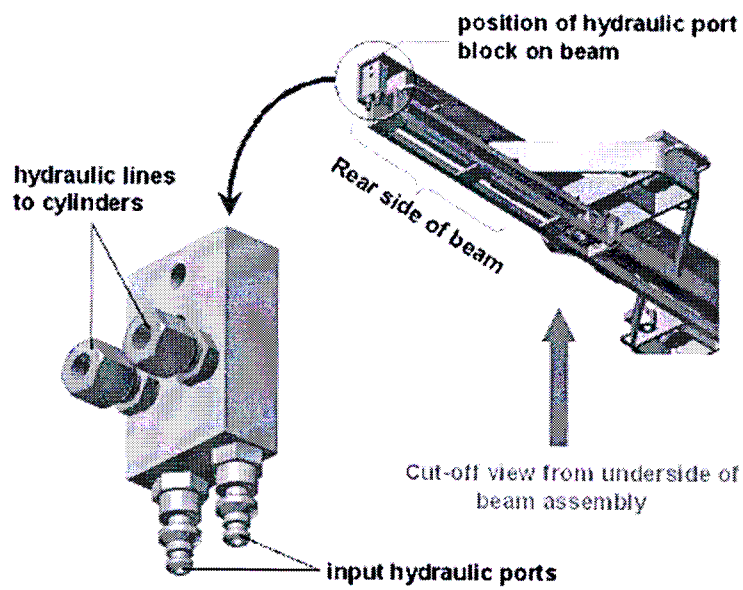
The hydraulic props are then pressurised by means of the hydraulic control system, to set the beams against the hangingwall. Once the beams are set, the hydraulic lines from the control system to the beam cylinders are connected via the port blocks located on the respective beams (Figure 2-14). The system is now ready for operation.

*Figure 2-14 Hydraulic lines for operation of beam cylinders*

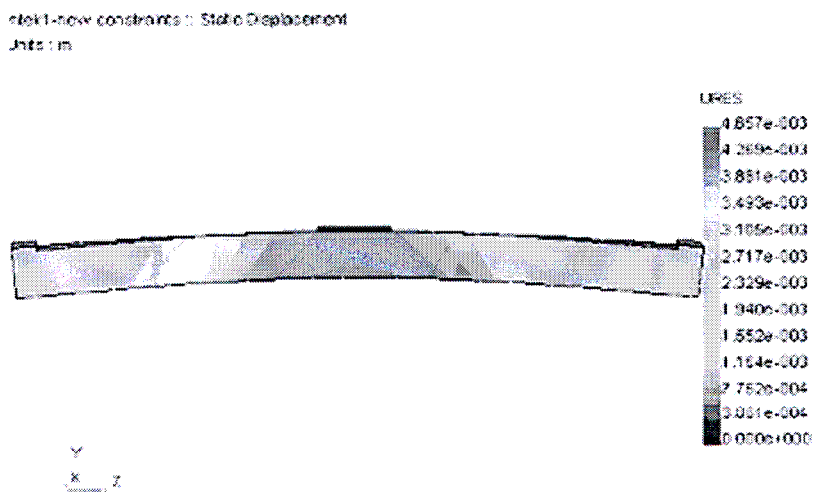
A basic finite-element analysis was performed and the results of the analysis matched well with the results from the actual tests performed. From Figure 3-3 it can be seen that the finite-element model gave a maximum deflection of 4.66 mm (at 20 ton loading) as compared with the actual test, which gave a maximum deflection of 4.58 mm (Figure 3-2) (Ismail, 2002).

Figure 3-3 Front view of headboard showing the position of maximum displacement (After Ismail, 2002)

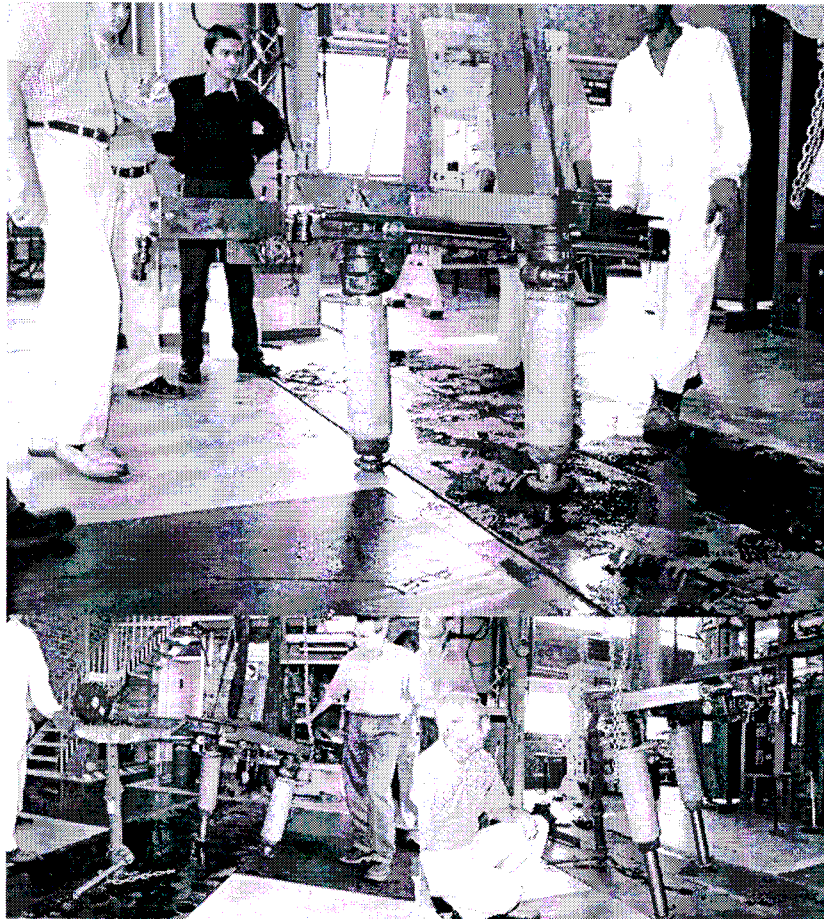
Inspections were performed on the units at CSIR: Mining Technology's support testing laboratory (Figure 3-4). The hydraulic props were attached to the unit and it was hoisted into position. The hydraulic props were then pressurised and depressurised and the system dynamics were checked from a functional perspective in order to identify hazards and to check whether there were any problems with the critical mechanical areas of the machine. Possible design improvements were noted after the inspections and these were finalised on the basis of the testing at Kloof Gold Mine, which is discussed in Section 3.3.3.

*Figure 3-4 Photos showing prototype unit being inspected by CSIR: Mining Technology*

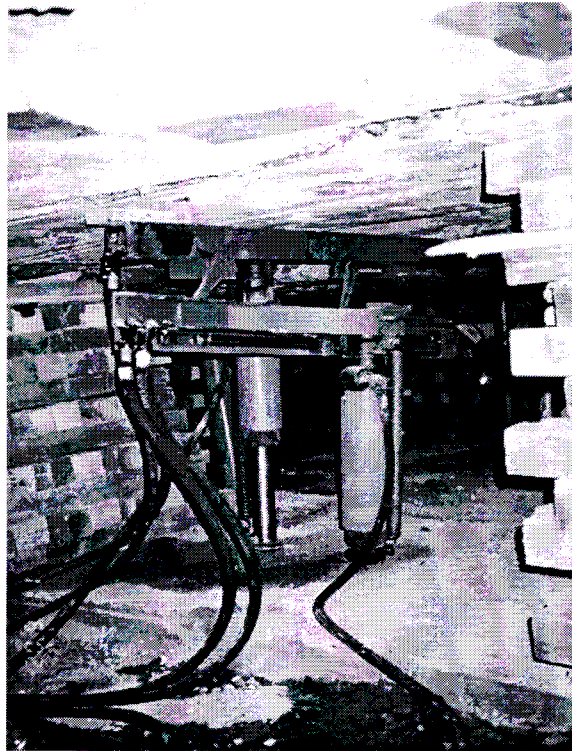
*Figure 3-5 Prototype unit installed in mock-up stope at Kloof Gold Mine*

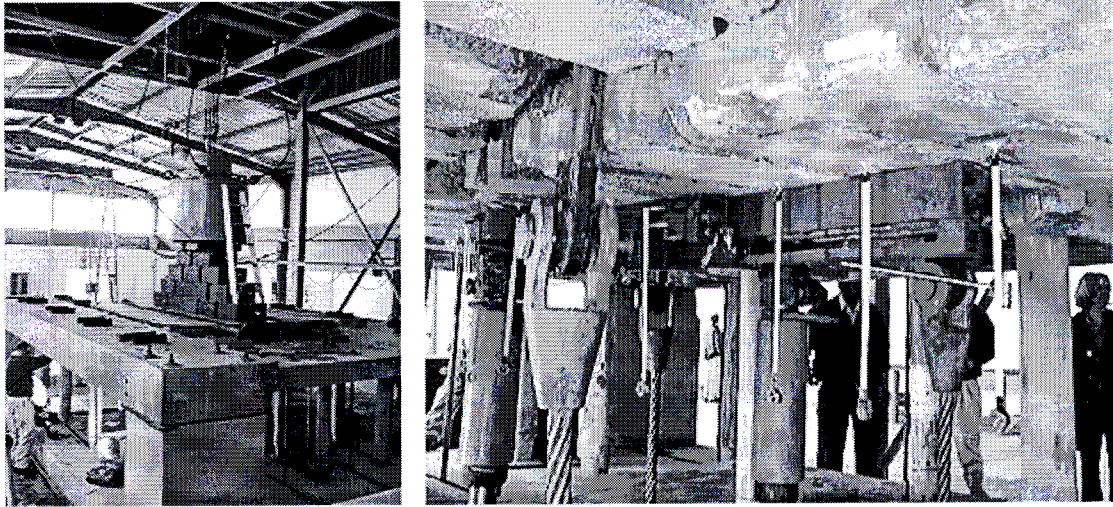
The walking beam supported the simulated hangingwall successfully after successive dynamic impacts from the 10 ton weight. SIMRAC members, mine personnel and manufacturers of underground support equipment attended the tests.

*Figure 3-6 Drop test*

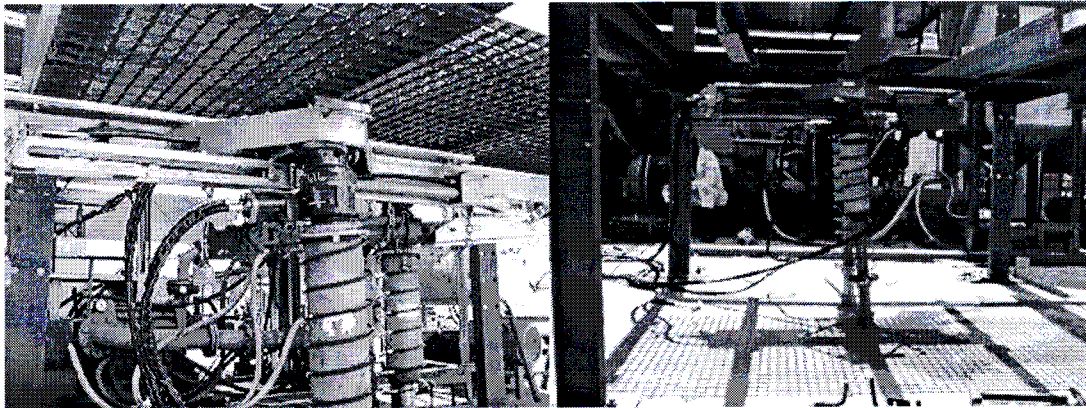
The headboards of one prototype unit were assembled and hydraulic props were attached to each headboard with torsion bars. The unit was then manually lifted into position and pressurised against the steel frame. The hydraulic props were observed to be not standing perpendicular to the ground as a result of the indentations and plastic deformation on the mild steel torsion bar connections. New spring steel torsion bars were then designed and manufactured for increased strength and elasticity in order to avoid these problems. The new torsion bars were tested and found to perform significantly better. Figure 3-7 shows photos of the unit installed in the test rig.

*Figure 3-7 Prototype unit installed in test rig at CSIR: Mining Technology*

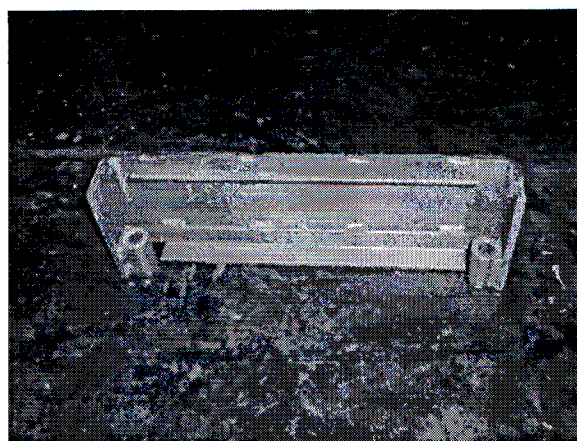
The surface tests also enabled conceptualisations to be made for designing blast-protective mechanisms for the system. Special blast-protective shields were designed for the purpose of protecting components that would be susceptible to damage by blasted rock. These shields are made of mild steel and have angle-iron reinforcements along their lengths for increased buckling resistance. The shields have encased sleeves for bolt attachments onto the headboards. Figure 3-8 shows one of these shields.

*Figure 3-8 Blast-protective shield*

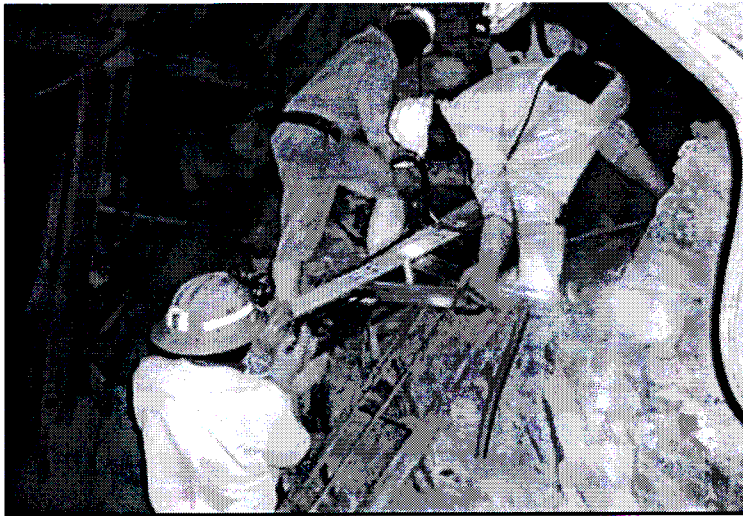
The units were transported to the stope panel in two assembly configurations. One prototype was taken fully assembled and the other with the headboards linked to each other and with the hydraulic props detached. Although the units were heavy, they presented no serious problem during the transportation process. There is, however, room for improvement in this area. Figure 3-9 shows some of the workers lifting the headboards out of the cross-cut into the centre gully.

*Figure 3-9 Moving the units towards the test panel*

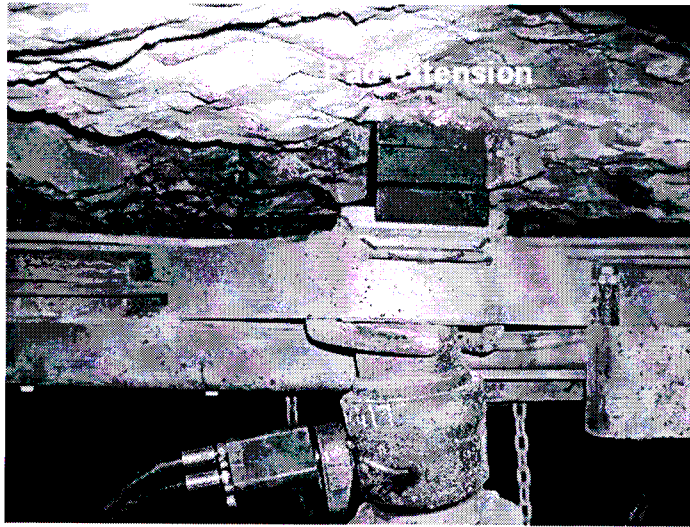
For certain areas along the hangingwall, the headboard pads did not contact. As a result, a rotational moment was induced in a plane parallel to the headboard, causing the unit to rotate. To alleviate this problem, special pad extensions were manufactured (Figure 3-10). These pad extensions were made in various sizes to accommodate irregularities in the hangingwall.

*Figure 3-10 Extension slid over pad to enable contact with hangingwall*

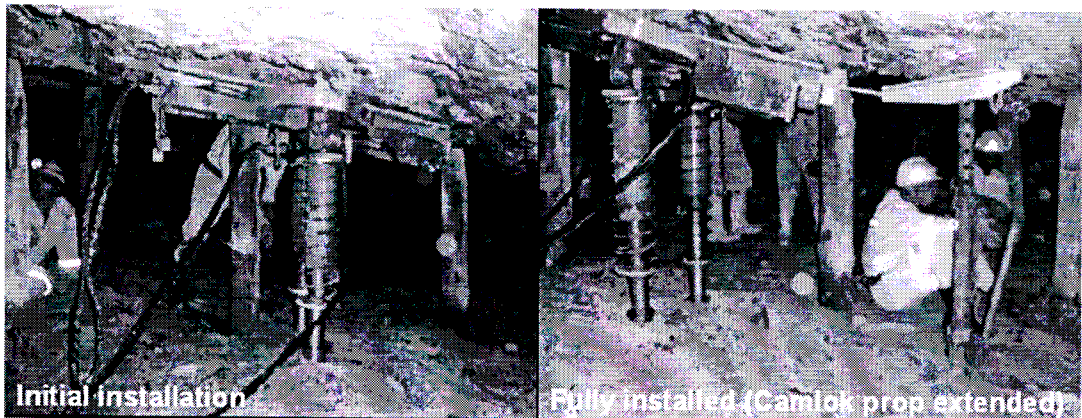
It was concluded that further tests would have to be done on the units on surface to evaluate their performance for steeper dip angle conditions. On a relatively shallow dip, the unit had proved its functionality and had 'walked' satisfactorily. Figure 3-11 shows photos of the initial and final installations of the unit in the test stope.

*Figure 3-11 System installation*

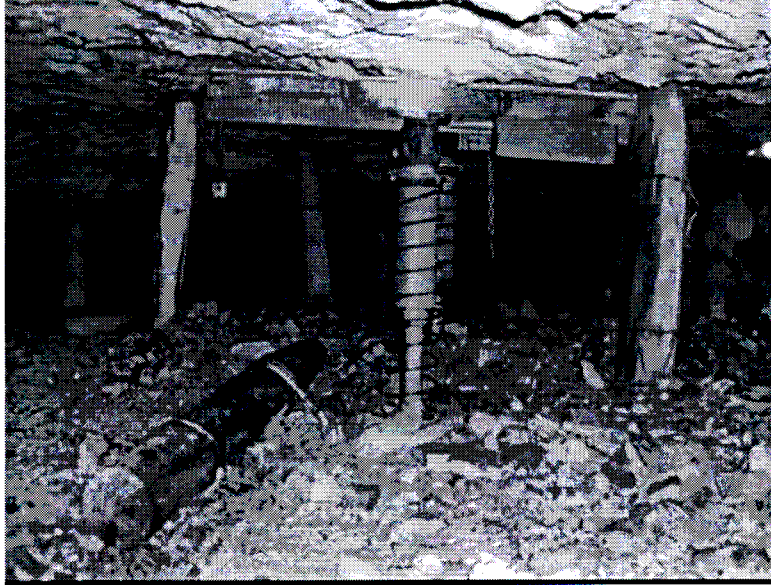
advance per blast was approximately 0.6 m. The units did not sustain any serious damage and the trials proved successful for the given blasting conditions (Figure 3.12).

*Figure 3-12 Condition of unit after being subjected to blasted rock*

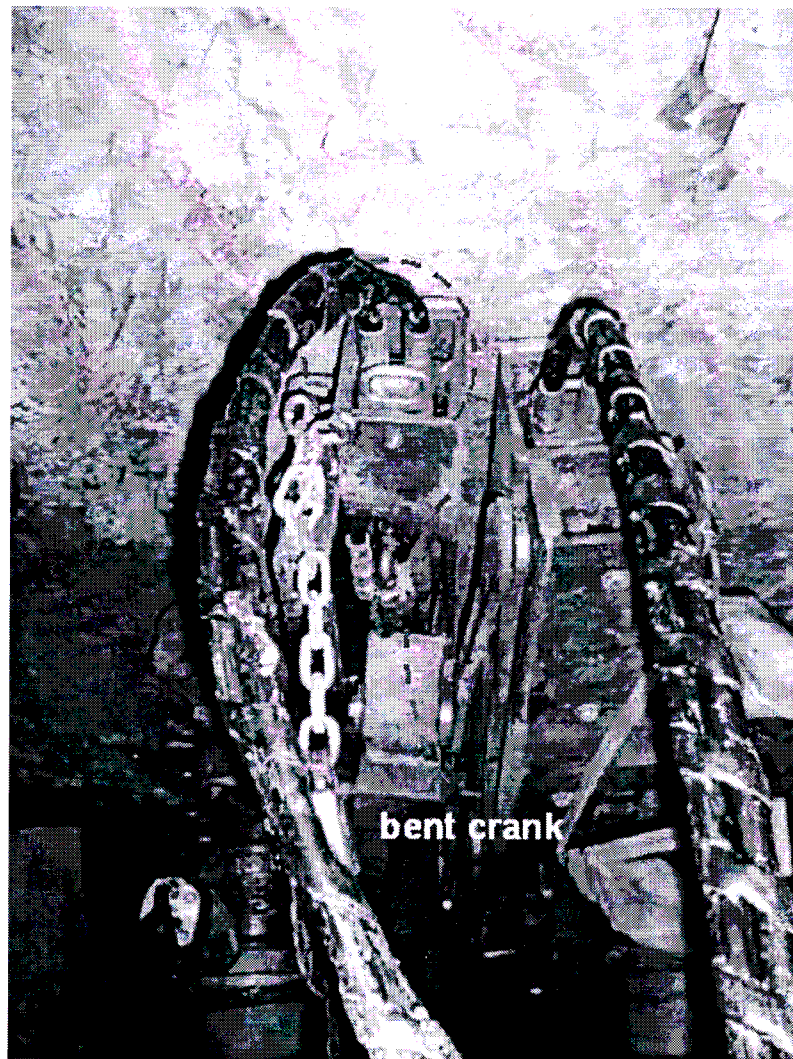
*Figure 3-13 Underside of headboards showing the position of the hose adaptors at the back of the headboards, and the slightly deformed crank*

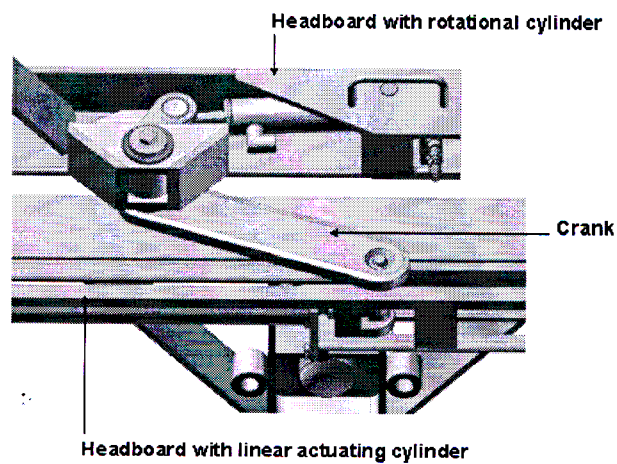
Figure 3-14 Side view showing crank connection between headboards

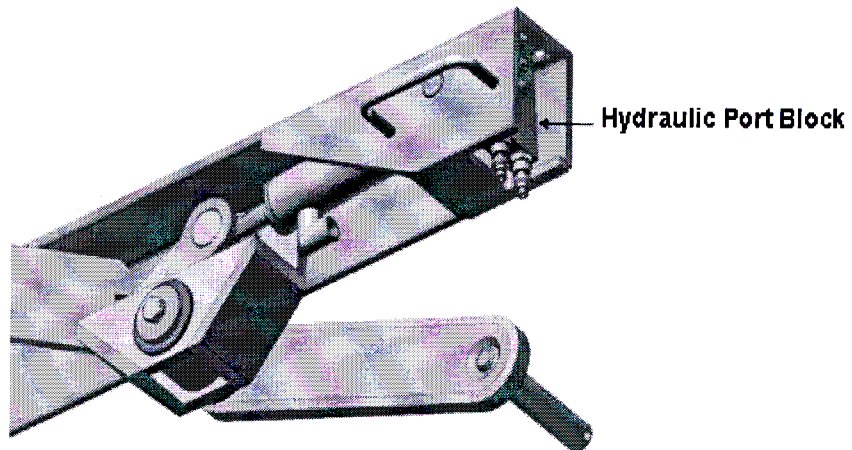
*Figure 3-16 View showing position of hydraulic port block in headboard*

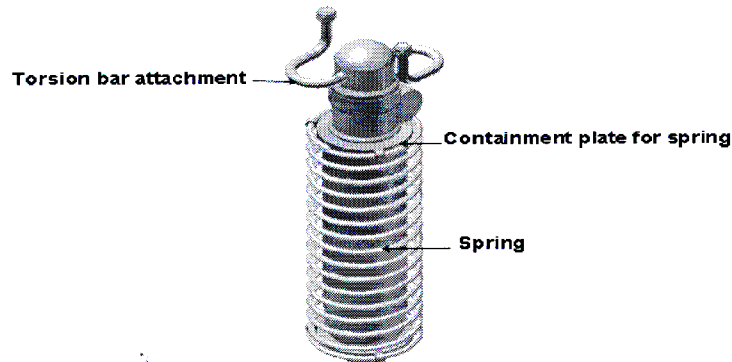
*Figure 3-18 Hydraulic prop and its spring assembly*

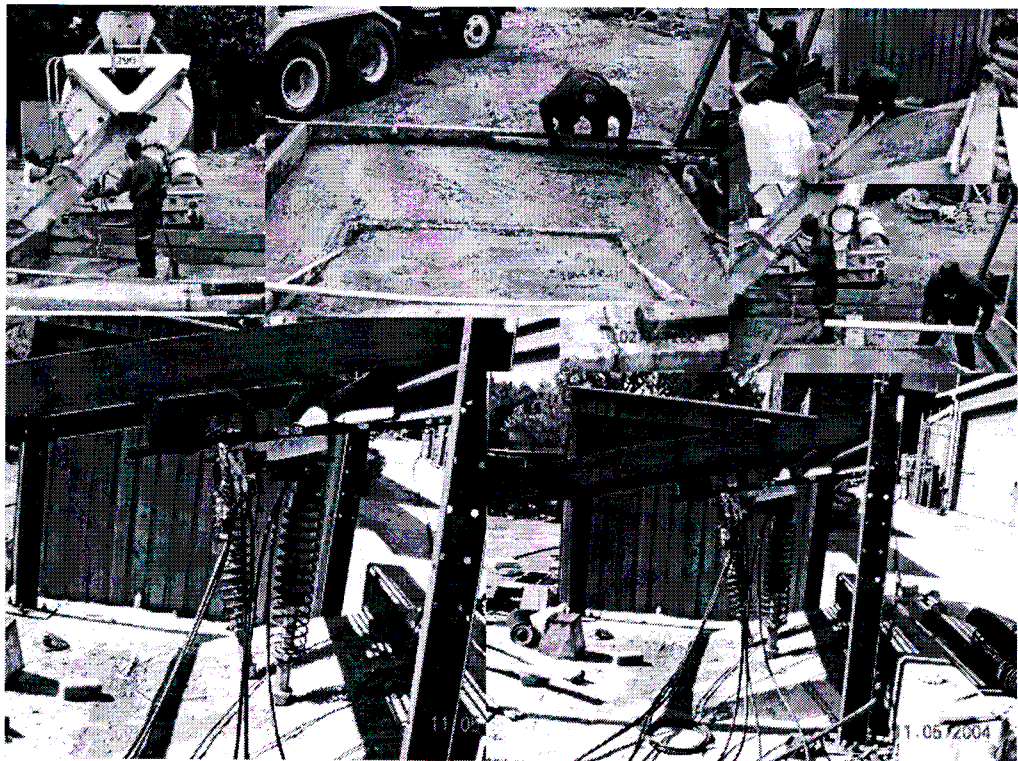
*Figure 3-20 Collage of photos showing building of concrete foundation and testing of system in the rig*

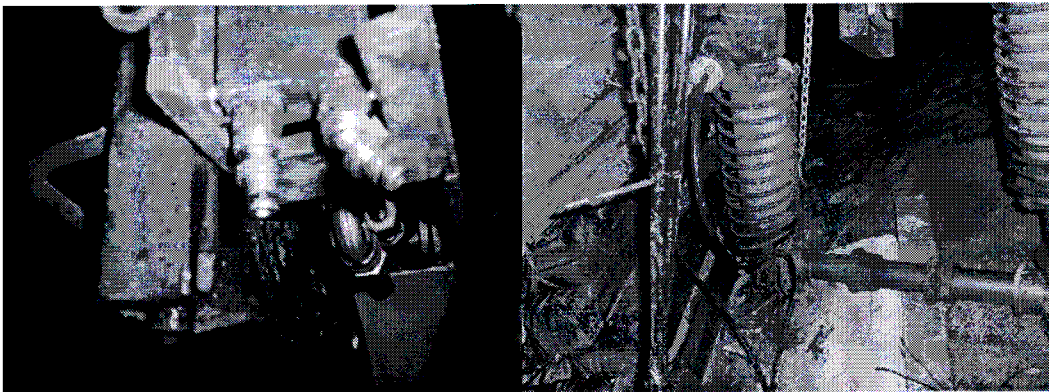
*Figure 3-23 Damaged hose fitting and broken hydraulic prop*

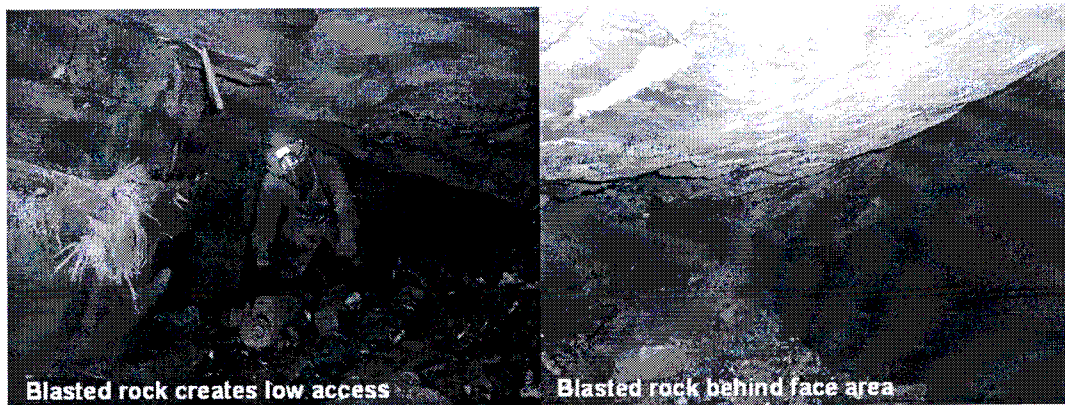
*Figure 3-28 Condition of test panel after blasting operations*

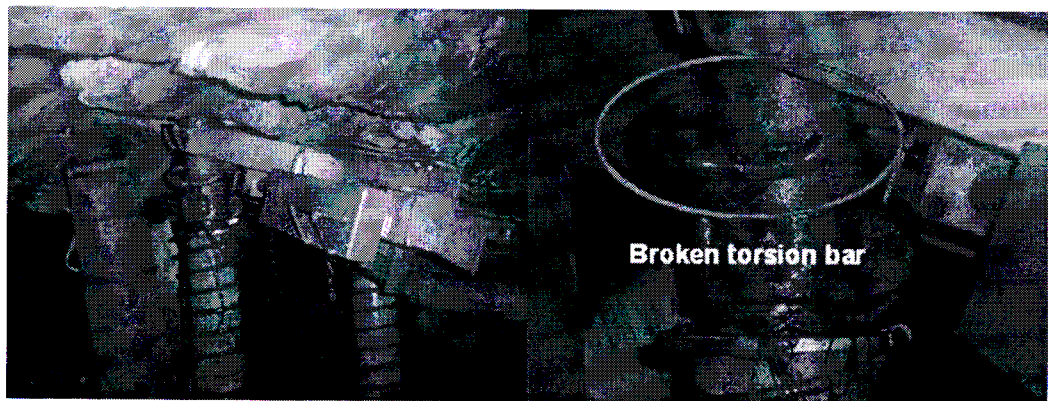
*Figure 3-29 Photos showing installed unit and broken torsion bar*

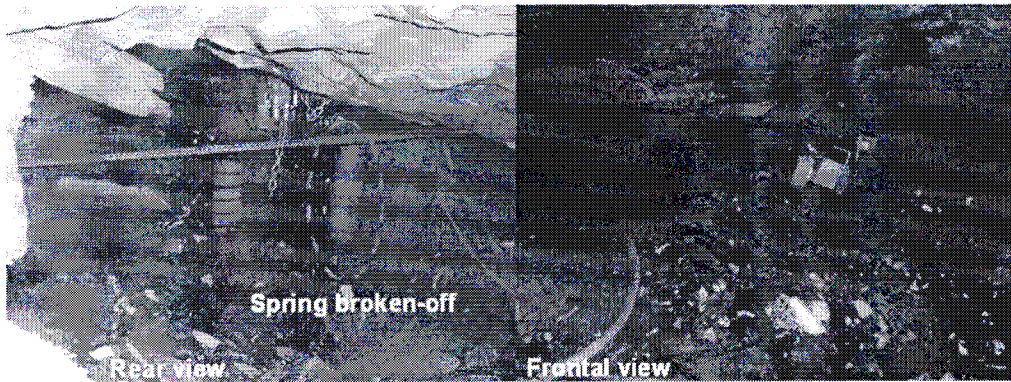
*Figure 3-30 Rear and front view photos of unit after blast*

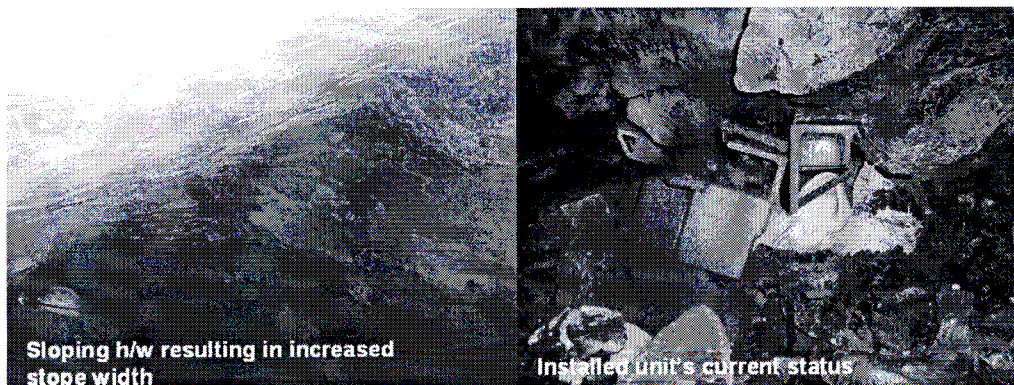
*Figure 3-31 Photos showing increased stope width and buried unit*

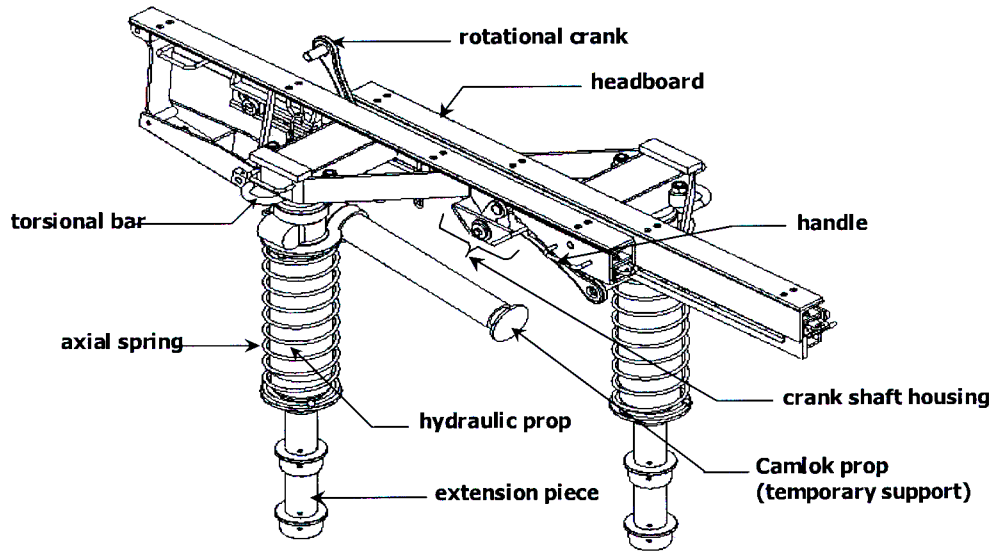
*Figure A-4 Main elements of the walking beam unit*

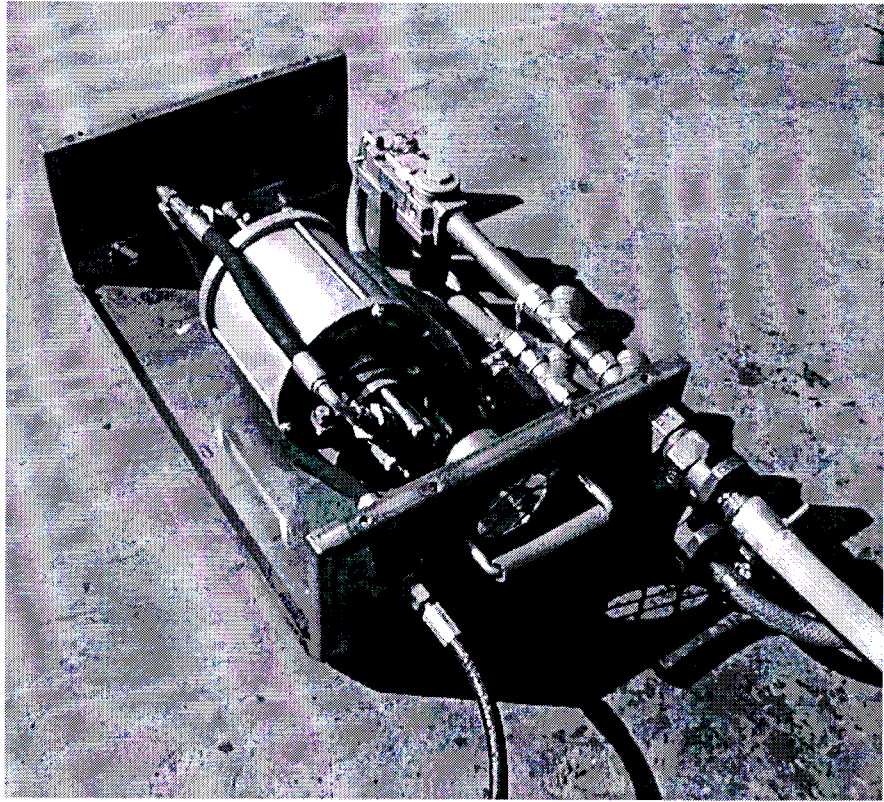
*Figure A-5 General arrangement of pump assembly (without cover)*

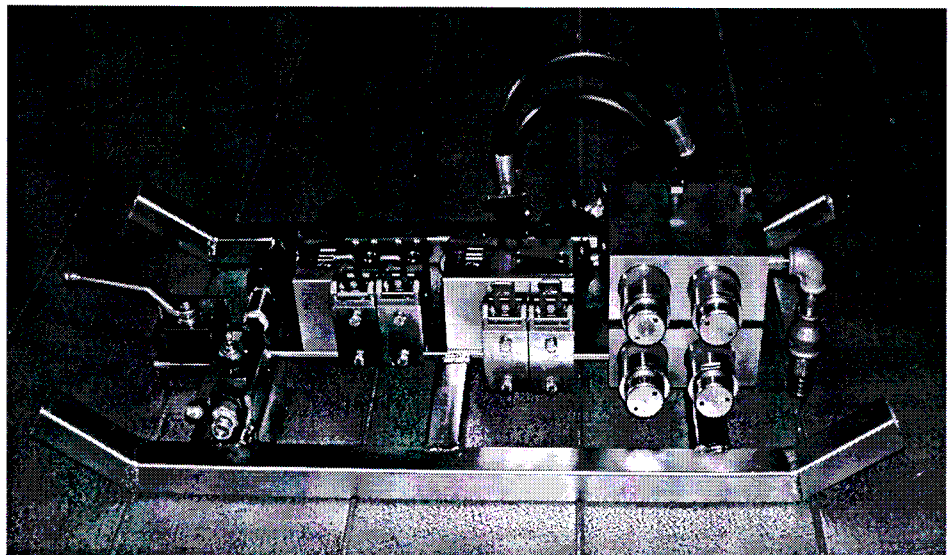
*Figure A-6 General arrangement of control box assembly (cover removed for clarity)*

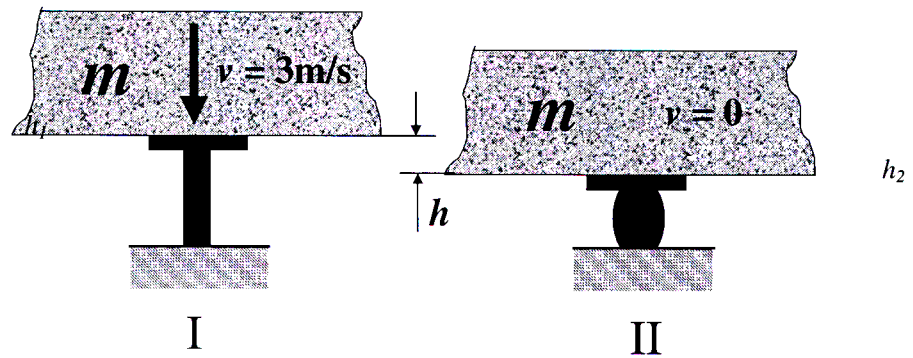
Figure B-2 Conceptual model of dynamic hangingwall displacement and associated energy-absorption requirements of the support system (after Daehnke et al., 1998)

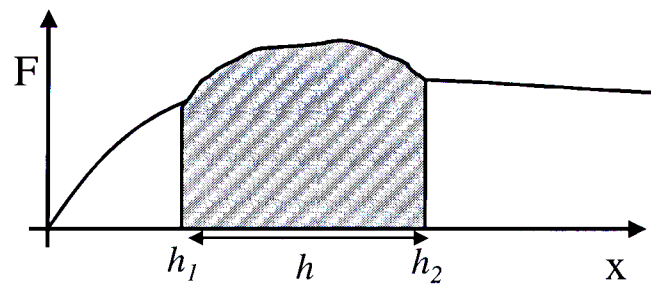
Figure B-3 Quasi-static and dynamic force-deformation behaviour of a support unit prior and during a rockburst (after Daehnke et al., 1998)
