**THE DESIGN AND DEVELOPMENT OF A MECHANISED  
SUPPORT SYSTEM FOR TABULAR STOPES**

**A dissertation submitted to the Faculty of Engineering, University of Kwa-Zulu Natal, in fulfilment  
of the requirements for the degree Master of Science in Engineering**

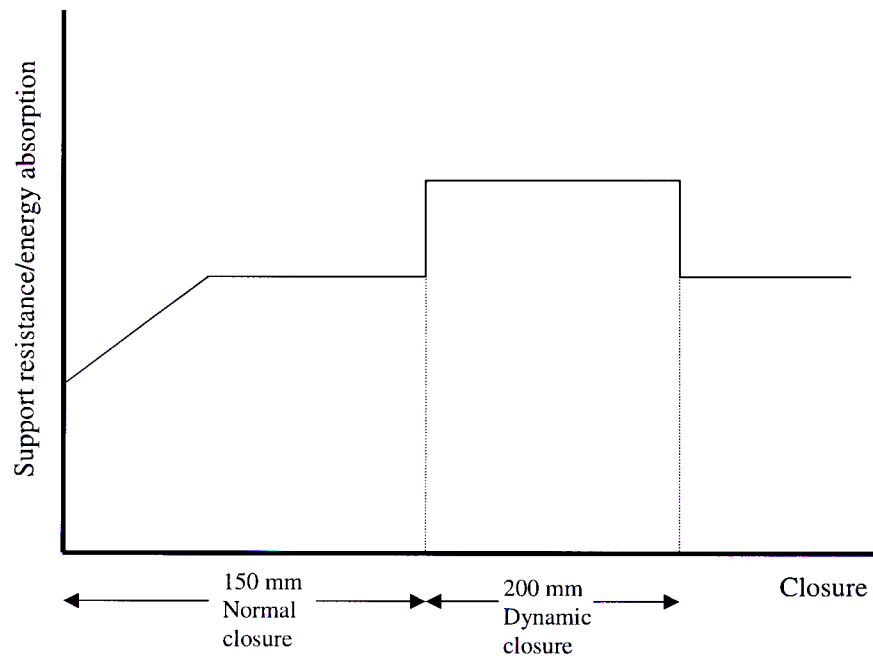
*Figure B-4 Support resistance/energy absorption versus closure*

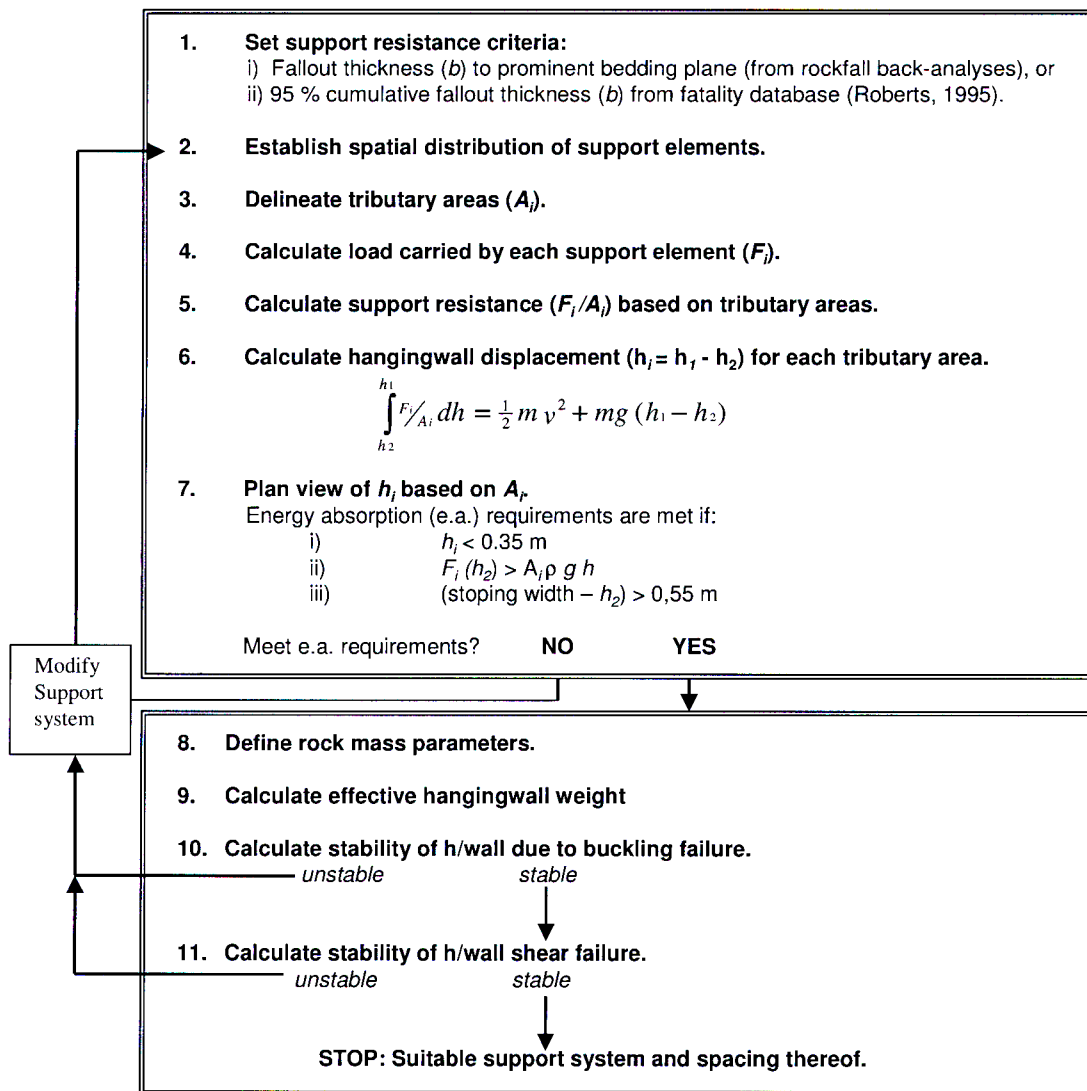
Figure B-5 Flow chart showing features of the rockburst support design methodology (modified after Daehnke et al., 1998)

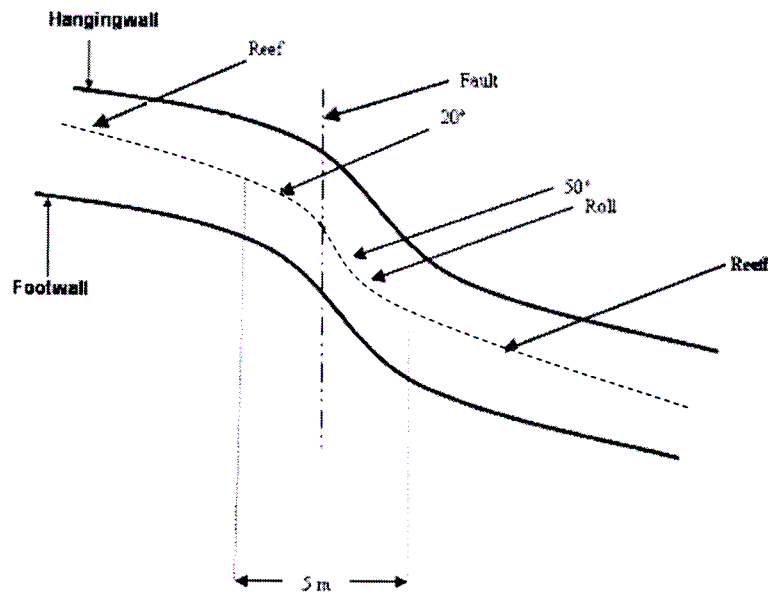
*Figure C-1 Strike section of a stope showing the geometry a support system may be required to cope with in the case of a reef roll or fault*

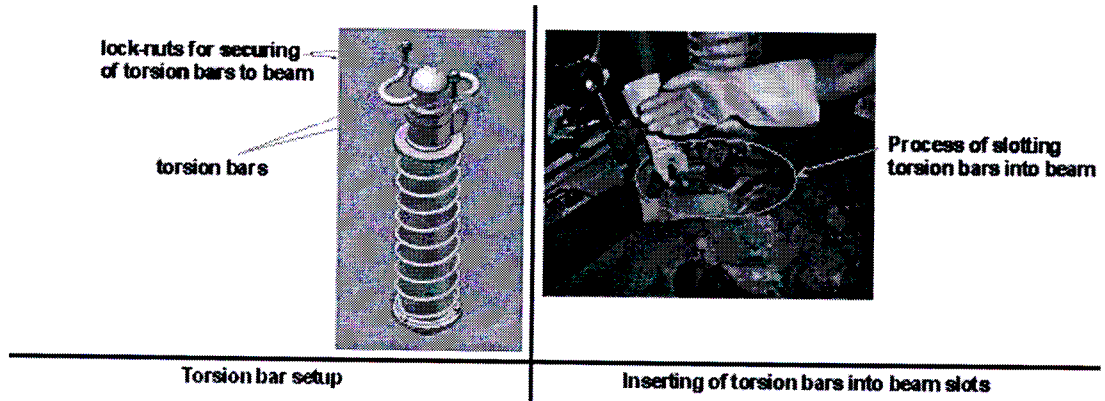
*Figure D-3 Hydraulic prop assembly*

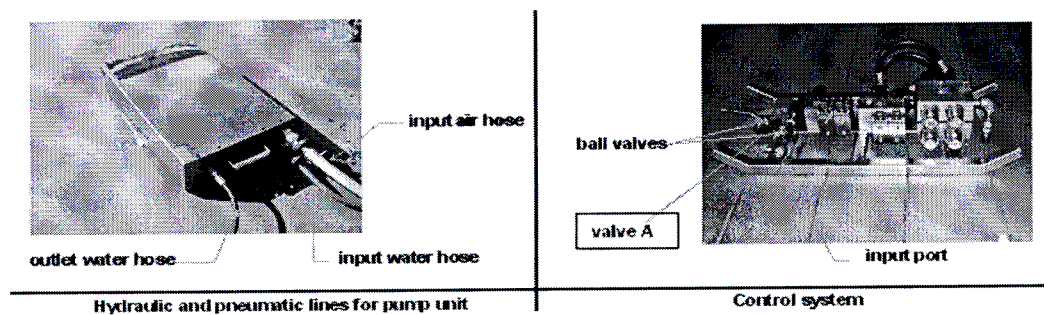
*Figure D-4 Photos of hydraulic pump and control system*

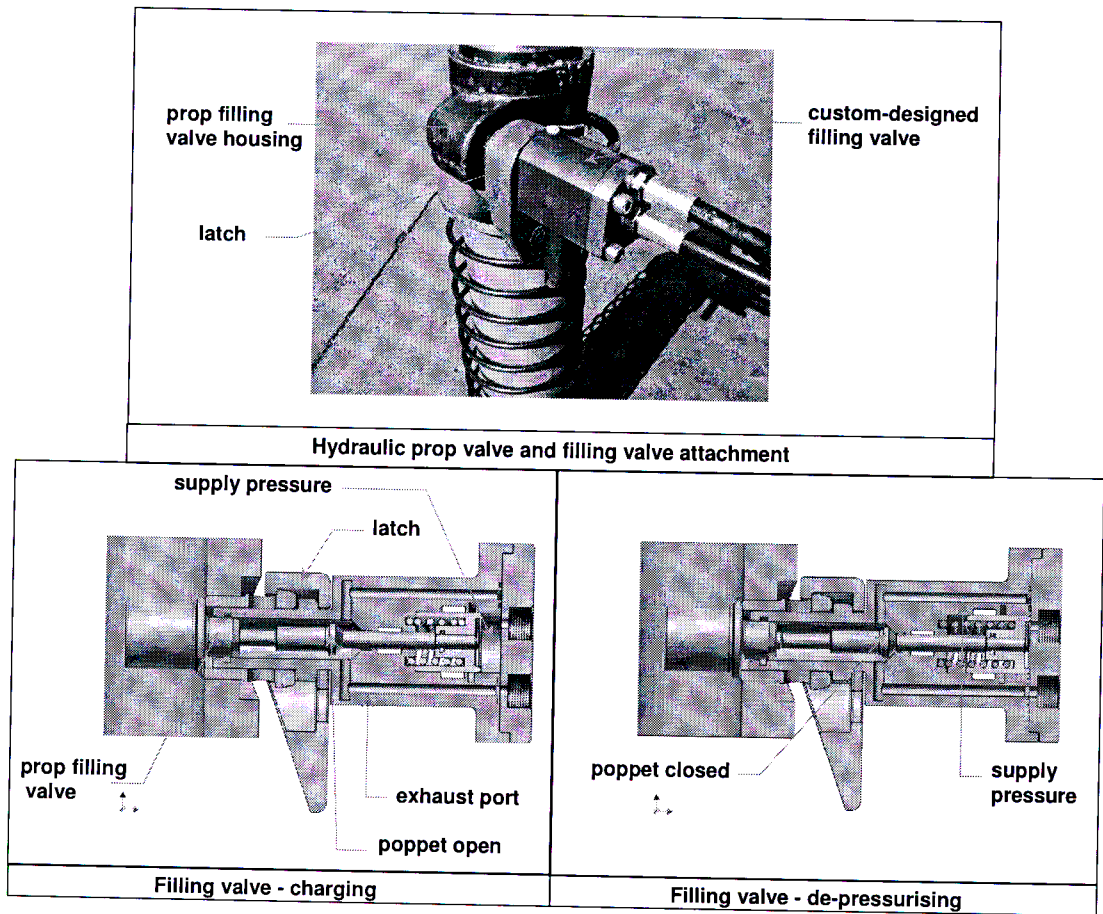
Figure D-8 Hydraulic prop and filling valve interface

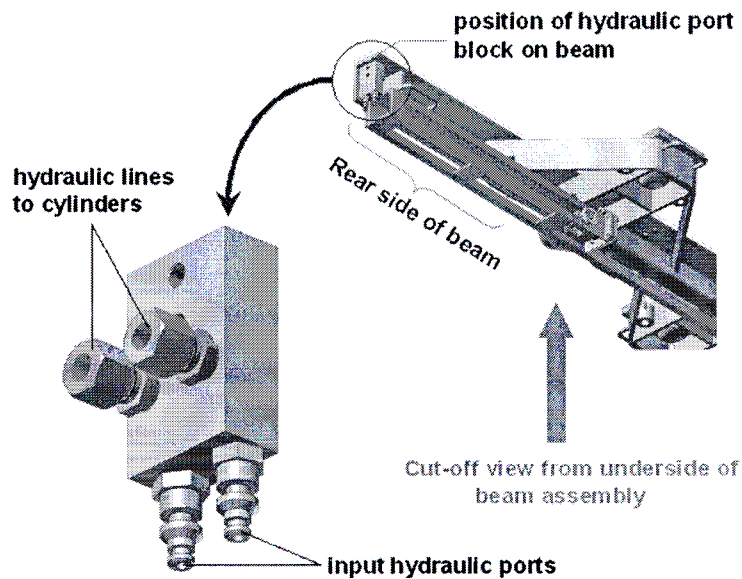
Figure D-9 Hydraulic lines for operation of beam cylinders

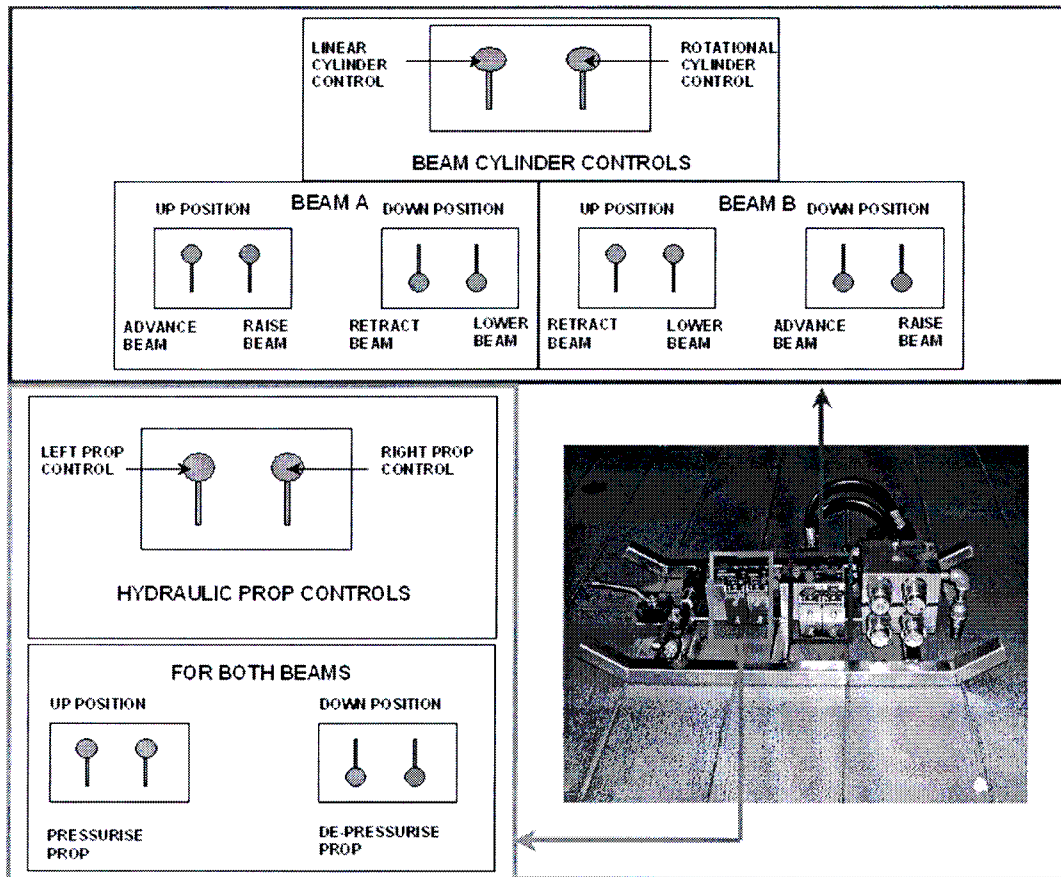
Figure D-10 Control diagram

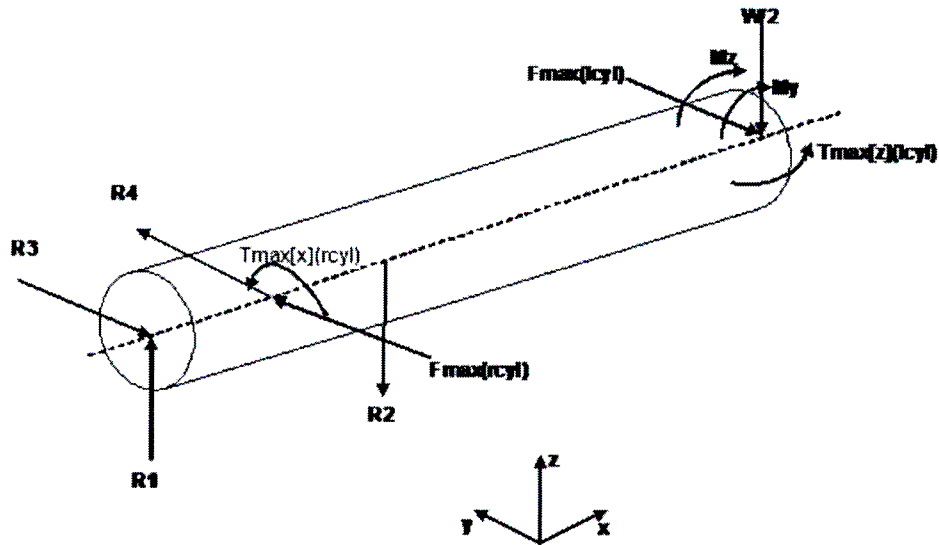
Figure E-1 The derived force diagram for the splined shaft

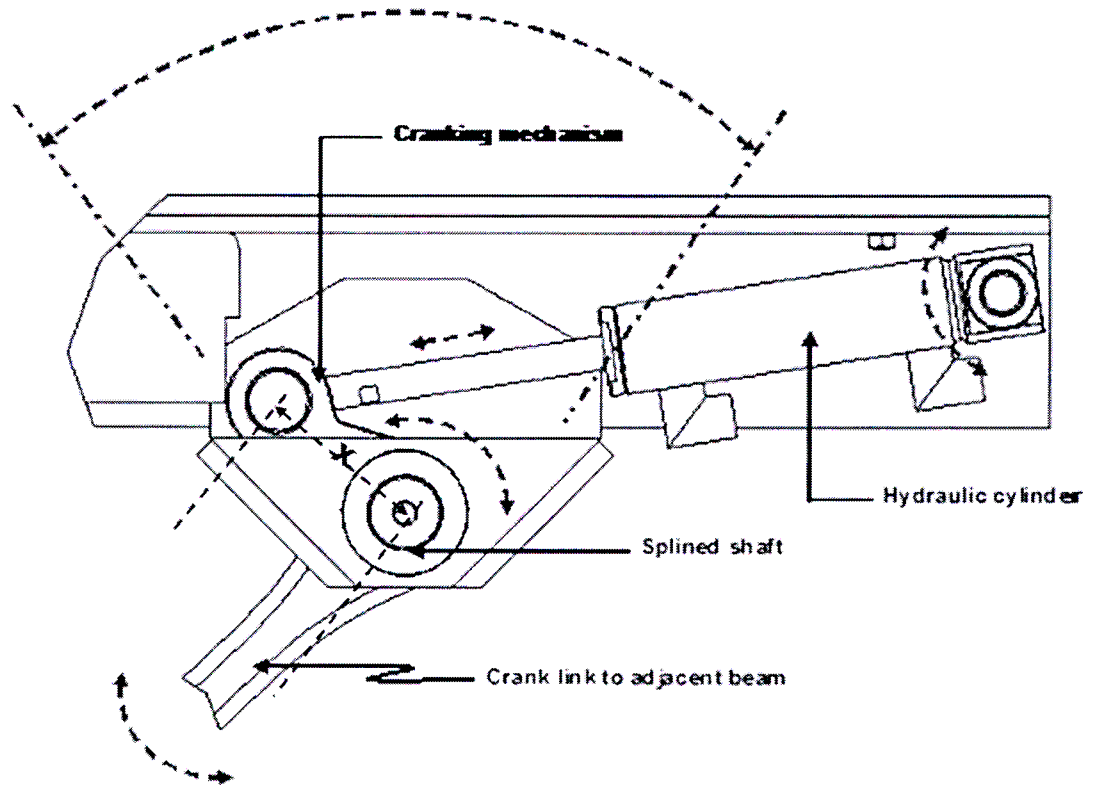
Figure E-2 Rotational cylinder components and dynamics

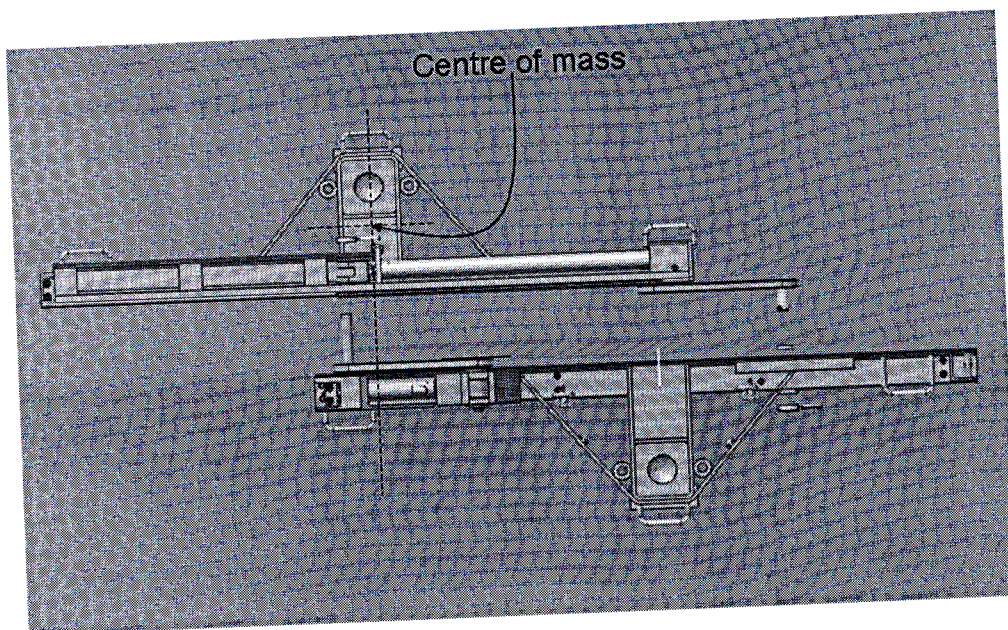
Figure E-3 Centre of mass for beam assembly

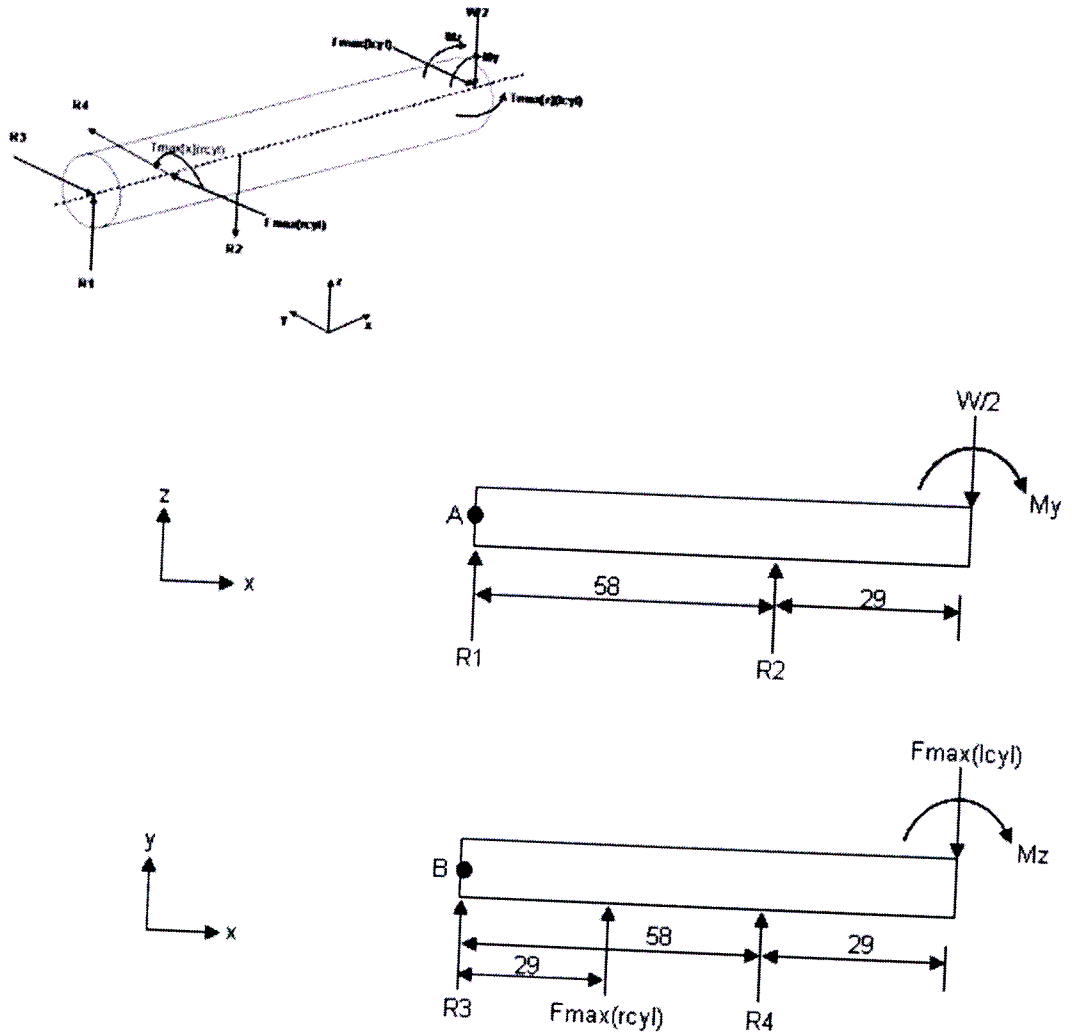
Figure E-4 Planar views of the splined shaft showing forces and moments

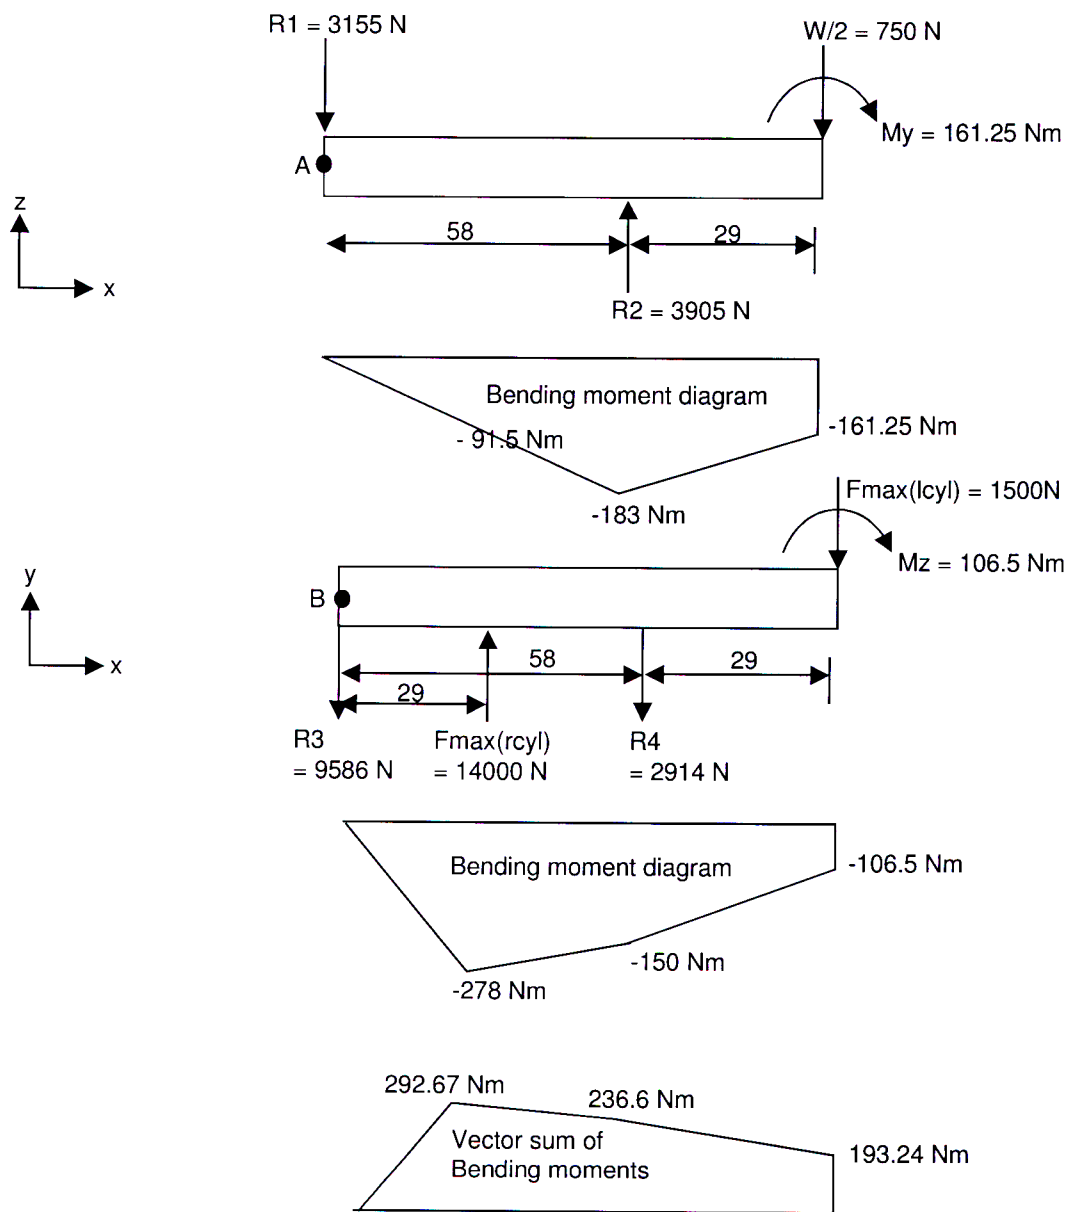
Figure E-5 Bending moment diagrams

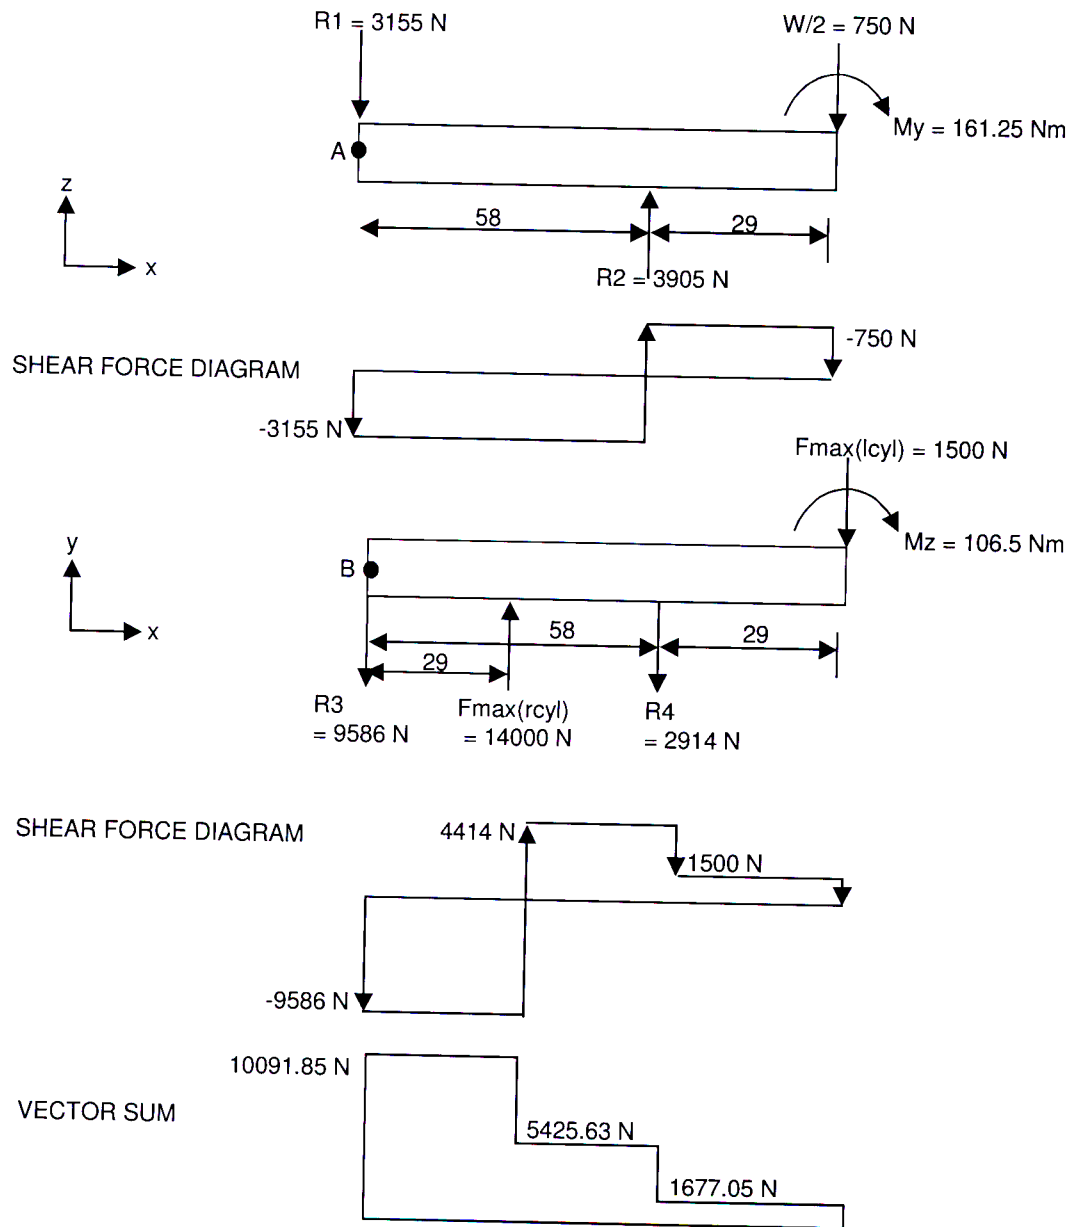
Figure E-6 Shear force diagrams
