**ON-SITE SANITATION IMPACTS ON WATER RESOURCES
NEAR TAYLORS HALT, KWAZULU-NATAL, SOUTH
AFRICA**

Dissertation

Submitted in partial fulfilment of the requirements for the degree of MSc

University of KwaZulu-Natal

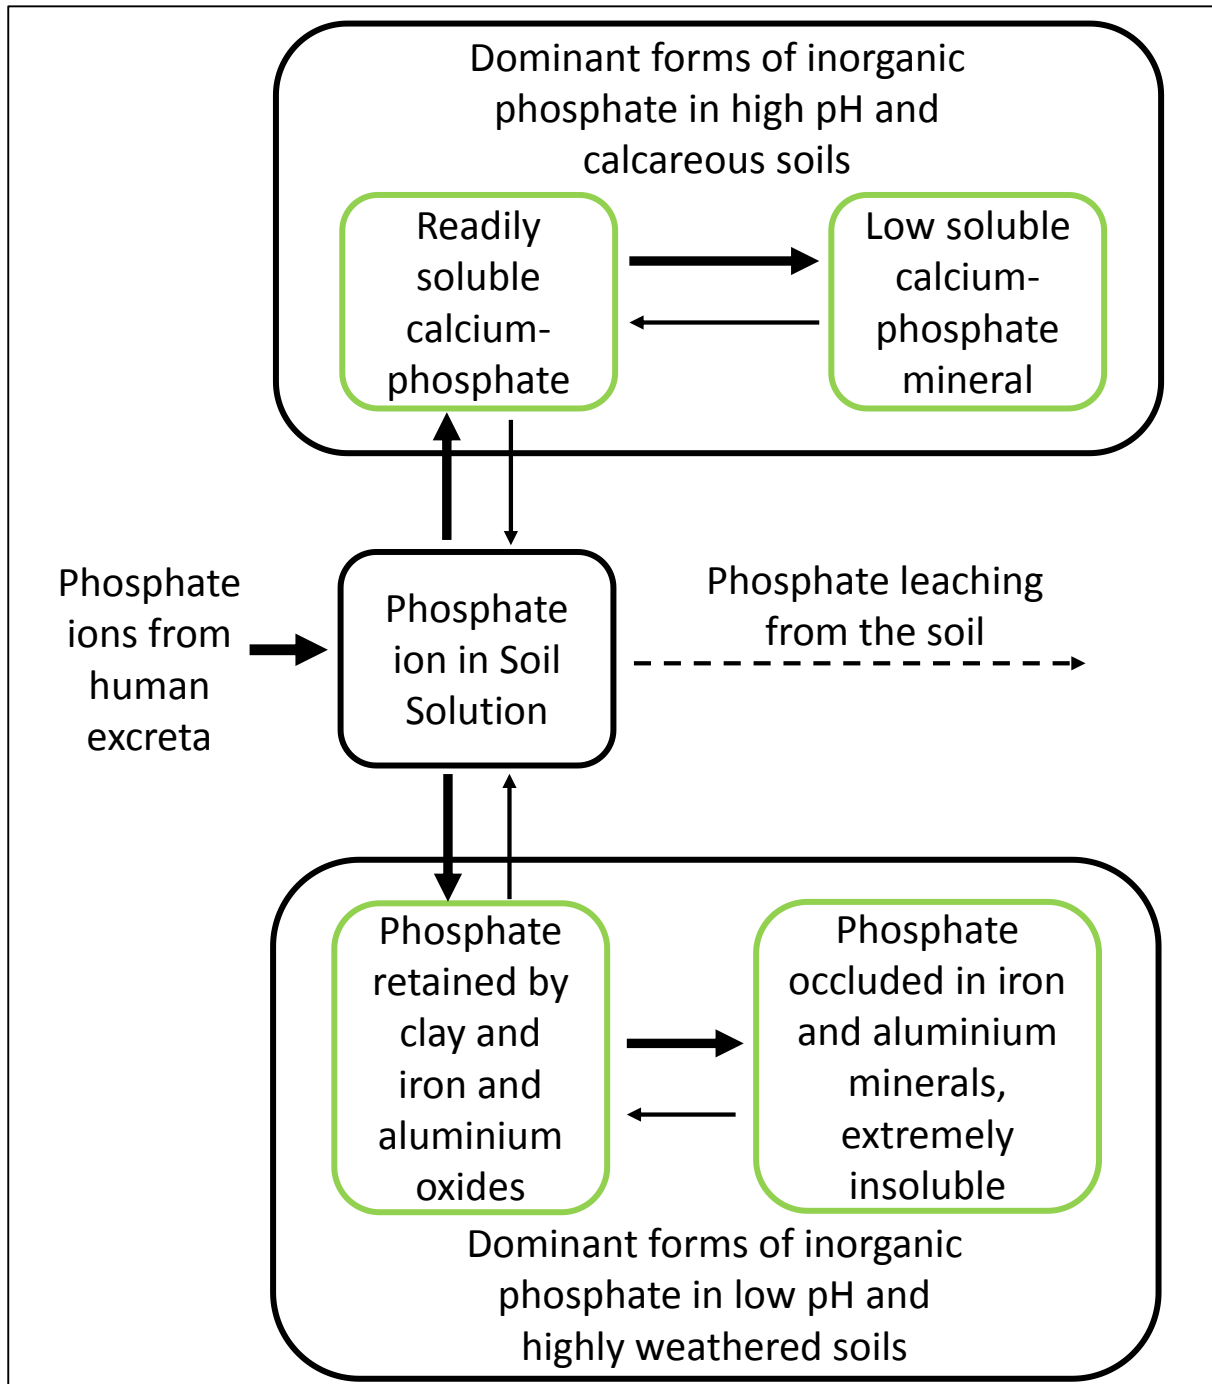
Figure 3.2 The different pools and transformations of inorganic phosphate in the soil (adapted from Brady and Weil, 2000)

Phosphorus (as phosphate) in a soil mainly exists in two pool of low solubility products (figure 3.2). Under high pH conditions and calcareous soil, it is fixed in a calcium-phosphate compound, and at low pH it is fixed in iron and aluminium compounds (figure 3.2). Classically only a small portion of the total soil phosphate is in the soluble pool, which is subjected to leaching (figure 3.2). Figure 3.2 depicts the dominant pools of inorganic phosphate in a soil, as well as the main processes acting upon phosphate, as described by the literature. The arrows

indicated the pathways between the different pools, with the thick arrows depicting the dominant process (i.e. adsorption and fixation).

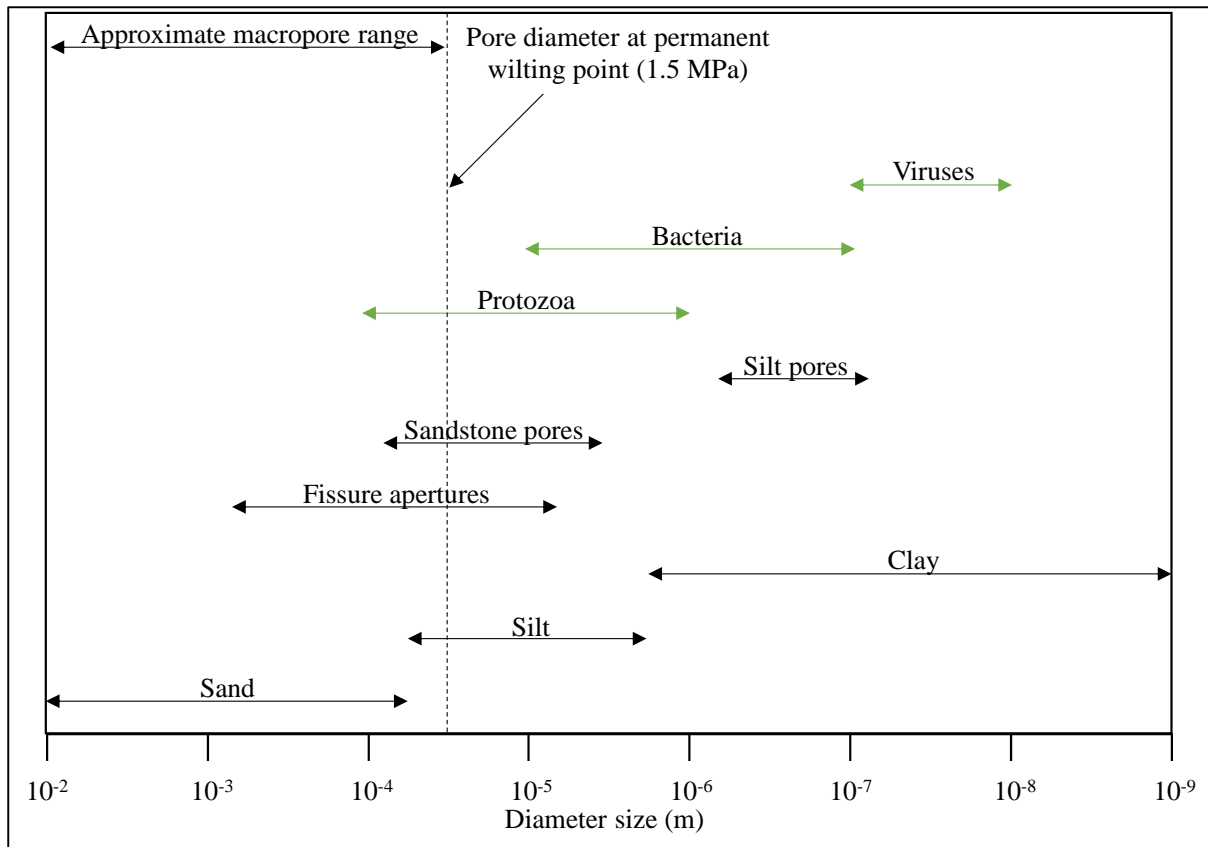
Figure 3.3 The approximate sizes of protozoa, bacteria and viruses from human excreta relative to sand, silt and clay particle sizes and fissure apertures, sandstone and silt pore sizes (after Buchan and Flury, 2004 and Taylor *et al.*, 2004)

The relatively large helminths and protozoa are larger in size when compared to silt particles (i.e. $>2\ \mu\text{m}$) and are usually filtered out effectively by the soil adjacent to the leach pit, except in coarse soils or fissured settings (Figure 3.3) (Fourie and Van Ryneveld, 1995; Franceys *et al.*, 1992; Lewis *et al.*, 1982). The smaller sized bacteria and viruses are affected by other processes such as adsorption onto soil particles and natural die-off, which play a significant role in the attenuation of these pathogens in a soil (Carodona, 1998; Fourie and Van Ryneveld, 1995). The adsorption of viruses onto clay particles is due to electrostatic double layer interaction and van der Waal forces (Fourie and Van Ryneveld, 1995). Sobsey *et al.* (1980) report a 99.00% reduction of viruses in clayey soil, whereas sandy and organic soils were less effective. Whilst viruses may have a greater potential of mobility in a soil, they generally have a low survival time and cannot reproduce outside of a host, unlike bacteria (Fourie and Van Ryneveld, 1995). Consequently, it is often bacteria that are responsible for many of the waterborne illnesses reported globally.

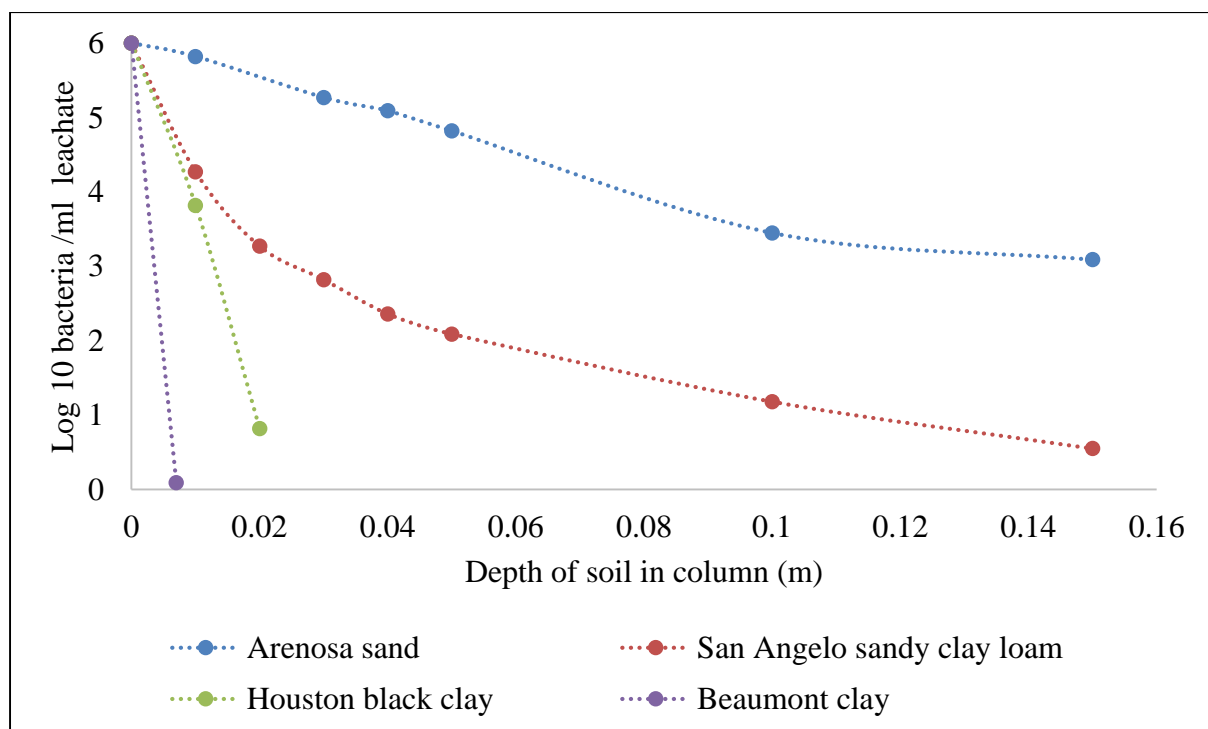
Figure 3.4 *Escherichia coli* count reduction as a function of depth for different soil textures (after Crane and Moore, 1984)

Several studies have reported a significant reduction of bacteria within the first few centimetres of the soil surrounding a leach pit, due to the filtration and adsorption processes. Crane and Moore (1984) remark that 60.00 – 98.00% of bacteria in an effluent applied to a soil are adsorbed onto the soil particles > 1.00 µm in diameter. Gerba *et al.* (1975) report a 92.00 – 97.00% removal of bacteria in an effluent within the first 0.01 m of the soil and the almost complete removal within the first 0.05 m of soil. Similarly, Butler *et al.* (1954) report the formation of a “limiting zone” in a fine sandy loam soil, from 0.10 – 0.50 m. In the study, the initial coliforms count of 1.10×10^8 MPN/100 ml was reduced to 230.00 MPN/100 ml after passing through 0.60 m of soil (Butler *et al.*, 1954). Furthermore, clayey soils have a greater reduction of bacterial effluent leaching through a soil compared to sandy or gravel soils (Crane and Moore, 1984; Brown *et al.*, 1979). Experiments demonstrate that leachate containing *Escherichia coli* is affected by the soil type, as depicted in Figure 3.4.

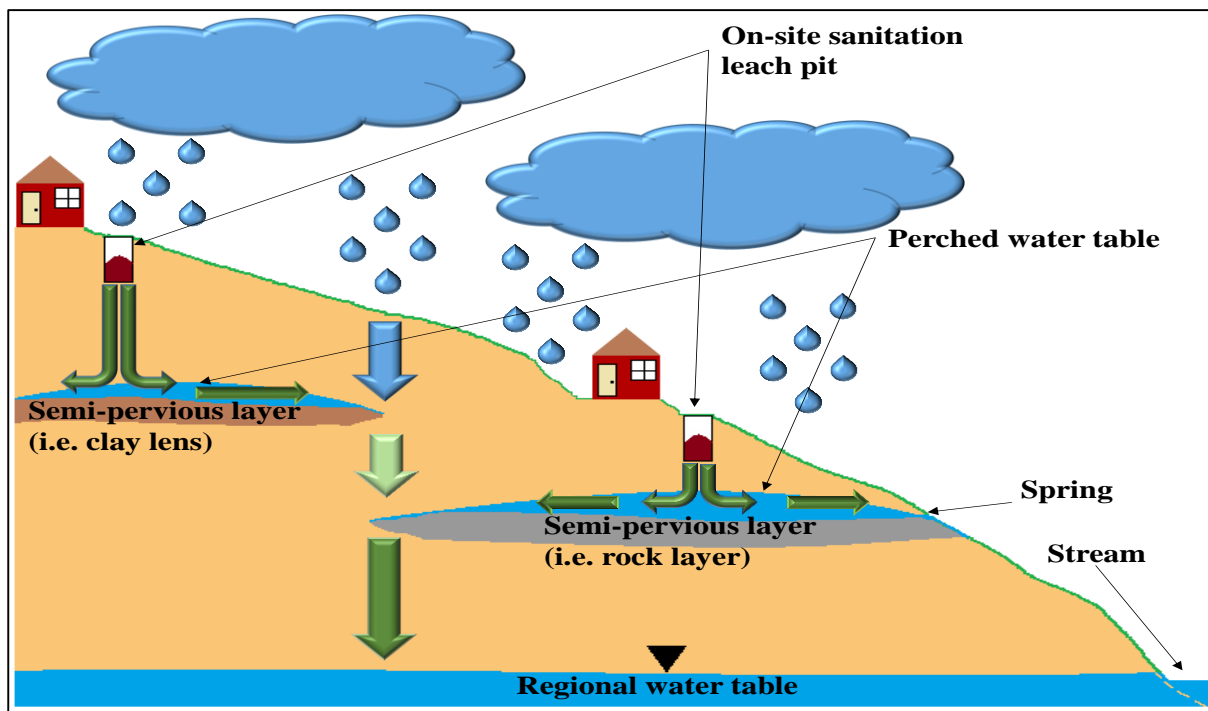
Figure 3.6 Semi-pervious layers leading to the formation of a perched water table and lateral spread of on-site sanitation contaminants

In the context of on-site sanitation, the contaminants leaching from these systems which reach a semi-pervious layer, will travel in a lateral direction along this layer in the direction of groundwater flow (Figure 3.6) (Caldwell, 1937; Dawes and Goonetilleke, 2003; Engel *et al.*, 1974; Wells, 2001).

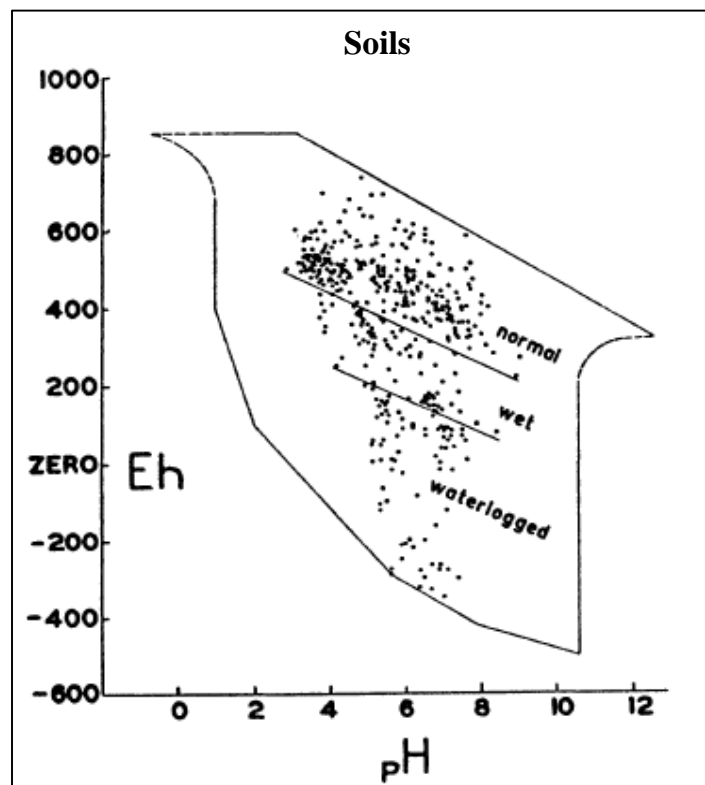
Figure 3.9 Generic Eh-pH value range for normal, wet and waterlogged soils (from Baas-Becking *et al.*, 1960)

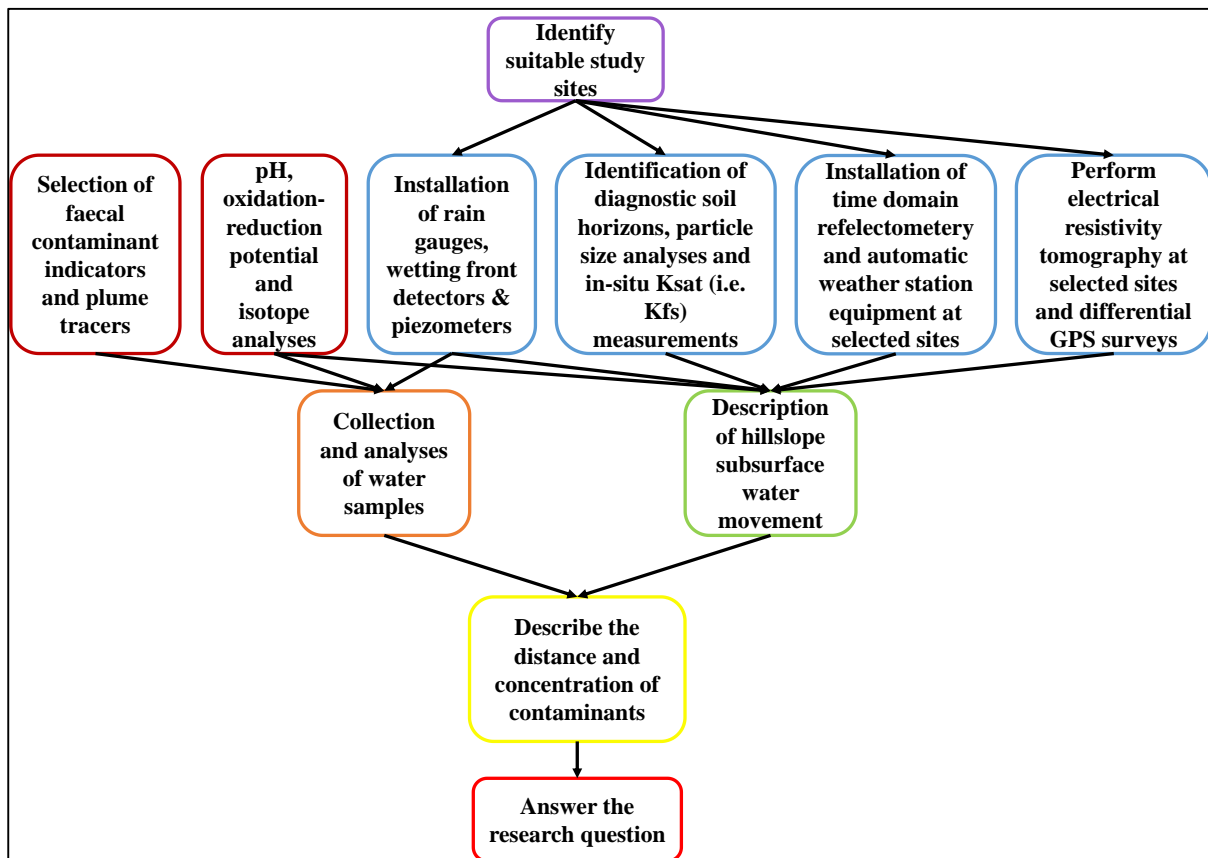
Figure 4.1 Overview of methodology

The methodology presented in this chapter was designed to answer the research question. Here, suitable study sites were identified, where various instrumentation and equipment were installed to describe the subsurface hillslope water movement, and to collect numerous water samples. The water samples were analysed to obtain information on the distance and concentration of the contaminants in the near surface. The overall methodology is described in Figure 4.1. This chapter will be broken down into three sections *viz.* (i) Study sites, (ii) Water sample collection and (iii) Water sample analyses.

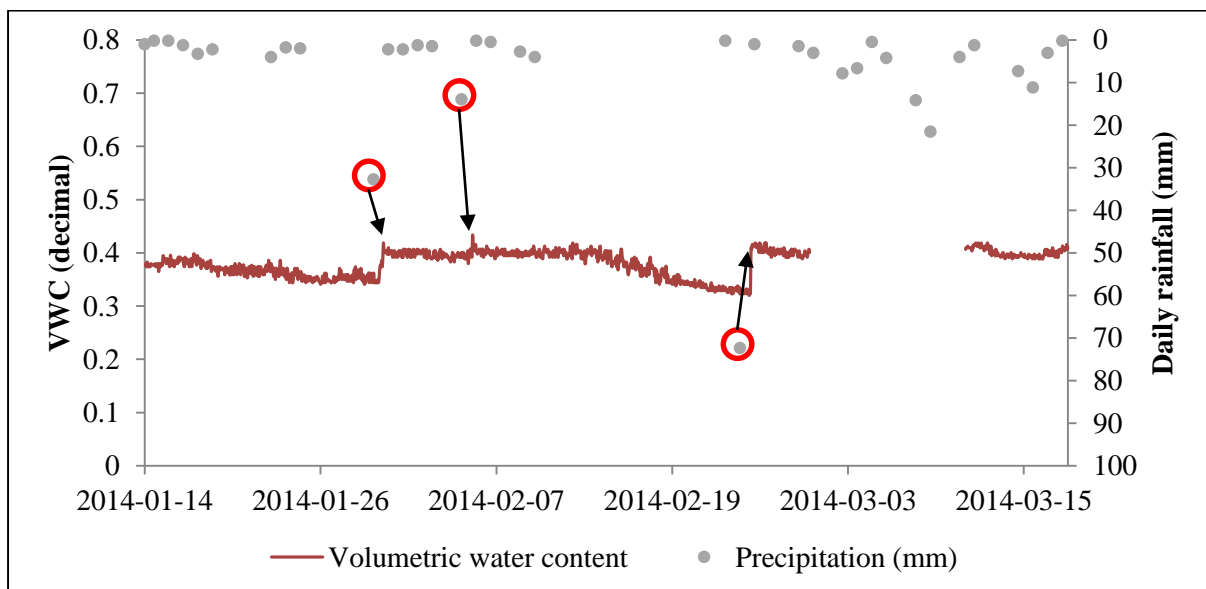
Figure 5.2 Volumetric water content (VWC) at 0.2 m below the soil surface at the Slangspruit site

The TDR data at the Slangspruit site revealed the change in the volumetric water content at different depths in the soil profile (Figures 5.2, 5.3 and 5.4). The soil profile remained moderately saturated near the end of the wet season. From 14 January 2014 to 18 March 2014, the average volumetric water content increased down the soil profile to the start of the clayey layer: 0.38 to 0.54 at depths of 0.20 m and 0.50 m, respectively. The TDR probes 5 & 6 which were installed at 0.80 m (i.e. in the middle of the clay semi-pervious layer) failed to produce a usable water volumetric result. Below the clayey layer, the average volumetric water content was slightly lower than in the top soil: 0.46 at 1.30 m. This highlighted the semi-pervious nature of the clay layer within the soil profile. The gap in the data from the 28-02-2014 to 11-03-2014 refers to a period of data that was over-written, due to a collection error. Furthermore, there were several high rainfall events which caused a visible increase in the volumetric water content in the soil (i.e. red circles in Figures 5.2, 5.3 and 5.4). These rainfall responses were more prominent at 0.20 m and became less noticeable at deeper depths. The TDR data down the soil profile indicated that the water content in the soil was sensitive to high rainfall events, and that the clayey layer had a significant impact retarding the movement of the infiltrating water.

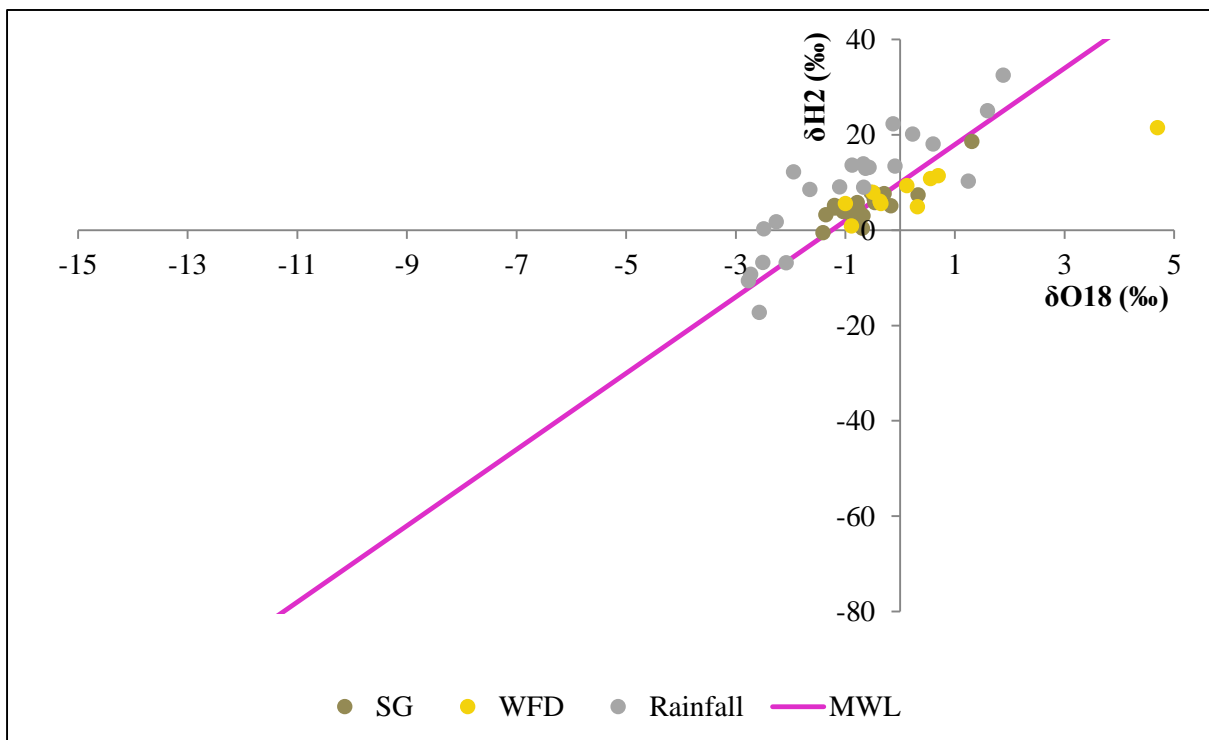
Figure 5.6 Isotope values for the surface gutter, wetting front detectors and rainfall at the Slangspruit site

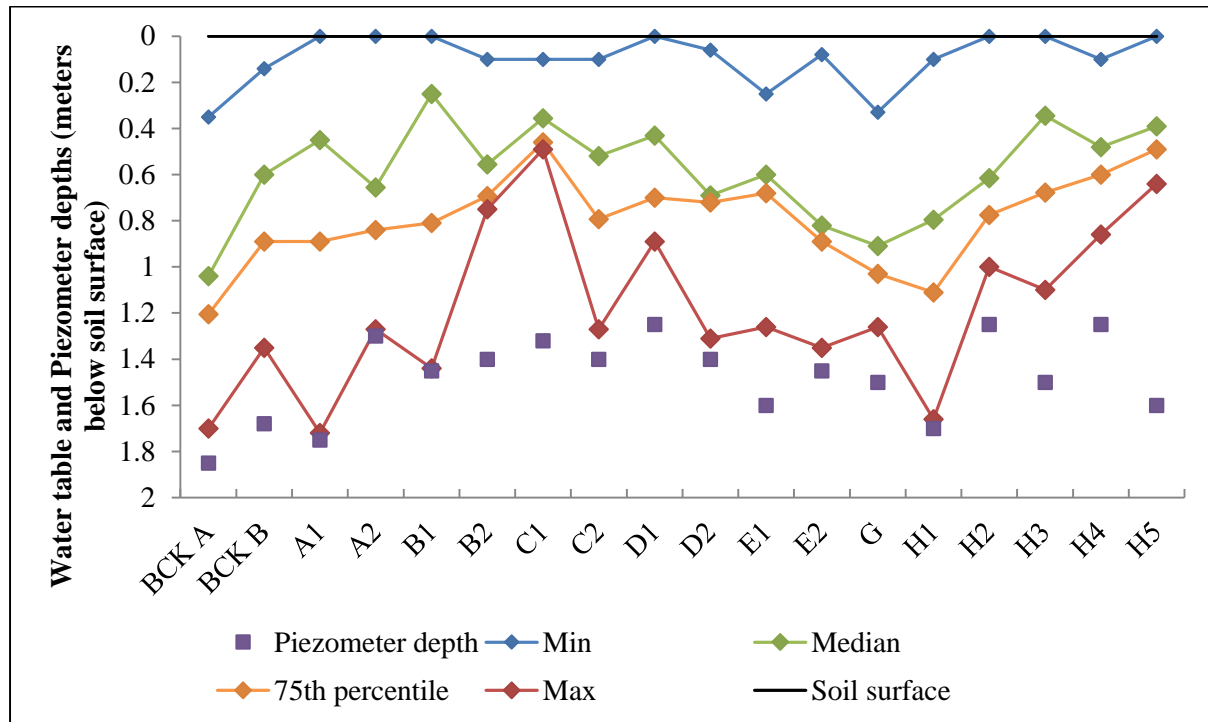
Figure 5.8 Water table and piezometer depths at the Slangspruit site

supplied water to the soil and caused an increase in the water table. This was evident in piezometers B2 and C1, given their close proximity to the leach pits, and at H4 and H5, given their close proximity to the surface gutter (i.e. < 3 m).

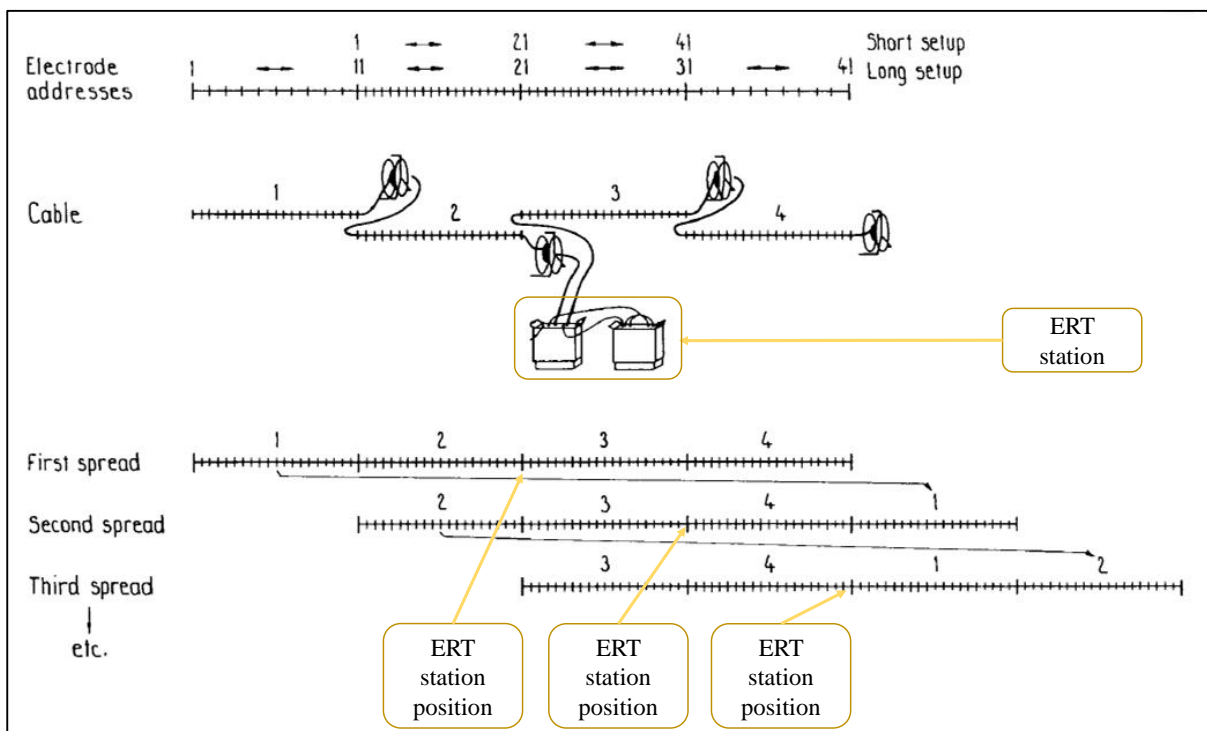
Appendix 24: Layout of ERT apparatus for Schlumberger short and long protocols, and a roll-along procedure (from ABEM, 2009)

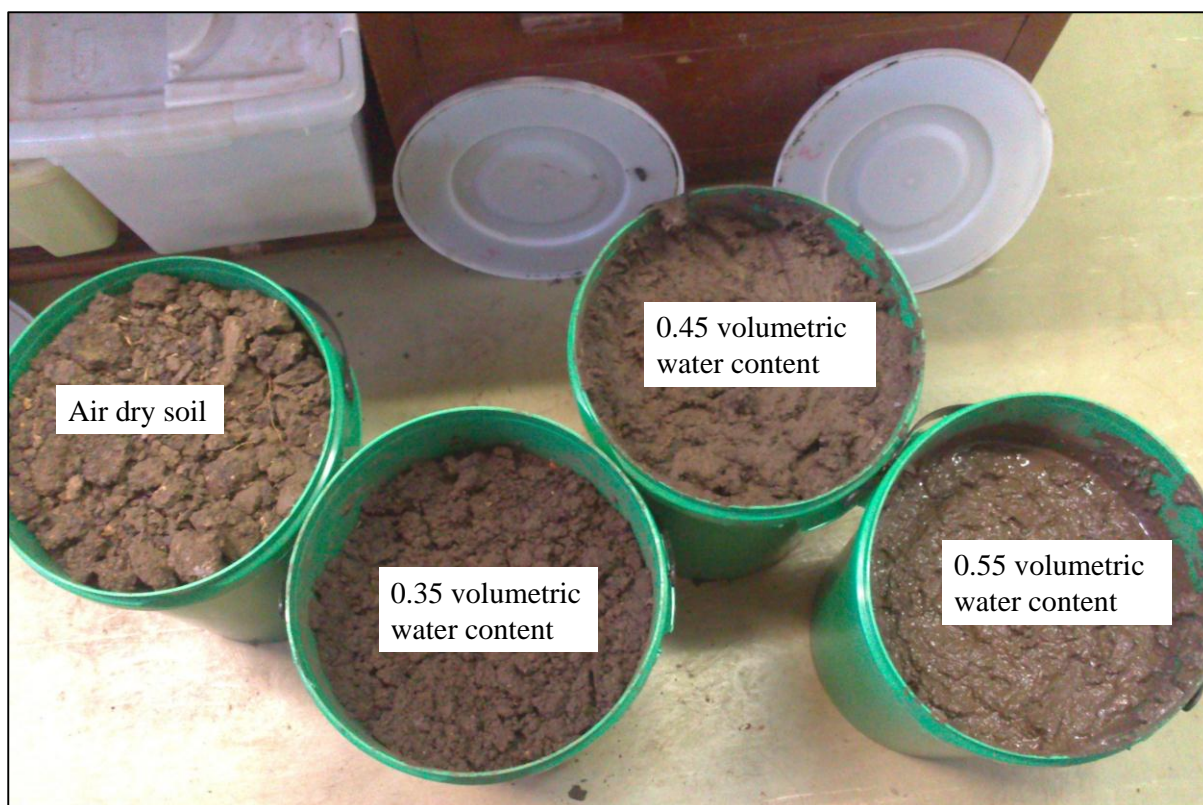
Appendix 28: Four 20 litre buckets with a known volumetric water contents

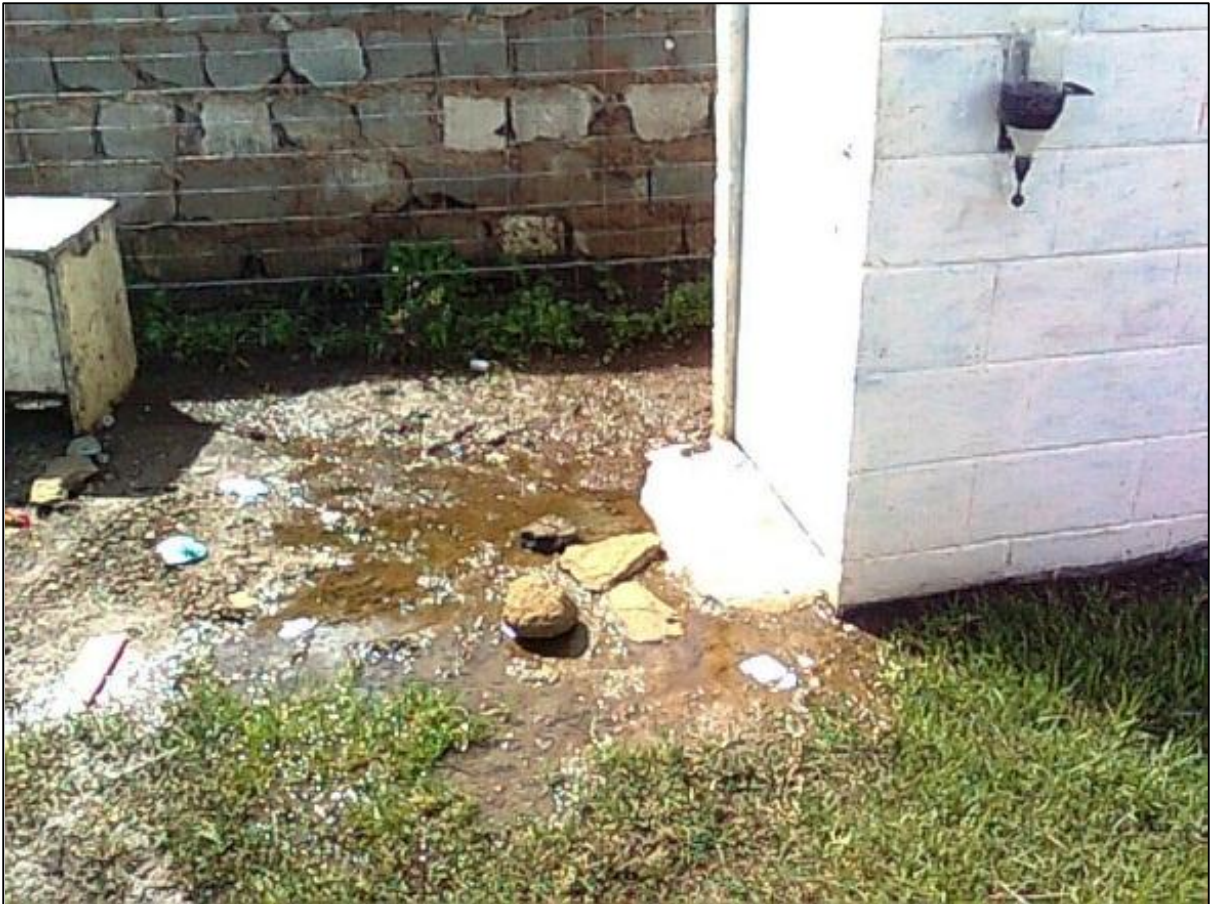
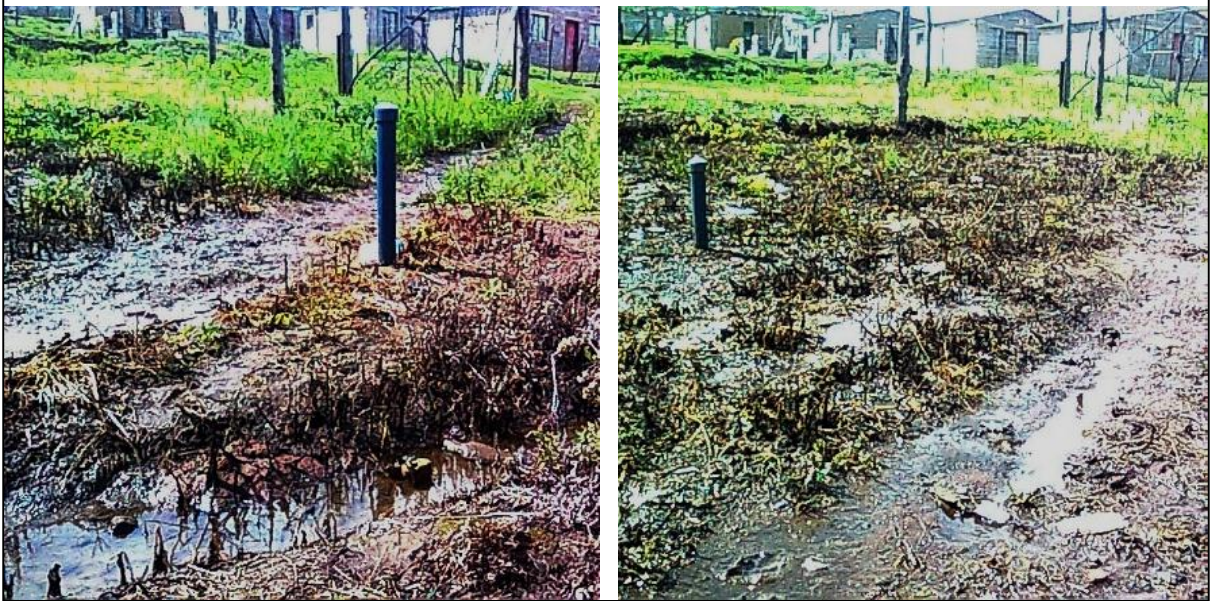
Appendix 30: Surfacing of water table at the Slangspruit site after prolonged rainfall conditions

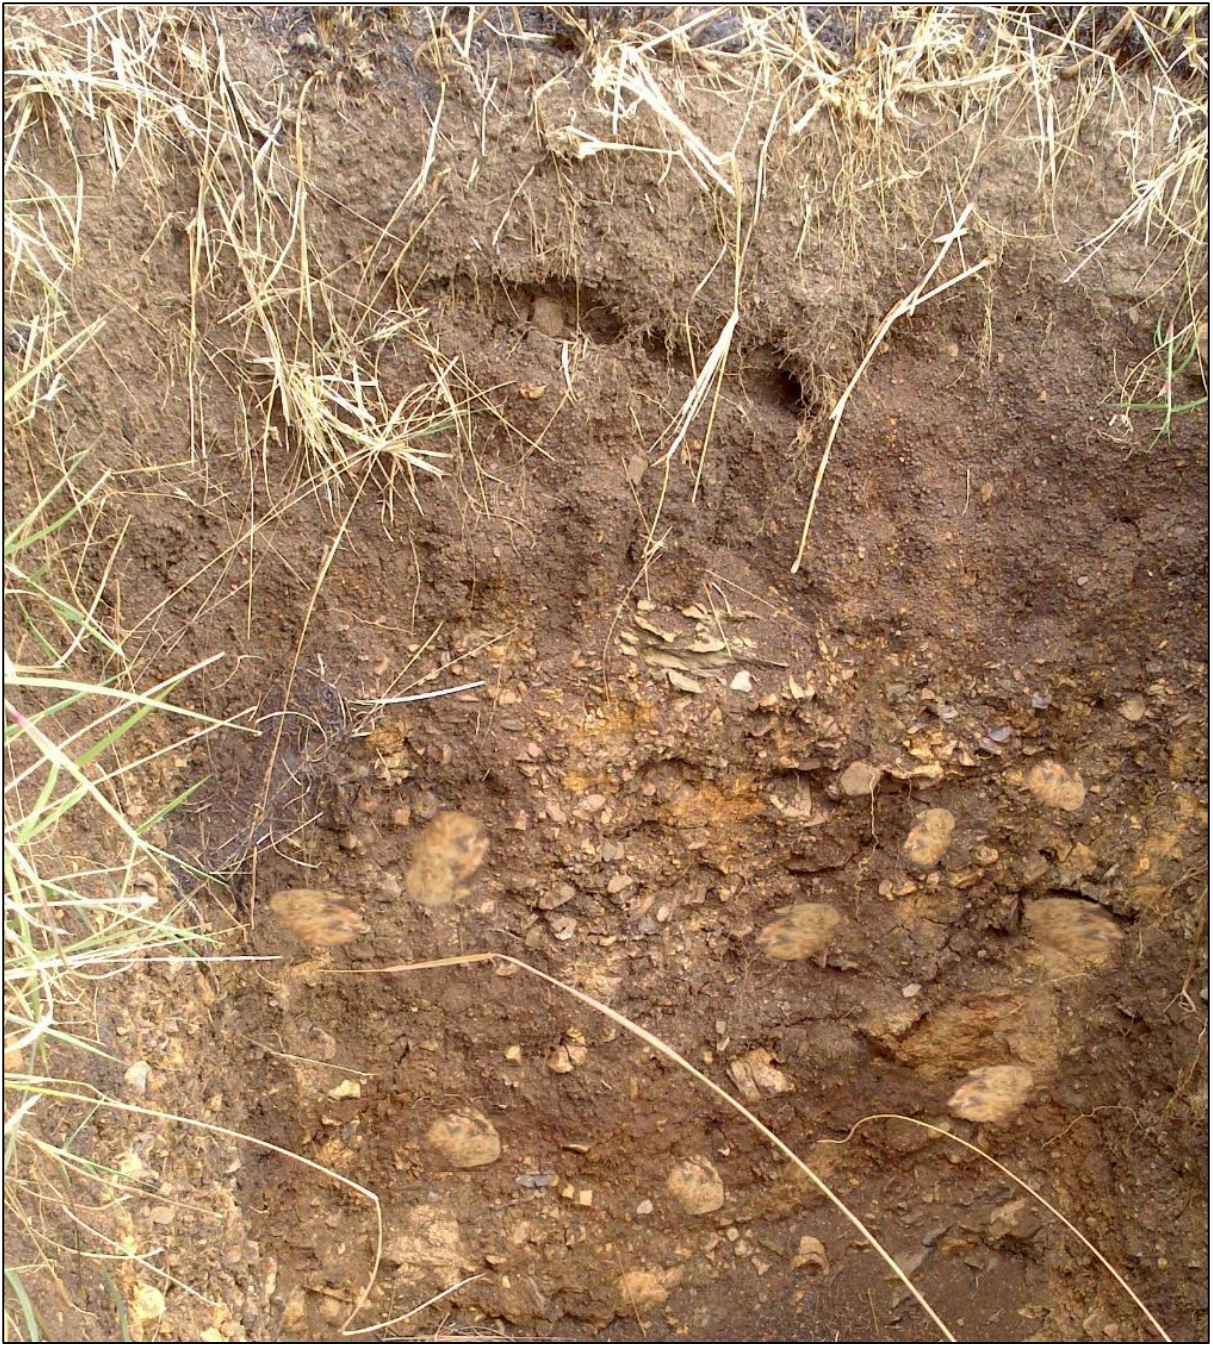
Appendix 31: Disturbed soil profile at the Crèche site

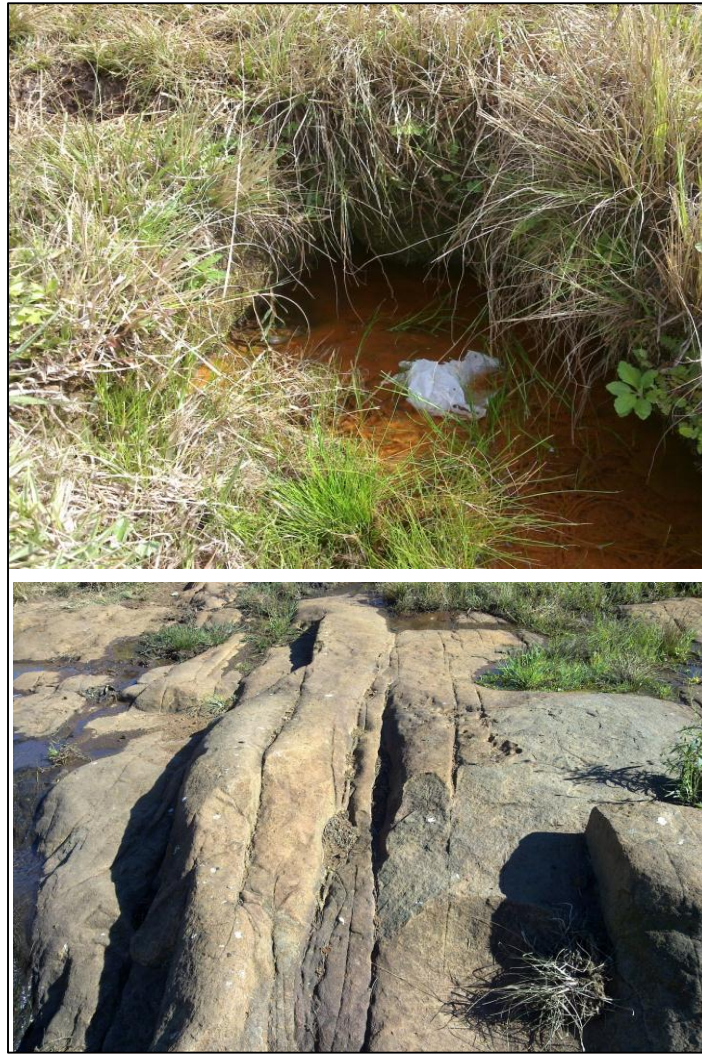
Appendix 34: Preferential flow paths via large animal burrows and joints or cracks in the parent material at the Taylors Halt site
