**INVESTIGATION OF THE STRUCTURAL BEHAVIOUR
OF
MEGALITHIC MNAJDRA MONUMENT**

Submitted in fulfilment of the requirements for the degree of
Master of Science in Engineering

University of KwaZulu-Natal

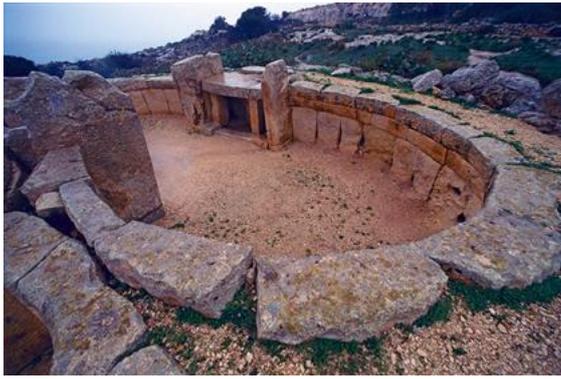
Figure 3: Picture showing the internal wall and part of the soil and debris retained by the middle temple of Mnajdra (Gray, 2018).

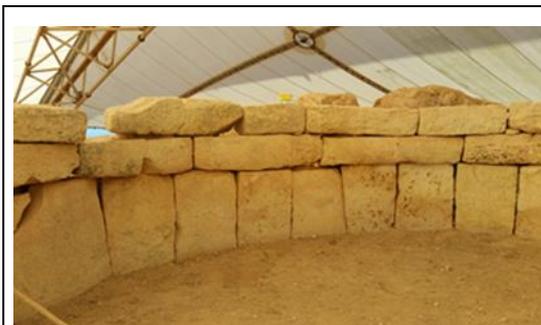
Figure 20: Position Y33 of yellow ambient vibration monitor with maximum frequency of 57.41 Hz.

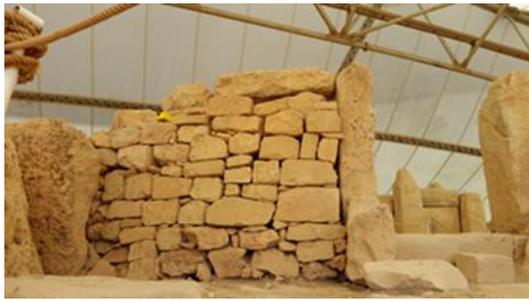
Figure 22: Position Y34 of yellow ambient vibration monitor with maximum frequency of 52.81 Hz.

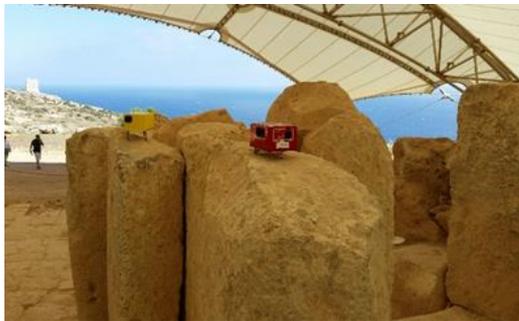
Figure 24: Positions R12 and Y42 of red and yellow ambient vibration monitor respectively with maximum frequency of 18.66 Hz and 45.63 Hz respectively.

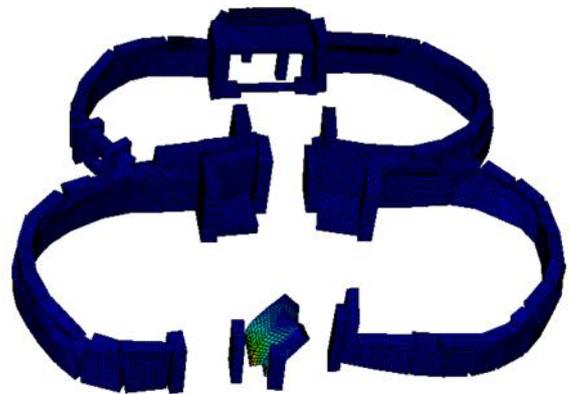
Figure 25: The mode shape with frequency of 51.90 Hz corresponding to R12 and Y42.

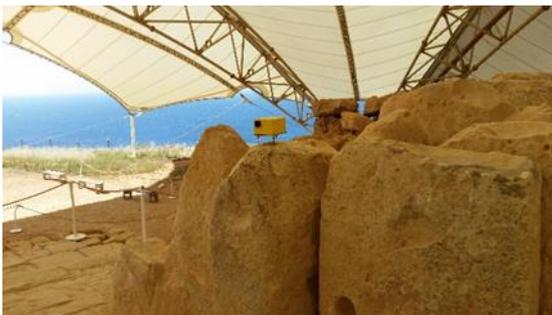
Figure 26: Position Y35 of yellow ambient vibration monitor with maximum frequency of 49.69 Hz.

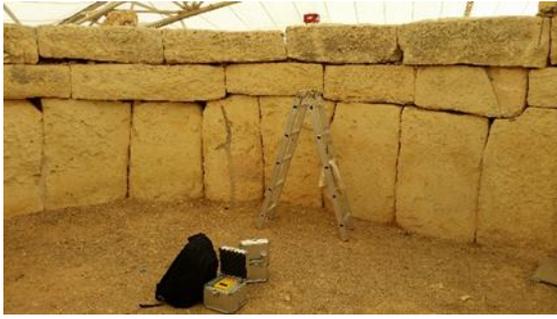
Figure 28: Position R10 of red ambient vibration monitor with maximum frequency of 28.75 Hz.

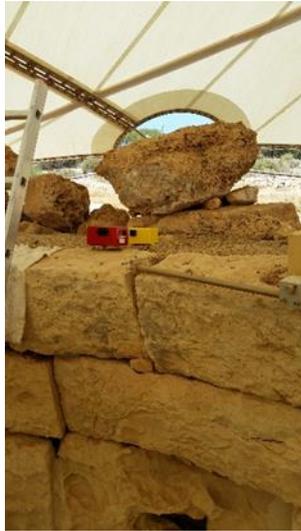
Figure 30: Position R11 of red ambient vibration monitor with maximum frequency of 29.06 Hz.

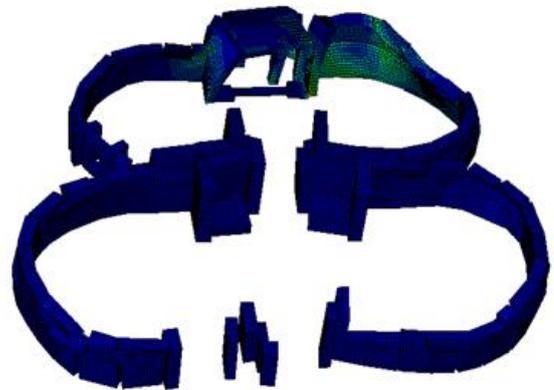
Figure 31: The mode shape with frequency of 34.71 Hz corresponding to R11.

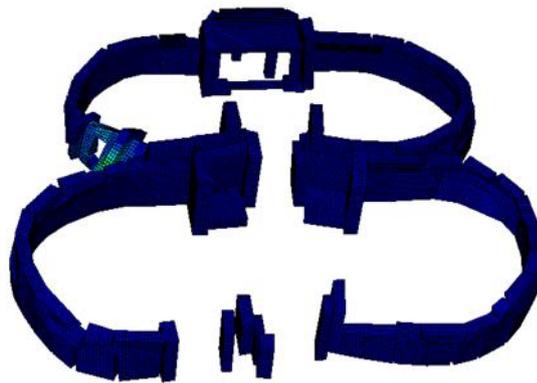
Figure 32: The mode shape with frequency of 54.69 Hz from the model which corresponds to the maximum frequency on 46.39 Hz recorded on position M39 on situ.

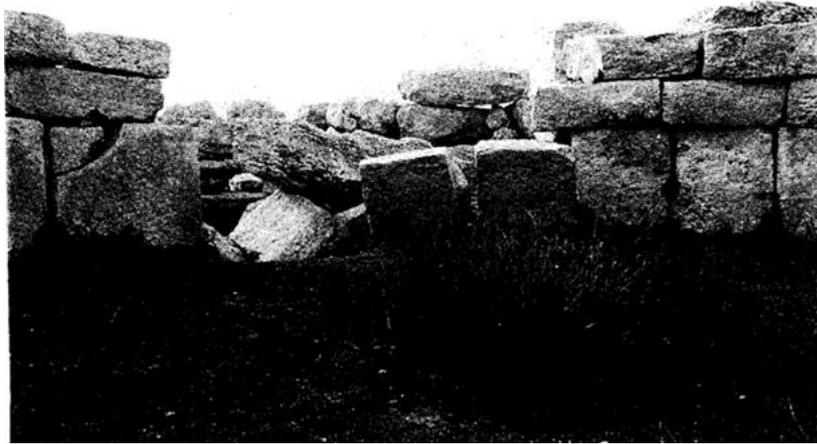
Figure 42: Collapsed wall from first apse of Middle Temple (Torpiano, 1995).

Another conclusion is that the movement of one stone can cause a ripple reaction which causes stones in the surrounding region to be destabilized. This is more pronounce in the model D6 (Figures 36 and 43), where a horizontal displacement load of 10cm was applied perpendicular to the face of the stones at the top edges of the bottom stones. The results show some of the surrounding stones to be dislodged into the opposite direction of the load applied (Figure 43). A similar damage pattern, depicting stones dislodged from their stable positions and overturning, was obtained after the actual event took place in 1995, Figure 42.

2. The structural integrity of the monument can be significantly reduced by the increase in backfill pressure due to heavy rainfall. This was one of the major causes of the first apse wall to collapse in 1995. The failure pattern from the numerical model closely matched the damage pattern from the real collapse. From this study, a better understanding of the effects of increase in backfill pressure is achieved. This explains a subsequent intervention, where a new drainage system was built following that event.
