# MITIGATION FOR FLOATING NEUTRAL IN DISTRIBUTION SYSTEMS

Master of Science in Electrical Engineering

College of Agriculture, Engineering and Science, University of KwaZulu-  
Natal

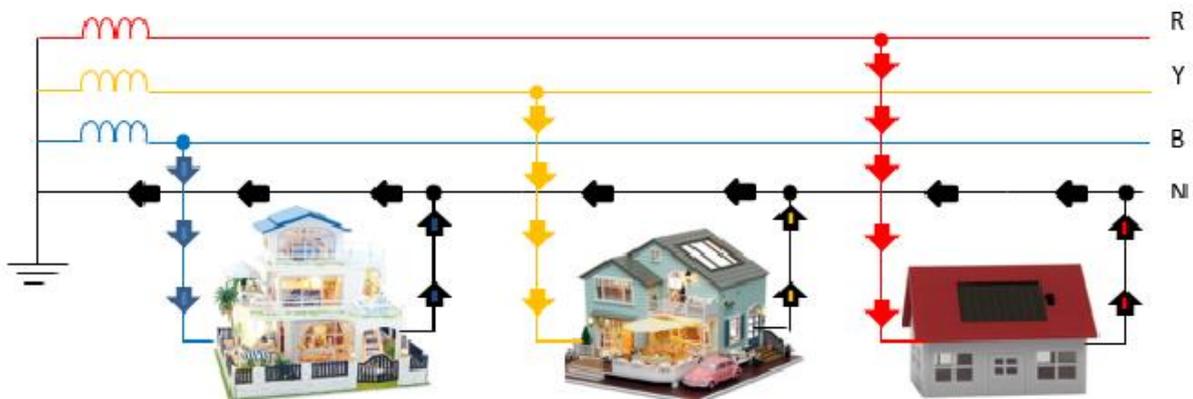
Figure 2.1 Power flow on three-phase supply with single-phase customers under normal conditions

Figure 2.1 above shows the flow of power from the different connected phases to the load under normal operating conditions. For all the connected loads, the neutral is the return path for the current flow resulting in all the customers connected between phase and neutral conductor. The voltage experienced by all customers is the phase voltage, which is 230 V.

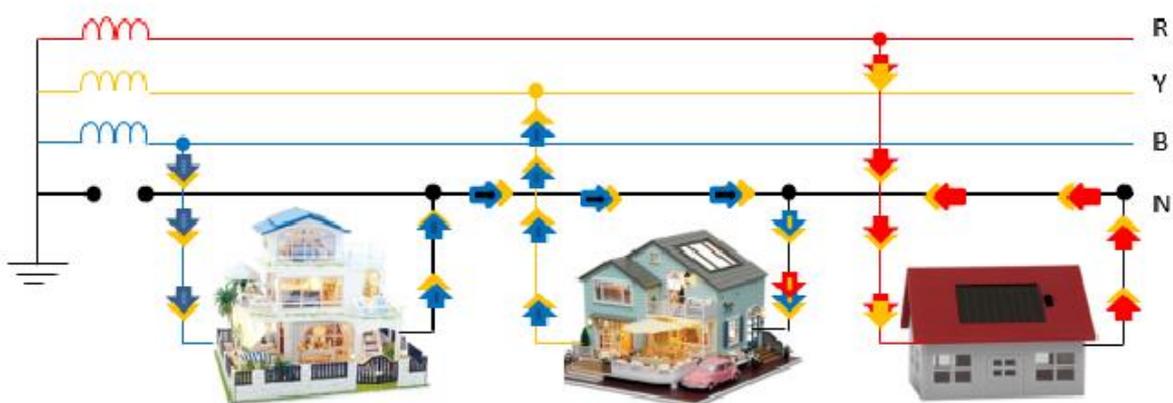
Figure 2.2 Power flow on three-phase supply with single-phase customers under broken neutral conditions

A broken neutral in a distribution network will result in an abnormal situation since there will be no continuity of current flow back to the neutral point as demonstrated in figure 2.2 above. The current from the blue phase that was supposed to use the neutral as a return path end up being directed to return via the red and yellow phase, resulting in them connected to phase-phase conductors instead of phase to neutral. That result in customers connected to the network experiencing voltage fluctuations up to the line voltage instead of the standard phase to neutral voltage of 230V or voltages close to 0 V depending on the load at different customer installations [4] [11].

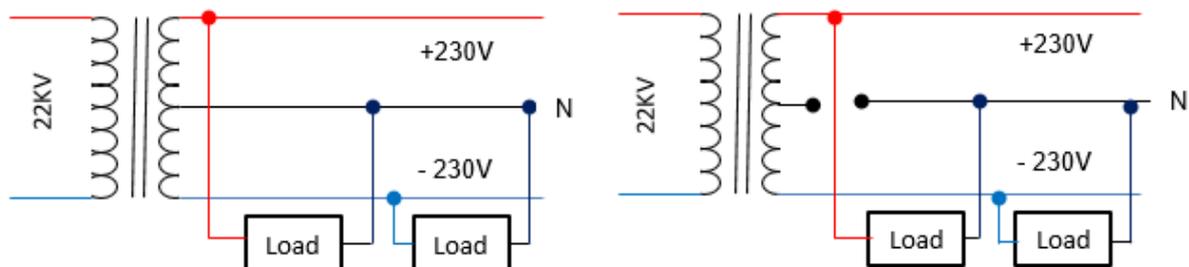
Dual phase transformer are connected between two-phase conductors. The secondary side of the transformer is 230V, measured between any of the connected phase and neutral. The voltage across the phase-phase conductors is 460 V. A loss of neutral on a dual phase source will cause the neutral to float resulting in voltage fluctuations between -240V and + 240V. Customers connected to the network might experience voltage up to 460V. There can also be a potential of dangerous touch voltages on exposed conductive parts that can be harmful to people [11] [4].

Figure 2.3 Power flow on a dual phase transformer under (a) normal condition and (b) broken neutral condition

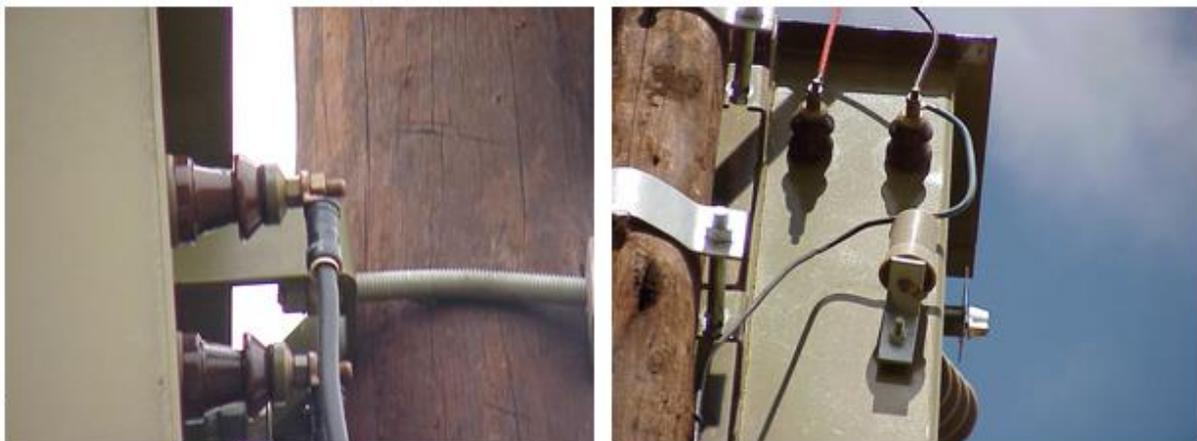
Neutral conductor failures on the transformer bushings are mostly caused by poor workmanship as well as the use of incorrect or non-standard material. The standard requires that all neutral connections needs to be connected directly to the neutral bushing. Figure 2.4 below shows the transformer neutral bushing connection on the network. The first picture on 2.4 (a) shows a direct neutral connection method using a transformer lug and It can be seen on the picture on figure 2.4 (b) that the 16mm<sup>2</sup> copper insulated conductors is connected via the neutral surge arrester not directly on the neutral bushing. The pictures in 2.4 above were taken at Phokwane village electrification project in Limpopo during the project quality inspection. If the bridge piece between the surge arrested and the neutral bushing can be compromised, the network will be exposed to the risk of floating neutral. There was a time where there was a high rate of bimetallic lugs connector failures due to the quality of the materials that were used. The connectors were failing at the point where the aluminum was joint with copper. That left a number of customers connected to the network exposed to the risk of floating neutral.

Figure 2.4 (a) Direct neutral connection & (b) Neutral connected via the surge arrester

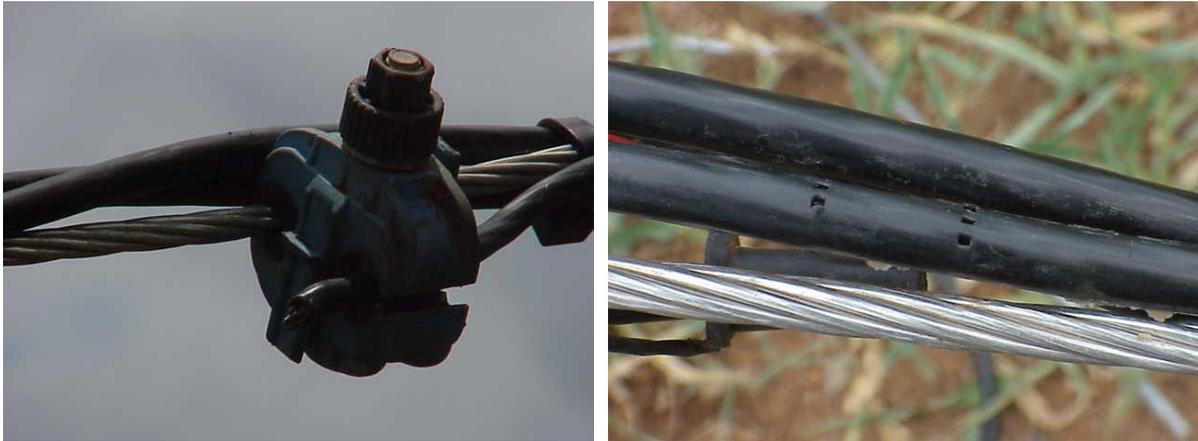
Figure 2.5 (a) IPC Connection and (b) IPC removed from ABC

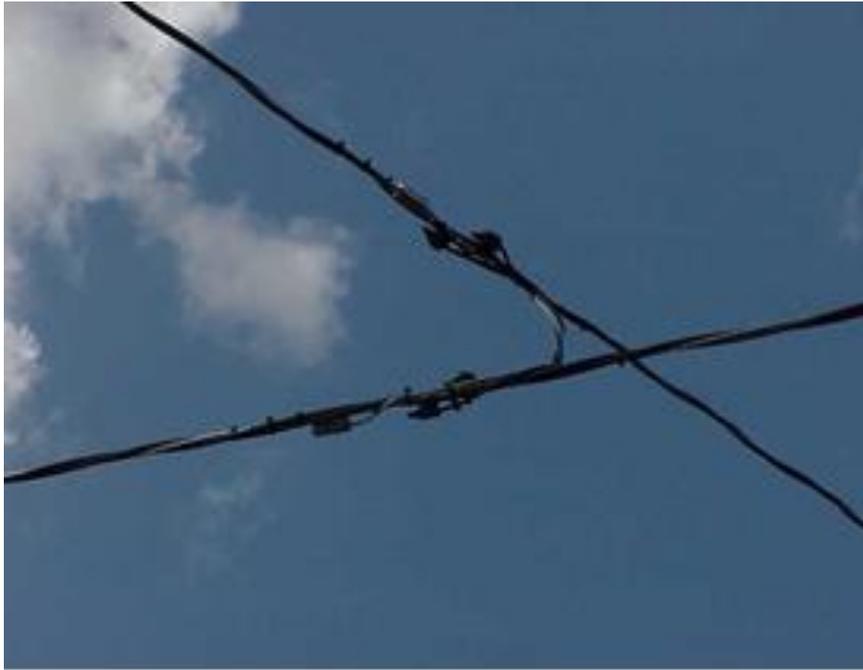
Flying jumpers refers to connection or bridging of two conductors mid-span without a supporting structure as depicted in figure 2.6 below which was taken at Elliotdale in Eastern cape during electrification project quality inspection. The conductor movement due to wind and other mechanical forces that can cause movement on any of the conducts create friction between the conductor and jumpers. The movement combined with increased temperatures due to atmospheric as well as the heat generated by the electrical load on the conductor create a very conducive environment for the conductor failure. It is not standard practice to have flying jumpers on the network and such non-standard installations require normalization.

Figure 2.6 Flying jumpers connection on aerial bundled conductors

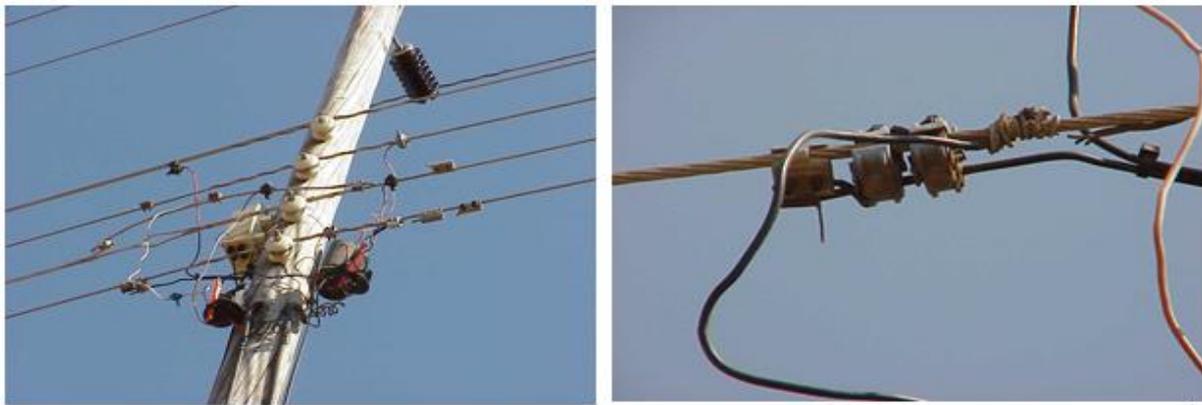
Figure 2.9 State of some low voltage networks

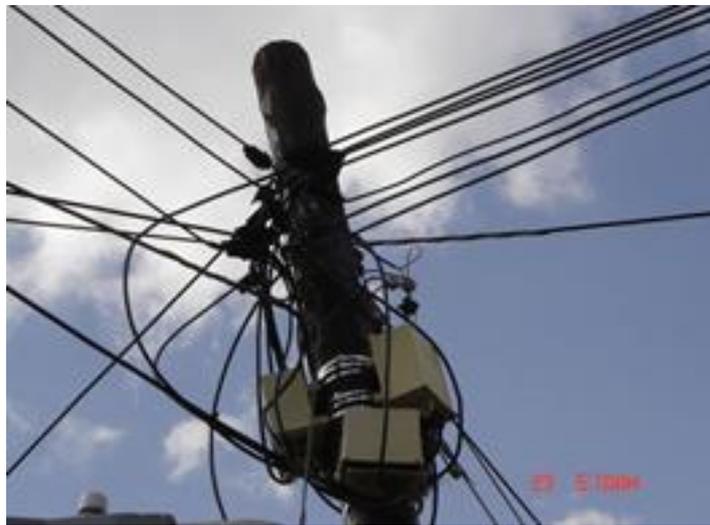
Figure 2.10 Network overloading

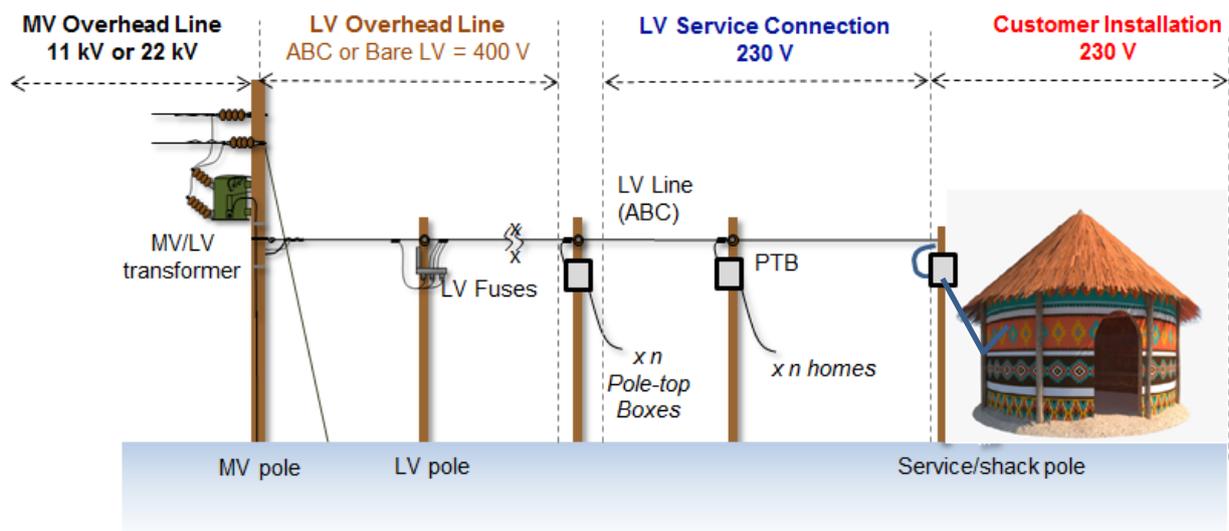
A typical distribution network in South Africa is shown in figure 3.1 below. The network take off point is from the medium voltage network which is normally 11 kV or 22 kV. In rare cases we do get 33 kV networks being used for medium voltage reticulation but majority of the networks are 11 kV and 22 kV [49]. Overhead lines are mostly used for rural electrification medium voltage distribution and underground cables are mostly used for urban reticulation [52]. The medium voltage is then stepped down with a reticulation transformer to low voltage, which is: 400 V line voltage for three phase supplies, 420 V line voltage for dual phase supplies and 230 V phase voltage for single phase supplies [52] [53]. Bare low voltage conductors or Aerial Bundled Conductors (ABC) are used for low voltage reticulation and can be three phase, dual phase or single phase depending on the type of transformer used. Customers are connected to the network from the pole top boxes which are mounted on the LV poles. A service distribution cable (airdac) is used to connect the customer houses to the network [54]. The figure 3.1 below shows the network layout as well as the boundaries between Medium voltage, low voltage and customer installation. The customer installation point is also referred to as a service point in the document

Figure 3.1 Distribution network model

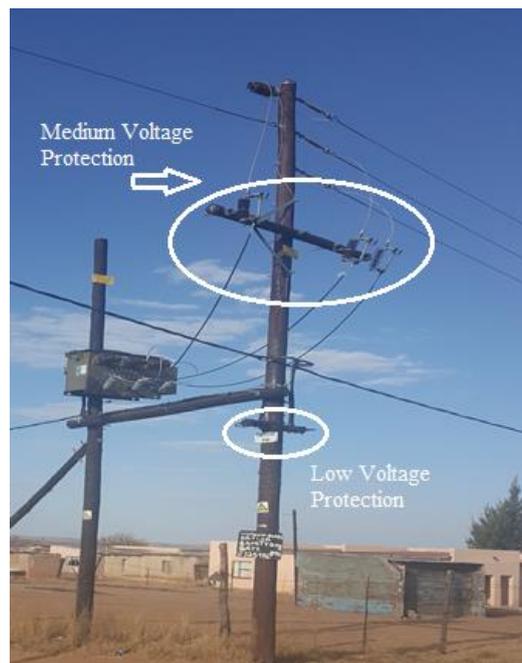
The Medium Voltage (MV) side of the transformer is protected against faults inside the transformer using drop out fuses which are mounted on the cross arm above the transformer [52] [45], as shown in figure 3.2 below. There are few transformers in the network with internal oil immersed circuit breaker known as Complete Self Protected Transformers (CSP). Both the fuse and circuit breaker on the transformer MV side are meant for over current protection [55] [45]. Three MV surge arresters are also installed in parallel with the bushings of all three phases to protect the transformer against lightning surges [52]. The transformer is adequately protected against both over current and over voltage fault conditions that has got potential to damage the transformer.

Figure 3.2 Reticulation Transformer Protection

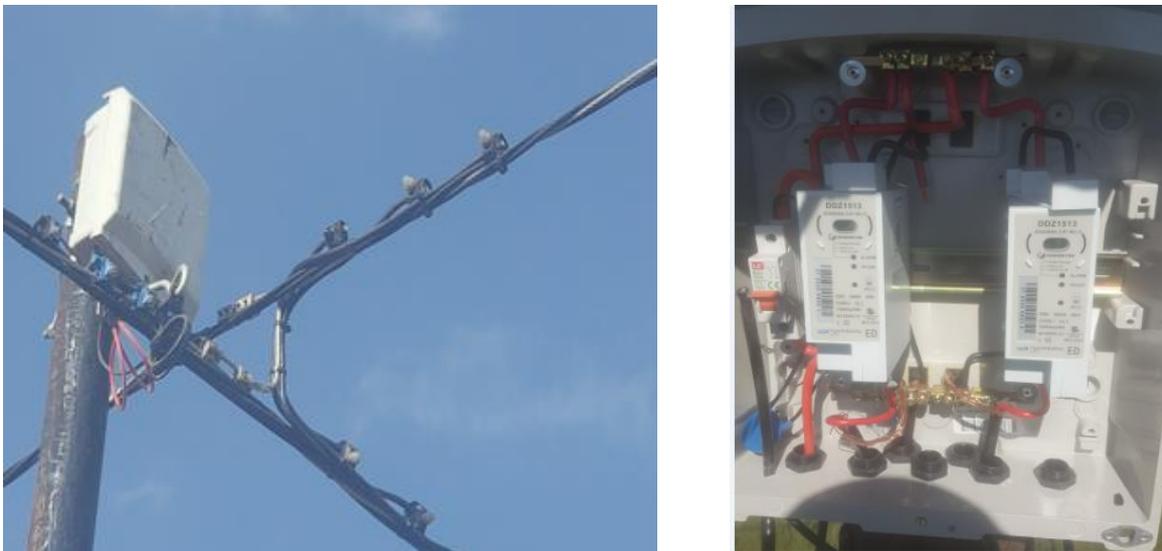
The house connections or service connections are connected from the pole top box which is mounted on the LV pole through a concentric service conductor (airdac) as in figure 3.3 below. Service connections are protected against faults on the service cable by means of a 50 A circuit breaker inside the pole top box. The 50 A circuit breaker can protect up to four houses connected to the network [45]. The circuit breaker can only protect the network against Over Current and short circuit conditions and would not operate under over voltage or over voltage conditions [57].

Figure 3.3 and 3.4 Service Pole Top Box

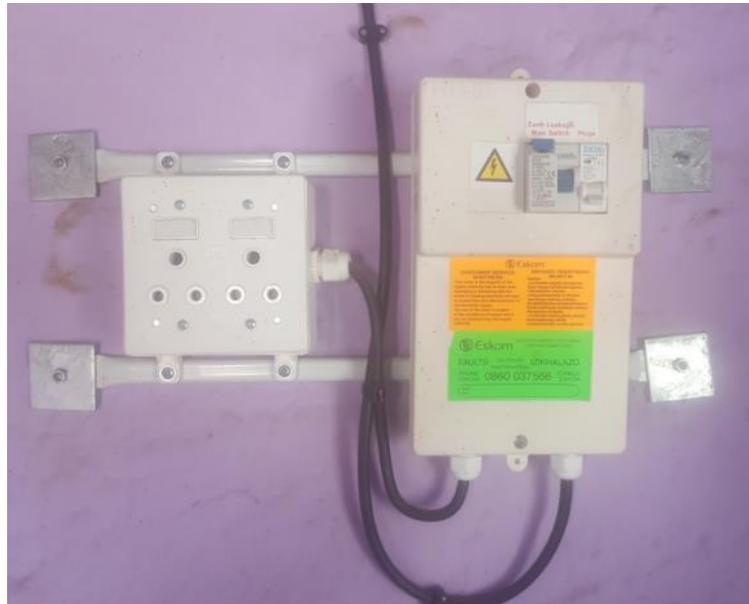
Figure 3.5 below shows a typical rural house connection with a ready board and a plug box mounted on a rail for ease of installation. A ready board is a low cost distribution board that act as a termination point from the utility supply point. The unit consists of an earth leakage and circuit breaker for over load protection [56]. In electrification houses where Eskom supplies the ready board for 20A customers, a surge arrester for lightning protection is also included inside the unit. All the above mentioned protection will not protect the customers against under voltage and over voltage faults [45] [54].

Figure 3.5 Services installation for 20A customers

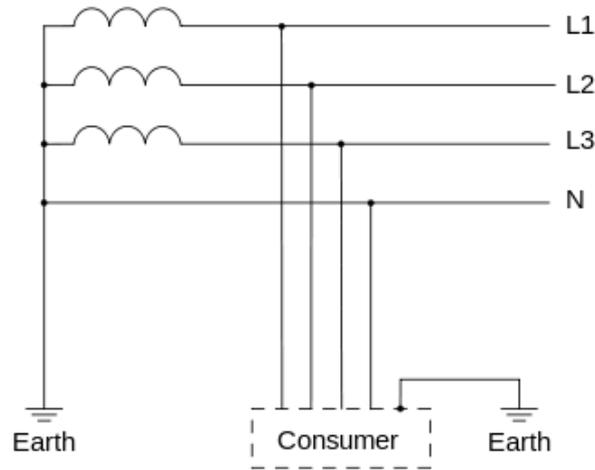
The TT (terre-terre) earthing system is characterised by two or more independent and separate earth electrodes between the source and the customer. The neutral point of the supply is directly connected to an earth electrode with no physical connection to the local earth electrode installed at the customer point. The system has a high earth loop impedance, as a result a Residual Current Device (RCD) is strongly recommended as a first line of protection against earth fault. There is no risk in case of a broken neutral in a TT system. Where power is distributed using overhead infrastructure, earth conductors are not at risk of becoming live in case fallen trees and branches come into contact with the network [50] [58] .

Figure 3.6 TT Earthing arrangement [58] [60]

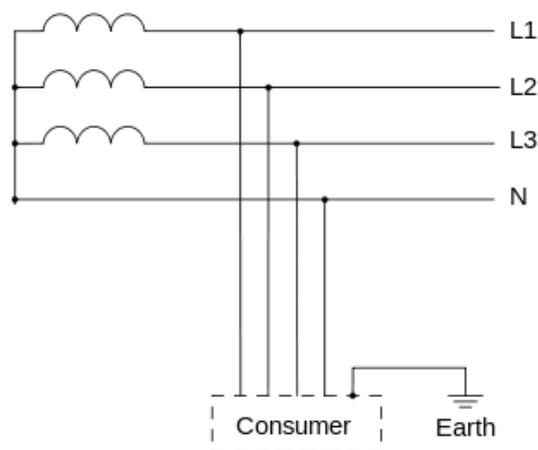
Figure 3.7 IT Earthing arrangement [60] [58]

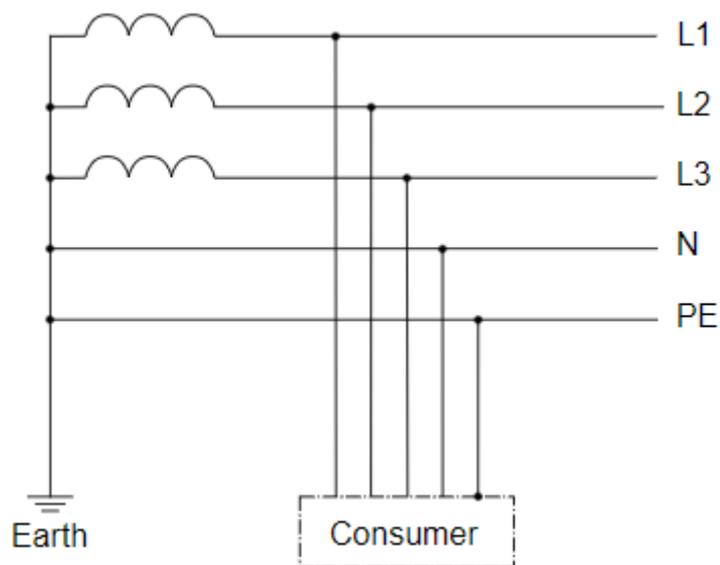
Figure 3.8 below shows the earthing arrangement of the TN-S (Terre Neutre – Séparé) system. It consist of a separate protective earth (PE) and neutral (N) conductors from the source to the customer installation. The protective earth and neutral conductors remain separated through out the system and does not get connected at any point. The system consist of five separate conductors as a result it is the least cost effective though it is safer compared to the other systems. There is no additional earthing required at the customer point, the system is completely reliant on the source earth electrode [63] [56].

Figure 3.8 TN-S Earthing arrangement [60] [58]

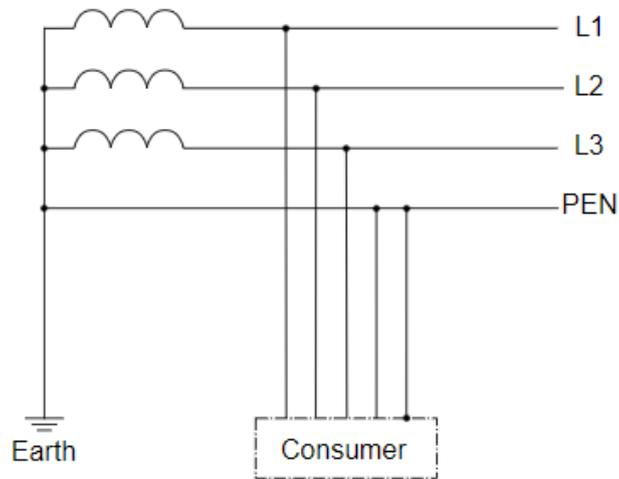
Figure 3.9 TN-C Earthing arrangement [60] [58]

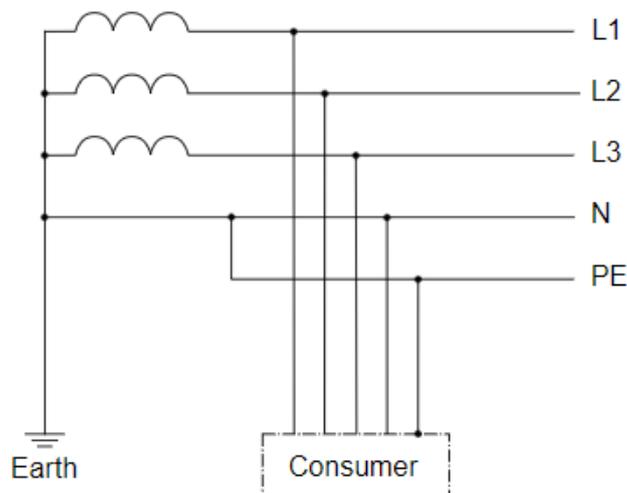
The TN-C-S earthing arrangement (Terre Neutre–Combiné–Séparé) is a combination of TN-S system and TN-C system. The protective earth (PE) and neutral (N) conductors are combined from the source to the customer installation distribution point. From the distribution point, there is a separate protective earth (PE) and neutral (N) conductors. The wiring inside the customer premises run separate protective earth and a neutral conductors as well as all the flexible power cords utilised in the buildings. There is no local earth electrode required at the customer installation; the system is completely reliant on the source earth electrode [50] [62] [58].

Figure 3.10 TN-C-S Earthing arrangement [60] [58]

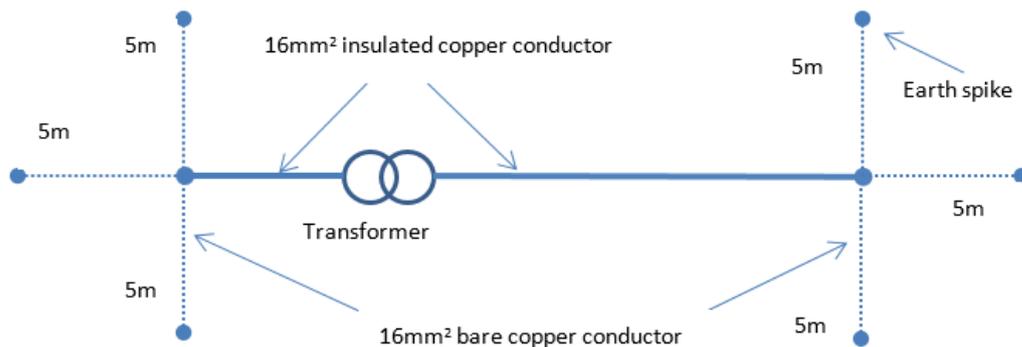
Traditionally, the transformer MV and LV earth for reticulation transformer earthing in Eskom are applied at the transformer pole, with minimum separation distance of 5m between the two earths as in figure 3.11 below [64]. Where practically possible, the earths are installed on the opposite directions of the pole separated using an insulated  $16\text{mm}^2$  copper conductor and the actual earths using  $16\text{mm}^2$  bare earth conductors connected to 4 vertical earth spikes [60]. That is done to achieve the electrode resistance of less than  $30\Omega$  for both MV and LV [64]. The  $30\Omega$  earth electrode maximum limit is for ensuring that the fault in the network does not stay for longer period before sensitive earth fault protection operates to minimise the risk of people in close proximity to the network [59].

Figure 3.11 Transformer earthing with MV & LV on the same pole [64] [12]

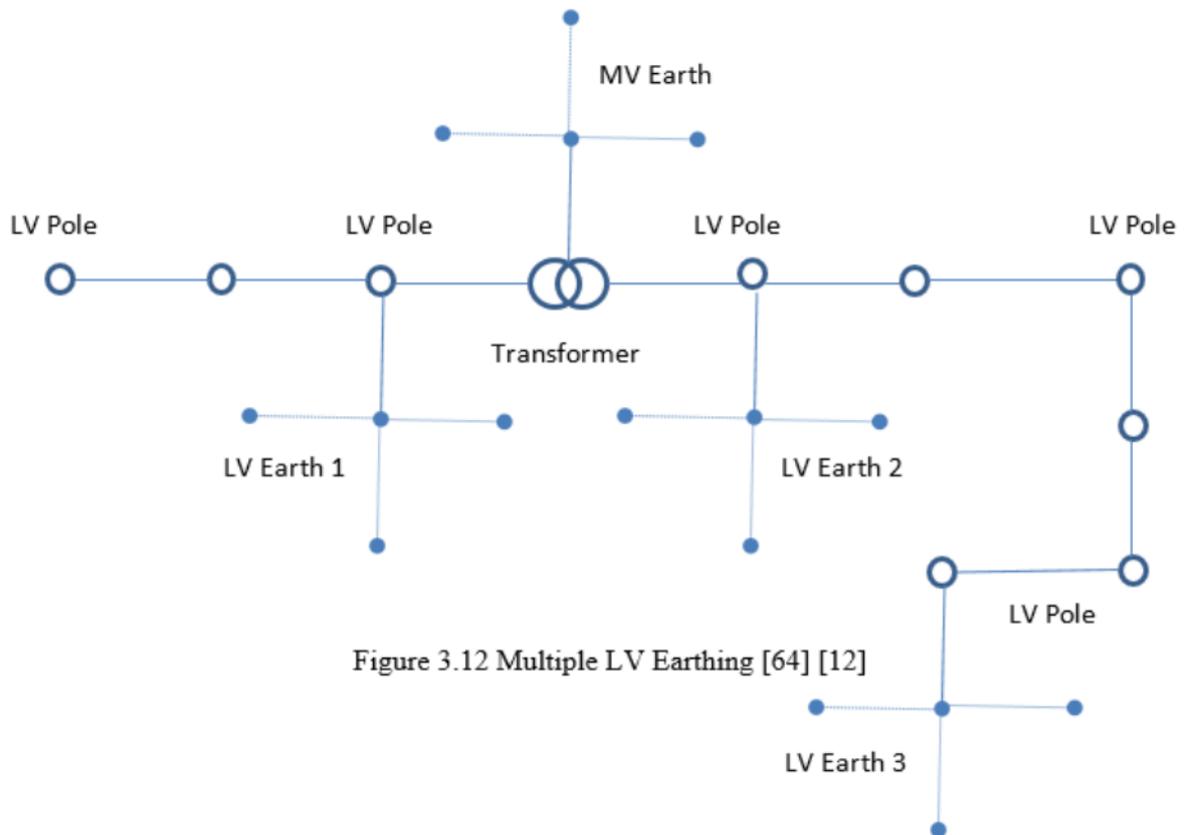
With the escalating risk of earth theft and the risk associated with having unearthed networks, multiple LV earths were introduced as a mitigation measure. Only MV earth is applied at the transformer pole and the LV earthed one pole away from the transformer as in figure 3.12 below. If the transformer zone consists of more than one LV feeder, each feeder is earthed one pole away from the transformer. In high risk areas, the LV earth electrodes can also be applied on the last pole of the LV feeders depending on the length of the LV feeders. In case of one earth being compromised, the risk of potential touch voltages in the system remains under control [53] [64].

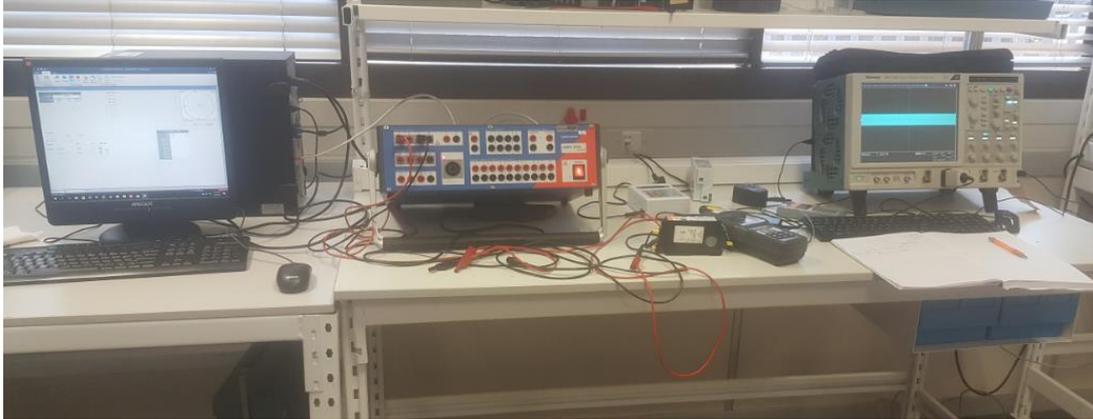
connected to the load. Comparison of the metering unit's performance to the manufacturer specification were done, to determine if the meters works as specified or if there were any deviations from the expected performance.

Figure 4.1 Overview of the meter testing setup

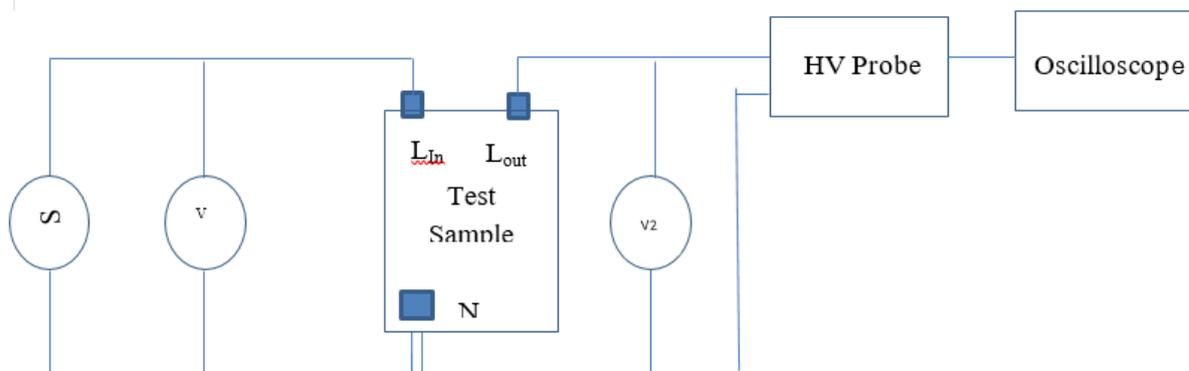
Figure 4.2 Single line diagram of the test circuit

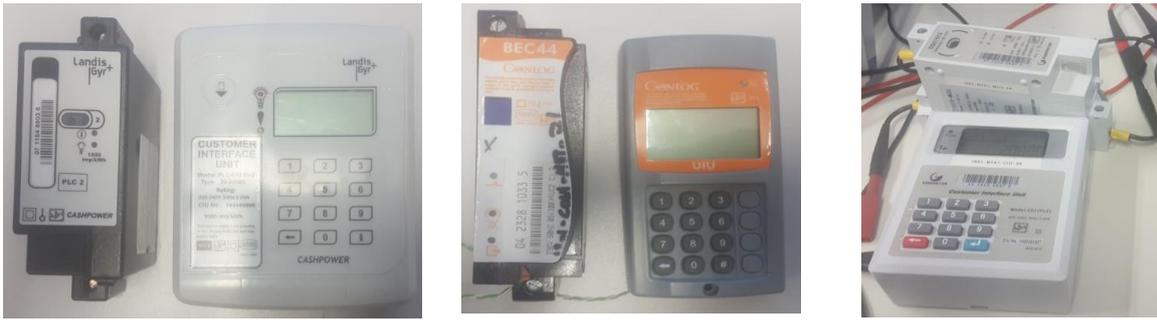
Figure 4.3 Pictures of the test samples

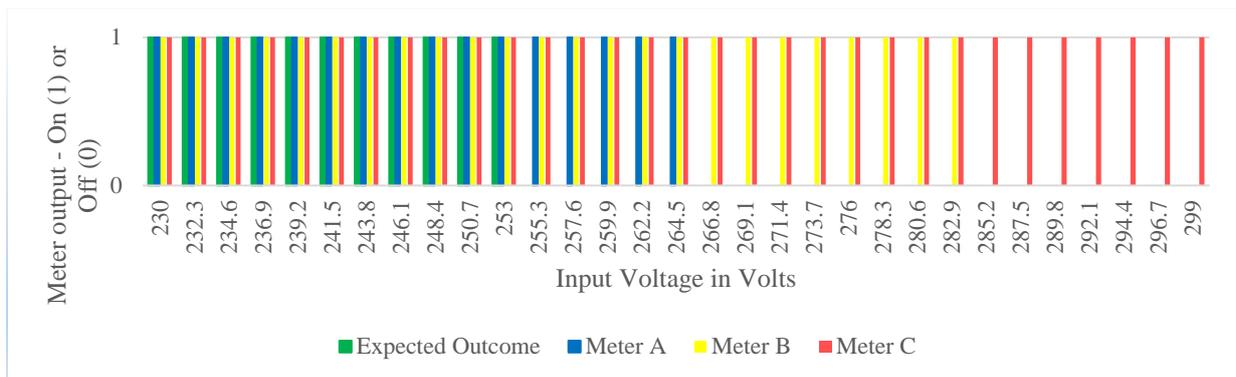
The over voltage protection test was conducted to determine how the different metering units responded when voltage level which is above the rated voltage limit was applied across the meters [69]. Step voltage increase of 1% supplied to the meters from 230 V until the meter trip or reach the line voltage of 400 V. For compliance with the regulatory limits, the meter protection was expected to operate and cut off the supply to the load as soon as the voltage exceed 10% of the standard supply voltage. That means that any voltage above 253V was outside the maximum permissible voltage and the meter was supposed to disconnect the load. Operating equipment and appliances rated for 230 V above 253 V can puncture the insulation of such equipment and appliances resulting in damage to the components. It is important that customers are protected from exposure to over voltage when it does occur on the network to comply with regulatory requirements as well as maintaining good customer relations [69]. The Eskom specification prescribes the disconnection of load at 80% of the rated operating voltage, which is 10% above the National Regulator’s limit [66].

Figure 4.4 Over voltage protection graph

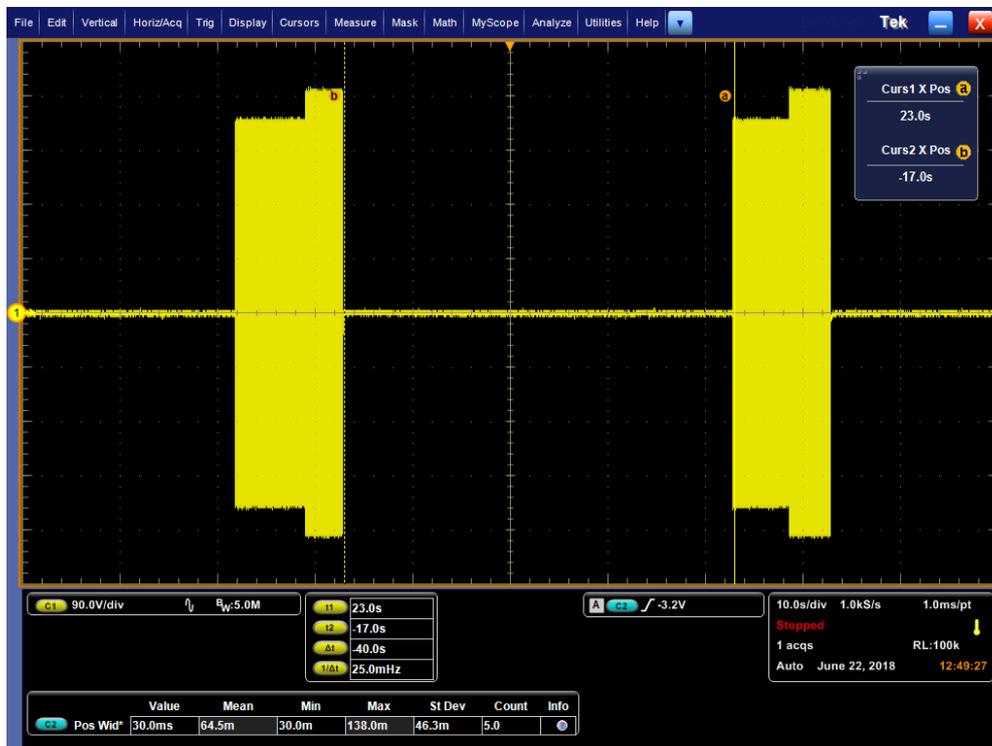
The diagram 4.5 below shows the response of metering unit A when supplied with over voltage. The system remained stable between the rated operating voltage of 230 V and 265 V. At 267 V the metering unit tripped in 4 seconds and remained off. When voltage was ramped up to 230V, the system switched back on and stabilised after 30 seconds. As much as the meter operated outside the NRS limit of 10% variance, it was still within the 20% limit specified by Eskom as an optional protection requirement [66] [69]. The oscilloscope recorded a time difference of 40 seconds, the variance of 10 seconds was due to the time taken to reduce the voltage back to 230 V. There was no change in response time for all voltage ranges between 267 V and 400V. The tripping time on over voltage as well as time taken for system stabilization after restoring supply remained constant at 4 seconds and 30seconds respectively. Even though metering unit A continued to operate outside the maximum permissible voltage, the exposure to the load connected beyond the meter was limited since it operated at 16% (267 V).

Figure 4.5 Metering unit A response on Over voltage

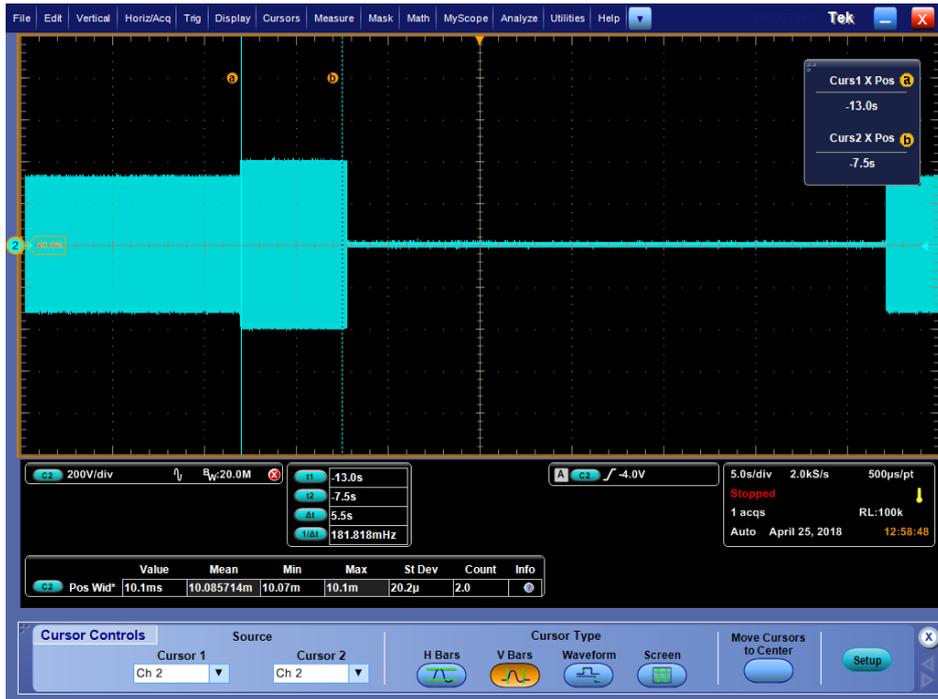
Figure 4.6 Metering unit B Over voltage response time

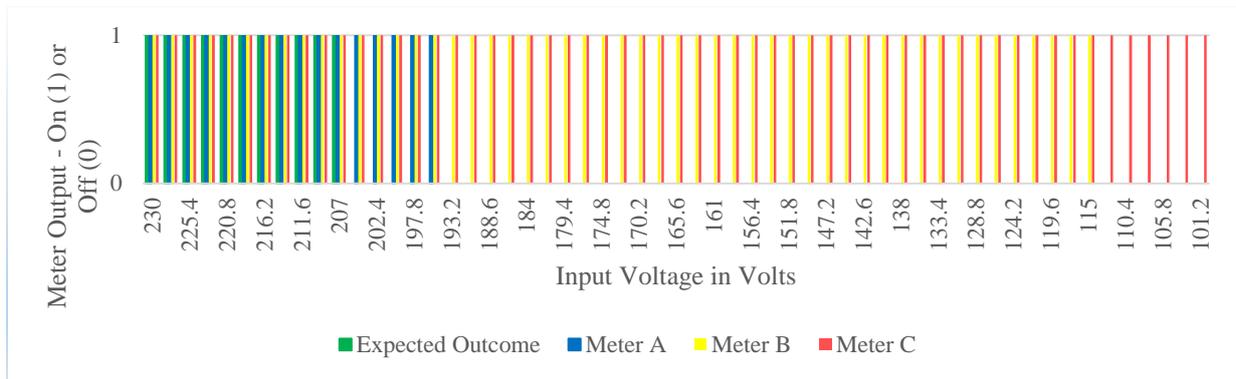
represented by a 0. The output voltage measured was the same as the input voltage, the graph only indicates the ON and OFF state.

Figure 4.7 Under voltage protection graph

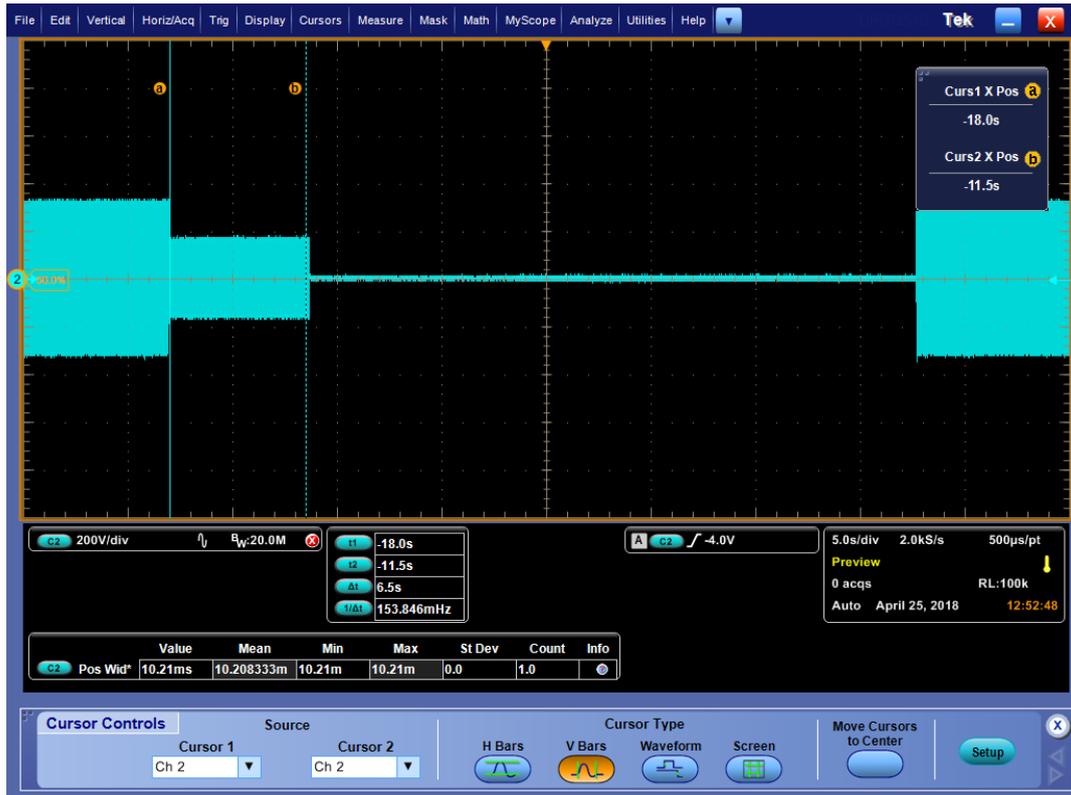
Figure 4.8 Metering unit B Under voltage response time

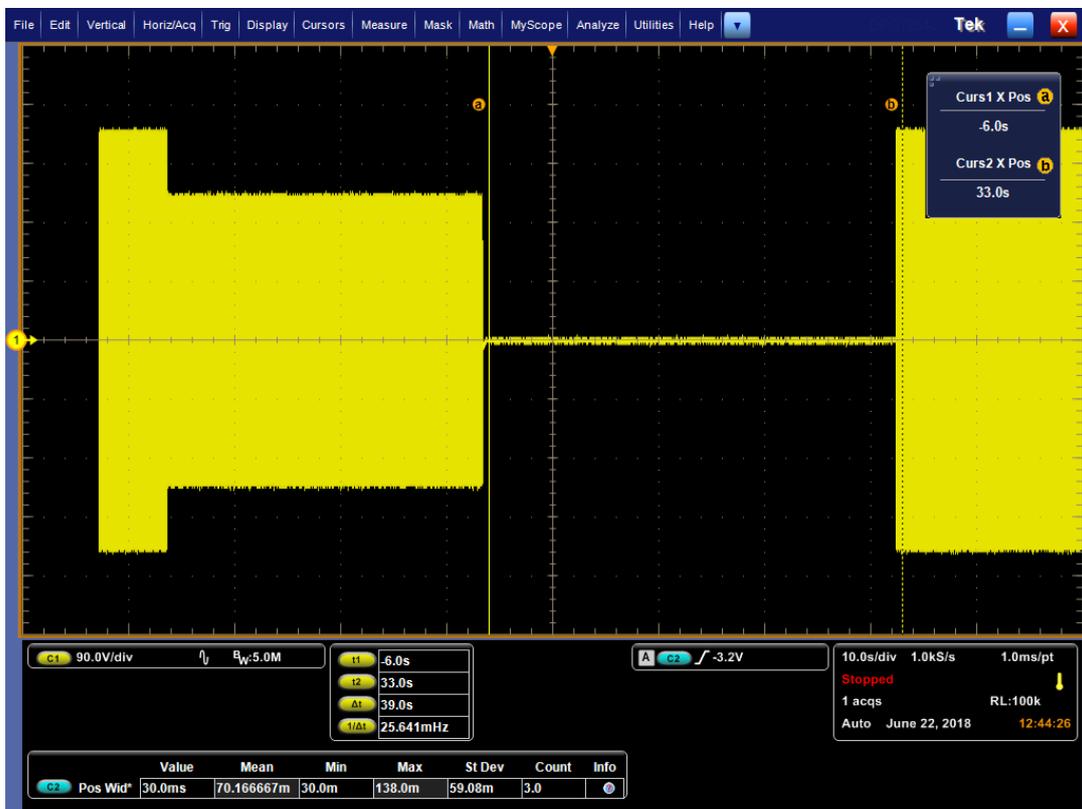
Figure 4.9 Metering unit A response on Under voltage

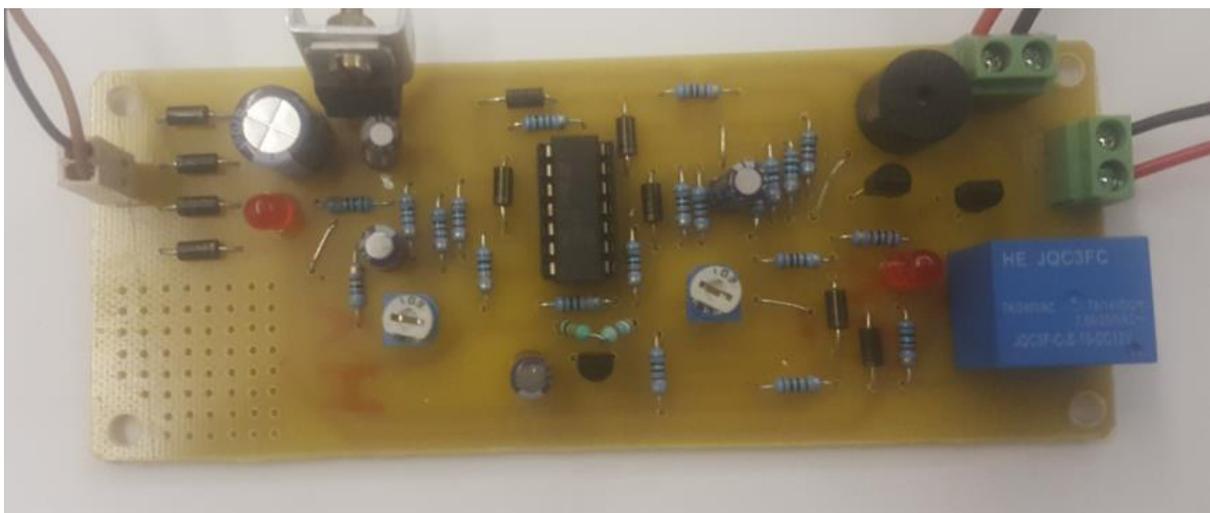
There is a number of over voltage and under voltage protection units already available in the market that come as complete units that can be connected on the customer distribution board supplying the load. There is also units that can be plugged on the socket outlet and protect only the appliances connected from that socket. For the purpose of this academic project, the researcher opted for a circuit designed from basic principles instead of final products that come as complete units. The magnitude and duration of the over-voltage are some of the major considerations when designing an effective protection against fluctuation voltages. The protection involved setting a threshold voltage above and below which the control circuit shuts down the supply to the load.

Figure 5.1 Over Voltage and Under Voltage protection circuit

Similar results in figure 5.17 below were observed with the electronic circuit that was built as per figure 5.1 above. The laboratory test proved that it was possible to set the voltage window where the circuit must operate as well as lower and upper voltage threshold where the circuit was supposed to be off.

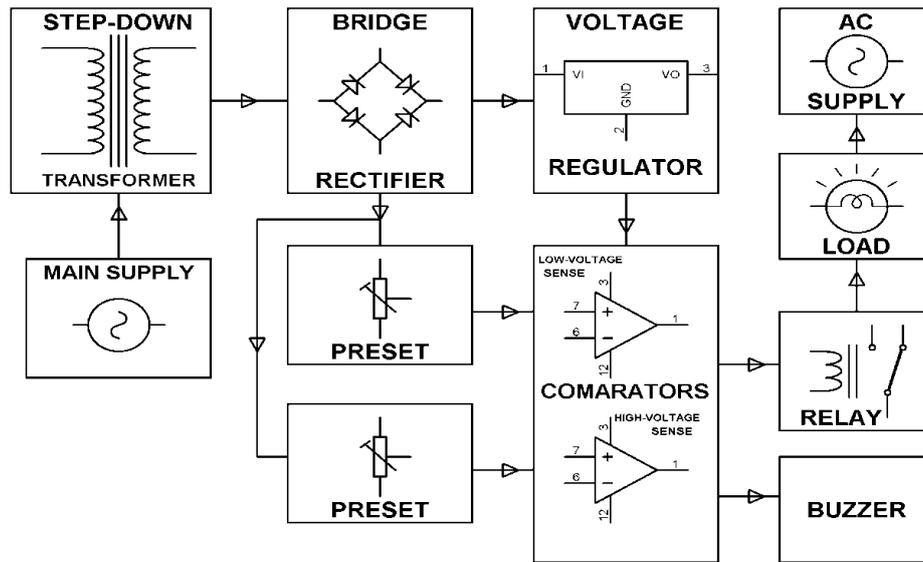
Figure 5.2 Block diagram of the protection circuit [71]

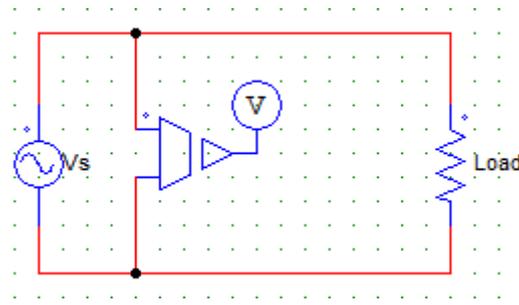
to 400V. The circuit that was used to simulate the results is displayed in figure 5.3 below with the output waveform in figure 5.4.

Figure 5.3 Power Supply Circuit

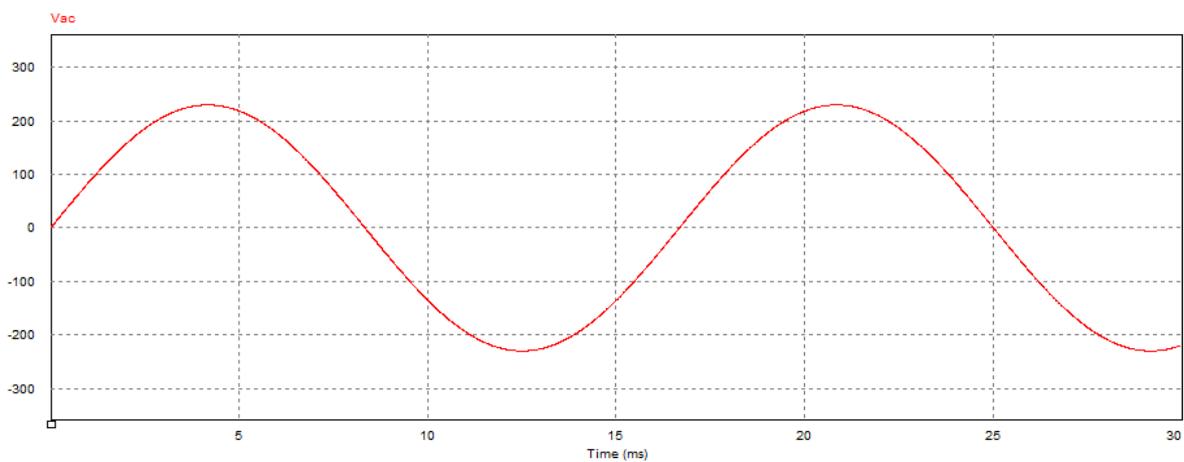
Figure 5.4 230 V Supply voltage wave form

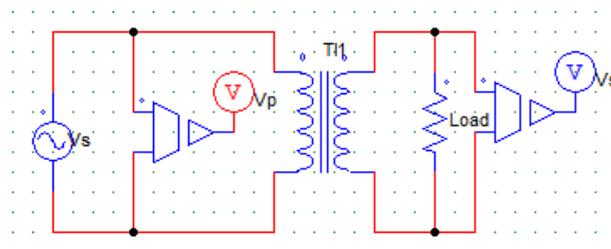
Figure 5.5 below shows the transformer connected to the AC power supply. A transformer with ratio of 19:1 was selected to give the desired secondary voltage of 12 V under normal condition when the supply voltage is 230 V. When the supply voltage fluctuates under broken neutral condition, the output voltage will proportionally increase or decrease in accordance with the supply voltage [43] [2]. The simulated input and output voltage waveforms displayed in figure 5.6 below shows input voltage of 230 V and output voltage of 12 V.

Figure 5.5 Transformer Circuit

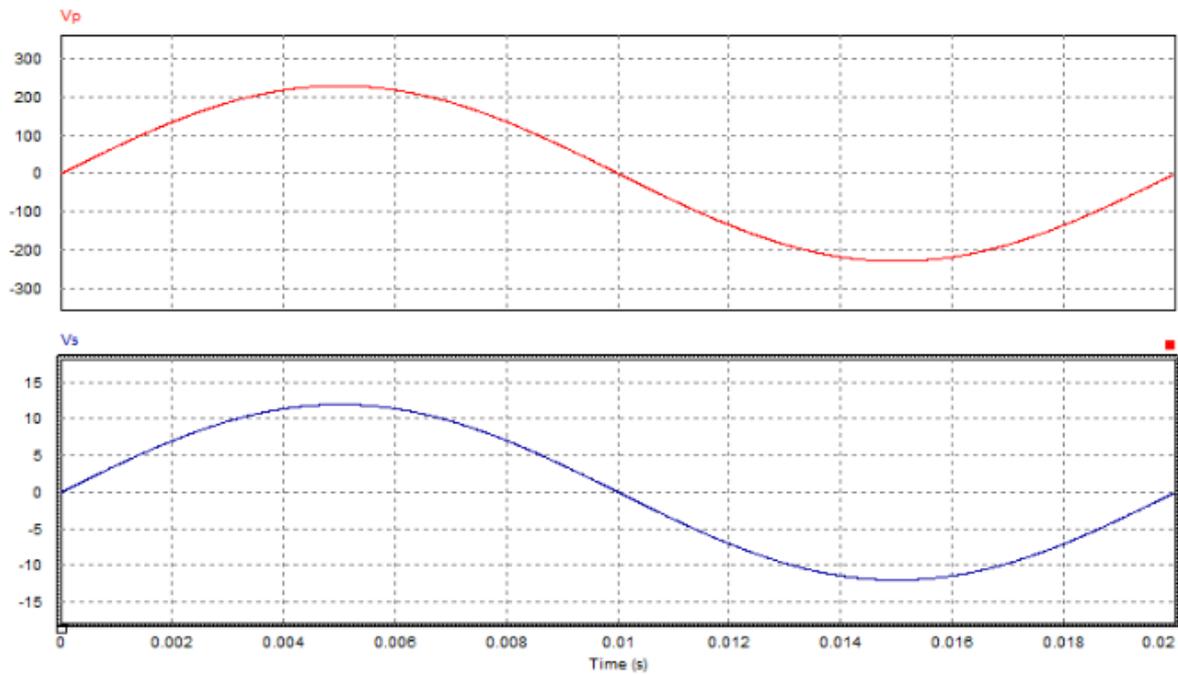
Figure 5.6 Transformer primary and secondary voltage waveform

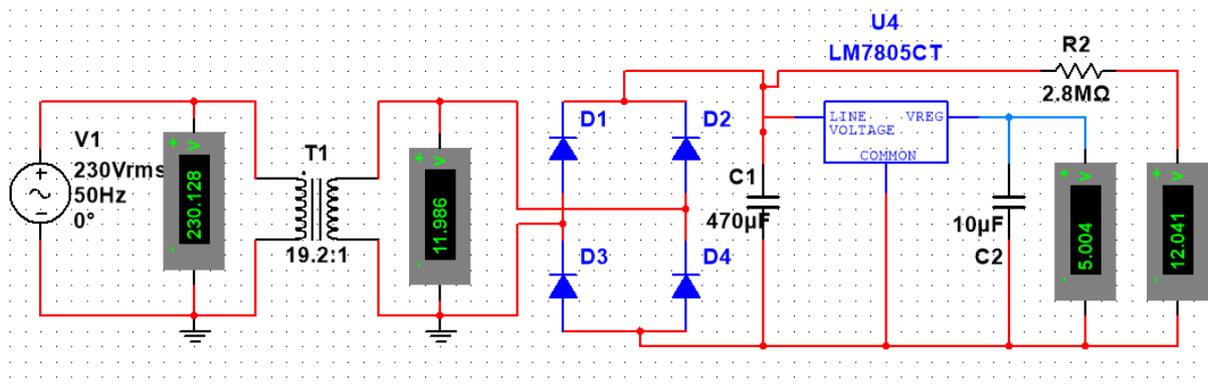
The stepped down voltage from the transformer output of 12 V was connected the bridge rectifier which converted the Alternating Current (AC) to Direct Current (DC). The In the positive half cycle, two diodes conduct and in the negative half cycle the other pair of diodes conduct, there by converting AC into pulsating DC [23] [72]. Figure 5.7 below shows the AC voltage of 12 V rectified to 12 V DC as displayed in the voltmeter 4 connected to the circuit.

Figure 5.7 Bridge rectifier

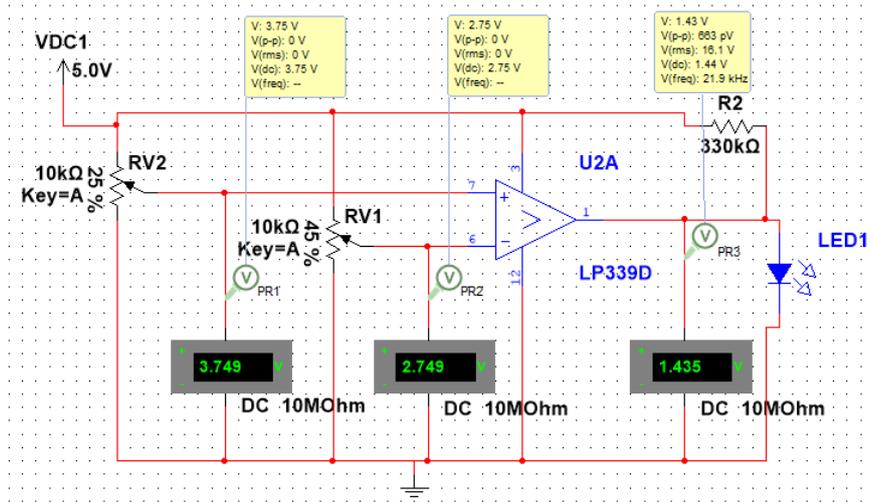
The basic formula or operation logic of the comparator is that when the voltage at the non-inverting input is greater than the voltage at the inverting input, the output of the operational amplifier would be high as in figure 5.8 below. The variable resistor RV2 was set at 25% and RV1 set at 45% resulting in the voltage at the non-inverting input voltage of 3.75 V which is greater than the inverting input voltage of 2.75 V. That resulted in a logic high output for the operational amplifier to give 1.44 V.

Figure 5.8 Comparator circuit with high output
