# MITIGATION FOR FLOATING NEUTRAL IN DISTRIBUTION SYSTEMS

Master of Science in Electrical Engineering

College of Agriculture, Engineering and Science, University of KwaZulu-  
Natal

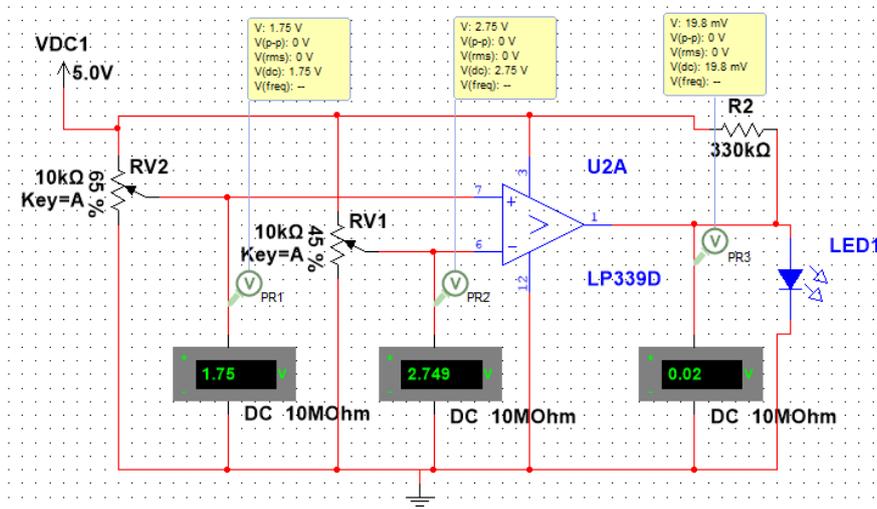
When the resistance of the variable resistor RV2 was increased to 65% with the resistance of the variable resistor RV1 constant at 45%, the input voltage of the non-inverting input dropped to 1.75 V which was less than the inverting input voltage of 2.75 V. That resulted in a logic low output of 0 V, as in figure 5.9 below. It was demonstrated in the two circuits in figure 5.8 and 5.9 that: the operational amplifier only gives a high signal when the non-inverting input is greater than the inverting input and a low output when the non-inverting input is less than the inverting input.

Figure 5.9 Comparator circuit with low output

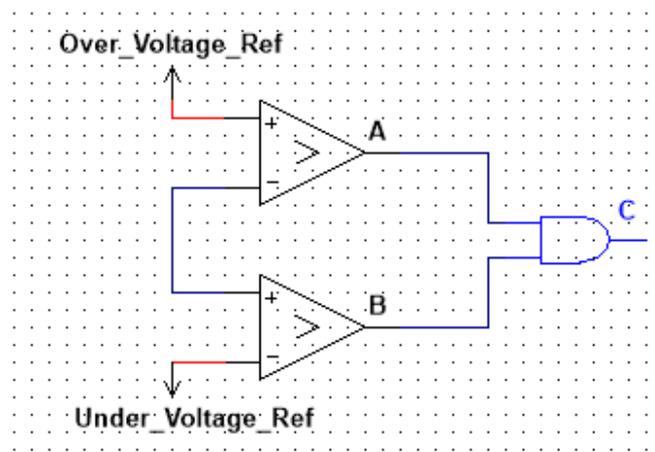
The overvoltage and under voltage protection circuit uses two comparators that are connected in such a way that one comparator measures the overvoltage and the other one measures the under voltage as in figure 5.10 and 5.13 below. The inverting input of the overvoltage comparator is connected to the non-inverting input of the under voltage comparator and the common input voltage source. The other two terminals of the comparators are used as reference voltage for the overvoltage and under voltages. The window comparator only gave a high output when the output of both the over voltage and under voltage comparators are high. If any of the two comparators gives a low output, the circuit output will be low as demonstrated in figure 5.10 simplified window comparator diagram and the logic truth table in table 5.1. below [73] [74].

Figure 5.10 Window comparator simplified diagram

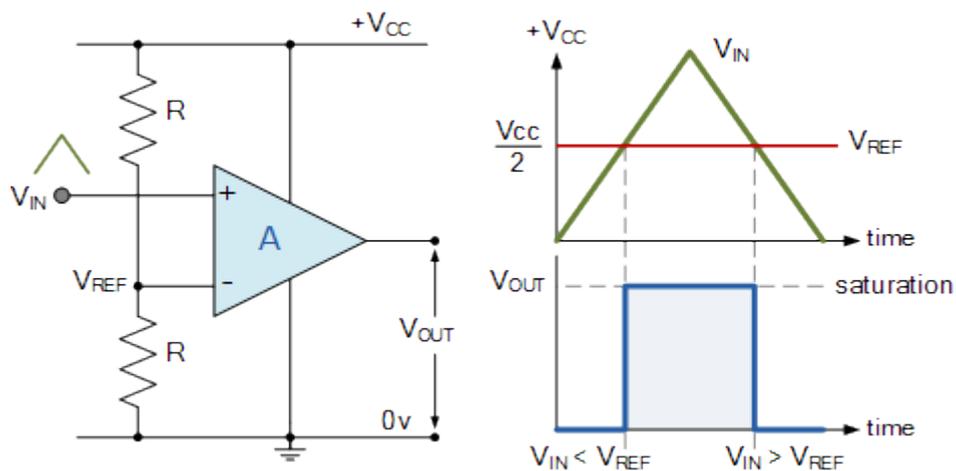
With the reference voltage set at a voltage equivalent to the Ac voltage of 206 V, the under voltage comparator only gave a high output for voltages above 206 V. With voltage of 207 V applied to the circuit, the comparator output saturated towards the positive supply rail,  $V_{cc}$  resulting in a high output [75]. For voltages equal to and less than 206 V, the operational amplifier comparator changed state and saturate at the negative supply rail with a low output as demonstrated in figure 5.11 below.

Figure 5.11 Non-inverting comparator circuit [75]

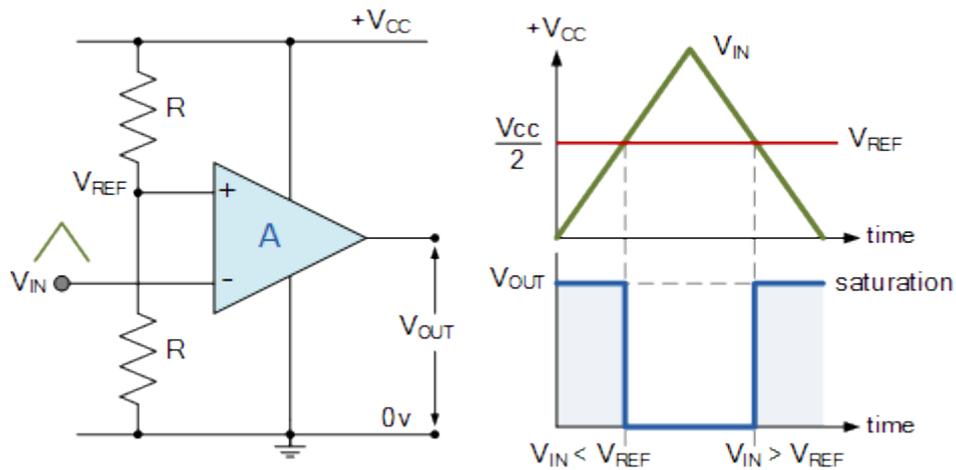
Figure 5.12 Inverting comparator circuit [75]

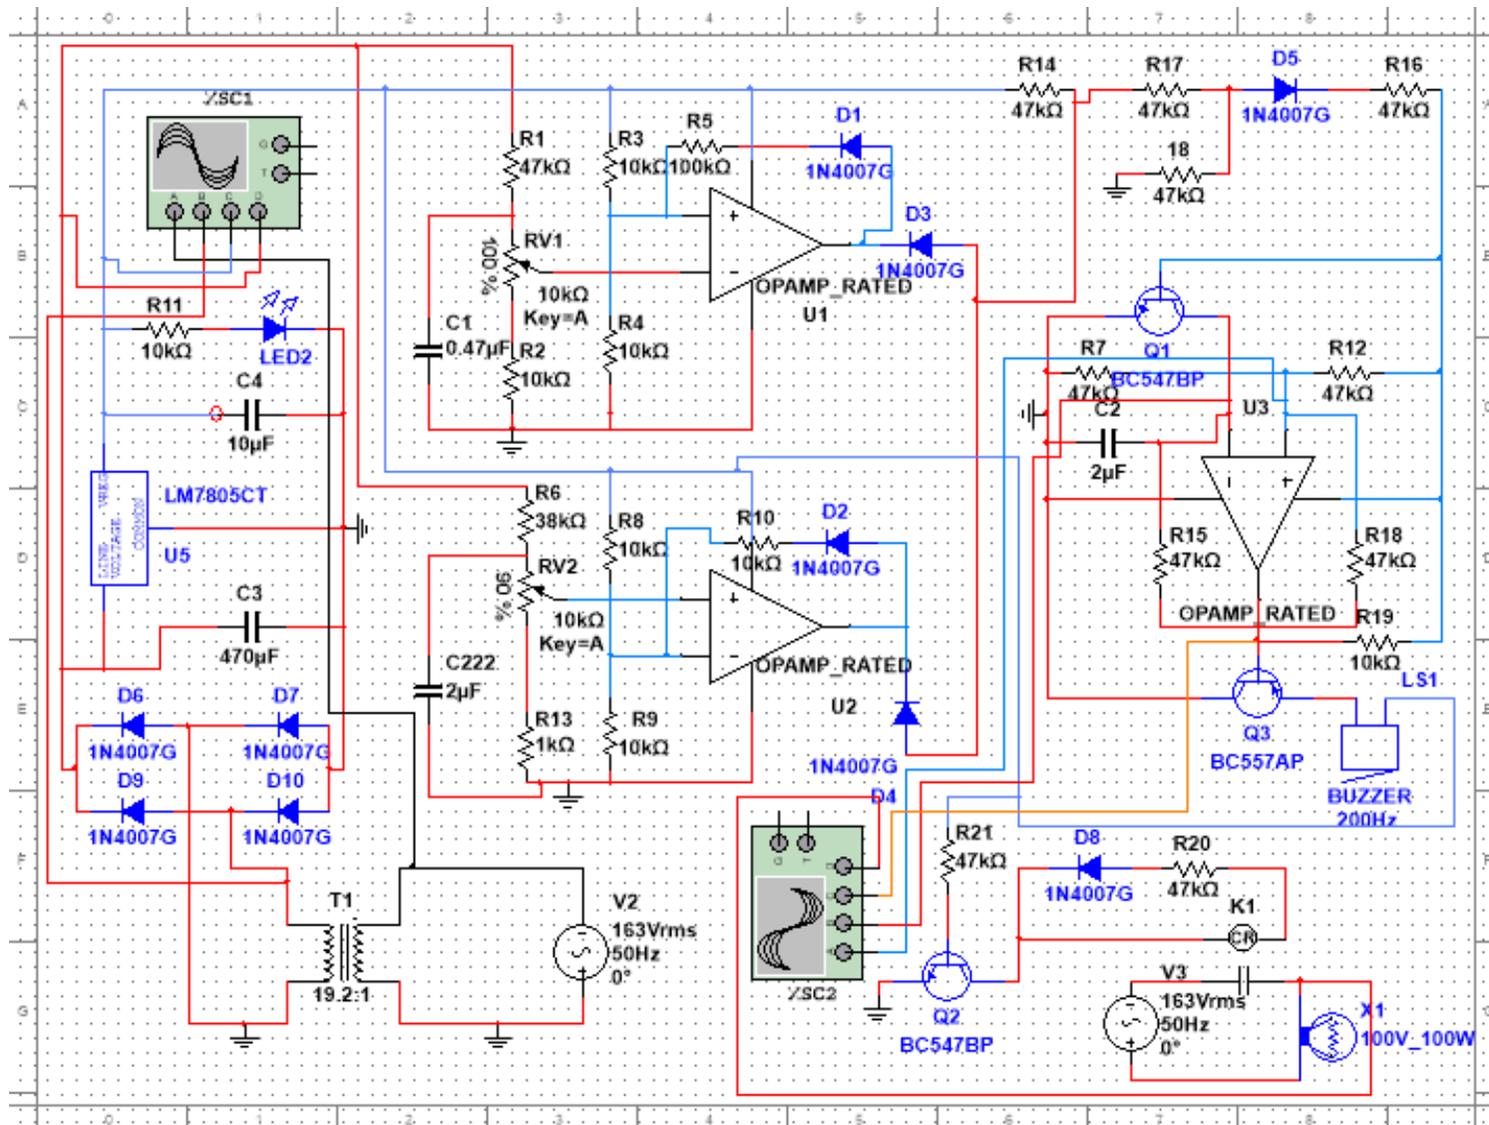
When the input goes above the upper limit of the pre-set 253 V, the voltage at the centre of RV1 goes above 2.5 volts DC. That resulted in output going low to forward bias the D3, which starts conducting and takes away the driving voltage from the transistor Q1 and Q2. While the Q1 is off the relay drops to cut off the load. At the same time the Q2 is also going off so that the pin 8 of the inverting comparator become higher than the non-inverting input voltage forcing PNP transistor Q3 to get biased so that the current flows through Q3 to sound the buzzer. Similarly, the circuit operation will be the same for the low voltage condition when the supplied voltage drop below 207 V.

Figure 5.13 Overvoltage and under voltage protection circuit diagram

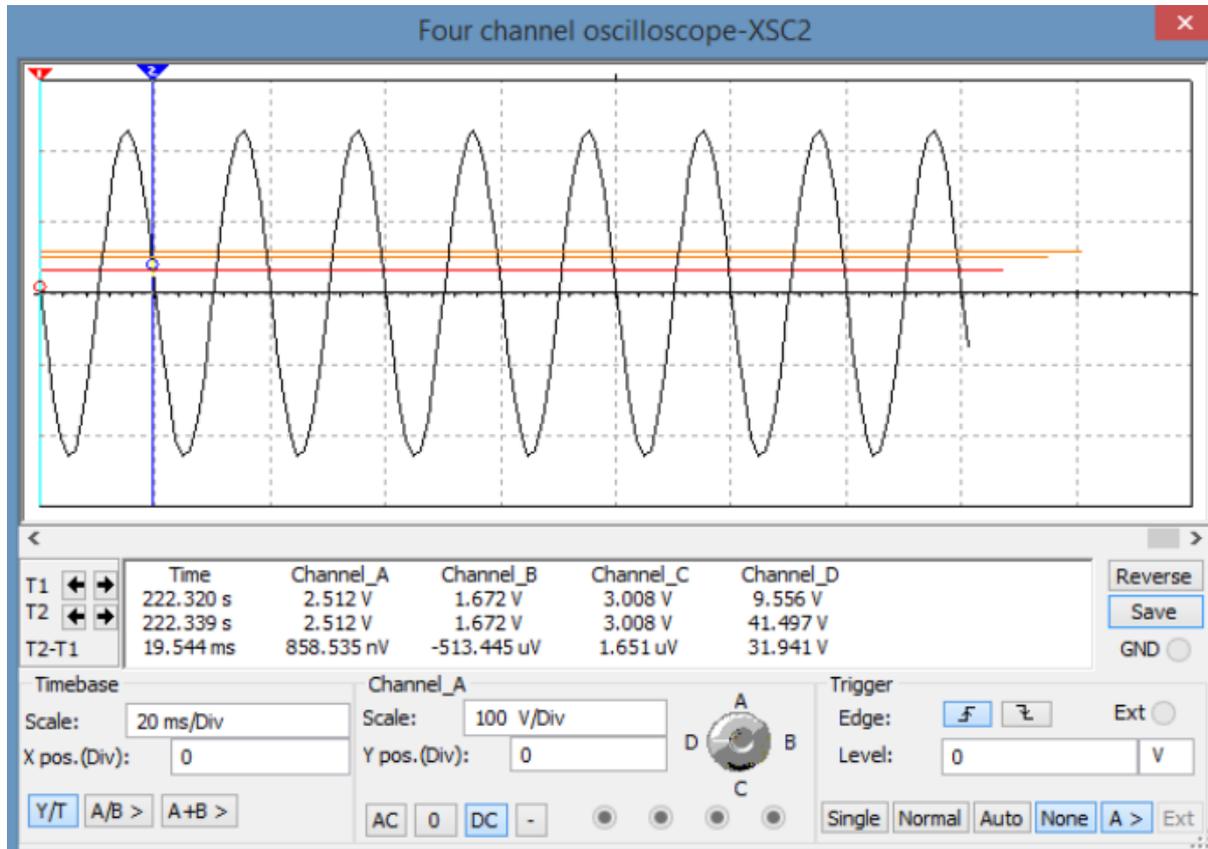
blue waveform in channel C with the scale of 5V/Div. The supplied voltage resulted in the output displayed in figure 5.15 below on the comparator circuit.

Figure 5.15 Window Comparator output voltage under normal condition

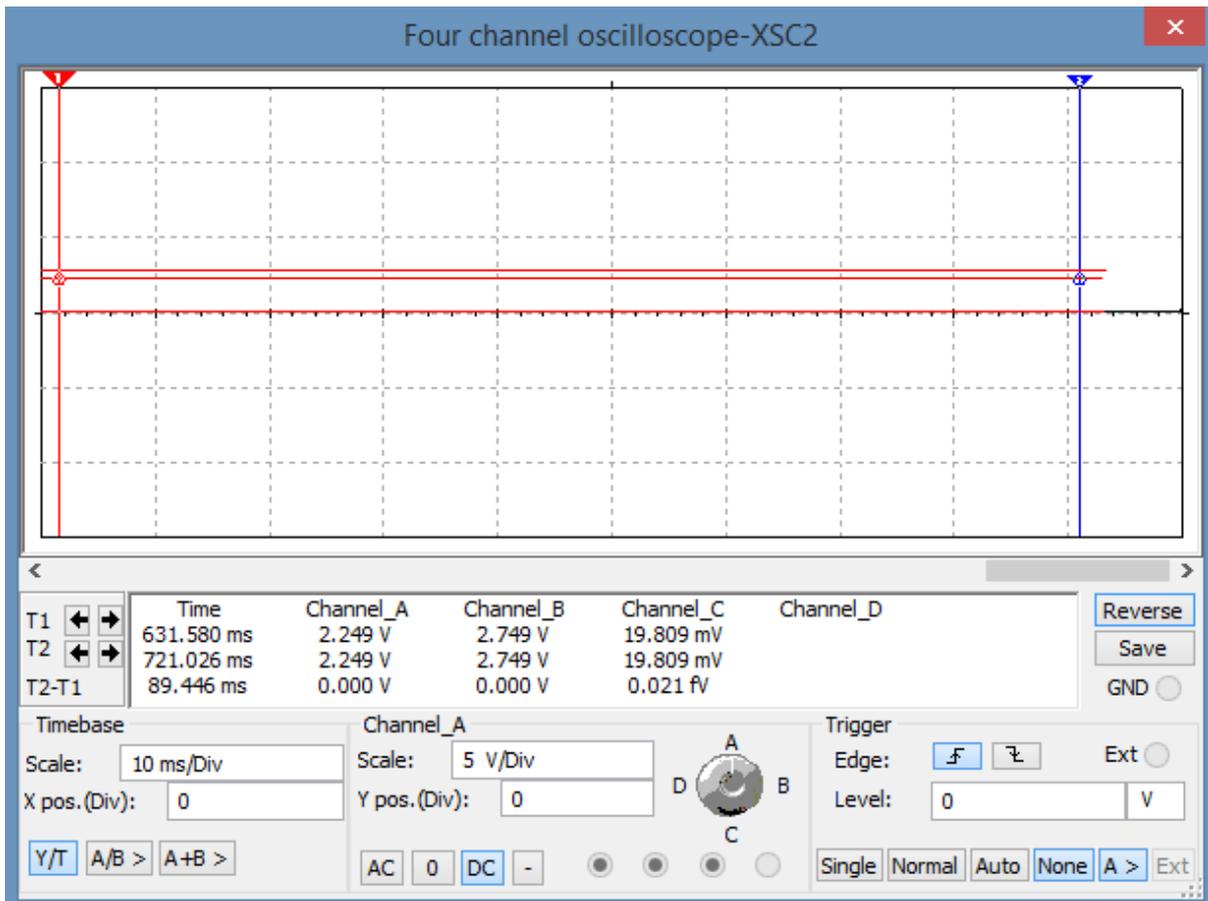
When voltage increased beyond the upper voltage window limit of 253 V, the inverting input of comparator 1 increased beyond the reference value resulting in a low output of the comparator. Figure 5.16 below shows the reference voltage or the non-inverting input voltage of 2.25 V DC in channel A of the oscilloscope. The value is less than the input voltage at the inverting input of 2.75 V in channel B. With the inverting input voltage greater than the non-inverting input voltage, that resulted in low output voltage of  $19.8 \times 10^{-3}$  V in channel C.

Figure 5.16 Window Comparator output voltage during over voltage condition

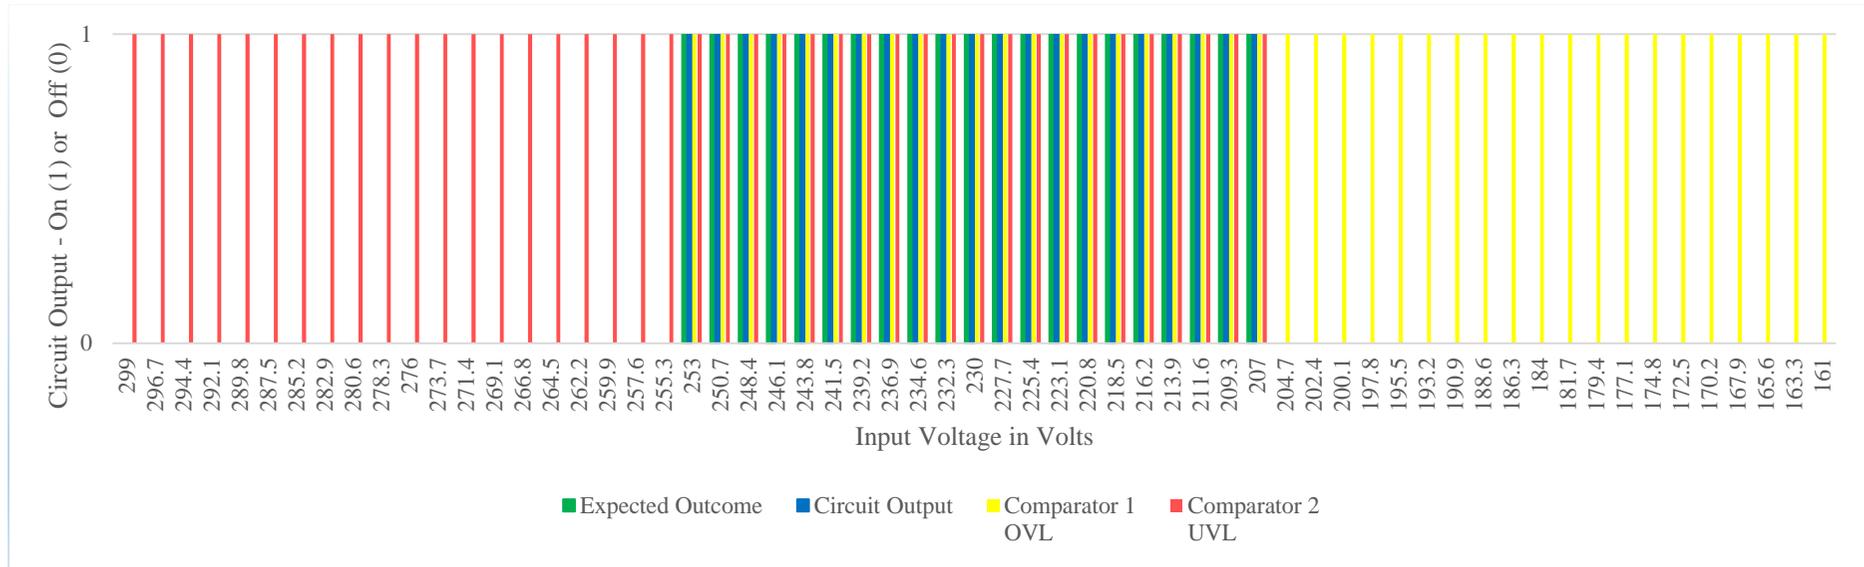
Similar results in figure 5.17 below were observed with the electronic circuit that was built as per figure 5.1 above. The laboratory test proved that it was possible to set the voltage window where the circuit must operate as well as lower and upper voltage threshold where the circuit was supposed to be off.

Figure 5.17 Protection circuit results
