**CRITIQUE OF DURABILITY SPECIFICATIONS FOR
CONCRETE BRIDGES ON NATIONAL ROADS IN
SOUTH AFRICA**

In partial fulfillment of the degree of Master of Science, Faculty of
Engineering, University of KwaZulu-Natal

March 2011

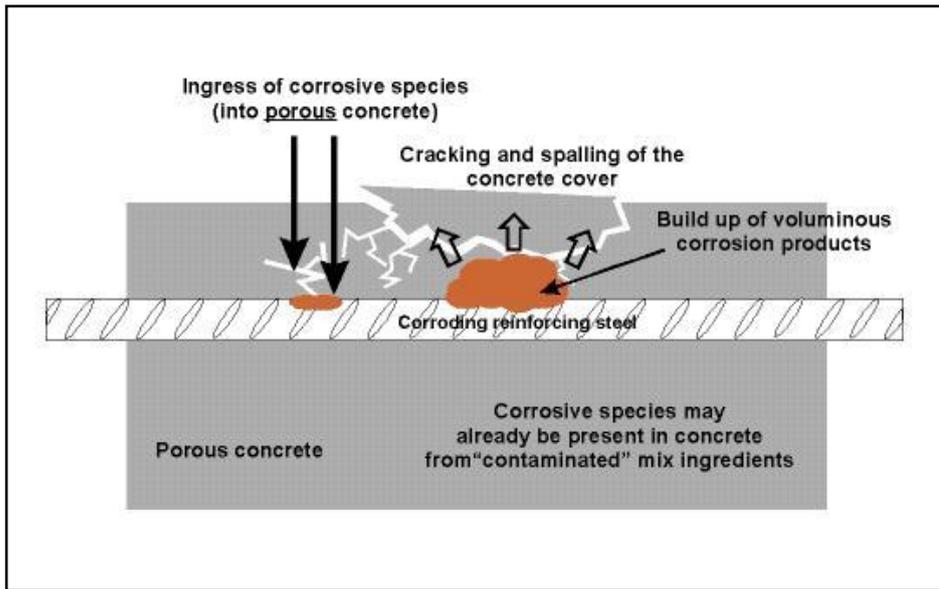
Figure 2.1 : Mechanism of deterioration of reinforced concrete (Corrosion-Club.com, 2002)

Reinforcing steel that is present in fresh concrete is protected from corrosion. A passive oxide film forms on the surface of the steel as a result of the initial corrosion reaction. Concrete in its fresh state develops a high alkalinity as a result of the initial hydration process in cement. As a result of the presence of oxygen, there is stabilization of the film on the surface of the steel embedded in the concrete, which ensures a continuous protection and the high alkalinity of concrete is retained. The presence of three chemical compounds viz. calcium hydroxide, sodium hydroxide and potassium hydroxide in concrete results in it exhibiting a PH above 12. The reinforcement may corrode upon depassivation of the passive layer due to a reduction in the alkalinity of the concrete where the pH drops to below 8, mainly due to the ingress of carbon dioxide (carbonation) and aggressive ions such as chlorides and sulphates (Raath B and Horten J, 2006). Once depassivation of the ferric oxide layer takes place, the reinforcement may corrode provided that sufficient oxygen and moisture is present. Figure 2.1 below shows the mechanism of deterioration of a reinforced concrete element. A durable concrete must therefore be able to resist the movement of chloride ions and carbon

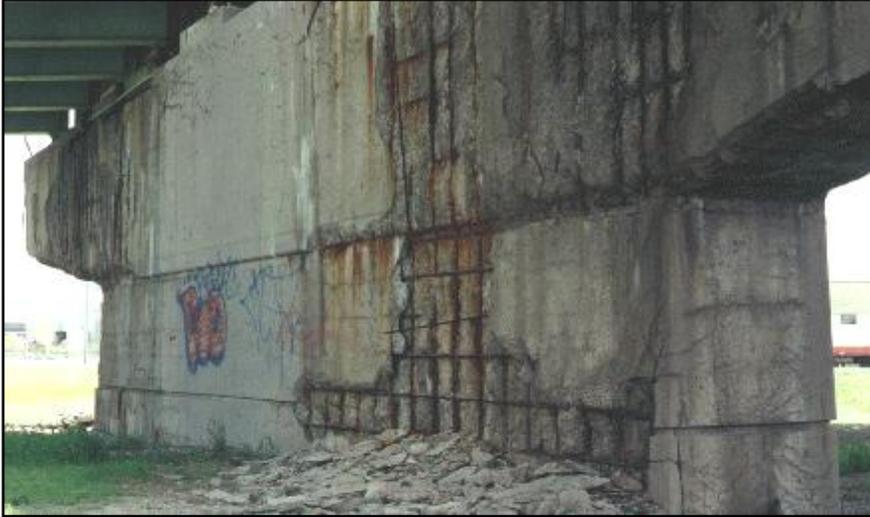
Figure 2.2- Severe cracking and spalling of a bridge pier (Source- Corrosion-Club.com, 2002)

The following photos below in Figures 2-2 to 2-4 show extent of the damage that can be caused to concrete bridges as a result of the corrosion process. Figure 2-2 shows severe cracking and spalling to a bridge pier, while Figure 2-3 shows large portions of concrete spalling from a bridge deck. Figure 2-4 shows deterioration to parapets of a bridge deck. In South Africa, we are however fortunate that bridges are in relatively good condition when compared to northern hemisphere countries like the UK, the US and Canada. In those countries, deicing salts are one of the major reasons for the premature failure of concrete bridges as well as freeze-thaw attack.

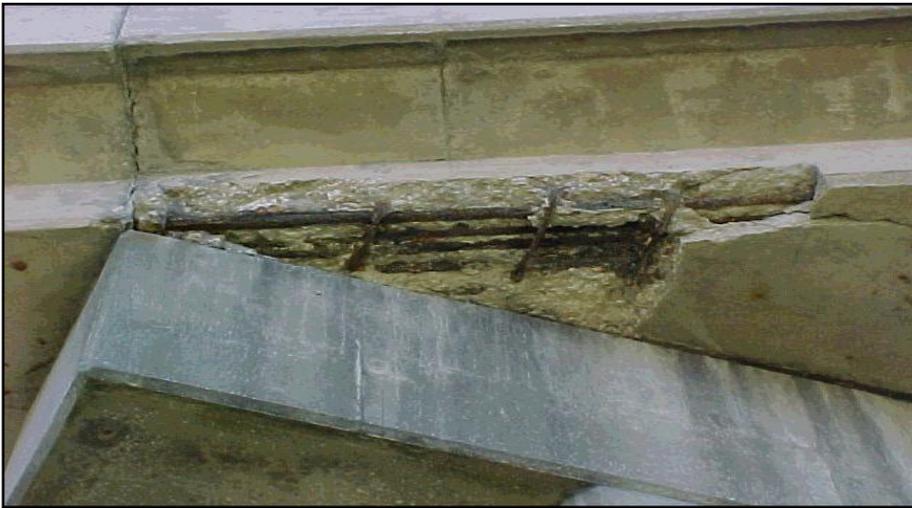
Figure 2.3- Large sections of concrete spalled in a bridge deck soffit (Source-Author)

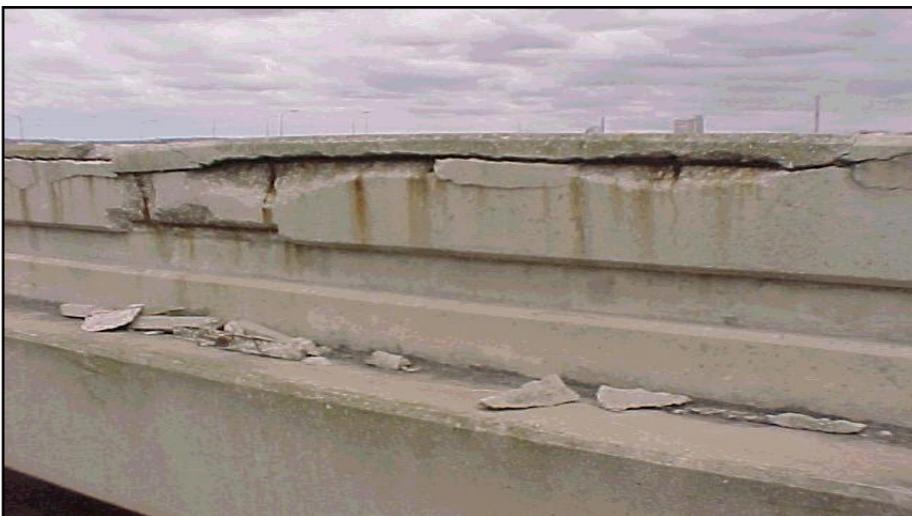
Figure 2.4- Cracking and spalling of a bridge parapet (Source-Author)

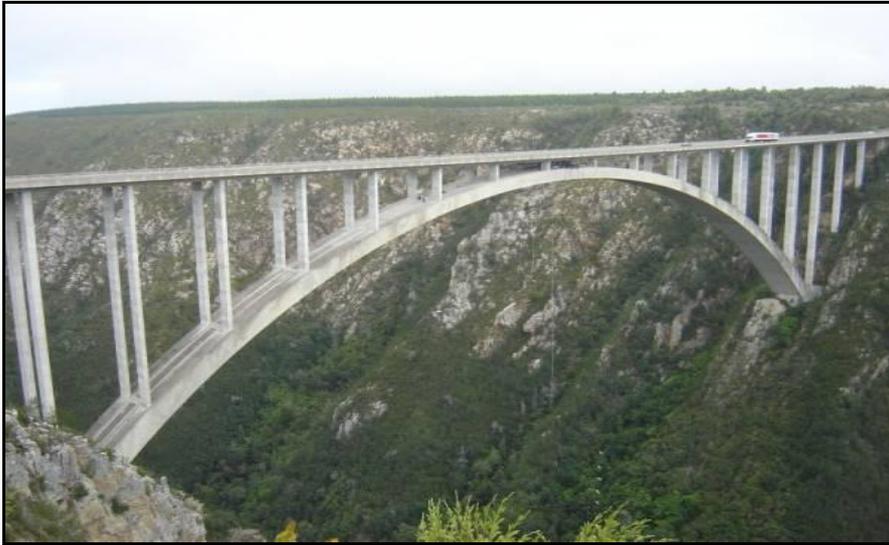
Figure 2.5: Bloukrans River Arch Bridge on the N2 Garden Route

(see Fig 2-5 below), Bobejaans and Groot Brak Bridges) on the national road in the Western Cape that were constructed in the early 1980's.

These bridges have shown little sign of degradation due to environmental exposure, although they are located very close to the sea and highly prone to chloride attack from a saline atmosphere in which they are located.

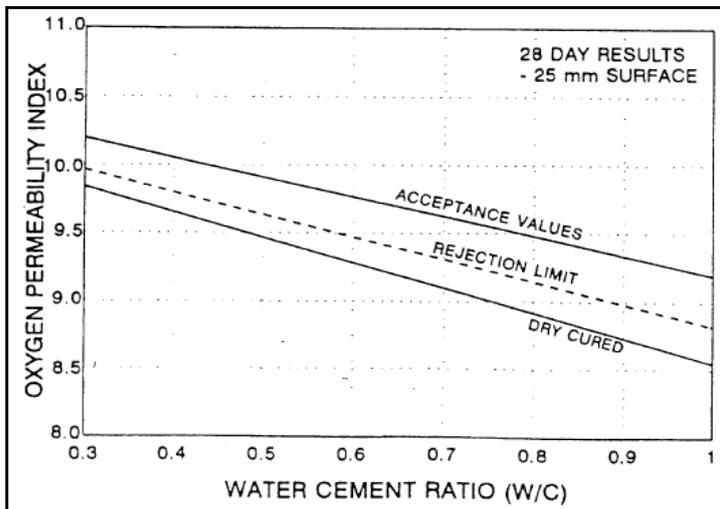
Figure 2.6: Tentative values for Oxygen Permeability Tests (Alexander, Mackechnie & Hoppe ,1994)

It was recommended that laboratory tests be used in future specifications and graphs of tentative values of each of the tests varying with water binder ratios were provided. Both acceptance and rejection limits were provided in each of the graphs as shown in Figures 2-6 to 2-8 below.

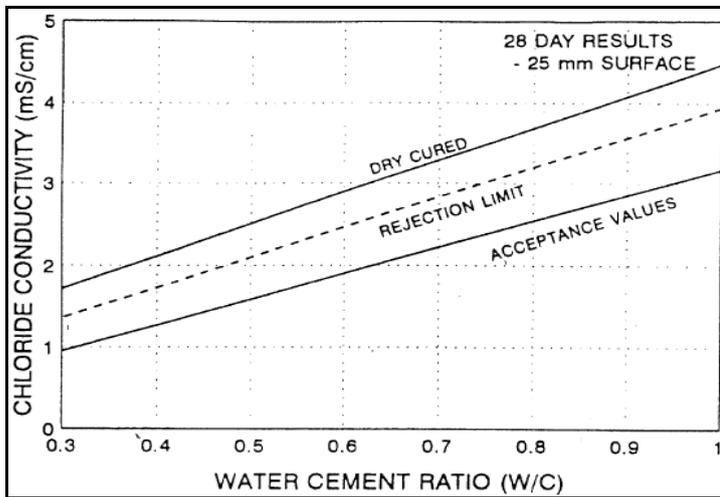
Figure 2.8: Tentative values for Chloride Conductivity Tests (Alexander, Mackechnie & Hoppe ,1994)

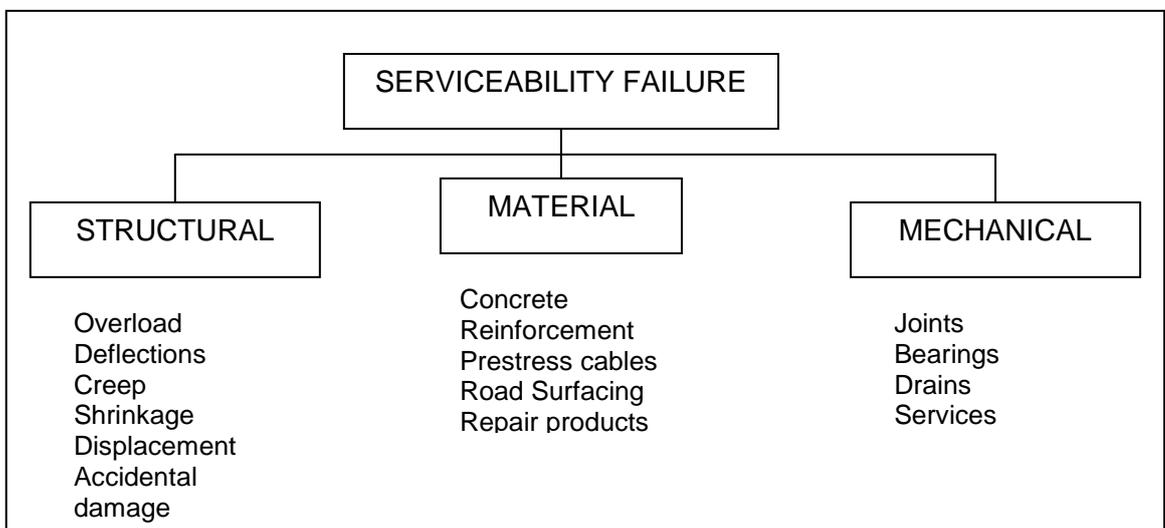
Figure 2.10: Serviceability failure of concrete bridges (Mackechnie, JR, 1999)

Durability problems of concrete bridges in South Africa are often a result of a multiple of causes associated with the interaction of material, structural and environmental factors. Serviceability failure of bridges may result in a multitude of factors as shown in Figure 2.10 below.

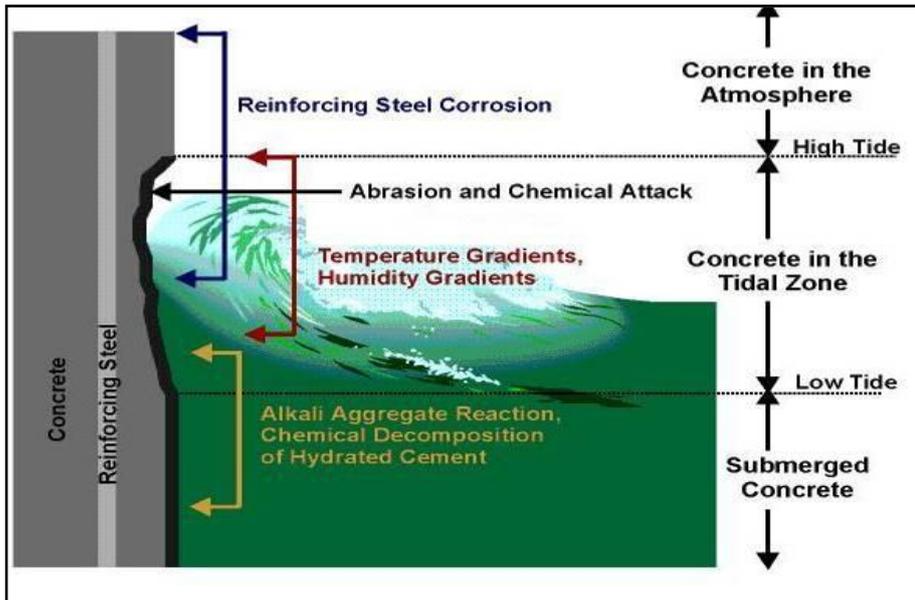
Figure 2.11: Deterioration of concrete in a marine environment (Corrosion-Club.com, 2002)

The chloride front can reach the reinforcement at fairly deep cover depths with the aid of moisture. In South Africa, there has been severe damage to some of the coastal bridges due to chloride induced corrosion, resulting in either large sections of the bridge requiring replacement, demolition and reconstruction of the bridge or desalination (an electrolytic process of removal of chloride ions from the concrete) This type of corrosion can be so severe that chunks of concrete could spall off bridge elements. Figure 2.11 below shows the deterioration of concrete in a saline environment due to a number of causes from reinforcing steel corrosion, abrasion and chemical attack, temperature gradients, and alkali aggregate reaction. Figure 2.8 indicates the effect of the saline environment on a reinforced concrete member.

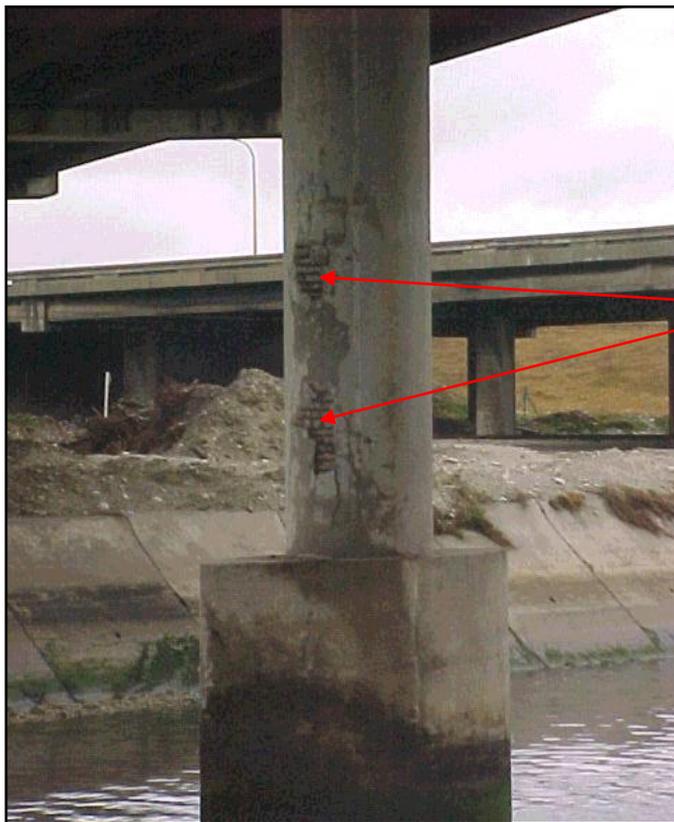
Figure 2.12: Chloride induced corrosion of a bridge pier in Port Elizabeth (Source, Author)

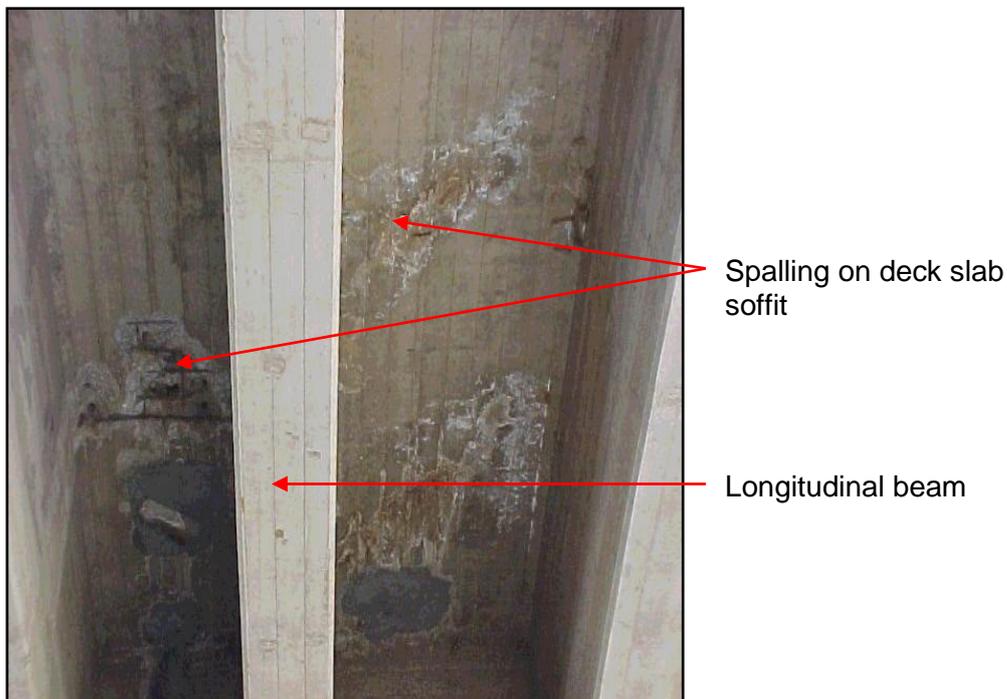
Figure 2.13: Carbonation induced corrosion of a bridge deck soffit in Gauteng (Source, Author)

Corrosion of the reinforcement leads to the formation of expansive oxide products, which exerts large forces onto the surrounding concrete thereby causing cracking and eventual break outs of the concrete. Figure 2.13 indicates the extent of carbonation induced corrosion of a bridge deck.

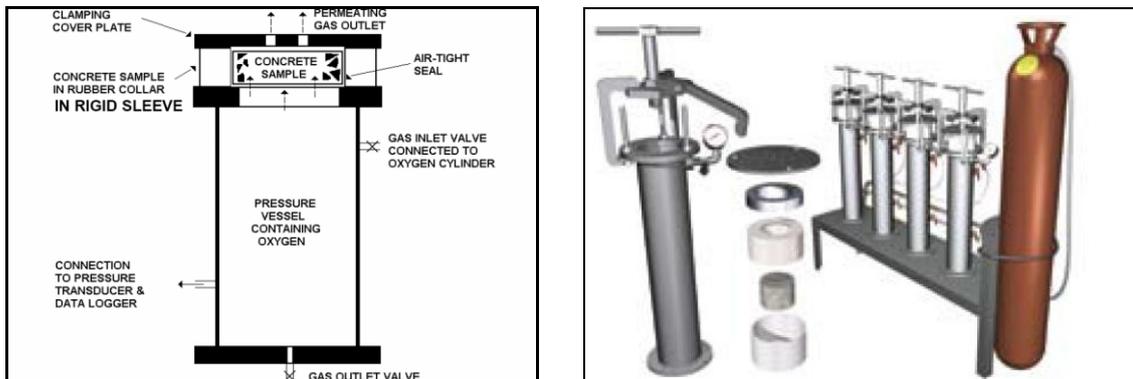
Figure 2.14: Oxygen permeability apparatus (Ballim, 1991)

The oxygen permeability test involves the use of a falling head permeameter devised by Ballim (1991), and is shown in Figure 2.14 below. It involves oven drying concrete samples at 50°C for 7 days which are 68mm in diameter and 25mm thick (recently revised to 70mm diameter and 30mm thickness due to standard core barrel sizes and to allow for larger aggregate sizes up to 25mm in the mix). These are secured on top of the permeameter cell, which is filled with oxygen to a pressure of 100kpa before being isolated, where after the pressure decay with time (over several hours) is monitored. The Darcy coefficient of permeability, k , is obtained from the slope of the line produced by plotting the log of the ratio of initial pressure to decaying pressure against time.

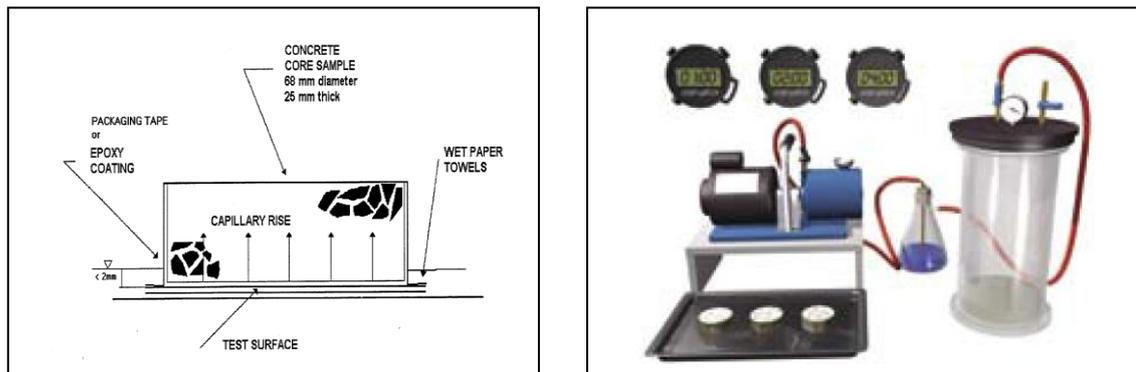
Figure 2.15: Water sorptivity test (Kelham, 1988 & Ballim, 1993)

Sorptivity can be defined as the rate at which fluid is attracted into a porous, unsaturated material under the action of capillary forces. The Kelham's (1988) sorptivity test (modified version) and that of Ballim (1993) was chosen for accuracy and their ease of use. It involves the unidirectional absorption (by sealing edges with epoxy) of water into a single face of pre-conditioned (dried at 50°C to ensure low moisture content), concrete disk sample of 68mm diameter and 25mm thickness, and shown in Figure 2.15 below. This was recently revised to 70mm diameter and 30mm thickness due to standardized core barrel sizes and to allow for larger aggregate sizes up to 25mm in the mix. The sample is weighed at calculated predetermined time intervals in order to determine the mass of water absorbed. This sample is then vacuum saturated with water to determine its mass. The sorptivity is determined from the plot of mass of water absorbed versus square root of time. The index range works opposite to the oxygen permeability index in that the smaller the index value the better the potential durability of the concrete.

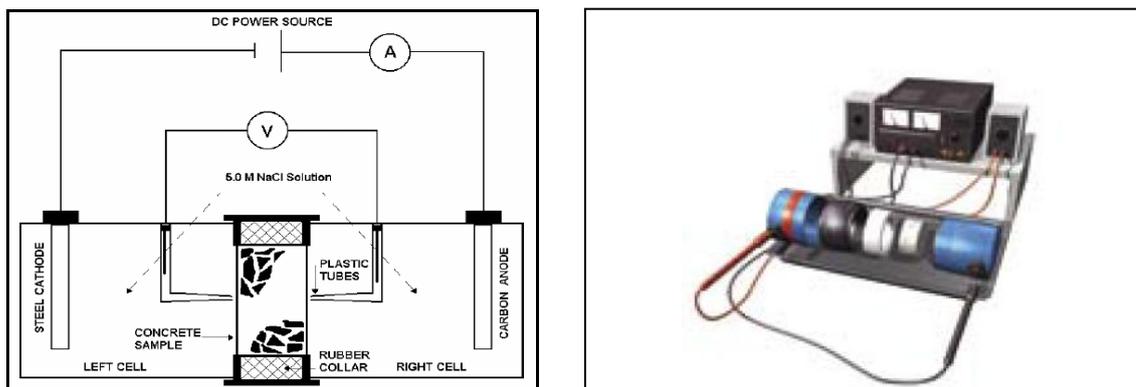
Figure 2.16: Chloride conductivity test (Streicher and Alexander, 1995)

Chloride ions move through the sample through any pores of sufficient size that are present and therefore the test provides an indication of the diffusivity of the material where the test is sensitive to pore structure and cement chemistry. The lower the chloride conductivity index, means there is an increased potential of the durability of the concrete. Mackechnie (1996) further observed that the 28 day results decreased with increased binder grades (i.e. higher concrete strengths) and affected by the degree of curing and type of binder. Proper curing and use of cement extenders such as fly ash and slag, resulted in a very fine pore structure and the test was found to be extremely sensitive to these changes.

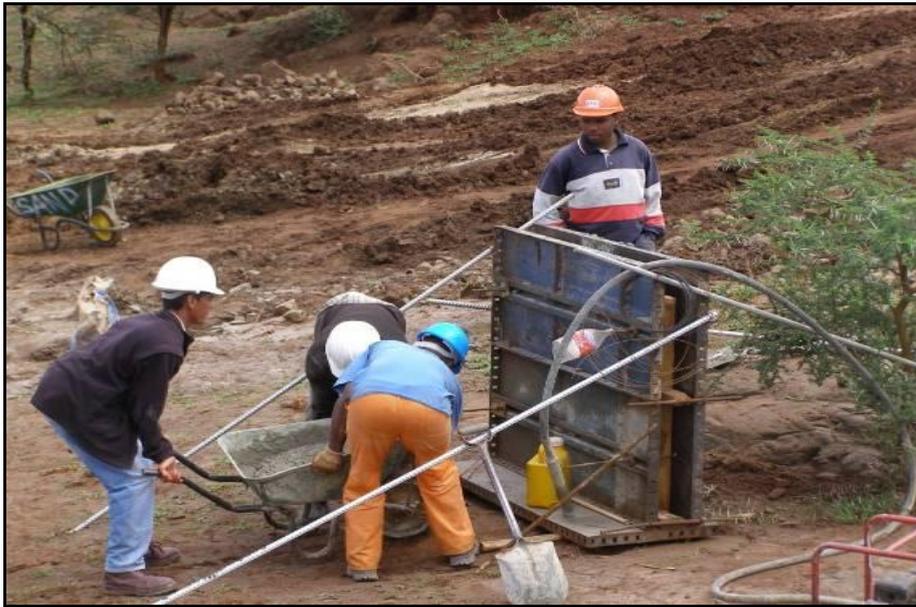
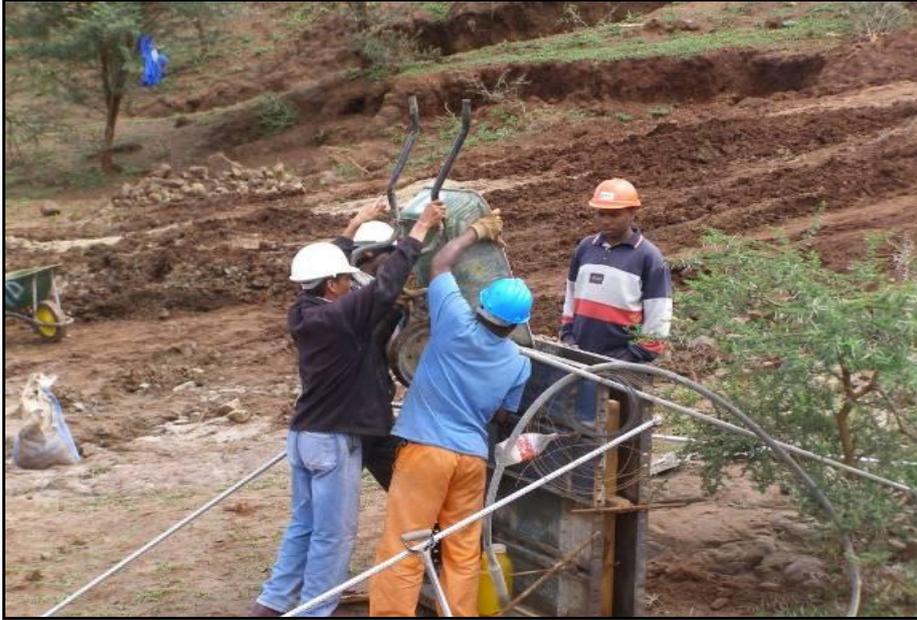
The trial panels are constructed using the same method of construction as the bridge elements. Therefore for all substructure elements viz. the piers and abutments, the panels are cast vertical using the same type of formwork i.e. either steel or timber forms, and for bridge decks, a horizontal panel is also cast to simulate the large horizontal area of the deck. The concrete for the panels is compacted using vibrators as will be used for the bridge construction. The panel is then left to cure either within the shutters (if this will be done on actual structural elements), or the shutters are removed and either the concrete is kept moist or curing compound is applied. The type of curing to be used must also be followed for construction of the bridge. Figures 3.1 (a) and (b) below shows a typical panel being cast on one of the sites.

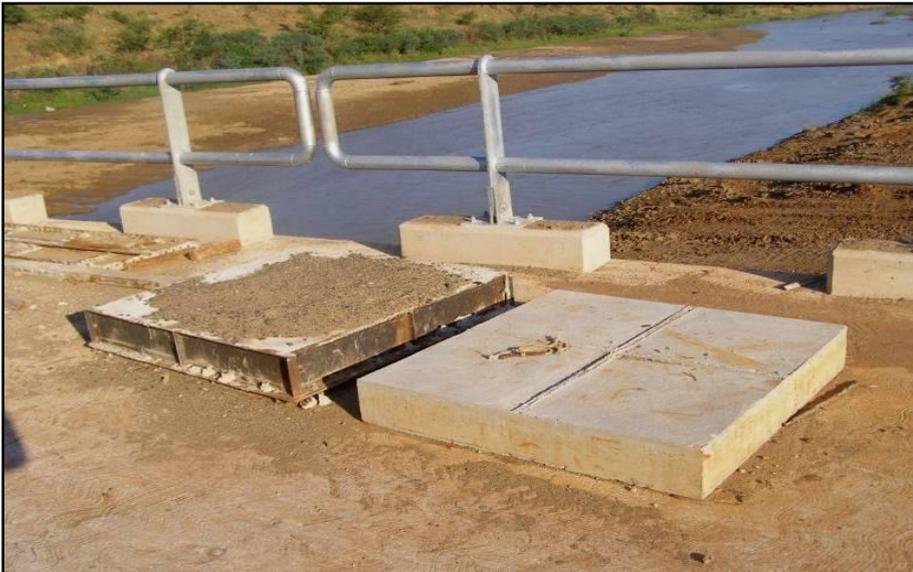
Figure 3.2 : Curing of a horizontally cast trial panel representing a deck top slab (Source, author)

Figure 3.2 shows the curing of horizontally cast trial panels on a particular project.

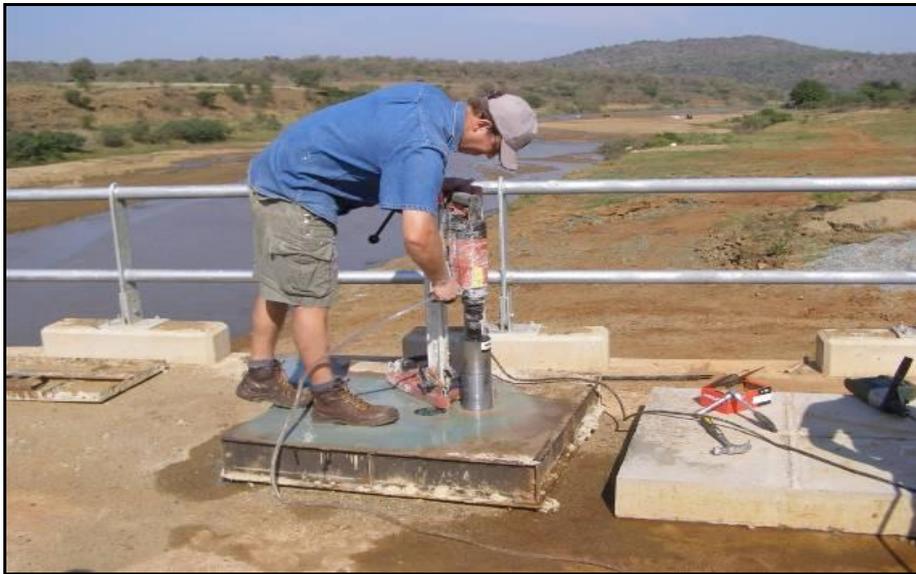
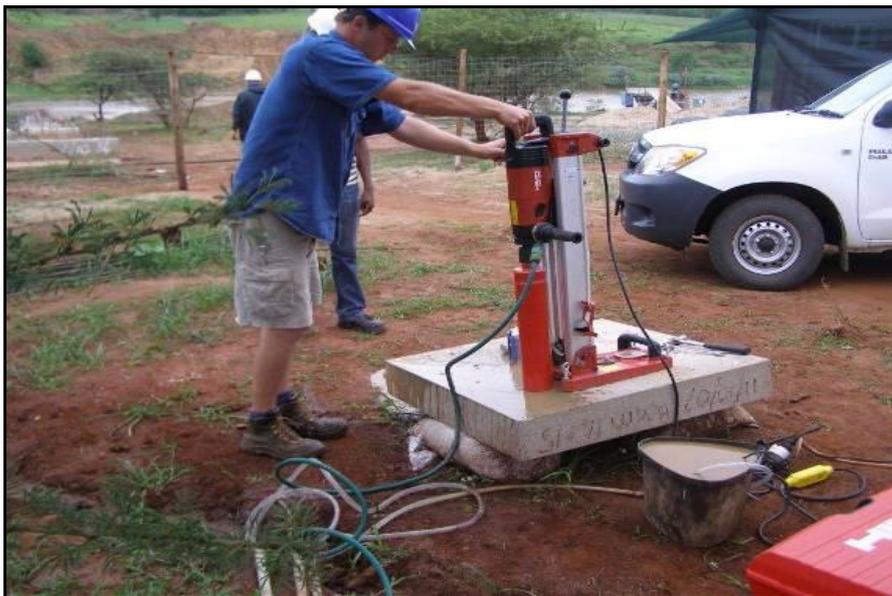
then taken to a laboratory which can undertake the required durability index tests as described in section 2.3.4. Figures 3.3 (a) and (b) shows extraction of cores to horizontal panels.

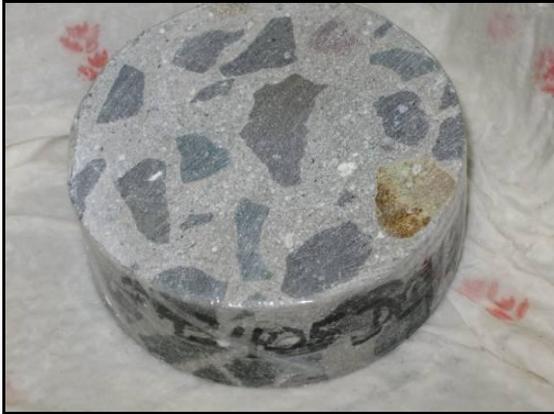
Figure 3.4: (a) Typical disk during sorptivity test, (b) Chloride conductivity cell, (c) Oxygen Permeability rig with sample positioned in collar , (d) Typical Oxygen permeability rig, (e) Collar containing concrete disc ready to be assembled and placed in OPI rig (Source, Contest Concrete Services)

laboratory extracted the required size from the site cores. Figure 3.4 (a) shows a typical 70mm diameter core to be tested. Figures 3.4 (b) to (e) shows the apparatus used to undertake the relevant durability index tests.

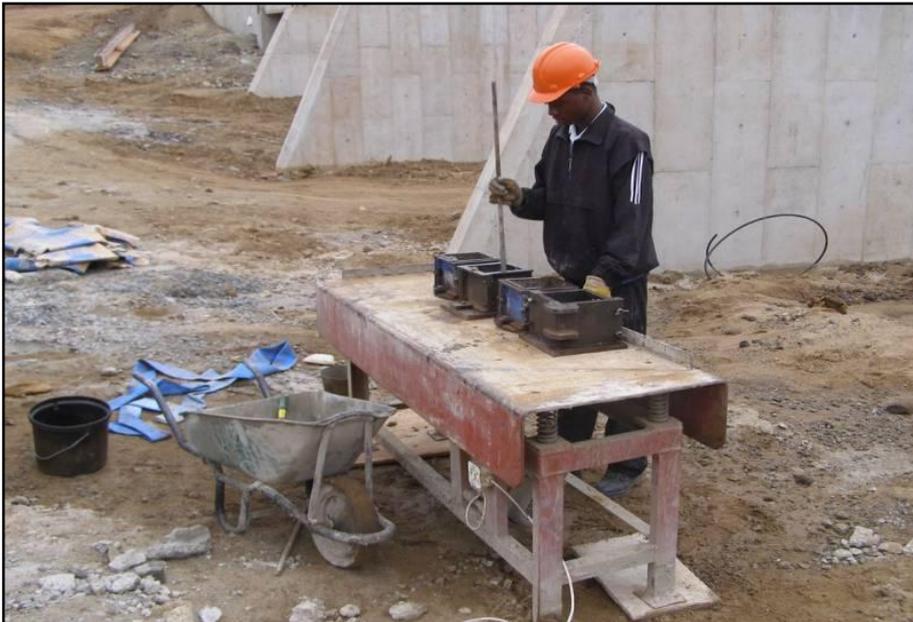
Figure 3.5 : Casting of test cubes on site for durability testing (Source, author)

SANRAL's specifications also require that additional test cubes be taken during concrete casting. Cores are extracted from the additional cubes and tested for the required durability indexes. The 150mm standard test cubes are cast and left to cure on the site adjacent to where the bridge is being constructed for it to be exposed to the same environmental conditions as the bridge. In this way, any effects of the environment will be equally applied to both the structure and the test cubes. Additional test cubes are also cast and cured in the laboratory under standard conditions. This is done so that effects of the environment could be determined on the durability index results, as well as to check if concrete supplied has met the durability requirements. Figure 3.5 shows the casting of cubes on the site for durability testing.

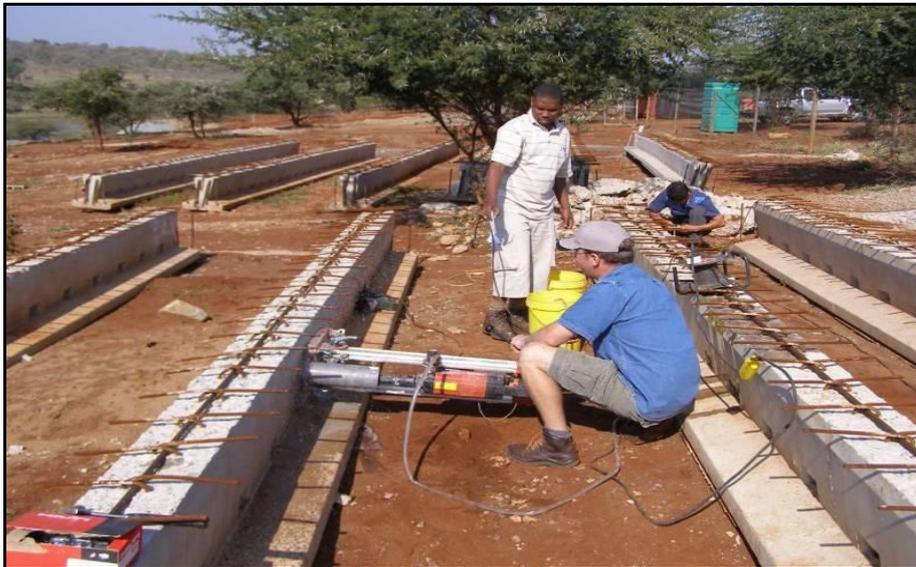
Figure 3.6: Extraction of cores from a precast beam in the casting yard (Source, author)

Core extraction and sampling of the in-situ concrete was undertaken using a rotary core drill. Drilling horizontally at elevated heights on platforms constructed from scaffolding is challenging and safety of the laboratory staff is always a concern. For beam type superstructures, core extraction was done in the casting yard once the concrete reached a minimum of 28 days strength, as can be seen from Figure 3.6 below.

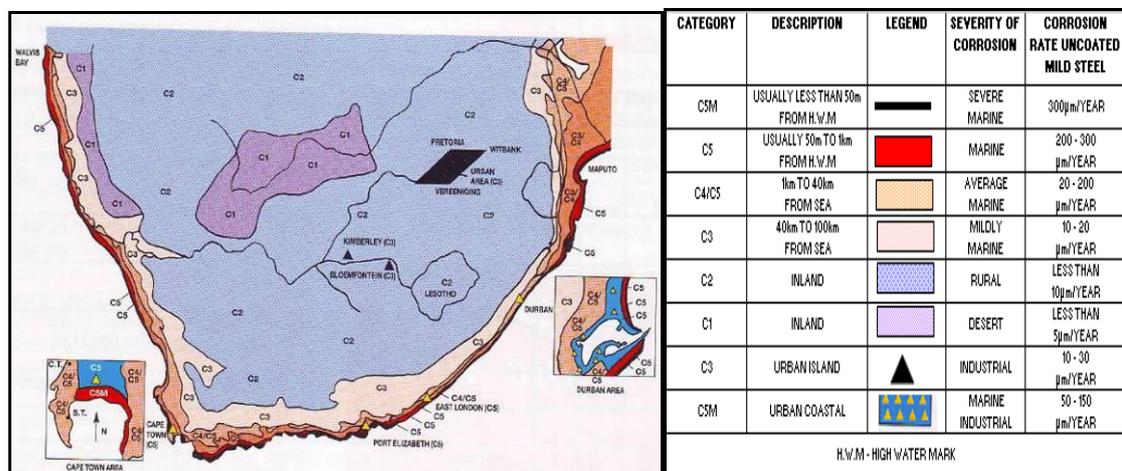
Figure 4.1: Aggressive environments in South Africa (Barnard J, 2007)

It must be noted that the cover depths provided are greater than that proposed in EN206, and it may be that in future specifications values in Table B6301/1 of the SANRAL generic specifications (2008) may be revised. The only major change was to re-define the “Very Severe” category for members exposed to airborne salts in a saline atmosphere. The previous definition included all structures located within a 30km radius from the coast being prone to chloride attack. However research carried out by the SA Corrosion Institute suggests that this limit is between 1 to 5km from the coast. Figure 4.1 below shows the typical graph produced in the South African Hot Dip Galvanisers Association for corrosion rates in South Africa.

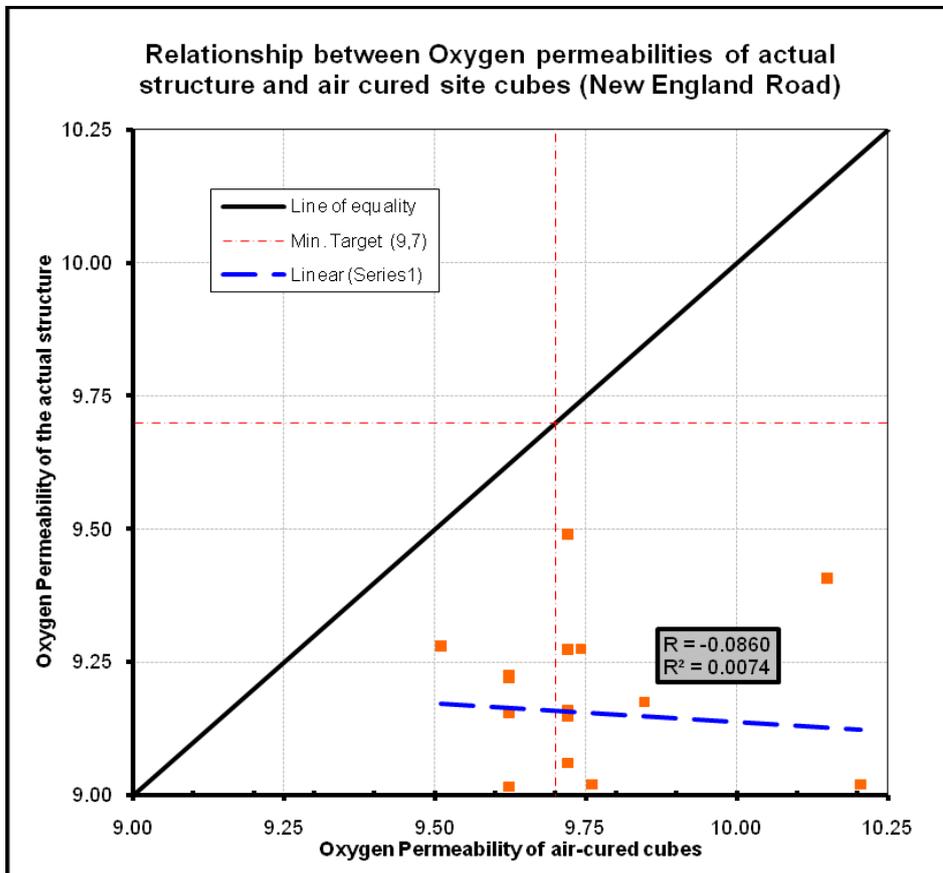
Figure 7.6 : Relationship of OPI for in-situ versus site (air) cured cube results

The results in Table 7-6 shows that while majority of the results from the site cured cubes met the minimum target, the core results drilled from the structure has not met the minimum requirement for all the cores drilled. In-situ cores were drilled at three different locations and all the results proved unsuccessful. Noting that all tests were done on the same batch of concrete, the results of cores from the site air cured test cubes were superior to the in-situ results. The scatter diagram in Figure 7-6 below shows the relationship between in-situ and site (air) cured test cube results.

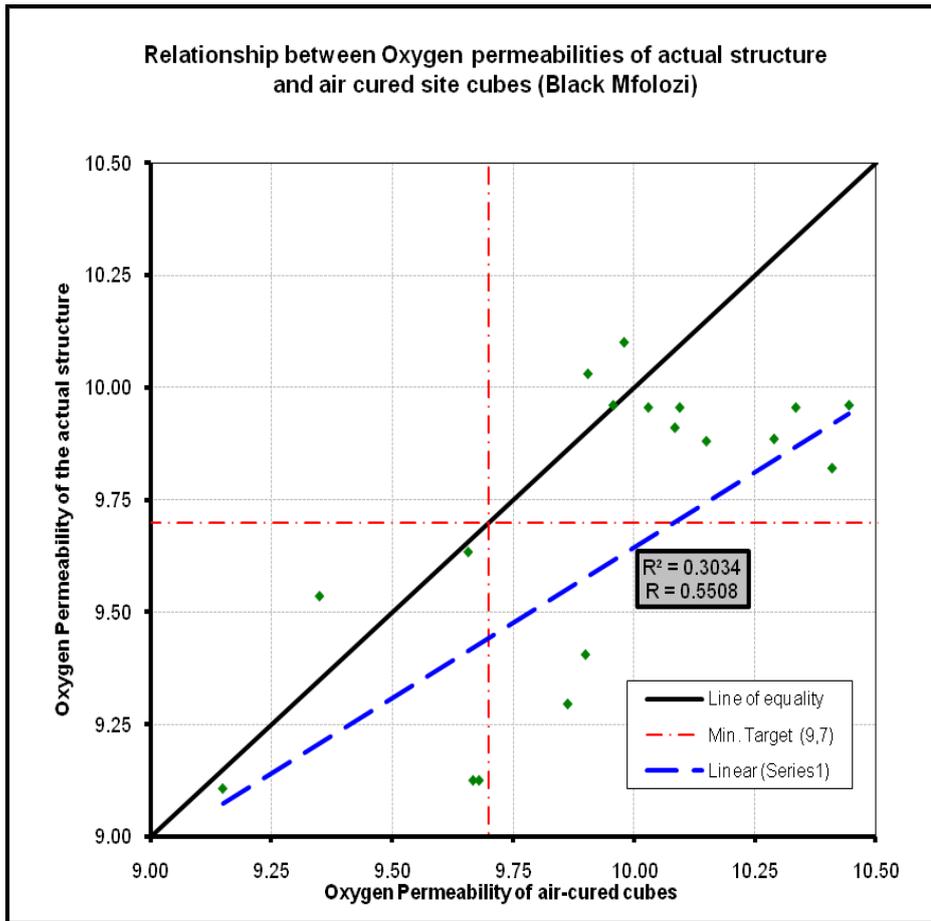
Figure 7.8: Relationship of OPI for in-situ versus site (air) cured cube results

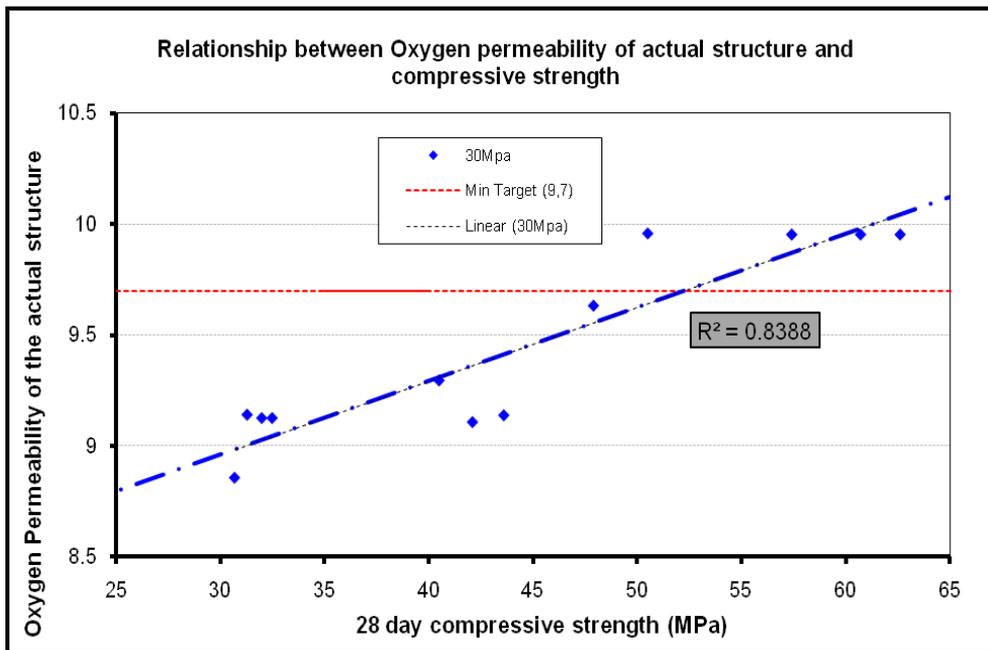
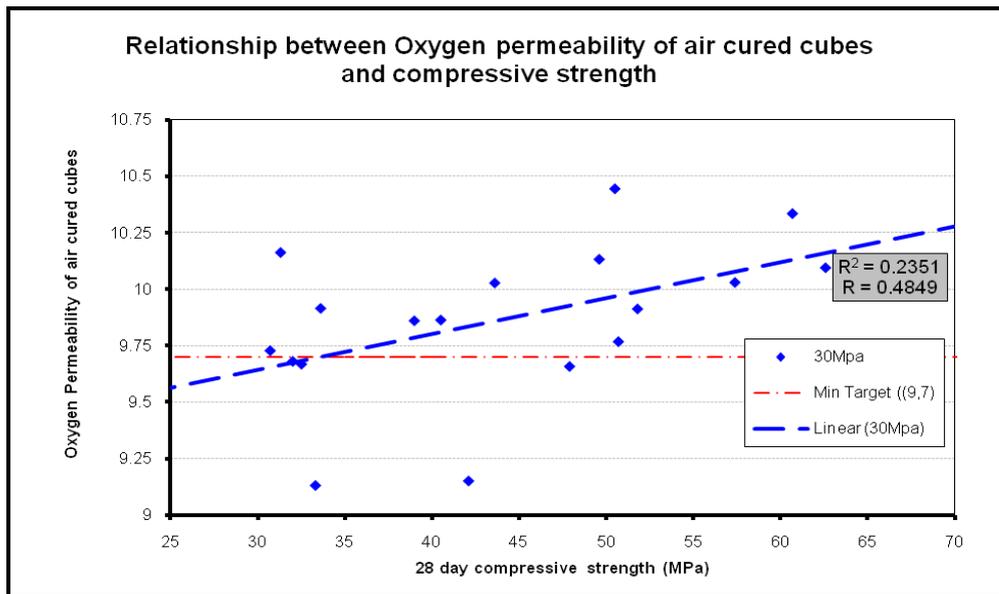
The scatter diagrams in Figure 7-9 (a) and (b) below shows the relationship between OPI and strength results. The results indicate that the in-situ results are spread on either side of the minimum target value of 9,7 for in-situ concrete. The results from the site cured cubes show that majority of the values are very much higher than the minimum requirement indicating the concrete has met the target value. With regard to relationships of OPI and strength, the linear trend line indicates increasing OPI values with increasing strength for both the in-situ values and air cured cubes. while the slopes of the trend lines show a relationship between OPI and strength, the 'r' and 'r²' values are low and therefore also indicative that durability is not related to strength.

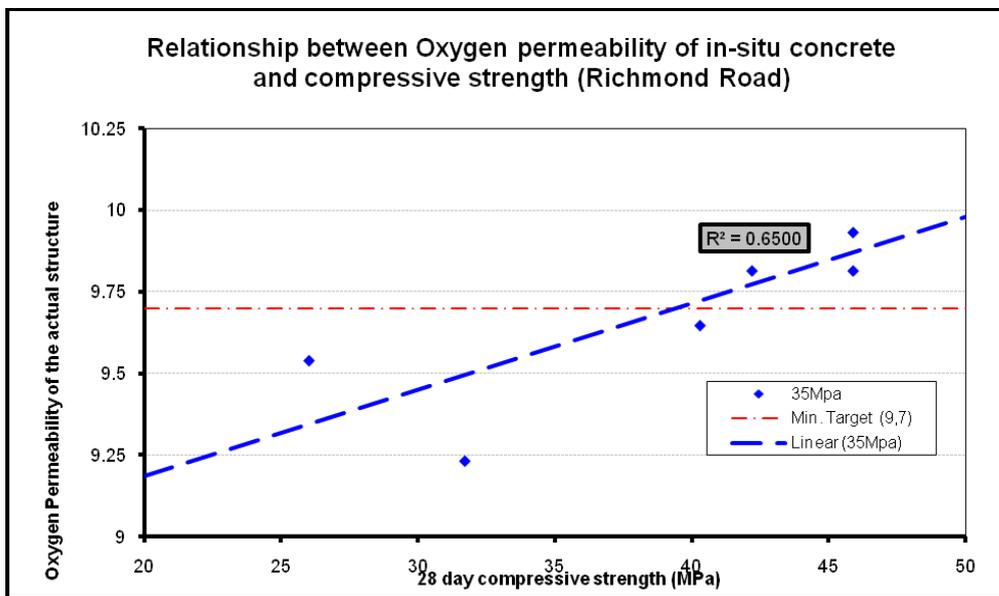
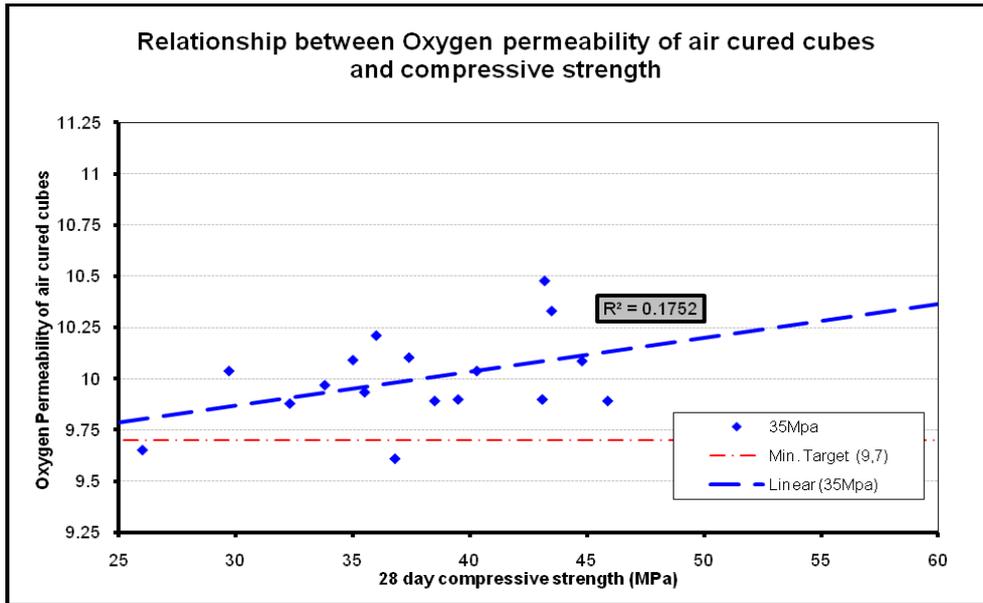
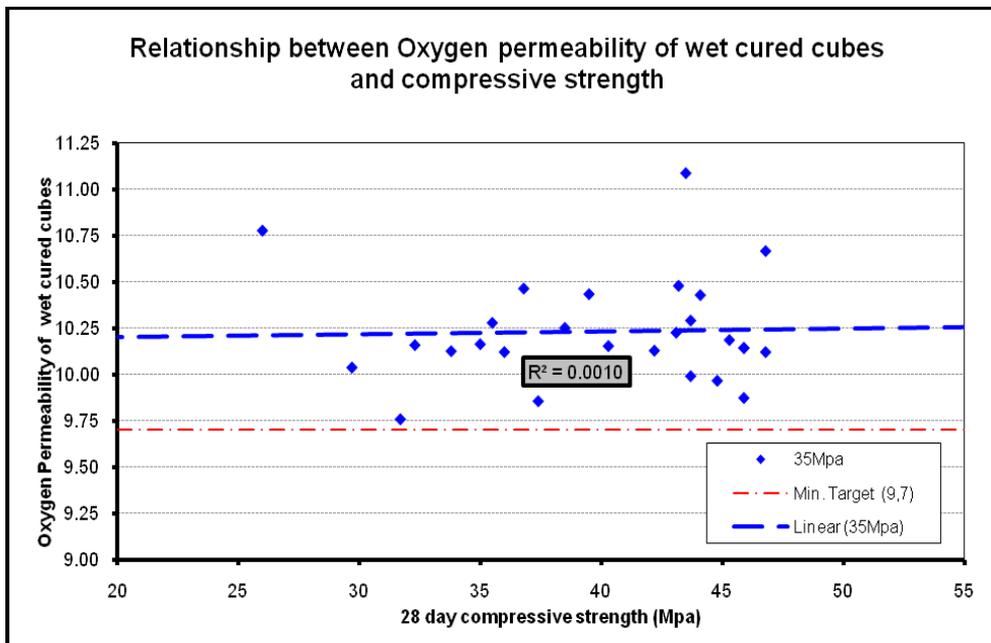
The scatter diagrams in Figure 7-11 (a), (b) and (c) below shows the relationship between OPI and strength results.

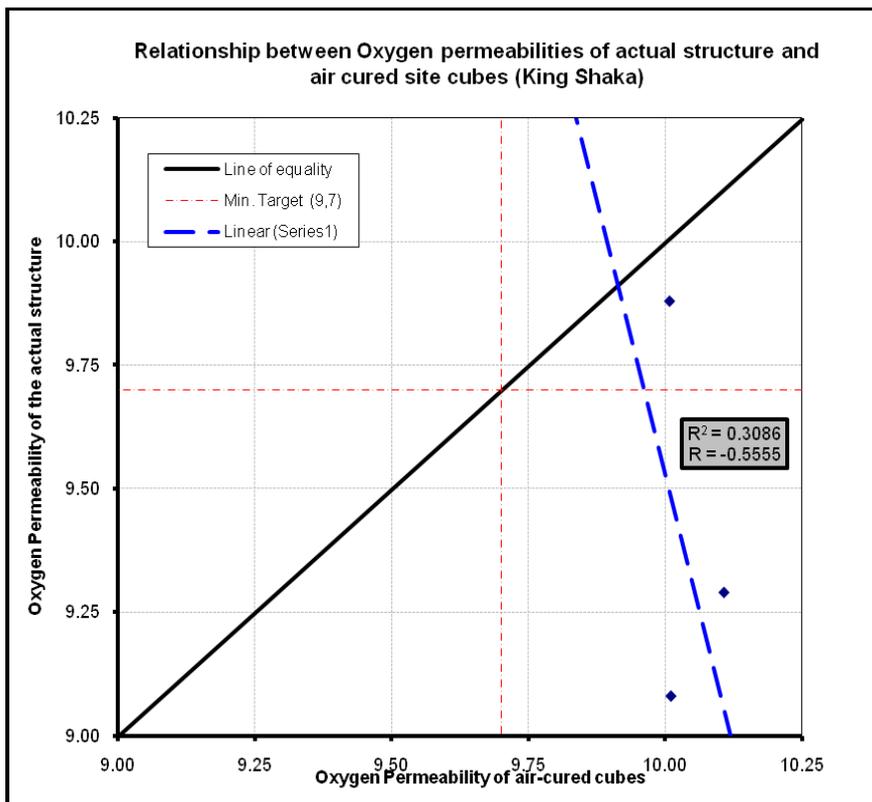
Figure 7.12: Relationship of OPI for in-situ versus site (air) cured / wet cured cubes

The results in Table 7-9 above shows that all of the tests from the site and laboratory cured cubes met the minimum target. The core results drilled from the sub-structures however indicated failure on one of the three samples tested. In addition, the value of the test results was superior on the air cured cube results than the in-situ concrete. The scatter diagram in Figure 7-12 shows the relationship between in-situ and test cube results for OPI.

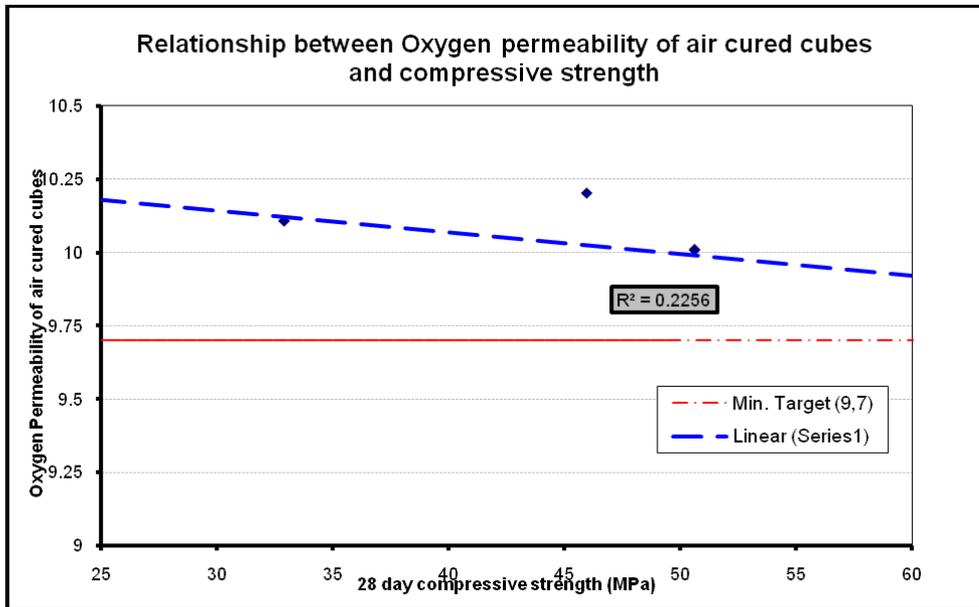
Figure 7.13: Relationship of OPI versus strength for in-situ and , site cured and wet cured cubes

and 'r²' are 0,5555 and 0,3086 respectively shows higher values than the other projects but these are only based on a limited number of samples. The scatter diagram in Figure 7-13 below shows the relationship between OPI (air cured cubes) and strength results.

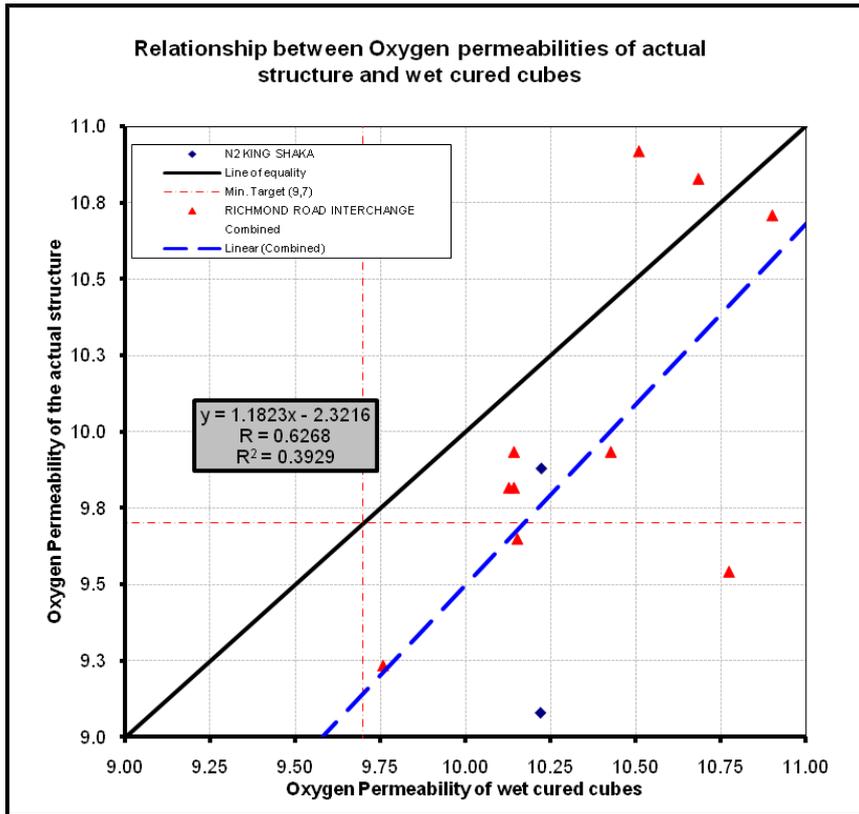
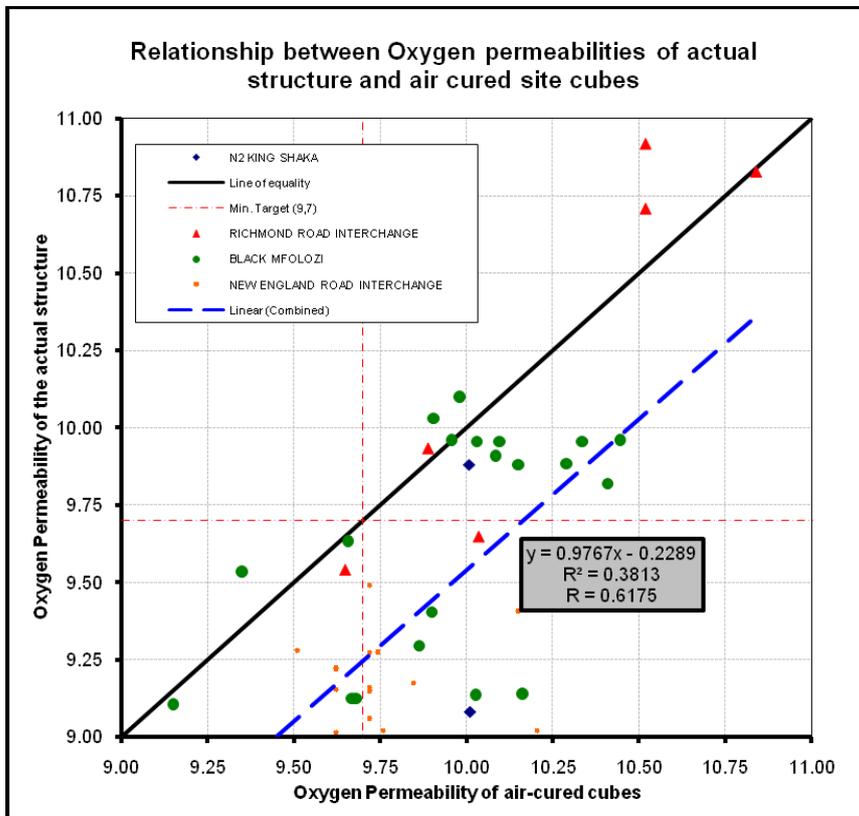
The results from each of the projects for the oxygen permeability tests were combined into common scatter diagrams to examine the overall trend for the in-situ and test cube results. These were plotted and shown in the scatter diagrams of Figure 7-14 (a) and (b) below.
