**CRITIQUE OF DURABILITY SPECIFICATIONS FOR
CONCRETE BRIDGES ON NATIONAL ROADS IN
SOUTH AFRICA**

In partial fulfillment of the degree of Master of Science, Faculty of
Engineering, University of KwaZulu-Natal

March 2011

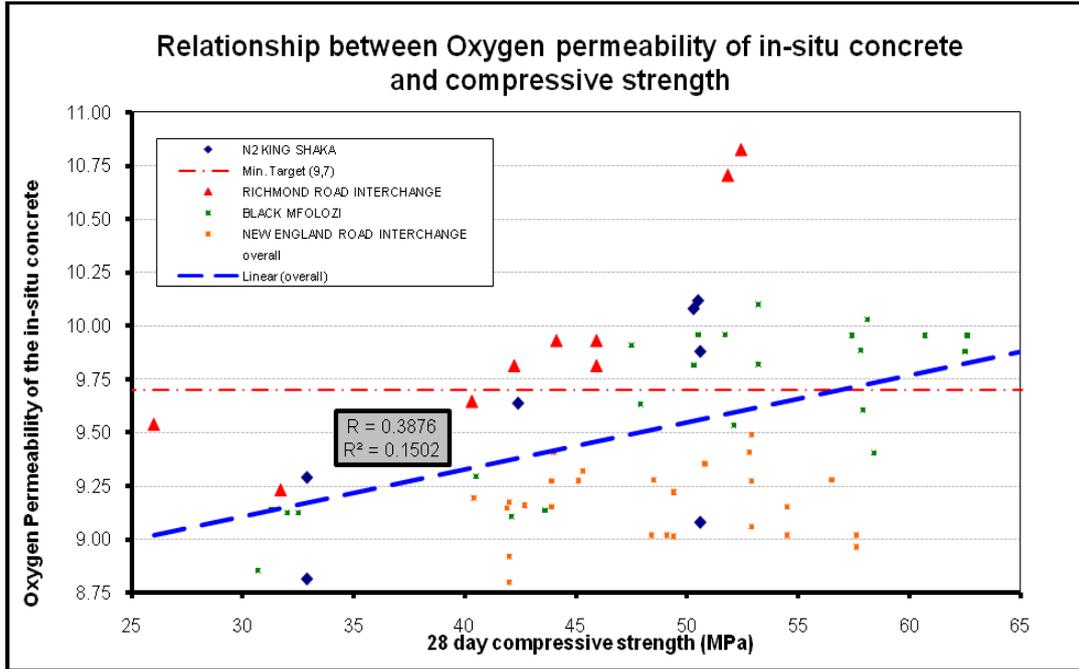
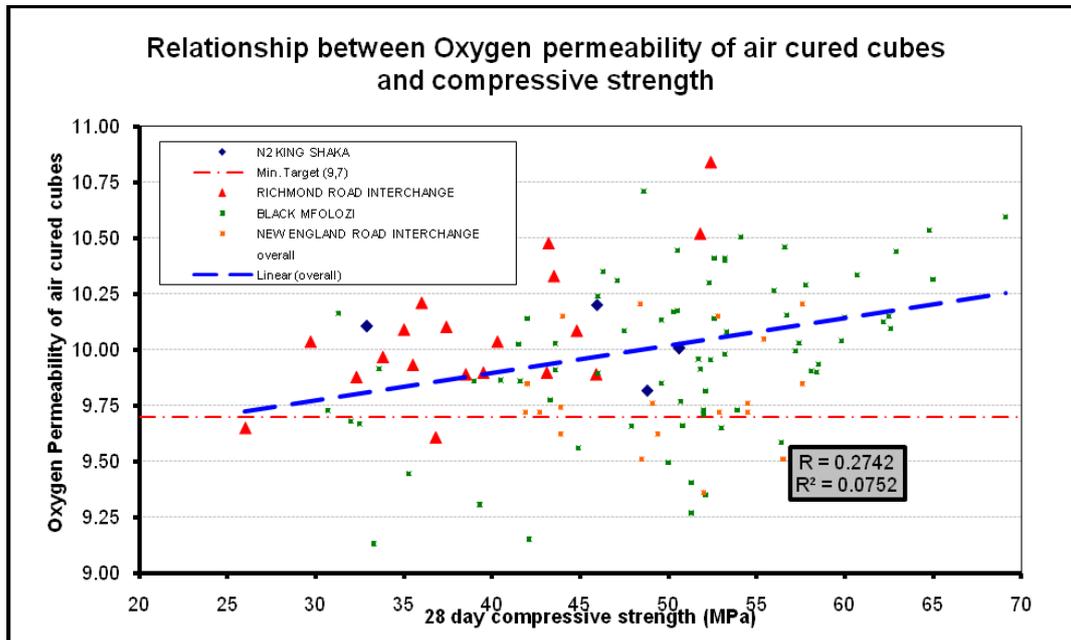
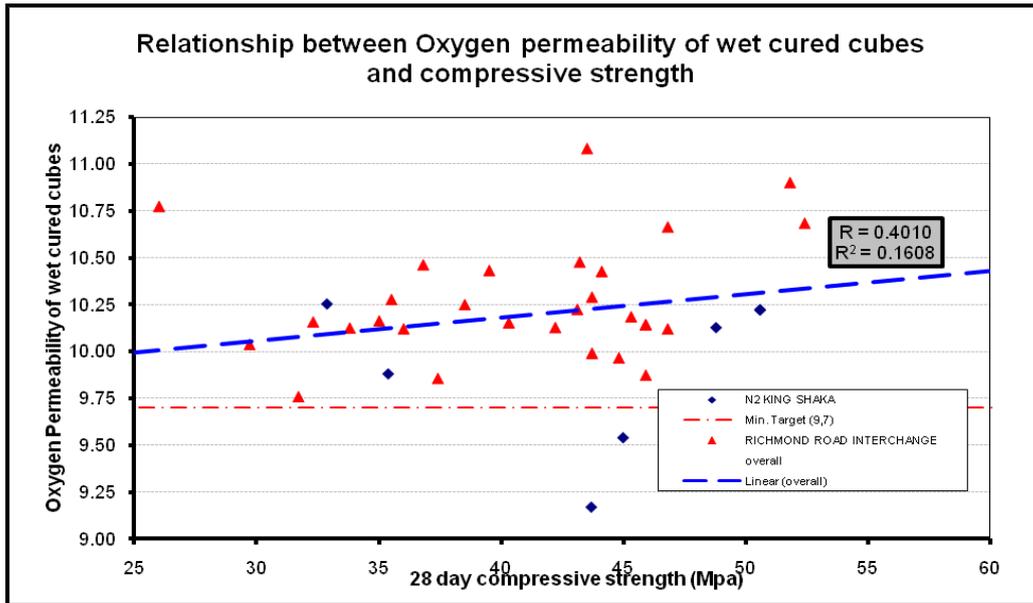
From Figure 7-15 (a) for the in-situ tests, it can be seen that the results are distributed on either side of the minimum target of 9,7, while Figure 7-15 (b) shows majority of the results are above the minimum target. Figure 7-15 (c) shows except for two values, all of the results are above the minimum target line. The value of ‘r-square’ is very low and close to zero indicating a very poor correlation of strength and OPI.

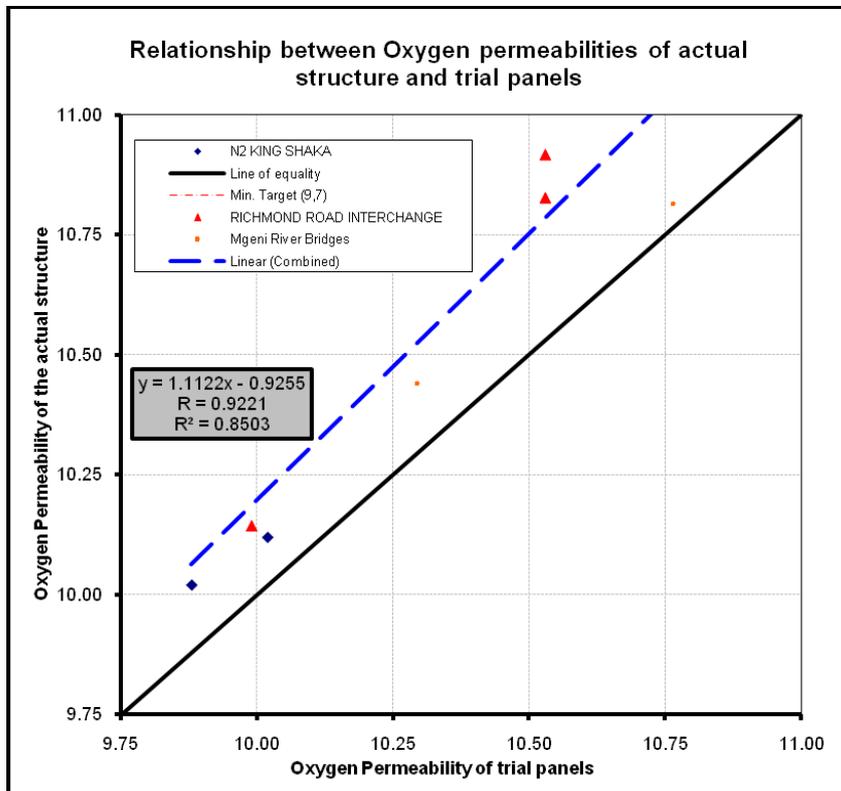
Figure 7.16: Relationship of OPI for trial panels and in-situ concrete

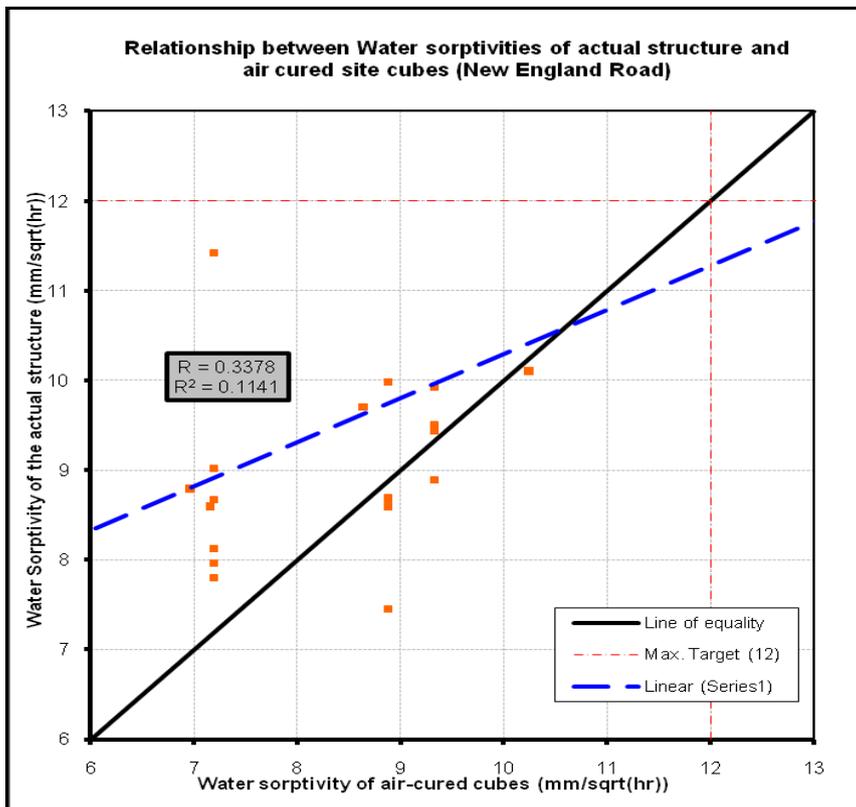
Figure 7.17: Relationship of Sorptivity for in-situ versus site (air) cured cube results

The results in Table 7-6 shows that while the sorptivity target has been met in the test cube and in-situ results, the in-situ results are closer to the target requirement of 12,00. The test cube results are superior to the in-situ results. The scatter diagrams in Figure 7-17 shows the relationship between in-situ and test cube results for both strength concretes.

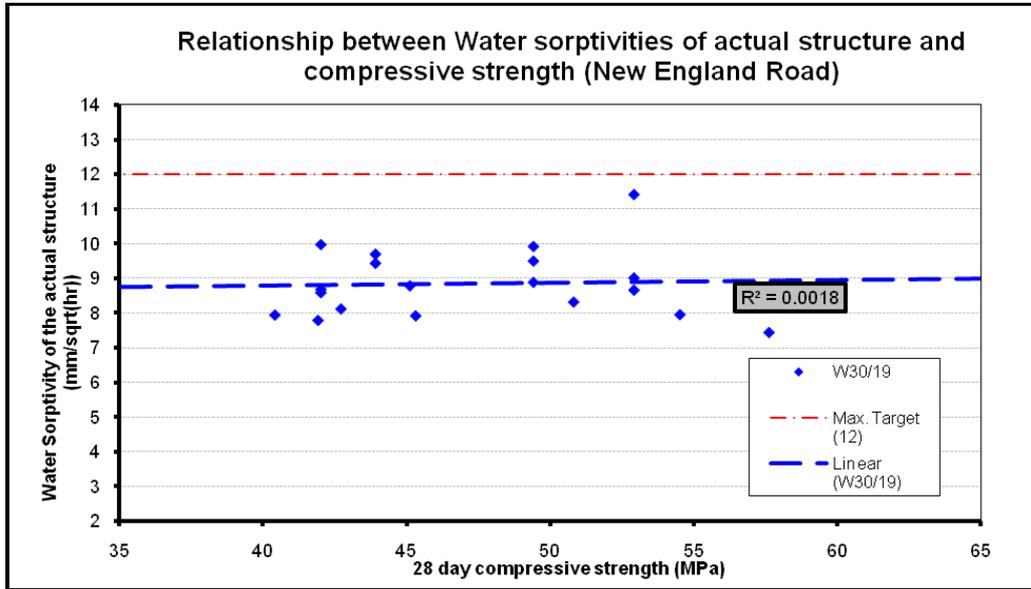
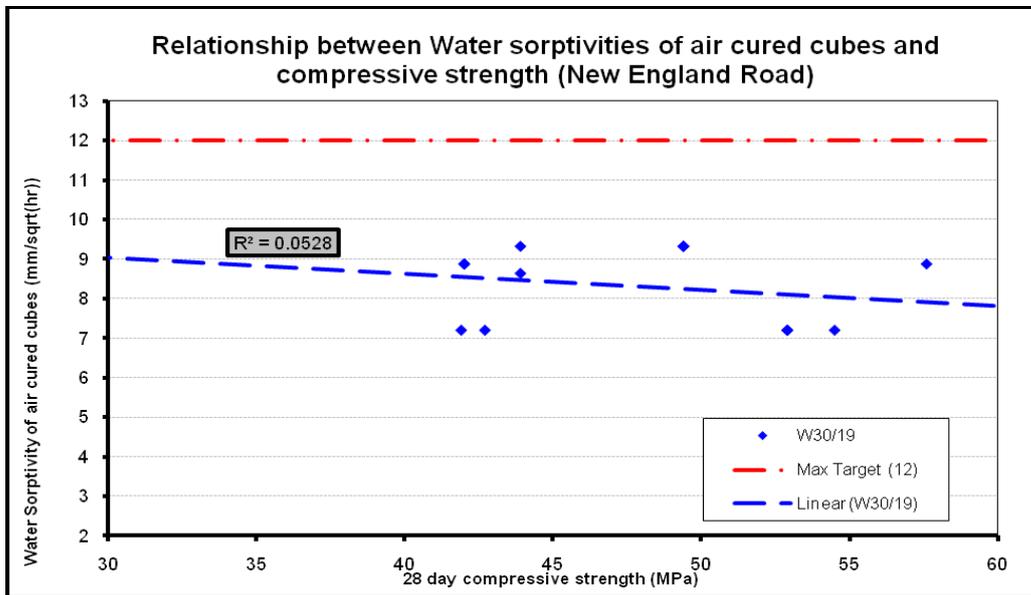
The scatter diagrams in Figure 7-18 (a) and (b) below shows the relationship between sorptivity and strength results.

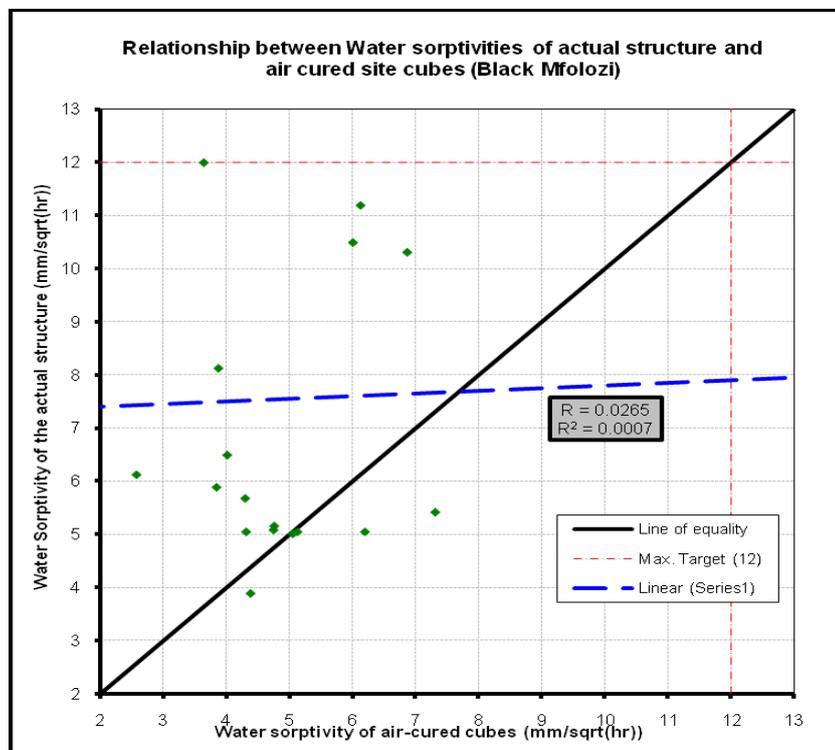
Figure 7.19: Relationship of Sorptivity for in-situ versus site (air) cured cube results

The results in Table 7-7 shows that while the sorptivity target has been met in both the test cube and in-situ results (except for three sample lots), the in-situ results are closer to the target requirement i.e. the in-situ results are higher than the cube results. The test cube results are therefore superior to the in-situ results, and can be attributed to the degree of curing and possibly the volume of concrete being compacted in the cube compared to that in the structure. The scatter diagram in Figure 7-19 shows the relationship between in-situ and test cube results for both strength concretes.

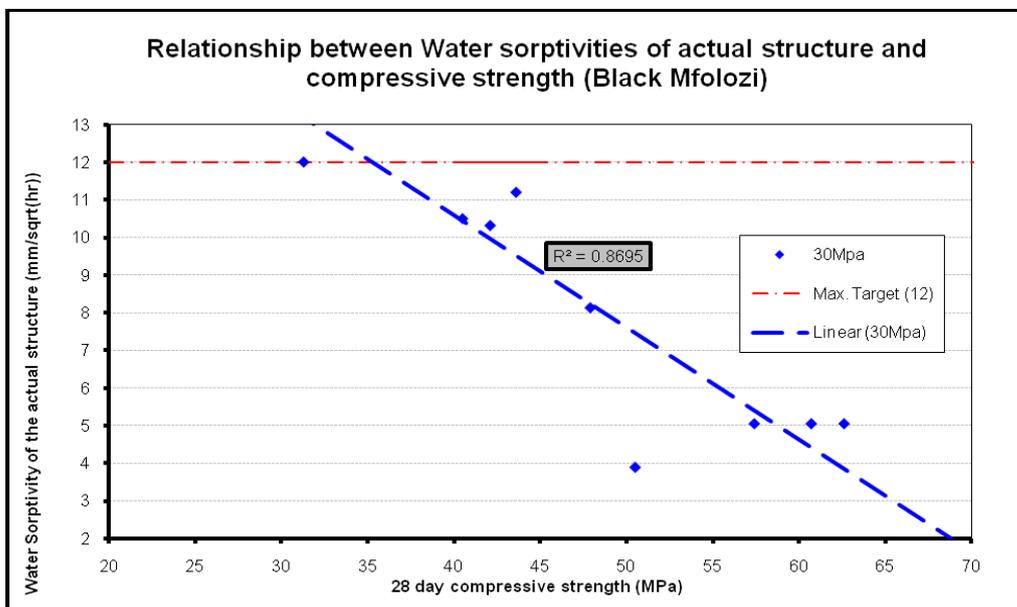
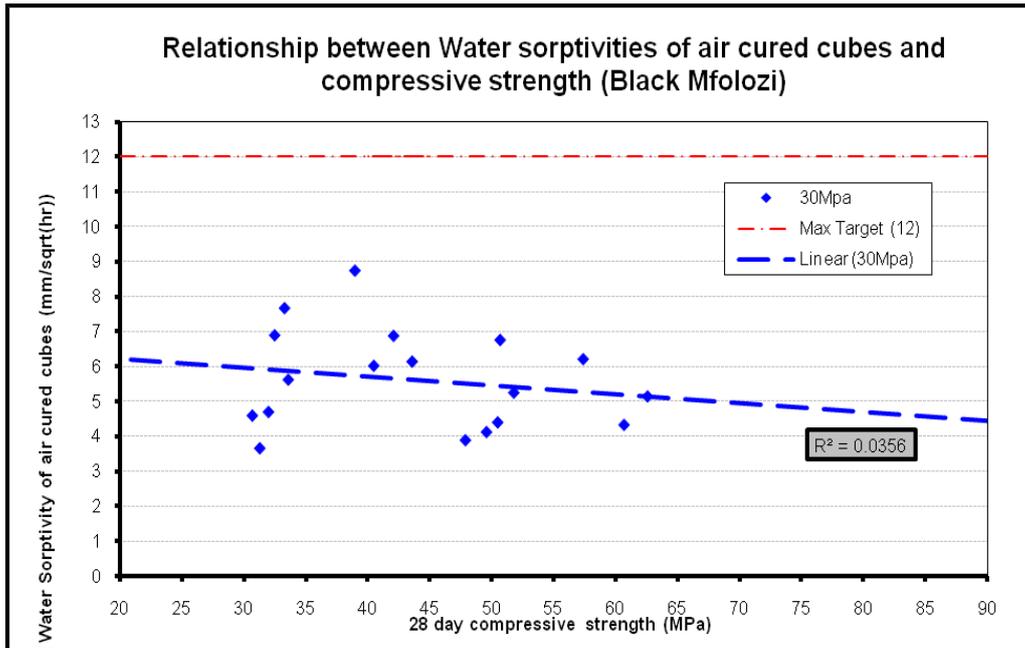
With regard to the relationship of sorptivity and strength, the in-situ trend line indicates decreasing sorptivity values with increasing strength (with a steep gradient). This indicates once more that that the trend lines are indicative that durability is not related to strength and again confirms the conclusions of Gouws et al (2001) that durability is not related to strength.

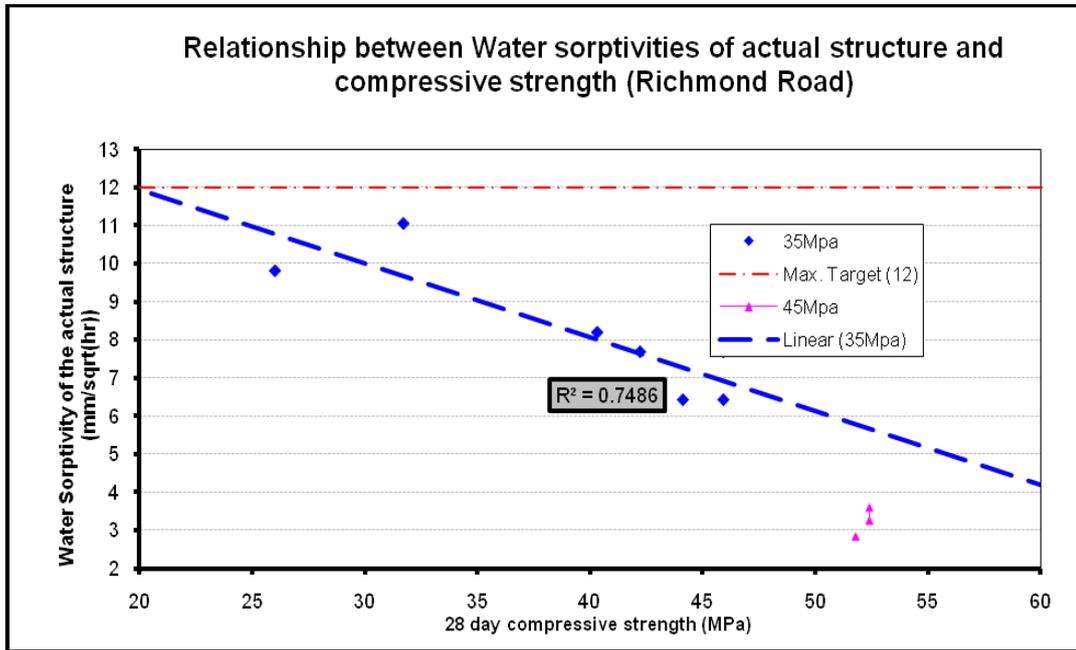
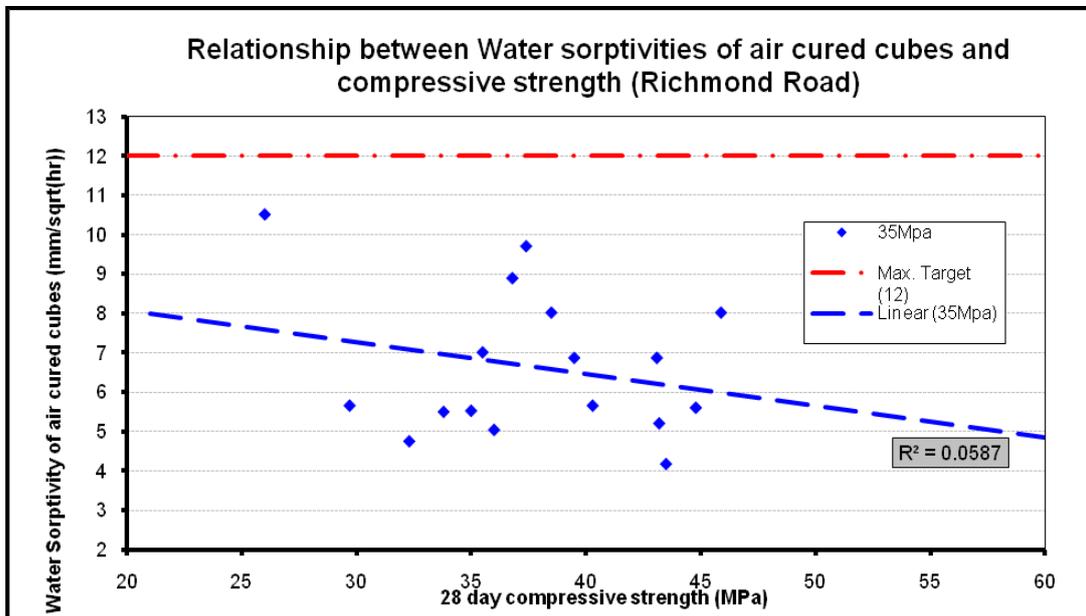
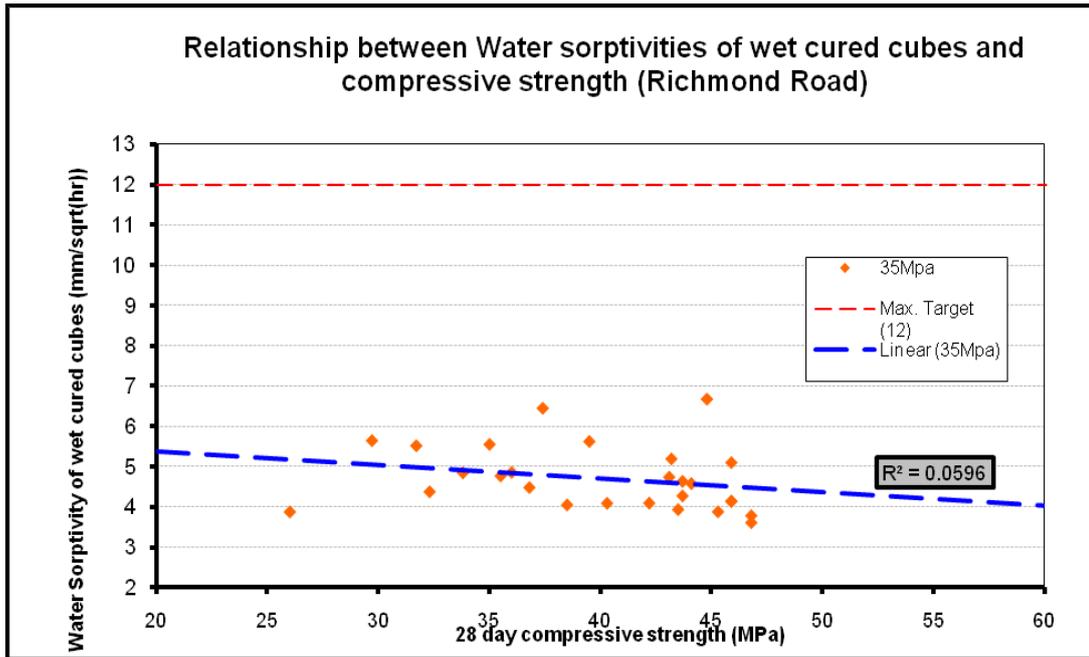
The scatter diagrams in Figure 7-22 (a), (b) and (c) below shows the relationship between sorptivity and strength results.

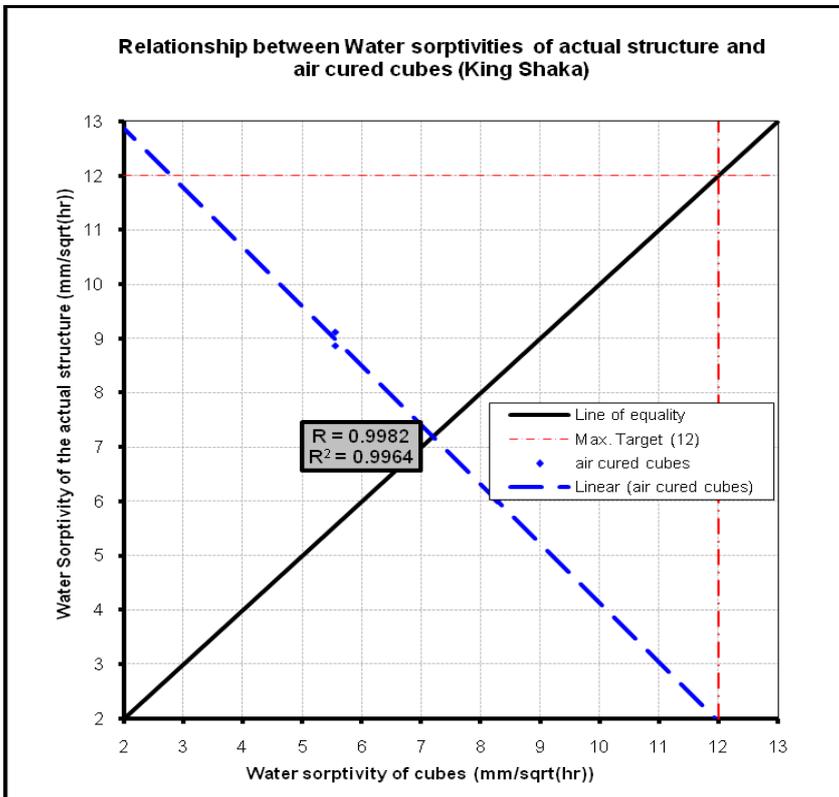
Figure 7.23: Relationship of Sorptivity for in-situ versus cube results (site cured)

diagram in Figures 7-23 and 7-24 below shows the relationship between in-situ and test cube results (both site cured and wet cured).

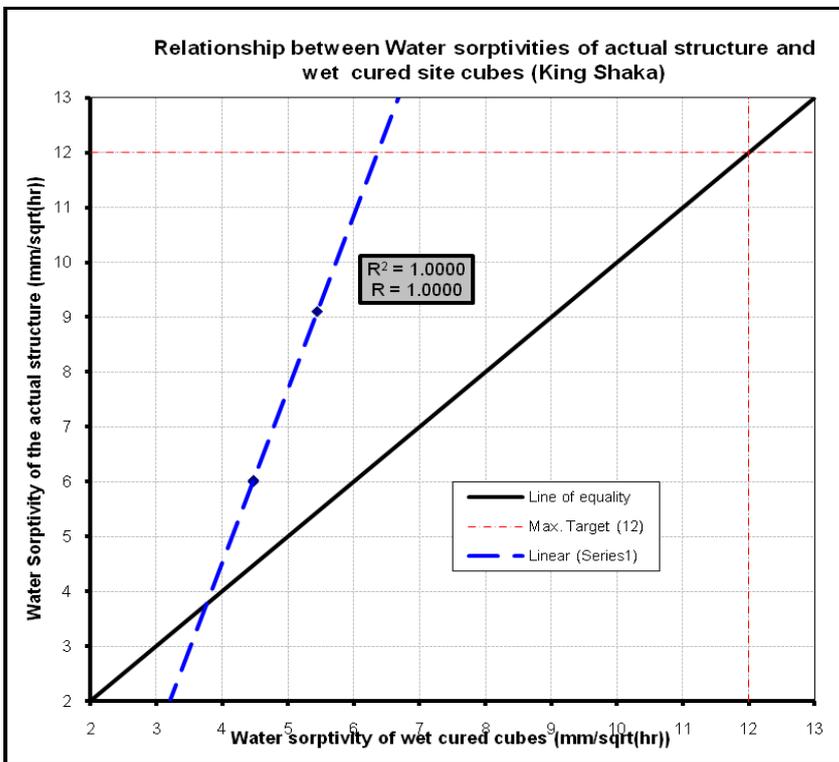
Figure 7.24: Relationship of Sorptivity for in-situ versus cube results (wet cured)

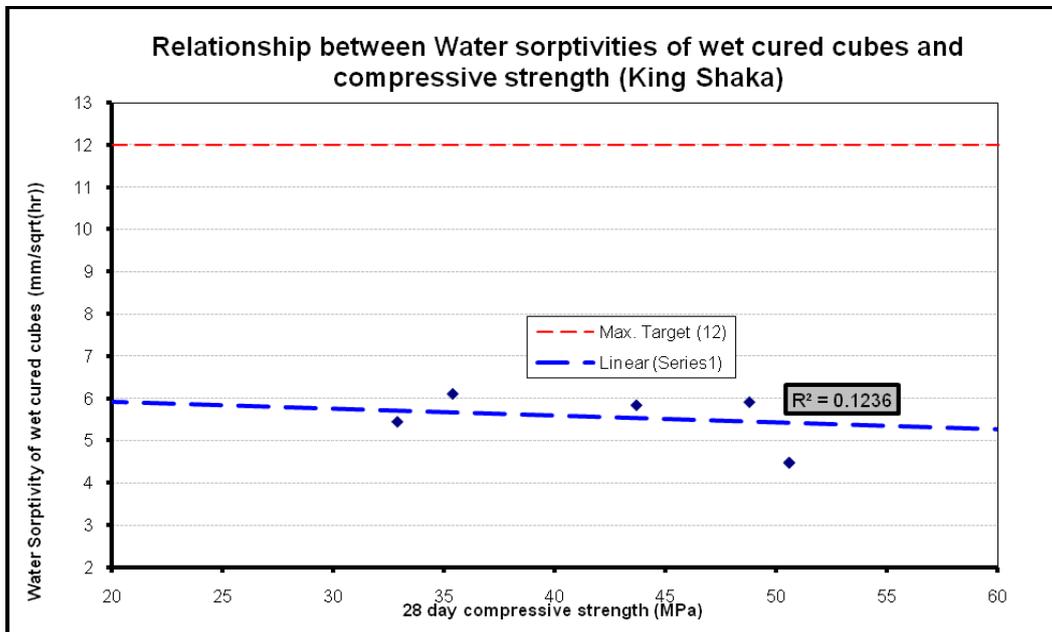
Figure 7.25: Relationship of Sorptivity versus strength for wet cured cubes and in-situ concrete

The scatter diagram in Figure 7-25 below shows the relationship between Sorptivity and strength results for wet cured cubes. The graph indicates that all results are below the maximum target value of 12,00 and the trend line shows a poor correlation with a correlation value of only 0,1236. due to the limited results for the air cured results a correlation was not undertaken.

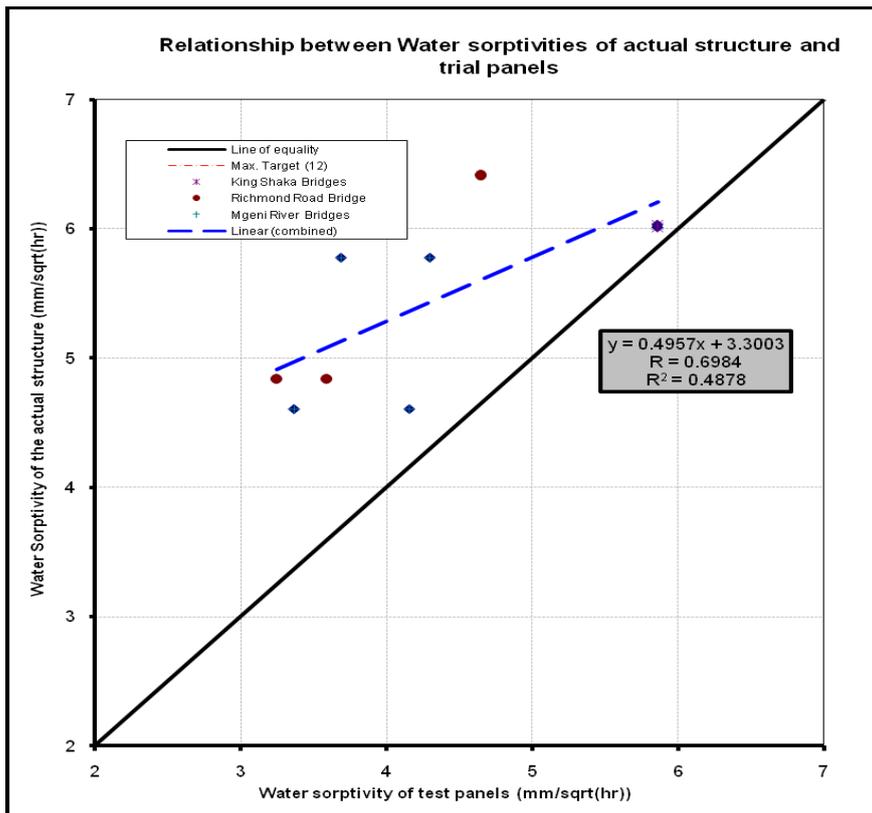
Figure 7.28: Relationship of Sorptivity for trial panels and in-situ concrete

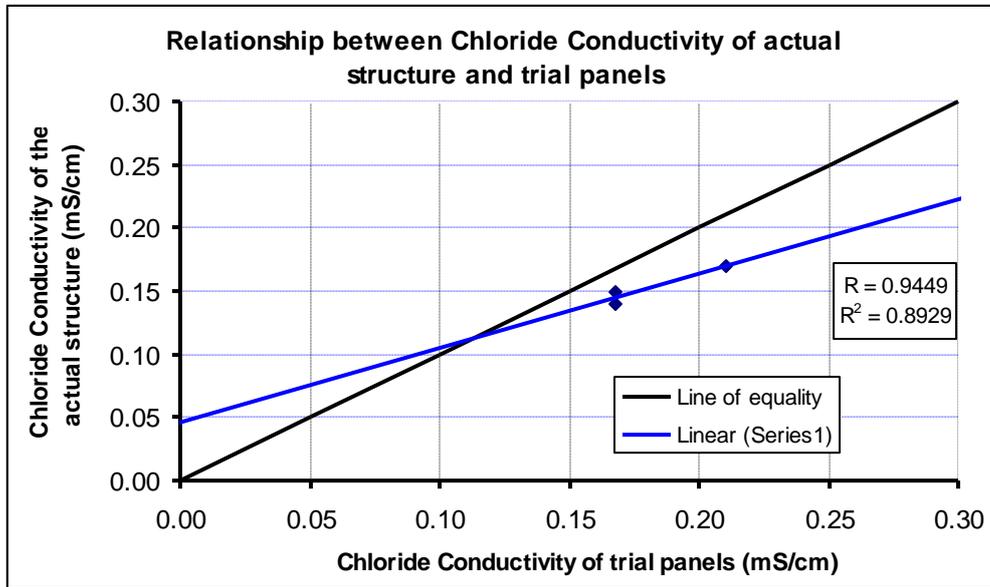
Figure 7.30: Relationship of Chloride Conductivity for trial panels and in-situ concrete

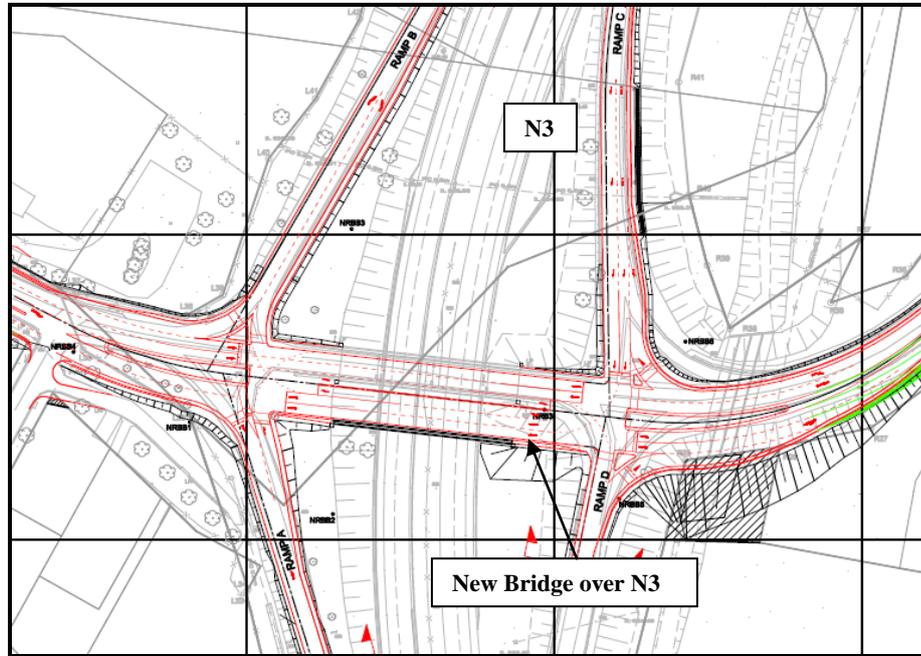
Figure A1 : Plan View of the New England Road Site (SANRAL Contract N003-003-2005/1, 2007)

Figure A1 below shows the plan view of the new bridge.

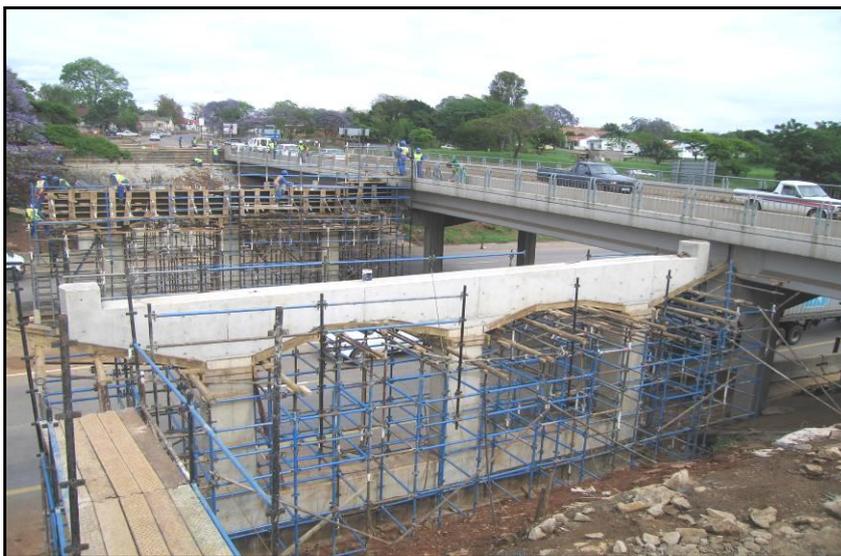
Figure A2 : Construction of Substructures (Piers and Abutments) (Source, Author)

Figure A2 below shows the construction of the piers and abutments.

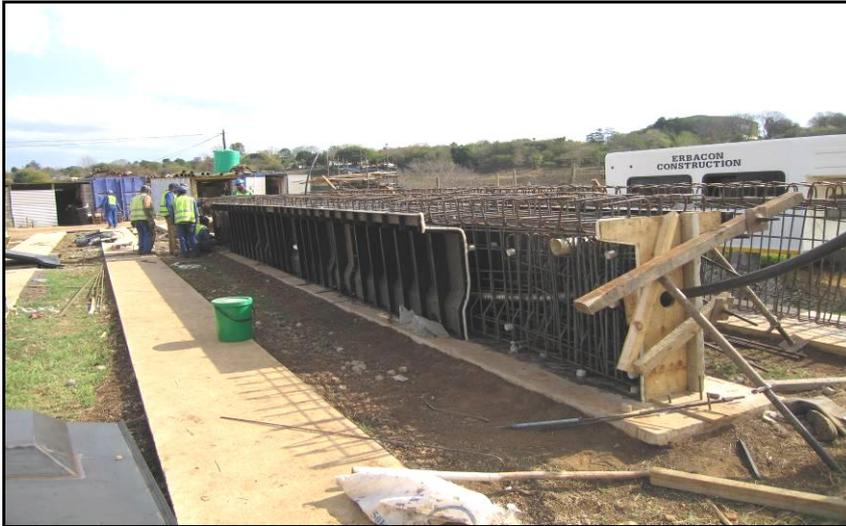
Figure A3 : Construction of Precast Beams (Source, Author)

Reinforcement provided at the ends of the beams to control bursting stresses always presents a problem of proper compaction to concrete due to the limited space as can be seen in Figure A3 above. The deck area was very wide as can be seen in Figure A4, and curing was done using a mist spray which proved very effective.

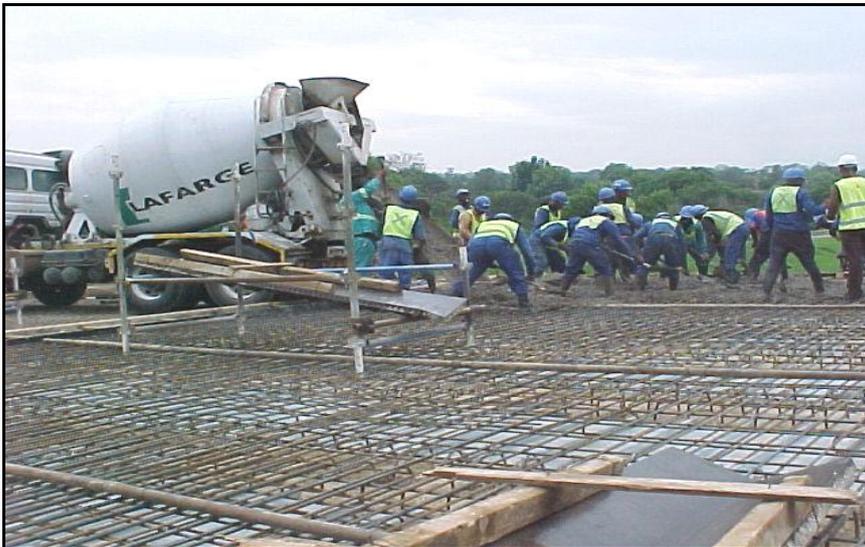
Figure A4 : Construction of Bridge Deck (Source, Author)

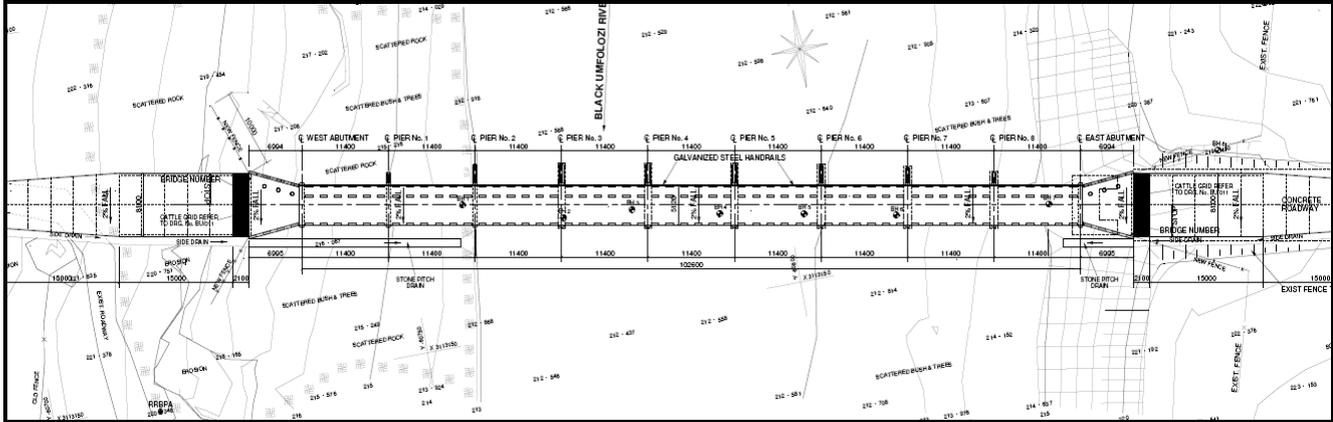
Figure A5 : Plan View of the Black Mfolozi River Bridge Site (SANRAL Contract P006-032-2007/1, 2007)

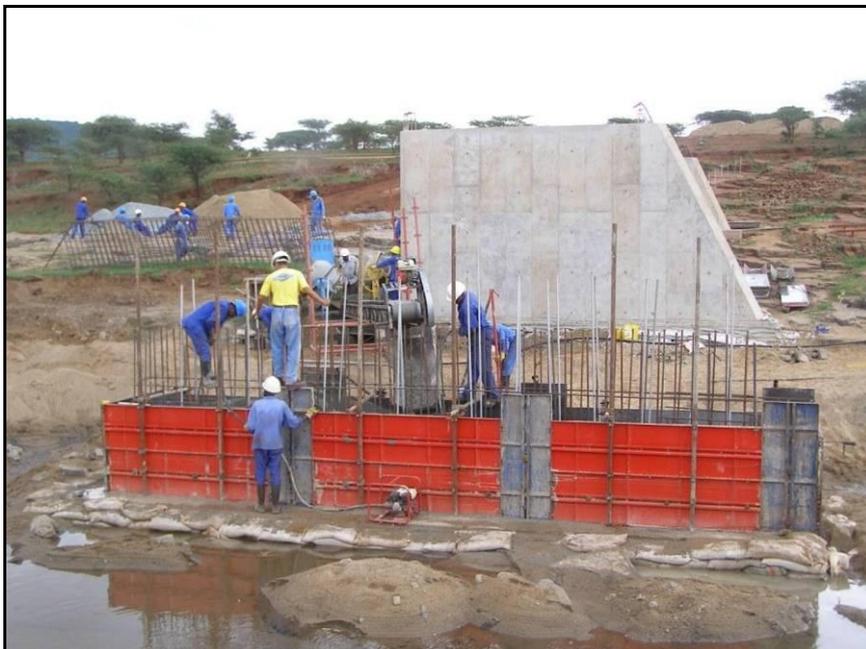
Figure A6 : Construction of Substructures (Piers and Abutments) (Source, Author)

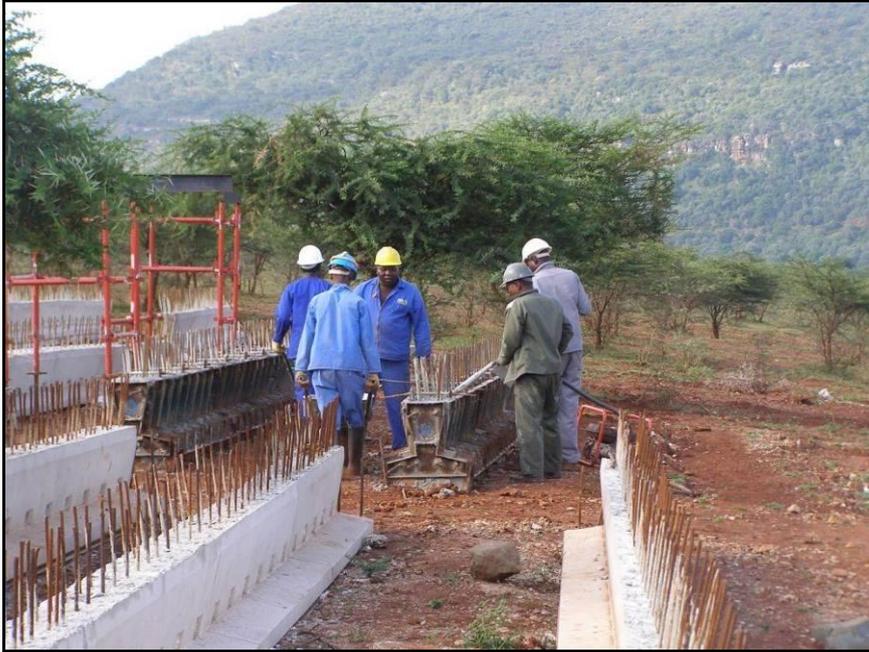
Figure A7 : Construction of Precast Beams (Source, Author)

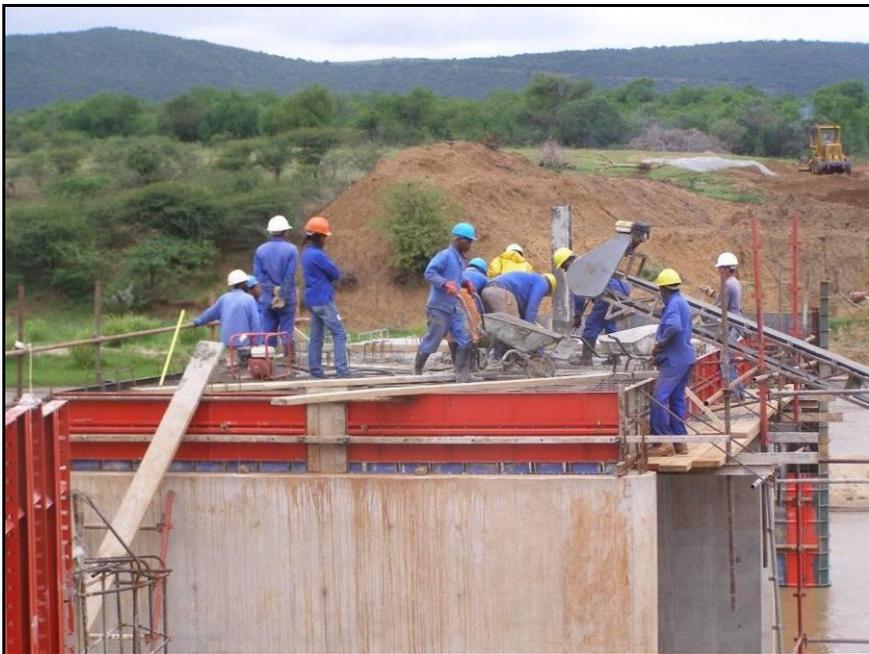
Figure A8 : Construction of Bridge Infill and top slab (Source, Author)

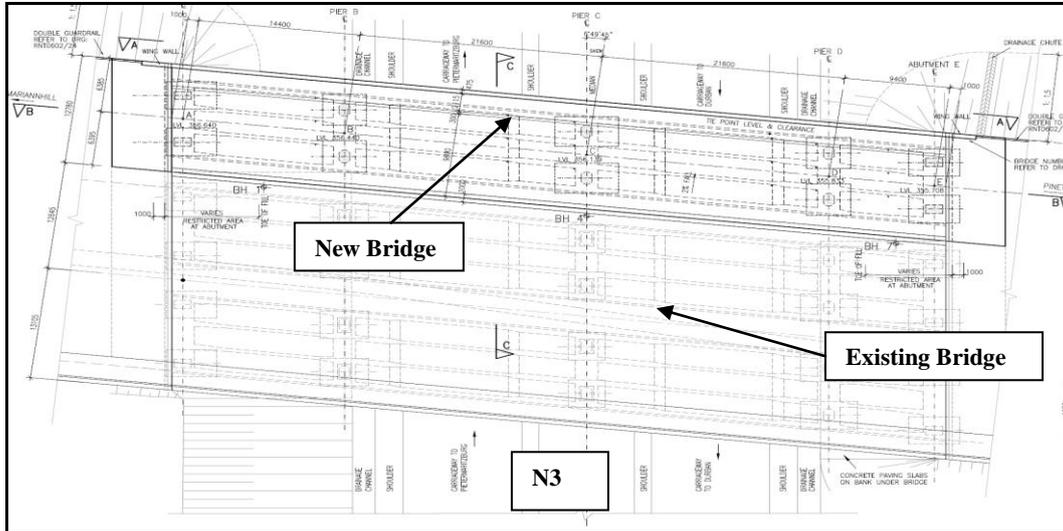
Figure A9 : Plan View of the Richmond Road Interchange Bridge Site (SANRAL Contract N003-010-2008/1, 2008)

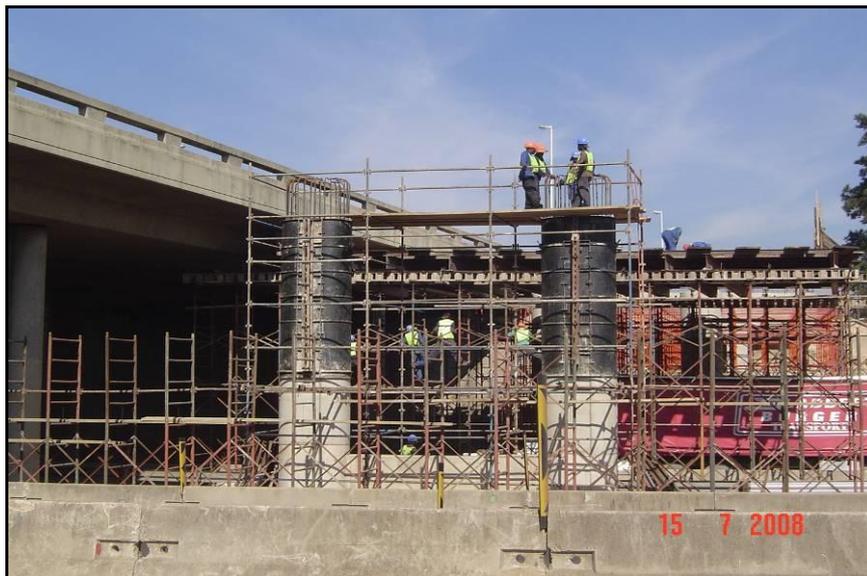
Figure A10 : Construction of Substructures (Piers and Abutments) (Source, Author)

Figure's A10 and A11 shows construction of the substructures (piers) and the bridge deck. The deck concrete was designed to be pumped and made compaction easier especially around the bursting reinforcement around the prestress anchorages.

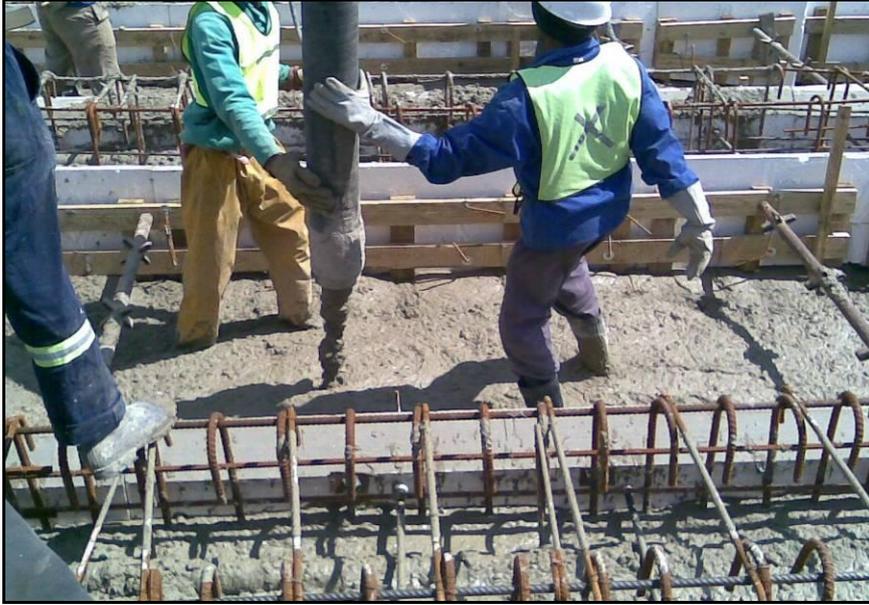
Figure A11 : Construction of Bridge Deck (Source, Author)

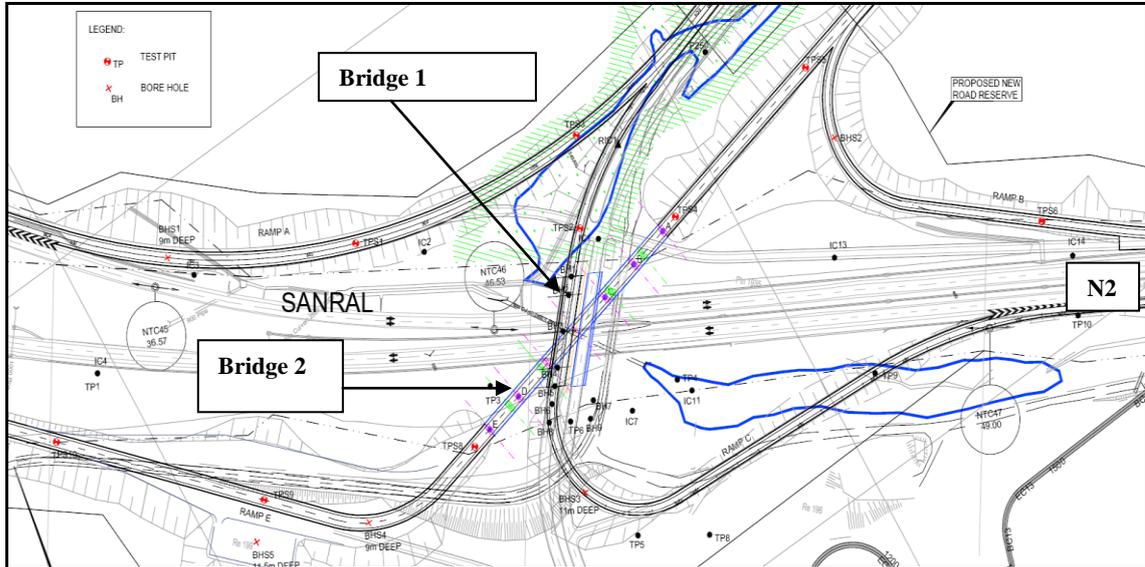
Figure A12 : Plan View of the King Shaka International Airport Interchange Site (SANRAL Contract N002-260-2005/1, 2008)

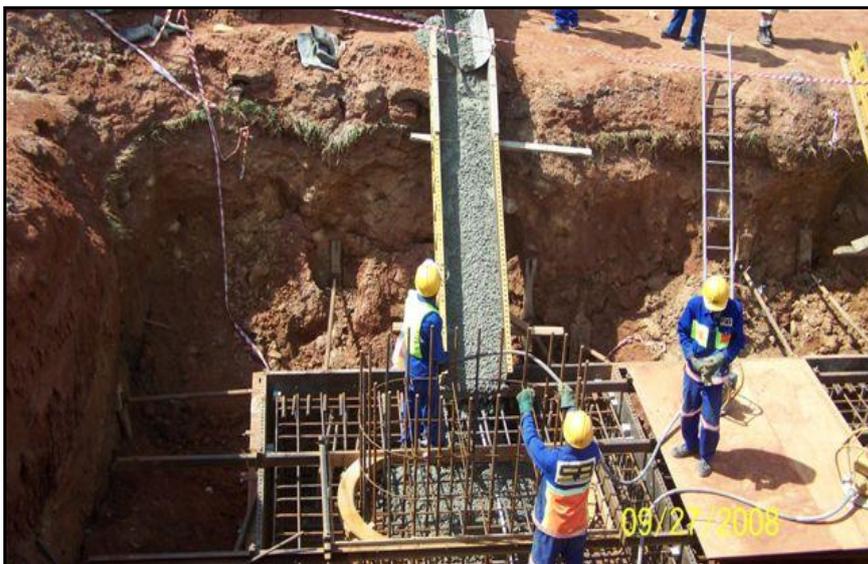
Figure A-13 : Construction of Bridge 1 Pier 3 Pile-cap (Source, Author)

Figure's A13 and A14 shows construction of the Bridge 1 Pier 3, where the finish of the concrete surface was to a high standard. Curing compound was used to cure the concrete surfaces.

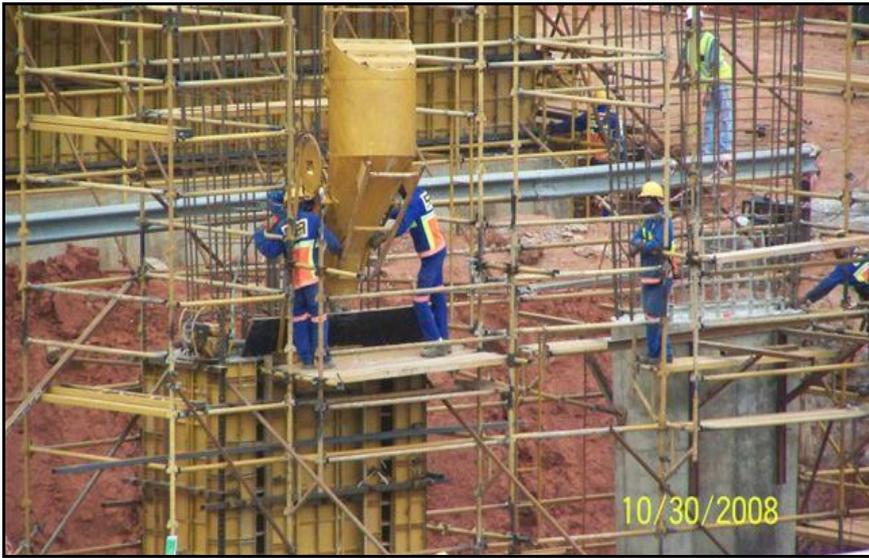
Figure A14 : Construction of Bridge 1 Pier3 - 2nd Lift (Source, Author)
