**The Influence of Sulphidizing Attack on the
Mechanism of Failure of Coated Superalloy Under
Cyclic Loading Conditions**

**Submitted in fulfilment of the academic requirements for the degree of
PHD in Mechanical Engineering in the Department of Mechanical
Engineering, University of Natal, Durban.**

January 1998

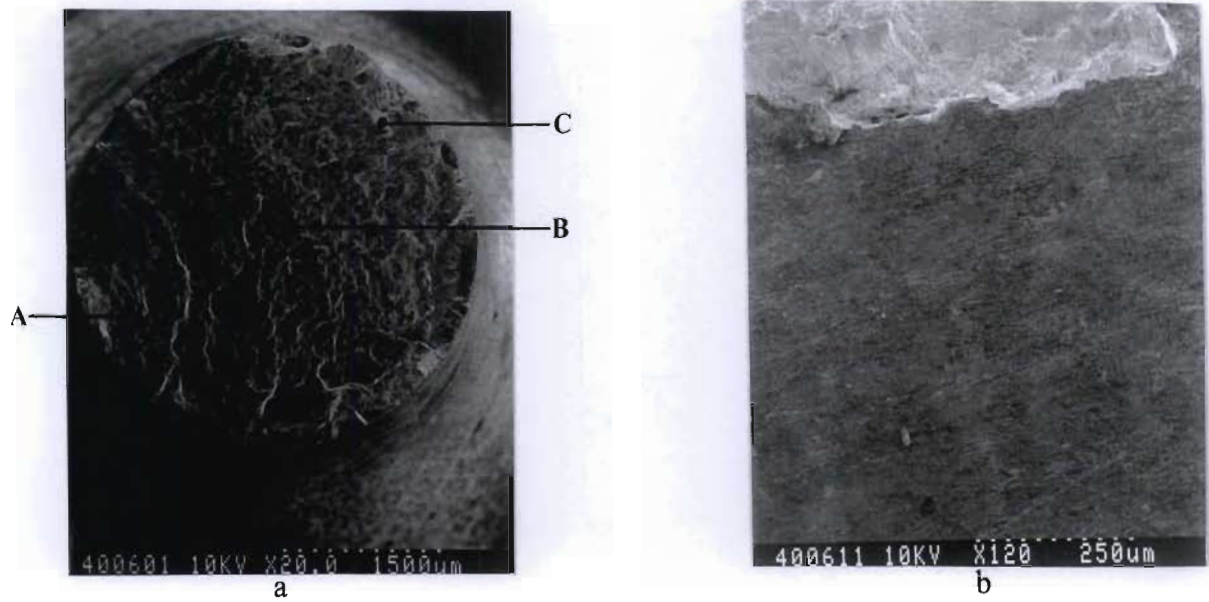
The fracture surface, figure 3.14a, showed no evidence of environmental interaction. Chemical analysis of the fracture surface showed no evidence of corrosion product, with the chemical composition being similar to the nominal composition of the alloy. An analysis with oxygen was performed in order to demonstrate that there was an insignificant amount of oxidation. The relatively small amount of oxygen detected could have been as a result of minor oxidation when the specimen was being removed from the furnace on completion of the fatigue test. The external surface close the fracture (figure 3.14b) indicated the presence of fine discontinuous cracks. The cracks were, in general, perpendicular to the direction of loading.

Figure 3.14 : a) Fracture surface of uncoated MAR-M002 after HTLCF in argon atmosphere at 870°C
 b) Fractography of uncoated MAR-M002 after HTLCF in argon atmosphere showing the external region close to the fracture surface

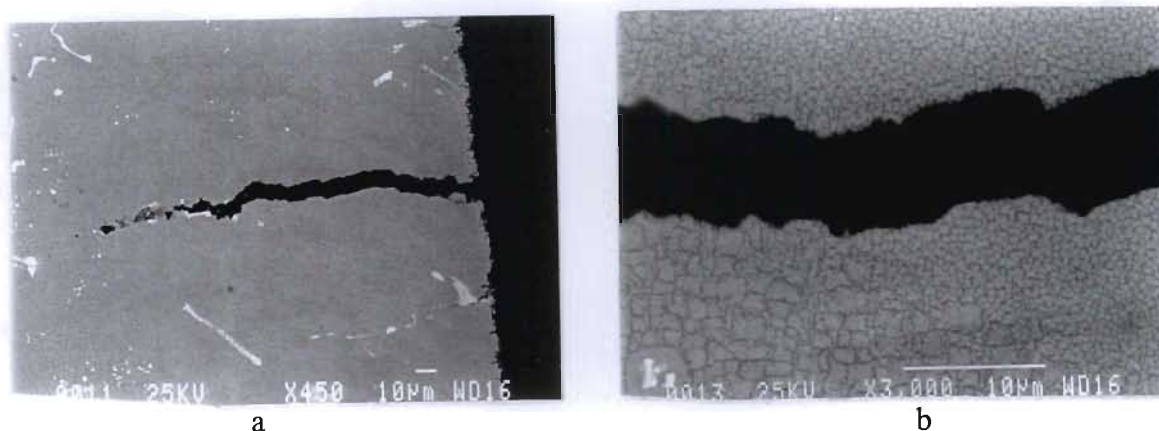
Figure 3.15 : Micrographs of the cross-section of a fatigue sample after HTLCF in argon

Several cracks were observed on the metallographic sample of the longitudinal cross-section (figure 3.15a&b). The crack propagation was relatively “straight” with no evidence of environmental interaction and branching. EDS analysis of the crack edge and of the bulk alloy (table 3.2) shows little variation in the chemical compositions between these regions indicating the absence of corrosion reactions. The evidence indicated that the mode of crack propagation was transdendritic and the failure was due to pure mechanical loading.

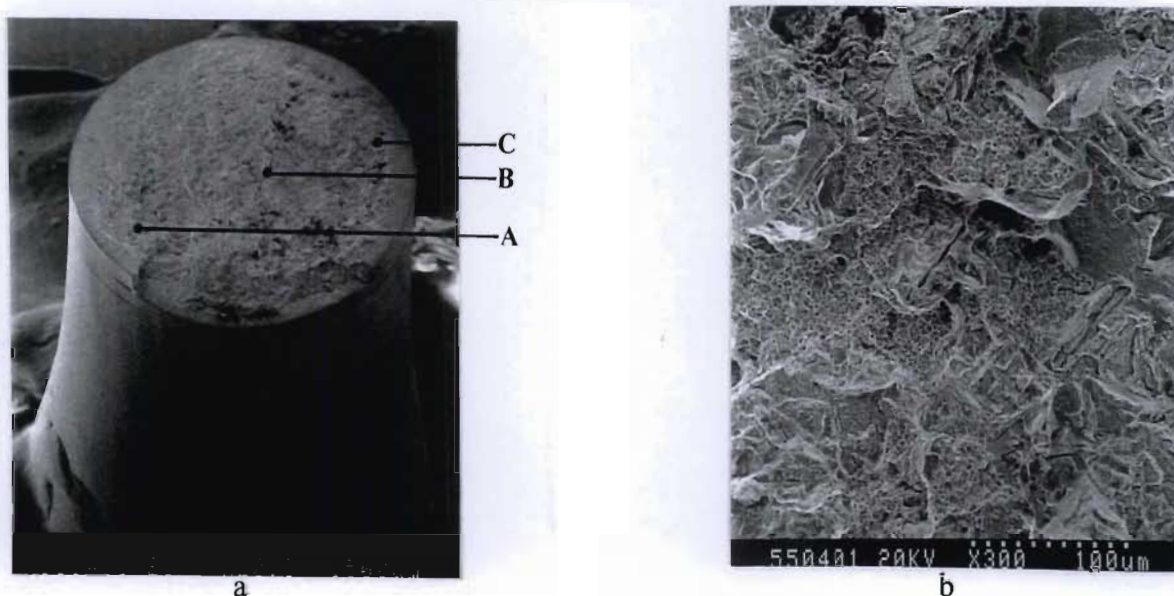
The fracture surface of aluminide coated MAR-M002 after HTLCF in inert argon atmosphere is shown in figure 3.16. The number of cycles to failure was 859 cycles. The final failure occurred, as in the uncoated sample, at a relatively high tensile load.

The fracture surface (figure 3.16b) revealed a clean surface devoid of any environmental

interaction. Micro probe analysis of the fracture surface showed no evidence of interaction with the environment. The external surface close the fracture (figure 3.16a) displayed severe cracking of the coating (around the circumference) perpendicular to the direction of loading. Cracks parallel to the loading direction were also apparent from figure 3.17. The nature of the cracks indicated a very brittle type failure of the coating.

Figure 3.16 : Fracture surface of aluminide coated MAR-M002 after HTLCF in argon atmosphere

- a) Overall fracture surface
- b) High magnification of the fracture surface

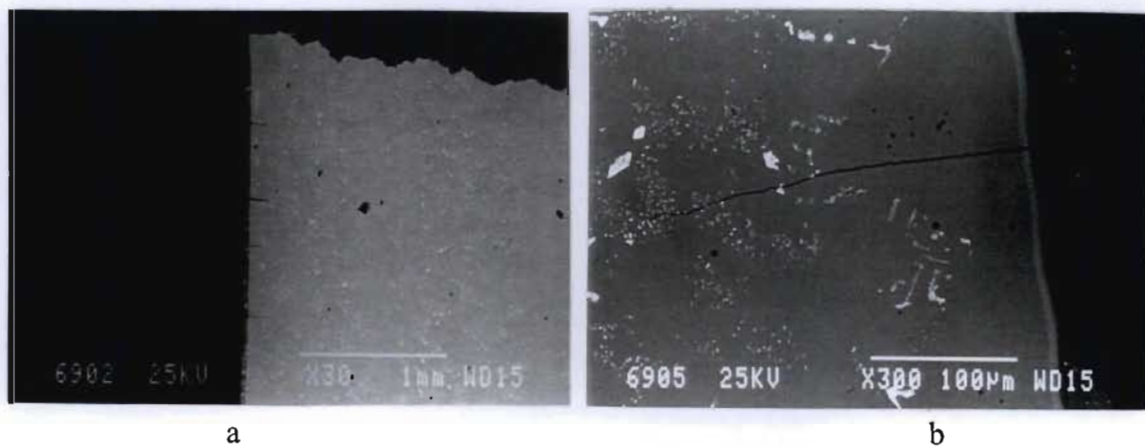
Examination of a cross-section of the fatigue sample revealed severe cracking of the coating (figure 3.18). The cracks in the coating showed no evidence of environmental interaction. Crack propagation in the substrate was transdendritic, perpendicular to the direction of loading. The crack was relatively “straight” with no indication of environmental interaction.

Figure 3.18 : Cross-sectional analysis showing cracking of the coating.

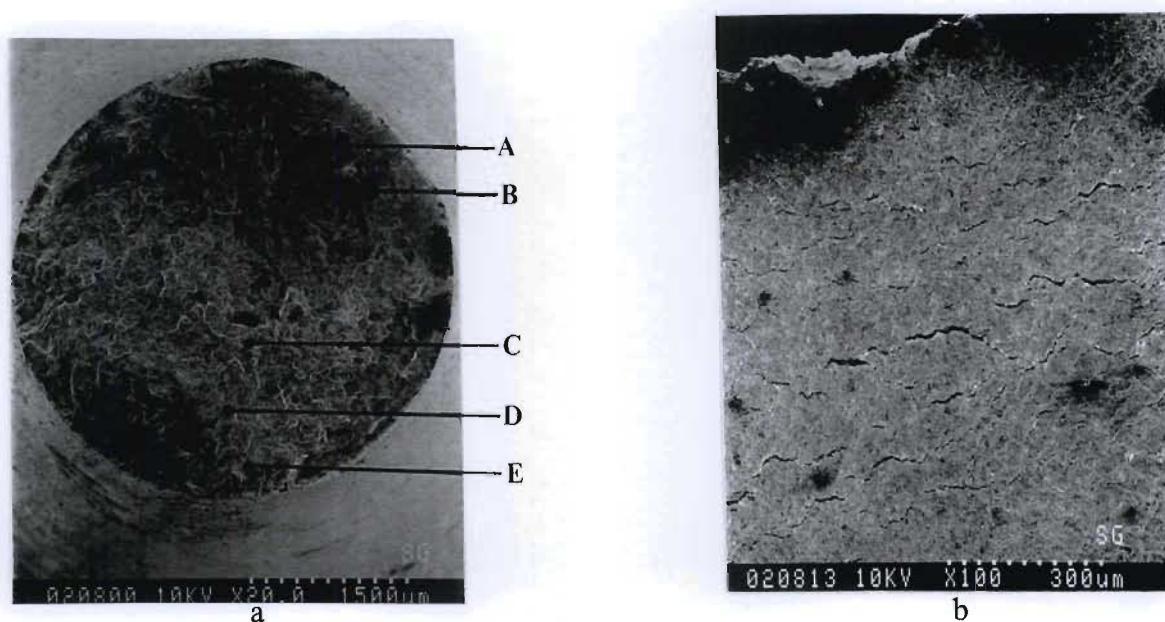
Figure 3.19 : Fractography of TYPE I platinum aluminide coated MAR-M002 after HTLCF in an argon environment

HTLCF of TYPE I platinum aluminide coated MAR-M002 in argon atmosphere resulted in a life of 1119 cycles. Fractography analysis uncovered a region that showed minor environmental interaction, due to the corrosion chamber around the neck splitting during the test (figure 3.19a). Interaction with the environment was confirmed by the significant amount of oxygen detected in the EDS (figure 3.19) and AES (figure 3.20) analyses. It was noted that only part of the fracture surface was exposed to air.

Examination of the external region close to the fracture exhibited cracking of the coating (figure 3.19b). The cracking of the coating was as a result of the mechanical loading. The cracks in the coating were very fine and were only visible at relatively high magnifications. A significant feature was that the cracking of the coating was not as severe as that observed in the unmodified aluminide coating.

- a) Fracture surface
- b) Cracking of the coating close to the fracture surface

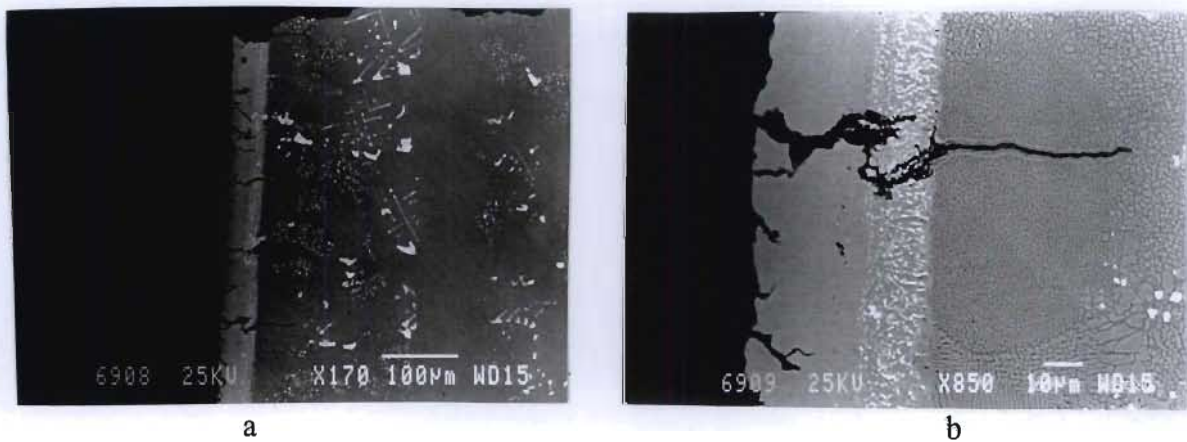
Figure 3.21 : a) Longitudinal cross-section showing cracking of the coating after HTLCF in argon atmosphere
b) Cracking of the coating plus environmental interaction

Examination of the longitudinal section after HTLCF in argon revealed several branched cracks in the coating (fig 3.21& 3.22). A significant feature in figure 3.21 was that the cracks in the coating had propagated to various degrees indicating that crack propagation through the coating occurred over a number of cycles. Crack propagation in the substrate was transdendritic and relatively straight. Figure 3.21a&b shows that there was some environmental interaction due to contamination of the argon atmosphere during the test.

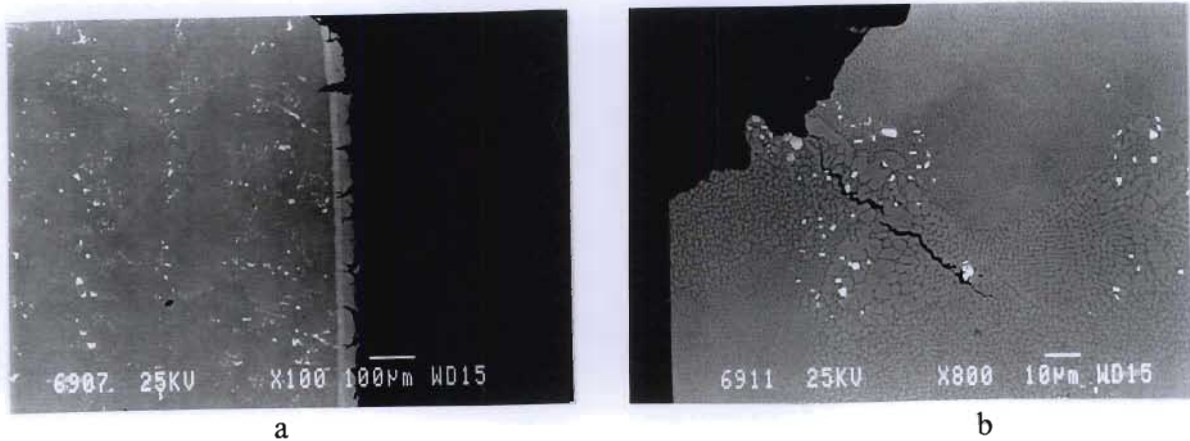
Figure 3.22 : Longitudinal cross-section after HTLCF in argon atmosphere

However, the cross-section of the fracture surface, figure 3.22, shows no environmental interaction. This indicates that for the major part of the test the environment was not contaminated. The secondary crack observed at the fracture surface interface also shows no evidence of environmental interaction. The secondary crack was parallel to the direction of loading and occurred in the interdendritic zone.

- a) Cracks in the coating with no evidence of environmental interaction
- b) Secondary cracking along the fracture surface showing no environmental interaction

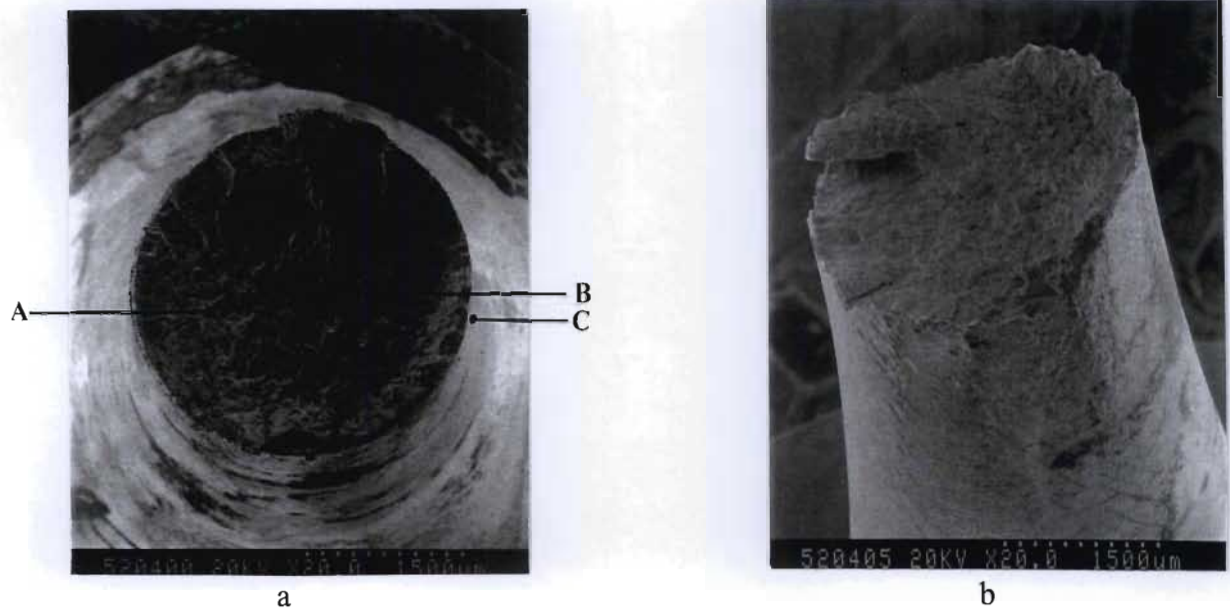
Figure 3.23 : Fractography of TYPE II platinum aluminide coated MAR-M002 after HTLCF in argon atmosphere

HTLCF of TYPE II platinum aluminide coated MAR-M002 in inert argon atmosphere produced a life of 1442 cycles. There was no evidence of any environmental interaction on the fracture surface (figure 3.23a). EDS analysis of the fracture surface, showed no significant change in the chemical composition when compared to the nominal composition of the alloy. Final failure of the fatigue sample, again occurred at a relatively high tensile load, indicating a brittle type of failure.

The external region close to the fracture, figures 3.23b & 3.24, revealed “eroding” of coating, i.e., regions where the Pt_2Al layer had delaminated. The cracking in general was random, forming a “network” of cracks. However, figure 3.24 shows a series of parallel cracks at approximately 45° to the loading direction over half the circumference while the cracks were circumferential over the other half. It must be noted that cracking of the coating, in general, occurred randomly in relation to the direction of loading. The most severe cracking was observed perpendicular to the loading direction and at the 45° angle to the loading direction.

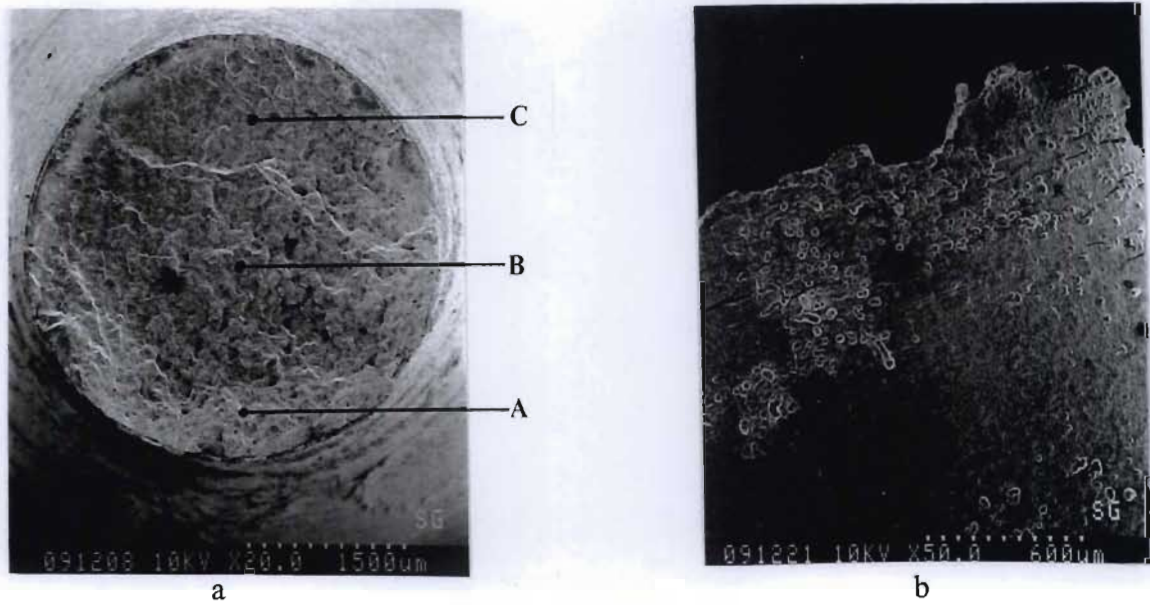
Figure 3.26 : a) Fracture surface of a platinum coated sample after HTLCF in argon atmosphere
b) Fractography showing the coating close to the fracture surface

HTLCF of platinum coated MAR-M002 in argon atmosphere resulted in a life of 1518 cycles. Fractography of the failed fatigue sample indicated a “clean” fracture surface. The absence of environmental interaction was manifested by the chemical analysis of the fracture surface (Figure 3.26a). Delamination/peeling of the coating from the substrate was evident

Fine, discontinuous circumferential cracks were observed on the coating (Figure 3.26b). The more severe cracks were most prominent in the region adjacent to the fracture surface. The “bubble” like features present on the coating, figure 3.26b, was a feature of the coating and not the due to environmental interaction.

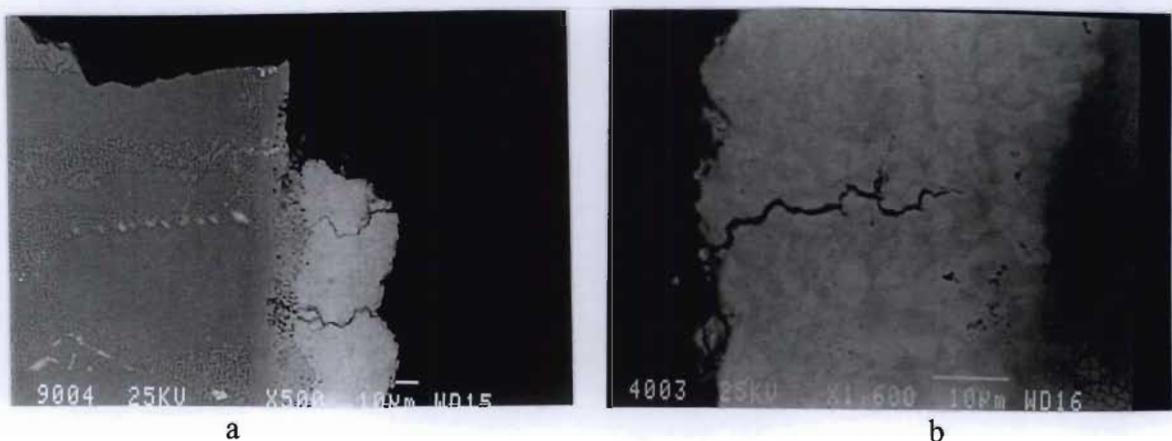
Cross-sectional analysis of the fatigue sample revealed two important features: i) the cracking of the coating layer and ii) porosity at the coating substrate interface (figure 3.27). The thickness of the coating had increased significantly, varying from $50\mu\text{m}$ to $60\mu\text{m}$ compared to approximately $17\mu\text{m}$ in the as received sample. The cross-section of the coating-fracture interface, figure 3.27, indicated that a piece of the coating had “peeled” off the substrate.

The coating layer consisted of two regions, namely, the “white” regions and “grey” regions. The crack propagation in the coating had occurred through the “grey” regions predominantly, indicating that the “white” regions were more resistant to cracking. Porosity had occurred in the regions where the crack had penetrated the coating (in the interdiffusion zone or γ' depleted zone). This factor was instrumental in the delamination of the coating during the fatigue test.

Figure 3.27 : Cross-sectional analysis of platinum coated MAR-M002 after HTLCF in argon atmosphere showing peeling of the coating and crack propagation through the coating.

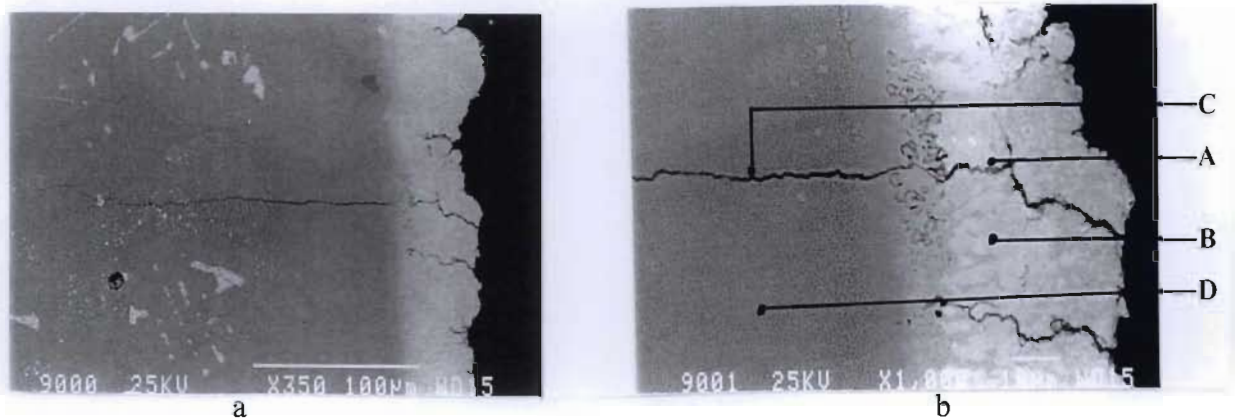
Figure 3.28 : EDS analysis of the crack through the coating of a platinum coated MAR-M002 fatigue sample after HTLCF in argon

Crack propagation in the substrate was relatively “straight” (figure 3.28) and the crack tip was relatively sharp showing no indication of environmental effects. Chemical analysis along the crack edge and the bulk material, figure 3.28, showed little variation in the chemical composition.

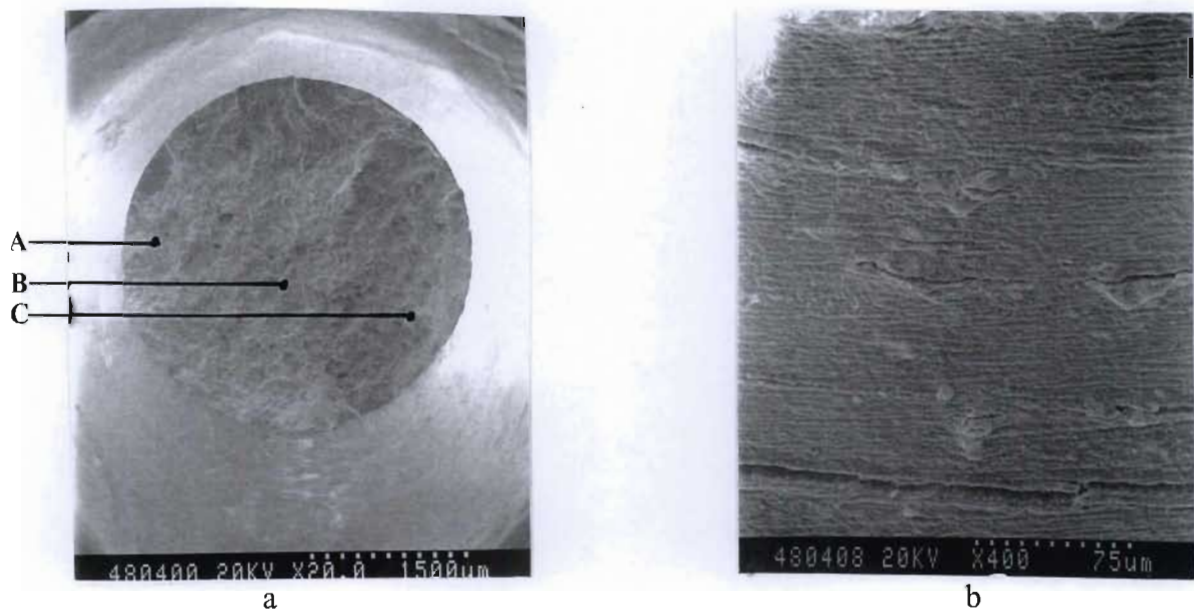
HTLCF tests performed on uncoated MAR-M002 in air atmosphere produced a life of 2412 cycles. The final failure occurred at a relatively high tensile load and in a very brittle manner. The fracture surface (figure 3.29) showed evidence of oxidation. Oxidation of the fracture surface was manifested by the high oxygen content detected (figure 3.29). Fine cracks were observed on the external surface close to the fracture (figure 3.29b). There was a build up of corrosion product around the lip of the cracks. The corrosion product was made up of mainly Cr, Ni, Al and oxygen.

Figure 3.29 : a) Fracture surface of uncoated MAR-M002 after HTLCF in air
 b) External surface close to the fracture showing cracks and oxidation of the cracks

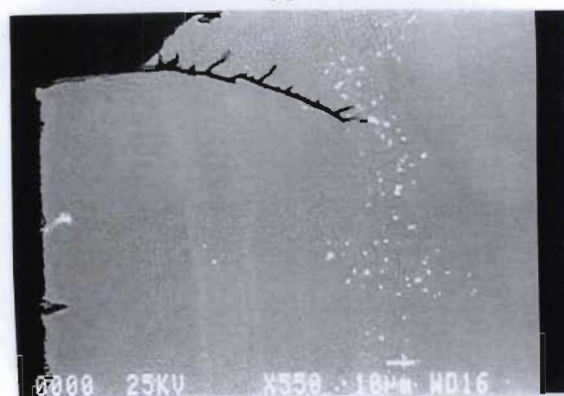
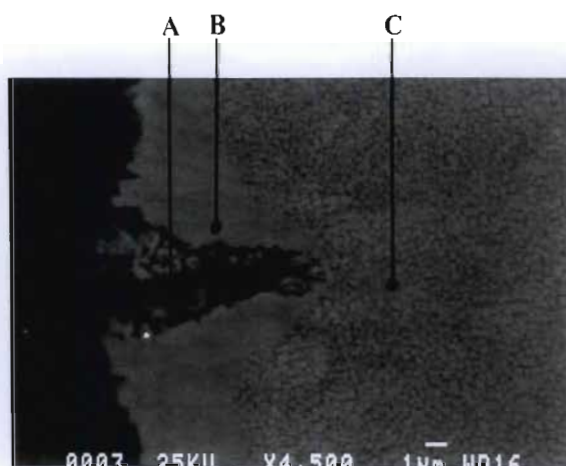
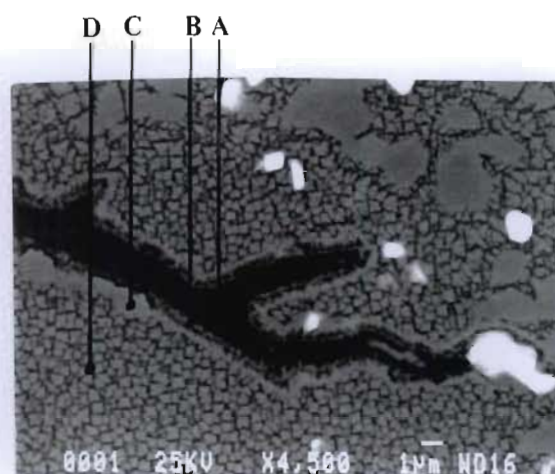
γ' depletion/coarsening was observed along the external surface exposed to the environment (figure 3.30) and along the fatigue crack edges. Several cracks had initiated on the surface of the fatigue sample but had not propagated further. It was evident from the cross-sectional analysis that crack propagation had occurred preferentially along the interdendritic segregation zone. This indicated that the dendritic grain was more resistant to fatigue crack initiation and propagation under oxidation conditions. Chemical analysis of the corrosion product filling these cracks (figure 3.30b) showed that it was made up of mainly Cr, Ni, and oxygen with small amounts of Al, Ti, Co and Ta. The γ' denuded region was depleted of the reactive elements (in particular aluminium). The secondary crack shown in figure 3.30a was branched and the crack tip was relatively "blunt". There was evidence of environmental interaction along the crack edges and the presence of corrosion product within the crack.

Analysis of the crack tip (figure 3.30c) revealed that the corrosion product at the crack tip was made up primarily of nickel oxides. The "porous" region adjacent to the crack exhibited a high oxygen and Ni content with significant amounts of the alloying elements. This layer was produced due to internal oxidation of the crack edge. The γ' denuded region showed a reduction in Al, Cr and Ti content when compared to the base material indicating that these elements were consumed in the oxidation reaction.

Figure 3.30 : a) Cross-section of uncoated MAR-M002 after HTLCF in air.
 b) High magnification of crack on the external surface with EDS
 c) Chemical analysis of the corrosion product at the crack tip

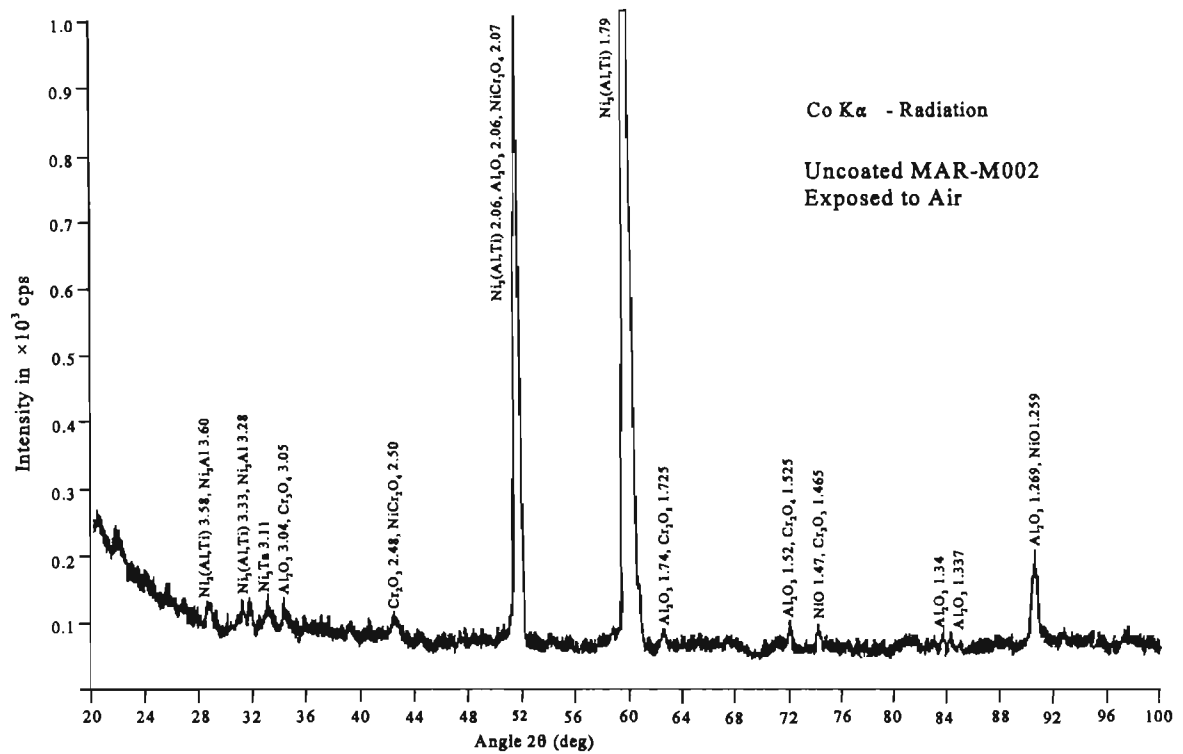
Figure 3.31 : X-ray diffraction analysis of an uncoated disc sample exposed to air environment at 870° for 5 hours

X-ray diffraction analysis of an uncoated MAR-M002 disc sample exposed to air at 870°C for five hours (figure 3.31) revealed the following oxide phases produced as result of the oxidation process: Cr_2O_3 , Al_2O_3 and NiO . The corrosion tests were performed on unstressed samples, hence, the results obtained only give an indication of the type of oxide phases that will be present. It was evident from the XRD analysis that the oxides of Al and Cr are most prominent. The EDS analysis at the crack tip indicates that the corrosion product was made up of mainly nickel oxides. This was due to the combination of oxidation and the fatigue loading.

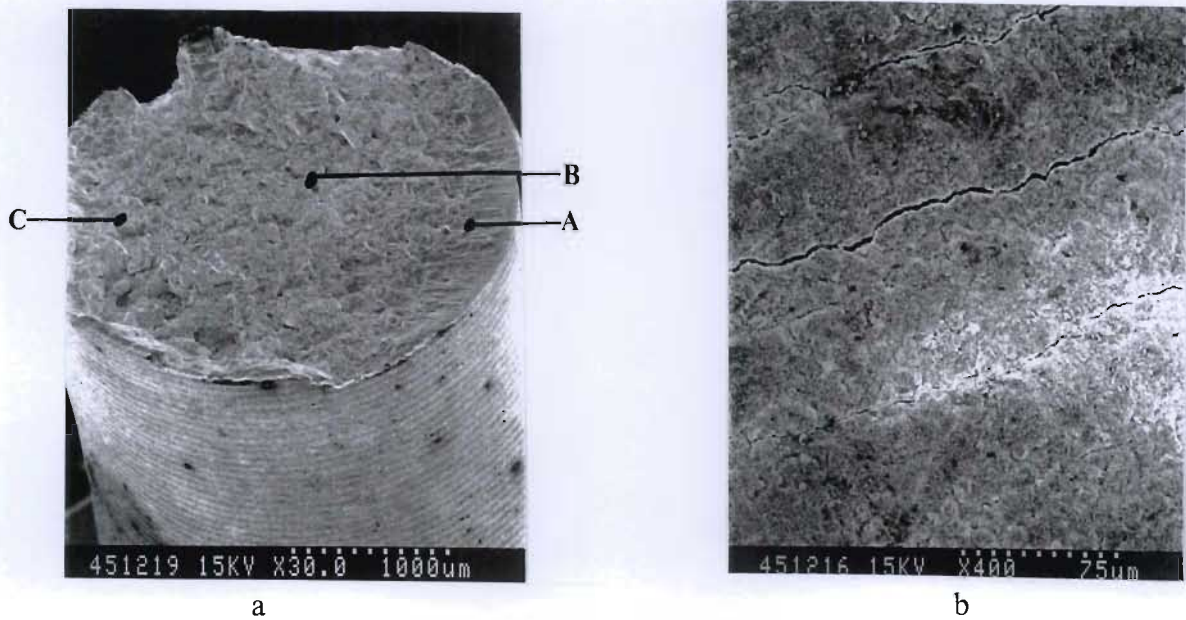
Aluminide coated MAR-M002 fatigue samples exposed to creep-fatigue loading in air at 870° produced a life of 826 cycles. The final failure occurred at a fairly high tensile load and occurred in a brittle manner. The fracture surface showed clear evidence of environmental interaction (figure 3.32a). EDS analysis revealed a high oxygen and Ni content indicating the presence of mainly Ni oxides. The chemical analysis was very similar to that of the uncoated samples.

The external surface close to the fracture showed that the coating had a rippled effect due to the sample not being polished after the machining process. This, however, did not affect the fatigue life significantly. "Fine" circumferential cracks were observed in the coating (figure 3.32b). The cracks in the coating were perpendicular to the direction of loading.

Figure 3.32 : a) Fracture surface of aluminide coated MAR-M002 after HTLCF in air atmosphere at 870°C
 b) Cracking of the aluminide coating close to the fracture surface

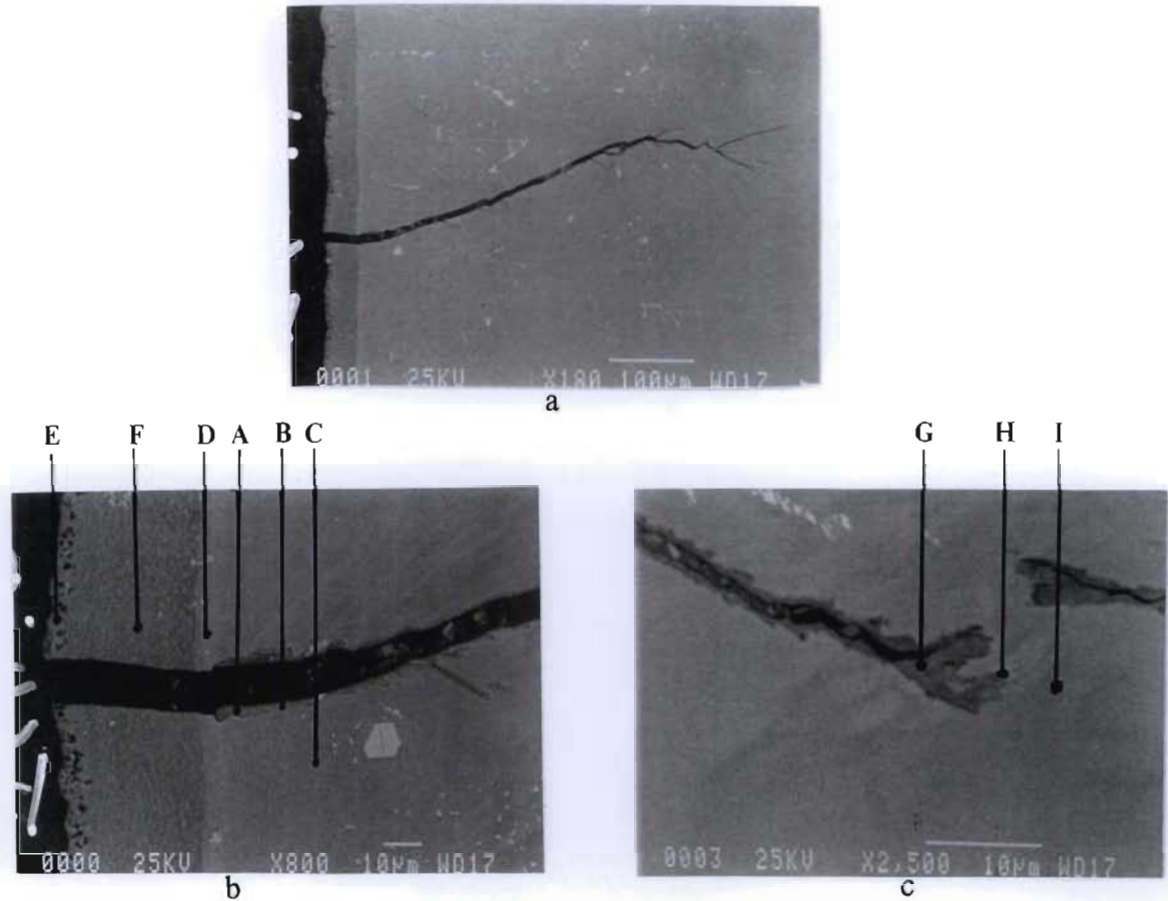
Figure 3.33 shows a crack that has propagated through the coating and into the substrate. It was evident that the coating failed in brittle manner (figure 3.33) very early in the fatigue test. The coating showed no evidence of oxidation in the crack, indicating a high resistance to oxidation. The substrate, however, showed a higher susceptibility to oxidation. Crack propagation through the substrate was transdendritic and branched. High magnification of the crack tip shows a relatively "blunt" crack tip with corrosion product filling the crack (figure 3.33). The corrosion product in the crack was made up of mainly Ni oxides.

Chemical analysis of the corrosion product in the crack close to the coating indicated relatively high Al, Cr, Co and Ni content, figure 3.33b. The external surface of the coating exposed to the environment was depleted of Al due to the formation of Al_2O_3 scales on the external surface.

Figure 3.33: a) Longitudinal section of aluminide coated MAR-M002 after HTLCF in air.
 b) High magnification of the crack in the coating with EDS analysis of the corrosion product.
 c) Chemical analysis of the crack tip.

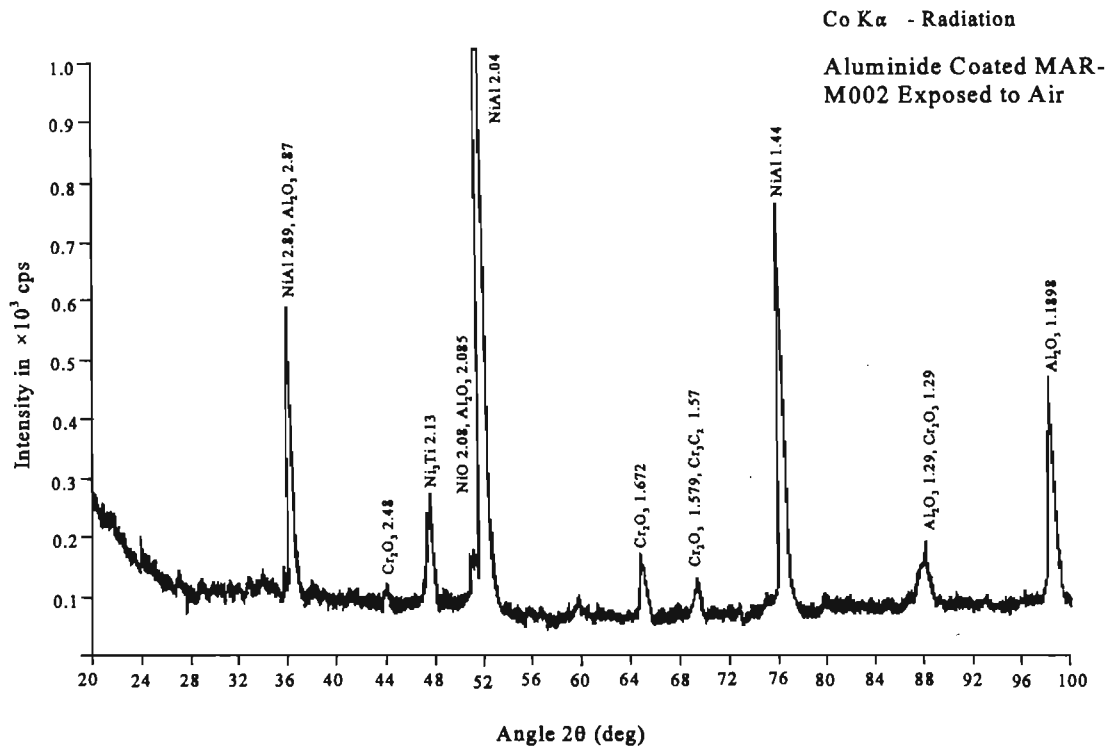
Figure 3.34 : X-ray diffraction analysis of an aluminide coated disc sample exposed to air at 870°C for 5 hours

X-ray diffraction analysis of an aluminide coated disc sample exposed to air at 870°C for five hours is shown in figure 3.34. There was a significant increase in the amount of Al_2O_3 and Cr_2O_3 phases detected. These are the principal oxide phases formed on the external surface of the coating. This result will only represent the corrosion products that are formed due to

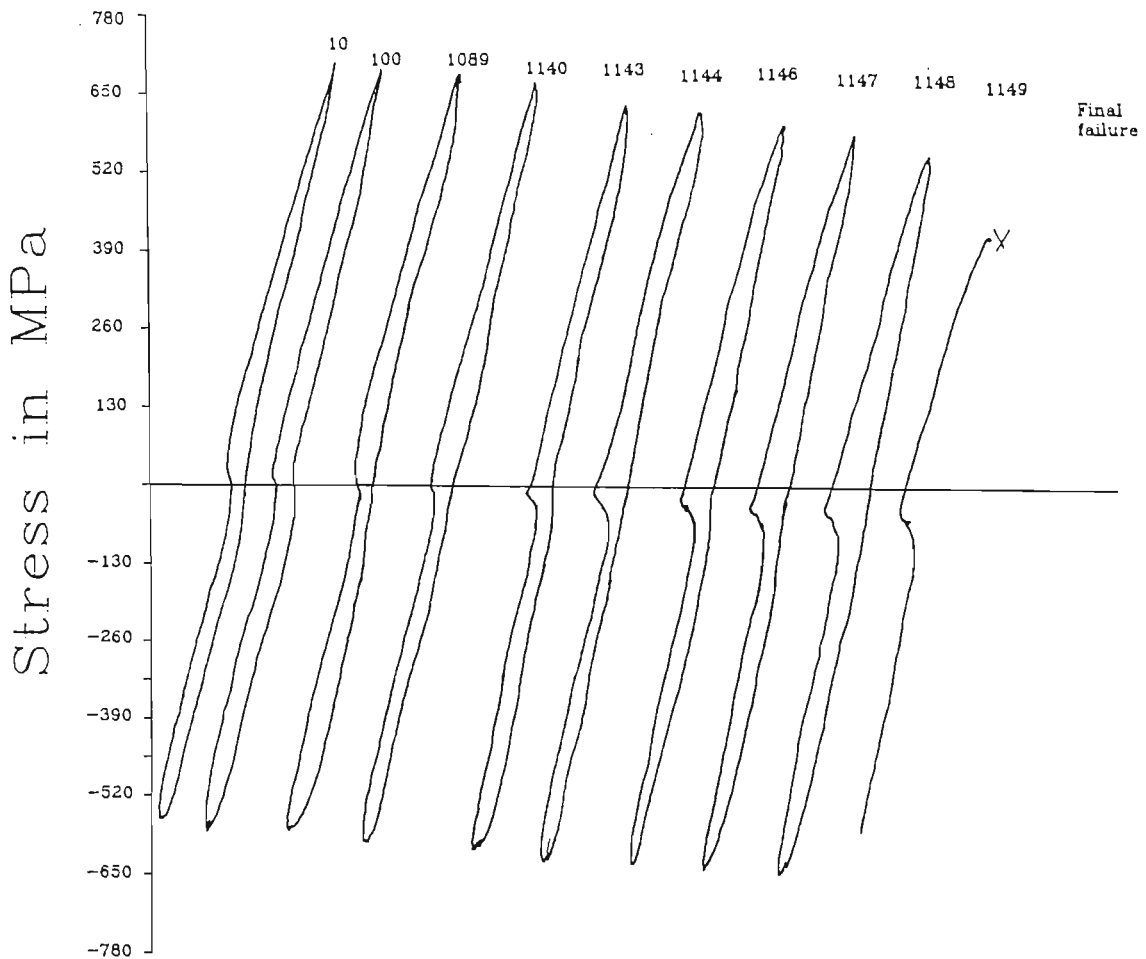
Figure 3.35 : Stress-strain hysteresis loops for TYPE I platinum aluminide coated MAR-M002 after HTLCF in air

The hysteresis loops produced for a TYPE I platinum aluminide coated sample exposed to HTLCF in air (figure 3.35) revealed that the final failure occurred at a relatively high tensile load. The number of cycles to failure was 1149 cycles. The fracture surface, figure 3.36, showed evidence of oxidation. EDS analysis of the fracture surface revealed a relatively high oxygen content. The corrosion product was made up of mainly Ni oxides. AES analysis of the fracture surface (figure 3.37) showed a relatively high oxygen content confirming the EDS analysis. The oxide composition again indicated that it was made up of mainly nickel oxides in some areas and a mixture of oxides in other areas. Fine circumferential cracks in the coating was observed close to the fracture surface (figure 3.38). In most instances they

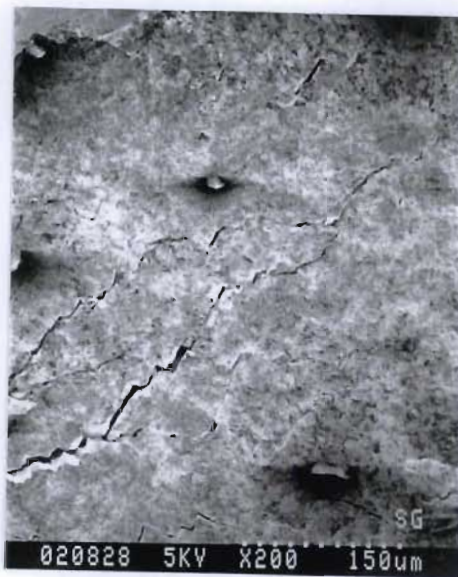
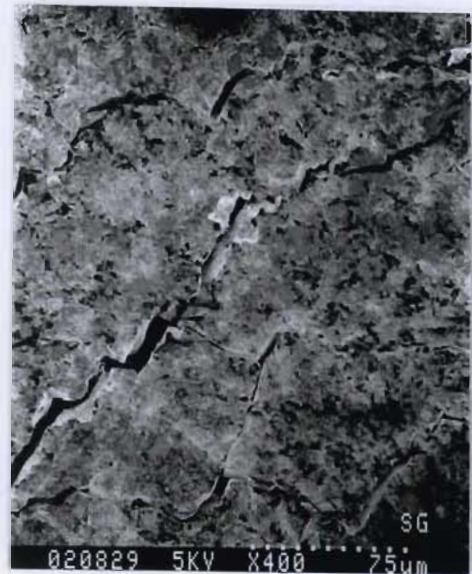
were neither parallel nor perpendicular to the loading direction. High magnification of the cracks showed that the cracks were branched with the major cracks occurring perpendicular to the loading direction.

Figure 3.38 : Brittle cracking of the TYPE I platinum aluminide coating close to the fracture surface due to the HTLCF loading in air atmosphere

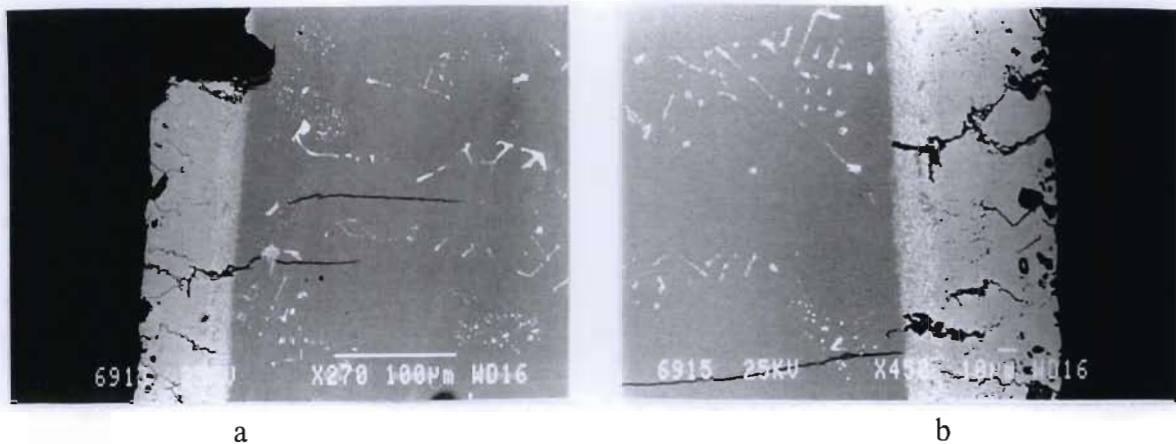
Cross-sectional examination revealed severe cracking of the coating (figure 3.39). A significant feature was that the cracks in the coating were branched and did not follow a “straight” path through the coating. This was also observed in the fatigue tests performed in argon which indicated that this was due to the mechanical properties of the coating. A number of the cracks had stopped at the coating substrate interface (interdiffusion zone) indicating that the substrate was more resistant to crack propagation. The presence of Cr rich and alumina particles interfered with the crack propagation through the coating (figure 3.39 and 3.40).

Figure 3.39 : Cross-sectional analysis of TYPE I platinum aluminide coated MAR-M002 after HTLCF in air atmosphere showing cracking of the coating.

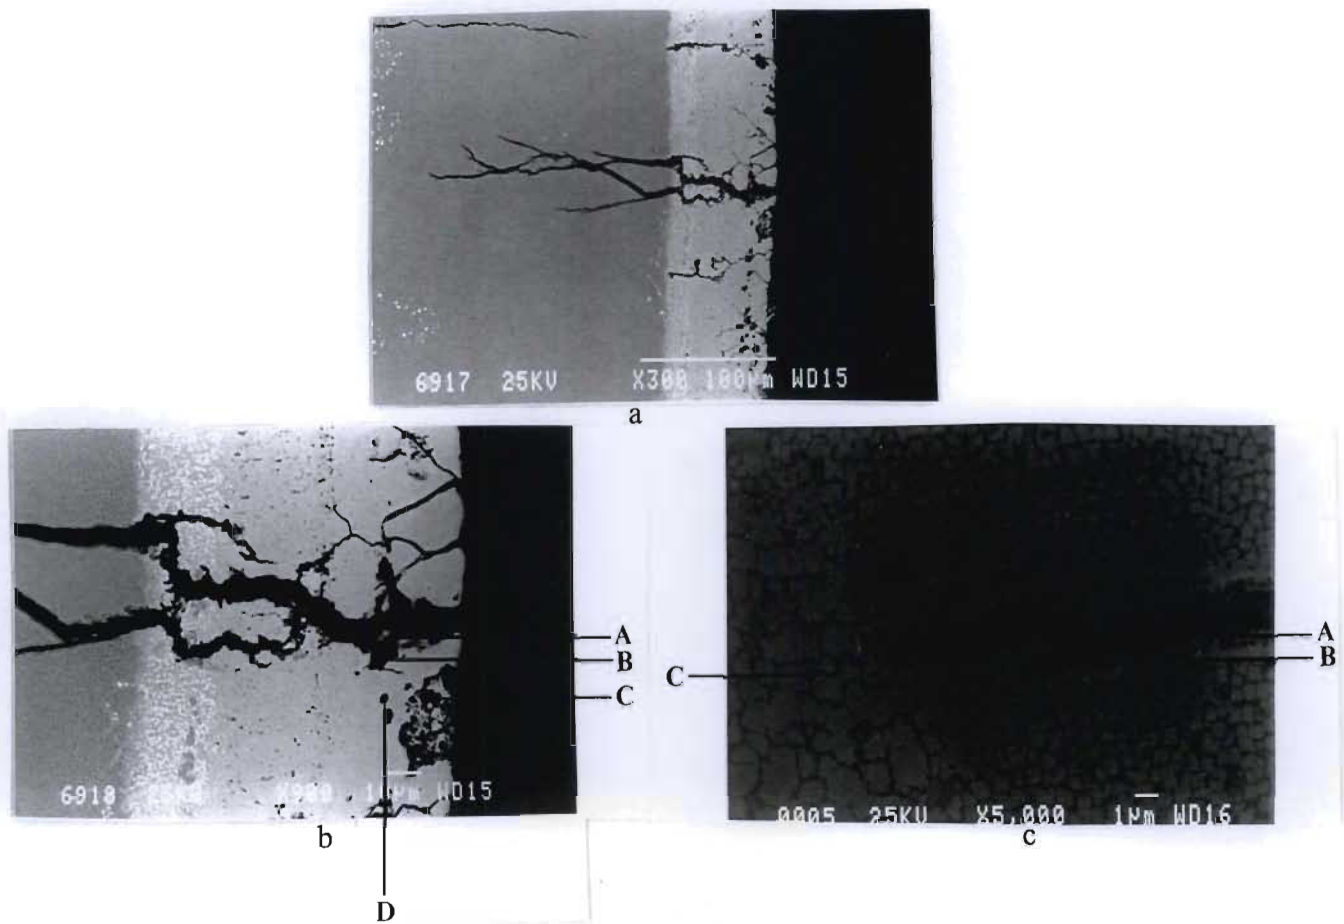
Figure 3.40 : Analysis of the a crack in a TYPE I platinum aluminide coated MAR-M002 fatigue sample after HTLCF in air.

Chemical analysis in the crack, adjacent to the crack and away from the crack in the coating (figure 3.40) showed that there was no severe environmental interaction. Crack propagation through the substrate was the characteristic branched cracking observed for fatigue tests performed in air. A high magnification of the crack tip shows evidence of oxidation of the substrate (figure 3.40). The corrosion product in the crack was made up of Ni, Cr, Co, W, Al, Ta and oxygen with Ni and Cr making up the major constituents.

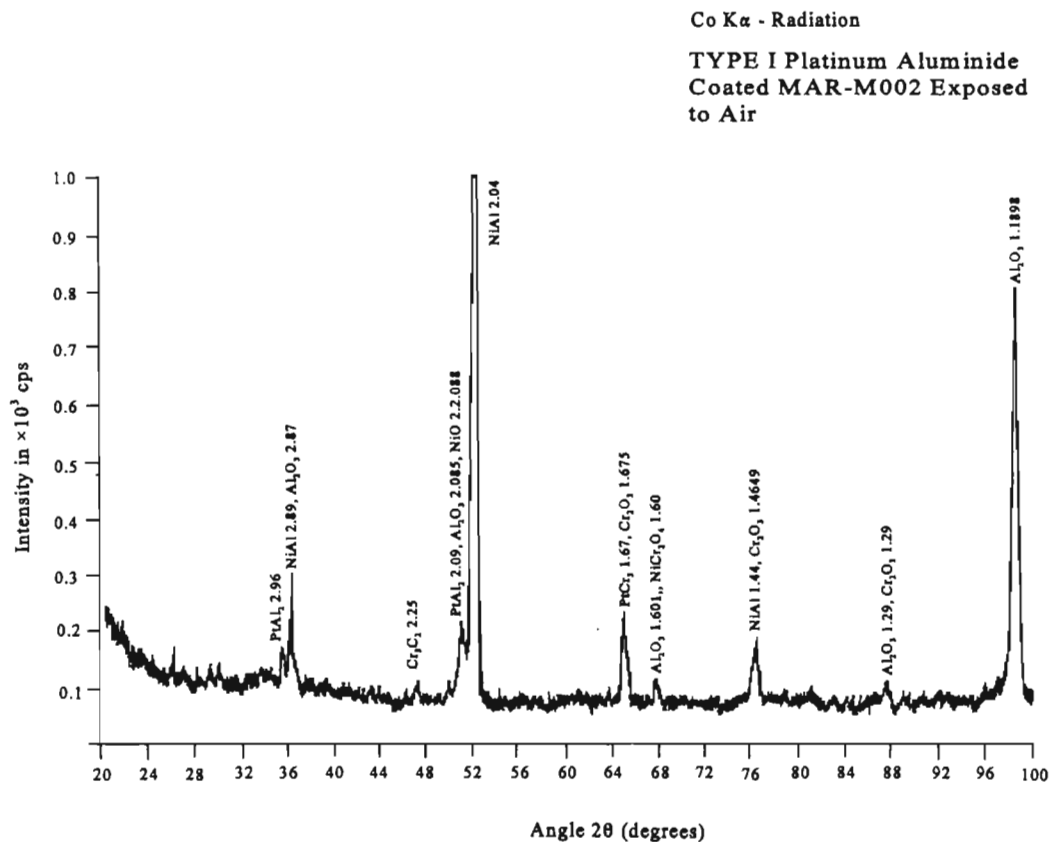
Figure 3.41 : X-ray diffraction of TYPE I platinum aluminide coated MAR-M002 exposed to air at 870°C for 5 hours

X-ray diffraction analysis of an unloaded disc sample exposed to air at 870°C for 5 hours revealed that the coating was resistant to oxidation (figure 3.41). Stable Al_2O_3 and Cr_2O_3 were present in significant quantities which provides effective protection against oxidation. This analysis gives the typical oxide phases that would form on the coating after exposure to oxygen at high temperature. The corrosion product formed on the fracture surface and at the crack tip was more accurately represented by the corrosion test performed on the uncoated alloy.

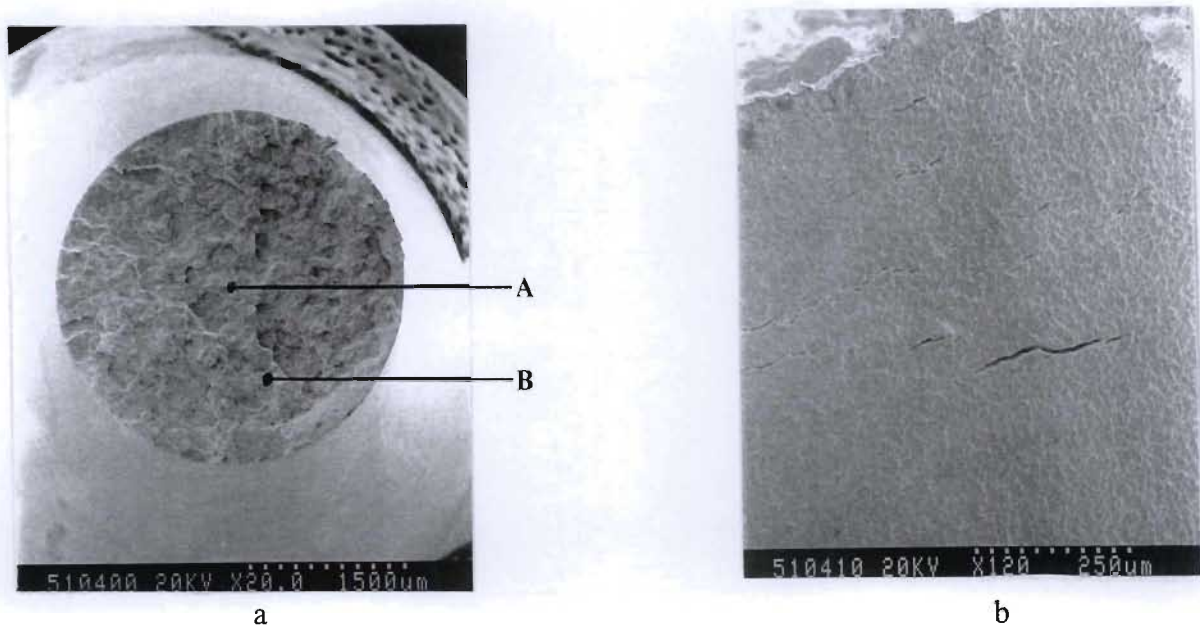
Figure 3.42 : Fractography of platinum coated MAR-M002 after HTLCF in air

Platinum coated MAR-M002 exposed to HTLCF and air atmosphere at 870°C failed after 1238 cycles. The fracture surface (figure 3.42) showed evidence of oxidation. As in all the fatigue tests performed in air, the evidence obtained from the EDS analysis indicates that the corrosion product on the fracture surface was made up of principally nickel and oxygen, with smaller amounts of aluminium and chromium. AES analysis of the fracture surface indicated that corrosion product was made up of mainly nickel and oxygen (figure 3.43). There was evidence of internal oxidation and a slight reduction in the aluminium content just below the fracture surface (figure 3.43).

The external surface close to the fracture (figure 3.42b) revealed fine cracks in the coating. The cracks were composed of mainly circumferential cracks, perpendicular to the direction of loading. Figure 3.44&45 shows cross-sectional images of platinum coated MAR-M002

- a) Fracture Surface
- b) Cracking of the coating close to the fracture.
