**The Influence of Sulphidizing Attack on the
Mechanism of Failure of Coated Superalloy Under
Cyclic Loading Conditions**

**Submitted in fulfilment of the academic requirements for the degree of
PHD in Mechanical Engineering in the Department of Mechanical
Engineering, University of Natal, Durban.**

January 1998

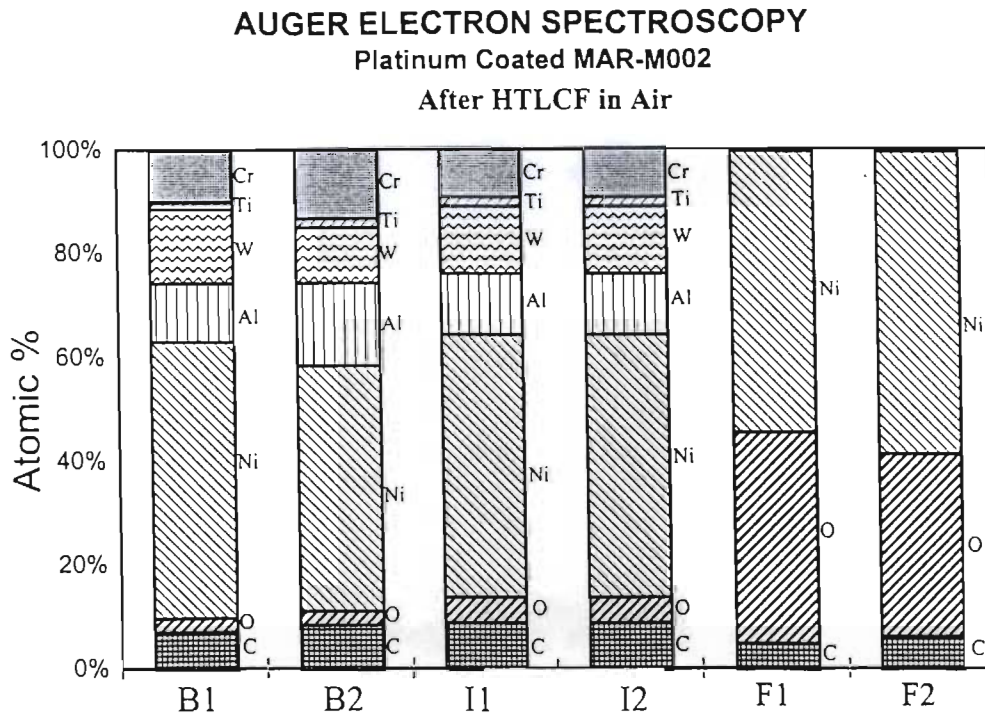
Figure 3.43 : AES analysis of the fracture surface of platinum coated MAR-M002 after HTLCF in air at 870°C

Platinum coated MAR-M002 exposed to HTLCF and air atmosphere at 870°C failed after 1238 cycles. The fracture surface (figure 3.42) showed evidence of oxidation. As in all the fatigue tests performed in air, the evidence obtained from the EDS analysis indicates that the corrosion product on the fracture surface was made up of principally nickel and oxygen, with smaller amounts of aluminium and chromium. AES analysis of the fracture surface indicated that corrosion product was made up of mainly nickel and oxygen (figure 3.43). There was evidence of internal oxidation and a slight reduction in the aluminium content just below the fracture surface (figure 3.43).

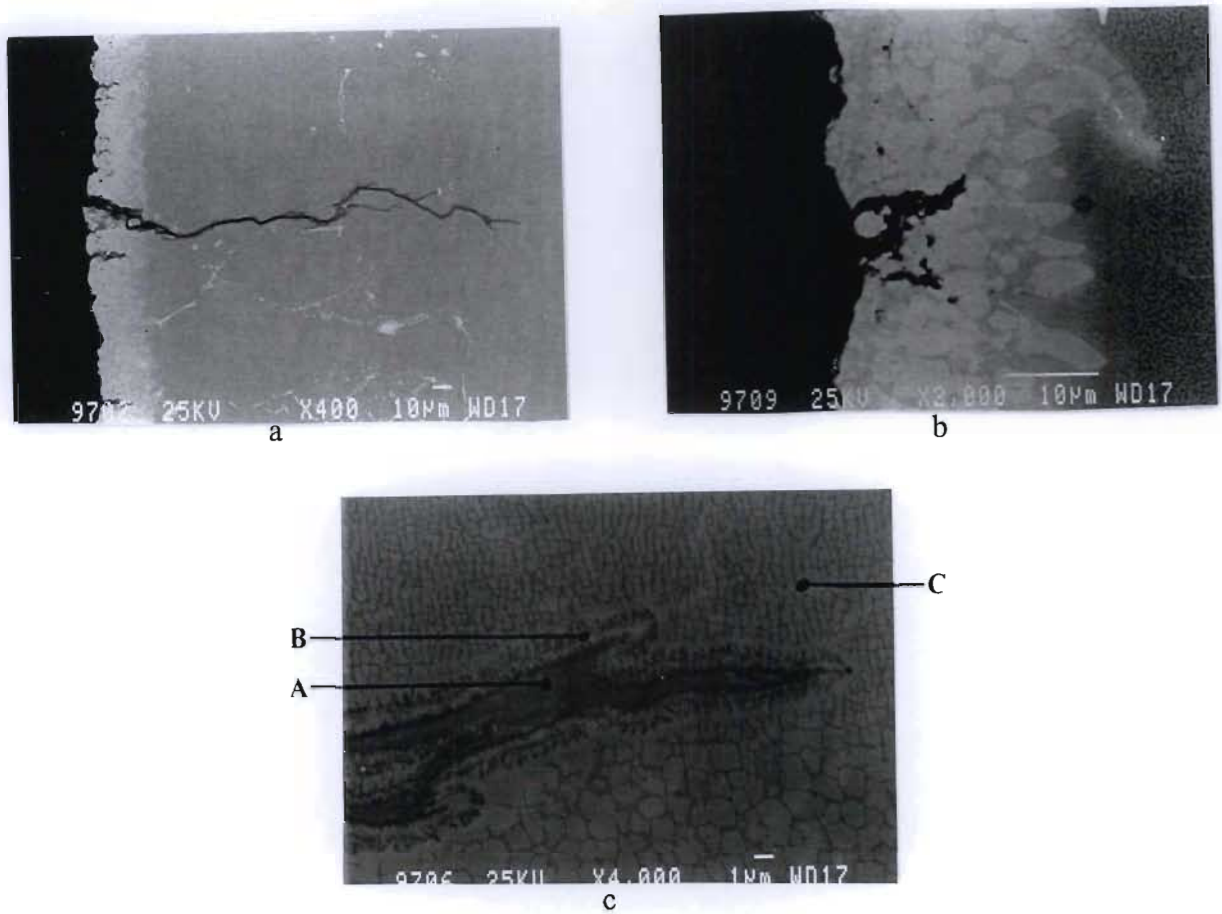
Figure 3.44 : a) Fatigue crack propagation in platinum coated MAR-M002 after HTLCF in air
 b) Fatigue crack propagation in the coating
 c) High magnification of the crack tip in the substrate

after HTLCF in air. There was evidence of a number of cracks that had initiated on the coating surface but which have not propagated all the way through the coating layer. Cracks in the coating showed a preference to propagate in the grey regions (figure 3.44b). The thickness of the coating had increased from 15 μ m to 30 μ m during the test due to the interdiffusion of platinum and alloying elements. The propagation of the fatigue crack through the substrate was branched and transdendritic. The crack tip, figure 3.44c, was “blunt” due the oxidation attack ahead of the propagating crack tip.

substrate was made up of a mixture of alloying elements and oxygen. The corrosion product in the crack tip was made up of essentially Ni, Cr and oxygen (figure 3.44). The region adjacent to the crack edge showed evidence of internal oxidation. Small amounts of oxygen were detected in this region with a slight increase in the aluminium content when compared to the base material.

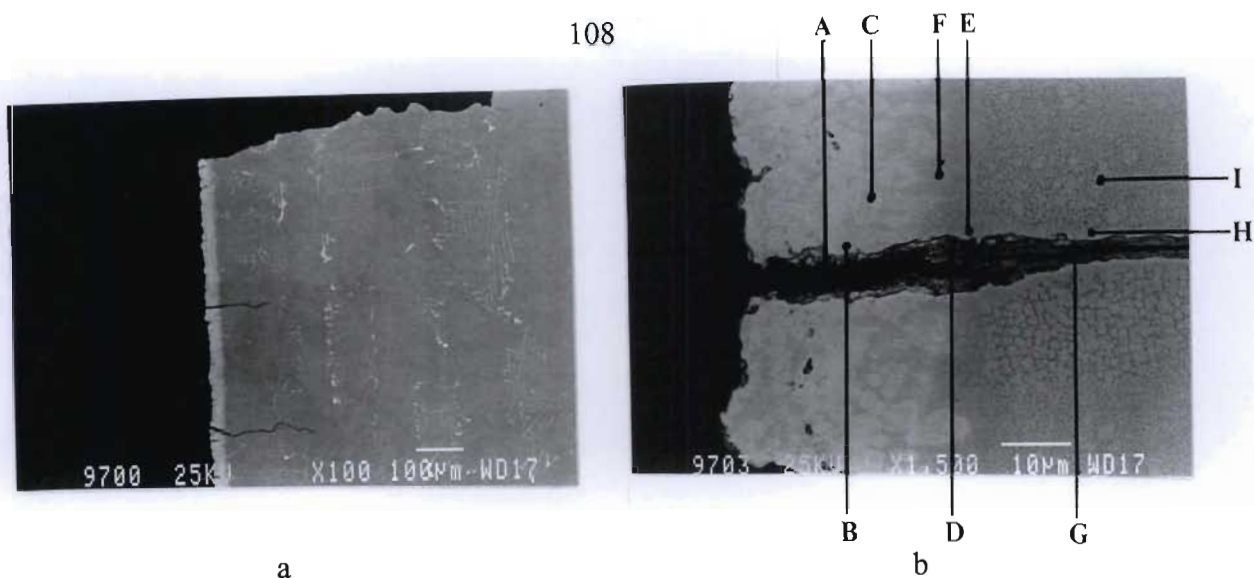
Figure 3.45 : Chemical analysis of the crack through the platinum coating after HTLCF in air

High magnification of the fatigue crack in the coating (figure 3.45) gave an indication of the oxidation resistance of the different regions: i) the coating was most resistant; ii) the γ' depleted zone was least resistant; and iii) the substrate was more resistant than the γ' depleted zone but less resistant than the coating layer. The corrosion product in the coating layer was made up of mainly Ni, Co, Cr, Pt and oxygen. This result indicated that the

electron beam spot size was too large and part of the coating was incorporated in the analysis. The analysis of the region adjacent to the crack edge and away from the crack for the white regions in the coating, did not show a significant variation in the composition, however, in the grey regions there was significant decrease in the Cr and Al content along the crack edge. The corrosion product in the γ' depleted zone was made up of mainly Ni, Co, and oxygen with small amounts of Cr and Al. The corrosion product of the crack in the

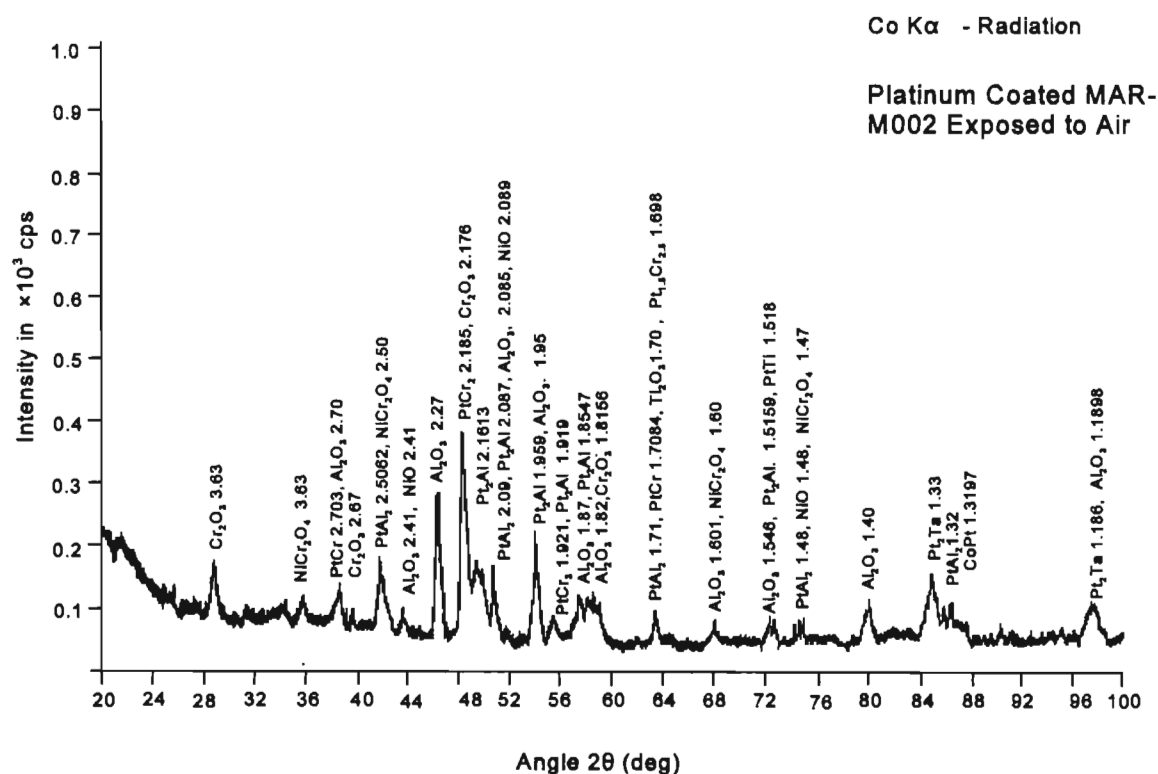
Figure 3.46 : X-ray diffraction of a platinum coated disc sample after exposure to air at 870°C for 5 hours

X-ray diffraction analysis of a platinum coated disc sample exposed to air at 870°C for five hours shows the typical oxides formed on the platinum coating (figure 3.46). Typical oxides formed are Cr_2O_3 , Al_2O_3 , Ti_2O_3 , NiO and NiCr_2O_4 . The oxides formed at the propagating crack tip in the substrate must be characterized using the results obtained for the uncoated disc samples.

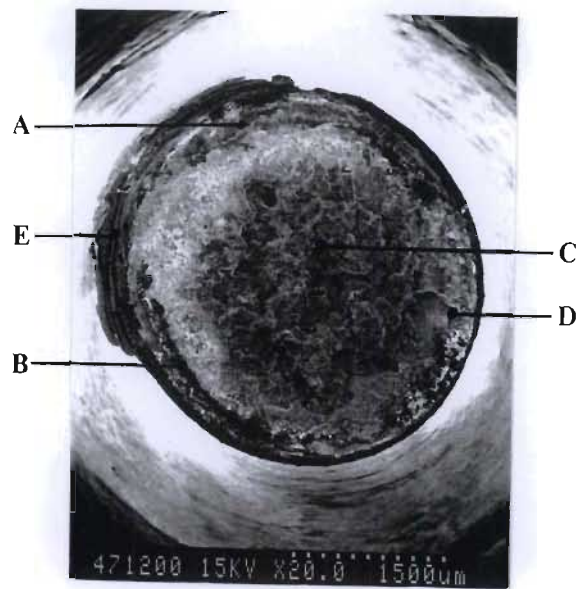
Figure 3.47 : Fracture surface of uncoated MAR-M002 after HTLCF in Ar + 5%SO₂ at a strain range of 0.66%

Uncoated MAR-M002 failed after 335 cycles due to the combination of HTLCF and Ar + 5%SO₂ environment at 870°C. Sulphidation attack of the fracture surface was very evident (figure 3.47). The fatigue crack had initiated around the circumference and propagated perpendicular to the loading direction. Final failure had occurred at the centre of the sample; showing a very brittle final failure. EDS analysis of the fracture surface showed that the corrosion product was composed of mainly Ni, Cr, oxygen and sulphur.

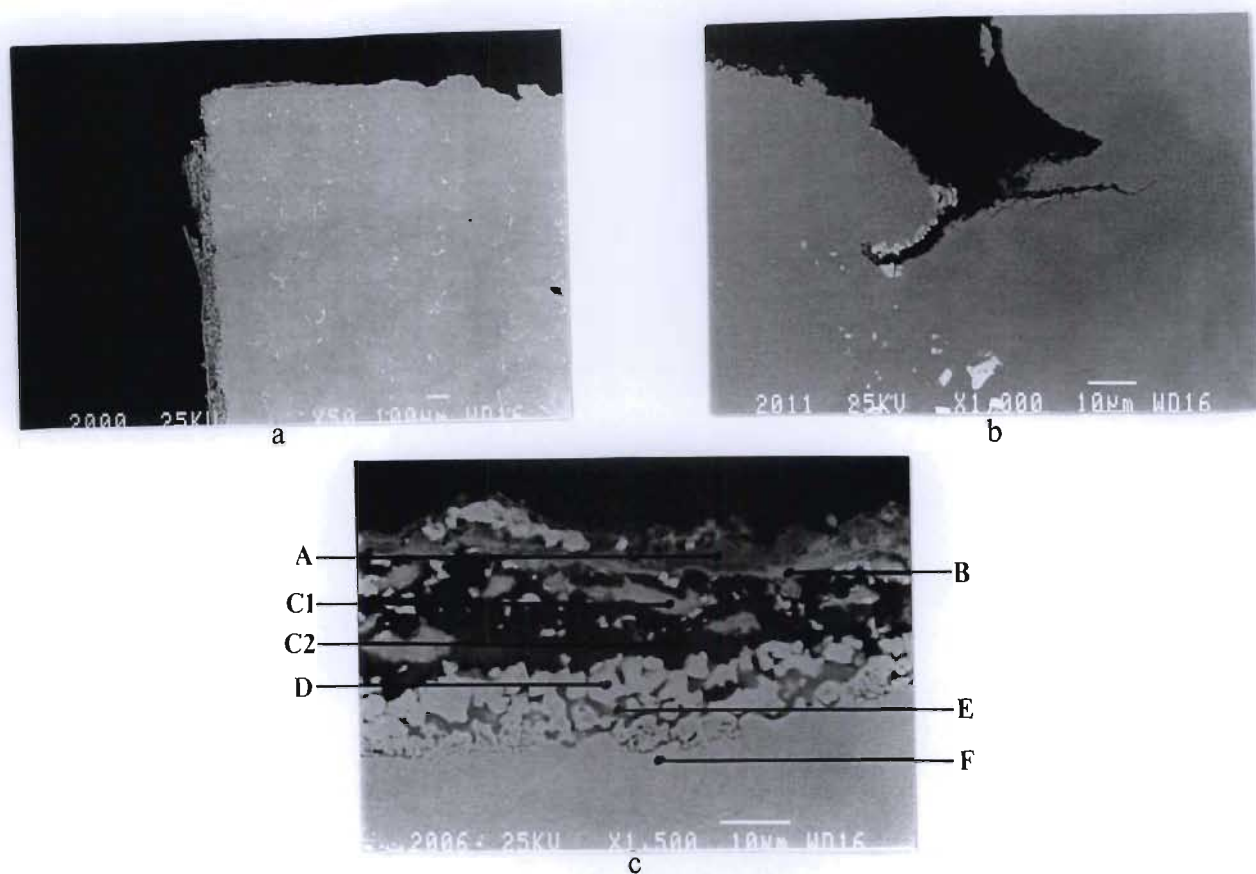
Cross-sectional examination of the fatigue sample after HTLCF in Ar + 5%SO₂ showed severe sulphidation attack of the fracture surface and the external surface (figure 3.49a). The corrosion product had spalled off in regions. Beneath the corrosion product was a "porous" region showing internal sulphidation of the substrate. The corrosion product on the fracture surface and external surface was found to consist of three distinctive layers (figures 3.49 & 3.50): black inner layer, light grey intermediate layer and dark grey outer layer. The chemical composition of the dark grey outer layer showed that it was made up mainly of Cr, Ni, S, and oxygen. This indicated that it was composed of a mixture of sulphides and oxides of Cr and Ni. The intermediate light grey layer was more complex with Ta, Ti and oxygen being the dominant elements with small amounts of Cr, Ni and sulphur compared to the dark grey layer.

The “black” layer was made up of mainly Al, Ni, S and oxygen. This region consisted of predominantly aluminium oxides and relatively small amounts of sulphides. It was also significant that this layer formed at the corrosion scale-substrate interface.

Chemical analysis of the “porous” γ' depleted region showed a significantly lower aluminium and chromium content compared to the base alloy. The dark corrosion product found in the “pores” in this region was composed of Ni, Cr, Co, Al and S with Ni and S making up the major constituents.

Figure 3.49 : a) Cross-sectional analysis of uncoated MAR-M002 after HTLCF in SO_2 containing environment
 b) Secondary cracking on the fracture surface
 c) Chemical analysis of the corrosion product on the fracture surface

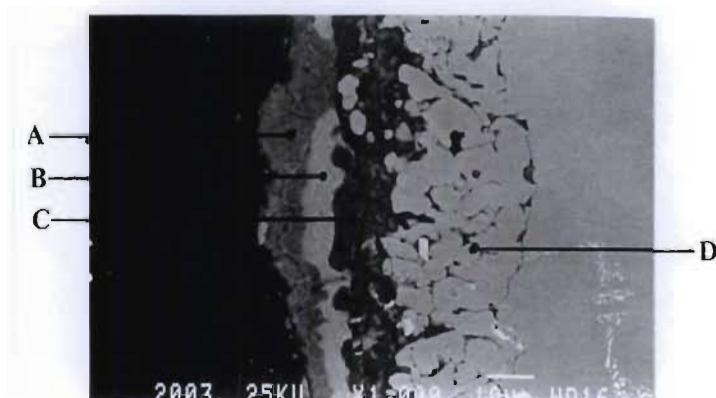
Figure 3.50 : Morphology of the corrosion product on the external surface of and uncoated fatigue sample after HTLCF in Ar + 5% SO₂

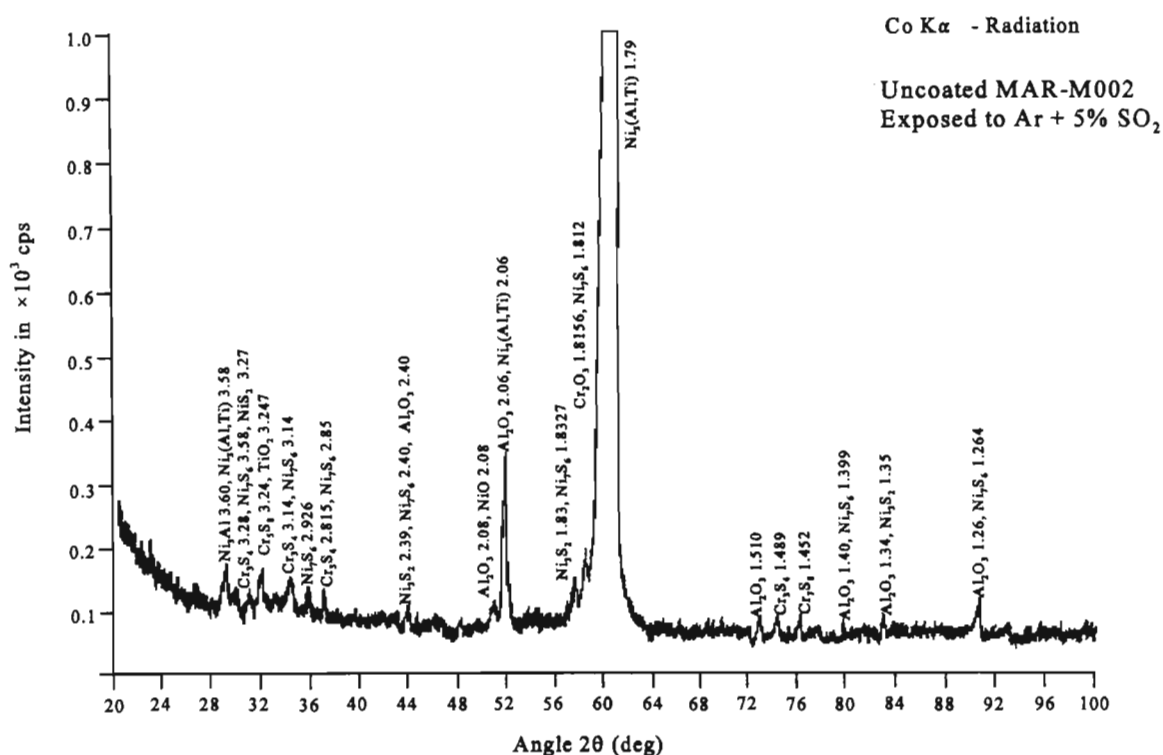
Figure 3.51 : X-ray diffraction of uncoated MAR-M002 exposed to Ar + 5%SO₂ at 870°C for 5 hours

X-ray diffraction analysis of an uncoated disc sample after exposure to Ar + 5%SO₂ at 870°C showed that the typical phases present in the corrosion product as a result of the sulphidation attack were Ni₇S₆, Cr₅S₈, TiO₂, Cr₃S₄, CrS, Al₂O₃, Cr₂O₃, Ni₃S₂ and NiO (figure 3.51). A significant feature of the corrosion product was that it was a combination of oxides and sulphides.

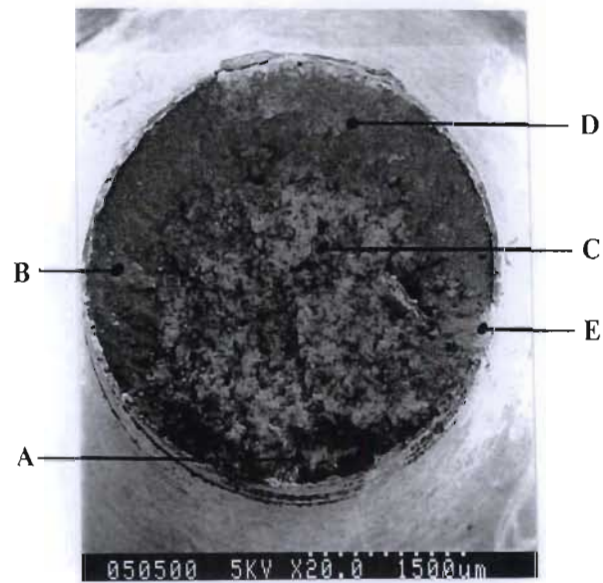
The aluminide coated MAR-M002 fatigue sample exposed to HTLCF and Ar + 5%SO₂ environment experienced an accelerated failure due to the highly corrosive SO₂ containing environment. The number of cycles to failure was 161. Sulphidation attack was manifested by dark sulphide and oxide phases on the fracture surface (figure 3.52). The corrosion product on the fracture surface was made up of principally Ni, Cr, S and oxygen (figure 3.52). This was similar to the chemical analysis of the corrosion product on the fracture surface of the uncoated sample. Analysis of the corrosion product close to the edge of the fracture surface revealed a higher nickel and aluminium content with significant amounts of oxygen and sulphur also present. AES analysis confirmed the presence of oxides in the corrosion product (figure 3.53) and showed that it consisted of a mixture of oxides and sulphides. The prominent substrate alloying elements present were Cr, Hf, Al and Ni.

Figure 3.52 : Fractography of aluminate coated MAR-M002 after HTLCF in Ar + 5%SO₂ environment at a strain range of 0.66%

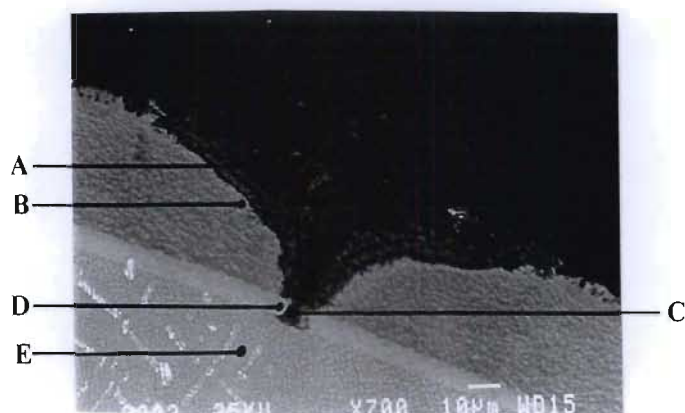
The corrosion product in the crack was composed of two regions, namely, a dark region down the centre of the crack and a region which was a mixture of dark and light phases along the crack edge (figure 3.56). The dark region down the centre was composed of mainly Al, Ni, oxygen and sulphur. From the quantitative analysis of this region it can be seen that it was made up mainly of aluminium oxides with smaller amounts of sulphides. The "mixed" region showed a significantly higher sulphur and tungsten content. The higher sulphur content clearly indicates the presence of a higher quantity of sulphide phases in this region. The region adjacent to the corrosion product/coating interface shows a slight depletion of aluminium when compared to the normal composition of the coating. Analysis of the crack tip showed that the corrosion product was essentially Al, Ni, oxygen and sulphur. The region adjacent to the crack tip in the interdiffusion zone revealed a depletion of aluminium and tungsten as a result of the corrosion process.

Figure 3.56 : Chemical analysis of the crack in aluminide coated MAR-M002 after HTLCF in SO₂ containing environment (S.R. 0.66%)

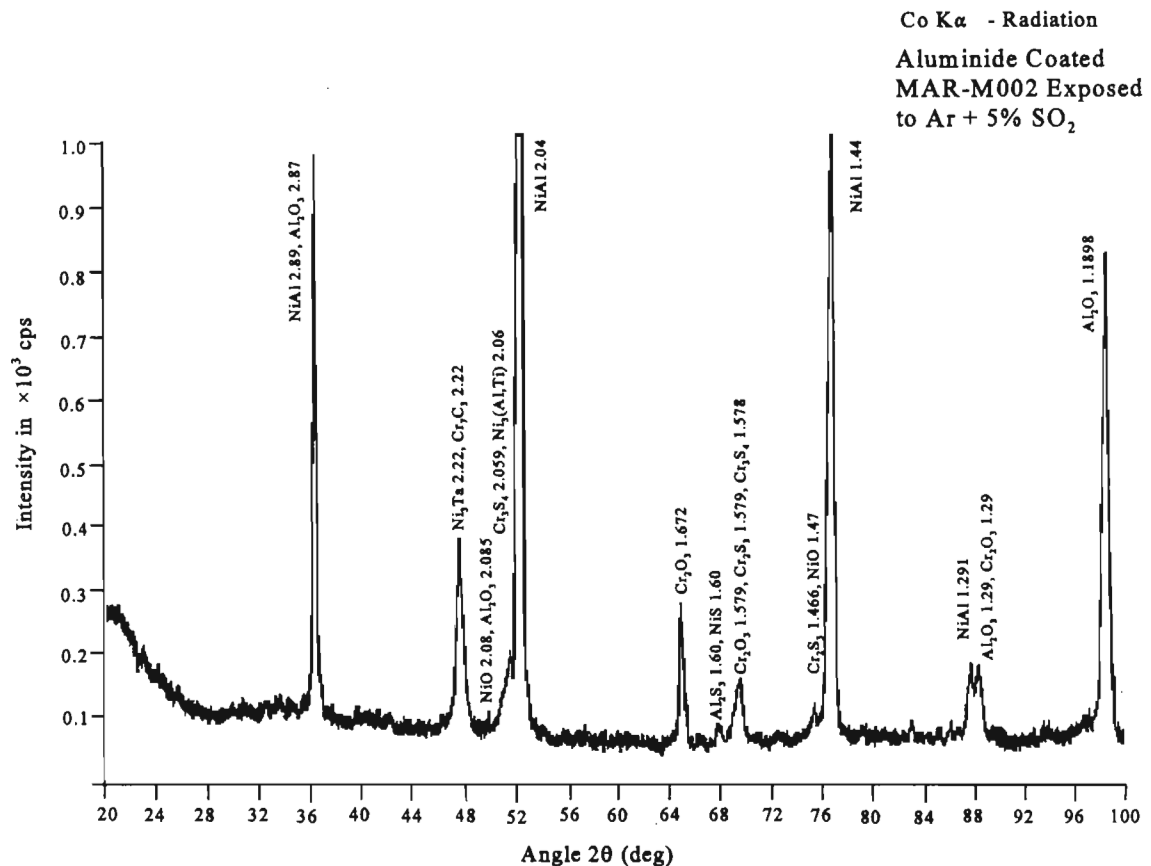
Figure 3.57 : X-ray diffraction analysis of aluminide coated MAR-M002 after exposure to Ar + 5%SO₂ for 5 hours at 870°C

Al₂O₃, NiO, Cr₃S₄, Ni₃S₂, Ni₇S₆, Cr₃S₈, Cr₃S₇, NiS and CrS were some of the typical sulphide and oxide phases detected on an aluminide coated disc sample exposed to Ar + 5%SO₂ for five hours at 870°C (figure 3.57). These phases made up the corrosion product on the coating and within the cracks in the coating. From figure 3.57, it can be seen that the oxides of Al and Cr made up a significant proportion of the corrosion product. The corrosion product on the fracture surface and the crack tip would be similar to that obtained for the uncoated sample.

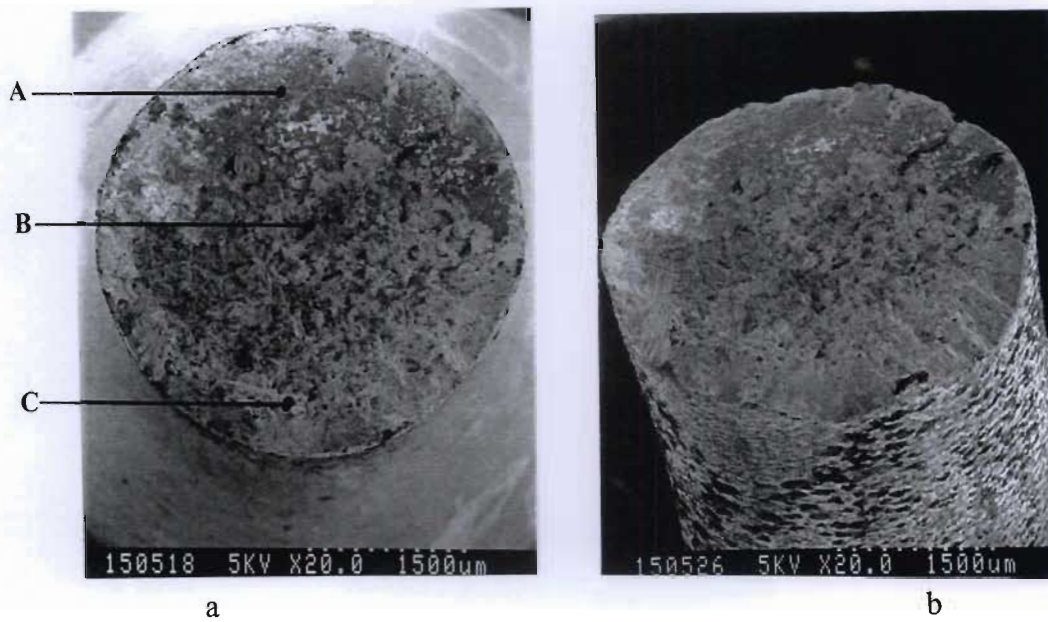
The fracture surface of a TYPE I platinum aluminide coated fatigue sample after HTLCF in Ar + 5%SO₂, figure 3.58, showed evidence of severe sulphidation. The number of cycles to failure was 1377, which was a significant improvement over the aluminide coated and uncoated MAR-M002 materials systems. There were two distinct regions, namely, a “smooth” region where crack propagation occurred and a “coarse” region where final failure occurred. The external surface close to the fracture (figure 3.58&59) had a “fish scale” type of appearance. This occurred as a result of the combined effect of sulphidation attack and mechanical loading. A number of fine cracks were present in the coating. The cracks were in general perpendicular to the direction of loading with “dark” corrosion product build-up along the crack edge (figure 3.59).

Figure 3.58 : Fractography of TYPE I platinum aluminide coated MAR-M002 after HTLCF in Ar + 5% SO₂ (S.R. 0.66%)

Chemical analysis of the fracture surface (figure 3.58) revealed a high sulphur, oxygen, Cr and Ni content in the corrosion product. This indicated that the corrosion product was rich in the sulphides and oxides of Ni and Cr. In the region where final failure had occurred, the sulphur and Ni content were significantly lower.

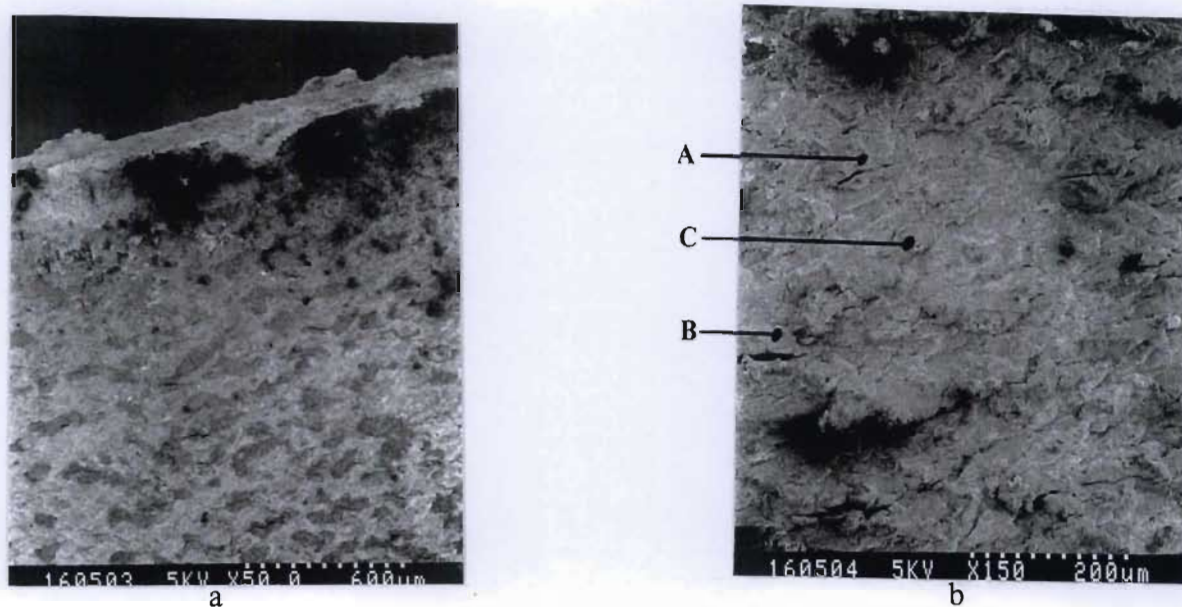
Figure 3.59 : Chemical analysis of the external surface close to the fracture surface of TYPE I platinum aluminide coated MAR-M002 after HTLCF in SO_2 bearing atmosphere (S.R. 0.66%)

Chemical analysis of the regions around the cracks in the coating (figure 3.59) showed that the corrosion products on the lips of the crack was composed of essentially Al and oxygen, indicating that these areas were composed of mainly aluminium oxides. The other regions analysed showed small but significant amounts of sulphur. A significant feature was that the major constituents were Al and oxygen in all the regions analysed.

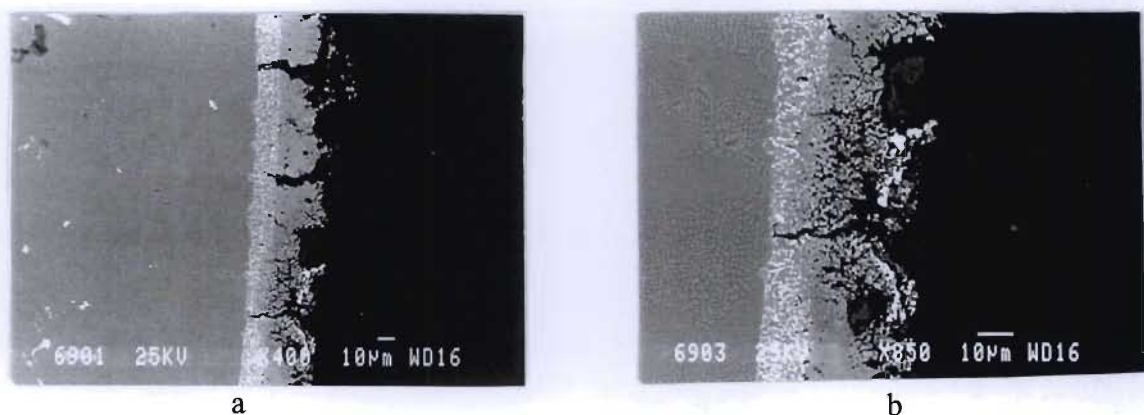
Cross-sectional examination of the TYPE I platinum aluminide coated sample exposed to SO_2 and HTLCF showed several cracks in the coating (figure 3.60). The cracks in the coating were branched indicating that the cracking of the coating occurred over a significant number of cycles. Corrosion product build-up on the coating was evident. It was noted that when the corrosion product had covered the crack, no corrosion proceeded within the crack. However, in the regions where the corrosion product was cracked, extensive corrosion of the coating was observed. The sulphidation attack was concentrated at the lip of the crack showing that the coating was most vulnerable in this region. The degradation proceeded

Figure 3.60 : Cross-sectional analysis of TYPE I platinum aluminide coated MAR-M 002 after HTLCF in SO_2 showing the “self healing” properties (S.R 0.66%)

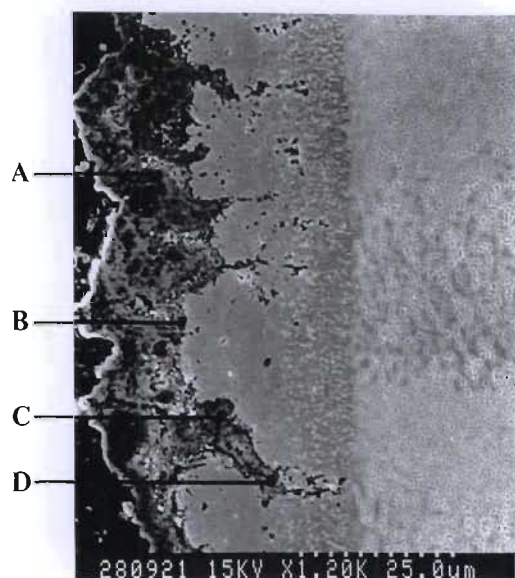
most rapidly along the coating surface and at a slower rate inwards. Chemical analysis of the corrosion product is shown in figure 3.61. The corrosion scale was composed of light and dark regions. Overall analysis of the corrosion product showed that it was made up mainly of Al and Cr oxides and sulphides. The dark region was found to be essentially Al and oxygen with relatively small amounts of S, Cr and Ni detected. The light regions were found to be composed mainly of Cr, Al, oxygen and S with smaller amounts of Ni, Ti, and Co. The Al content was significantly lower than that observed in the dark regions. At the coating-corrosion scale interface, a more complex structure was obtained with a relatively high Al, Cr, Ni, Pt, S and oxygen content. The sulphur content in this region was significantly higher as well. This indicated that the scale at this point was composed of the sulphides and oxides of Al, Cr and Ni with platinum "dissolved" in it. Analysis of the coating adjacent to corrosion scale indicated that this region was depleted of Al. There was also evidence of sulphur diffusing into the coating resulting in internal sulphidation attack. The corrosion product in the crack in the coating revealed that it was composed of mainly Al, Ni, S and oxygen with Ti and Cr being more significant in the interdiffusion zone. The sulphur content was highest at the crack tip.

Figure 3.61 : Chemical analysis of the corrosion product on the surface of TYPE I platinum aluminide coated MAR-M002 after HTLCF in SO₂ bearing atmosphere (S.R. 0.66%)

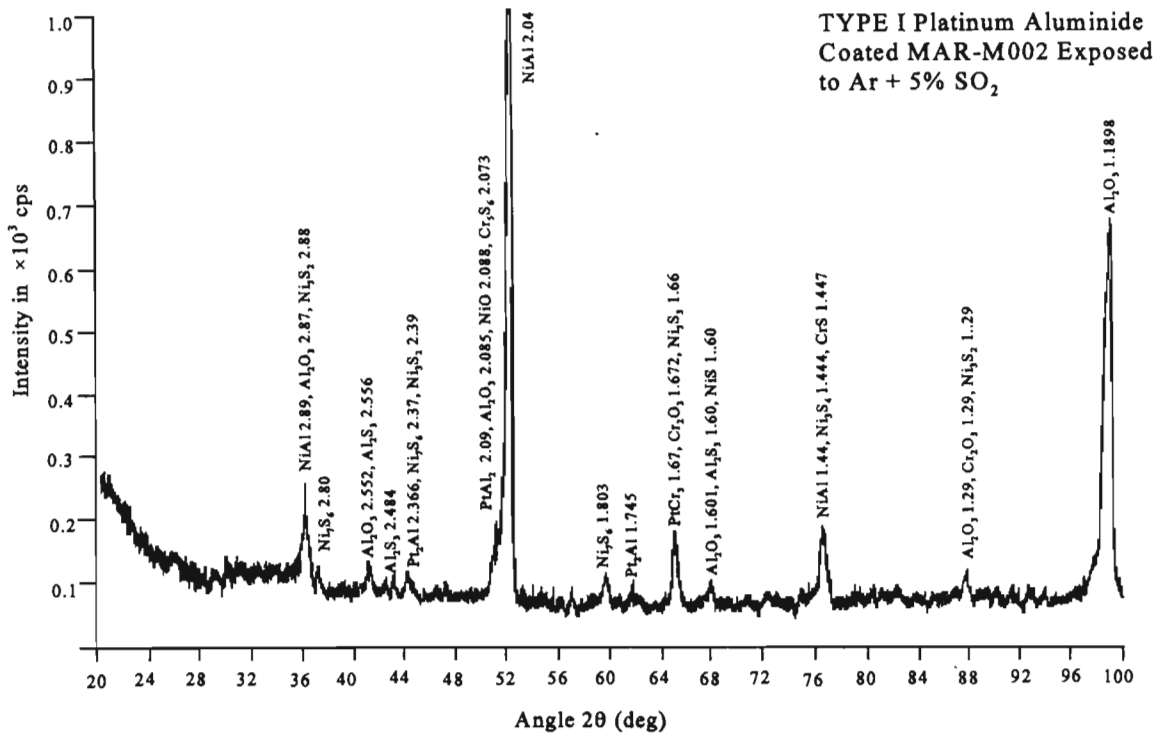
Figure 3.62 shows the X-ray analysis of a TYPE I platinum aluminide coated MAR-M002 disc sample exposed Ar + 5% SO₂ at 870°C. Typical sulphide and oxide phases produced as a result of the sulphidation attack is shown in Table 3.3. The corrosion product consisted of the oxides and sulphides of Al, Cr and Ni.

Figure 3.62 : X-ray diffraction of TYPE I platinum aluminide coated MAR-M002 after exposure to Ar + 5%SO₂ at 870°C for 5 hours

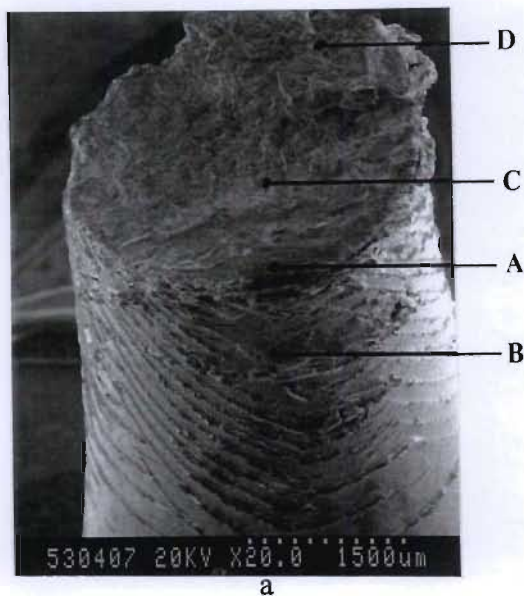
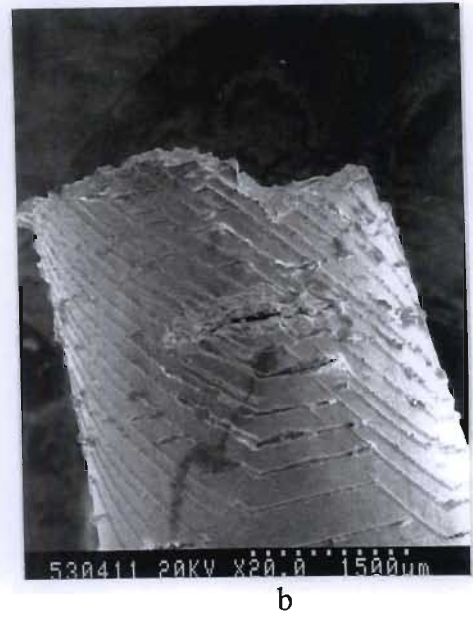
The fracture surface showed extensive sulphidation attack (figure 3.63) and the coating displayed severe cracking (figure 3.63 & 64). Two types of cracks were observed: cracks perpendicular to the direction of loading and cracks at approximately 45° to the direction of loading. The morphology of the cracks indicated that the coating was forced outward by corrosion processes occurring beneath the outer layer of the coating. The coating had fractured around the lip of the cracks in certain areas, figure 3.64a, due to the presence of the brittle platinum aluminide outer layer.

Figure 3.63 : Fractography of TYPE II platinum aluminide coated MAR-M002 after HTLCF in Ar + 5%SO₂ environment (S.R. 0.66%)

- a) Fracture surface
- b) Profile of fracture surface showing cracking of the coating.

Chemical analysis of the fracture surface (figure 3.63) indicated that the corrosion product was composed of essentially Ni and Cr oxides and sulphides. The corrosion scales in the lip of the crack (figure 3.63 pt A) was made up mainly of Cr, Al, Ni, oxygen and S. The region between the cracks (figure 3.63 pt B) showed very little evidence of sulphidation attack with the chemical composition indicating a high Al, Ni, Pt and oxygen content.

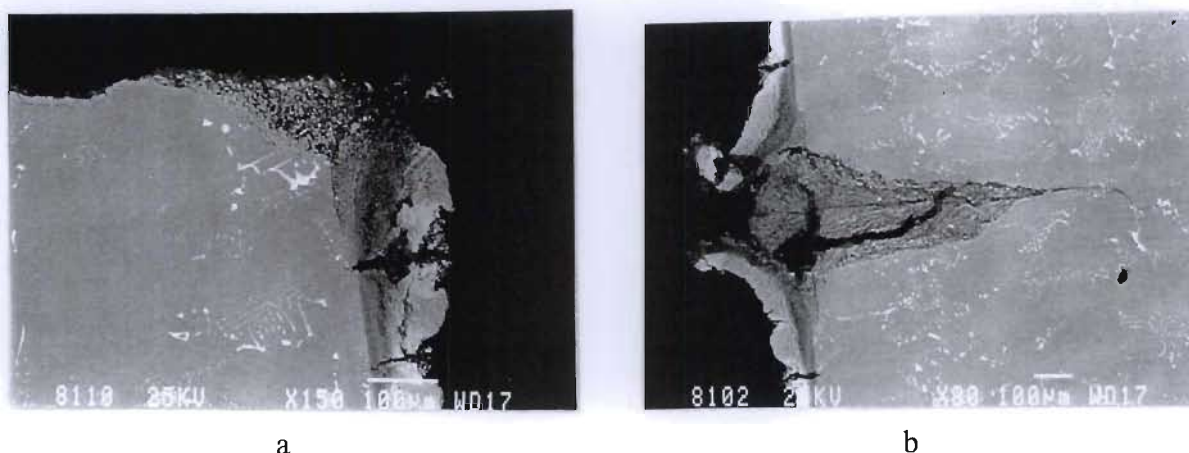
From the cross-sectional examination of the fatigue sample after HTLCF in a SO₂ bearing atmosphere, figure 3.65, it was evident that although the outer Pt rich layer was fairly resistant to sulphidation attack, however, it was very brittle and prone to cracking under mechanical loading. The NiAl and interdiffusion zones below the outer layer showed a lower resistance to sulphidation attack resulting in a “bell” shaped crack. The morphology of the cracks observed on the outer surface was revealed more graphically displayed in figure 3.65b. The sulphidation attack was concentrated below the Pt aluminide outer layer. This resulted in corrosion product build-up and internal sulphidation in this region. Eventually, the “pressure” of the corrosion product build-up caused the coating to be forced outwards. The substrate below the coating had also sustained extensive sulphidation attack. The morphology of the crack in the substrate indicated that there was a very broad corrosion “front” below the coating. This was due to the substrate being more resistant to crack initiation.

From figure 3.65 it can be seen that the NiAl rich zone and interdiffusion zone was more resistant to crack propagation. In these regions the cracks were branched and followed a more “jagged” path.

Figure 3.65 : Cross-sectional analysis of TYPE II platinum aluminide coated MAR-M002 after HTLCF in SO₂ Containing environment (S.R. 0.66%)

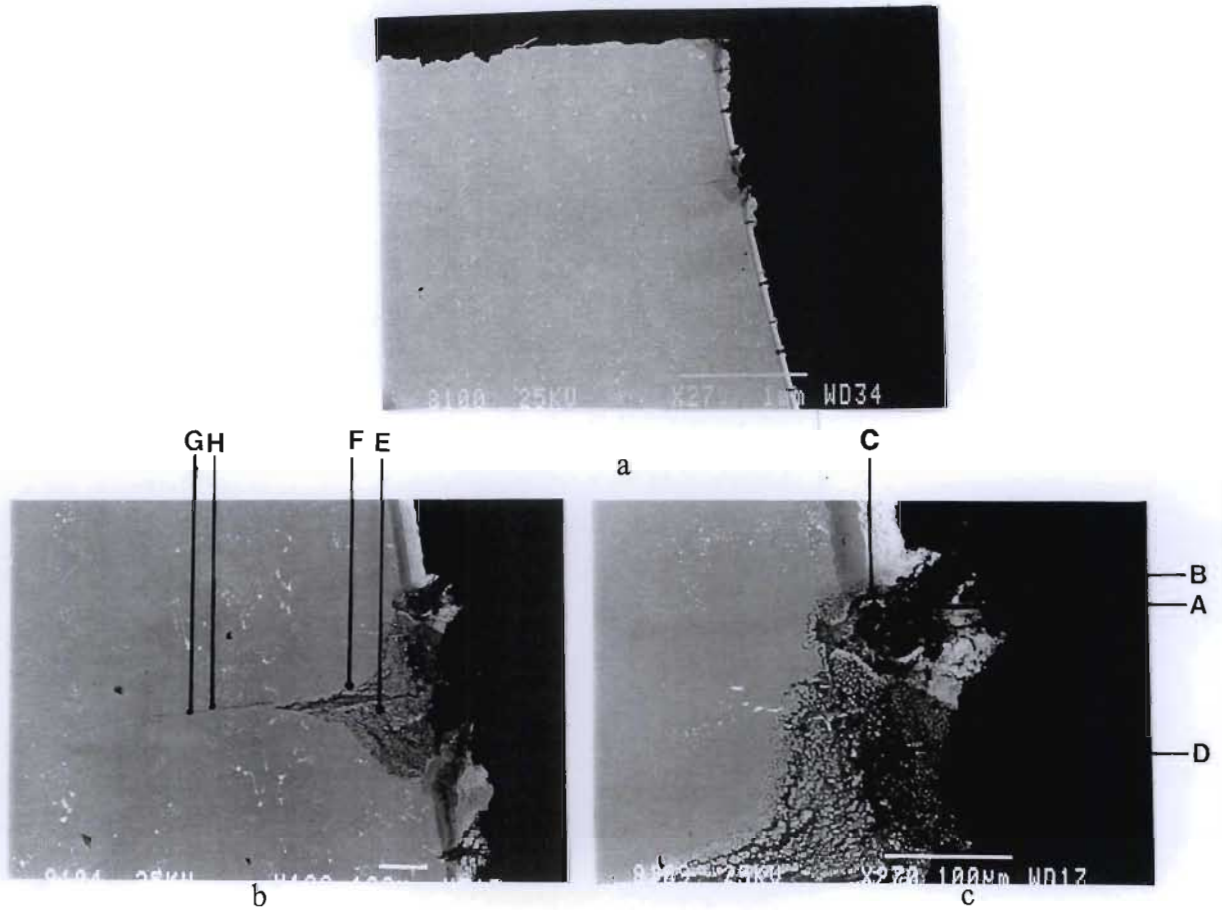
Figure 3.66 shows the chemical analysis of a crack that had progressed into the substrate. The corrosion product close to the Pt rich outer layer of the coating was composed of mainly Al, Ni and oxygen with a small amount of sulphur. The scale was composed of essentially aluminium oxides. The regions adjacent to the crack were depleted of Al due to the corrosion process. The black region at the coating/corrosion product interface (figure 3.66 pt.Cblack) was made up of essentially Ni, Cr, and S with smaller amounts of Al, Co, Hf and W. This indicated that the sulphides of mainly Ni and Cr were present. The white regions in the crack in the substrate (figure 3.66 pt.E) were particles of the substrate which were depleted of the reactive elements Al and Cr. The black regions (Figure 3.66 pt.E) were corrosion product made up of essentially Cr, Ni, oxygen and S. Analysis of the crack edge in the substrate, showed these regions to be severely depleted of Cr (figure 3.66 pt.F). The corrosion product at the propagating crack tip was made up of essentially Ni, Cr and S (figure 3.66 pt.G).

Figure 3.66 : Cross-section of TYPE II platinum aluminide coated MAR-M002 showing a fatigue crack that had propagated into the substrate after HTLCF in Ar + 5%SO₂ (S.R 0.66%)

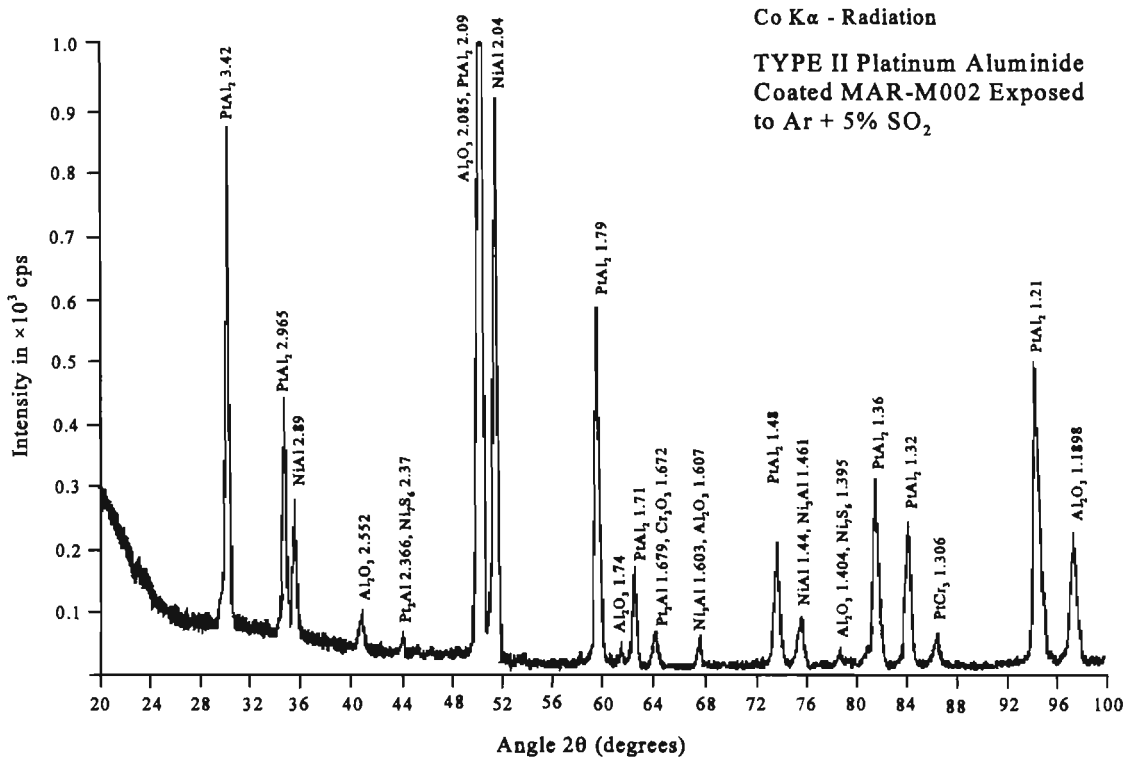
X-ray diffraction of a TYPE II platinum aluminide coated sample exposed to Ar + 5%SO₂ at 870°C for 5 hours, is shown in figure 3.67. Typical phases that will be found in the corrosion scale on the coating are Al₂O₃, Ni₃S₂, Cr₂O₃ and Ni₇S₆.

Figure 3.67 : X-ray diffraction analysis of TYPE II platinum aluminide coated MAR-M002 after exposure to Ar + 5% SO₂ at 870°C for 5 hours

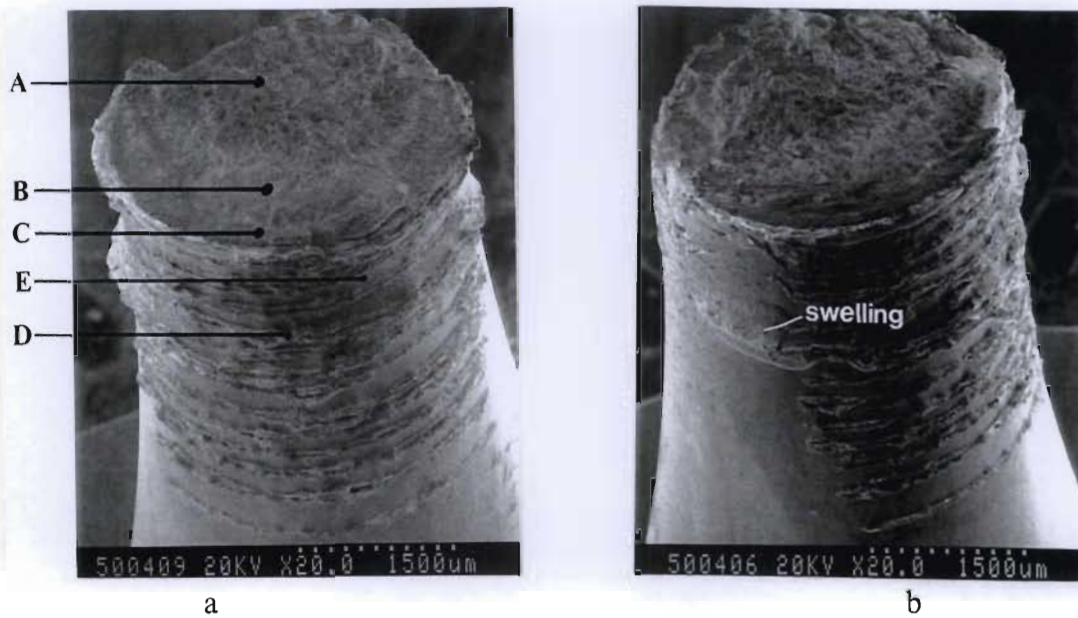
HTLCF of 2 μ m platinum aluminide coated MAR-M002 in Ar + 5%SO₂ at a strain range of 0.66% produced a life of 606 cycles. Fractography analysis (figure 3.68) revealed evidence of sulphidation attack of the fracture surface and severe cracking of the coating close to the fracture surface. The cracking of the coating was primarily circumferential and perpendicular to the direction of loading. The morphology of the cracks (figure 3.69) were similar to that observed in the TYPE II platinum aluminide coated sample. Figure 3.69 showed evidence that the coating was forced outward. The indicated region in figure 3.68 shows “swelling” of the coating due to subsurface sulphidation attack. The brittle platinum rich outer layer cracked due to the swelling of the coating (figure 3.69) and mechanical loading.

Figure 3.68 : Fracture surface of 2μm platinum aluminide coated alloy after HTLCF in AR + 5% SO₂ (S.R. 0.66%)

Chemical analysis of the fracture surface showed a high Cr, Ni, and oxygen content with a relatively small but significant amounts of sulphur present. The corrosion product on the crack on the external surface was composed of essentially Ni, Al, oxygen and sulphur. The region between the cracks showed a significantly lower sulphur content than the corrosion product on the crack edge.

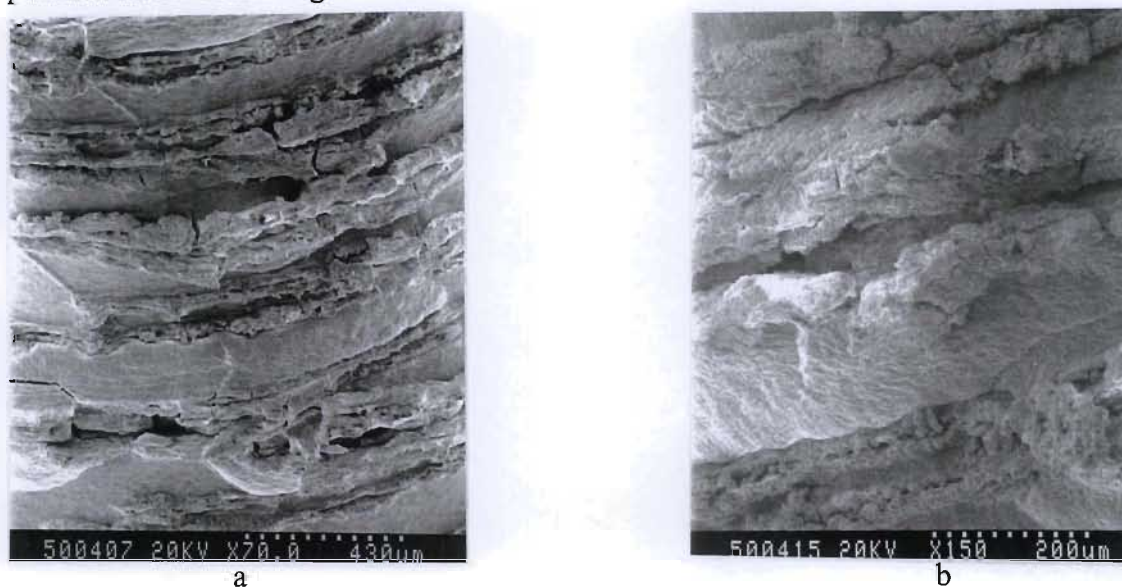
Figure 3.69 : Cracking of the 2µm platinum aluminide coated MAR-M002 close to the fracture surface after HTLCF in SO₂ containing environment (S.R. 0.66%)

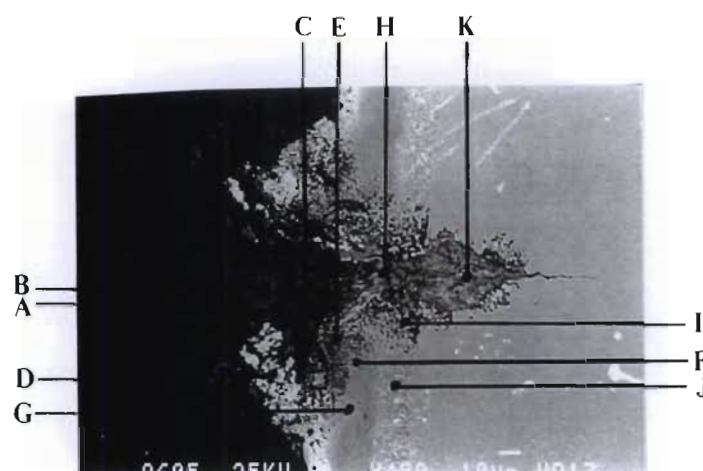
Chemical analysis of the cross-section of a crack in the coating (figure 3.71) revealed that the corrosion product was composed of mainly aluminium, chromium and oxygen with smaller amounts of sulphur and elements of the base alloy. The sulphur content was significantly higher in the “porous” region with oxygen being virtually non-existent (figure 3.71 pt.E). The region of the coating adjacent to the crack was depleted of aluminum when compared with the bulk coating analysis. Analysis of the corrosion product in the interdiffusion zone (figure 3.71 pt.H) indicated a high nickel and oxygen content with a significant amount of sulphur present. From the quantitative analysis it can be seen that the corrosion product in this region was essentially nickel oxides and sulphides, with sulphides

Figure 3.71 : EDS analysis of a crack in the coating of 2µm platinum aluminide coated MAR-M002 after HTLCF in Ar + 5% SO₂ environment (S.R. 0.66%)

making up the major constituent. A significant feature was that the sulphide phases were found to be concentrated more towards the corrosion scale/substrate interface. This was evidence that the oxides were formed first with sulphur diffusing through the corrosion scale to the substrate.

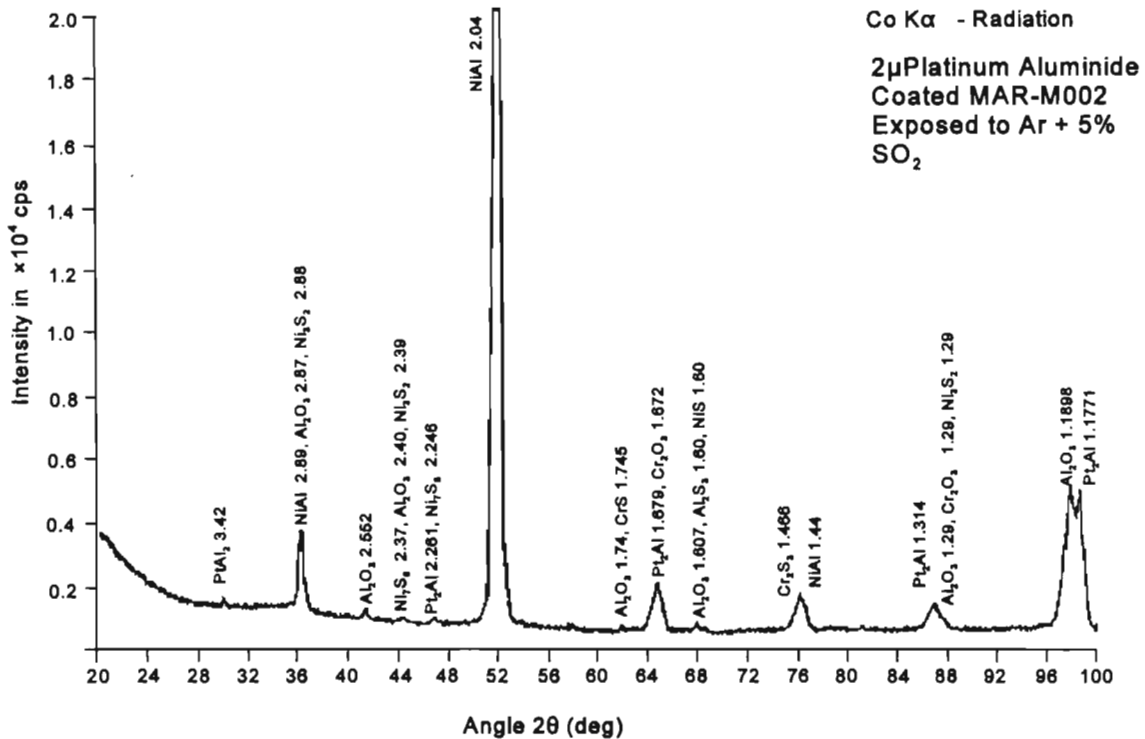
X-ray diffraction analysis of the of a 2 μ m platinum aluminide coated MAR-M002 disc sample exposed to Ar + 5%SO₂ at 870°C for 5 hours is shown in figure 3.72. The corrosion product was composed of Al₂O₃ and Cr₂O₃ oxides and in smaller quantities Ni₃S₂, CrS, NiS, Al₂S₃, Cr₃S₄, and Ni₇S₆. From this analysis it was evident that the coating had a higher tendency to form oxides rather than sulphides on the external surface.

Figure 3.72 : X-ray diffraction analysis of a 2 μ m platinum aluminide disc sample after exposure to Ar + 5% SO₂ at 870°C for 5 hours
