**The Influence of Sulphidizing Attack on the
Mechanism of Failure of Coated Superalloy Under
Cyclic Loading Conditions**

**Submitted in fulfilment of the academic requirements for the degree of
PHD in Mechanical Engineering in the Department of Mechanical
Engineering, University of Natal, Durban.**

January 1998

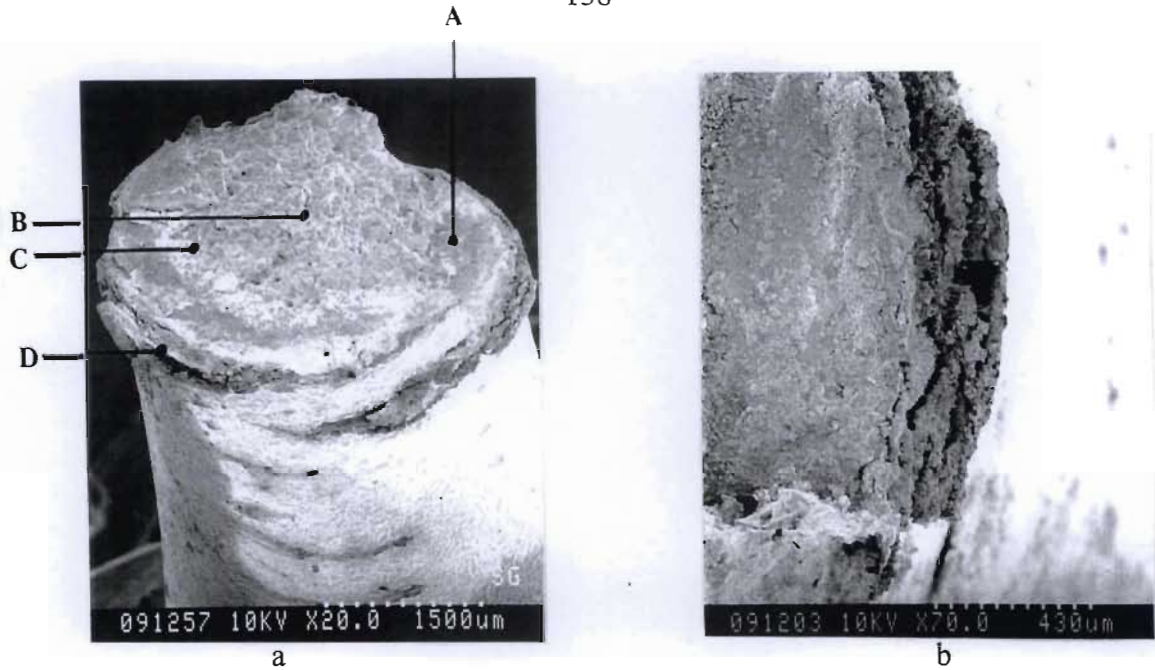
The platinum coated MAR-M002 fatigue sample failed after 271 cycles under the combined effect of HTLCF and SO₂ containing environment. The presence of the platinum coating did not influence the corrosion-fatigue life significantly compared to the uncoated alloy. The fracture surface (figure 3.73) showed evidence of sulphidation attack. High magnification of the fracture edge displayed evidence of delamination of the coating (figure 3.73b) due to the combined effect of fatigue loading and sulphidation attack. Chemical analysis of the corrosion product on the fracture surface showed that it was made of mainly Cr, Ni, sulphur and oxygen. AES analysis of the fracture surface (figure 3.74) confirmed the presence of oxygen in the corrosion product, and showed that it was made up of mainly Cr, Ni, Al, S and oxygen.

Figure 3.73 : a) Fracture surface of platinum coated MAR-M002 after HTLCF in SO_2 bearing atmosphere (S.R. 0.66%)
b) High magnification showing delamination of coating.

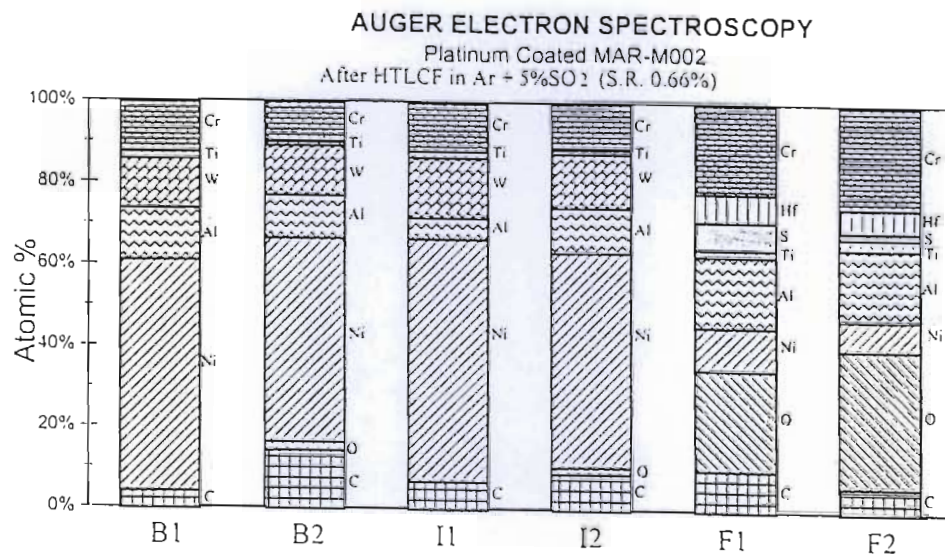
Figure 3.74 : AES analysis of the fracture surface of platinum coated MAR-M002 after HTLCF in Ar + 5%SO₂ (S.R. 0.66%)

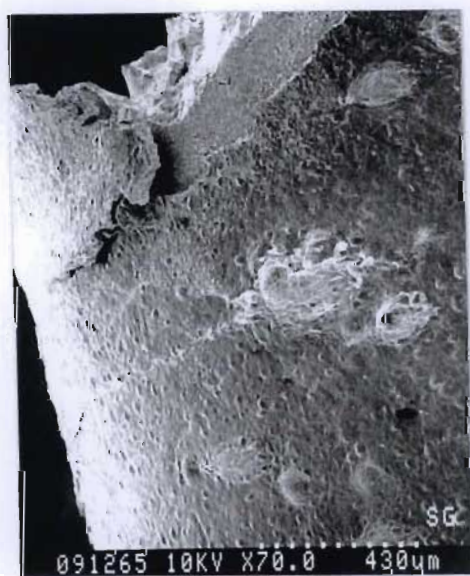
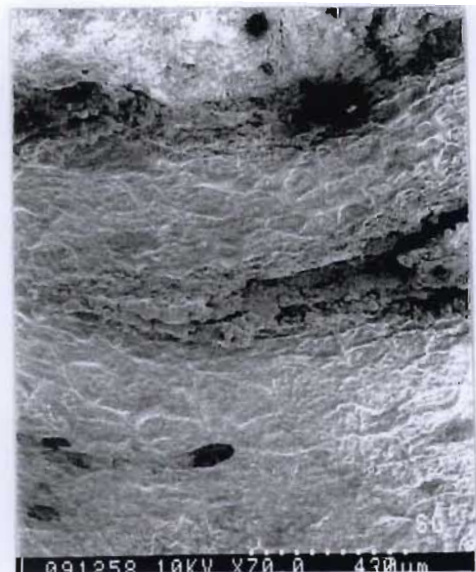
Figure 3.75 : Fractography of platinum coated MAR-M002 after HTLCF in SO₂ containing environment (S.R. 0.66%)

From the nature of the fracture surface it was evident that there was two major cracks propagating simultaneously which resulted in the final failure of the of the fatigue sample. The external surface close to the fracture revealed that the coating layer had “peeled” off in the region of the fracture (figure 3.75). No severe cracking of the coating was observed, however, there was evidence of “blistering” of the coating (figure 3.75a) due to the combined effect of sulphidation attack and mechanical loading. Figure 3.75b showed a “creased” effect on the coating on one half of the sample. The “bubble” like protrusions on the coating was evident as in the samples tested in argon and air atmospheres, indicating that this was a property of the coating and not due to the environment.

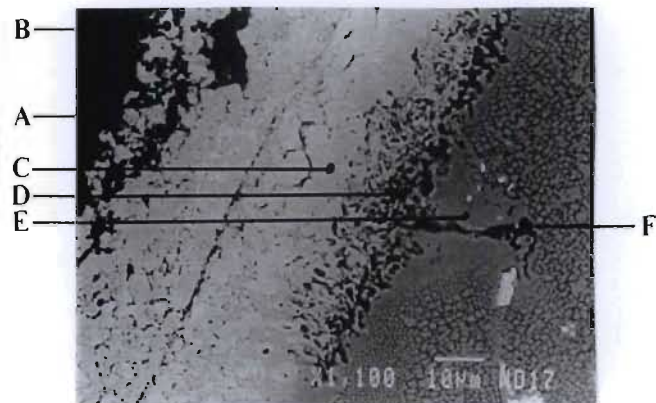
Figure 3.76 & 77 showed that the sulphidation attack was concentrated in the γ' depleted zone. The corrosion processes proceeded along this region resulting in the coating peeling off. This image compliments the evidence shown on the fractography analysis shown in figure 3.75. The corrosion product in the “pores” was made up of essentially Ni, Cr and sulphur with no evidence of oxygen. A significant feature was that the corrosion product had a similar composition to that found on the uncoated alloy. The corrosion product on the external surface was made up mainly of chromium, nickel, sulphur and oxygen (figure 3.77). From the quantitative analysis it was very evident that it was made up mainly of oxides. The white region (point B) was made up of mainly nickel and platinum and was depleted of aluminium and chromium.

Figure 3.77 : Transverse cross-section of platinum coated MAR-M002 showing sulphidation attack of the external surface and internal sulphidation of the γ' depleted zone

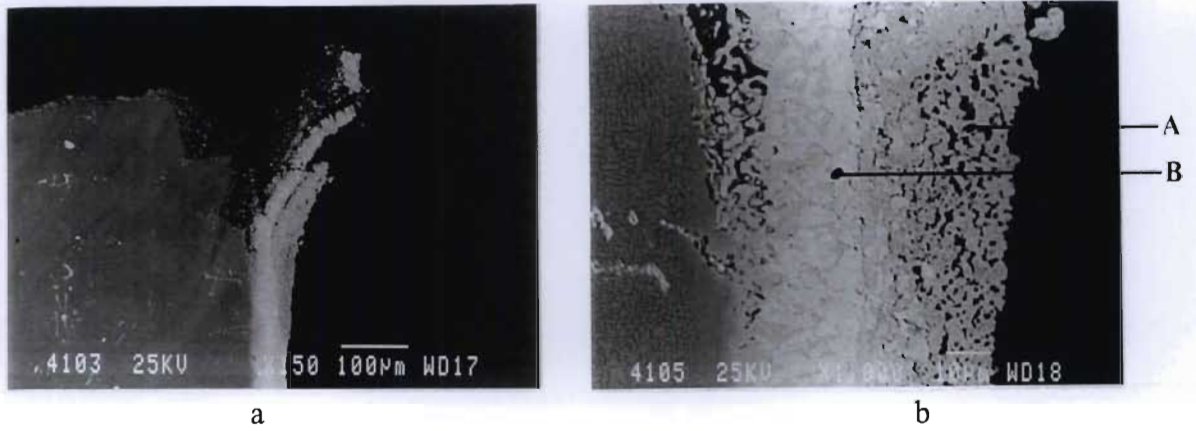
In certain regions of the coating the external surface of the coating did show sulphidation attack (figure 3.78). This, in general, had occurred close to the fracture surface. The “grey” region of the coating showed a higher susceptibility to sulphidation attack. This process produced “porous” regions. The dark regions or “pores” were made up of essentially Cr, Ni and sulphur, while the white regions (solid) was essentially nickel and platinum.

Figure 3.78 : Internal sulphidation of the platinum coating due HTLCF in AR + 5%SO₂ (S.R. 0.66%)

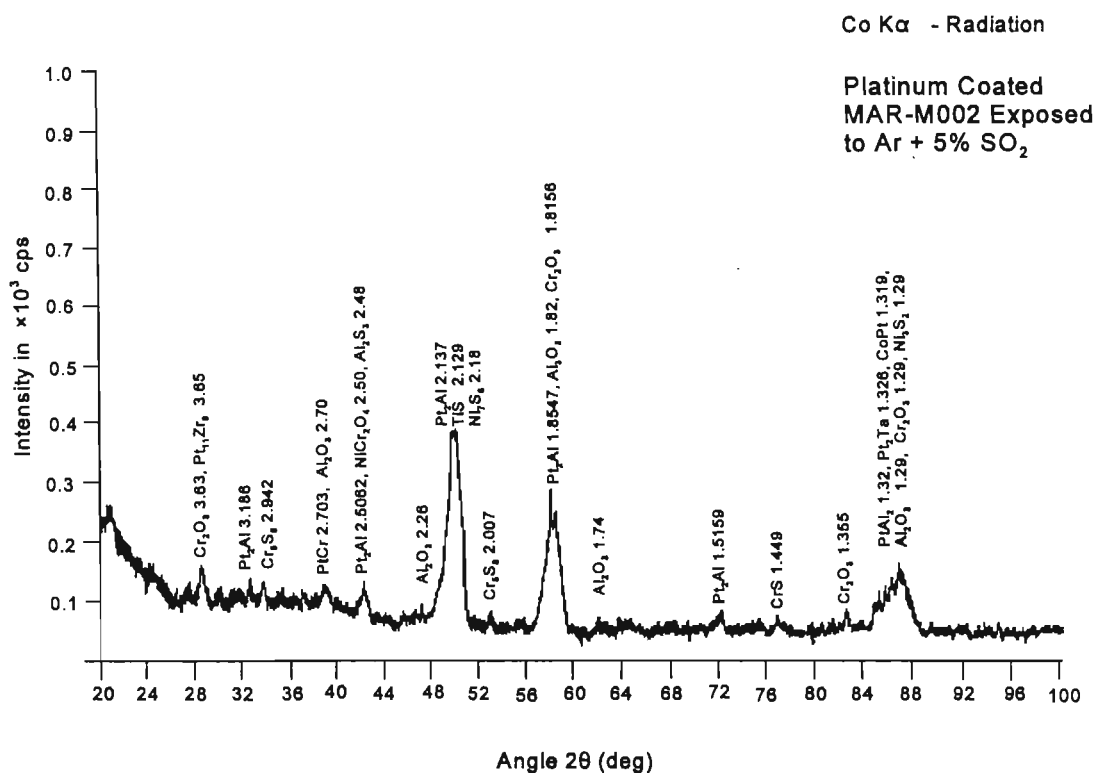
X-ray diffraction analysis of platinum coated disc sample exposed to $\text{Ar} + 5\%\text{SO}_2$ at 870°C for five hours is shown in figure 3.79. It can be seen that the coating was not very susceptible to sulphidation attack in the unstressed condition. From this analysis typical phases in the corrosion product on the coating was determined to be Cr_2O_3 , Al_2O_3 , NiCr_2O_4 , Cr_2S_3 , CrS_4 , Ni_7S_6 , TiS , Ni_3S_2 and CrS . The phases present in the substrate-coating interdiffusion zone will be more accurately determined using the corrosion test results obtained for the uncoated disc sample.

Figure 3.79 : X-ray diffraction analysis of platinum coated MAR-M002 after exposure to Ar + 5% SO₂ at 870°C for 5 hours

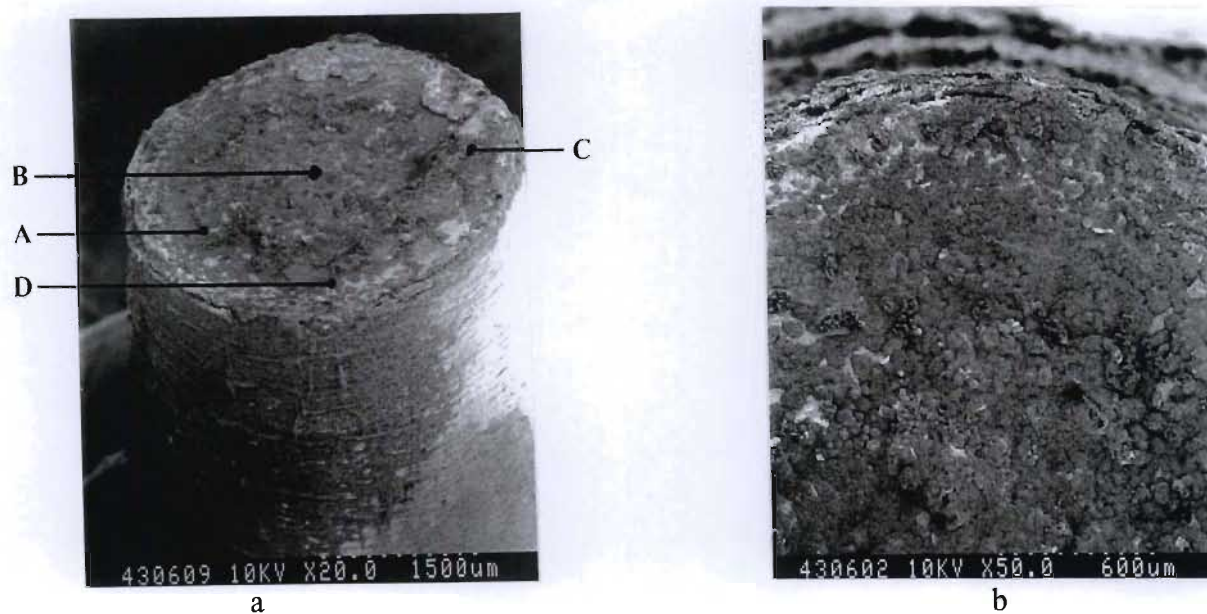
Chemical analysis of the corrosion product on the external surface close to the fracture (figure 3.80) indicated that it was composed of mainly aluminium and nickel oxides and sulphides. The corrosion product on the fracture surface was made up of mainly nickel and chromium oxides and sulphides. This was consistent with the tests performed at the higher strain range. Auger electron spectroscopy (figure 3.82), indicated that the corrosion product was made up of mainly Cr, S, Al, Ni and oxygen. The region just below the fracture surface (I₁ and I₂) showed no significant variation from the base metal. The AES analysis of the fracture surface complimented the EDS analysis and confirmed the presence of oxygen in significant quantities.

Figure 3.80 : Fracture surface of uncoated MAR-M002 after HTLCF in Ar + 5% SO₂ (S.R. 0.38%)

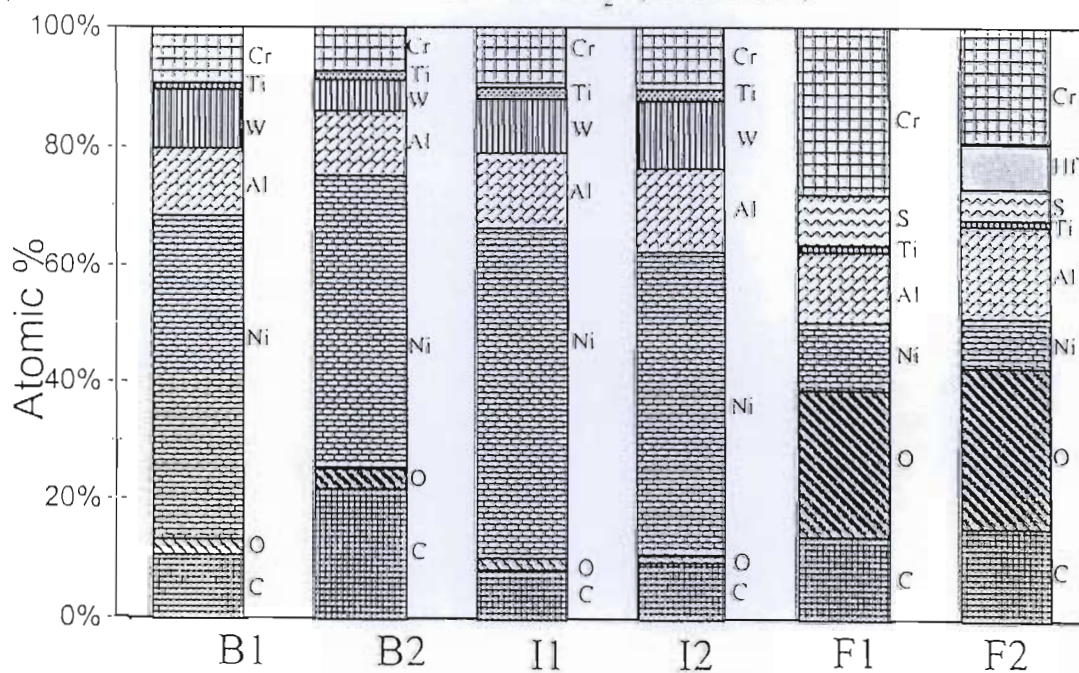
Figure 3.82 : AES analysis of the fracture surface after HTLCF of uncoated MAR-M002 in SO_2 containing environment (S.R. 0.38%)

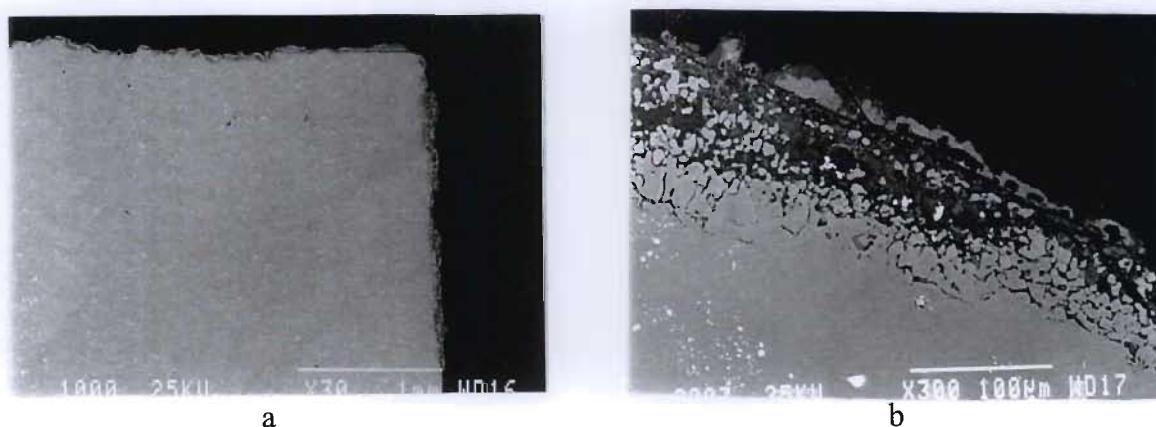
Cross-sectional analysis of an uncoated fatigue sample after HTLCF in SO_2 bearing atmosphere at a strain range of 0.38% revealed severe sulphidation attack of the surface (figure 3.83 & 84). A significant feature, as observed in tests performed at the higher strain range, was that only one major crack had propagated to final failure. The corrosion product morphology on the surface was very similar to that observed in the tests performed at a strain range of 0.66%, indicating that the corrosion processes was not affected by the change in the mechanical loading. It is evident from figure 3.83 that the corrosion scale had “spalled” off in regions. The cracking of the corrosion scale (figure 3.83b) did not affect the corrosion process significantly.

Figure 3.83 : Cross-sectional analysis of uncoated MAR-M002 after HTLCF in SO_2 Containing environment (S.R. 0.38%)

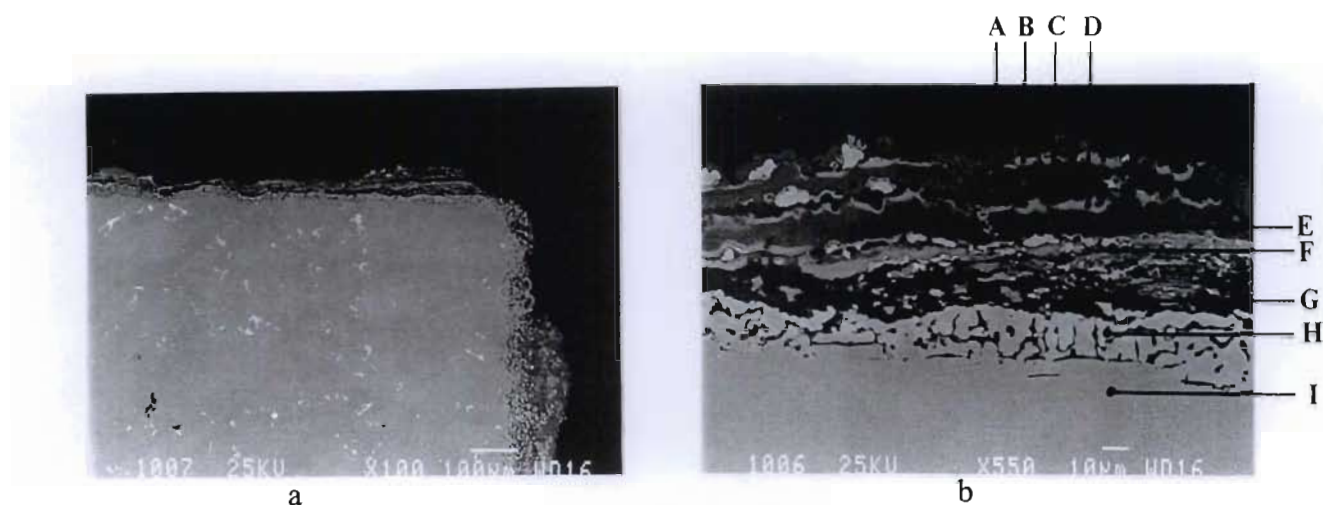
The corrosion scale on the fracture surface (figure 3.84) was significantly thicker than that observed in the test performed at a strain range of 0.66%. However, the morphology of the scale was very similar. The corrosion scale was differentiated into three regions/zones according to their shading: (I) light grey region, (ii) dark grey region, and the (iii) black region. The chemical composition of these regions were discovered to vary significantly. The light grey region was composed mainly of Ta and oxygen with smaller amounts of Al, S, Cr, Ni, Ti, and Hf. The dark grey region was composed essentially of Cr, Ni, oxygen and sulphur. This region made up the major part of the corrosion product and formed the layer of the corrosion product that was exposed to the environment. The black region was made

Figure 3.84 : Corrosion product on the fracture surface after HTLCF of uncoated MAR-M002 in SO_2 bearing atmosphere (S.R 0.38%)

up of mainly Al, Ni, oxygen and sulphur. These regions were found in the middle of the corrosion scale and at the scale/substrate interface. The “porous” region below the corrosion scale shows clear evidence of internal sulphidation. The “pores” were filled with black corrosion product which was essentially composed of nickel sulphides (figure 3.84). The corrosion scale on the external surface close to the fracture was made up of a similar morphology to that found on the fracture surface.

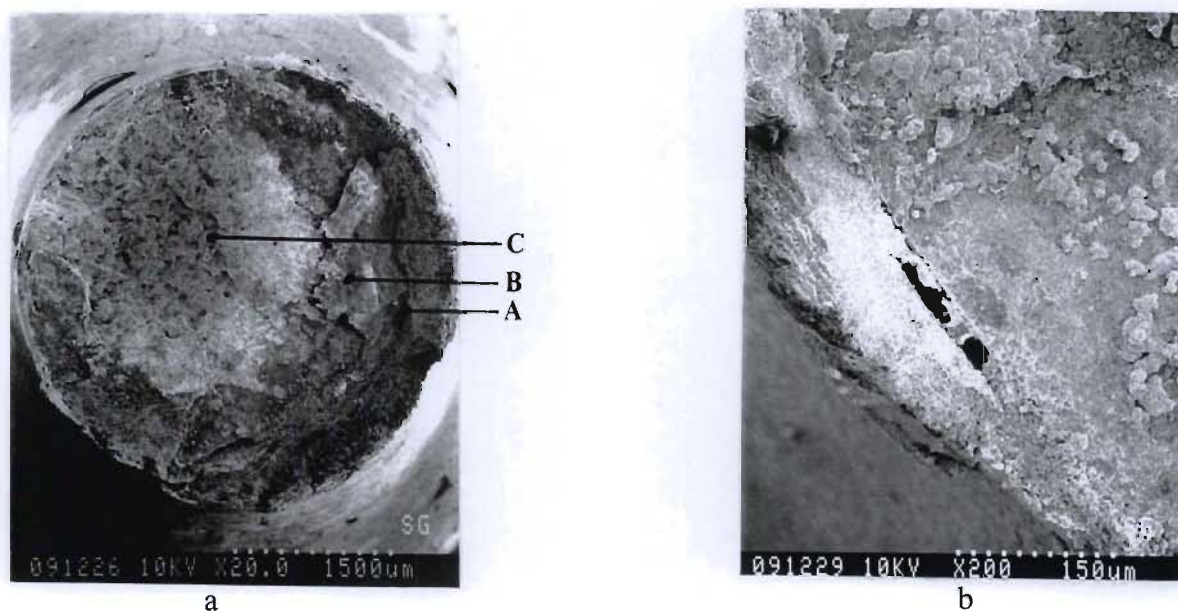
Aluminide coated MAR-M002 exposed to creep-fatigue loading and Ar + 5%SO₂ atmosphere at 870°C and creep-fatigue loading at a strain range of 0.38% failed after 6769 cycles. The fracture surface (figure 3.85) showed two distinct regions: a “smooth” region (where crack propagation occurred) and a “coarse” region (where final failure occurred). Sulphidation attack was manifested by the presence of dark sulphide phases on the fracture surface. The corrosion product on the “smooth” region was complex with significant amounts of a number of the alloying elements of the substrate, plus oxygen and sulphur. It was evident from that the main constituents were Ni, Cr and oxygen with a smaller but significant amount of sulphur being present. The coarse region showed only minor sulphidation attack and this was confirmed by the lower oxygen and sulphur content detected. AES of the fracture surface, region just below the fracture surface and bulk alloy (figure 3.86) showed that the corrosion product was composed of significant amounts of oxygen, Cr, S Ti, Al, Hf and Ni.

High magnification of the region close to the edge of the fracture surface (figure 3.85b) revealed delamination of the coating and the presence of “spongy” corrosion product. The external region close to the fracture showed severe deterioration of the coating. Swelling (figure 3.87a) and blistering of the coating (figure 3.87b) was observed. There was also evidence of localised sulphidation attack of the coating. The cracking of the coating was not as severe as that observed in the tests performed at the higher strain range. However, cracking of the coating in the region adjacent to the fracture surface was observed due to this region experiencing the highest stresses.

Figure 3.85 : Fracture surface of aluminide coated MAR-M002 after HTLCF in Ar + 5% SO₂ (S.R. 0.38%)

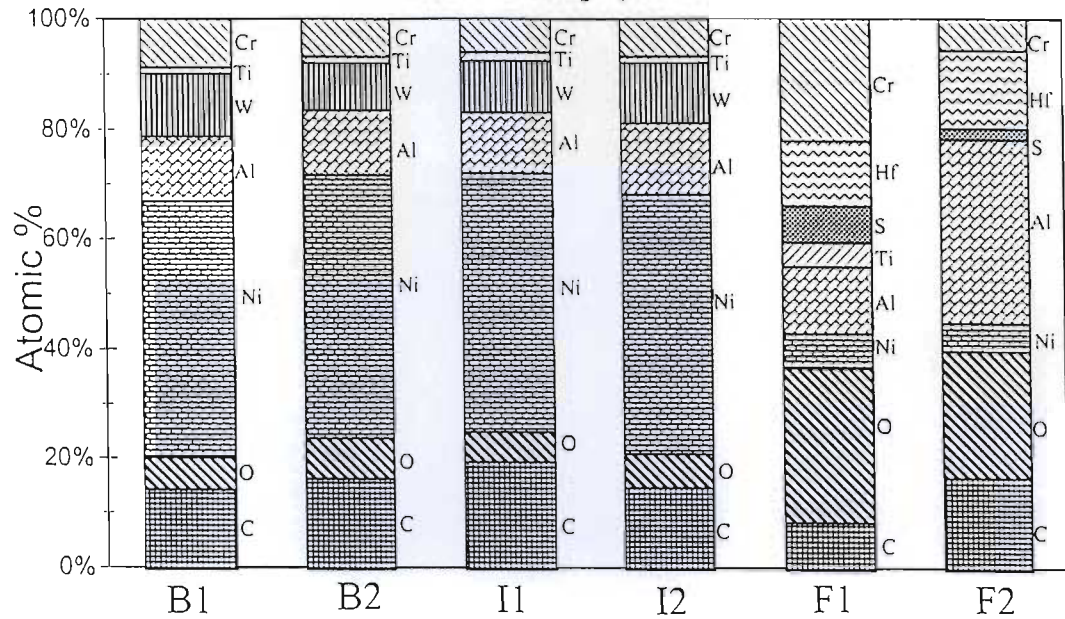
Figure 3.86 : AES analysis of the fracture surface an aluminide coated sample after HTLCF in SO₂ bearing atmosphere (S.R. 0.38%)

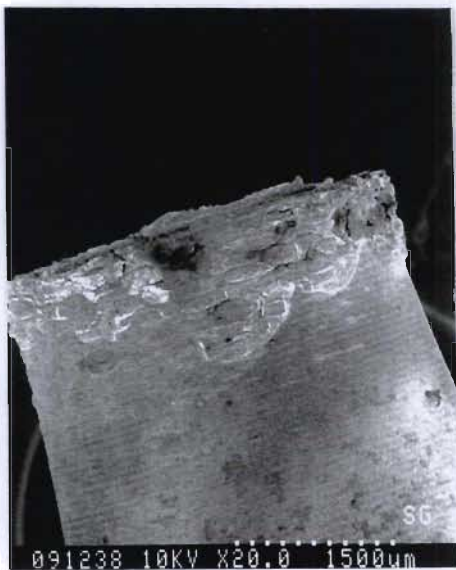
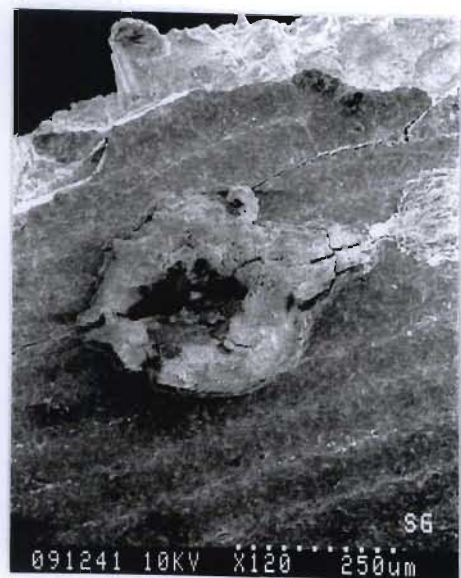
Figure 3.87 : Fractography showing blistering of the aluminide coating after HTLCF in Ar + 5% SO₂ (S.R. 0.38%)

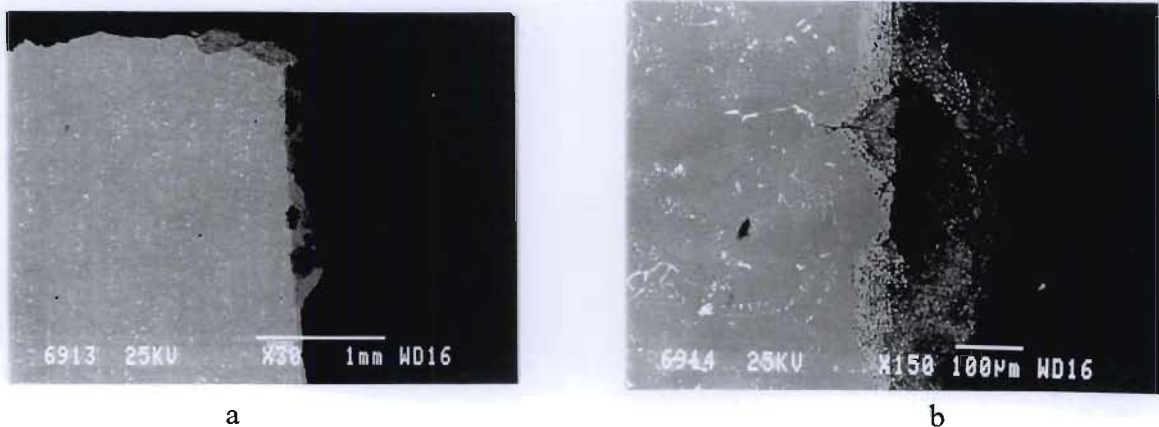
Cross-sectional analysis of an aluminide coated sample after HTLCF in AR + 5%SO₂ at a strain range of 0.38% showed severe damage to the coating (figure 3.88a). The coating immediately adjacent to the fracture surface was completely destroyed. The “blistering” of the coating was vividly displayed and the sulphidation of the coating was very evident. Internal sulphidation of the NiAl layer resulted in a “sponge” like effect with the “pores” being filled with corrosion product. This process plus the susceptibility of the interdiffusion zone to sulphidation resulted in the blistering of the coating.

Figure 3.88 : Cross-sectional analysis of aluminide coated MAR-M002 after HTLCF in SO_2 Containing environment (S.R. 0.38%)

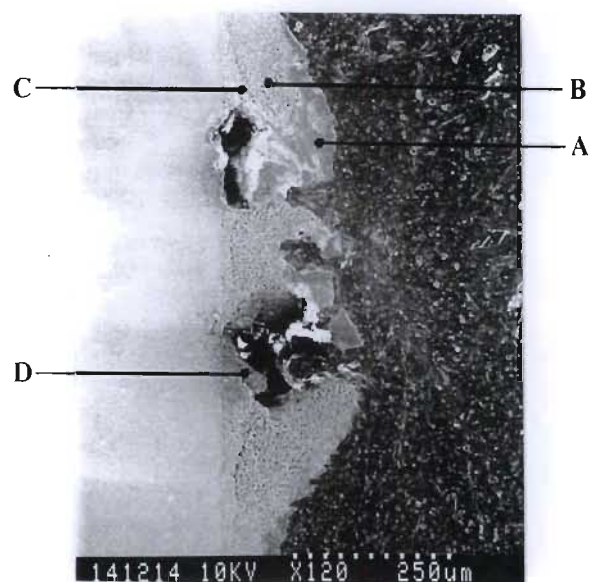
Chemical analysis of a blister in the coating (figure 3.89) showed that the corrosion scale on the outer region was made up of mainly Ni, Al, and oxygen with smaller amounts of S, Cr and W. The corrosion product in this region was essentially Al and Ni oxides and sulphides with Al being the dominant constituent. Chemical analysis of the “porous” region in the coating showed that this region was depleted of aluminium and the corrosion product was made up of mainly oxides.

Figure 3.89 : Chemical analysis of the blister in the aluminide coating after HTLCF in SO_2 (S.R. 0.38%)

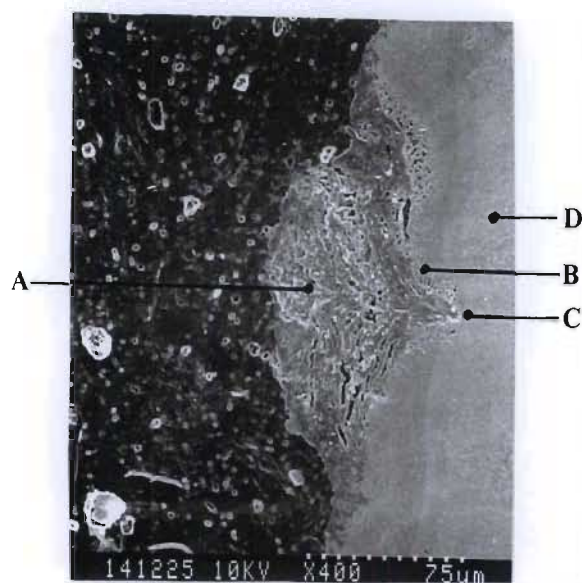
The corrosion product on the coating was made up of essentially aluminium oxides and sulphides due to the high aluminium content in the NiAl layer (figure 3.90). This analysis also indicates that the aluminium was significantly more reactive under the environmental conditions tested. The region adjacent to the corrosion scale (figure 3.90) was depleted of aluminium, dropping by approximately 60% when compared with the as received coating. The NiAl layer was effectively leached of aluminium.

Figure 3.90 : Corrosion process in a crack that had developed in the aluminide coating after HTLCF in Ar + 5% SO₂ (S.R. 0.38%)

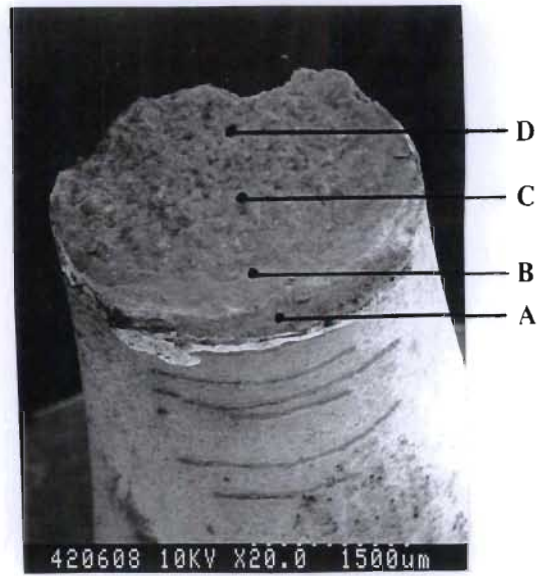
The life of TYPE I platinum aluminide coated MAR-M002 after HTLCF in Ar + 5%SO₂ at a strain range of 0.38% was significantly lower than that of the aluminide coated and uncoated samples tested under similar conditions. The number of cycles to failure was 1400, which was very similar to the samples tested at the higher strain range. The fracture surface (figure 3.91) was covered with dark corrosion product as a result of the sulphidation attack. There were two distinct regions on the fracture surface; the smooth region where crack propagation occurred and the coarse region where final failure occurred. The corrosion product on the fracture surface was made up of mainly Ni, Cr, S and oxygen (figure 3.91). A qualitative AES analysis of the fracture surface (figure 3.92) showed that there was a significant amount of oxygen and sulphur present in the corrosion product. (A quantitative analysis was not possible due to the contamination of the fracture surface with carbon.) The most prominent alloying elements present were Al and Ni with smaller amounts of Cr and Ti.

Figure 3.91 : Fracture surface of TYPE I platinum aluminide coated MAR-M002 after HTLCF in Ar +5% SO₂ (S.R. 0.38%)

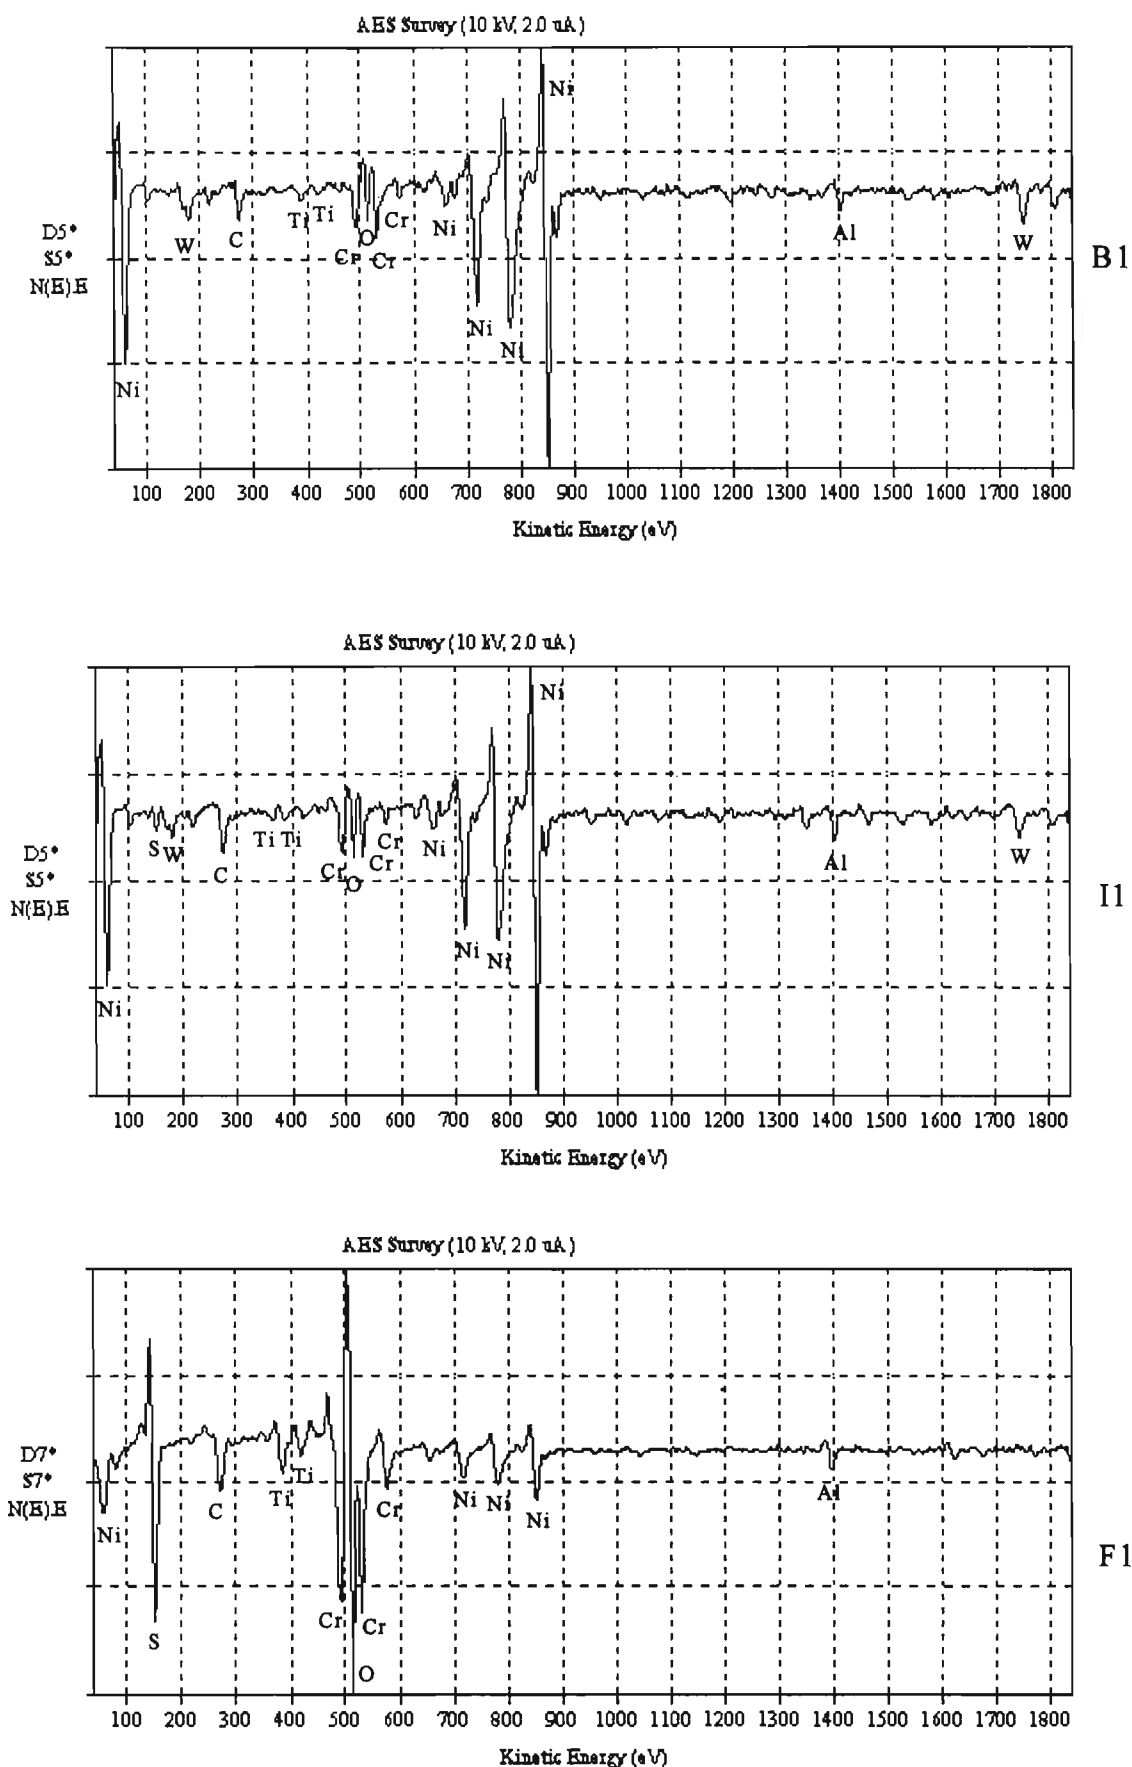
Figure 3.92 : AES analysis of the fracture surface of TYPE I platinum aluminide after HTLCF in SO_2 containing atmosphere (S.R. 0.38%)

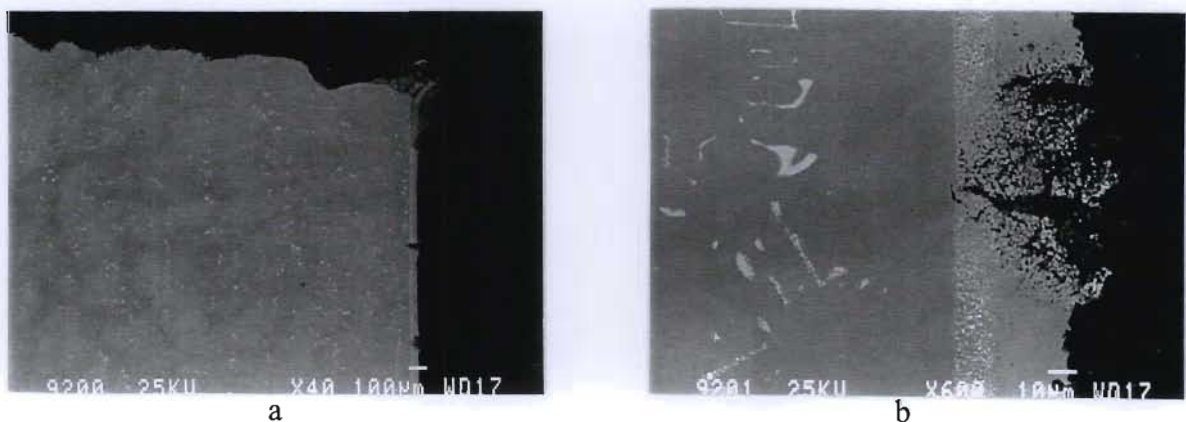
Sulphidation attack of the coating was concentrated in the regions where the coating had failed (figure 3.94). The deterioration of the coating was most severe at the fracture surface/coating interface (figure 3.94). Severe internal sulphidation of the coating was evident. The interdiffusion/substrate zone was very susceptible to sulphidation and the corrosion proceeded more rapidly along this region than into the substrate. High magnification of the crack in the coating (figure 3.94b) revealed severe internal sulphidation of the coating along the crack edge resulting in "swelling" of the coating. The sulphidation attack progressed more rapidly "laterally" along the coating resulting in the widening of the crack.

Figure 3.94: Micrographs showing the morphology of cracks and corrosion -fatigue damage of the TYPE I platinum aluminide coating after HTLCF in Ar + 5% SO₂ (S.R. 0.38%)

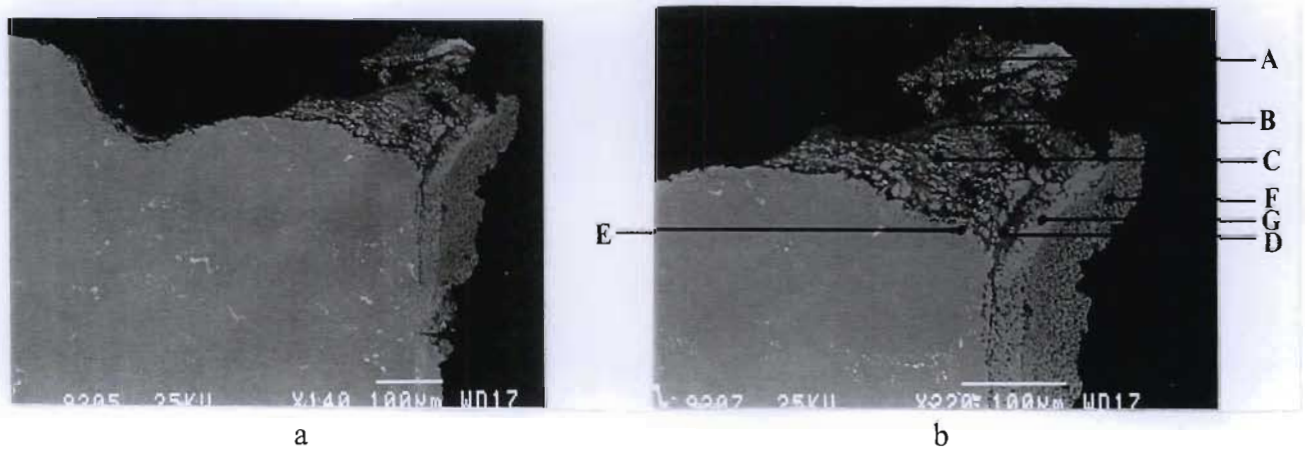
Chemical analysis of the region close to the fracture surface is shown in figure 3.95. The evidence indicated that the corrosion product on the outer region was composed of mainly Cr, Al, Ni, oxygen and sulphur. The edge of the fracture surface showed a more complex corrosion product morphology (figure 3.95). The outer layer of the corrosion product (figure

3.95) was made up of principally Cr, Ni, Co, oxygen and sulphur. The region below this was a mixture of particles of the alloy and dark corrosion product. The dark corrosion product was made up of the alloying elements, Ti, Cr, Ni, Ta, Hf, and Al, and oxygen and

Figure 3.95 : Chemical analysis of the coating close the fracture surface of a TYPE I platinum aluminide coated sample after HTLCF in SO₂ (S.R. 0.38%)

sulphur. The major constituents were Cr, Ni, Ta, Al and oxygen. This indicated that mainly the oxides of these elements were present. The “white” alloy particles were depleted of the reactive elements and were composed of mainly of Ni, Co, and W. The corrosion product in the “pores” in the coating was made up of the sulphides of Cr, Co, Ni, and Al with no oxygen evident. The “white” coating alloy was depleted of aluminium and Cr.

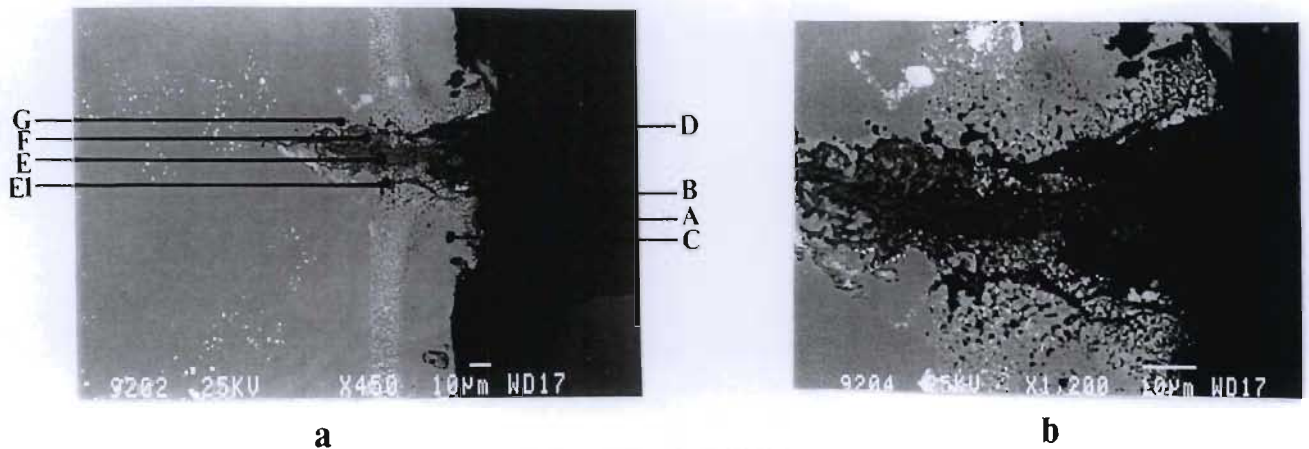
Figure 3.96 : Chemical analysis of crack through the TYPE I platinum aluminide coating after HTLCF in Ar + 5% SO₂ (S.R. 0.38%)

The corrosion product in the crack in the coating and on the external surface (figure 3.96) was composed of mainly aluminium oxides and sulphides. The black region in the coating adjacent to the corrosion scale (figure 3.96 pt. E1) was found to be essentially chromium sulphides with the oxygen content being insignificant. The corrosion product in the interdiffusion zone (figure 3.96 pt. E) was predominantly Ni, Co, and oxygen. As the corrosion-fatigue crack proceeded into the substrate the corrosion product became more complex with significant amounts of Ti, Cr, Ni, Ta, W, Al, oxygen and sulphur being detected. The distribution of sulphur and oxygen indicate that oxides are formed on the outer regions, with sulphides being formed in the scale/substrate interface. The corrosion front progressing into the alloy was fairly broad due to the sulphidation attack progressing "laterally" in the coating. The coating showed a high resistance to sulphidation attack with sulphidation attack being concentrated in the cracks.

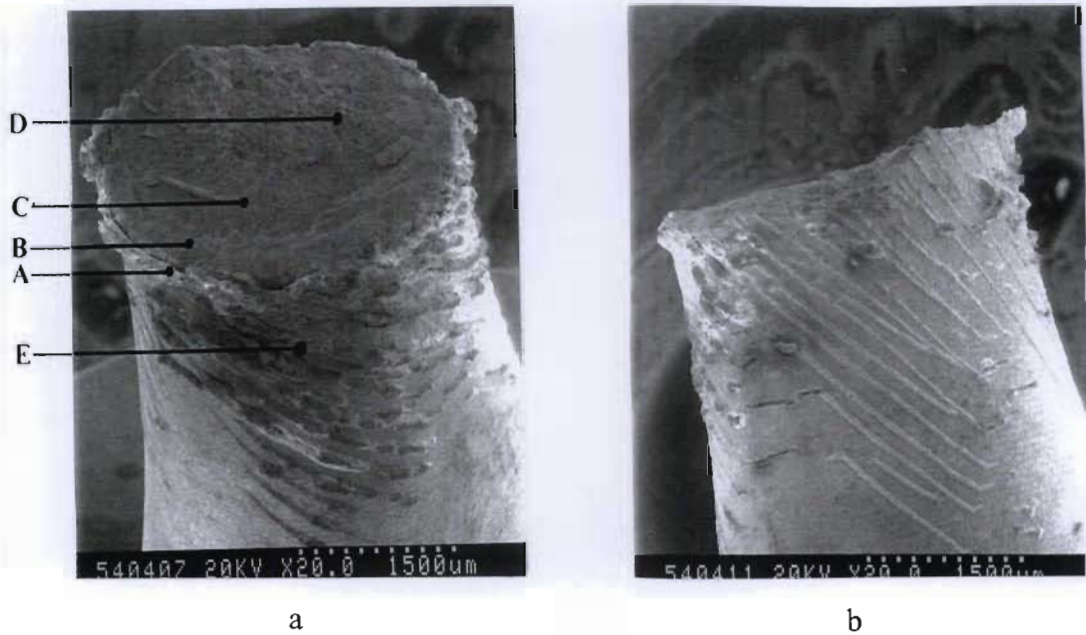
The fracture surface was covered with dark corrosion product (figure 3.97). There were again two distinct regions on the fracture surface, i.e., a smooth region where crack propagation occurred and a coarse region where final failure occurred. Chemical analysis of the fracture surface showed that the corrosion product was made up of a mixture of oxides and sulphides of the alloying elements. Cr, Ni and Co were the most significant of the alloying elements present. The amount of aluminium became much more significant closer to the coating/fracture surface interface. This was due to the higher aluminium content in the coating. The composition of the corrosion product on the external surface close to the fracture was essentially Ni, Cr, Al, oxygen and sulphur and platinum. The aluminium content was significantly higher than that on the fracture surface. The corrosion product on the lip of the cracks showed a composition similar to that detected on the fracture surface

Figure 3.97 : a) Fracture surface of TYPE II platinum aluminide coated MAR-M002 after HTLCF in Ar + 5%SO₂ (S.R. 0.38%)
b) Profile of the fracture surface showing cracking of the coating

The coating close to the fracture surface showed evidence of severe cracking and sulphidation attack (figure 3.97&98). Two modes of cracking was observed, namely, 45° to the direction of loading and circumferential cracks perpendicular to the direction of loading. The sulphidation attack was concentrated at the cracks in the coating. Swelling of the coating as a result of internal sulphidation was evident. The nature of the corrosion product, figure 3.98, indicated that it was in the molten state at the test temperature.

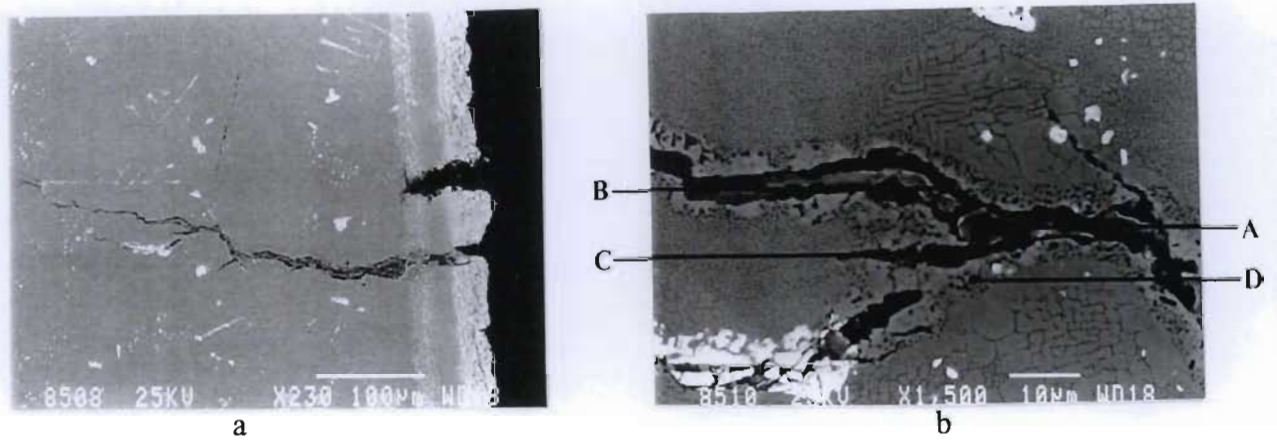
Figure 3.100 : Chemical analysis of the corrosion product in the crack propagating in the substrate of TYPE II platinum aluminide coated MAR-M002 after HTLCF in Ar + 5%SO₂ (S.R. 0.38).

Crack propagation was transdendritic and branched (figure 3.100). γ' denuded regions along the crack edge was evident. The corrosion product along the crack edge in the substrate (figure 3.100) was made up of mainly Cr, Ni, Al, S and oxygen. Chromium was found to be the major constituent in the centre of the crack (grey corrosion product). The sulphides

were concentrated at the crack edge indicating that the more stable oxides formed initially followed by sulphur being transported inwards and the formation of sulphur bearing phases at the crack edge. The corrosion product was a mixture of the oxides and sulphides of various alloying elements with the reactive elements Al, Cr, and Ni being most prominent.

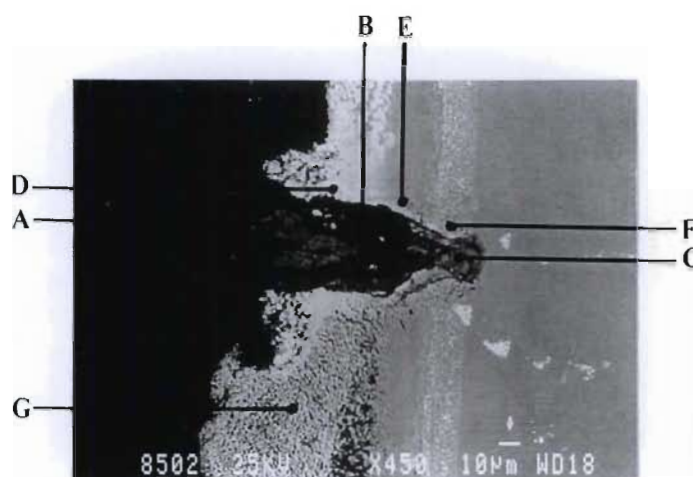
Figure 3.101 : Cross-section of TYPE II platinum aluminide coated MAR-M002 after HTLCF in Ar + 5% SO₂ showing chemical composition of the crack in the coating (S.R. 0.38%)

Figure 3.101 revealed that the corrosion product in the crack in the coating was made up of two distinct regions: the black region along the crack edge and the grey region in the centre of the crack. The grey region was made up of mainly Cr and oxygen with relatively small amounts of sulphur. The dark region was essentially a mixture of Al, oxygen and sulphur. At the crack tip (figure 3.101), the corrosion product was made up of mainly Co, Ni, S and oxygen with sulphur making up a significant proportion of the corrosion product. The coating adjacent to the crack was depleted of aluminium and chromium. The platinum aluminide (platinum rich white regions) phases were denuded along the crack edge.

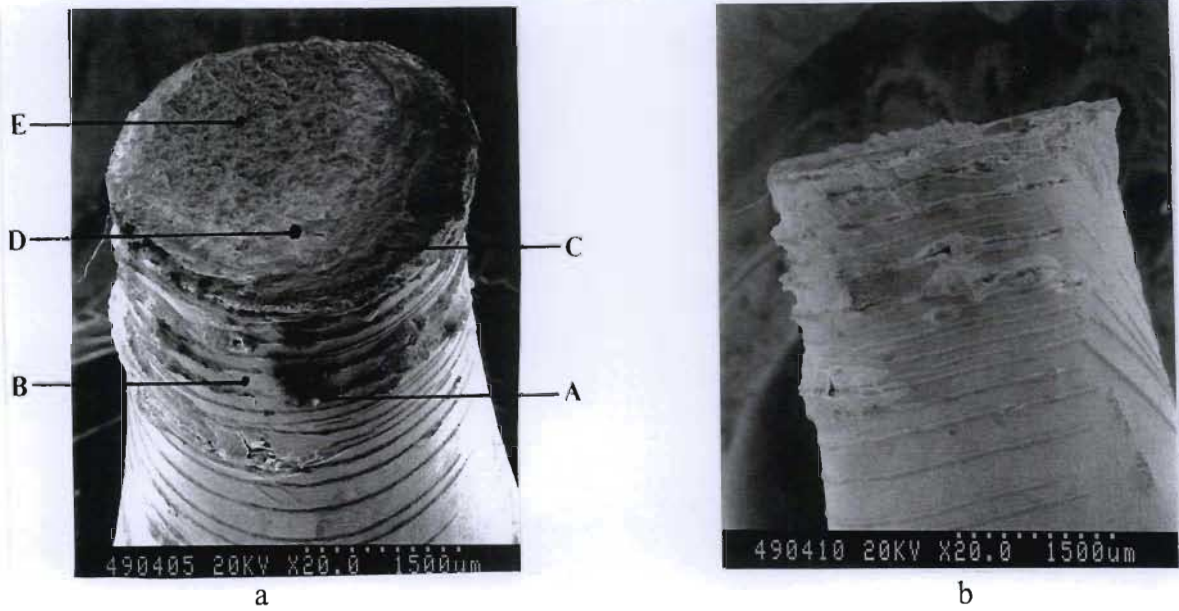
Sulphidation attack was evident on the fracture surface of 2 μ m platinum aluminide coated MAR-M002, figure 3.102. The fracture surface consisted of the two regions typical of corrosion fatigue in sulphidation environment, i.e., the "coarse" region and "smooth" region. The number of cycles to failure was 1821, which was approximately 3 times the test performed on a similar sample and similar conditions at a strain range of 0.66%. However, this result was significantly lower than that observed in similar tests performed on aluminide and uncoated samples. The external surface close to the fracture showed severe damage to the coating, i.e., cracking and even spalling of the coating in regions. Chemical analysis of the corrosion product on the fracture revealed that it was made up of a mixture of oxides and sulphides of the substrate alloying elements with Ni and Cr being the major constituents. The corrosion product on the cracks on the external surface was made up of mainly chromium and nickel oxides and sulphides. The "undamaged" coating between the cracks showed less evidence of sulphidation with the EDS analysis indicating that it was made up mainly of aluminium oxides.

Figure 3.102 : a) Fracture surface of 2 μ m platinum aluminide after HTLCF failure in Ar +5% SO₂ (S.R. 0.38%)
 b) Profile of fracture surface showing cracking of the coating.

It was evident that the coating was very brittle and prone to cracking (figure 3.102). Cracking of the coating occurred in two modes: one was circumferential cracks perpendicular to the loading direction and the other was cracks at approximately 45° to the loading direction. When the outer platinum rich layer was breached the sulphidation attack proceeded in the NiAl layer resulting in “swelling” of the coating in these regions. This process resulted in the lips of the cracks being forced outwards. Evidence of further cracking and spalling of the coating as a result of this process was also present (figure 3.103).

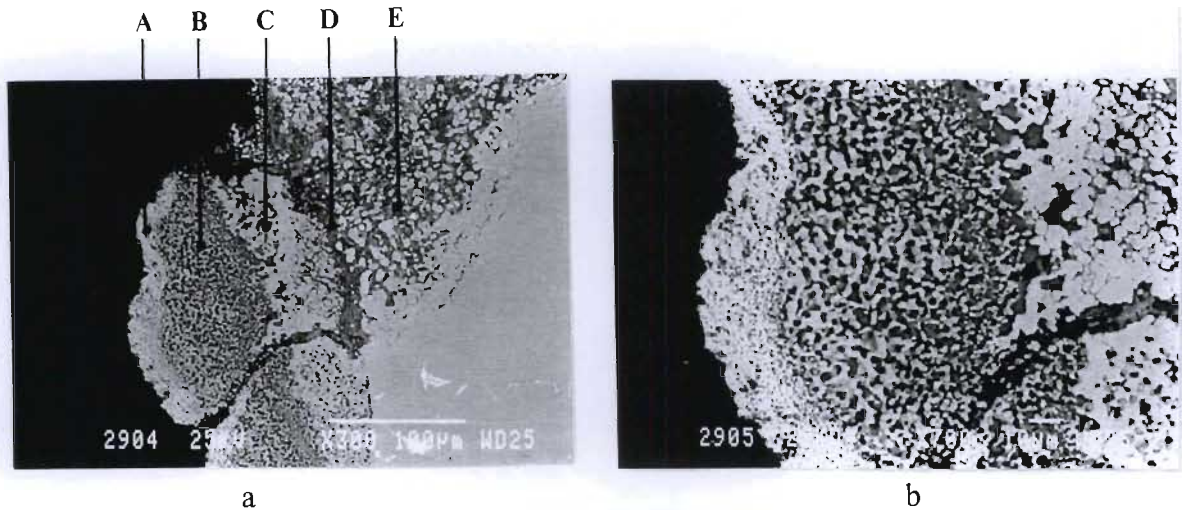
Chemical analysis of the cross-section close to the fracture (figure 3.105) showed that the corrosion products in the crack were made up of mainly oxygen, Ni, Cr and Al. It was evident that the main constituent of the corrosion product was oxides. The corrosion product in the “pores” in the coating was made up of essentially the sulphides of Ni and the NiAl zone was severely depleted of aluminium. Again “leaching” of the aluminium was instrumental in resulting in the “porous” nature of the coating.

Figure 3.105 : Chemical analysis of the region close to the fracture surface showing internal sulphidation of the 2 μ m platinum aluminide coating (S.R. 0.38%)
