**The Influence of Sulphidizing Attack on the
Mechanism of Failure of Coated Superalloy Under
Cyclic Loading Conditions**

**Submitted in fulfilment of the academic requirements for the degree of
PHD in Mechanical Engineering in the Department of Mechanical
Engineering, University of Natal, Durban.**

January 1998

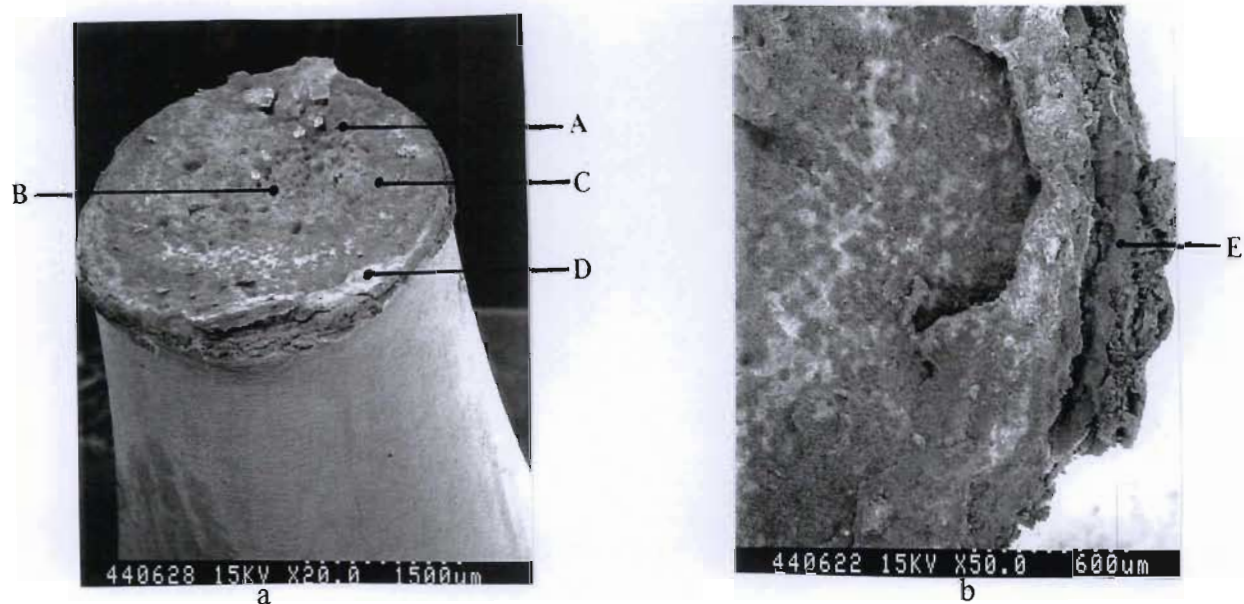
The fracture surface of platinum coated MAR-M002 after HTLCF, at a strain range of 0.38%, in SO₂ bearing atmosphere is shown in figure 3.106. The surface was covered with dark corrosion product. The “smooth” region where crack propagation had occurred and the “coarse” region where final failure had occurred were evident. The number of cycles to failure was 3037. The “coarse” region where final failure had occurred was much smaller than that observed in the test performed at the higher strain range. The number of cycles to failure was about 11 times that observed at a strain range of 0.66%. However, the life of the platinum coated sample was approximately $\frac{1}{2}$ that of the aluminide coated sample and $\frac{1}{3}$ that of the uncoated sample. Chemical analysis of the fracture surface indicated that the corrosion product was made up of Cr, Ni, S and oxygen. Oxygen was very prominent in the surface analysis indicating a high presence of oxides in the corrosion product. The external surface close to the fracture revealed a higher resistance to sulphidation attack with the oxygen and sulphur contents being significantly lower than that observed on the fracture surface. Aluminium played a more prominent role since the amount of aluminium detected was much higher than that on the fracture surface.

Figure 3.106 : Fracture surface of platinum coated MAR-M002 after HTLCF in Ar + 5%SO₂ (S.R. 0.38%)

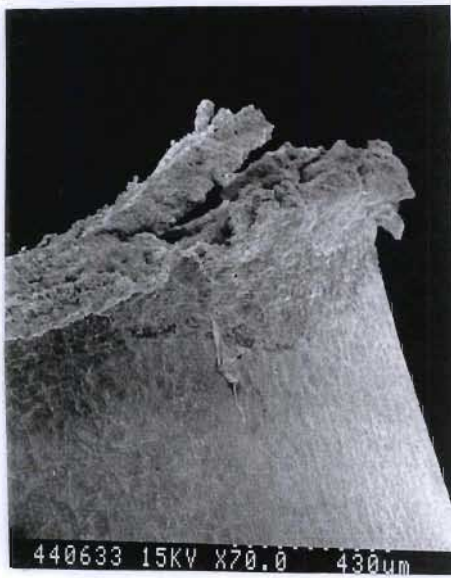
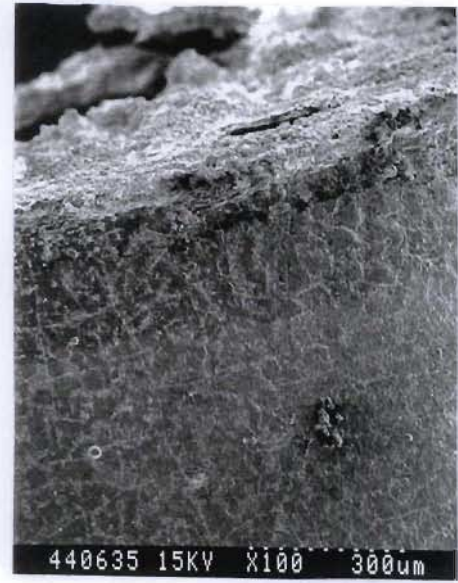
AES analysis of the fracture surface (figure 3.107) indicated that the corrosion product was made up of mainly Cr, Ni, Al, Ti, sulphur and oxygen. The amount of oxygen was present in significant quantities, confirming the EDS analysis. There was some evidence of internal sulphidation of the of the substrate as can be seen by the sulphur detected in the region just below the fracture surface (figure 3.107). Close up examination of the fracture/coating interface showed evidence of peeling of the coating (figure 3.108).

The external surface close to the fracture showed little evidence of cracking. The coating was fairly resistant to sulphidation attack except in the regions immediately adjacent to the fracture surface (figure 3.108).

Figure 3.108: Fractography of platinum coated MAR-M002 after HTLCF in Ar + 5% SO₂ (S.R. 0.38%)

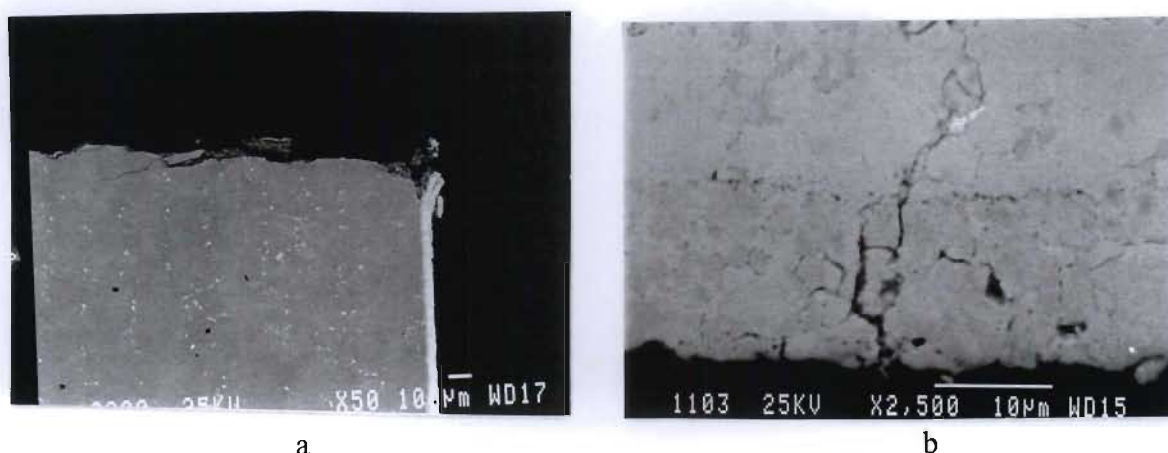
Cross-sectional examination revealed that the coating thickness had grown to approximately 46 μm (figure 3.109). There was no evidence of severe cracking of the coating. The coating had peeled away from the substrate at the coating/fracture interface. It was evident that the γ' depleted zone was prone to sulphidation attack. The corrosion process proceeded more rapidly in this region than in the coating itself. High magnification of the region where the coating was peeling (figure 3.110) showed depletion of the "white phases" present in the coating. The cracks in the coating (figure 3.109) were branched and tended to propagate in the "grey" regions. There was also evidence of internal sulphidation (indicated in figure 3.109). Again, the evidence indicated that the grey region was more susceptible to sulphidation attack.

Figure 3.109 : Cross-section of platinum coated MAR-M002 after HTLCF in Ar + 5% SO₂ (S.R. 0.38%)

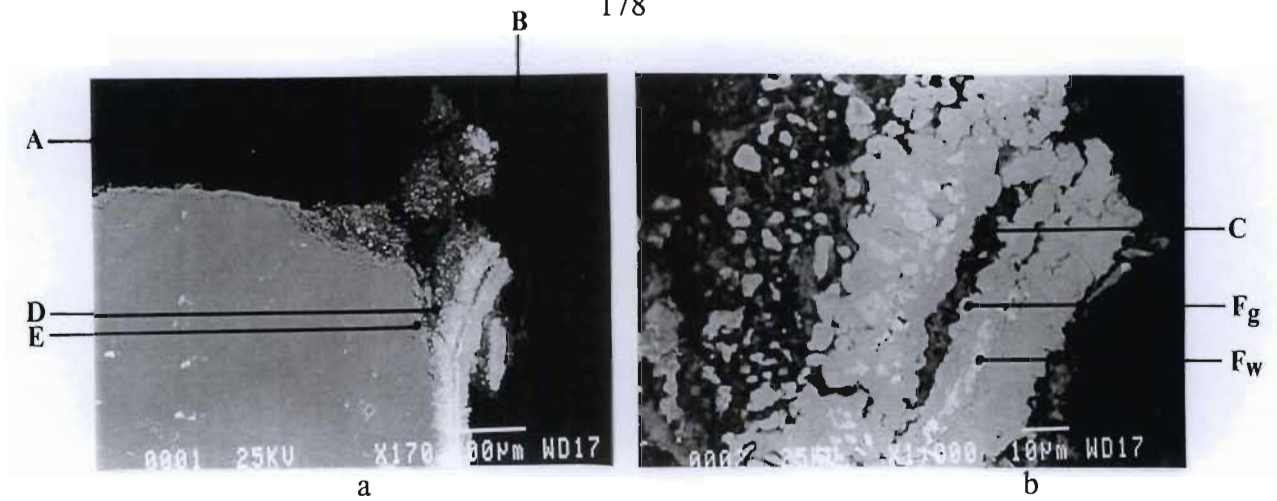
The corrosion product in the region where peeling of the coating occurred was in general composed of a mixture of oxides and sulphides of the alloying elements (figure 3.110a). The major constituents were Cr, Ni, sulphur and oxygen, with small but significant amounts of aluminium present. From the analysis of region A, figure 3.110a, it was evident that a large proportion of the of the corrosion product was made up of sulphides. Analysis of the corrosion product on the external surface (figure 3.110 pt.B) indicated that it was made up

of essentially Cr and Ni oxides and sulphides with the oxides being more prominent. The corrosion product inside the coating (figure 3.110 pt. C) was essentially composed of Ni, Hf, Ta, sulphur and oxygen with smaller amounts of other alloying elements. The regions adjacent to this point were depleted of the reactive elements Cr and Al. Corrosion product in the γ' depleted zone contained significant amounts of the refractory elements W, Ta and Ti and Ni, sulphur and oxygen.

Figure 3.110 : Cross-section of platinum coated MAR-M002 after HTLCF in SO_2 showing peeling of coating and EDS analyses (S.R. 0.38%)

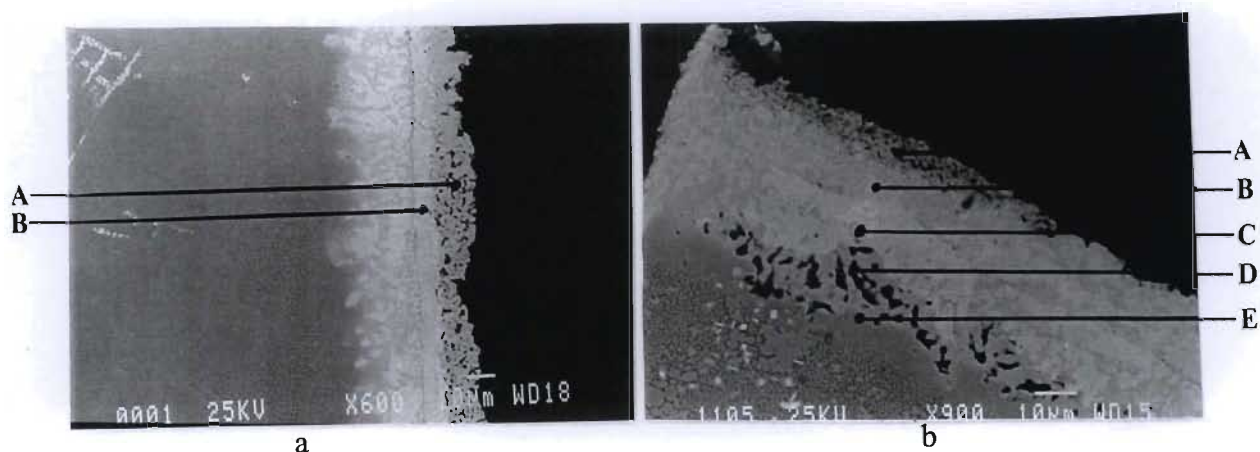
Although the coating in general showed evidence of adequate sulphidation resistance, there were regions in which internal sulphidation was evident (figure 3.111a&b). This resulted in a “porous” type outer layer. The corrosion product in the “pores” was made up of the sulphides of Cr and Ni essentially with no evidence of oxides. The region adjacent to these “pores” was depleted of chromium. Figure 3.111b is a micrograph of a transverse cross-section showing corrosion process proceeding in the γ' depleted zone and internal sulphidation of the coating. The “pores” in the γ' depleted zone were filled with mainly Cr and Ni sulphides with no oxygen being detected.

Figure 3.111 : Sulphidation of the external surface of the platinum coating after HTLCF in SO_2 (S.R. 0.38)

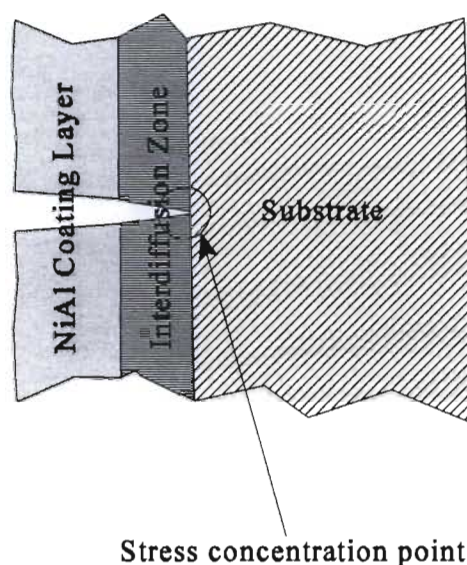
The aluminide coated superalloy may be regarded as a composite with the coating having very brittle properties and the substrate being fairly “ductile”. Under tensile loads the NiAl coating fractured in a brittle fashion. It was evident that the failure of the coating had occurred early in the fatigue test. The crack was straight and propagated perpendicular to the direction of loading. The crack in the coating resulted in a high stress concentration point at the coating substrate interface (figure 4.2). Initiation of fatigue cracks in the substrate had

occurred at the points where the coating had failed, and did not show any preference to initiate at the interdendritic zones. The controlling factor in the HTLCF of the aluminide coating was the failure/cracking of the aluminide coating. Failure of the coating accelerated the initiation of fatigue cracks in the substrate and accelerated the failure of the material system. Fatigue crack propagation in the substrate proceeded as in the uncoated alloy.

Figure 4.2: Brittle failure of aluminide coating due to mechanical loading

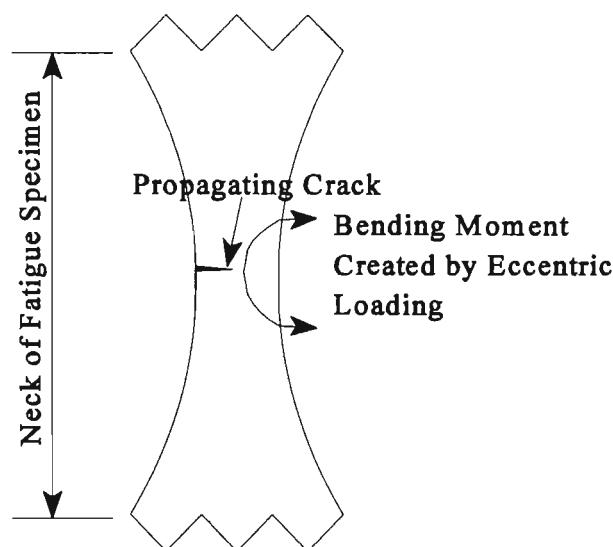
The “45° cracks” observed in the fractography analysis was produced by the mechanism illustrated in figure 4.5. Once the propagating fatigue crack had penetrated the substrate to a sufficient depth, the tensile load did not act uniaxially on the material supporting the load. This resulted in a bending stress in the material under the tensile half of the fatigue cycle. The combination of tensile load and bending load resulted in the “45° cracking” of the brittle PtAl_2 .

Figure 4.5 : Mechanism that may have produced the cracks in the coating at an angle of 45°

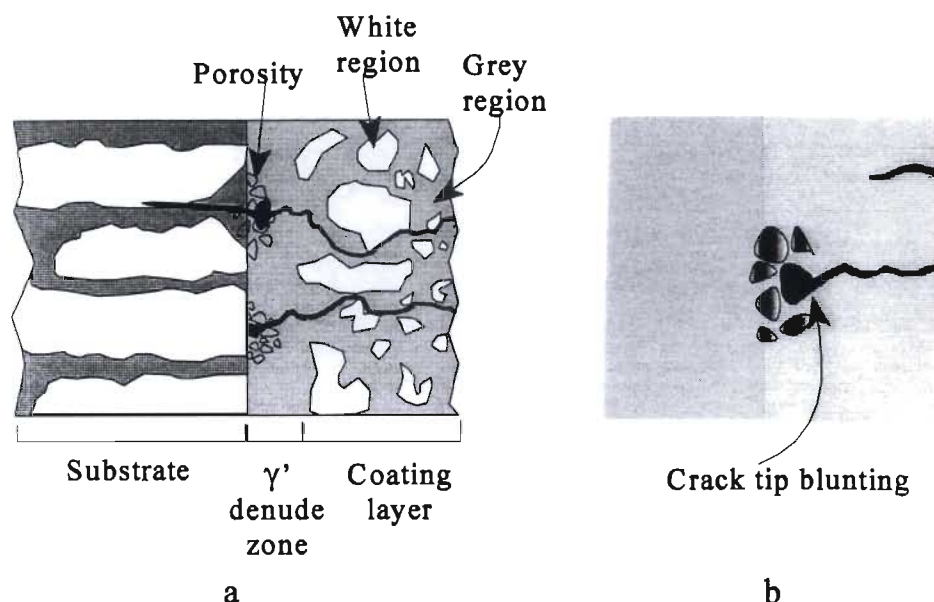
Cracks were initiated in the “grey” region due to its brittle nature. The fatigue crack also tended to propagate through this region (figure 4.6a). The platinum rich “white” regions acted as crack “stoppers”, forcing the crack to propagate around these particles. This slowed down the crack propagation through the coating. In general, it was found that the crack initiation in the substrate had occurred in the interdendritic segregation zone, which was a similar behaviour to the uncoated alloy.

Another feature in the coating which probably contributed to its poor performance was the presence of porosity at the substrate/coating interface. This was most probably Kirkendall porosity which resulted from the preferential diffusion of certain alloying elements outwards. The porosity was most prominent in the regions where the fatigue cracks had been arrested at the dendritic grains.

Figure 4.6 : a) Crack propagation through platinum coating after HTLCF in argon
b) Crack tip blunting due to porosity

From the characterization of the sample it was evident that the Kirkendall porosity is an inherent property of the coating, hence, this is going to be present even without fatigue loading. The extent of the porosity will be dependent on the exposure time of the specimen. Once the propagating fatigue crack “broke” into the porous region, the crack tip was blunted reducing the stress concentration at the crack tip (figure 4.6b). This resulted in the crack being arrested and the crack had to be “reinitiated” in order for propagation to proceed. Coalescence of these pores resulted in delamination of the coating.

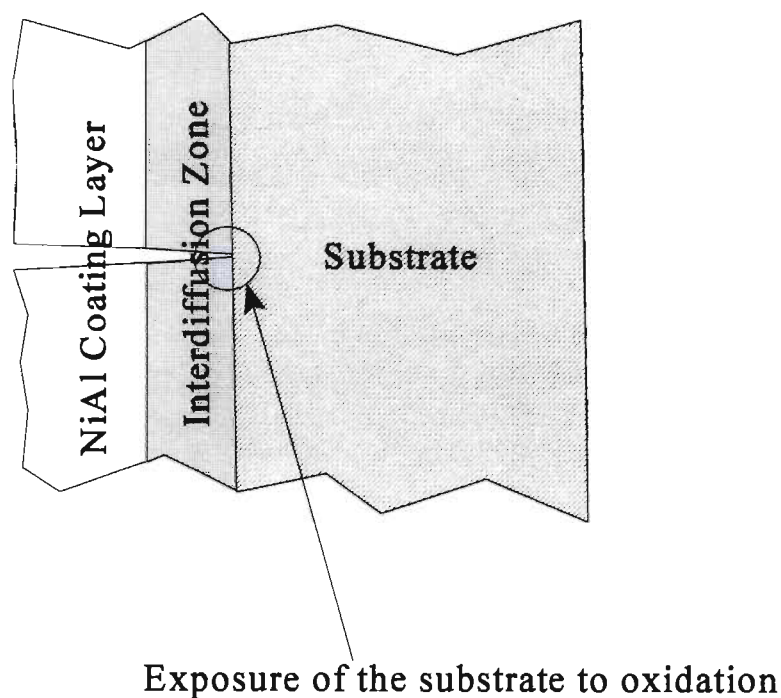
Once the coating fractured the air environment was transported to the crack tip in the coating where oxidation of the substrate proceeded (figure 4.8). Similar results were observed by Czech *et al* [171] where the creep rupture life was influenced by the cracking of the chrome-aluminide coating. The corrosion protection function of the coating was effectively bypassed due to the cracking of the coating. The cracks in the coating had the additional effect of creating stress concentration points at the coating/substrate interface which, combined with the materials susceptibility to oxidation accelerated the initiation of fatigue cracks in the substrate. The crack propagation in the substrate was of a similar mechanism to that observed in the uncoated alloy. The edge of the cracks in the coating showed no evidence of corrosion which was probably due to the formation of a stable Al_2O_3 early in the oxidation process. This indicated that the aluminide coating was not suitable under conditions of high stress due to its brittle nature. This type of coating will perform most effectively under conditions of much lower mechanical stresses.

Figure 4.8 : HTLCF failure of the aluminide coated MAR-M002 in air

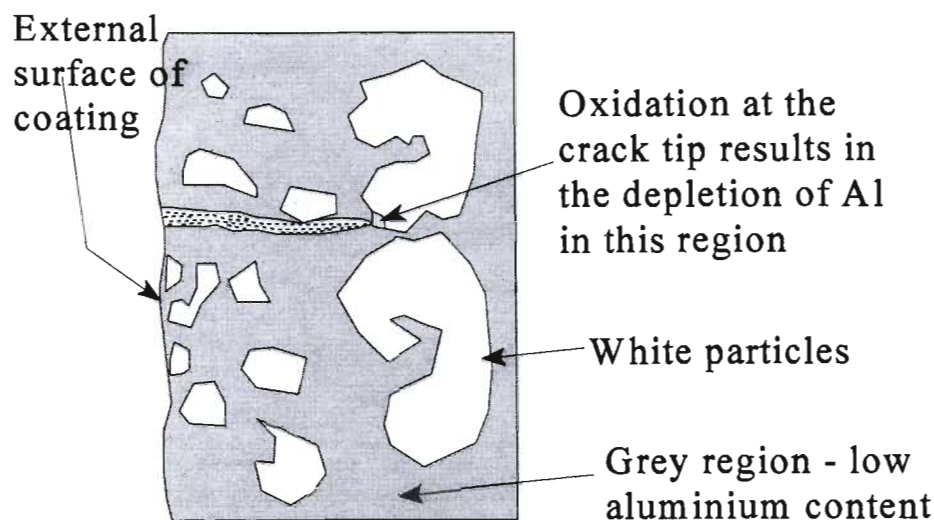
Oxidation occurring at the crack tip altered the crack propagation mode through the coating with the results indicating a "straighter" crack through the coating. Although the white particles did show some resistance to crack propagation, they were not as effective as that observed in the argon atmosphere. The oxidation process occurring at the propagating crack tip depleted this region of the reactive elements (aluminium) resulting in the alteration of the chemical structure which in turn resulted in the change in the mechanical properties (figure 4.9). This resulted in the crack propagation in the coating being relatively straight. The γ'

Figure 4.9 : Mechanism of fatigue crack propagation in the platinum coating in air atmosphere

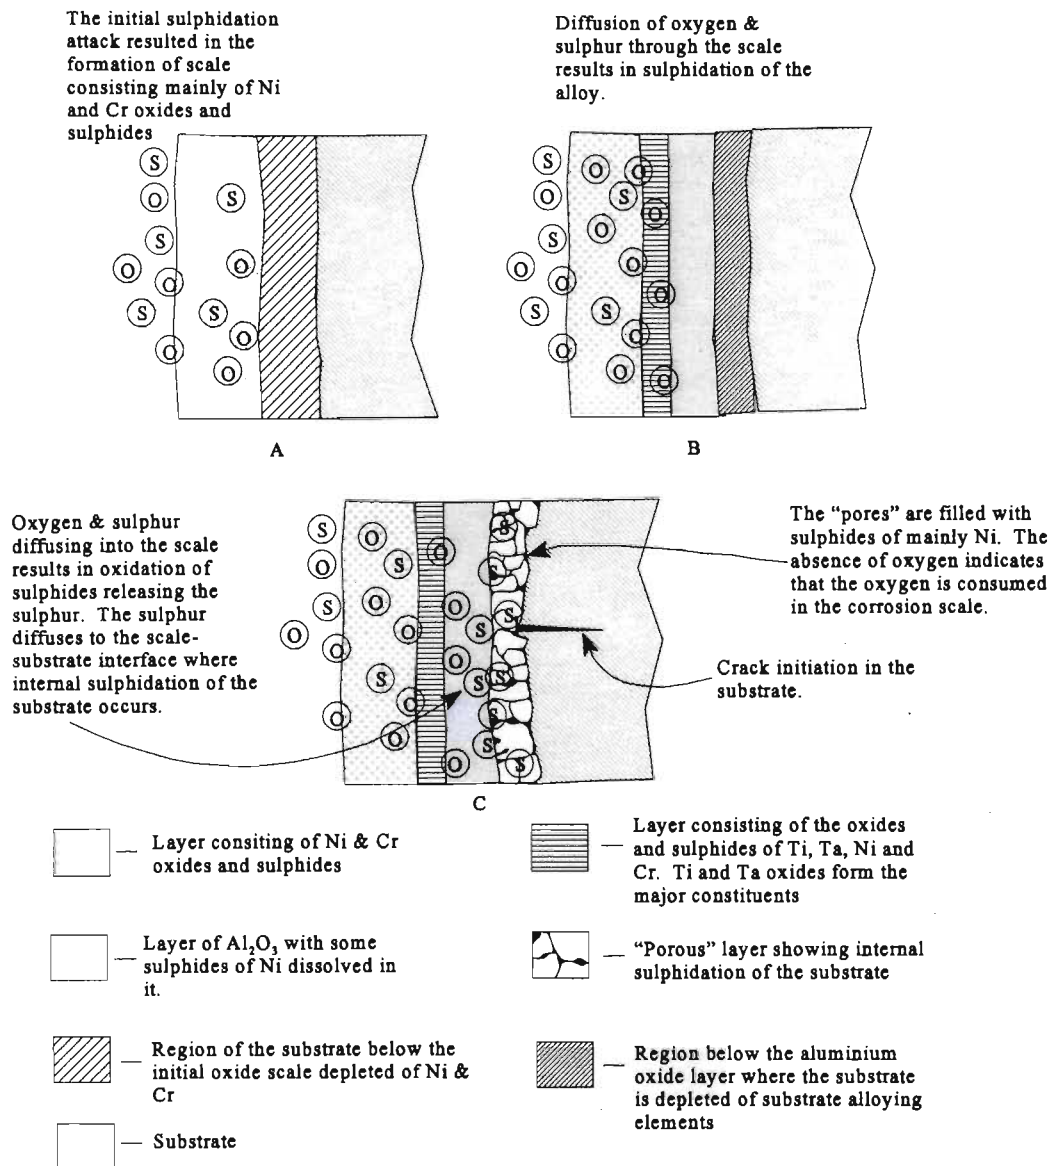
The HTLCF in Ar + 5%SO₂ consisted of the incubation period, crack initiation and crack propagation stages. During the incubation period severe sulphidation of the external surface occurred resulting in a "layered" structure (figure 4.10) with each layer having distinctive

Figure 4.10 : Mechanism of sulphidation of the uncoated MAR-M002 after HTLCF in Ar + 5%SO₂

The initial sulphidation attack resulted in the formation of a scale consisting of mainly Ni and Cr oxides and sulphides. The alloy below this corrosion scale became depleted of these elements (figure 4.10a). The diffusion of oxygen and sulphur through the scale resulted in the oxidation of this region. The oxidation mechanism will be the same as that observed in the case of alloys. Initially a mixture of oxides of the alloying elements will form followed by formation of the more stable oxide phases at the substrate-corrosion scale interface. This resulted in the "continuous" Al_2O_3 below a layer rich in Ti and Ta oxides (figure 4.10b). It must be noted that although the oxidation reaction was predominant, there was a significant

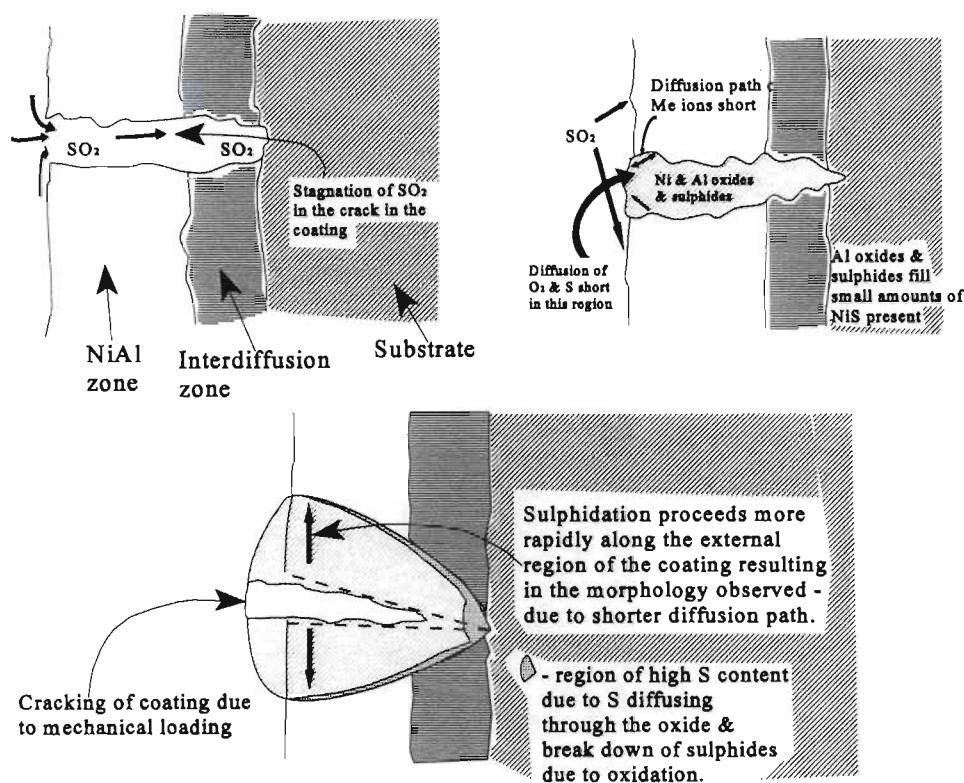
There were additional cracks observed in the coating which had not propagated into the substrate. These had occurred due to brittle failure of the coating but there was insufficient time for them to propagate into the substrate due to high propagation rate of the initial fatigue crack. Sulphidation attack in cracks present in the coating occurred by the following mechanism (figure 4.11):

SO₂ filled the crack once the coating had fractured and stagnation of gas occurred (figure 4.11a). The corrosion process that occurred was similar to that observed in the uncoated alloy (figure 4.11b). In this case, however, a mixture of Al and Ni oxides and sulphides fill the crack with aluminium oxide being more prominent. The sulphide phases again tended to form closer to the corrosion scale/coating interface indicating that oxides formed first and

Figure 4.11 : Mechanism of corrosion that occurred in the cracks of the aluminide coating after HTLCF in Ar + 5% SO_2 at 870°C

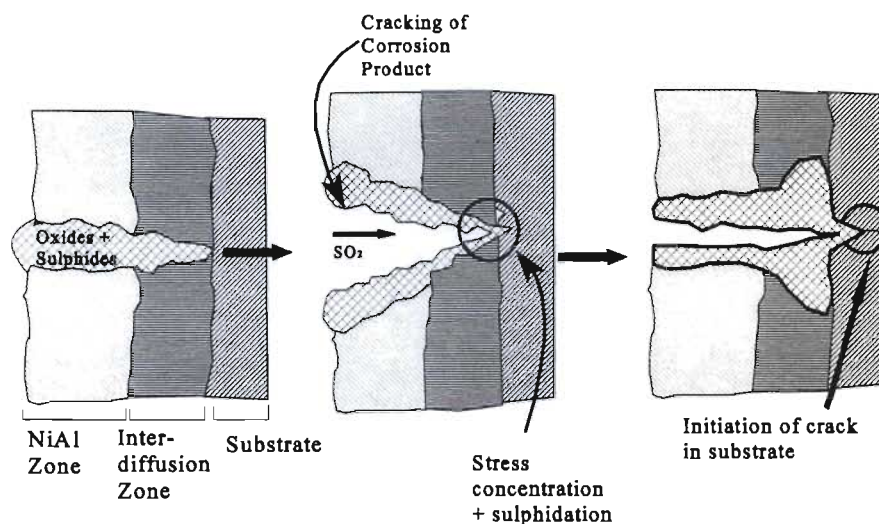
The cracks were filled with oxides which should have "stopped" or slowed down the sulphidation attack of the substrate, however, due to the mechanical loading, cracking of the oxides occurred under the compressive loading cycle which provided a path for the SO_2 gas to be transported to the crack tip. The following failure mechanism for the failure of the Al coating under high strain conditions is proposed (figure 4.12):

Figure 4.12 : Mechanism that resulted in the crack initiation in an aluminide coated MAR-M002 sample after HTLCF in Ar + 5%SO₂

the failure of the coating occurs via mechanical loading. The crack was filled with corrosion product (mainly oxides). Cracking of the corrosion product occurred during the compressive loads. This allowed gas to be transported to the crack tip during tensile loading. Sulphides in the corrosion scale were oxidized, releasing sulphur which was transported to crack tip. The interdiffusion zone which has a higher susceptibility to sulphidation allows sulphidation to proceed parallel to the substrate. The high stress concentration at the crack tip combined with the sulphidation attack initiated the fatigue crack in the substrate (figure 4.12)

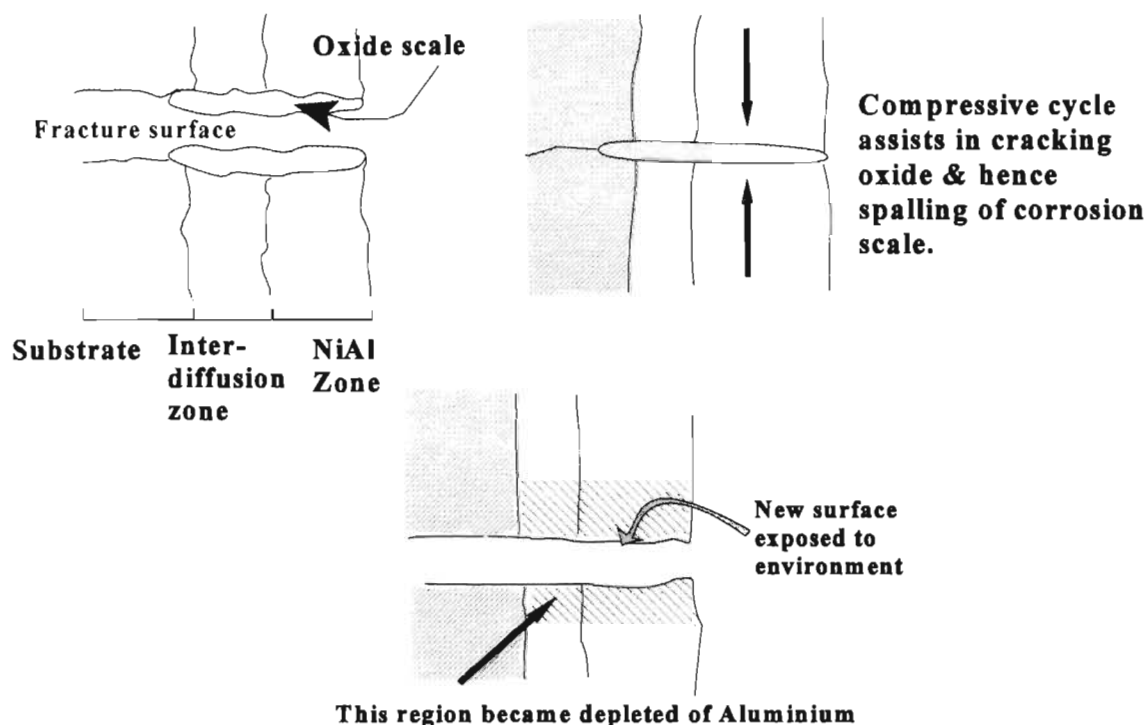
The “porous” nature of the coating at the coating/fracture surface interface occurred by the “fluxing” process illustrated in fig. 4.13. The opening and closing of the crack under the cyclic loading resulted in spalling of the oxide scale from the fracture surface. Hence, the protective oxide scale was “eroded” away continuously. This resulted in the aluminium being depleted from the coating by the repeated sulphidation attack since aluminium was most reactive. This allowed for the diffusion of sulphur into the coating and the formation of the less stable, low melting point Ni sulphides.

Figure 4.13 : Fluxing of aluminium from the aluminide coating due to the cyclic loading.

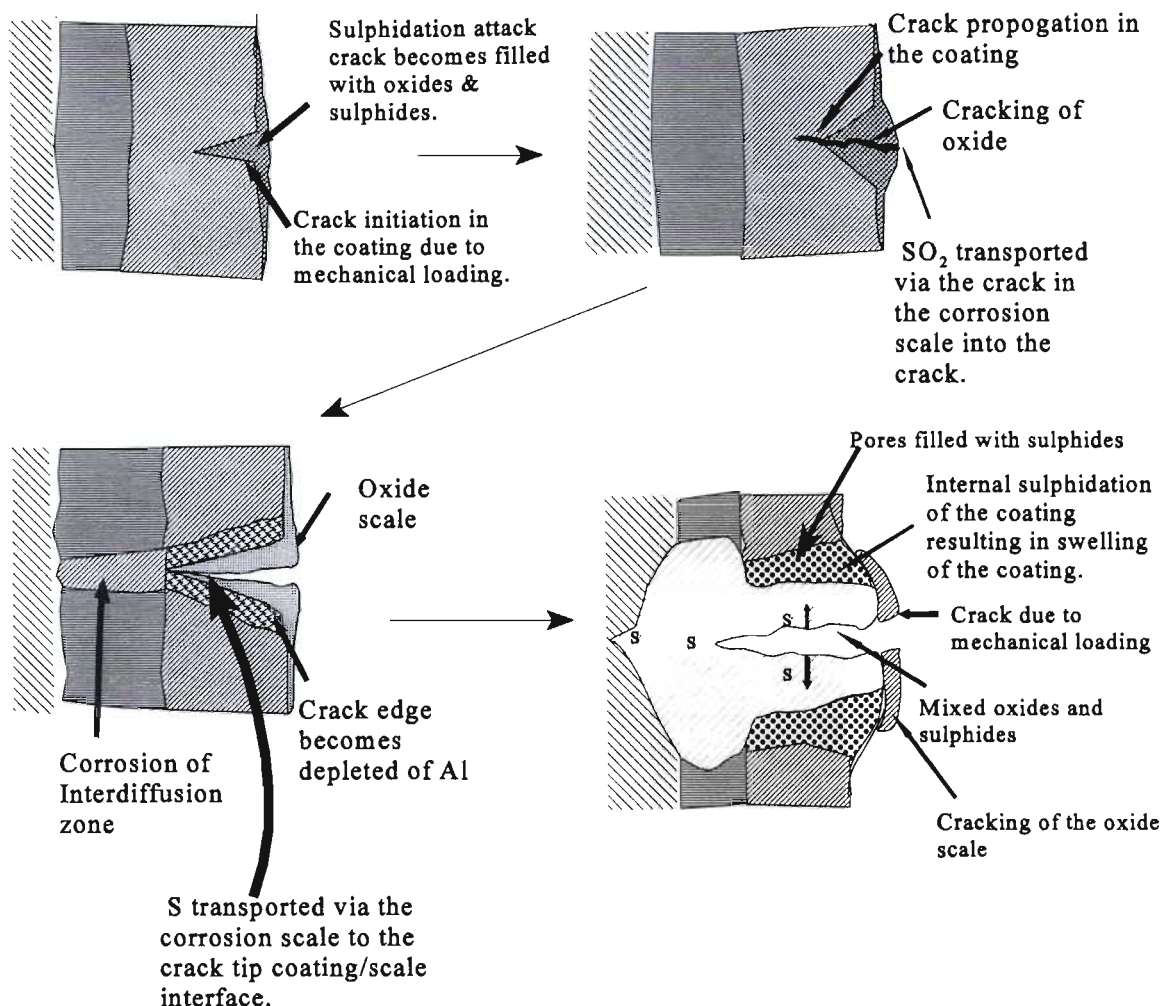
The proposed blistering mechanism which occurred during the incubation period was as follows (fig. 4.14):

When fatigue cracks were initiated in the coating they became filled with the oxides and sulphides of Al and Ni. This effectively protected the propagating crack tip in the coating.

Figure 4.14 : Blistering mechanism that occurred during the HTLCF of aluminide coating MAR-M002 in Ar + 5% SO_2 at a strain range of 0.38 %

However, due to mechanical loading, the corrosion scale was cracked allowing the environment to penetrate the scale. This resulted in a “fluxing” mechanism. Every time a crack was created in the oxide “fresh” SO_2 was supplied into the crack creating a concentration gradient which allowed for the diffusion of alloying elements and the reagent, in this case sulphur and oxygen. This continual fluxing mechanism resulted in the depletion of aluminium in the region adjacent to the crack and resulted in internal sulphidation. The presence of low melting point nickel sulphides in the coating accelerated the sulphidation attack in this region which resulted in the “swelling” of the coating. The sulphidation processes proceeded more rapidly along the interdiffusion zone resulting in a relatively broad corrosion “front”. This combined with the internal sulphidation resulted in the blistering of the coating. Crack initiation was accelerated when compared with the uncoated alloy due

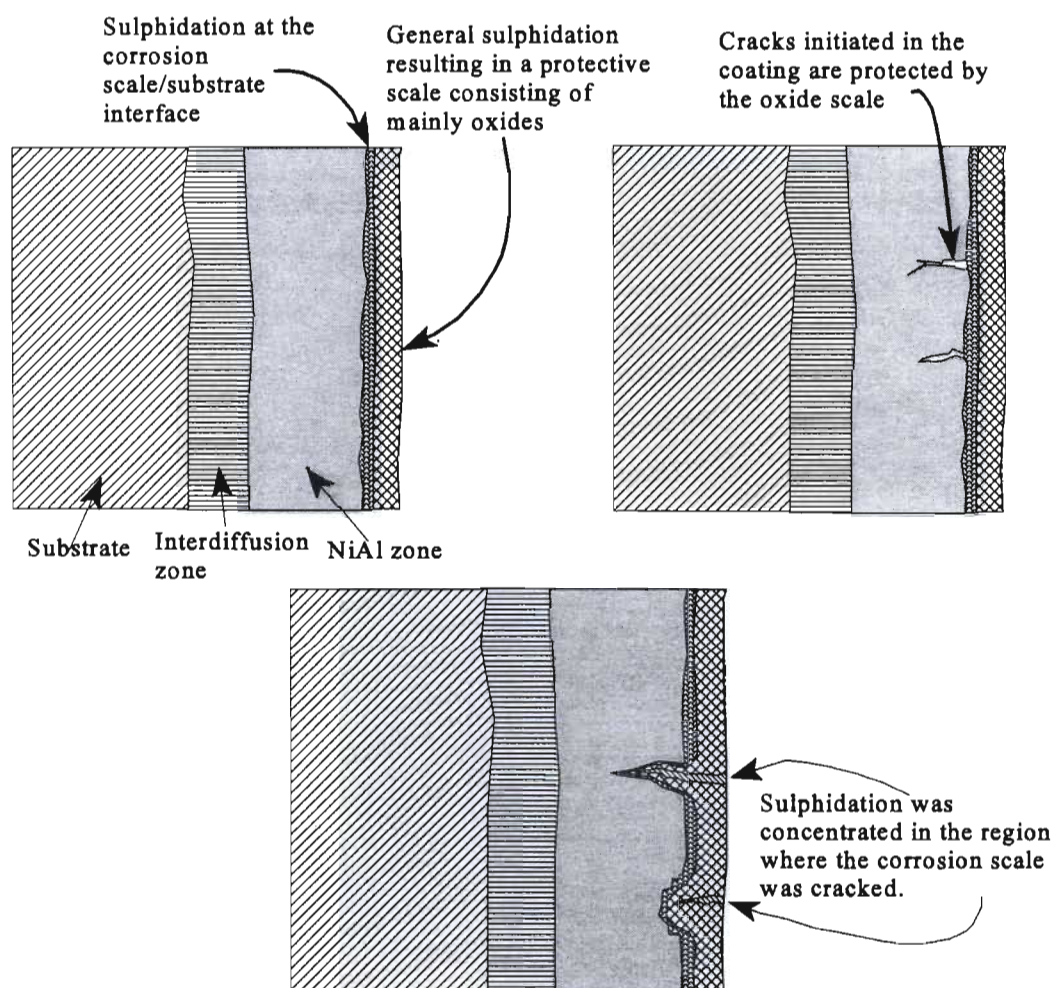
The coating evidently displayed a “self healing” mechanism even though there was evidence of fatigue cracks in the coating. Due to the improvement in the mechanical properties, cracking of the coating did not occur immediately. General sulphidation of the coating surface covered the external surface with an oxide rich continuous corrosion scale (figure 4.15). Hence, when cracks did initiate in the coating they were protected from the environment. The sulphidation mechanism was the same as described previously with oxidation occurring first and sulphidation occurring at the corrosion scale/coating interface.

The corrosion scale remained “protective” as long as it was “undamaged”. Once the oxide scale was cracked, sulphidation of the coating was concentrated in these regions. As long as the cracks in the coating were protected, the propagation mechanism in the coating was similar to that observed in the argon atmosphere. Once the oxide layer was breached

Figure 4.15: Self-healing mechanism of TYPE I platinum aluminide coated MAR-M002 after HTLCF in Ar + 5%SO₂ (S.R. 0.66%)

sulphidation at the crack tip controlled the crack propagation in the coating. Crack initiation in the substrate occurred at stress concentration points where the crack had penetrated the coating. Again crack propagation in the substrate was as that observed in the uncoated alloy. From this result, it was concluded that the increase in the incubation period (i.e time to crack initiation in the substrate) was the reason for the improved corrosion fatigue life in Ar + 5%SO₂ at the higher strain range.

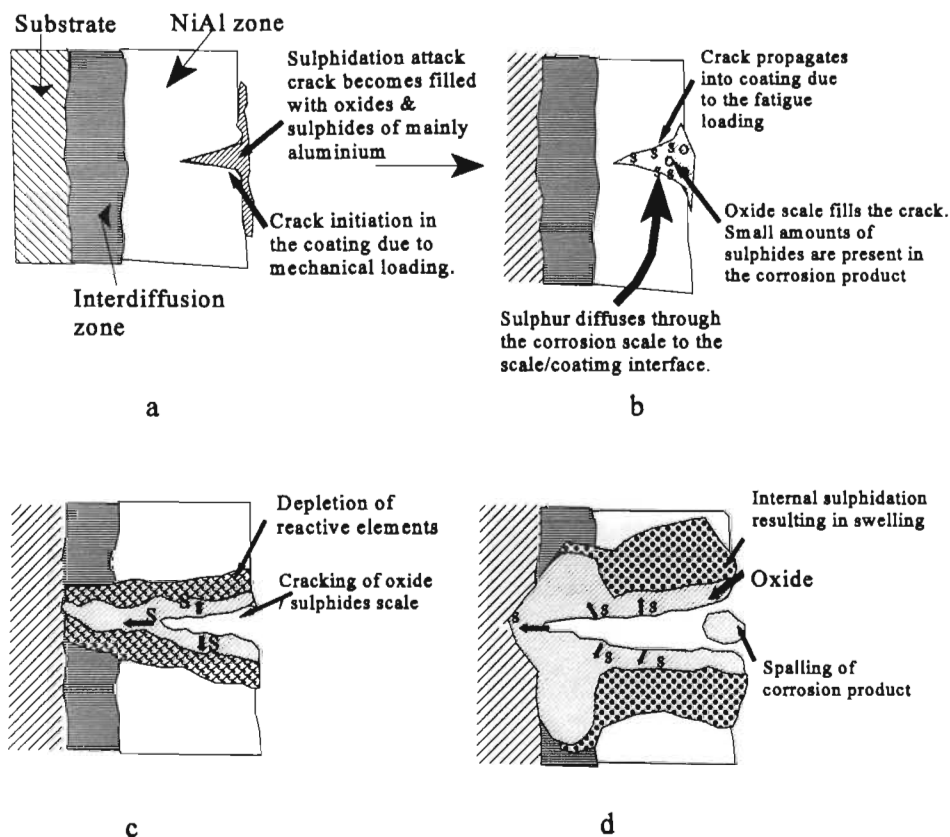
The following mechanism describes the corrosion process within the crack in the coating: Once the coating was cracked, SO₂ stagnated in the crack and the ensuing corrosion process filled the crack with oxides and sulphides (figure 4.16 a). The oxides layer failed due to the

Figure 4.16 : HTLCF failure mechanism of TYPE I platinum aluminide coated MAR-M002 in SO_2 containing environment at a strain range of 0.38%.

mechanical loading creating the “fluxing” effect described for the aluminide coating (figure 4.16c). This process depletes the coating of reactive elements and enhances the internal sulphidation of the coating due to sulphur being transported to the corrosion scale/coating interface (figure 4.16). The internal sulphidation of the coating resulted in the formation of low melting point nickel sulphides, hence, causing “swelling” of the coating. The interdiffusion zone again was most susceptible to sulphidation resulting in a wide corrosion “front” proceeding into the substrate, beneath the coating. The build up of corrosion product in the substrate and interdiffusion zone contributed to forcing the coating outwards. It was apparent that the platinum content in the TYPE I platinum aluminide was critical to its mechanical and corrosion properties. The higher the platinum content the more brittle the coating and failure occurred relatively rapidly, even under low strain ranges. The higher platinum content also improved the sulphidation resistance of the coating but the detrimental effect on the mechanical properties resulted in an overall reduction of the HTLCF in Ar + 5% SO_2 when compared to the aluminide coating tested at the 0.38% strain range.

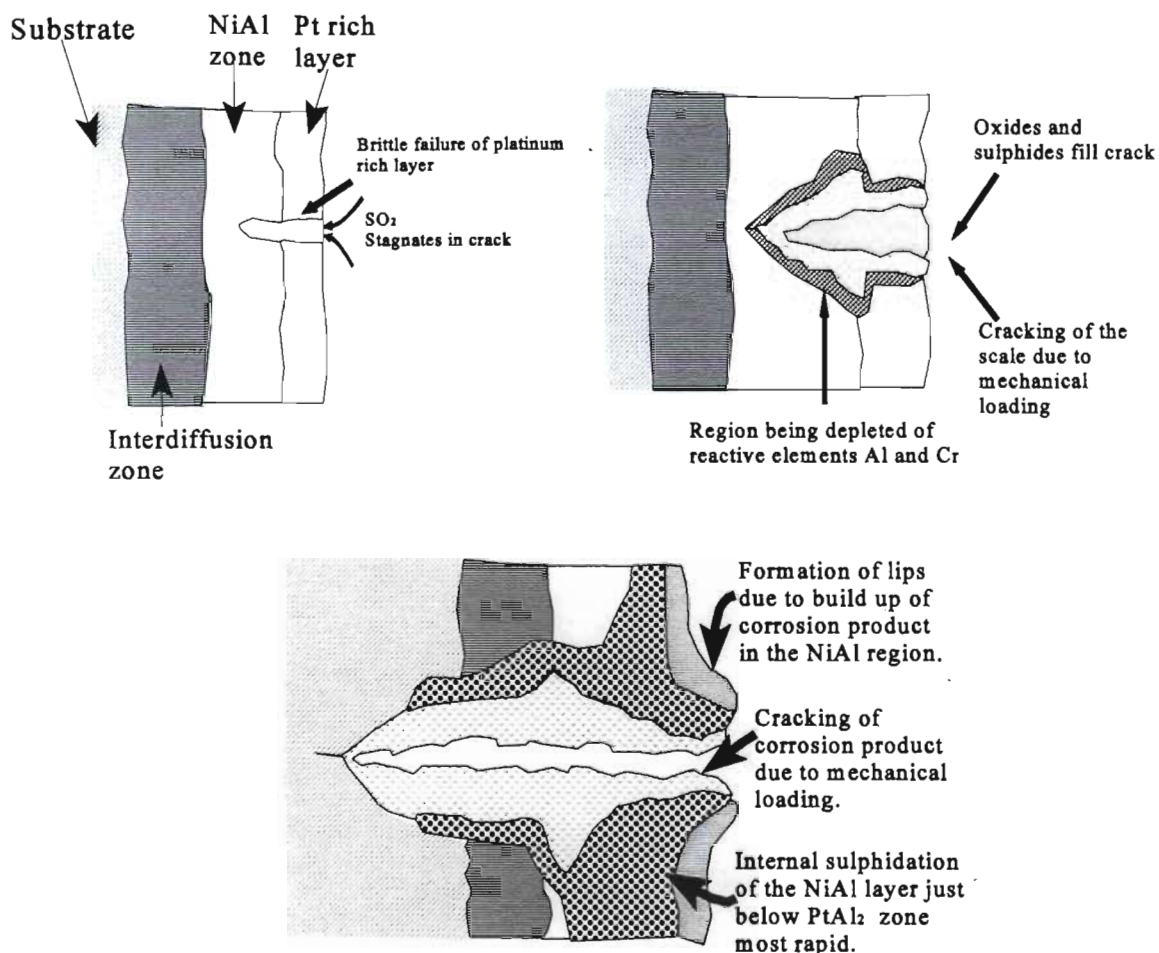
The mechanism via which these coatings failed under HTLCF loading in Ar + 5%SO₂ was as follows (figure 4.17):

The brittle platinum aluminide phase on the external surface failed under mechanical loading. This allowed the SO₂ gas to stagnate in the cracks. The thermodynamics of the corrosion reaction ensured the formation of oxides and small amounts of sulphides. The corrosion product filling these cracks provided some protection, however, the mechanical loading resulted in the cracking of the corrosion product.

The corrosion mechanism resulted in the formation of a oxide scale initially and sulphur diffused via this scale to the scale/coating interface and the crack tip in the coating. At the crack tip, Al and Cr sulphides formed initially, however, due to high sulphur content these elements were depleted and low melting point nickel sulphides formed. This combined with mechanical loading enhanced the sulphidation attack and the crack propagation rate in the coating.

Figure 4.17 : Failure Mechanism of TYPE II platinum aluminide coating in SO_2 containing environment

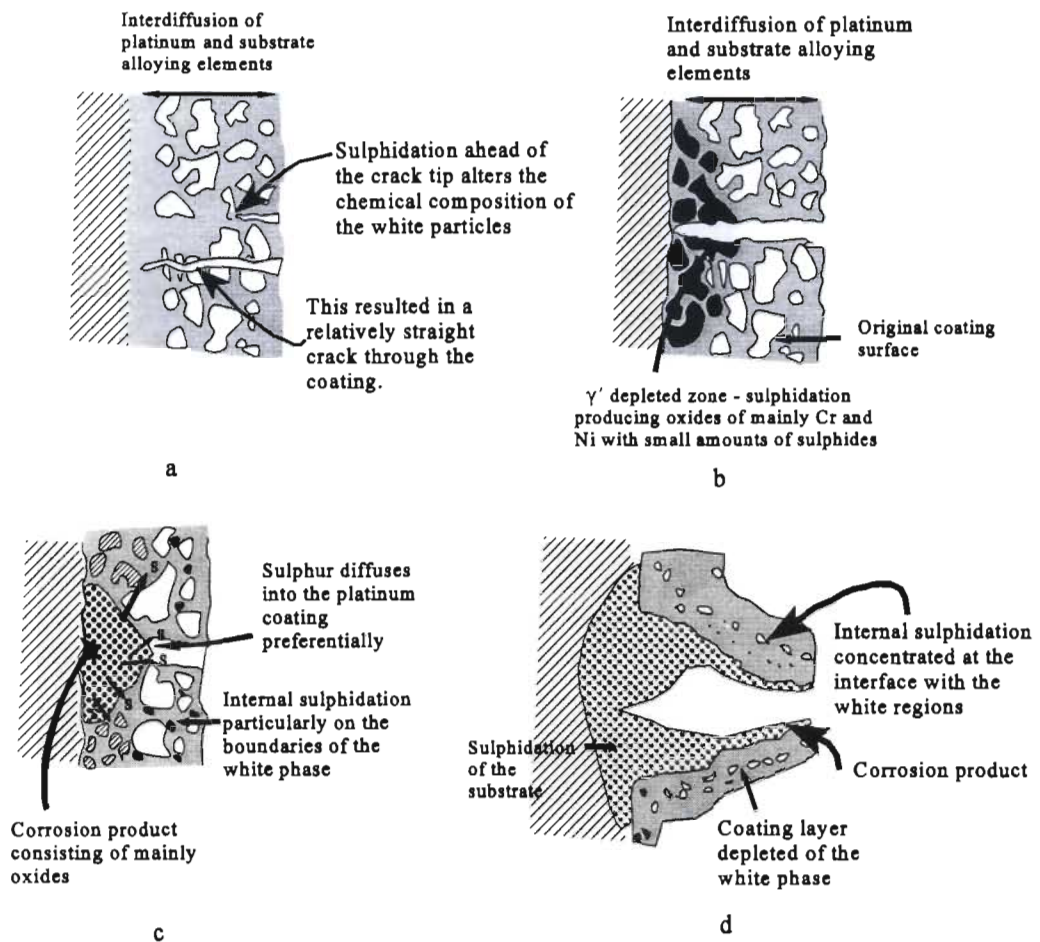
The corrosion-fatigue failure of the platinum coated MAR-M002 sample occurred via the mechanism illustrated in figure 4.18. Crack initiation on the coating occurred in the grey region of the coating and propagated rapidly through this region to substrate/ γ' depleted zone. The crack propagation through this region was accelerated due to the sulphidation attack at the crack tip. The white regions in the coating were ineffective as crack "stoppers" due to the sulphidation process altering the chemical composition of these regions and hence, the mechanical properties. The crack through the coating was relatively straight. Once the environment encountered the substrate, resistance to crack initiation and sulphidation was higher, however, the resistance of the γ' denuded zone to sulphidation was lower. The sulphidation attack proceeded more rapidly in this region than into the substrate. The corrosion product was made up of mainly oxides and small amounts of sulphides. This was consistent with the sulphidation mechanism observed in all samples tested, i.e., the oxidation

Figure 4.18: Failure mechanism of platinum coated MAR-M002 in SO_2 containing environment

reaction proceeded first followed by reaction with sulphur. The corrosion product was made up of significant quantities of Cr_2O_3 and NiO and significant amounts of Cr and Ni sulphides.

The presence of Ni oxides and sulphides would have reduced the “protective” nature of the initial scale formed. Oxygen diffusing through the scale was consumed first and also oxidised existing sulphides was oxidised, releasing the sulphur which diffused through the corrosion scale to the scale/substrate interface where sulphidation proceeded more rapidly. A significant feature was the diffusion of sulphur preferentially into the platinum layer than into the substrate resulting in internal sulphidation of the coating. The internal sulphidation of the coating was concentrated at the interfaces of the white particles in the coating and the original coating surface region. The accelerated sulphidation attack of the γ' depleted zone played the instrumental part in the “peeling” of the coating. The combination of internal
