**AN IN-DEPTH STUDY INTO THE
VARIOUS FACTORS CONTRIBUTING
TO THE UNEXPLAINED LINE FAULTS
ON A LARGE
HIGH VOLTAGE NETWORK**

**This Thesis was submitted to the University of Natal in fulfilment of the
requirements for a Master's degree in Electrical Engineering**

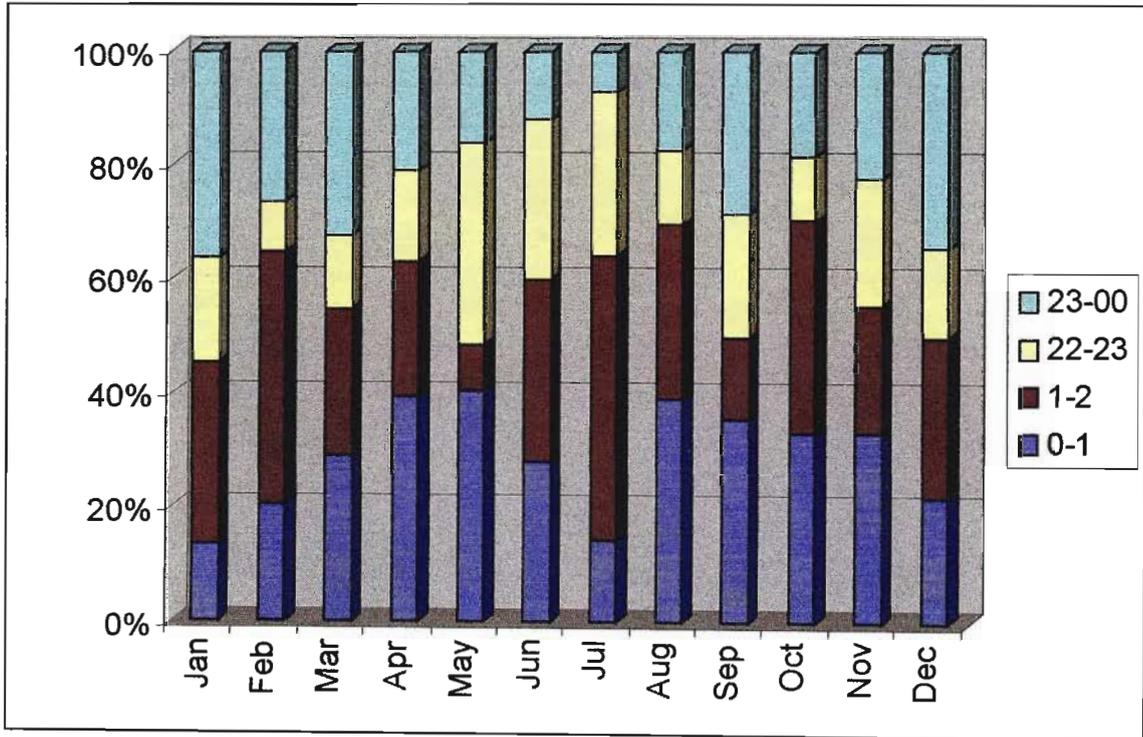
Figure 31. Percentage of unexplained line faults from 22:00 to 02:00 over an annual base.

Due to the fact that mist and dense fog develops at night times in April and May Figure 31 indicates that the highest number of unexplained flashover from 00:00 – 01:00 occur during these two months and then again in August to October. This then supports the theory that the highest number of unknowns occurs in the seasonal change over months.

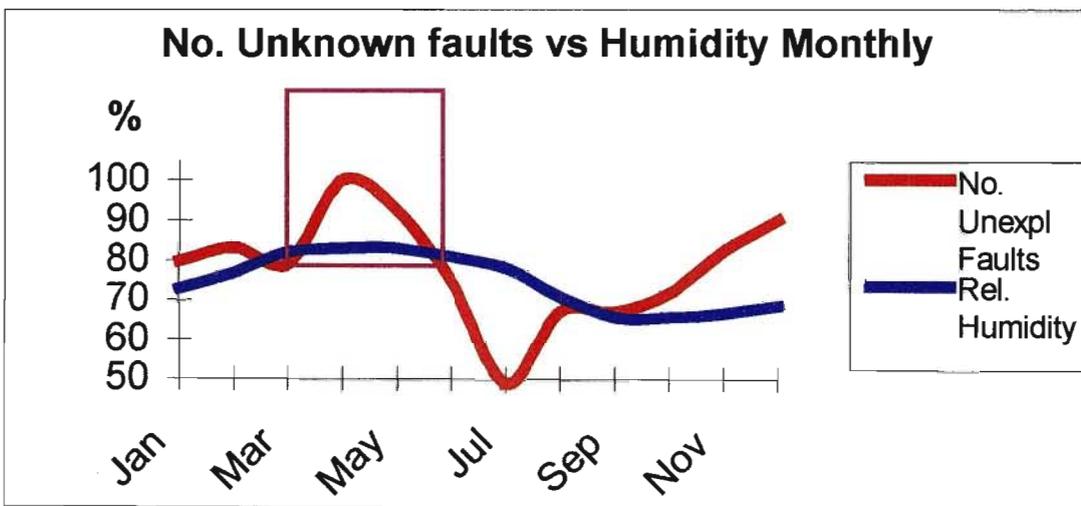
Figure 32. Percentage of unexplained line faults versus Relative Humidity over an annual base.

The relative humidity of the regions through which 10 rogue lines run per month is shown in Figure 32. The trend of this figures follows the trend of the number of unexplained line faults monthly of all the lines in Eskom Transmission in that the peak of unknown faults co-incides with the peak average monthly humidity (April and May).

This indicates that the mechanisms by which a number of unknown faults are caused are related to high humidity. From the figure above it is interesting to note that during the seasonal change over months, May and September, the unexplained line faults increase.

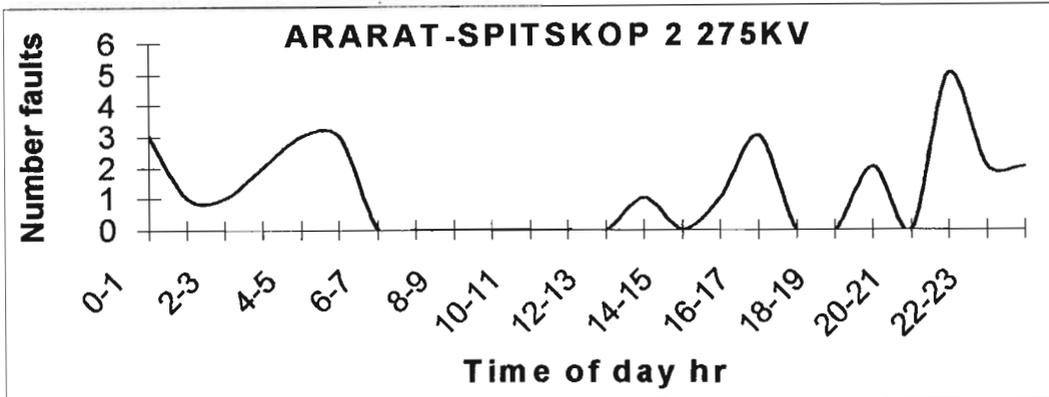
Figure 33. Number of Unexplained line faults of the Ararat-Spitskop line over a 24 hour period.

From Figure 33 it can be seen that a large number of unexplained line faults occur in the early morning hours of the day, late afternoons and around midnight. When the monthly line fault (Figure 34) analysis is also brought into consideration it

A significant number of the unexplained line faults occurred between the late afternoon hours of 16:00 to 18:00. This could indicate lightning is a probable cause.

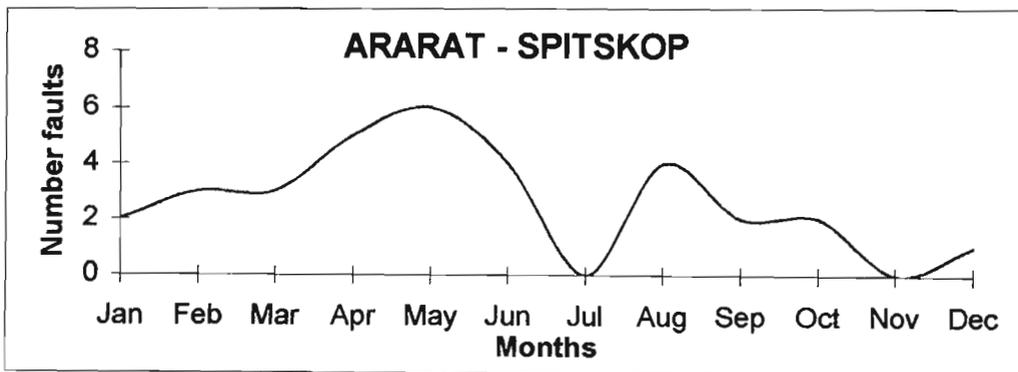
Figure 34. Number of Unexplained line faults of the Ararat-Spitskop line on an annual base.

may be determined that this line tends to trip more during the seasonal changes (namely May and August) than during the rest of the year. As this line falls in the sub-tropical climatic area it indicates that dew could possibly form on the glass discs of the insulator string. The line faults occurring from 17:00 to 18:00 possibly indicates to lightning being the likely cause.

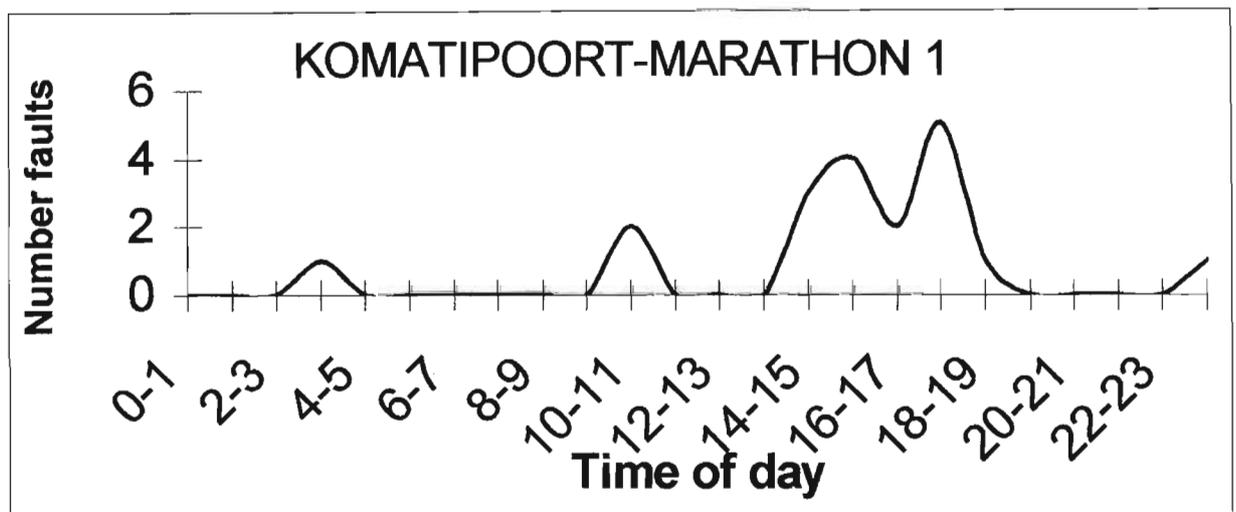
Figure 35. Number of Unexplained line faults of the Komatipoort-Marathon line over a 24 period

Figure 35 indicates that unexplained faults mostly occurred during the late afternoons. An analysis of Figure 36 shows that most of the faults occurred in June –July and November –December.

The time of day analysis indicate that line faults occur during mid day and late afternoons.

This clearly indicates that this line does not trip due to bird streamer, pollution or due to light pollution, light wetting but due to veld fires, sugar cane fires (June-July) and lightning (November –December).

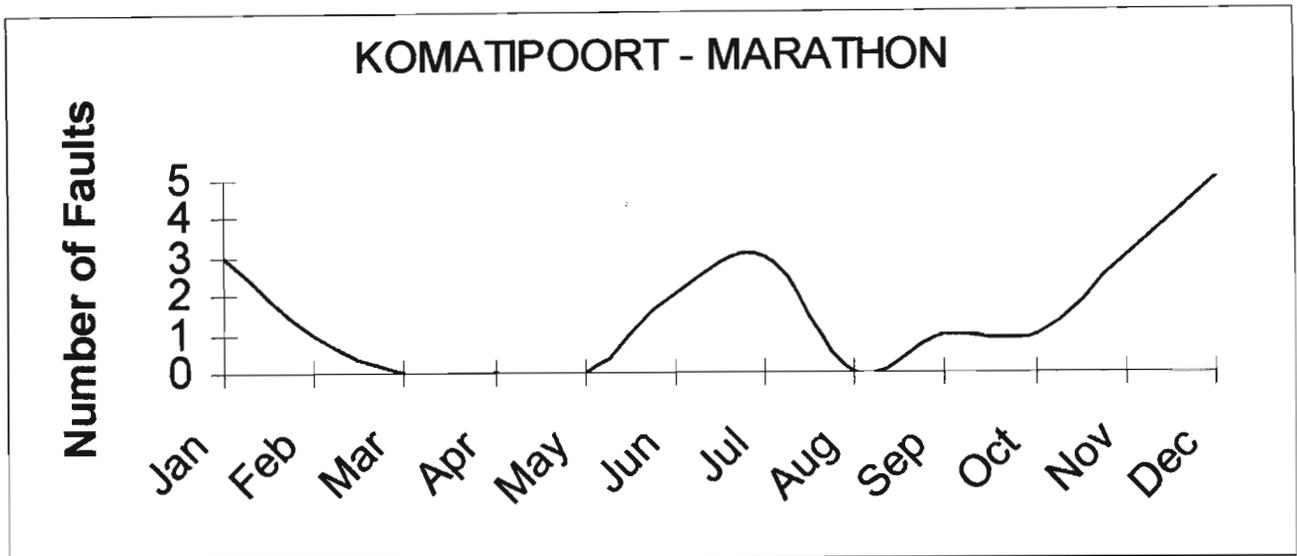
Figure 36. Number of Unexplained line faults of Komatipoort-Marathon line over an annual base

The line is running over large areas of sugar cane. Correlation between records indicates that during mid days, when the farmers burn sugar cane, the line do trip due to sugar cane fires.

Sugar cane fires therefore suspected as a cause of the line faults.

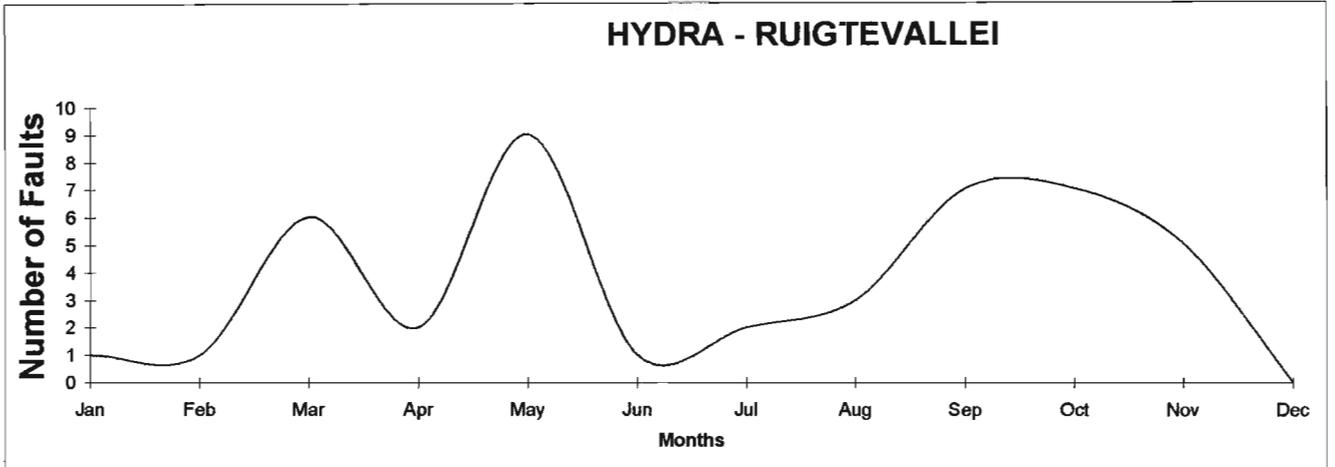
Figure 37. Number of Unexplained line faults of Hydra-Ruigtevallei line over an annual base

Figure 37 gives an indication during which months of the year these line faults mostly occur.

From Figure 37 it is very clear that the unexplained faults occur mostly in April (Seasonal change from autumn to winter) and again from early September to November (spring to mid summer).

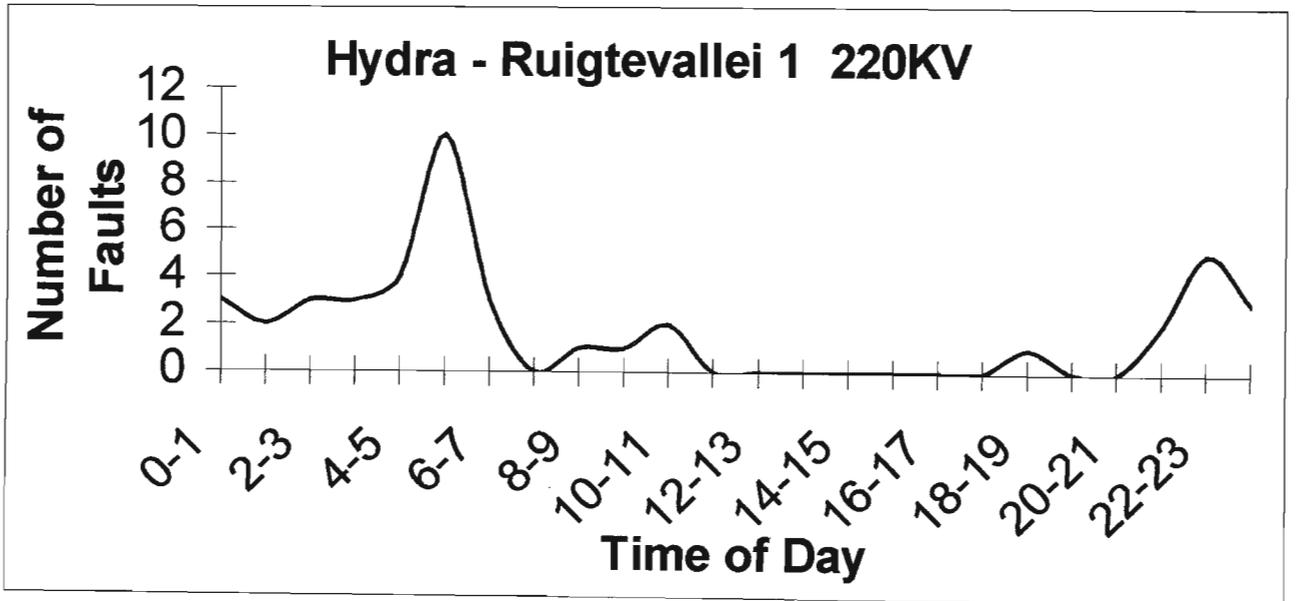
Figure 38. Number of Unexplained line faults of the Hydra-Ruigtevallei line over a 24 hour period.

As can be seen in Figure 38 most unexplained faults occur during the early morning periods (04:00 – 07:00) and then again a few line faults at 08:00 – 11:00.

Just before midnight there is again an increase in unexplained faults.

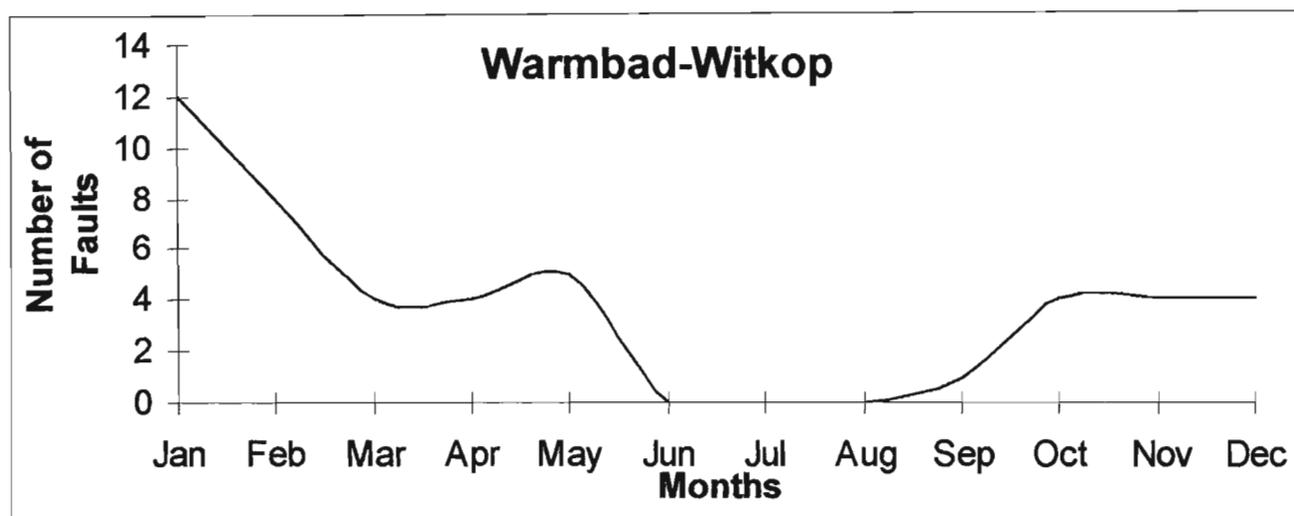
Figure 39. Number of Unexplained line faults for the Warmbad-Witkop line over an annual base.

The Warmbad – Witkop line is well known for all the unexplained trips it had over long period of time. Due to heat and wet conditions during the spring months and especially during the summer months one can make the assumption that high humidity will be present during these periods.

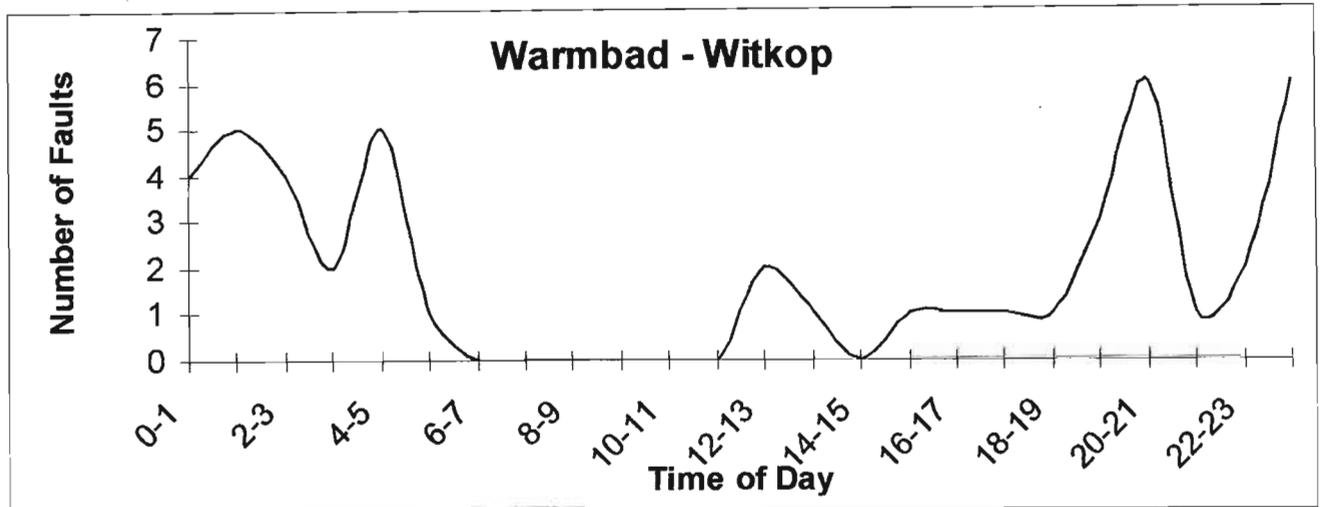
Figure 40. Number of Unexplained line faults of the Warmbad-Witkop line over a 24 hour period.

The time of day graph Figure 40 indicates that Time of Day and Time of Year do not indicate a definitive cause for these faults. During the evening hours of a day the line faults are most probably due to bird streamers and during the early morning (01:00 – 03:00) due to light pollution and light wetting. During the sunrise hours it is probably due to bird streamers again.

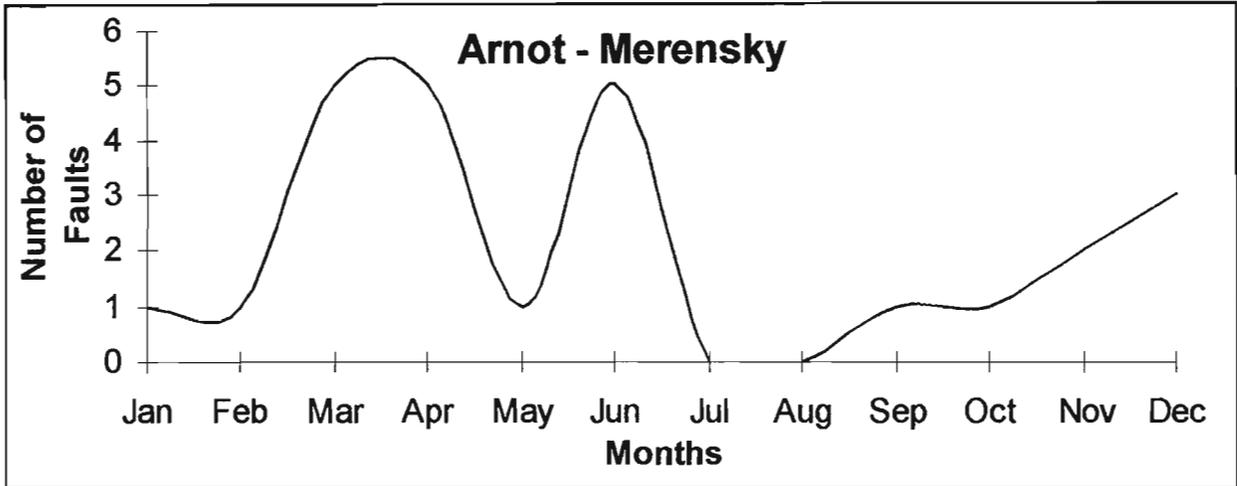
Figure 41. Number of Unexplained line faults of the Arnot-Merensky line over an annual base

As may be seen in Figure 41 unexplained faults normally occur from February months towards the end of April and then again during the mid winter months, middle May to the end of June.

The occurrence of mist/fog is very common during the changing over of seasons, from summer to autumn. Regular veld fires occur during the mid winter months towards the beginning of spring. The unexplained line faults start to pick up again from October to the end of December and the beginning of January.

During the winter months the dry weather results in dry veld grass. Fire caused faults then become likely. This is noticeable in Figure 41. The time of day analysis correlate excellently with the time of year analysis.

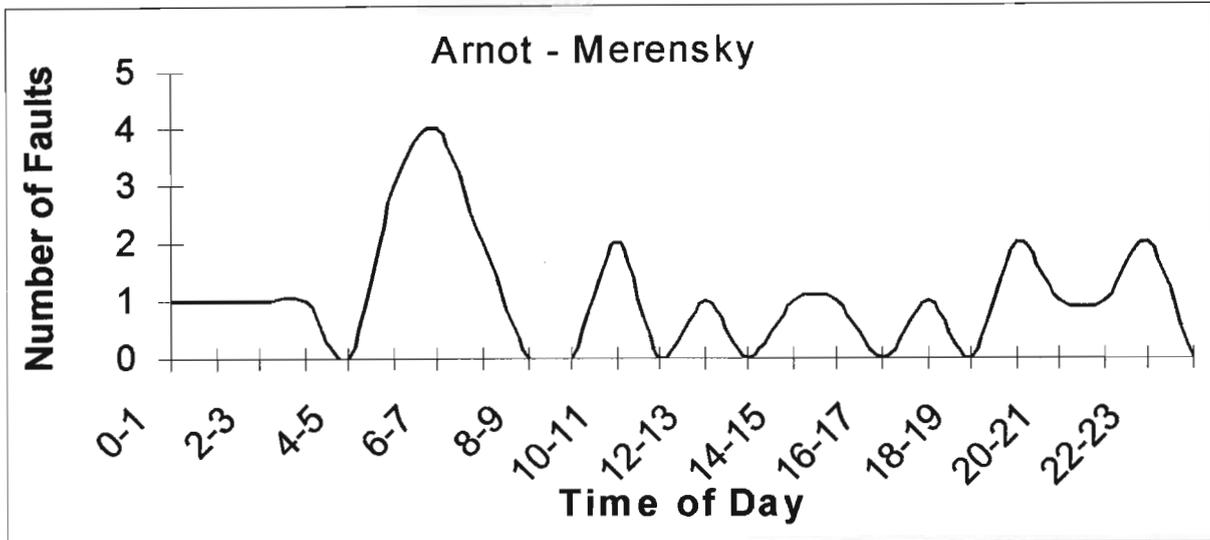
Figure 42. Number of Unexplained line faults of the Arnot-Merensky line over a 24 hour period.

The time of day figure indicates that the highest number of unexplained faults occur in the early morning, during mid day and some faults in the late afternoons and then again at 20:00 and 22:00.

This line is running through an area where mist/fog occurs regularly during March to May months. Birds are also very active in this area which means that a high number of unexplained faults may have been due to bird streamers and with the presence of the fog one can also expect light pollution, light wetting faults.

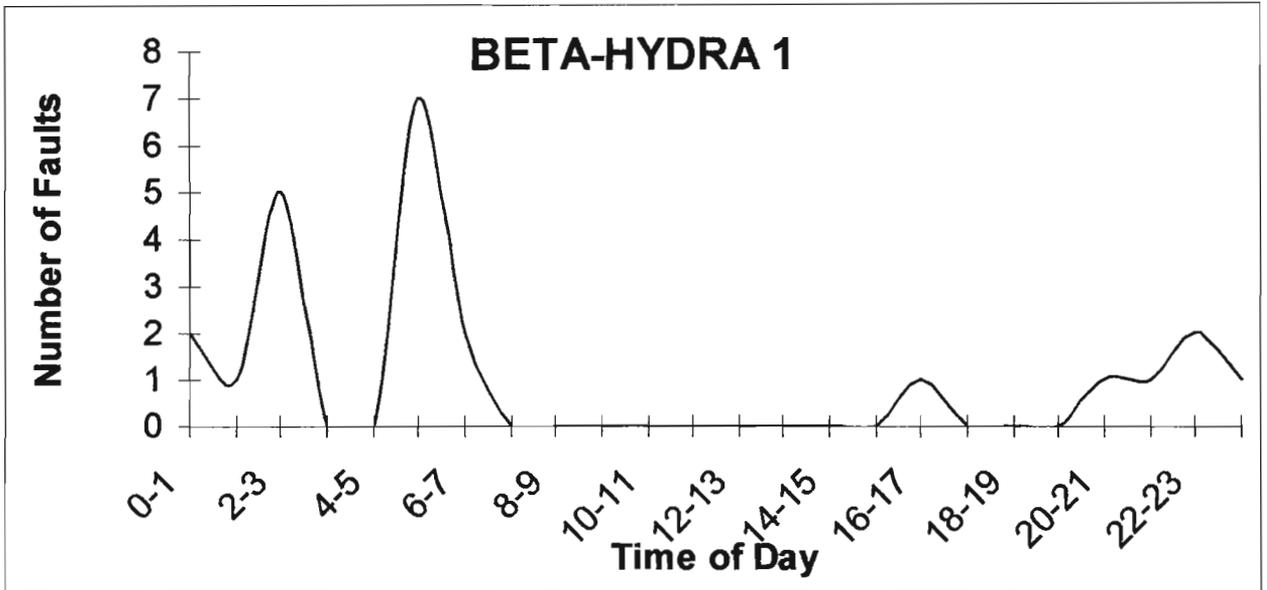
Figure 43. Number of Unexplained line faults of the Beta-Hydra 1 line over a 24 hour period.

In the early hours of the morning (02:00 – 03:00) the line most probably trips due to light pollution, light wetting and in the early mornings due to (06:00-07:00) bird streamers. This line has been known for tripping due to bird streamers for some considerable period.

Figure 43 indicates no correlation between fault records and unknowns. During the day there is no line faults and lightning normally occur during the day. Therefore lightning is not suspected to be a cause for the line faults.

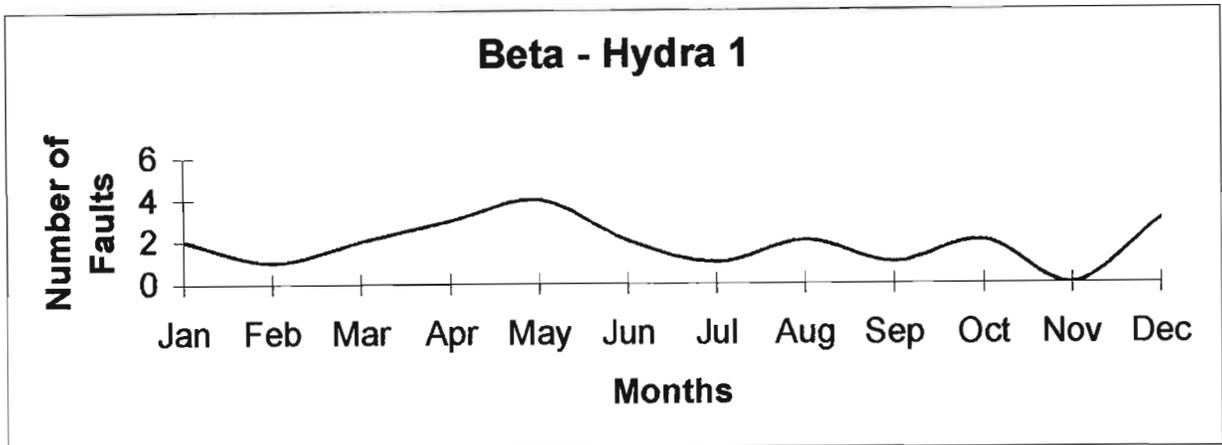
Figure 44. Number of Unexplained line faults of the Beta-Hydra 1 line over an annual base.

The time of year graph shown in Figure 44 indicates clearly that the line tends to trip during the changing over of seasons (May) and spring as well as December and January months.

Figure 44 indicates excellent correlation between records, especially just before mid night and early mornings. Bird Streamers are therefore suspected to be the major cause for line faults.

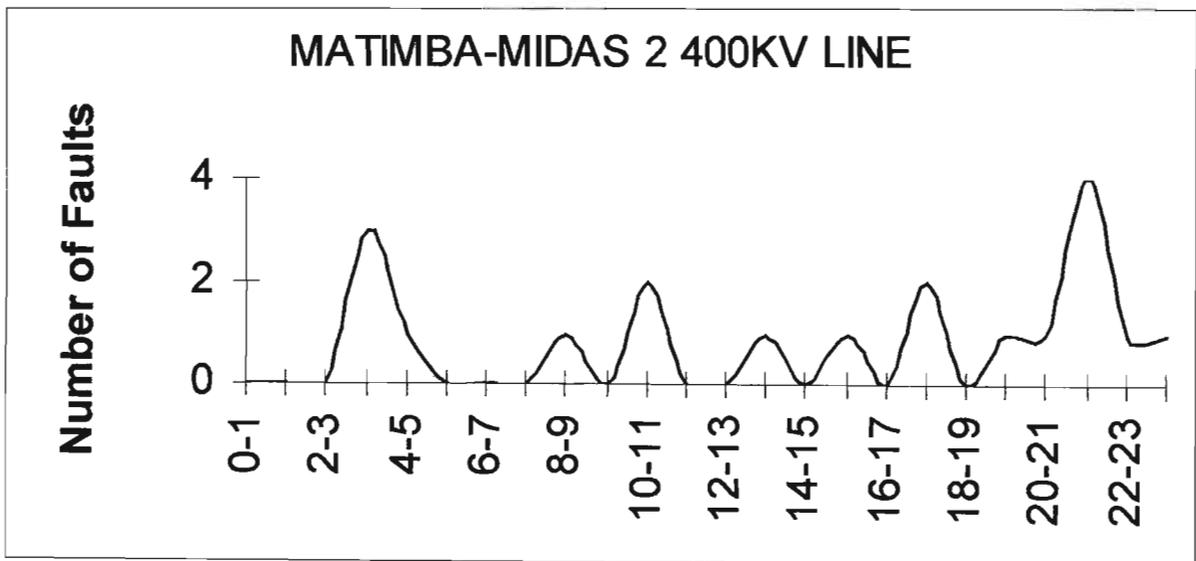
Figure 45. Number of Unexplained line faults of the Matimba-Midas 2 line over a 24 hour period.

The Matimba – Midas 2 line is the most difficult line out of all rogue lines to investigate due to the fact that it trips almost during all times of a day (see Figure 45).

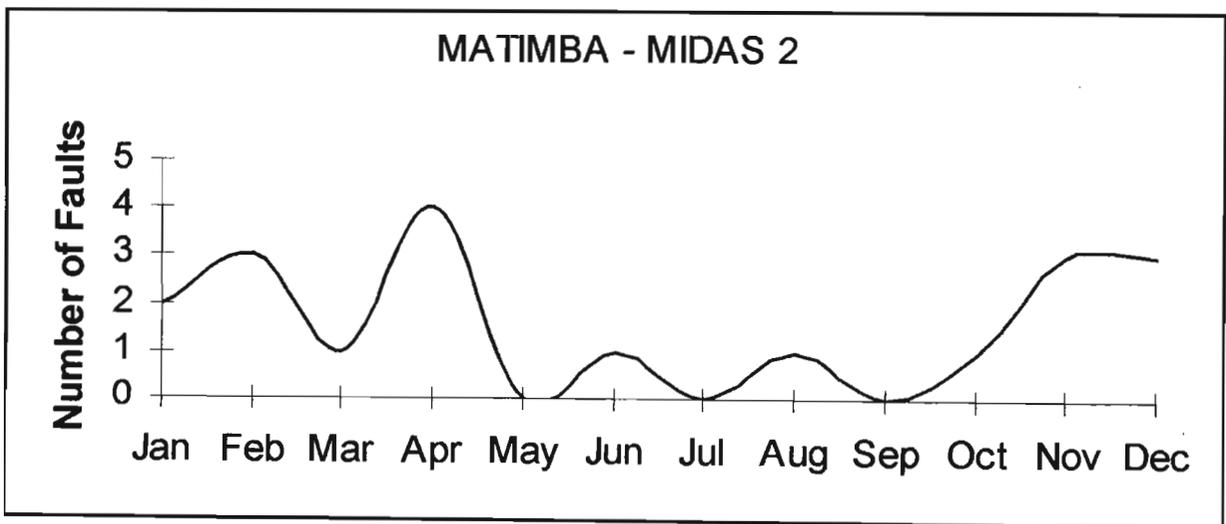
Figure 46. Number of Unexplained line faults of the Matimba-Midas 2 line over an annual base.

The time of the year graph indicates that the line faults occur during all seasons. It is therefore possible that these line faults are due to various causes. The first cause may be light pollution light wetting. During April and May where the time of day analysis indicates trips during the early morning hours. During the winter months, June and August, veld fires are the likely cause. Time of day analysis indicates that the line trips from 10:00 in the morning to 18:00 in the afternoons during these months.

During the November to December months the line most probably trips due to birds during the night-time.

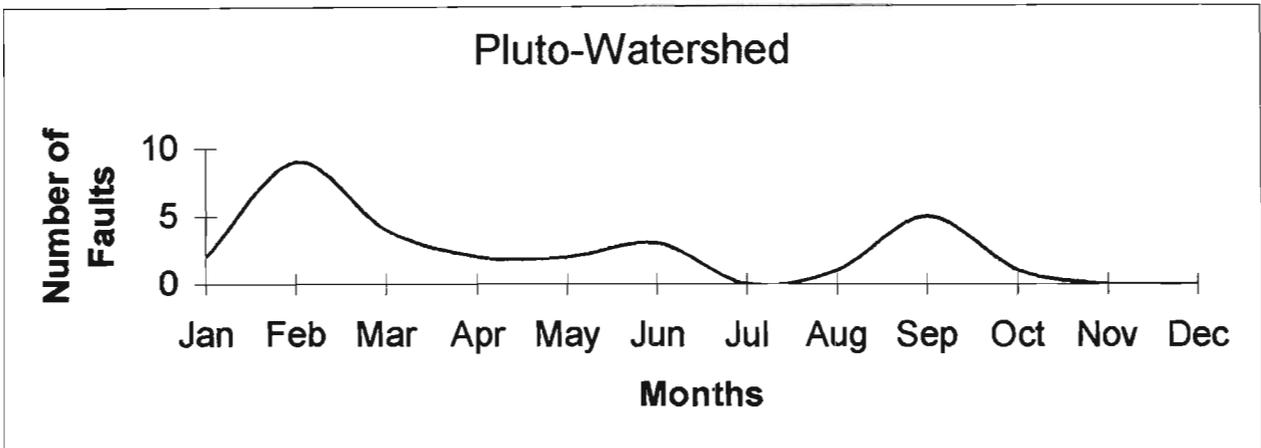
Figure 47. Number of Unexplained line faults of the Pluto-Watershed line over an annual base.

The Pluto – Watershed line is also very well known for its high number of unexplained line faults. From January to March the line tripped numerous times. More unexplained flashovers occurred in June and then again in September.

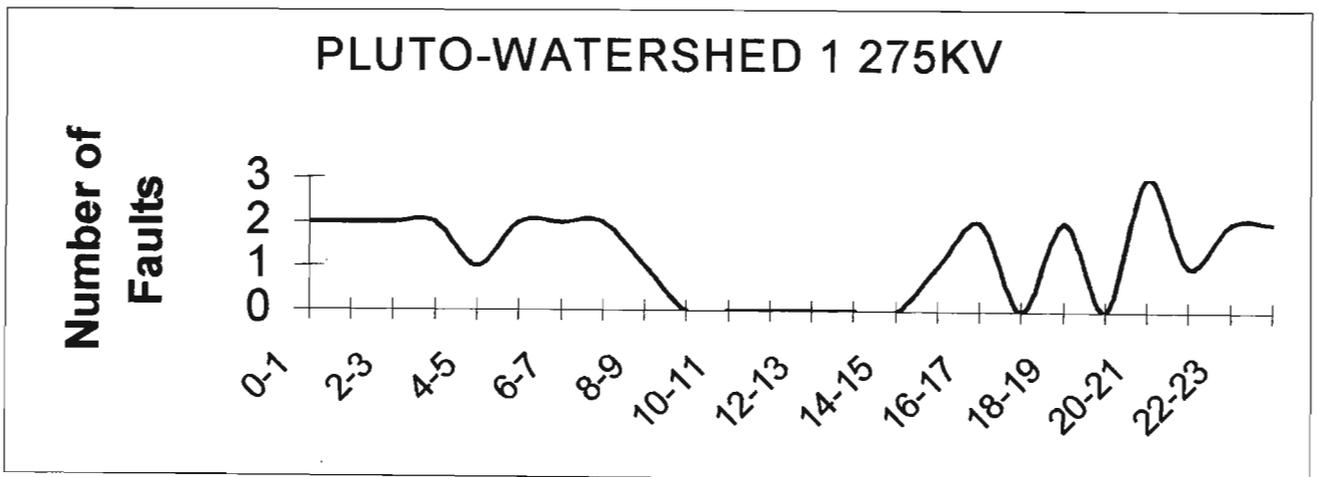
Figure 48. Number of Unexplained line faults of the Pluto-Watershed line over a 24 hour period.

When the time of day graph is also analysed it may be seen that the line tend to trip throughout the night time, peaking at around 21:00 at night. Due to the fact that this line also runs in an area that experiences a high density of lightning strikes, it probably is faulting due to lightning strikes during the late afternoon

periods of a day. This correlates back to the time of year when the line tended to trip more during the typical changing over of seasons, in April and September months.

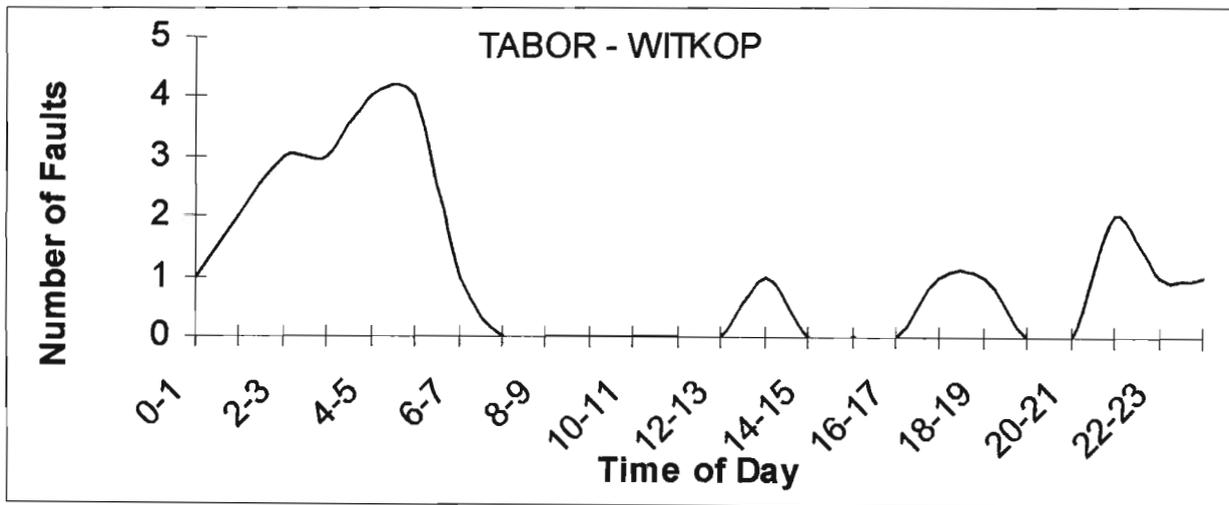
Figure 49. Number of Unexplained line faults of the Tabor-Witkop line over a 24 hour period.

The Tabor – Witkop line tends to trip from the early morning hours of 01:00 till 07:00. In the evenings there are one or two faults between 22:00 and 23:00. The line faults occur during seasonal changes. During seasonal changes mist or fog is present. Bird activity is also present in areas where this line is running through. The two possible causes for line faults can therefore be bird streamers and light pollution, light wetting.

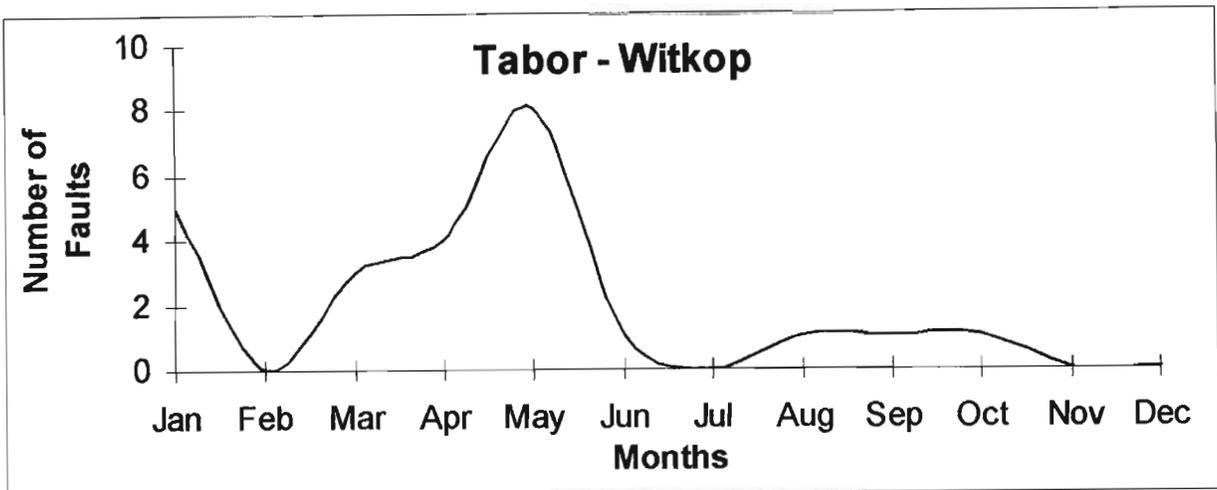
Figure 50. Number of Unexplained line faults of the Tabor-Witkop line over an annual base.

In the beginning of the year there is an increase of unexplained faults. This correlates with the behaviour patterns of birds, as they are very active during that period of the year. As a result it can be concluded that the unexplained faults in January and February are due to bird streamers and the faults in April and May are due to bird pollution and light wetting.

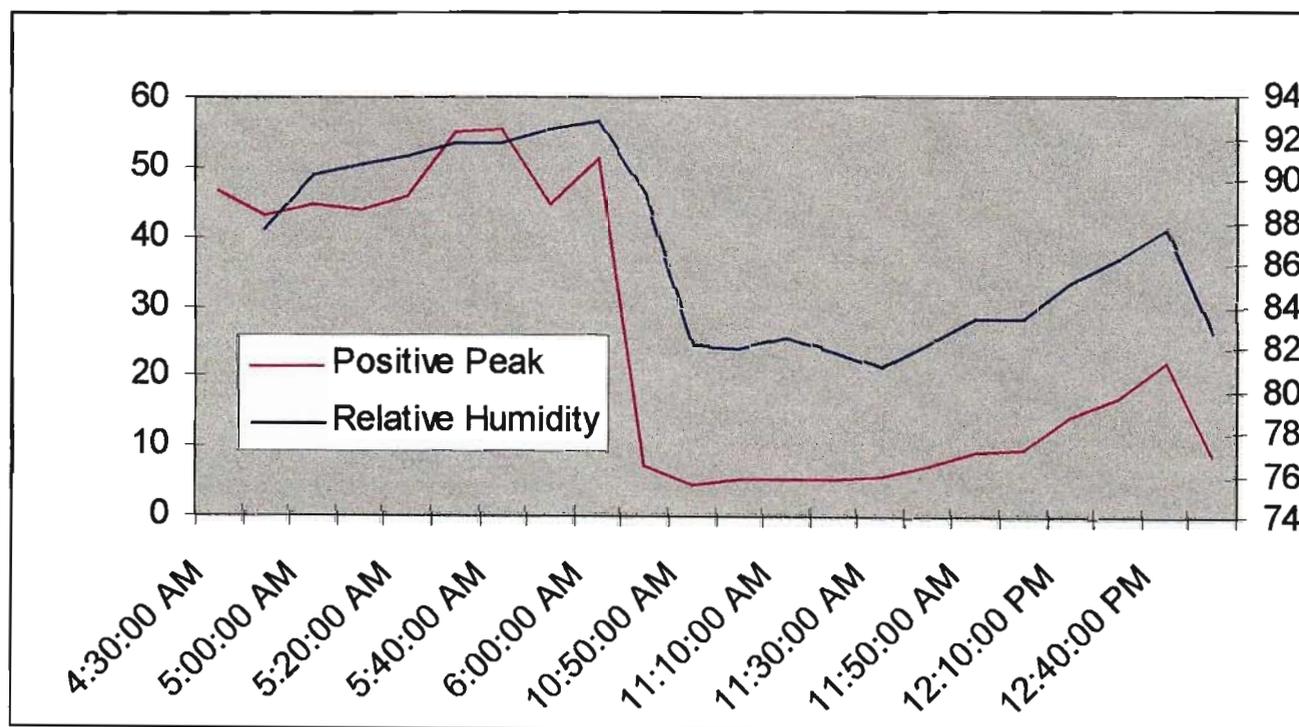
Figure 51. Positive Leakage Currents and Relative Humidity during a morning period.

Only a few days of accurate data was captured. It did, however give an indication on the leakage currents over the insulators one can expect with the humidity at the same time.
