CONTINUOUS ON LINE RELATIVE TAN DELTA MONITORING OF HIGH VOLTAGE INSULATION

**In fulfillment of the requirement for a research Masters of Science in
Engineering degree for candidate Roger Cormack, University of
Kwazulu-Natal Student Number 991263768**

September 2004

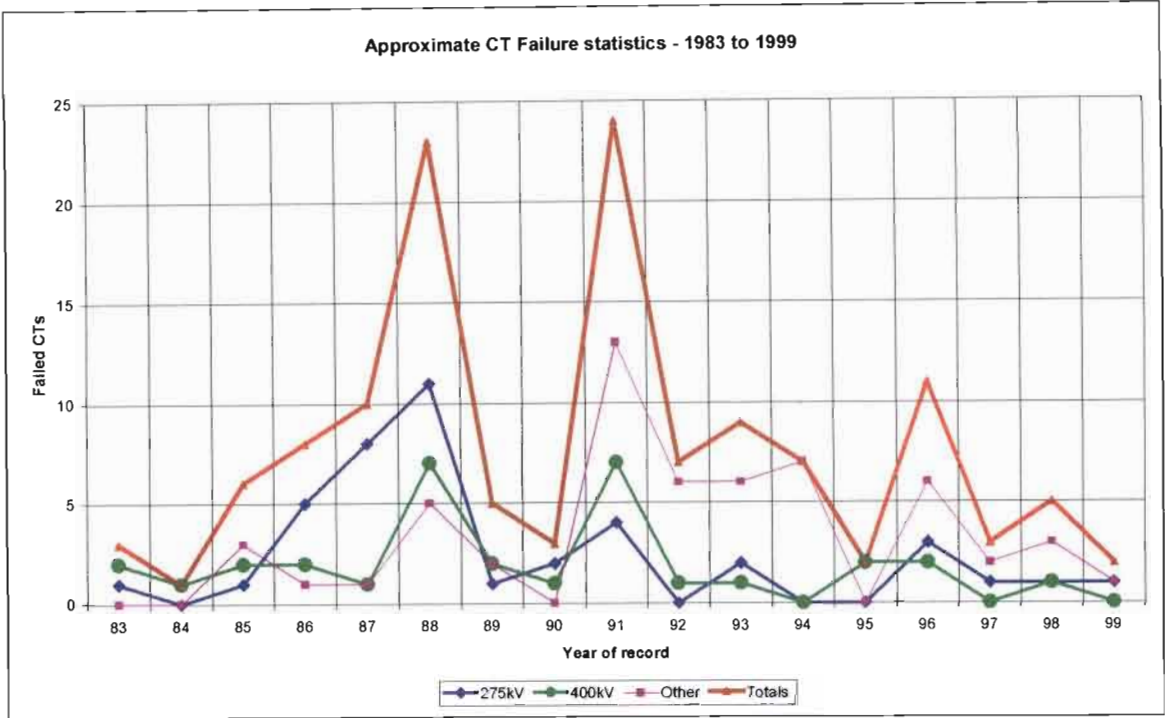
Table 1.2 indicates that there have been a total number of 129 recorded CT's that failed, which cost the utility R8.1 million in 1999 in SA rands. Of particular concern were the high failure rates observed in 1988 and 1991. The tabulated data is shown graphically in Figure 1.1 below.

Figure 1.1: Graph of CT failures on the Transmission network, 1983 – 1999 [2].

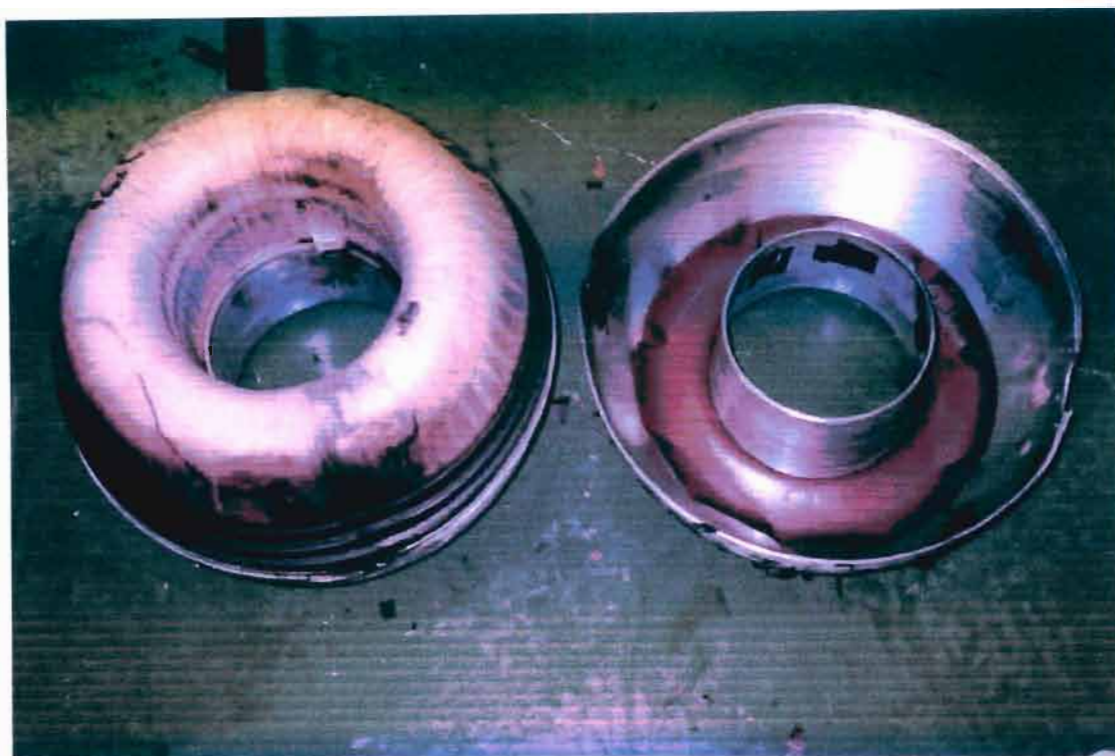
Figure 6.11: The CT secondary cores inserted inside the metallic, earthed shield.

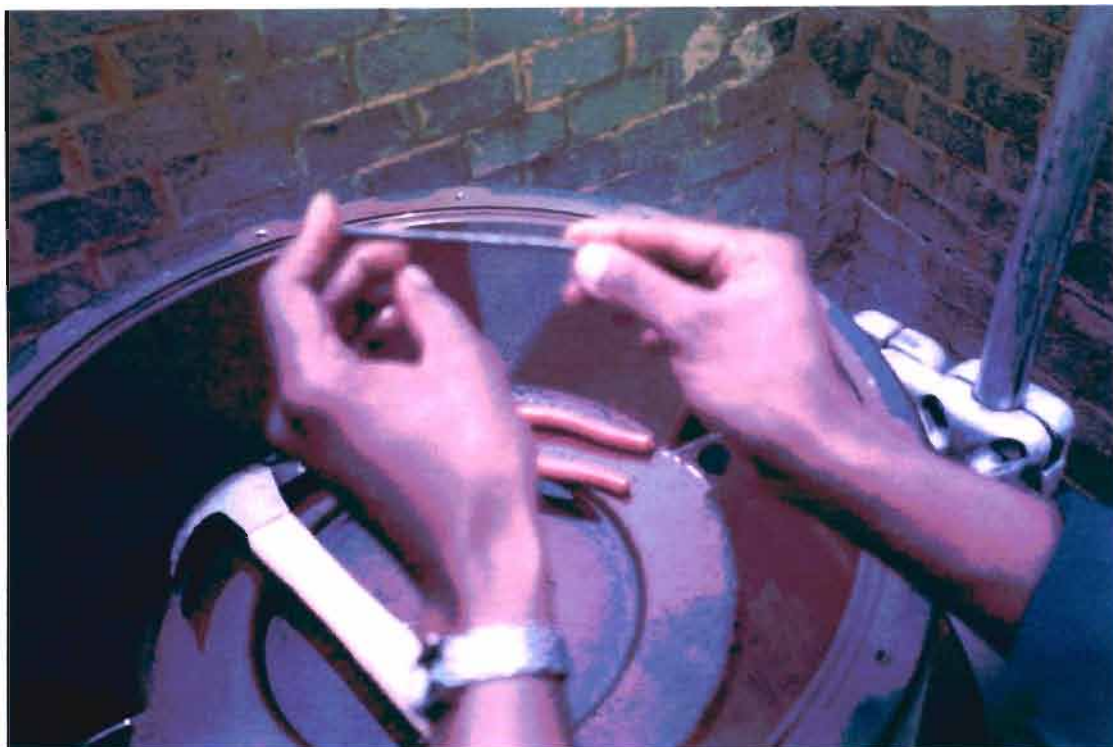
Figure 6.13: The top reservoir of the CT showing the insulation below the oil. The nail was used to damage the insulation.

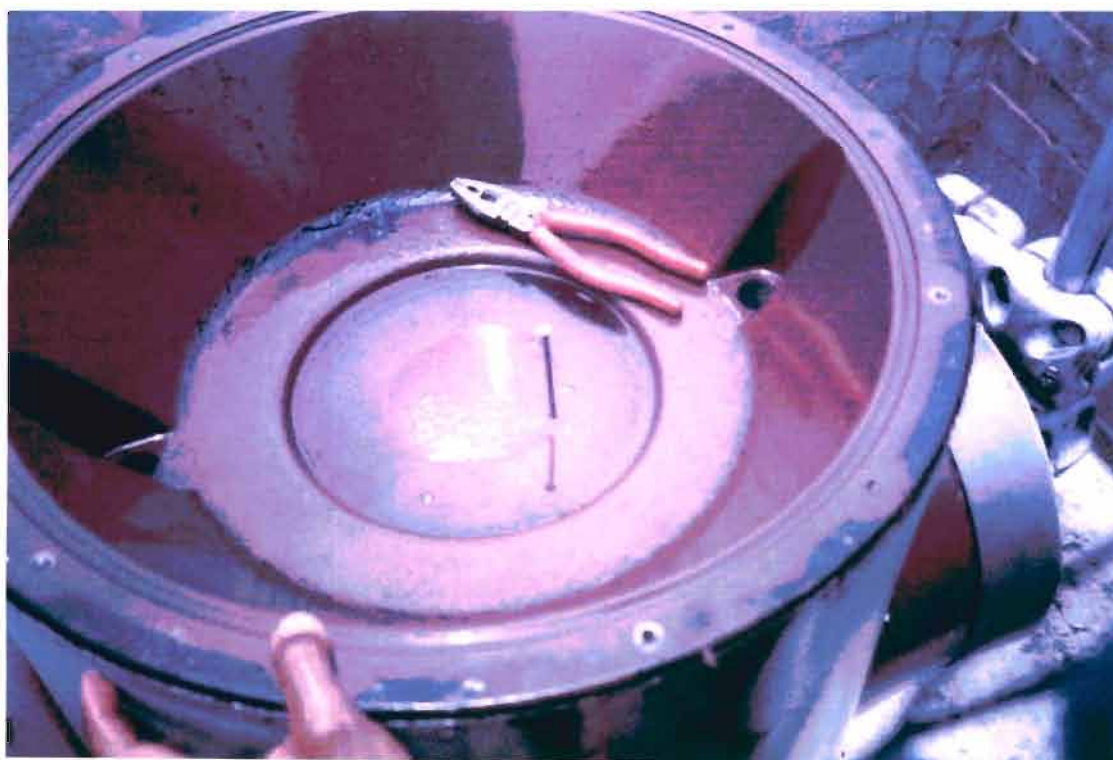
included using 10 metallic nails to puncture the insulation to a depth of half the overall primary insulation. The nails were then withdrawn. The basic procedure is shown in Figure 6.13 and 6.14.

Figure 6.14: The nail was used to make 10 holes in the HV insulation to a depth of half of the paper insulation. The holes were made in an evenly spaced circle 80mm from the centre.

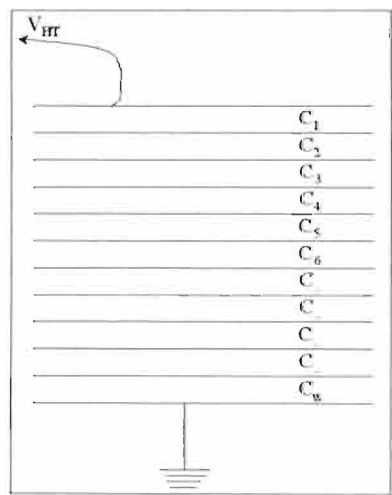
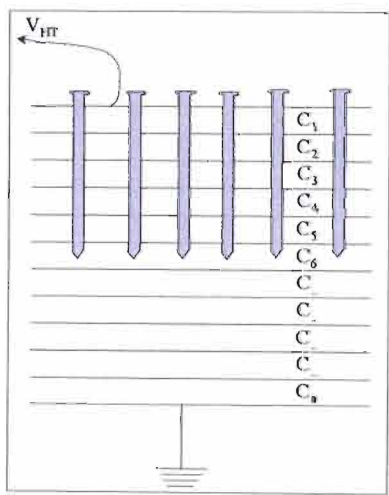
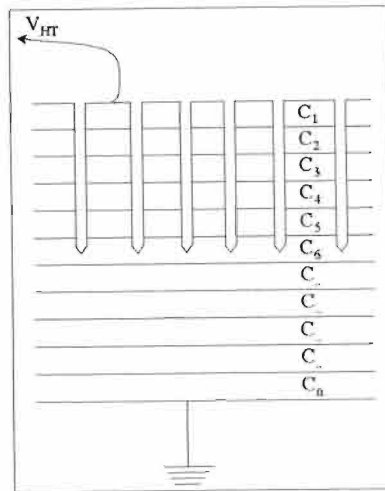
Figure 6.15 below illustrates the manner in which the insulation was damaged. Without the presence of pressure from the insulation walls surrounding the cavity and the oil in the paper, the distortion in the paper insulation would be longitudinal holes (figure c).

Figure 6.15a : Undamaged layers

Figure 6.15b: Nails into insulation bridging layers.

Figure 6.15c: Nails removed

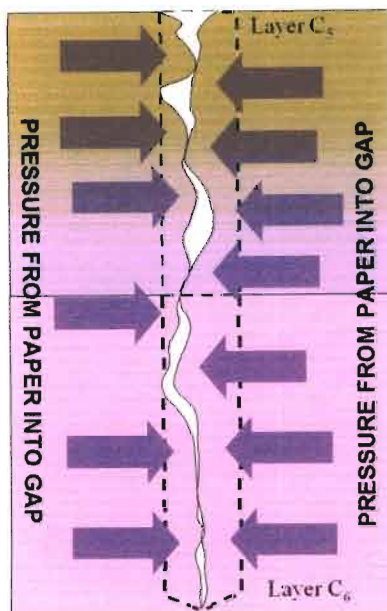
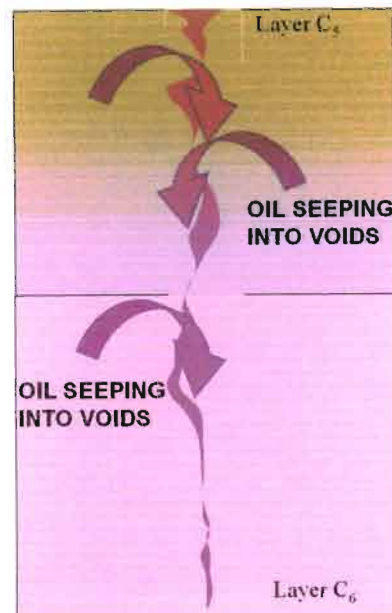
Figure 6.16 below represents an untested hypothesis of how the paper insulation may close around the cavities from layers C₅ and C₆ illustrated in Figure 6.15 above.

Figure 6.16a: Non-uniform cavity closure creating voids.

Figure 6.16b: Oil seepage into voids.

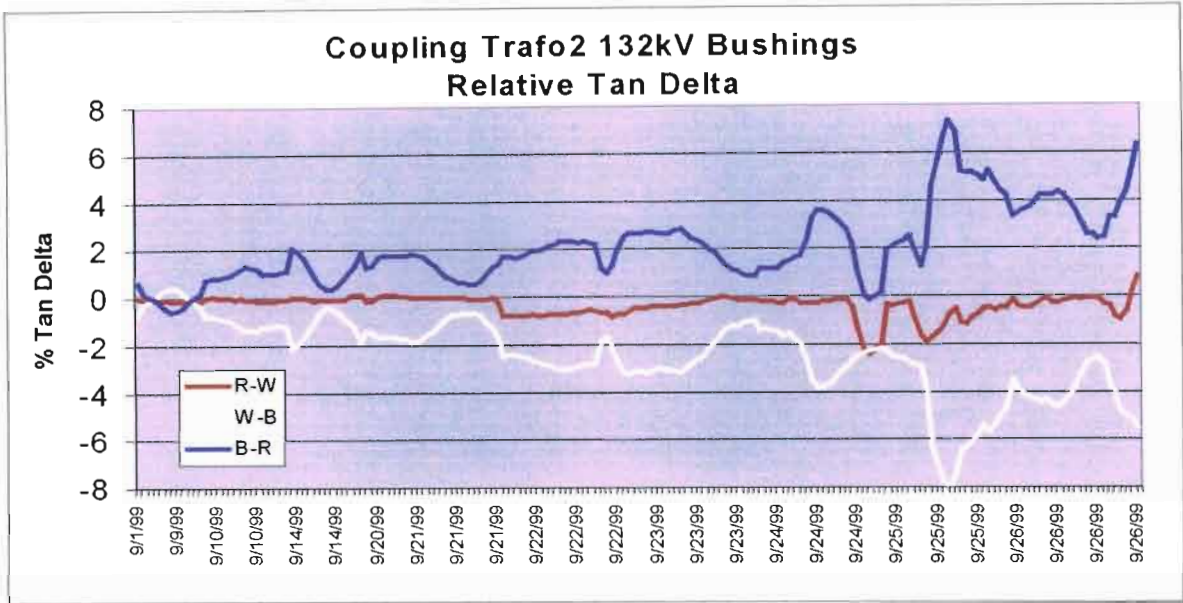
The failure of the transformer bushing had not been captured and alarmed by the HVIEWWS system. The investigation into the failure had found that a particular bushing was the cause of the failure. The type of bushing had caused 3 other failures of transformers on the system. These failures were caused by increasing partial

discharge in the bushing, degrading the insulation and resulting in a short circuit. When a drill down was done into the HVIEWWS data that had been captured it showed that not enough data had been stored to set up a trend as the service period had been too short, but instantaneous data indicated that a failure was imminent.

Figure 7.4: Instantaneous data signals from HVIEWWS at Hendrina power station.

From Figure 7.4 above it can be seen that the relative tan delta signals from the leakage currents of the 132kV bushings on the B–R and the W-B phases started to increase. The common signal was the B phase, which was distorting the signal, probably due to the increasing partial discharges degrading the insulation. The investigation into the transformer failure proved that the failure of the B phase bushing was root cause of the incident. Figure 7.4 indicates that the increase was gradual from 0 to 2% relative delta over a period of 16 days (9/9/99 to 25/9/99) On 25/9/99 the relative tan delta readings increased from 2% to 8% rapidly over a period of about 10 hours.

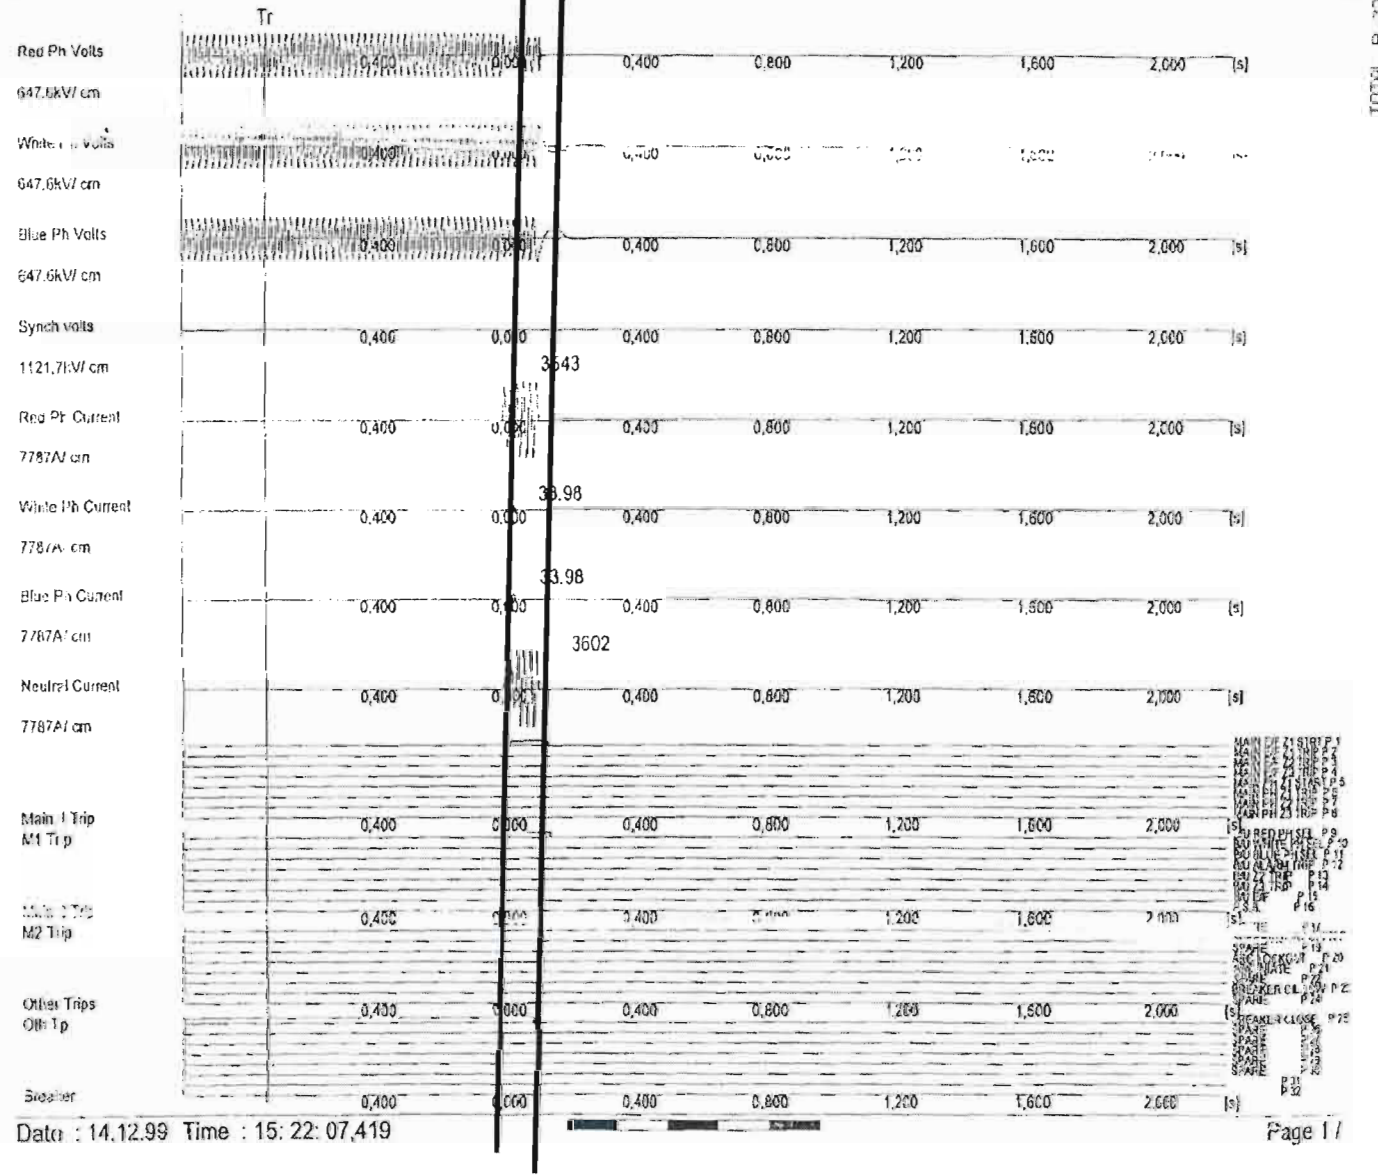
Figure 5.1. Siemens P531 recording taken at Bloukrans on the Tugela 275kV feeder, for a CT failure at Tugela test station on 14.12.99
