**CASE STUDY OF BIRD STREAMER CAUSED**  
**TRANSIENT EARTH FAULTSONA 275 KV**  
**TRANSMISSION GRID**

This thesis was submitted to the University of Natal in fulfilment of the requirements for a Master's degree in Electrical Engineering.

This thesis discusses the results of an investigation that was initiated in January 1996 to determine the root cause of the increasing fault trend in respect of transient earth faults on the 275 kV transmission grid in KwaZulu-Natal, South Africa. Historically it was thought that the persistently poor performance of this network was caused by pollution faults. This network was reinsulated with silicone composite insulators, and cane fire as well as veld fire management programmes were introduced. These projects did not result in a consistently decreasing fault trend on this 275 kV transmission grid.

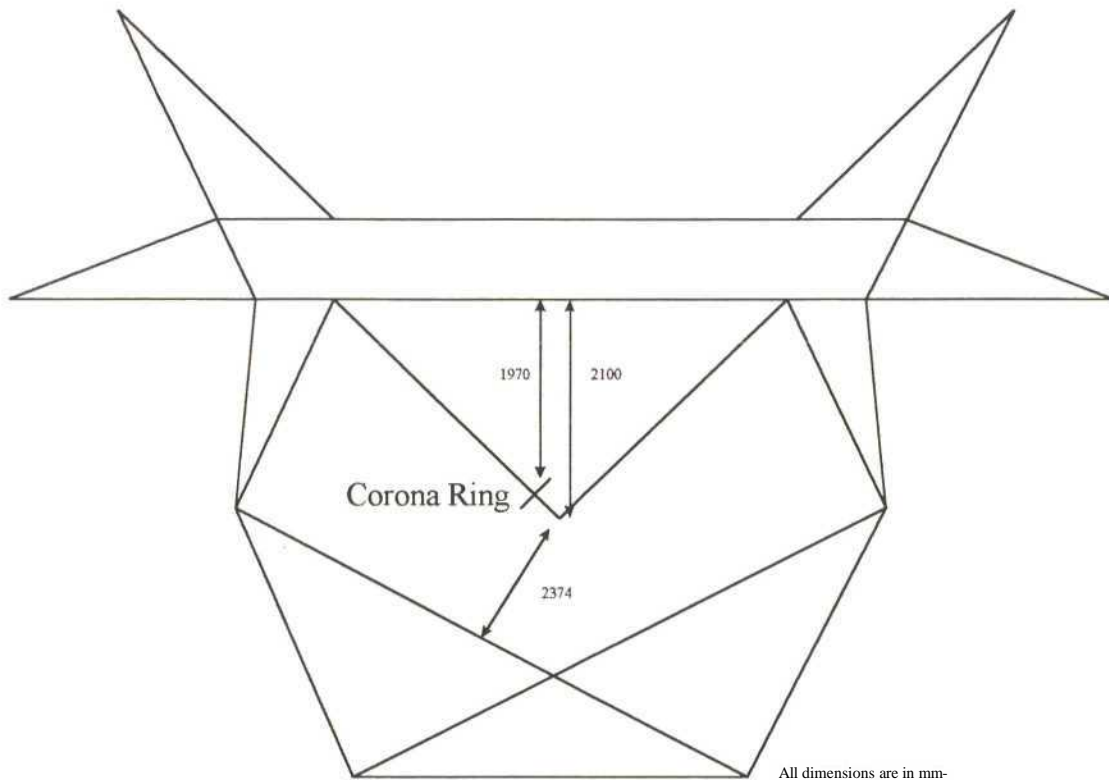
**Figure 8. Illustration of live hardware electrical clearances for the AIV tower type**

The IVI suspension towers of the Georgedale-Venus power lines are of the AIV tower type. The minimum air gap clearance on the Georgedale-Venus lines is 2.1 metres for the glass insulator string assemblies. This clearance was measured in the centre of the V string assembly on tower 61 of Georgedale-Venus 1. The electrical clearance of tower 61 is summarised in Figure 8.

However, after the IVI towers were reinsulated with silicone composite insulators, the minimum air gap clearance was measured as 1.97 metres. This decrease in air gap clearance was caused by the installation of the corona ring fitted on the live end of the silicone composite insulators. The reduction in air gap clearance would certainly increase the probability of air gap breakdown under bird streamer intrusion, as experienced in the sudden increase in line 2 earth fault trip incidence during 1996. Theoretically these

- The faults appeared to start on the live end corona ring and terminate directly above the live hardware on the tower steelwork, as depicted in Figure 8. Strain towers exhibited similar flash marks - burn marks on the jumpers and directly above the jumpers on the tower steelwork, as illustrated in Appendix 5. On glass insulation the yoke plate and usually the first disc were burnt, and there was a corresponding burn mark directly above the V string on the tower steelwork.

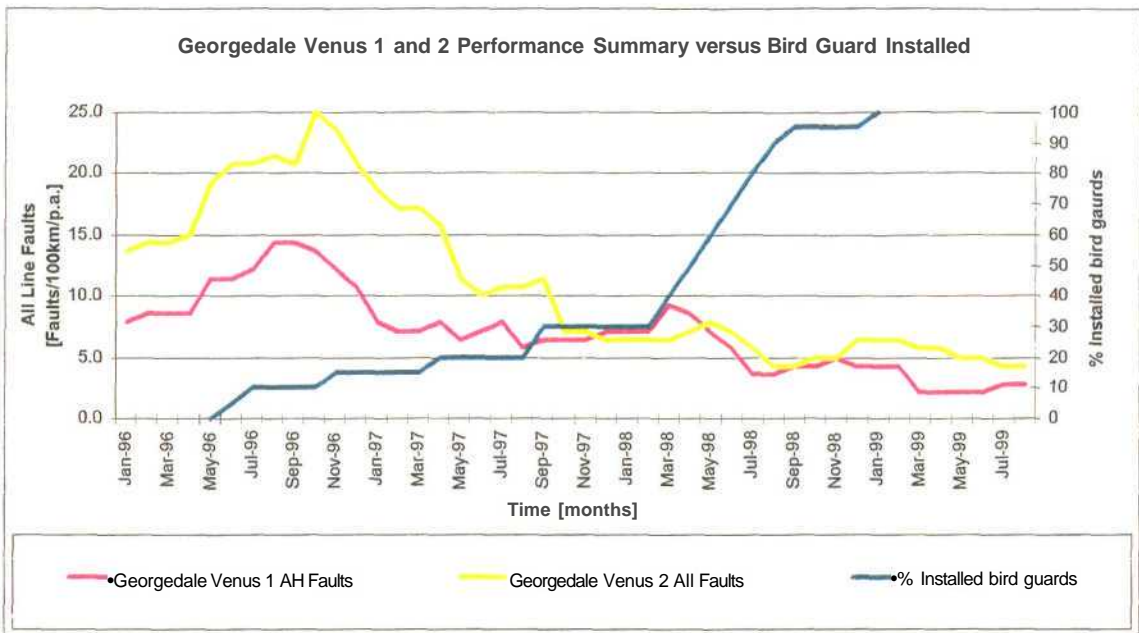
Figure 10. 12 MMA summary of the Georgedale-Venus lines

The 12 MMA is the cumulative sum of all the faults experienced by each of the transmission lines over the past 12 months. The 12 MMA, normalised to faults/100 km/pa, is presented in Figure 10.

The effectiveness of the welded rod bird guards (WRBGs) is clearly illustrated by the significant improvement in both transmission lines' performance (see section 6.2). Table 6 details the action taken in installing bird guards on the two Georgedale-Venus power lines. Since the application of the bird guards the performance summary of the power lines shows a decrease from more than 15 faults/100 km/pa to less than 5 faults/100 km/pa.

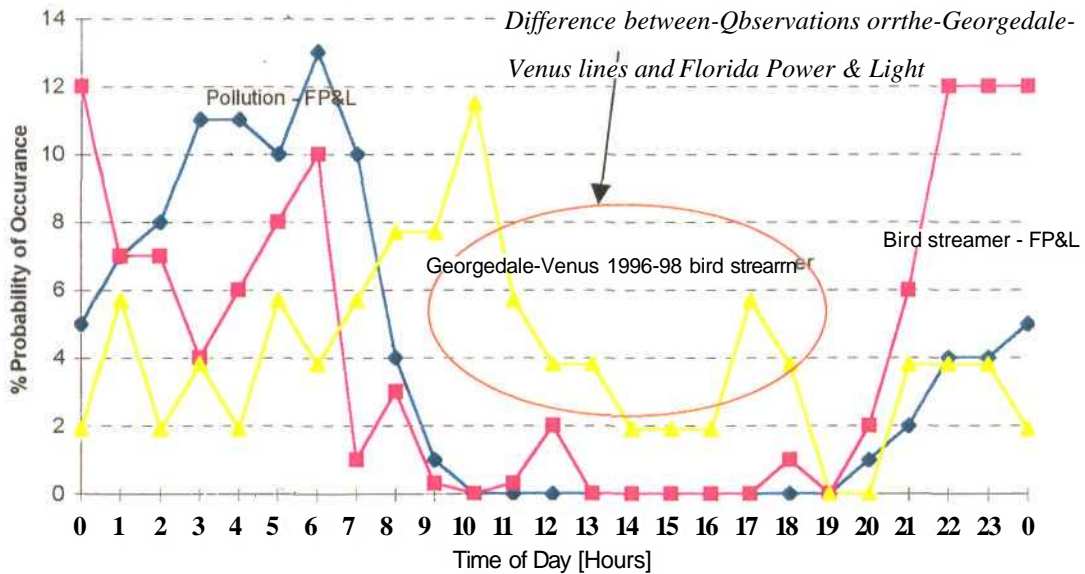
Figure 13. Bird streamer profile of the Georgedale-Venus lines

The time-of-day analysis by Burnham (Burnham, 1995) indicates that the profile of the time-of-day analysis and time of line faults are two parameters that can be used to differentiate between line faults caused by pollution and those caused by bird streamers. However, when the bird streamer faults were correlated with this model there were no noticeable similarities between the Florida Power & Light pollution correlation and the Georgedale-Venus bird streamer faults. A direct application of this model to the Georgedale-Venus power lines may therefore have resulted in the wrong conclusion being drawn. The correlation is presented in Figure 13. Clearly the profile of the Georgedale-Venus lines is significantly different from that of Florida Power & Light (Burnham, 1995). Although this analysis is extremely interesting, it clearly needs more detailed investigation before it can be accepted as conclusive.

The only similarity between the Florida Power & Light (Burnham, 1995) and the Georgedale-Venus lines is the shape of the time-of-day analysis as opposed to the time of

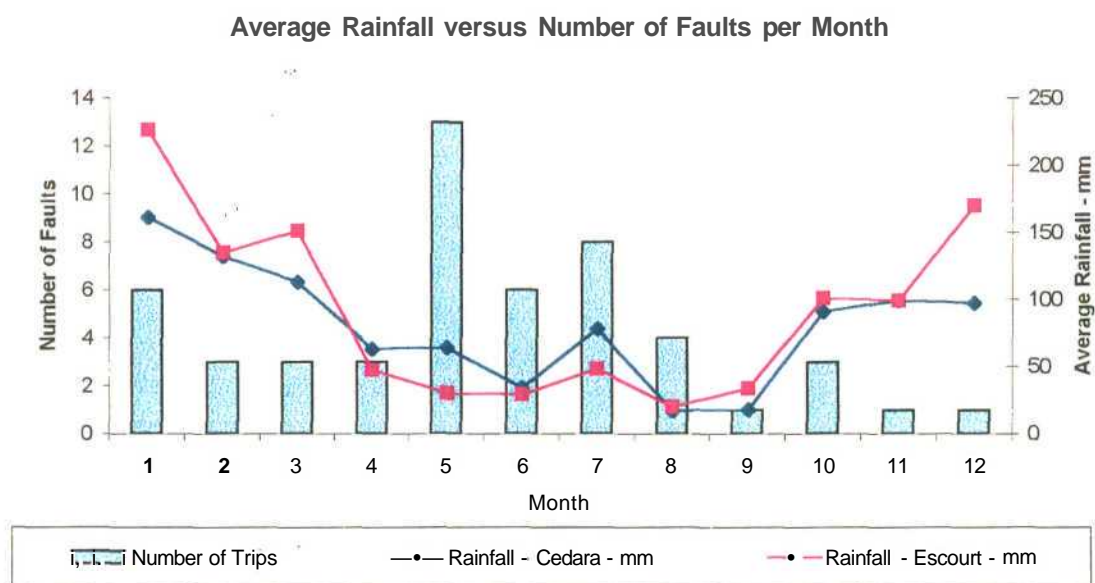
**Graph 4:** 1996-1998 faults per month versus average rainfall

The results presented in Graph 4 appear to indicate that most of the bird streamer faults occur during dry weather conditions (the winter months). For the purposes of this discussion, the dry months are defined as May, June, July and August and the wet months as the rest of the year. The results of this correlation are summarised in Table 8.

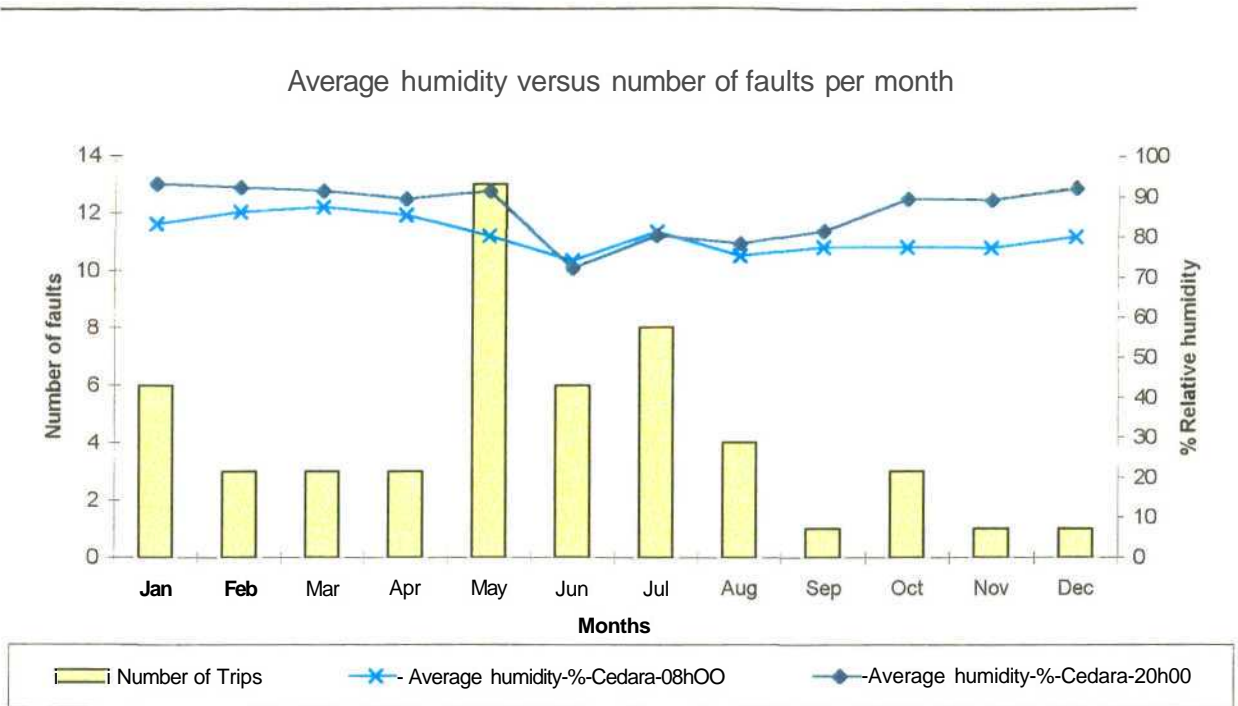
**Figure 14. Faults per month versus average humidity**

Figure 14 shows that natural wetting is likely to occur during most of the year, except June, July and August. During the months of April to September the average rainfall for Estcourt is less than 50 mm per month. These rainfall trends indicate that there will probably be an accumulation of pollution on the insulators and it is consequently expected that there may be pollution-related trips during this period. Figure 14 also indicates that during May and October there will probably be natural wetting of the insulators as the relative humidity is greater than 85%. It is interesting to note that both these months correspond with high trip incidence. This could explain why the unknown trips were historically associated with misty conditions and hence with the pollution mechanism.

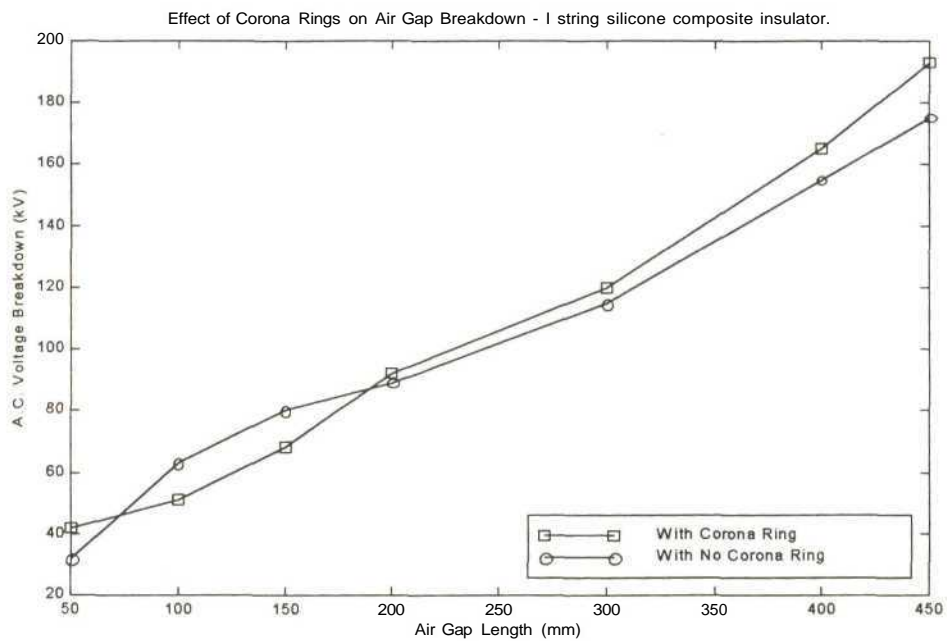
**Figure 21. AC breakdown trends versus corona ring application**

At small gap lengths (< 200 mm) the surface roughness effects of the corona rings appear to enhance the electric field as the breakdown strength is significantly less in this case than in the scenario where no corona ring was fitted. However, as the air gap spacing increases, space charge effects appear to negate the surface roughness effects of the corona rings in the breakdown process. The insulator fitted with corona rings has a greater voltage withstand (9%) than the insulator with no corona rings at 158 kV (or 275 kV service voltage).

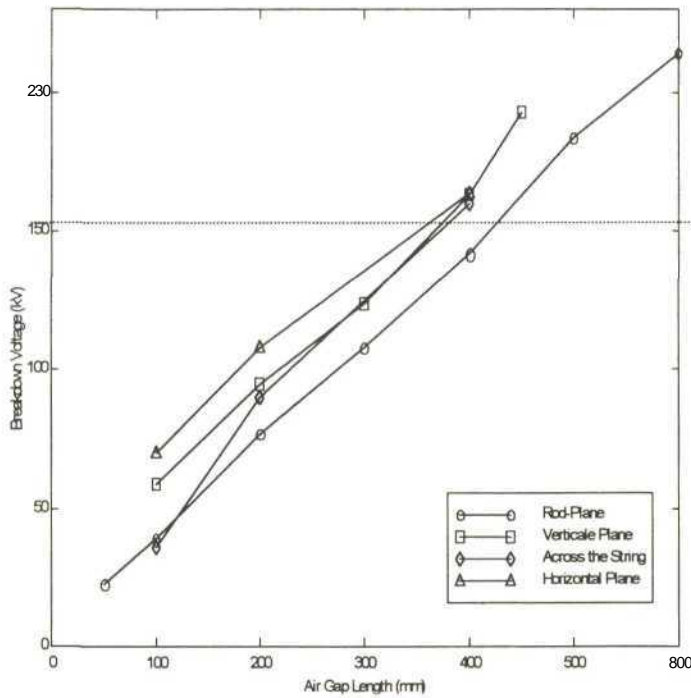
Figure 25. AC breakdown trends as a function of silicone composite insulation and electrode position - V string insulator configuration

At 158 kV rms (on both glass and silicone V string assemblies) the air gap breakdown length is essentially the same for all electrode positions. This observation is interesting as the breakdown voltage appears to be a function of the primary gap length and not of the creepage path of the insulators (under dry conditions).

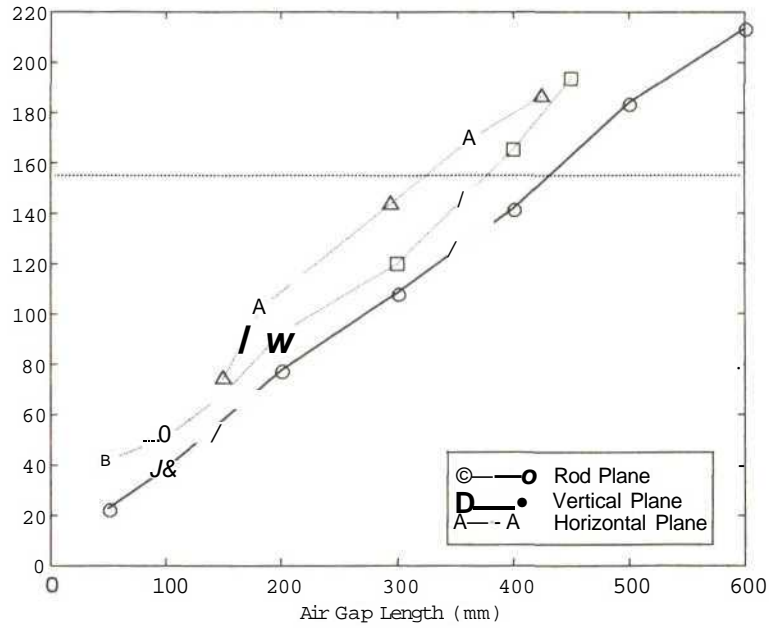
Figure 28. AC breakdown trends versus electrode position - silicone I string

The silicone composite I string configuration had very different characteristics for bird streamer intrusion with respect to the horizontal and the vertical planes, the latter showing a 15% greater voltage withstand. The glass I string does not show this trend. For the latter scenario the breakdown strengths tend to be independent of electrode position.

These results led to the conclusion that the voltage grading effect of the cap and pin glass insulators causes a more even distribution of electric field density in the air gap than that of the silicone composite insulators. The latter insulators would be expected to have a greater electric field concentration at the live hardware, but this would be expected to drop off more rapidly with distance than the field distribution obtained with the glass insulators.

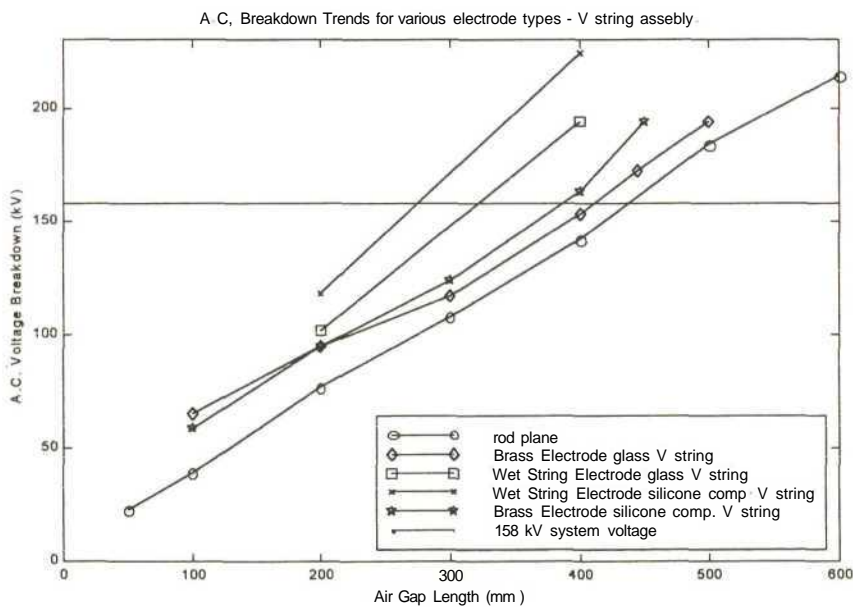
**Figure 30. V string AC voltage trend summary**

Intuitively it was expected that the electric field distortion under a liquid streamer intrusion in the air gap would be considerably less than in the case of a conducting brass rod. The results tend to support this reasoning; the wet string streamer yielded 24% and 18%

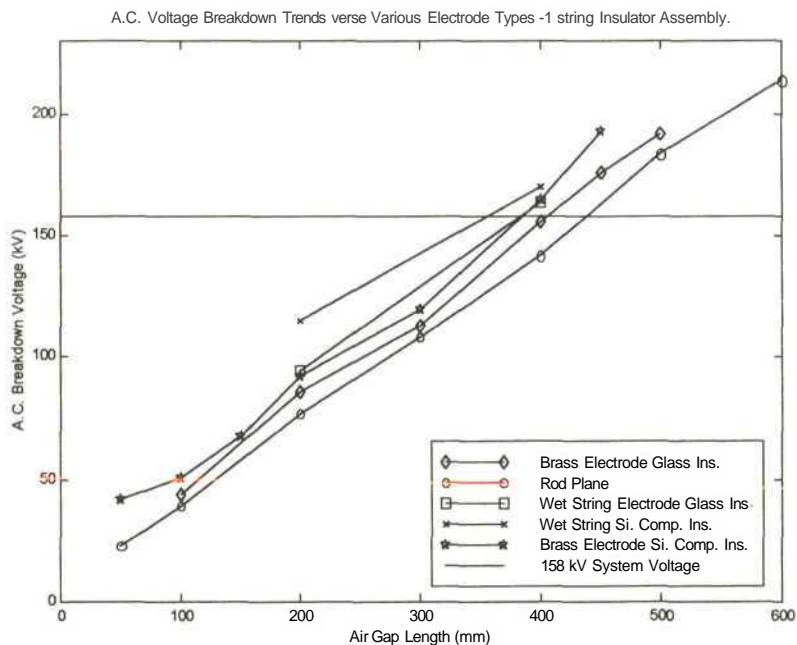
**Figure 31. Summary of I string AC voltage trends for various electrodes**

The I string simulations again yielded surprising results, in that the wetted string for the glass I string simulation yielded the same result as the brass rod of the silicone composite I string simulation. The results obtained are summarised below:

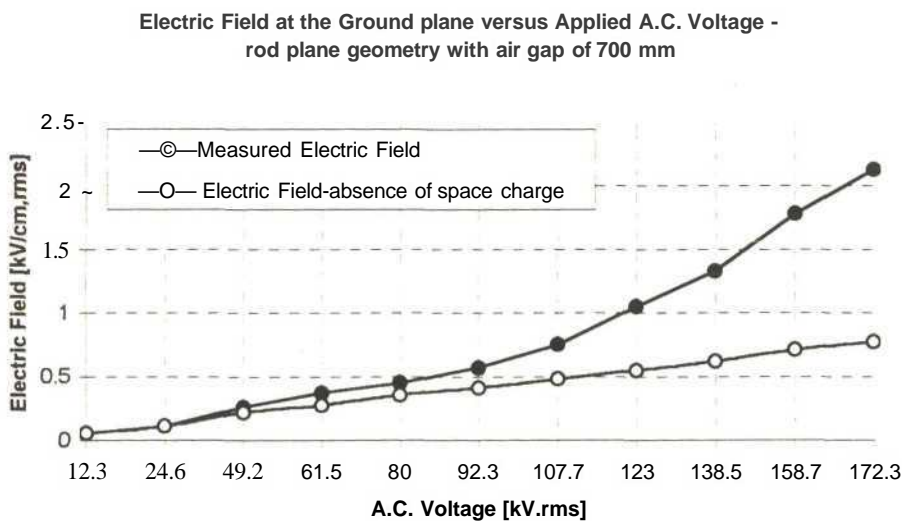
**Figure 36. Results of electric field measurements under bird streamer intrusion**

Figure 36 shows that at a 275 kV line voltage the electric field at the ground plane has a peak value of 2.5 kV/cm. This is significantly below the streamer propagation criteria of 4-5 kV/cm. If the gradient of the measured electric field in the absence of space charge is maintained, the second curve is derived. This curve has been titled "electric field - absence of space charge". The difference between this curve and the measured electric field at higher voltages indicates how the space charge in the air gap actually increases the electric field in the air gap at the ground plane at relatively large distances from the high-voltage electrode. For events of short duration, such as a falling bird streamer, it is postulated that

this lower curve may be a lower electric field limit and the measured electric field curve an upper limit. The most probable electric field enhancement caused by the falling bird streamer would be between these two limits.

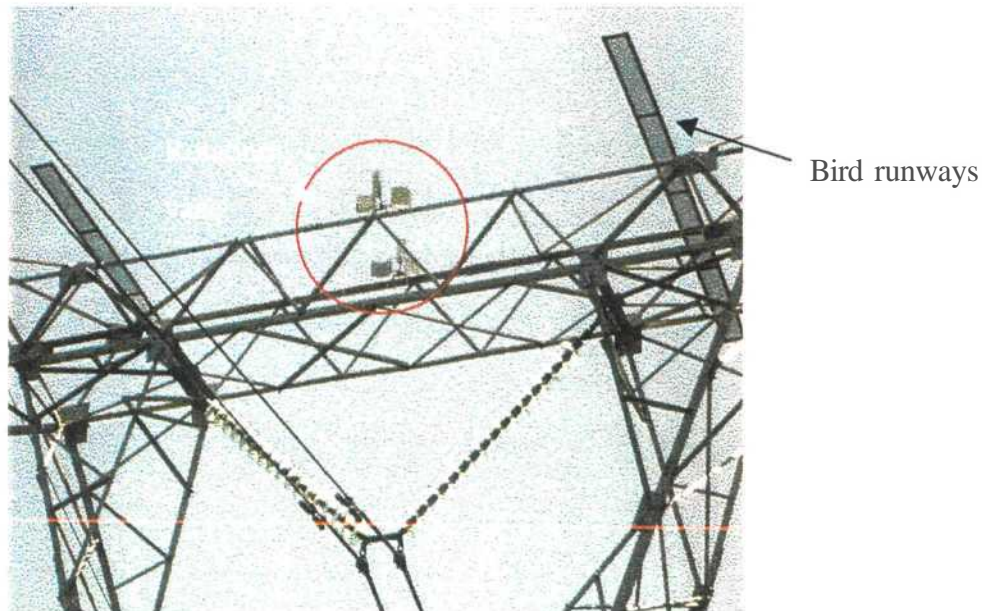
**Figure 39. Application of rotating vane bird guard with bird runways**

As illustrated in Figures 38 and 39, the bird guard application covers a relatively small area of the tower top. The intention of this design is not to eliminate bird activity on the transmission towers, nor to prevent the insulator assembly from being polluted. These diagrams also indicate possible areas where birds could still perch and could still cause a fault, eg the bottom of the tower boat, directly above the V string.

4. Bird runways: These devices are mechanically very strong. Birds were observed using them, but the birds also tended, after landing on the runway, to migrate towards the centre of the tower. It is suggested that these be used when there are recurring trips where WRBGs have been fitted. The bird runways are illustrated in Figure 39.

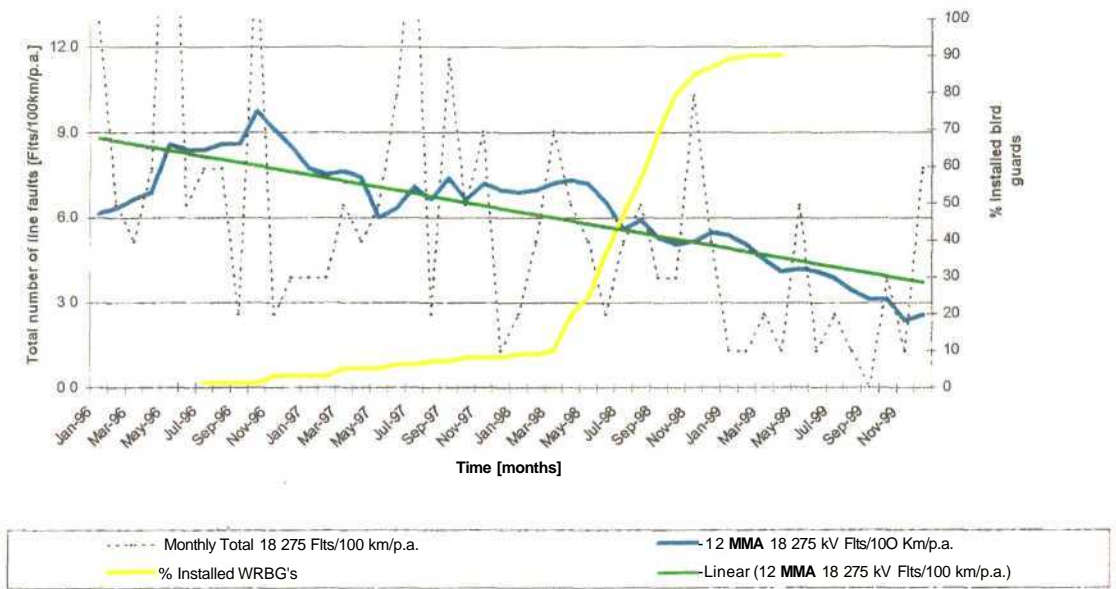
Figure 41. KwaZulu-Natal bird guard project results

Figure 41 shows the total number of faults experienced by the above transmission network of eighteen 275 kV transmission lines. The cumulative length of this network is 932 km. Since the application of bird guards, there has been a reduction in the total number of line faults experienced on this 275 kV network, from 9.8 faults/100 km/pa in October 1996 to 2.6 faults/100 km/pa in December 1999. This represents a 73.4% reduction in the total number of line faults experienced.

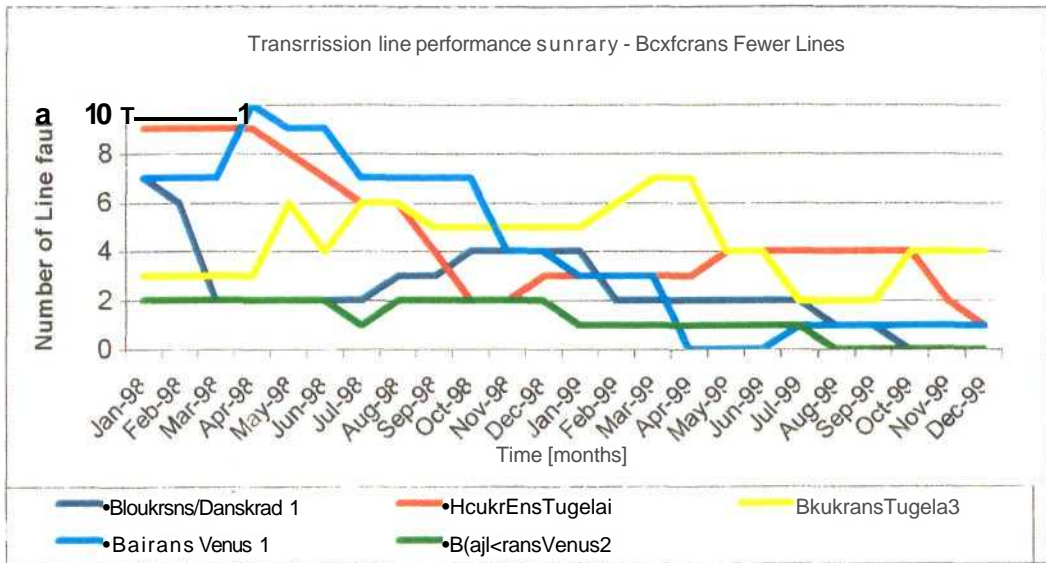
**Figure 42. Bird guard performance summary of the Bloukrans lines**

All of the 18 transmission lines except Georgedale-Venus 2 and Bloukrans-Danskraad 1 had welded rod bird guards installed on them during the period from May to November 1998. The other power lines had bird guards installed on them by January 1998. All the power lines at Bloukrans have experienced a reduction in the number of line faults.

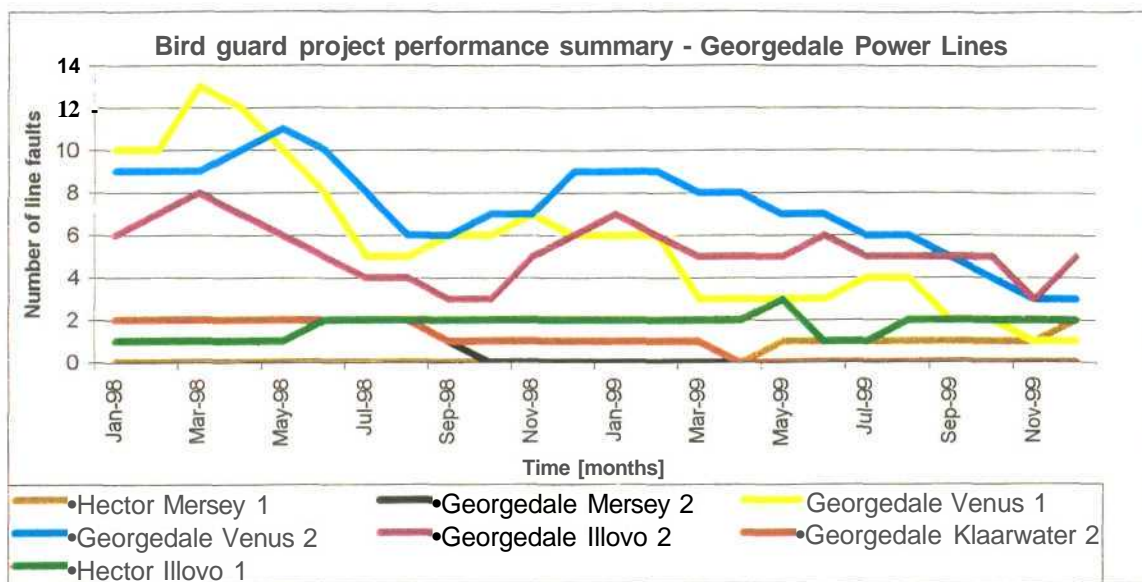
**Figure 43. Bird guard performance summary of the Geogedale lines, 1998-1999**

All these power lines, except Hector-Mersey 1, whose only line fault was caused by a cane fire, experienced a decrease in the number of line faults following the 1998 bird guard project. The most noticeable is the Geogedale-Venus 1 power line - from 13 line faults (March 1998) to only one line fault (December 1999).

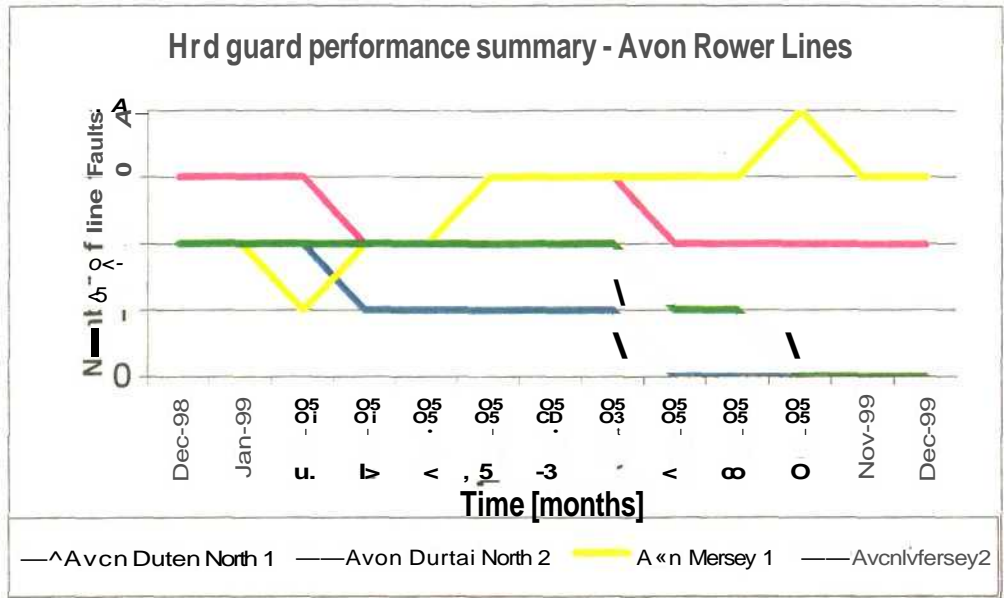
**Figure 44. Bird guard performance summary of the Avon lines, 1998-1999**

This network has relatively few line trips and most of the line faults are associated with cane fires. However, Figure 44 does show the success of the bird guard project on the Avon-Durban North 1 power line - the number of line faults was reduced from 4 to 0 faults per annum.

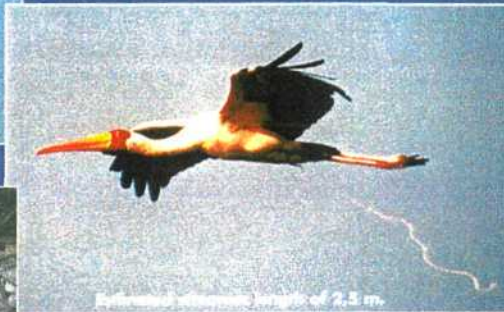
Bird streamers is a continuous conductive excrement.

Experiments at the CSIR have confirmed that if a bird streamer bridges power line air gap clearances, fkuhoversda result.
